**CRASH TESTING AND EVALUATION OF THE
NETC 2-BAR CURB-MOUNTED BRIDGE RAIL**

NETCR-10

Prepared by:
Texas Transportation Institute
The Texas A & M University System
College Station, Texas

**VOLUME IX: APPENDIX H -
CRASH TESTING AND EVALUATION OF THE
NETC PL-2 BRIDGE RAIL DESIGN**

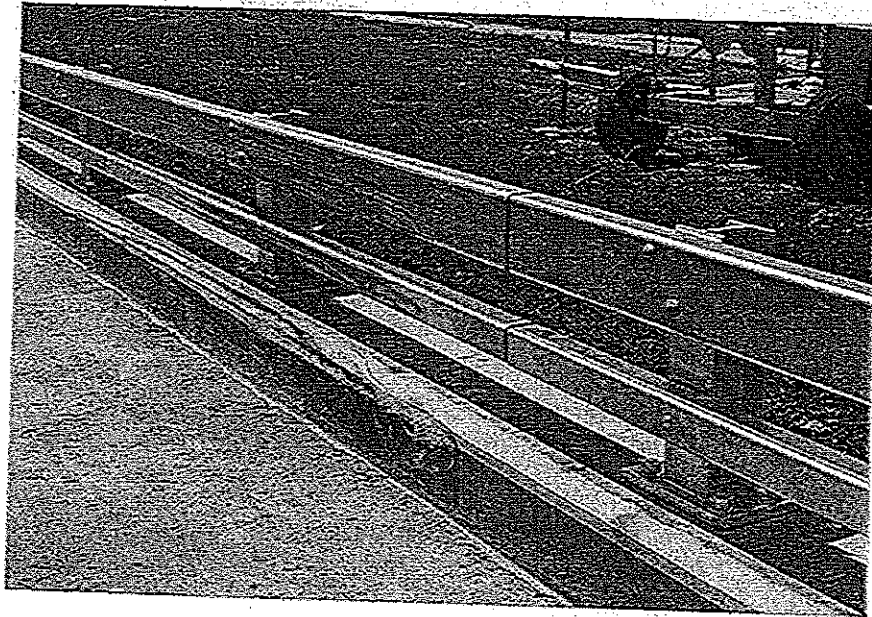
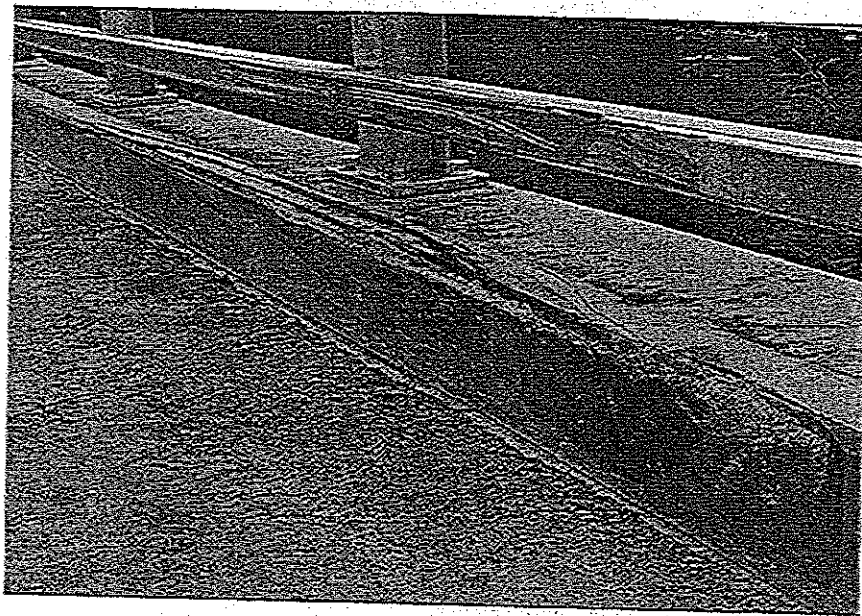
Figure 10. NETC bridge rail after test 471470-18.

As can be seen in figure 10, the bridge railing received minimal damage. The bridge railing and curb received only minor cosmetic damage. The vehicle was in contact with the

bridge railing for a total length of 4.0 m (13.2 ft). Shown in figure 11 are photographs of the post-test vehicle trajectory.

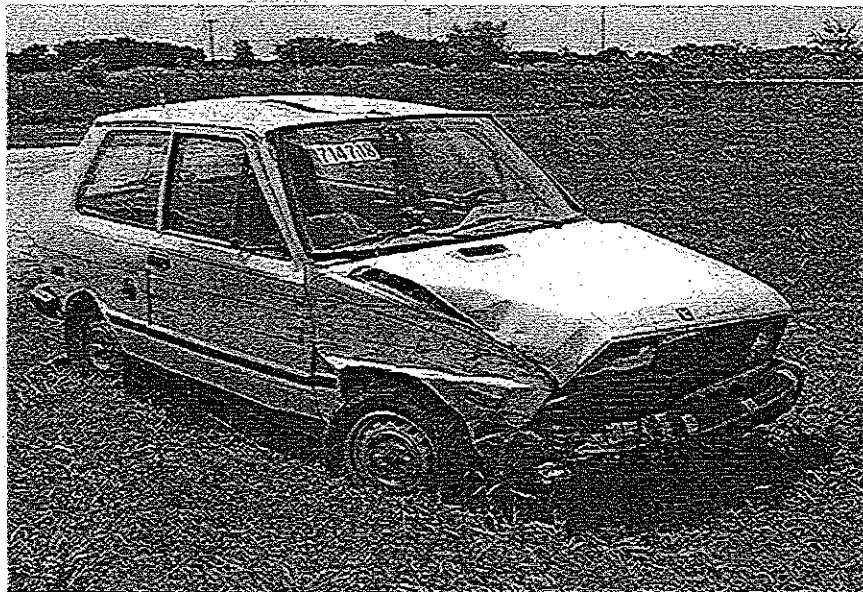
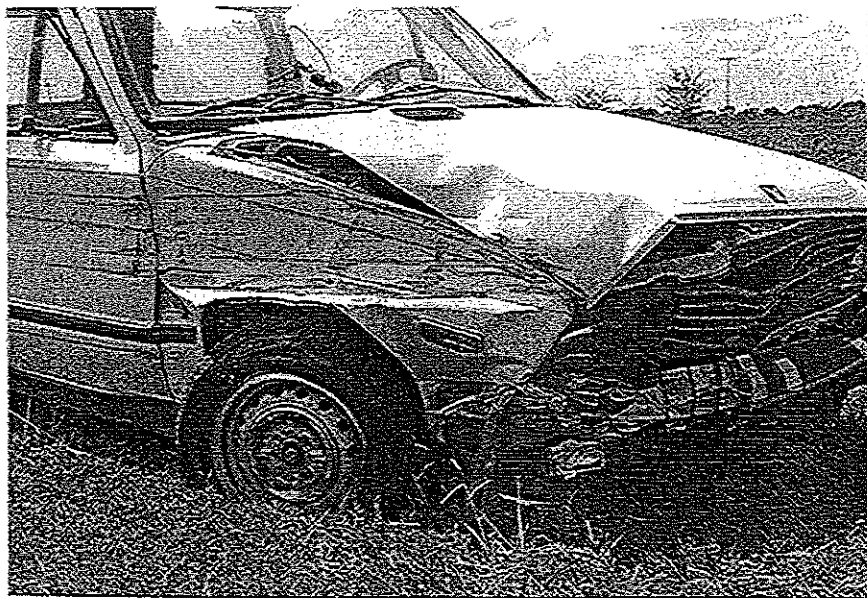
Figure 12. Vehicle after test 471470-18.

The vehicle sustained damage to the right side as shown in figure 12. Maximum crush at the right front corner at bumper height was 124 mm (4.9 in) and there was 20 mm (0.8 in) of crush at the right A-pillar. The wheelbase on the right side was shortened by 108 mm (4.3 in). The right front strut and sway bar were damaged. Also, damage was done to the front bumper, hood, grill, right front fender, right front rim, right door, right rear quarter panel, and right rear rim.

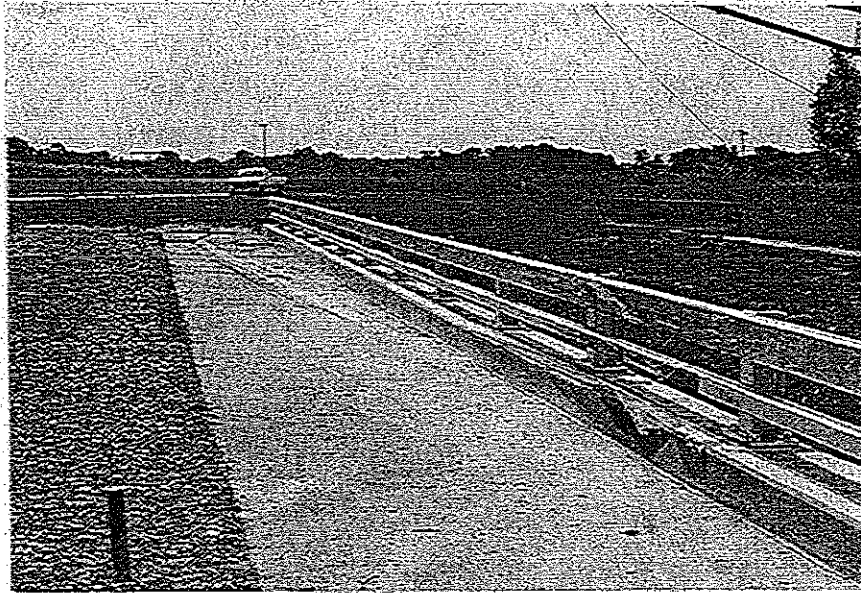
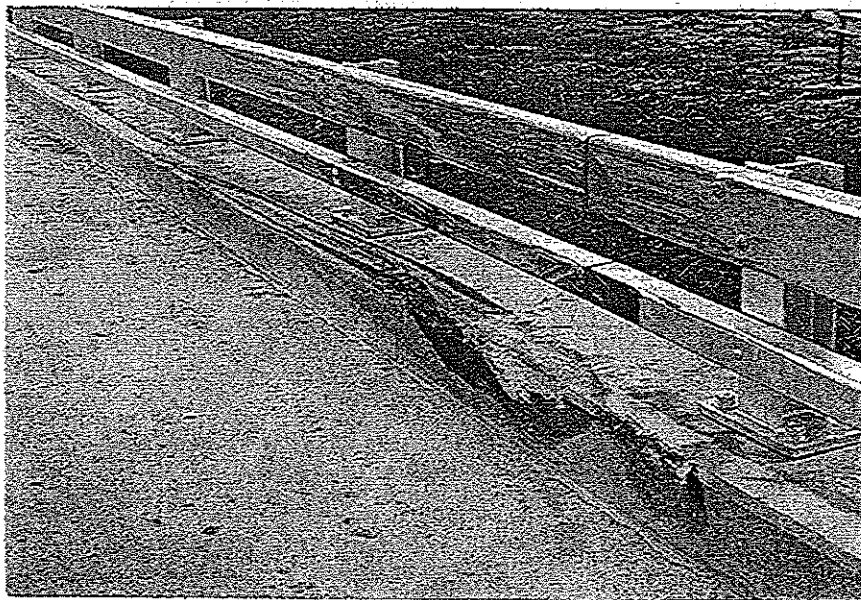
Figure 23. NETC bridge rail installation after test 471470-19.

As can be seen in figure 23, the bridge railing received only cosmetic damage. However, the curb section and bridge deck sustained structural damage at the two posts immediately upstream and downstream of the point of impact (posts 3 and 4). It appears from the damage patterns that the curb section and bridge deck failed under the combination of bending and shear forces (principally shear), as evidenced by the 45-degree cracks starting at the anchor bolts. This suggested that there might not be sufficient concrete cover and steel reinforcement around the anchorage bolts to resist the forces acting on the post and anchorage assembly during impact. Photographs showing the shear cracks are shown in figures 24 and 25. The vehicle was in contact with the bridge railing for a total length of 6.1 m (19.9 ft).

As discussed previously, the curb section and bridge deck sustained structural damage at the two posts immediately upstream and downstream of the point of impact in the pickup truck redirection test (test no. 471470-19). This resulted in some revisions to the design details for the bridge deck, curb section, and the steel reinforcement. The revisions included: increasing the thickness of the bridge deck; widening the width of the curb and deck to increase the cover on the anchor bolts; additional stirrups and distribution bar at the post anchors; and increasing the thickness of the spacer plate and the length of the anchor bolts. The redesigned bridge deck and curb section was constructed and evaluated in this crash test.

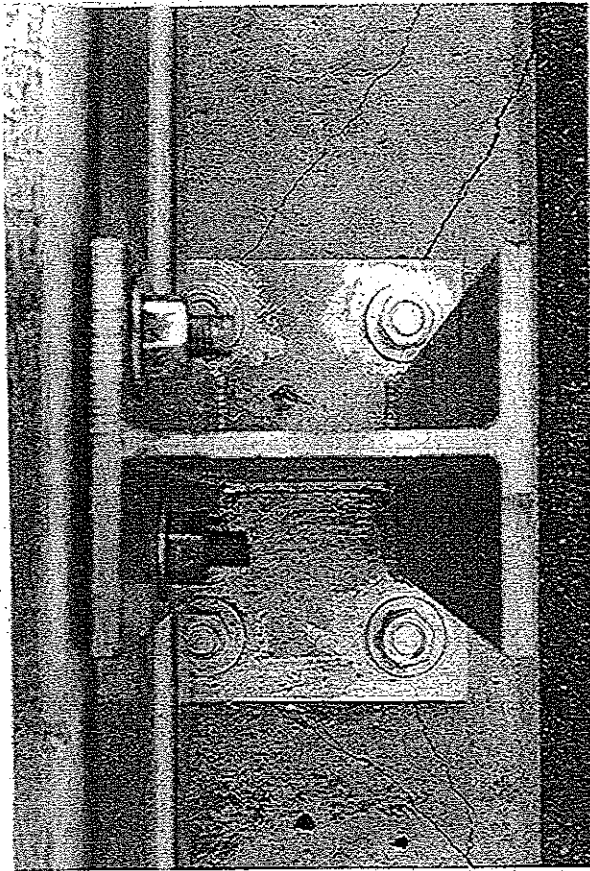
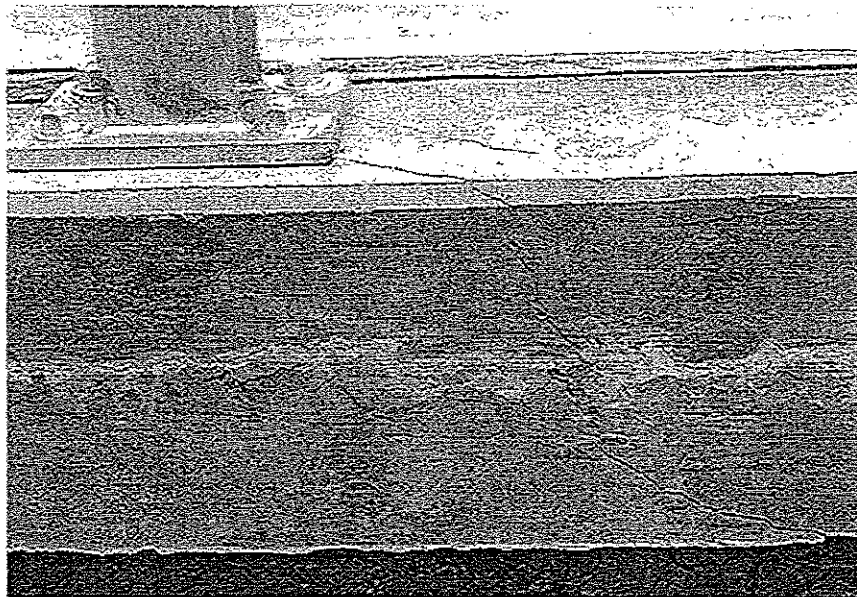
Figure 24. Cracks at post 4, test 471470-19.

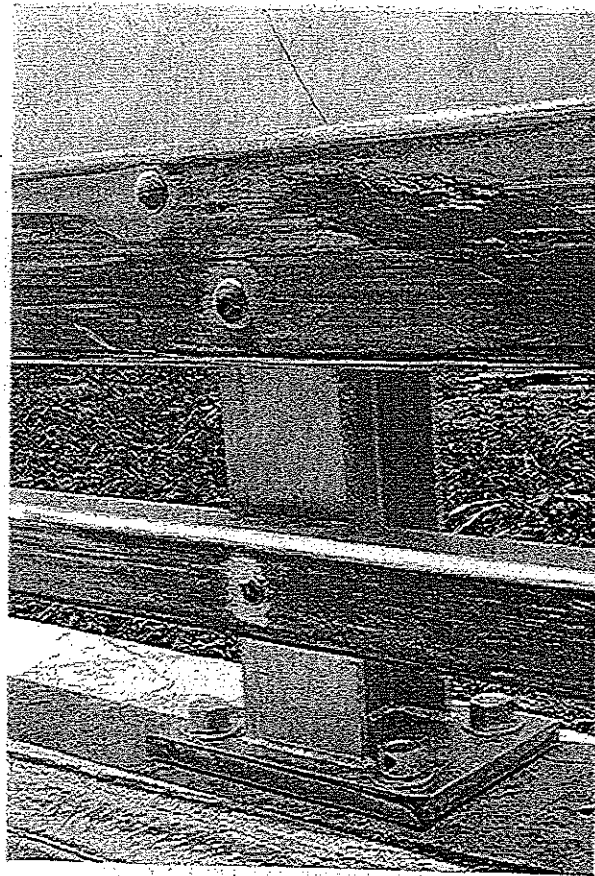
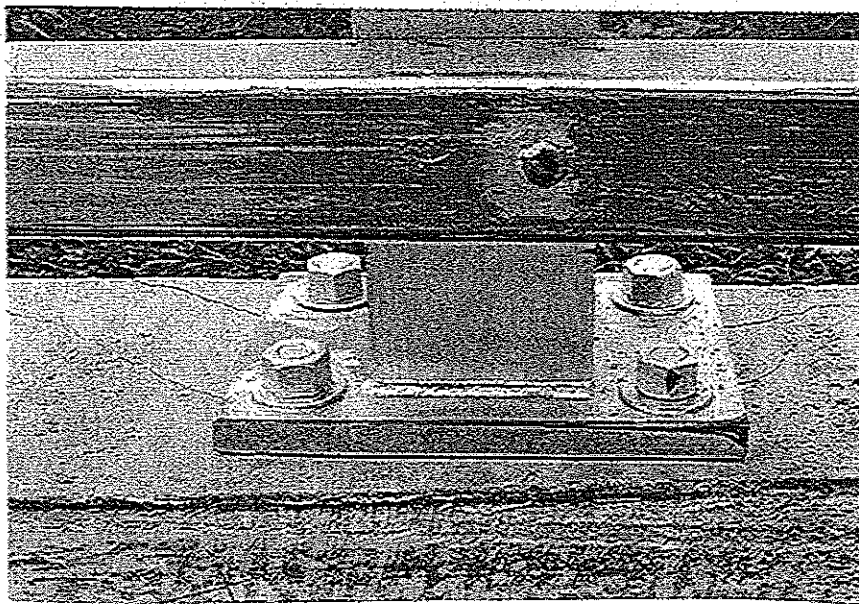
Figure 25. Damage to bridge rail at post 4, test 471470-19.

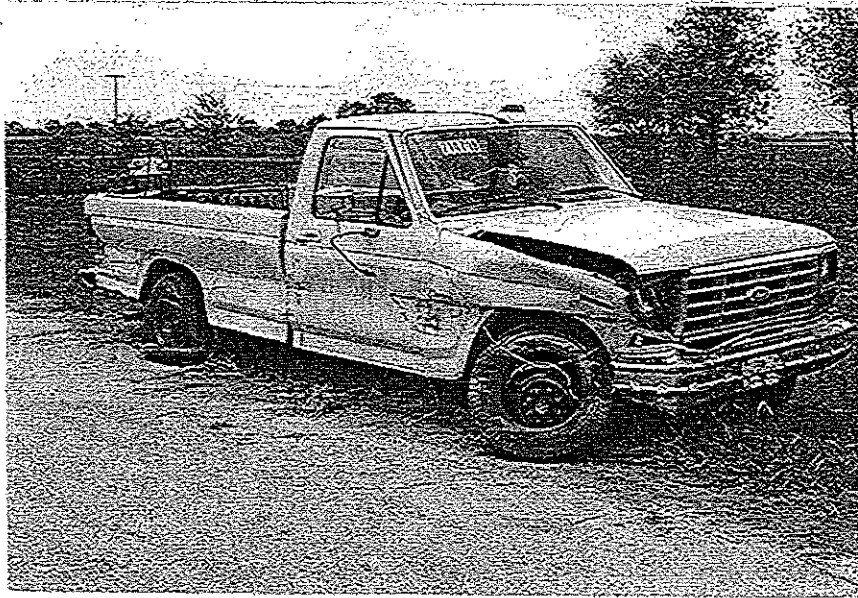
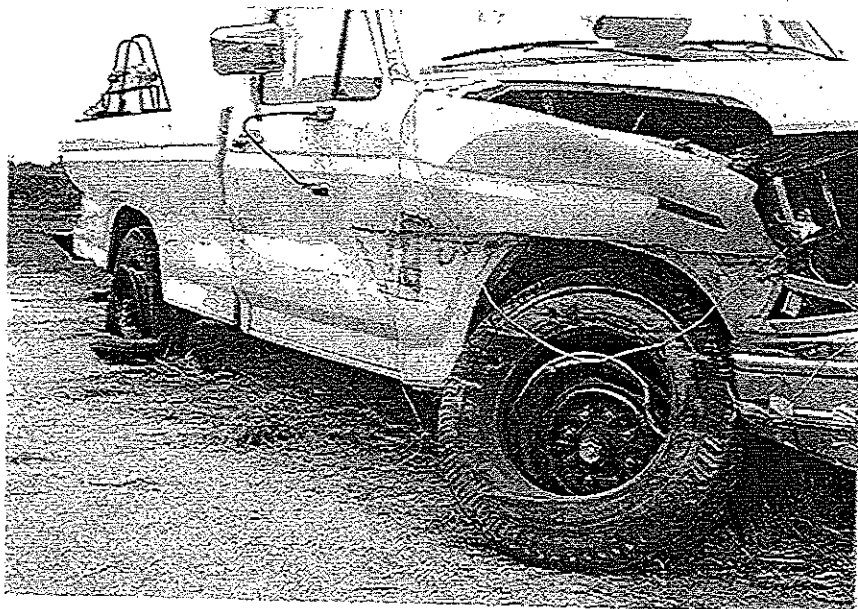
Figure 26. Vehicle after test for test 471470-19.

The vehicle sustained damage to the right side, as shown in figure 26. Maximum crush at the right front corner at bumper height was 254 mm (10.0 in) and there was 25 mm (1.0 in) of crush at the right A-pillar. The wheelbase on the right side was shortened by 32 mm (1.75 in). The tie rod and right radius arm were damaged. Also, damage was done to the front bumper, hood, grill, right front fender, right front rim, right door, right rear bumper, and right rear tire and rim.

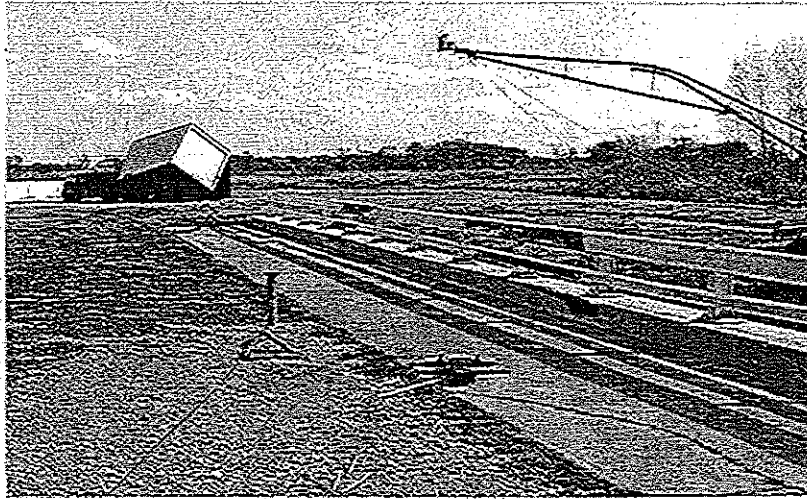
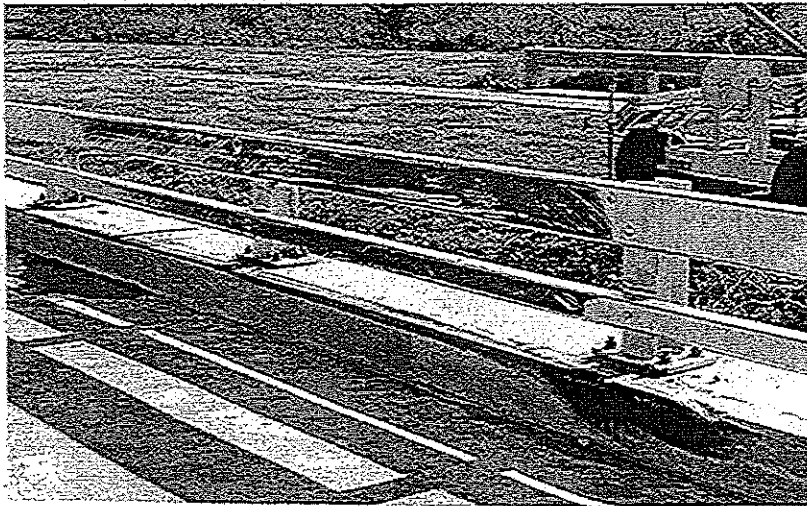
Figure 37. NETC bridge railing after test 471470-29.

As seen in figures 37 through 39, the bridge rail and deck test installation received moderate damage. There were tire marks and gouges on the face of the rail and curb. The length of contact with the curb was 5.5 m (18.0 ft), and length of the initial contact with the rail element was 4.3 m (14.0 ft). The box of the truck was in contact with the upper part of the rail from post 8 to the end of the test installation with tire marks on the face of the rail between posts 8 and 10. The bolts on the lower rail at posts 3, 4, and 5 were sheared off.

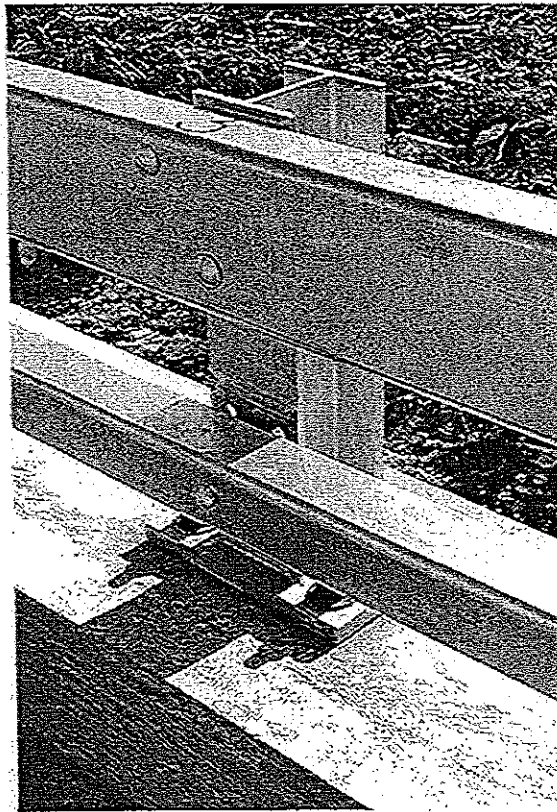
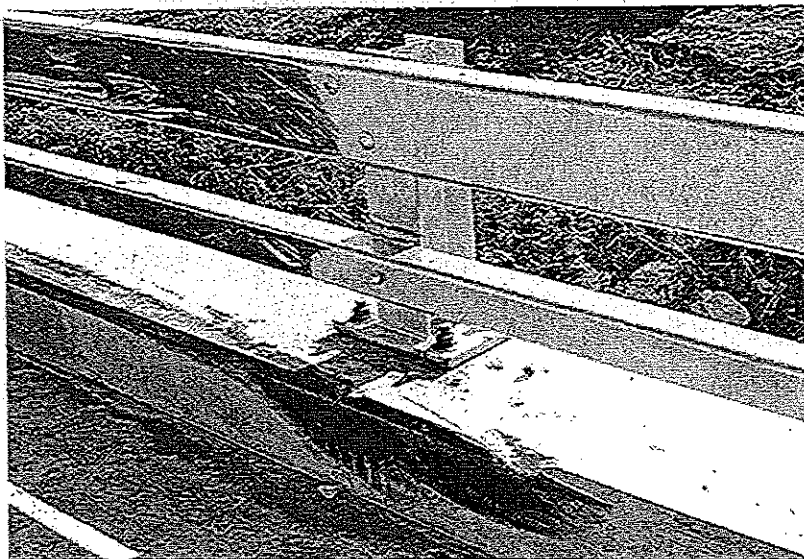
Figure 38. Damage at posts 3 and 4 after test 471470-29.

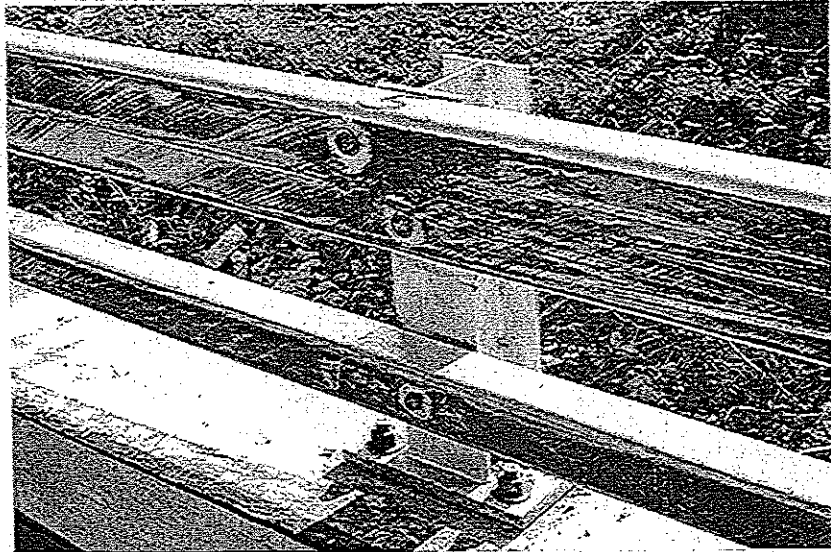
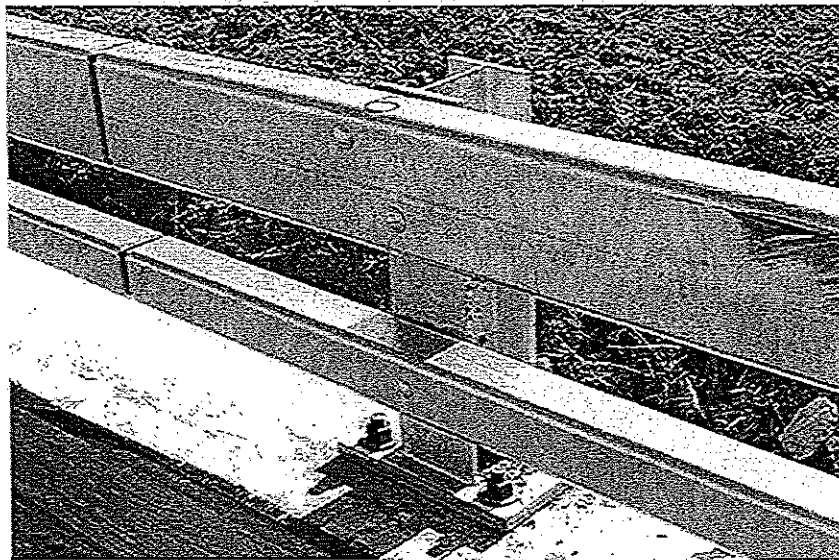
Figure 39. Damage at posts 5 and 6 after test 471470-29.

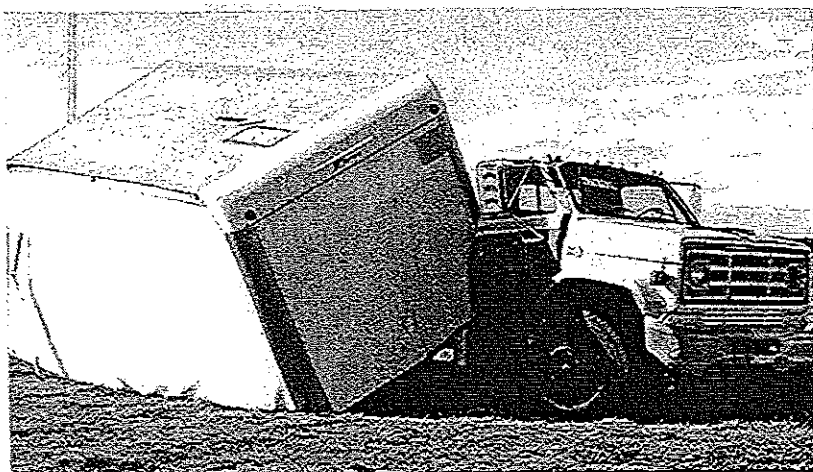
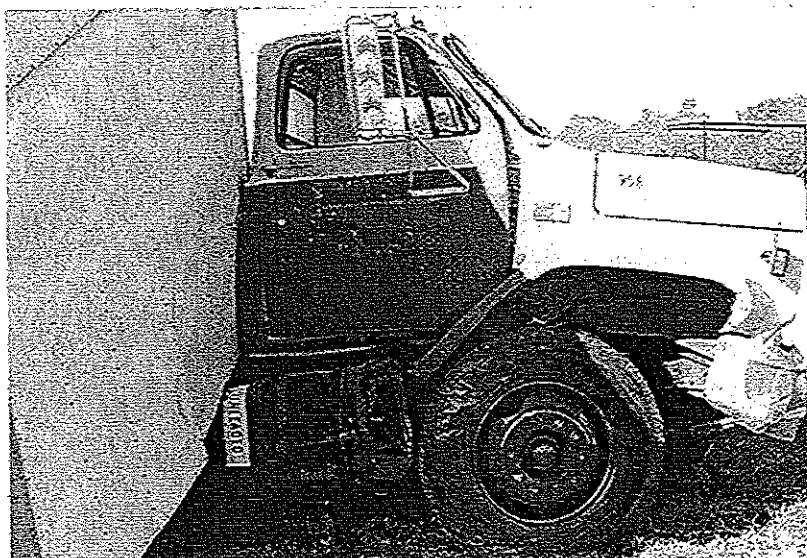
Figure 40. Vehicle after test 471470-29.

The vehicle sustained minimal damage, as shown in figures 40 and 41. Maximum exterior crush at the right front corner of the vehicle was 120 mm (4.7 in) and there was no deformation or intrusion into the occupant compartment. The right-side spring U-bolts were damaged and the right front tire and wheel were pushed rearward into the fuel tank. The box was partially separated from the frame and shifted to the right. The bumper, hood, right front quarter panel, and right door were also damaged.

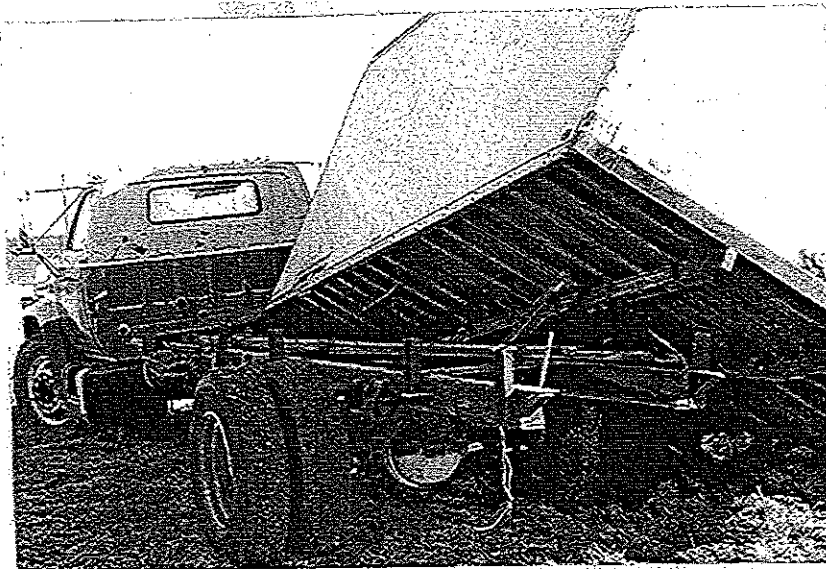
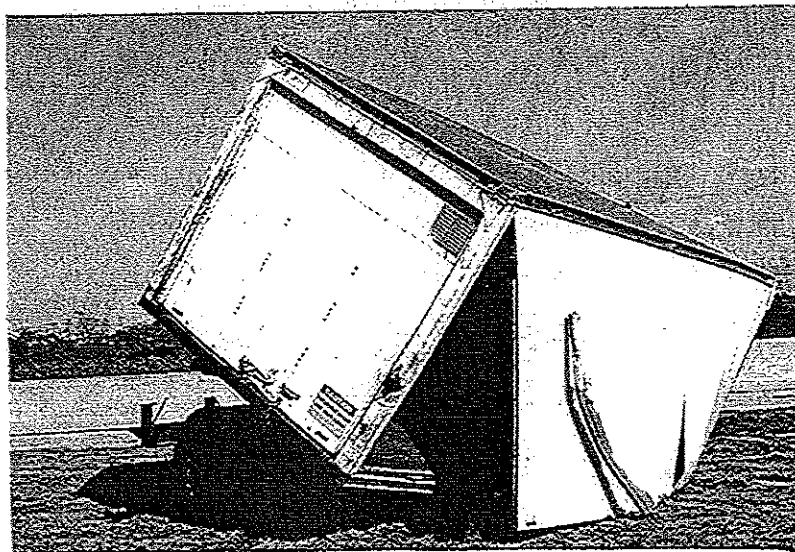
Figure 41. Damage to van-box after test 471470-29.
