GUARDRAIL TESTING – MODIFIED ECCENTRIC
LOADER TERMINAL (MELT) AT NCHRP 350 TL-2

Prepared for
The New England Transportation Consortium

July 2002

NETCR 35

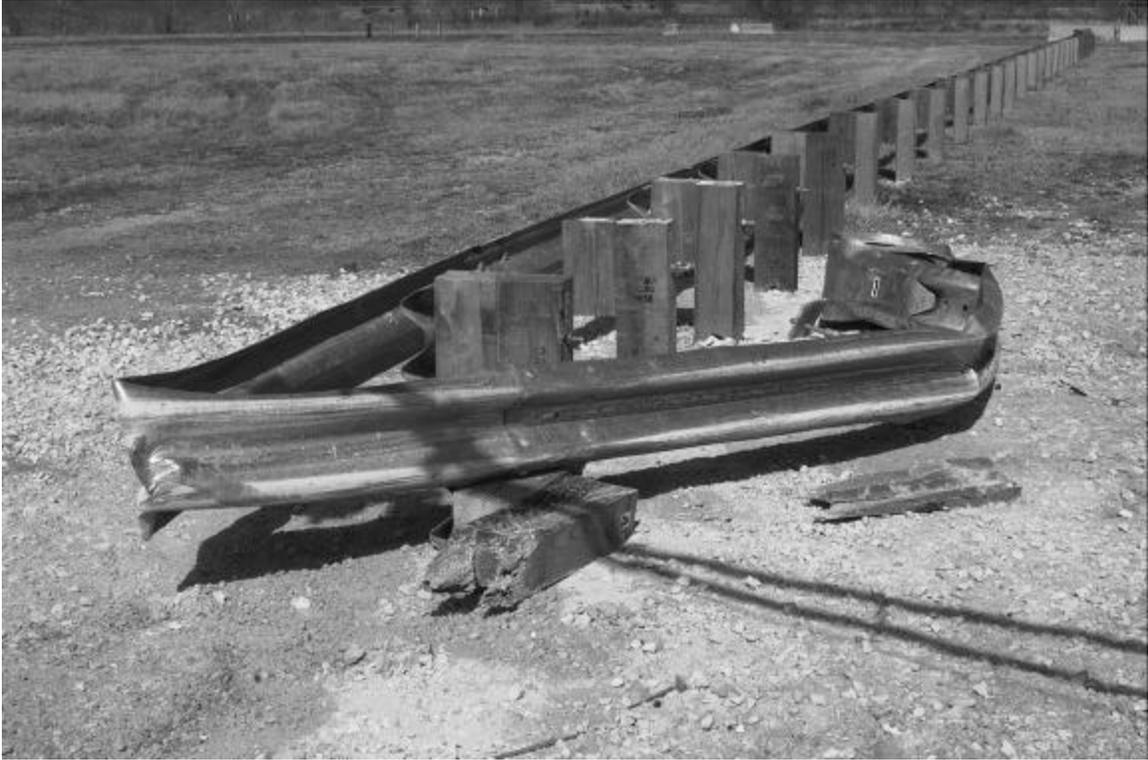
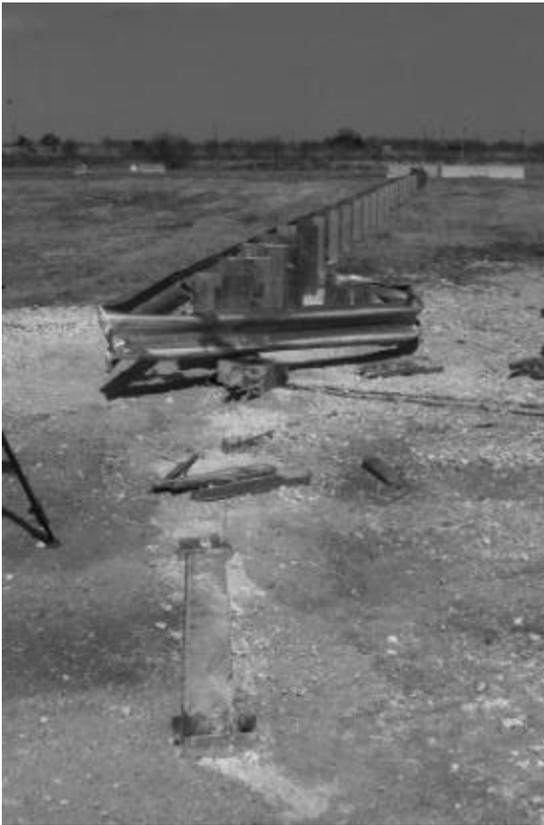
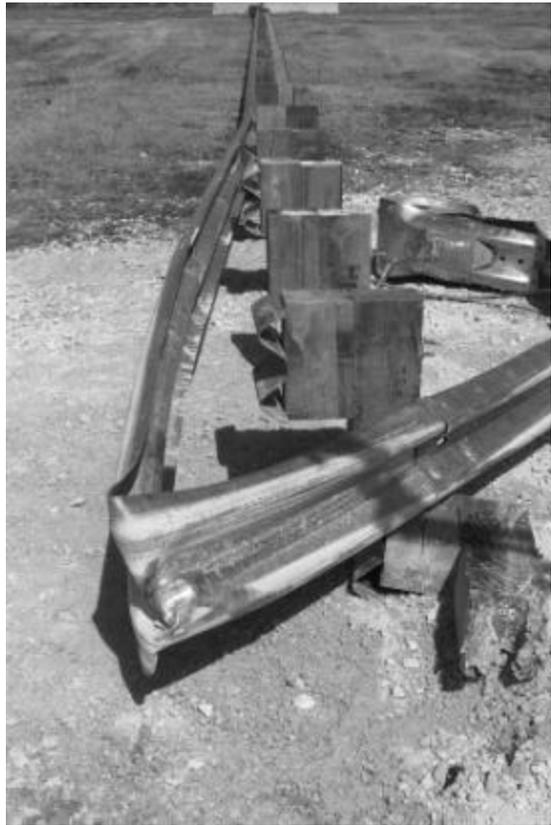
Figure 8. Installation after test 400401-1.

Posts 1 through 4 fractured at ground level as shown in figures 7 and 8. Most of the pieces followed along the vehicle path or were thrown behind the terminal. One piece came to rest 3.05 m forward of the face of the rail between posts 14 and 15. The ground strut on the upstream end moved 10 mm and no movement was noted on the downstream terminal. Three elbows formed in the terminal: one 490 mm from the beginning of the rail element, a second 2040 mm from the beginning of the rail element, and a third 1310 mm from the center of the first splice. Maximum deflection of the rail element toward traffic lanes was 1.78 m and maximum deformation occurred over a distance of 3.25 m. Working width was 5.08 m.

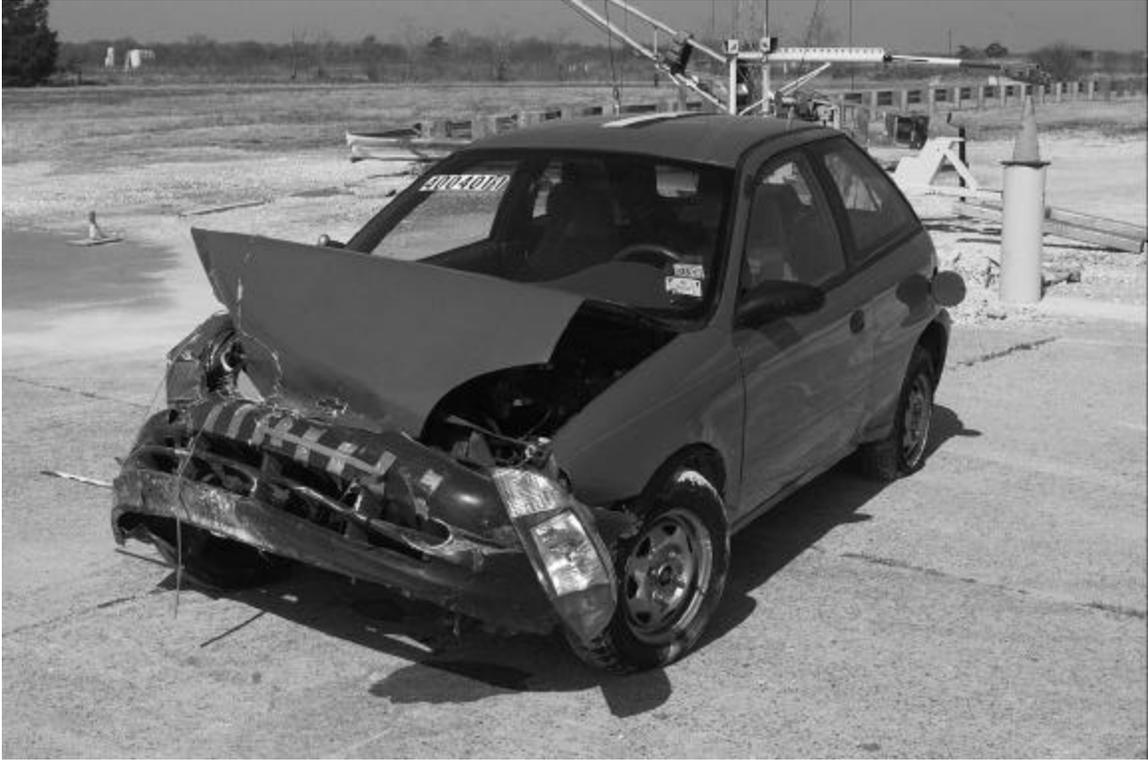
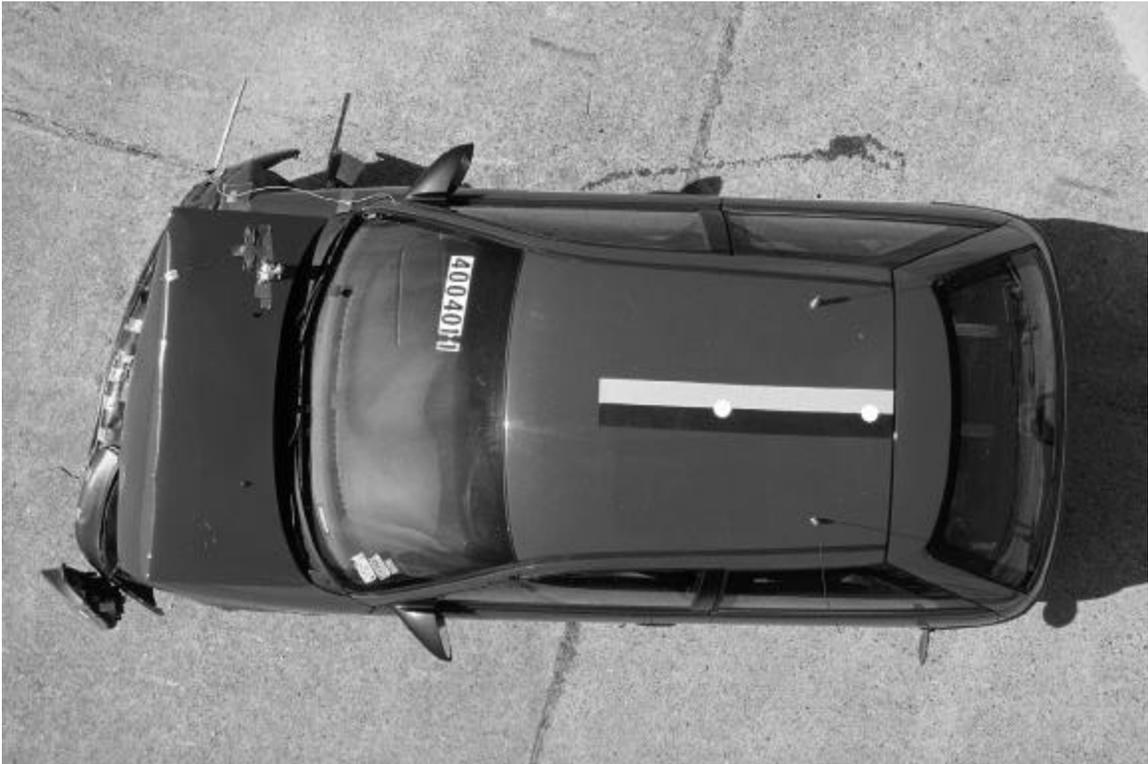
Figure 9. Vehicle after test 400401-1.

The vehicle sustained damage to the front as shown in figure 9. Structural damage was imparted to the right front strut, right front mount, and right front axle, and the firewall and floor pan were deformed. Also damaged were the front bumper, hood, fan, radiator, radiator support, right and left front quarter panels, left front tire and wheel rim, and the left rear tire. The right door was jammed and the windshield sustained stress cracking. Maximum exterior crush to the vehicle was 400 mm at the right front quarter point near bumper height. Maximum occupant compartment deformation was 37 mm just to the right of the center firewall area. Photographs of the interior of the vehicle are shown in figure 10. Exterior vehicle crush and occupant compartment measurements are shown in appendix B, tables 3 and 4.

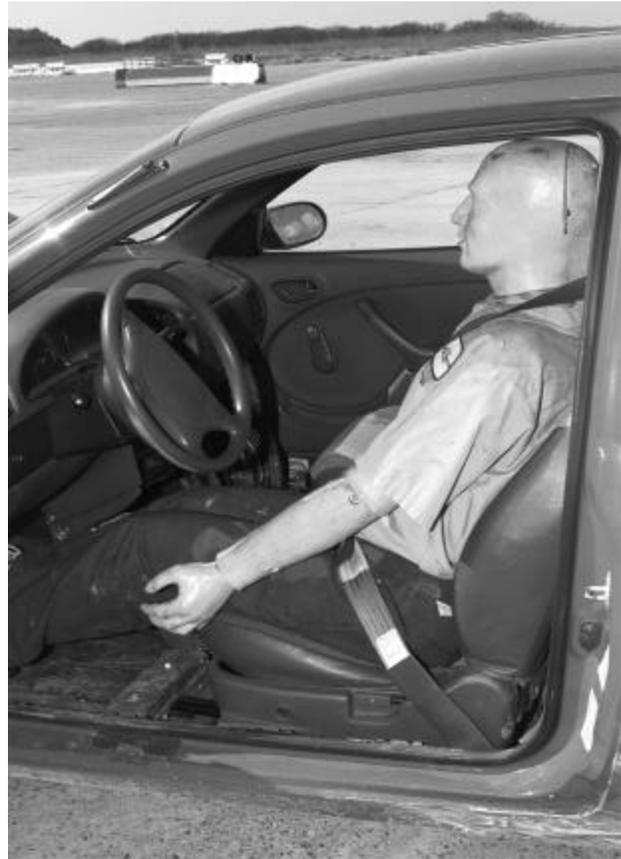
Figure 10. Interior of vehicle for test 400401-1.

Results: Posts 1 through 4 fractured at ground level but did not penetrate nor show potential for penetrating the occupant compartment. Most of the pieces of the fractured posts followed along with the vehicle or were thrown behind the installation. Maximum occupant compartment deformation was 37 mm in the center front firewall area.

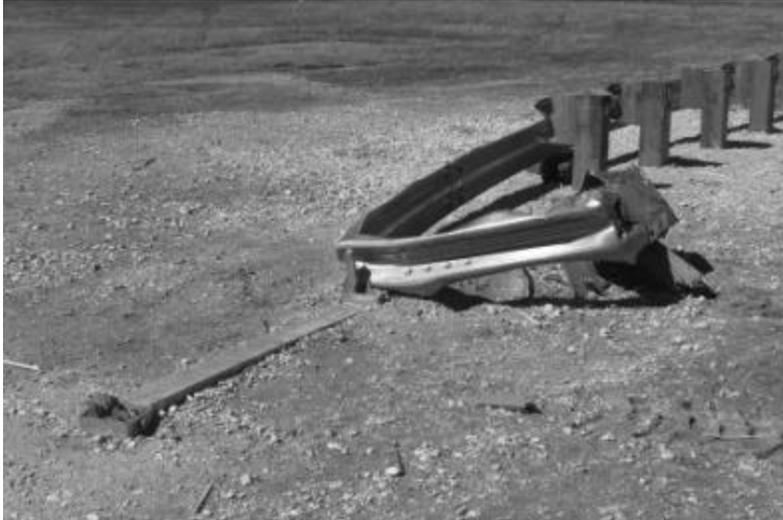
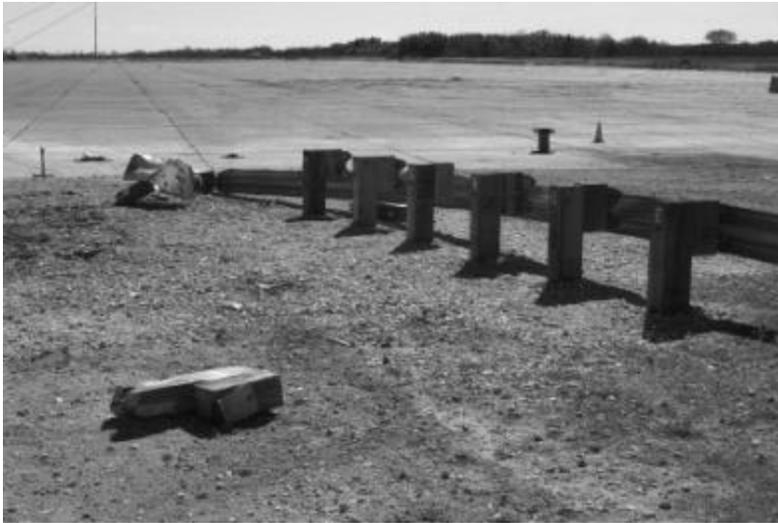
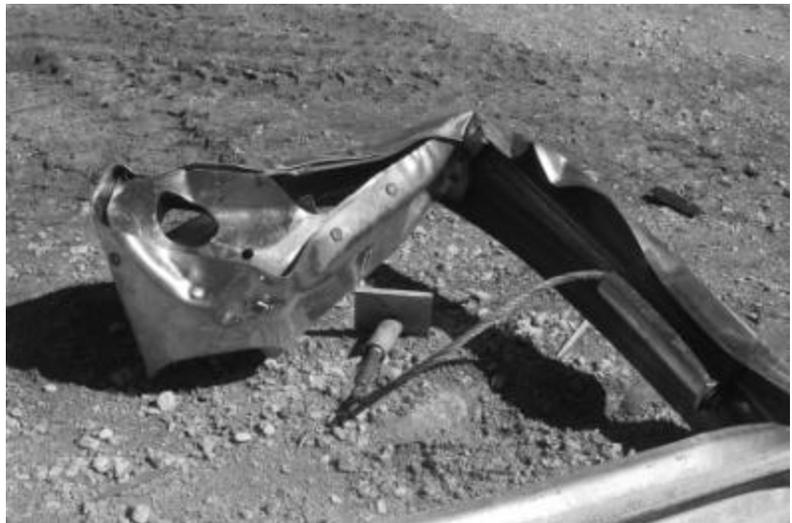
Figure 15. Installation after test 400401-2.

Posts 1 through 3 fractured at ground level, as shown in figures 14 through 15. Post 1 remained in the buffer head of the terminal and all other debris traveled along the vehicle path. Two elbows formed in the rail element: one 380 mm from the beginning of the rail element and the second 1730 mm from the beginning. The upstream ground strut moved 17 mm and no movement was noted in the downstream terminal. Posts 14 through 20 were rotated from the secondary impact.

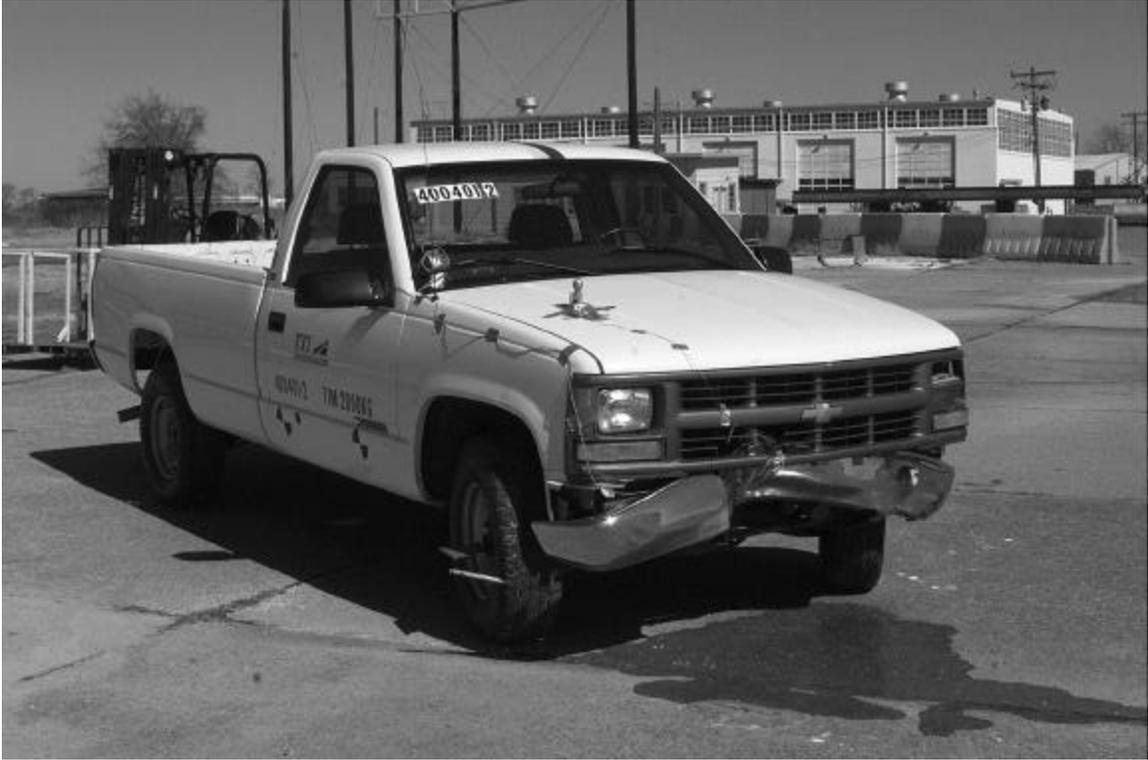
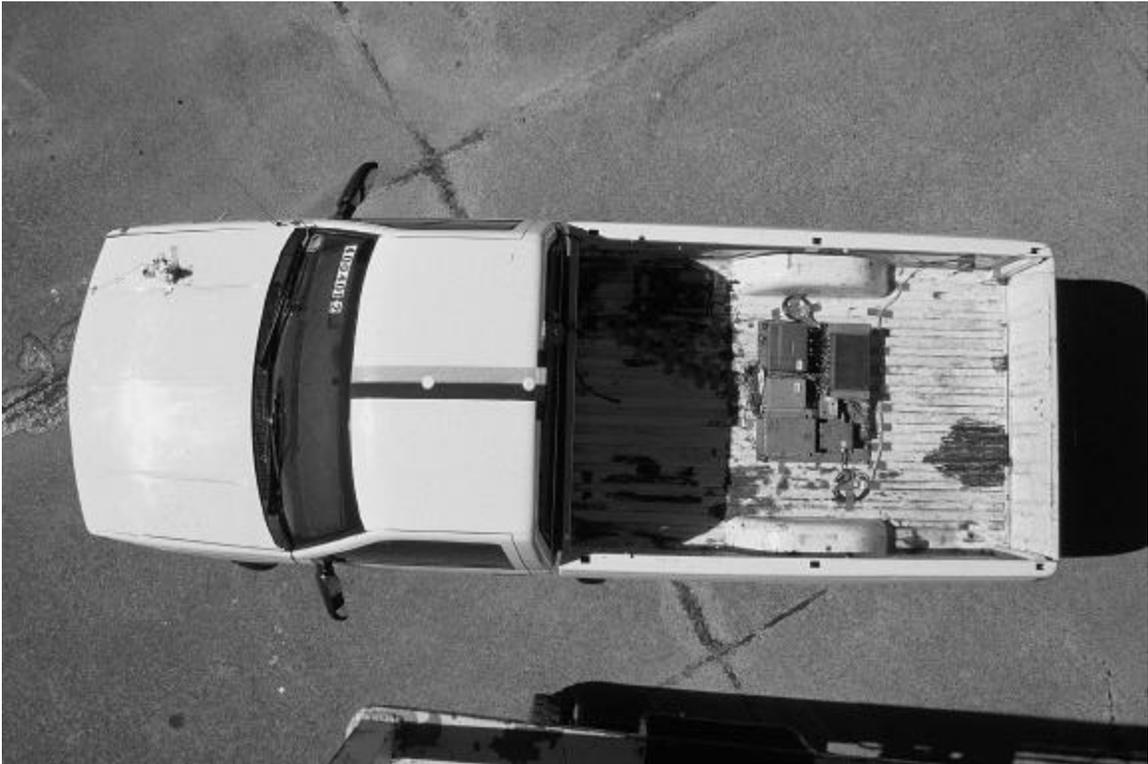
Figure 16. Vehicle after test 400401-2.

Damage to the vehicle was restricted to the front of the vehicle, as shown in figure 16. The stabilizer bar and the left and right front of the frame were deformed. Also damaged were the front bumper, fan, and radiator. Maximum exterior crush to the vehicle was 340 mm at the center front at bumper height. No deformation of the occupant compartment occurred. Photographs of the interior of the vehicle are shown in figure 17. Exterior vehicle crush and occupant compartment measurements are shown in appendix B, tables 5 and 6.

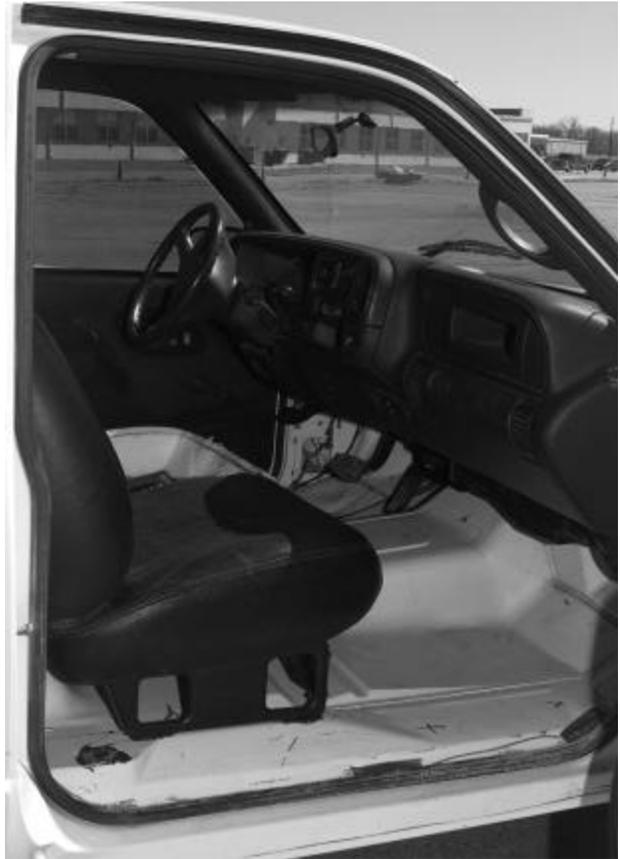
Figure 17. Interior of vehicle for test 400401-2.

Results: Posts 1 through 3 fractured at ground level but did not penetrate nor show potential for penetrating the occupant compartment. All of the pieces of the fractured posts followed along with the vehicle. No deformation of the occupant compartment occurred.
