New England Transportation Consortium (NETC) NETC 20-3

Investigating Thermal Imaging Technologies and Unmanned Aerial Vehicles to Improve Bridge Inspections

Task 2 Interim Report

Field Demonstration and Data Analysis

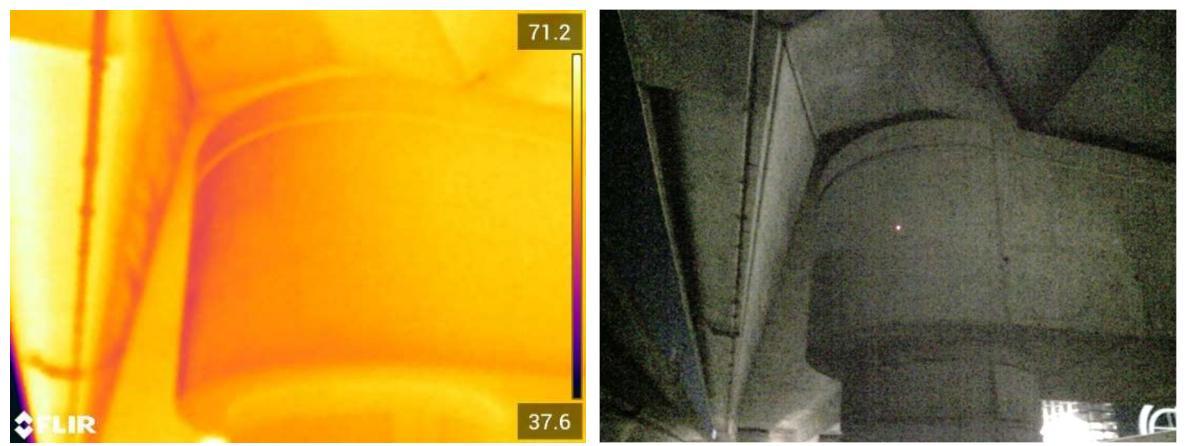
Figure 39 - Temperature Differential at Edge of Pier Cap caused by Angle of Data Capture

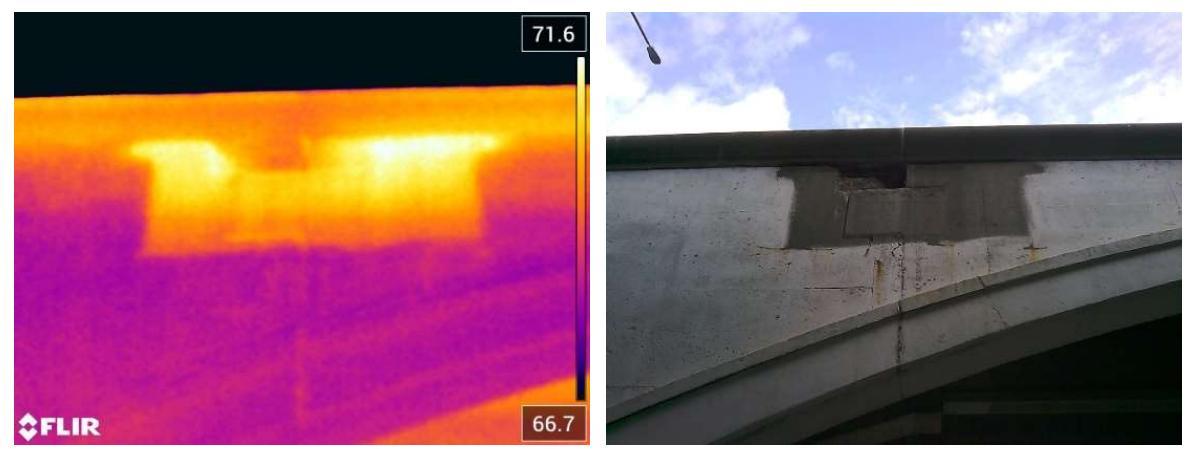
Figure 40 - Temperature Differential where Paint is Missing

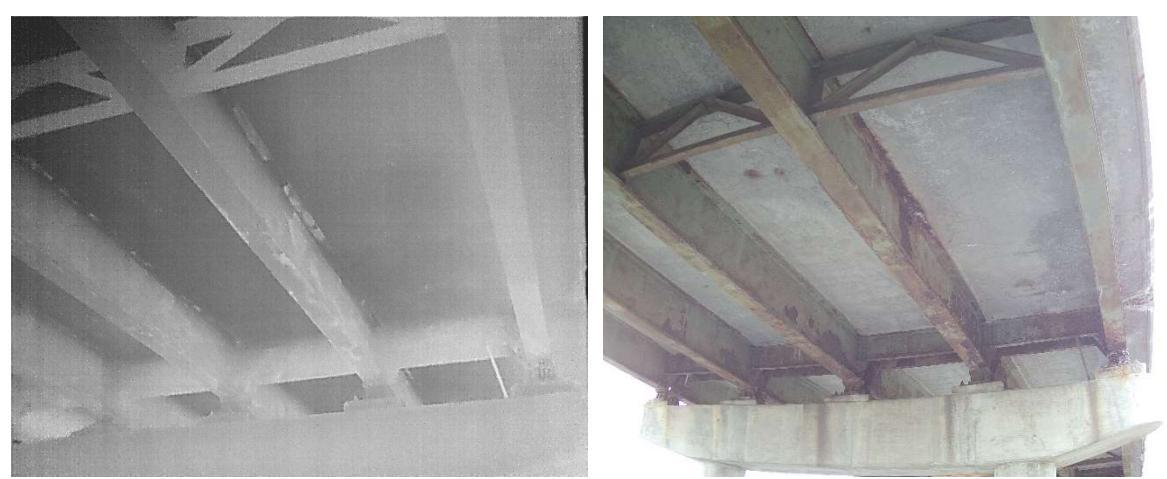
Figure 41 - Temperature Differential caused by Paint Failure along Top Flange

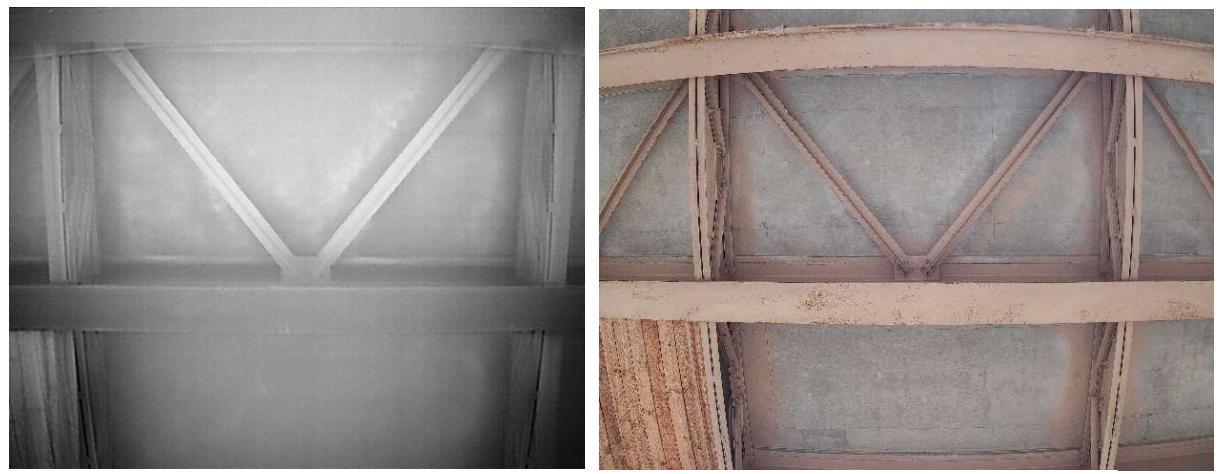
Figure 42 - Temperature Differential caused by Paint Overspray

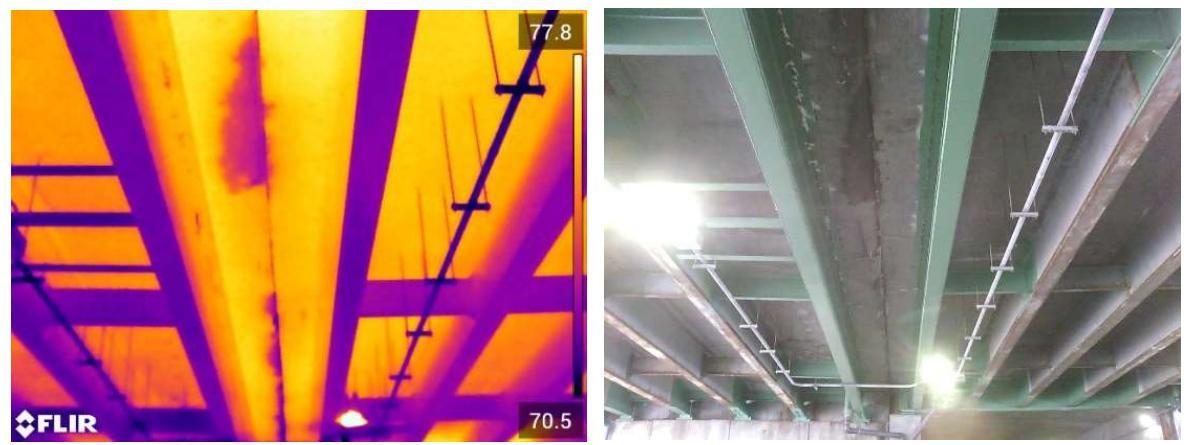
Figure 45 – Temperature Differential caused by Leakage along Joint

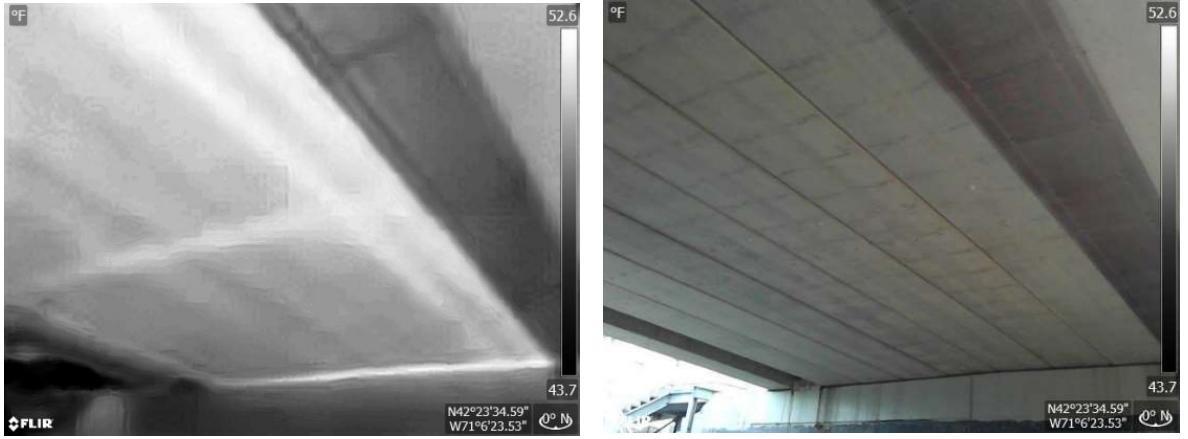
Figure 47 - Temperature Differential caused by Voids and Internal Diaphragms

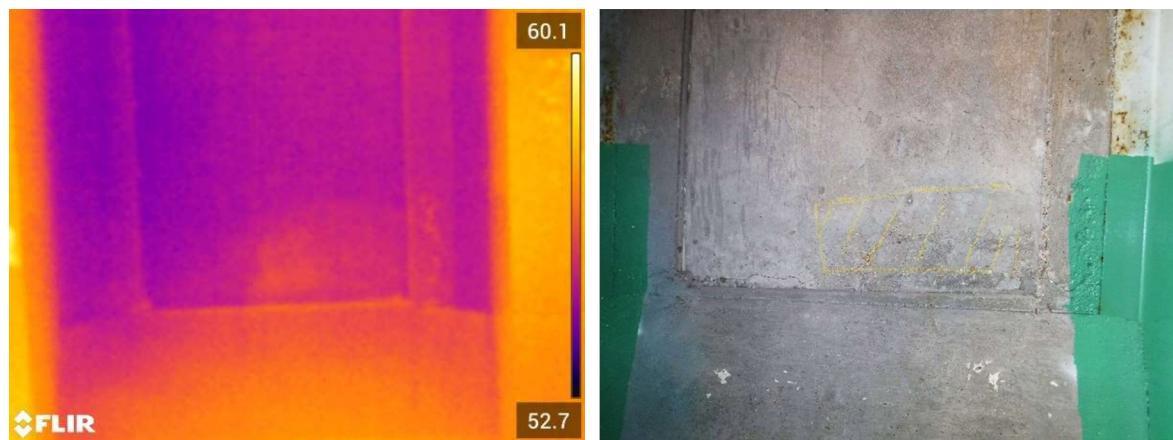
Figure 51 - Minor Delamination

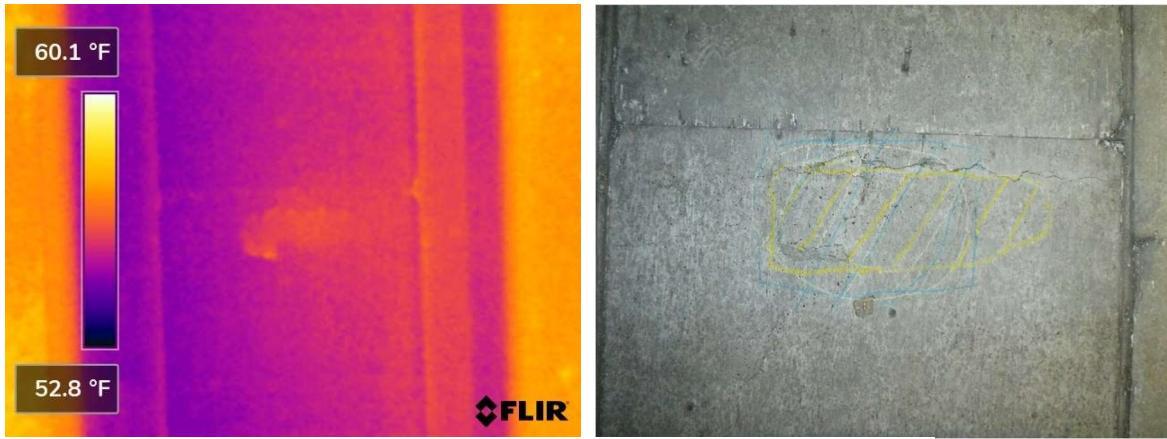
Figure 52 - Delamination with Cracking

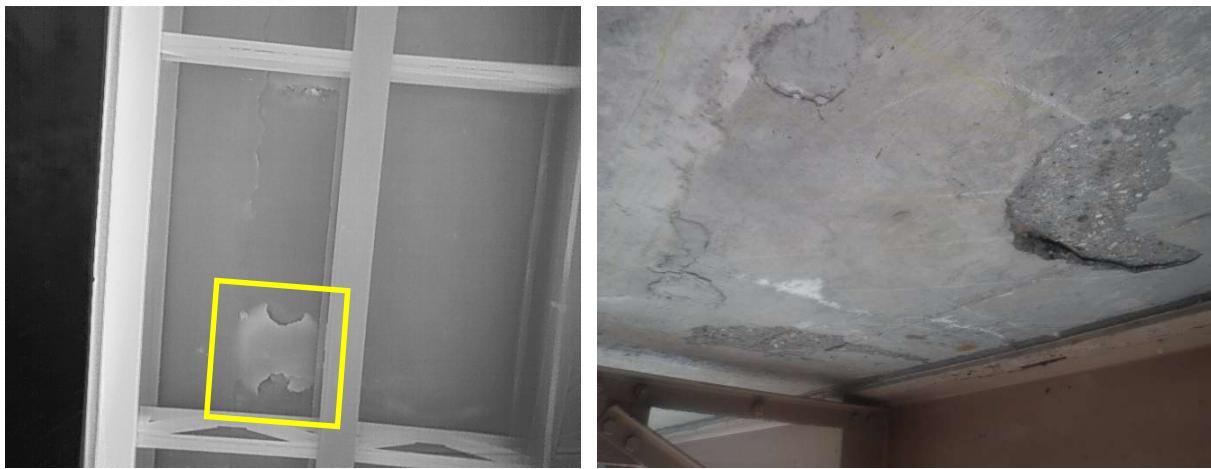
Figure 53 - Delamination without Visible Separation

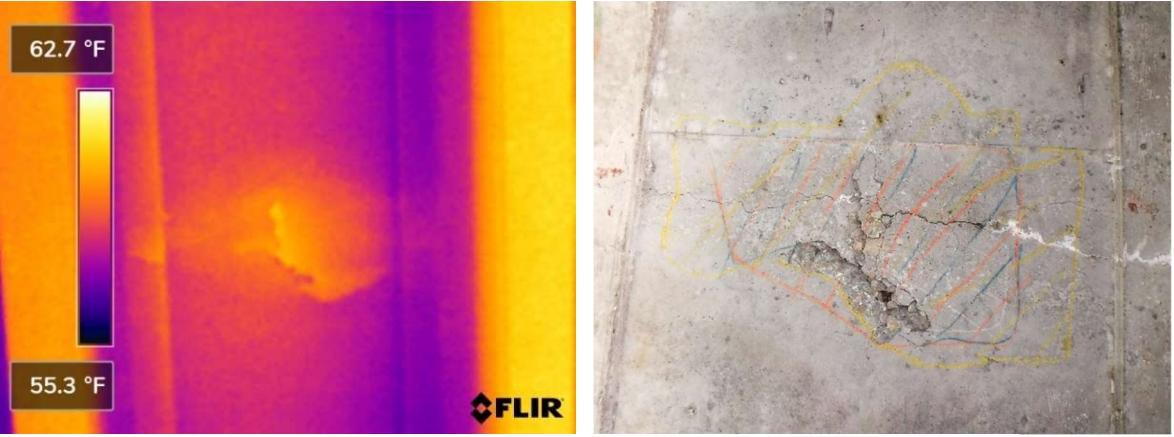
Figure 54 - Delamination with Cracking and Visible Separation

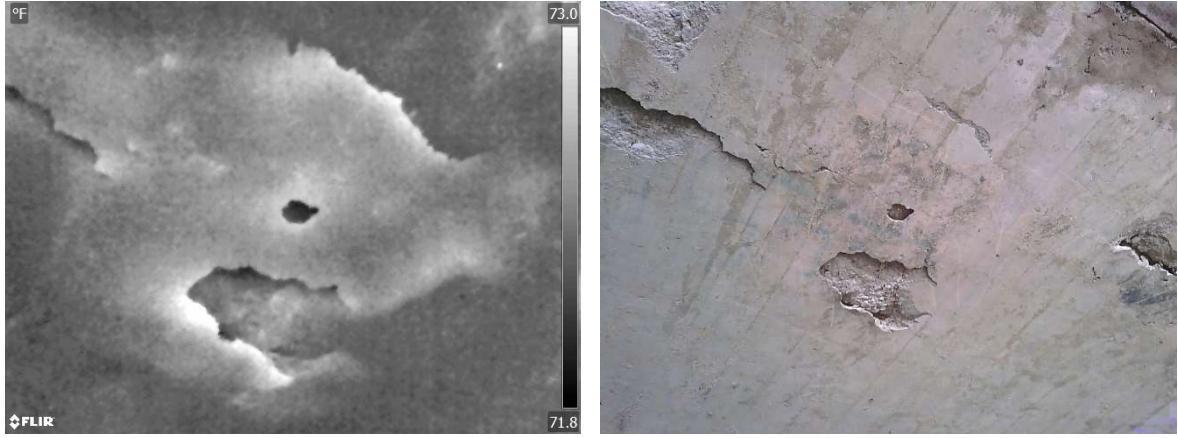
Figure 55 - Delamination with Visible Separation

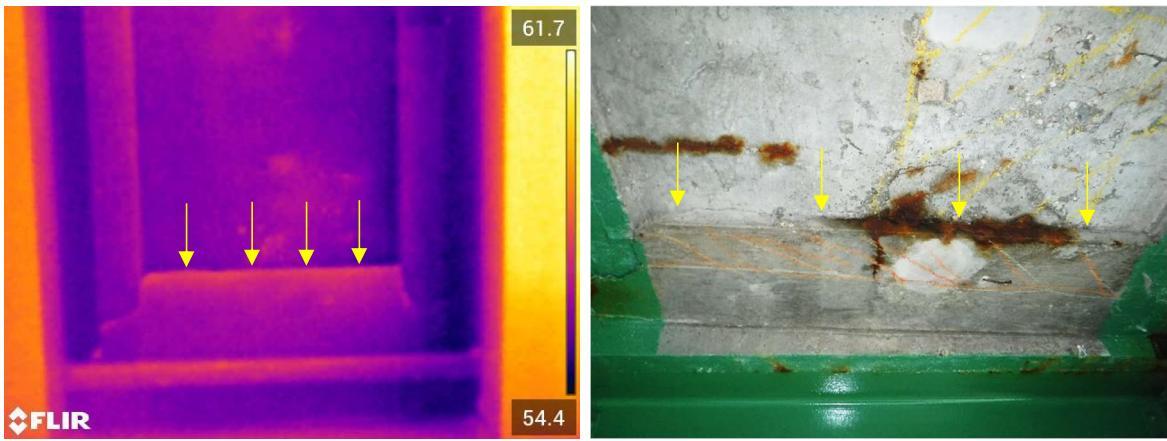
Figure 56 - Delamination along Repair due to Void / Overpour

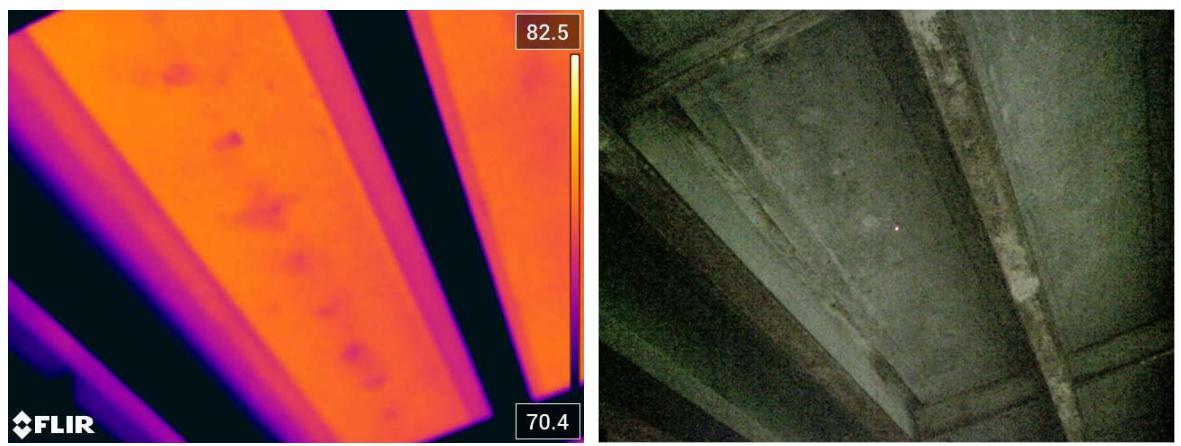
Figure 57 - Sound Patches and Delaminated Patches

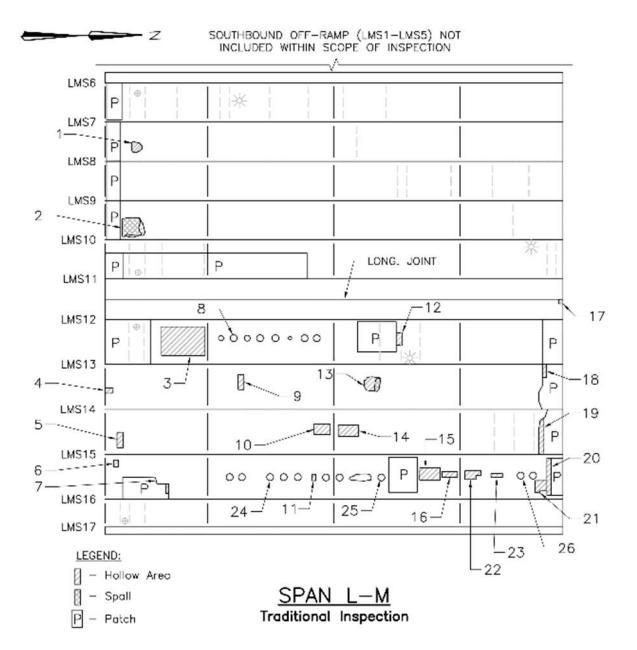
Figure 62 - Span L-M Traditional Inspection Findings

was not sounded 100% and that the bridge inspector used experience and judgement for the inspection. Identified areas were marked with an outline and hatch marks with lumber crayon (Figure 61). These areas were then documented onto a framing plan of the span. Twenty-six deficiencies consisting of delamination and/or spalling were identified within this span, (Figure 62). The full deficiencies and measurements for the traditional inspection findings sketch can be found in Appendix A-1. The traditional inspection of this span took approximately 2 hours.

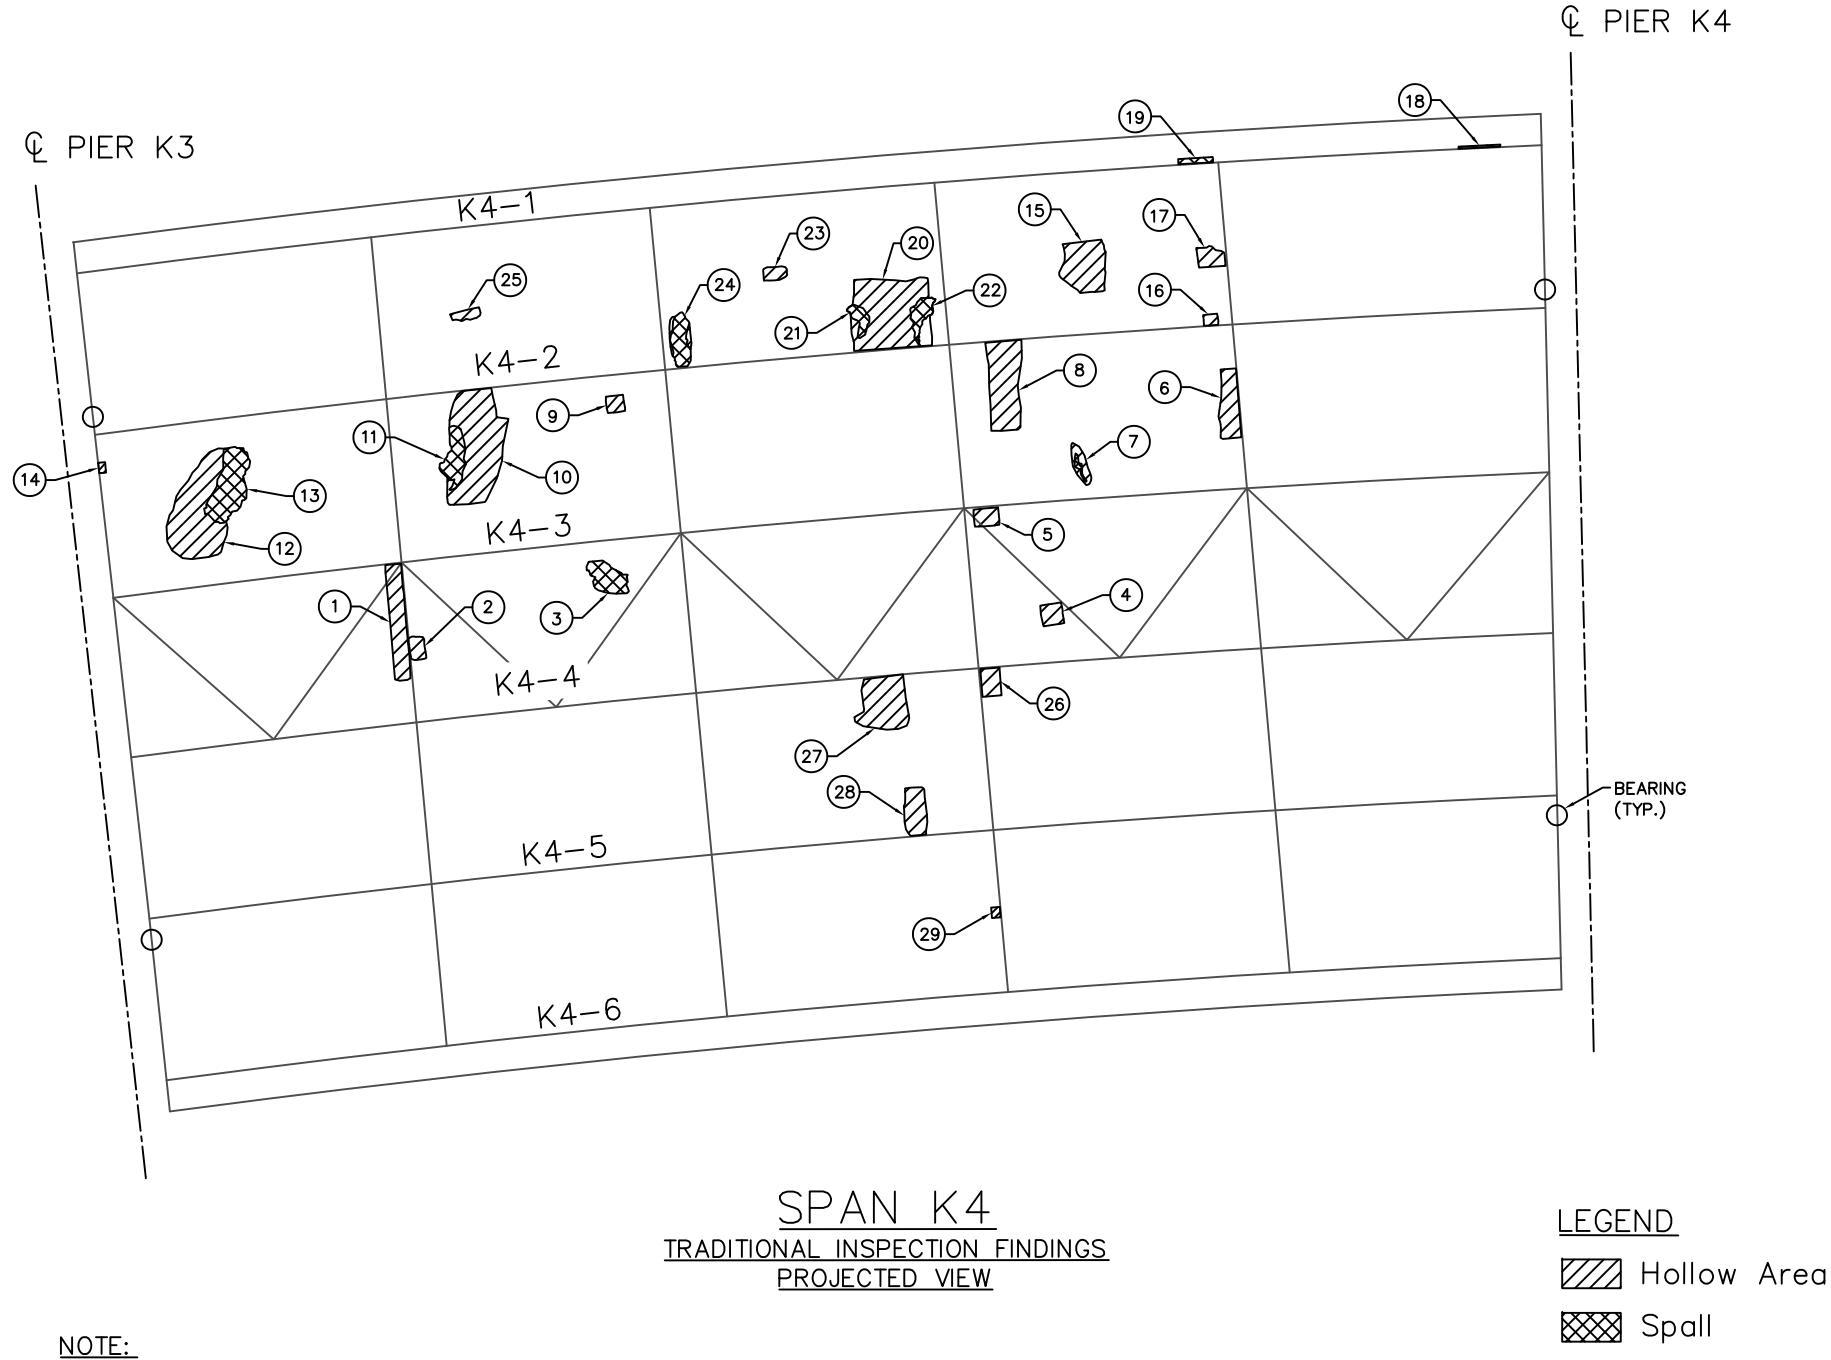
SPAN_K4 TRADITIONAL INSPECTION FINDINGS

- 18. $1\frac{1}{2}$ wide x 14 long spall
- 19. Up to 3" wide x 20" long spall
- 20. 38" wide x 46" long HSA
- 21. 21" wide x 12" long spall
- 22. 18" wide x 9" long spall
- 23. 7" wide x 14" long HSA
- 24. 30" wide x 10" long spall with two adjacent HSA measuring 14" wide x 3" long and 20" wide x up to 5" long
- 25. 6" wide x 17" long HSA
- 26. 16" wide x 11" long HSA
- 27. 28" wide x up to 31" long HSA
- 28. 25" wide x 13" long HSA
- 29. 5" wide x 6" long HSA

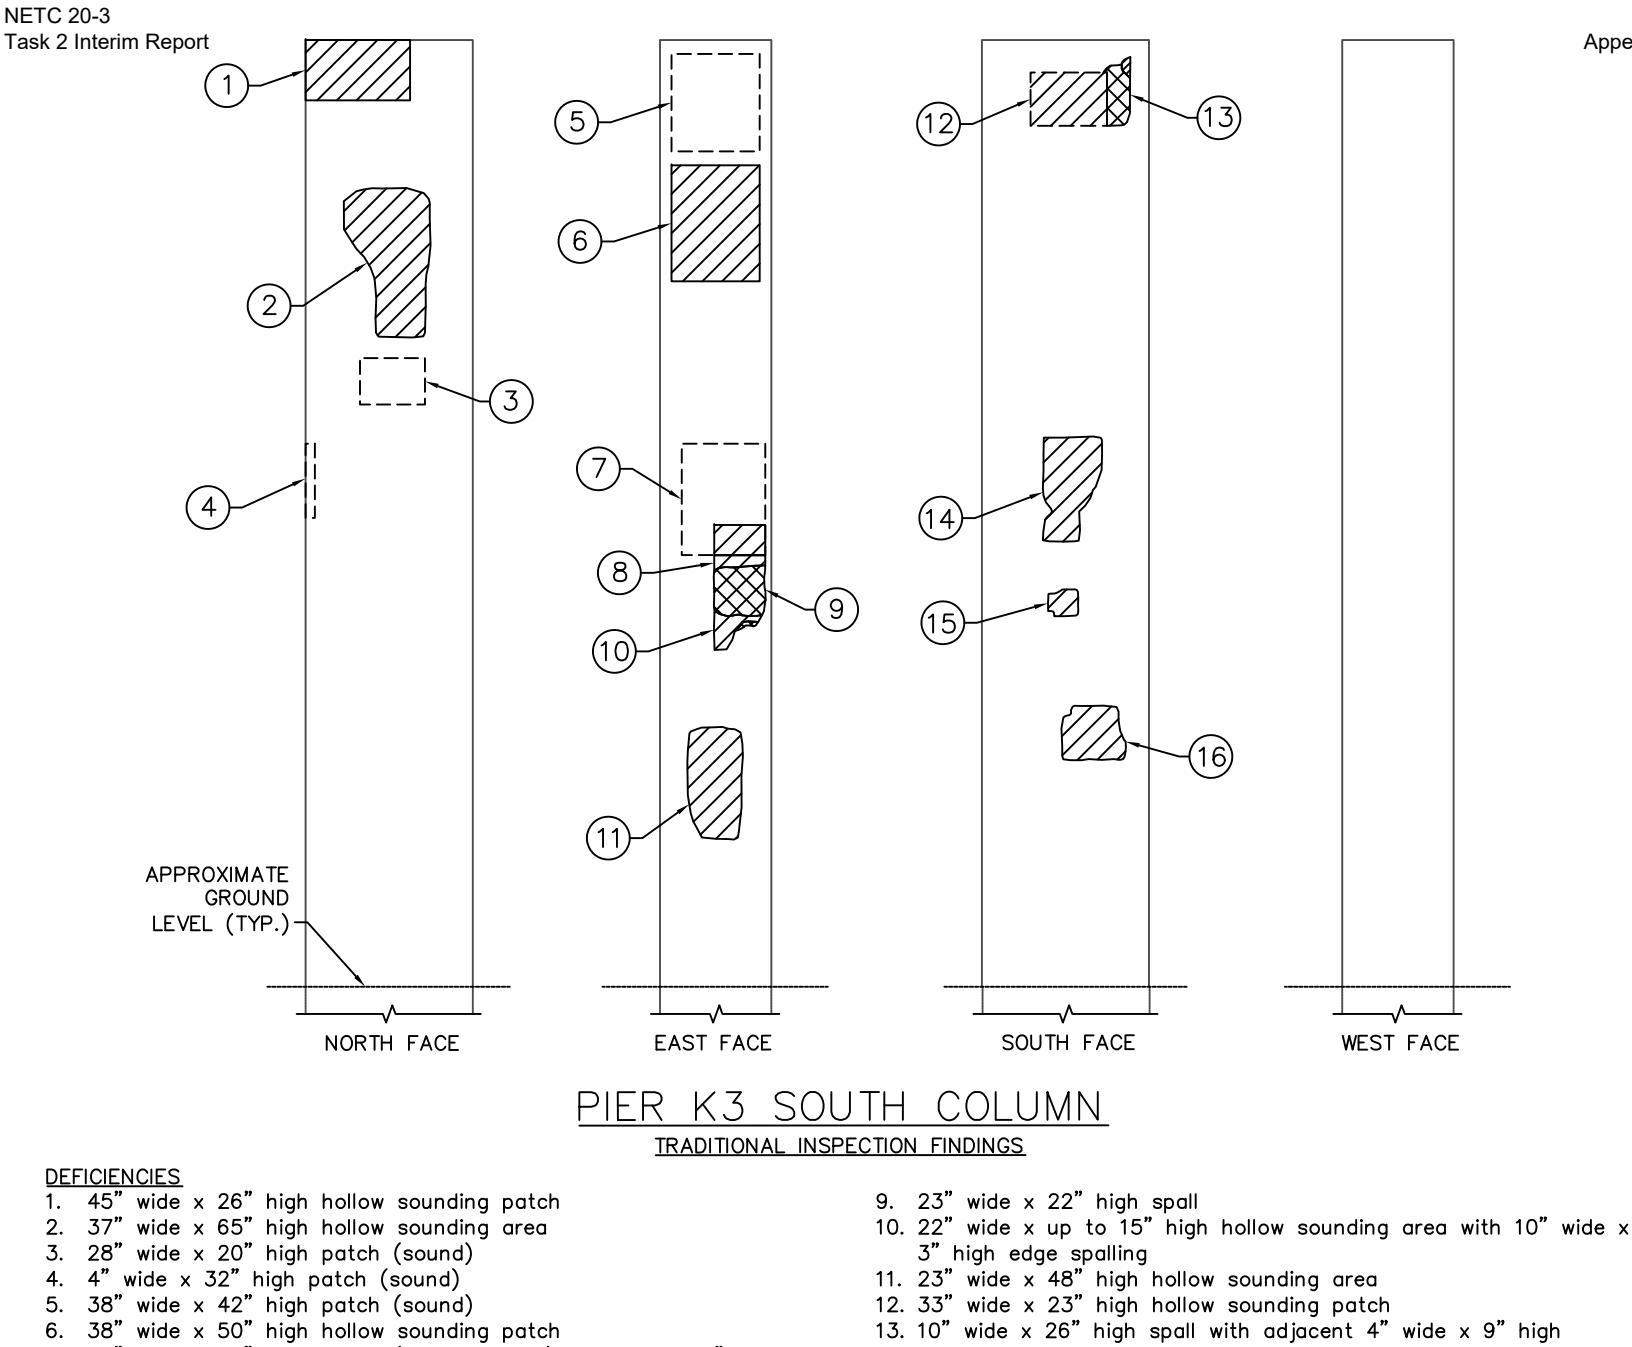
- 7. 36" wide x 48" high patch (mostly sound) containing 22" wide x 13" high hollow sounding area at bottom corner
- 8. 22" wide x up to 5" high hollow sounding area
