Development of MASH Computer Simulated Steel Bridge Rail and Transition Details

Project: NETC 18-1

Chuck A. Plaxico, Ph.D. Roadsafe LLC

NETC Webinar July 16, 2020

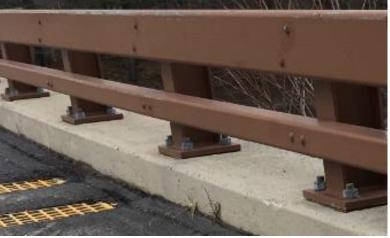
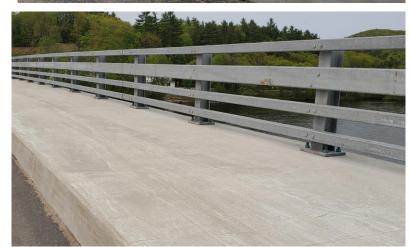
Three design details were evaluated:

- 1. NETC curb-mounted 2-Bar Rail (TL3)
- 2. NETC curb-mounted 3-Bar Rail (TL4)
- 3. NETC sidewalk-mounted 4-Bar Rail (TL4)

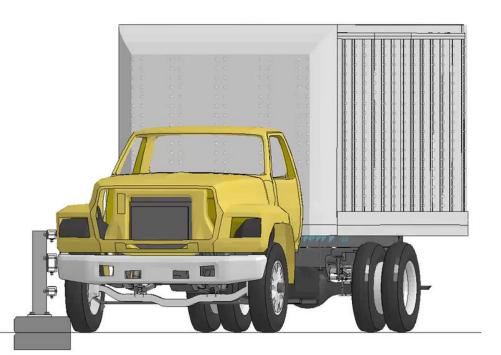
NETC 3-Bar BR (MASH Test 4-12) Time = 0.004999

- Impact Speed = 56 mph
- Impact Angle = 15 degrees
- Impact Point = 5.0 ft upstream from critical Post
- Bed Height = 47.5" (e.g., Ford F800)

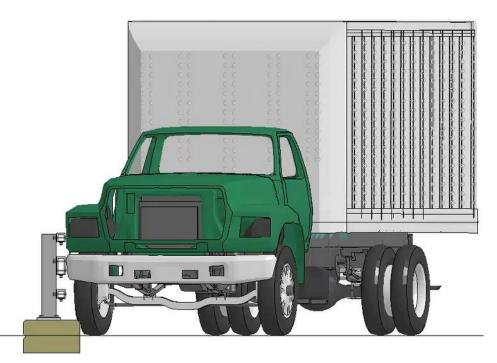
NETC 3-Bar BR (MASH Test 4-12 w/ Raised Truck) Time = 0.004999

- Impact Speed = 56 mph
- Impact Angle = 15 degrees
- Impact Point = 5.0 ft upstream from critical Post
- Bed Height = 50" (e.g., GMC)

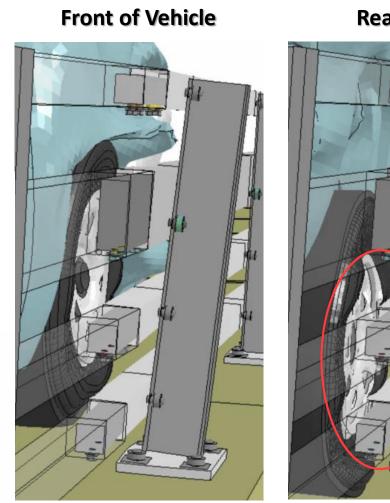
Assessment of Potential Vehicle Snag

- The front fender and bumper made slight contact with the post, but the contact force was negligible.
- The rear wheel tire and rim snagged on the rail tube at the splice, resulting in maximum ORA.

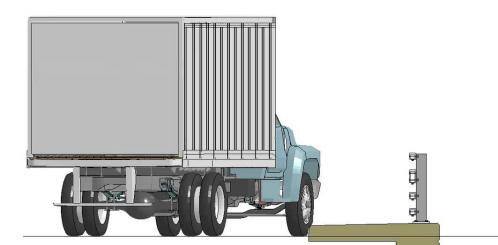
Lateral <u>Dynamic</u> Deflection

- Impact Conditions
 - Mass = 22,061 lb
 - Impact Speed = 56 mph (90 km/hr)
 - Impact Angle = 15 degrees
 - Target Impact Point = 5.0 ft upstream of Post 7

NETC 4-Bar BR (MASH Test 4-12) Time = 0.004999

Barrier Damage

- Analysis indicated probable crack opening in concrete at front anchor bolts at maximum dynamic deflection.
 - Max dynamic 1st Prin. Strain = 0.079
 - Final 1st Prin. Strain = 0.054

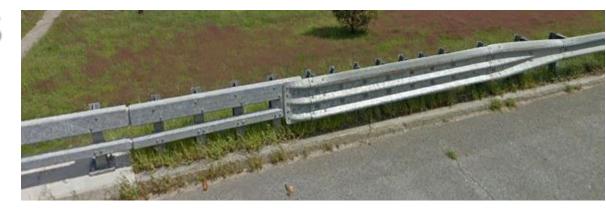
- Single taper on top
- No face taper

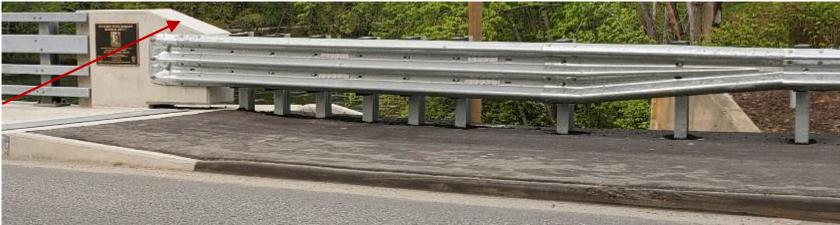
NETC 2-Bar Transition

The transition system for the 2-Bar bridge rail was modeled based on the detailed drawing from NHDOT

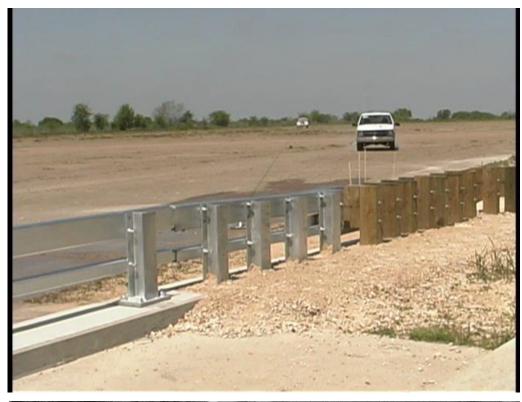
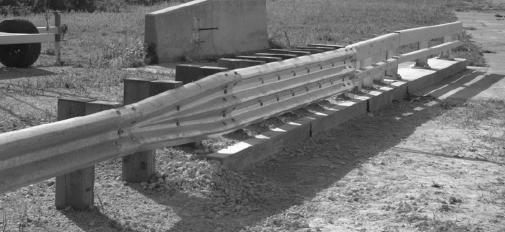
Report 350 Test Level 3

401181-1	
Test Designation	Test 3-21	
Test Vehicle	2000 Chevrolet 2500	
Gross Vehicle Weight (lb)	4,706	
Impact Speed (mph)	63.6	
Impact Angle (deg)	24.9	
Exit Speed (mph)	52.9	Preferred
Exit Angle (deg)	11.7	Limits
Occupant Impact Velocity		
Longitudinal (ft/s)	17.1	< 30 ft/s
Lateral (ft/s)	24.6	
Ridedown Accel		
Longitudinal (g's)	8.3	< 15 G
Lateral (g's)	10	
Maximum 50 msec Avg Accel		2
Longitudinal (g's)	8.1	
Lateral (g's)	13.5	
Max Deflection (in)	7.87	
Vehicle Trajectory		
Maximum YawAngle (deg)	56	Ъ
Maximum Roll Angle (deg)	14	- < 75°
Maximum Pitch Angle (deg)	19	
NCHRP Report 350 Evaluation		-
Structural Adequacy	Pass	
Ocupant Risk	Pass	
Vehicle Trajectory	Pass

NETC 2-Bar to Thrie-Beam AGT

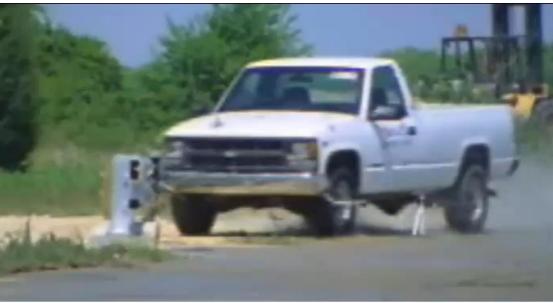
FEA of NCHRP Test 3-21 (IP 5.36 ft)

MASH T	est 3-11	Er	ror	W179 Criteria		
Occupant Risk Facto	ors	Test 401181-1	FEA					
		(0 - 1.0 seconds)	(0 - 1.0 seconds)	%	Absolute	Criteria	Pass	
Occupant Impact Velocity	x-direction	17.06 19.68		15.4%	2.62	<20% or < 6.6 f/s	Y	
(ft/s)	y-direction	-24.61	-24.93	1.3%	-0.33	<20% or < 6.6 f/s	Y	
	at time	at 0.0948 seconds on left side of interior	at 0.1005 seconds on left side of interior					
THIV		29.9	31.5	5.5%	1.64	<20% or < 6.6 f/s	Y	
(m/s)		at 0.0948 seconds on left side of interior	at 0.0986 seconds on left side of interior					
Ridedown Acceleration	x-direction	-8.3	-8.3	0.0%	0.00	<20% or < 4G	Y	
(g's)	x-unection	(0.1153 - 0.1253 seconds)	(0.1018 - 0.1118 seconds)					
	v-direction	10	7.5	25.0%	-2.50	<20% or < 4G	Y	
	y-unection	(0.1182 - 0.1282 seconds)	(0.1388 - 0.1488 seconds)					
PHD		11.9	9.1	23.5%	-2.80	<20% or < 4G	Y	
(g's)		(0.1180 - 0.1280 seconds)	(0.1344 - 0.1444 seconds)					
ASI		1.74	1.48	14.9%	-0.26	<20% or < 0.2	Y

A31		(0.0216 - 0.0716 seconds)	(0.0355 - 0.0855 seconds)					
Max 50-ms moving avg. acc.	x-direction	-8.1	-9.6	18.5%	-1.50	<20% or < 4G	Y	
(g's)		(0.0334 - 0.0834 seconds)	(0.0342 - 0.0842 seconds)					
	v-direction	13.5	11	18.5%	-2.50	<20% or < 4G	Y	
	y-unection	(0.0216 - 0.0716 seconds)	(0.0448 - 0.0948 seconds)					
	z-direction	-7.6	-3.8	50.0%	3.80	<20% or < 4G	Y	
	z-airection	(0.0209 - 0.0709 seconds)	(0.0359 - 0.0859 seconds)					
Maximum Angular Disp.	Yaw	55.6	48.2	13.3%	-7.40	<20% or < 5 deg	Y	
(deg)	Taw	(1.0000 seconds)	(0.9426 seconds)					
	Roll	-19.4	-17	12.4%	2.40	<20% or < 5 deg	Y	
	KUII	(0.5914 seconds)	(0.4713 seconds)					
	Pitch	-13.7	-16.5	20.4%	-2.80	<20% or < 5 deg	Y	
	PILCH	(0.6647 seconds)	(0.5674 seconds)

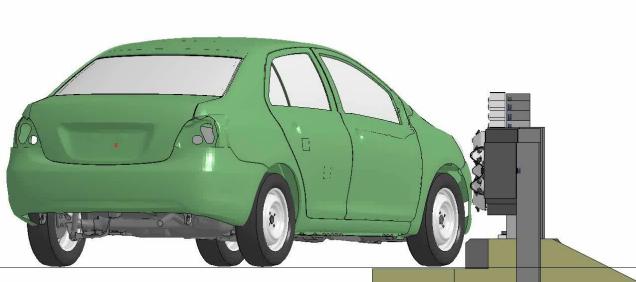
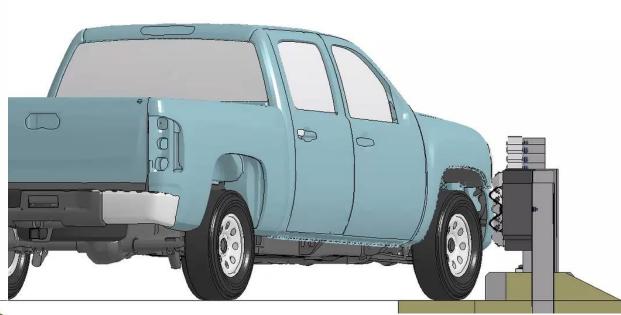
- Impact Speed = 62.1 mph
- Impact Angle = 25 degrees
- Impact Point = 6.2 ft upstream from end of tube rail

FEA of MASH Test 4-21 on AGT 3-Bar (IP 6.2 ft) Time = 0.004999
