New England Transportation Consortium

NETC 19-2: Multi-Scale Multi-Season Land-Based Erosion Modeling and Monitoring for Infrastructure Management

Technical Memorandum
Task 3: Ground Truthing

Prepared by:
GZA GeoEnvironmental, Inc.

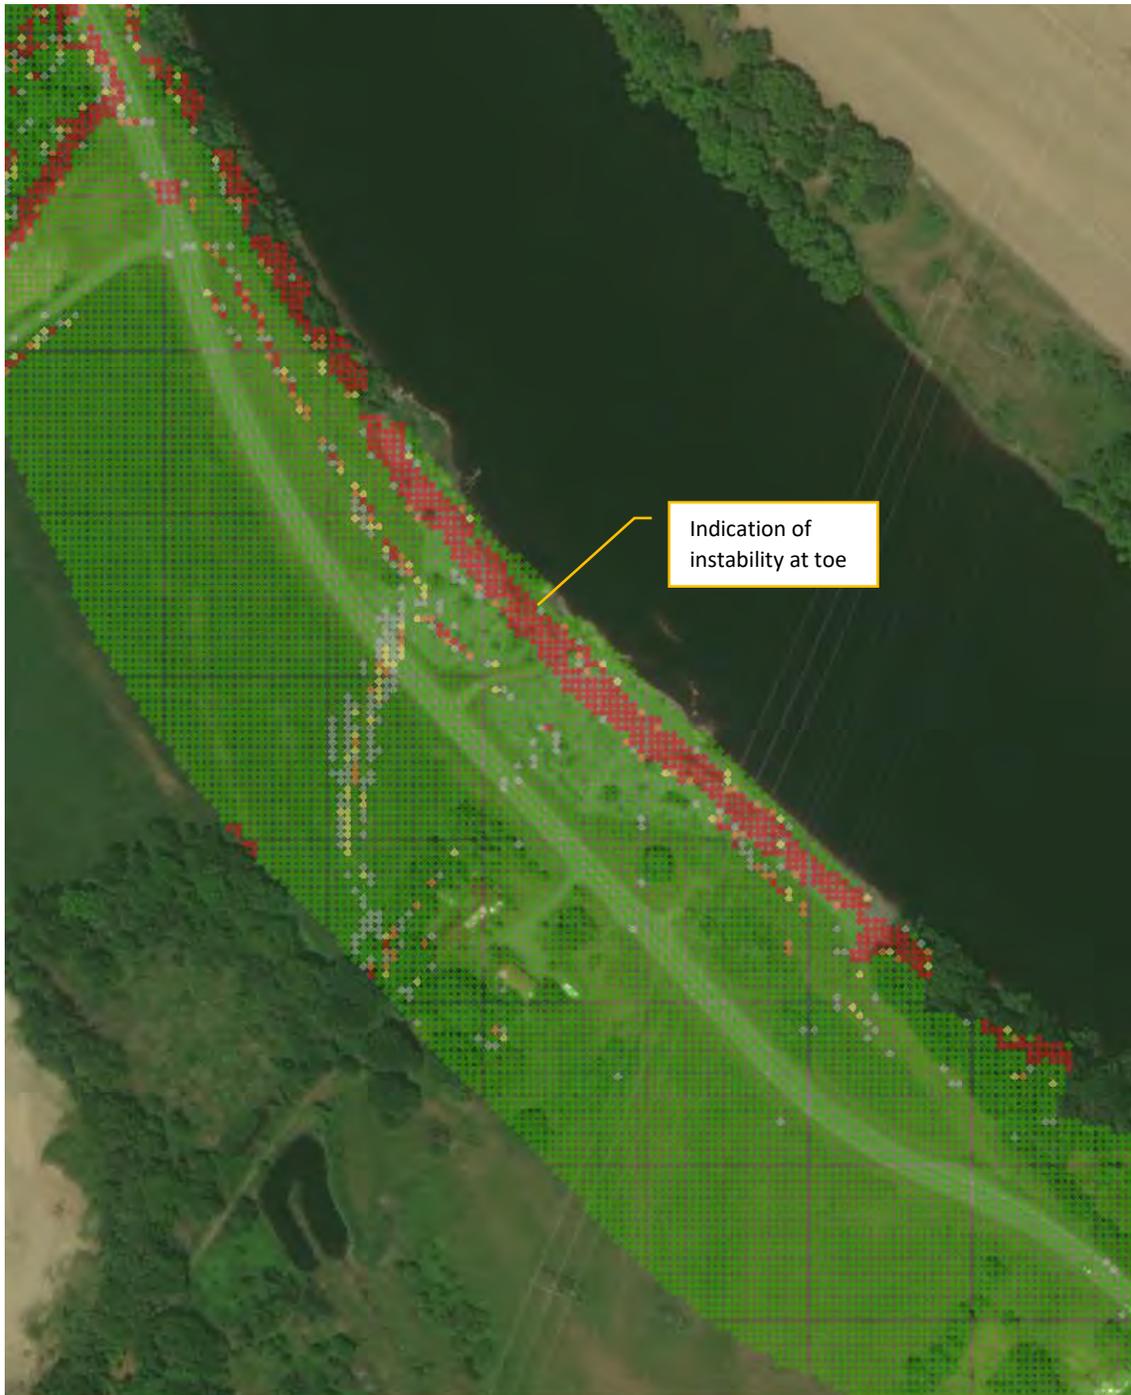
Figure 2: Slope Failure Site at Route 136

Note: Aerial image more recent than 2010; topography LiDAR from 2009. Failure occurred in Summer 2010.

The City of Auburn was selected due to its proximity to Lake Auburn and Androscoggin River with varying terrain and land cover types. The surficial material type in Auburn is locally referred to as the Presumpscot Deposit. It consists largely of soft clay, classified by GZA as “C1”² characterized as having undrained shear strength of 350 psf, with lesser layers of marine deltaic sands and silts. The Presumpscot Deposit is also the source of many if not most Maine landslides. GZA was involved with a previous roadside embankment slope project along Route 136 in 2010. Some natural failures had occurred due to oversteepening of the riverbank adjacent to the roadway. However, the major failure that GZA provided geotechnical services for was triggered by installation of steel sheet piles during proposed reconfiguration of the slope. **Figure 2** presents the predicted slope failure hazard indices along Route 136, adjacent to Androscoggin River. The calculation was based on a LiDAR³ dataset dated 2009, prior to the major failure incident in Summer 2010. It is clear that the modeled results were able to capture the low factor of safety values at the toe of the slope, which led to predicted high hazard level (red dots). **Figure 3** presents two representative photographs from the site, post-failure and post-construction.

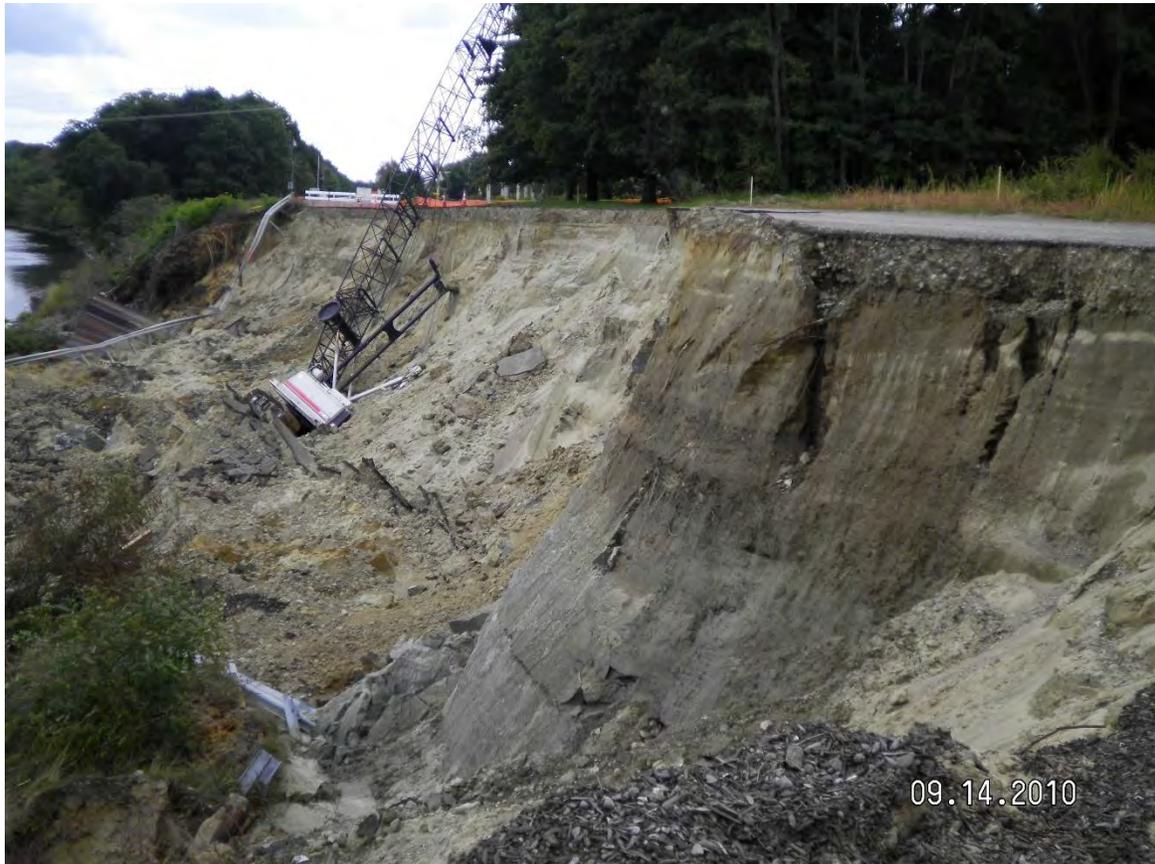
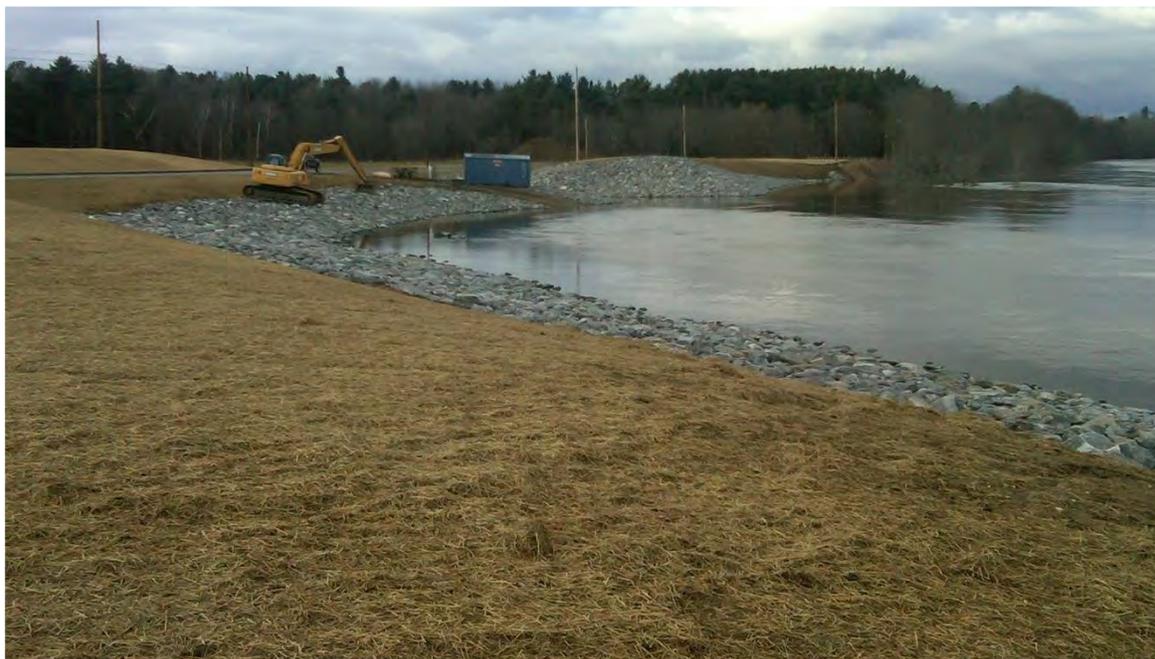
Figure 3: Project Photographs for Route 136 Slope Failure

Note: Top image after failure incident in September 2010; bottom image after construction/remediation completed in December 2010.
