NETC 20-3

Investigating Thermal Imaging Technologies and Unmanned Aerial Vehicles to Improve Bridge Inspections

Project Close-Out Webinar
August 8th, 2023

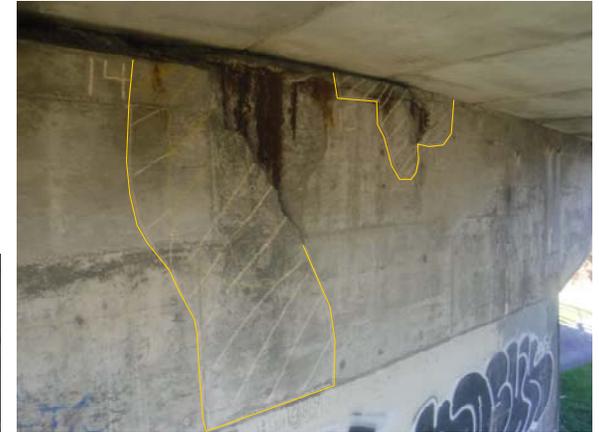
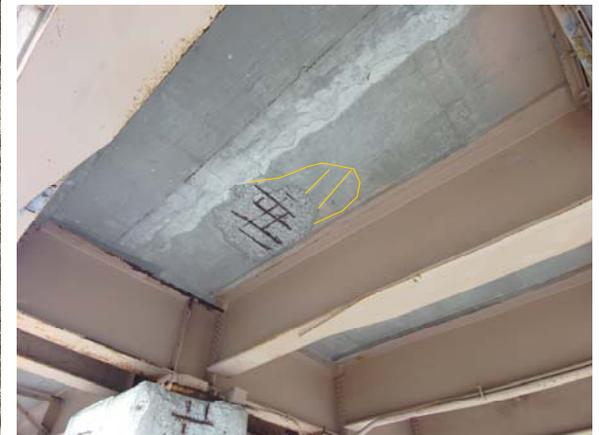
- Concrete delamination caused by expansion of corroding reinforcing steel
- Can be difficult to detect visually
- Presents critical safety hazard
 - Direct impact
 - Distraction of drivers

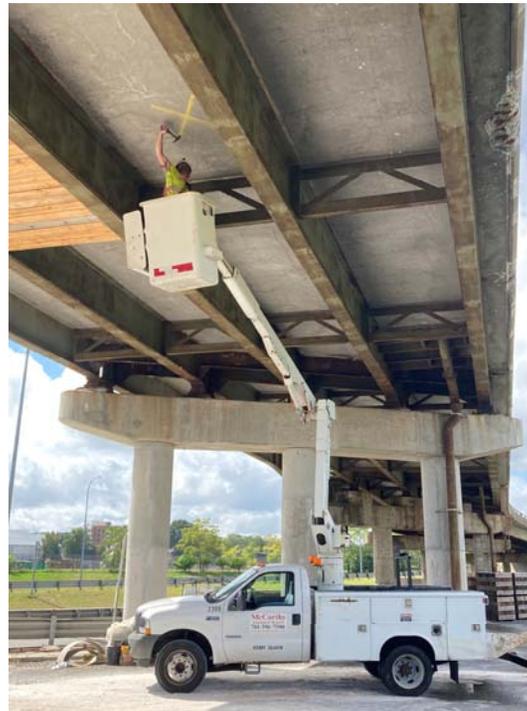
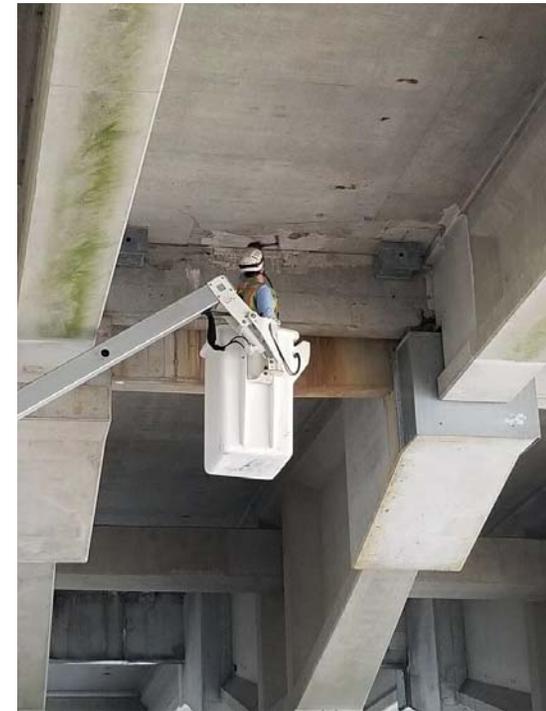
- Traditionally identified with manual methods:
 - Hammer Sounding
 - Chain Drag
 - Rotary Percussion Tool
- Requires hands-on access
- Subjective documentation
- Relies on ability to hear sound that is produced

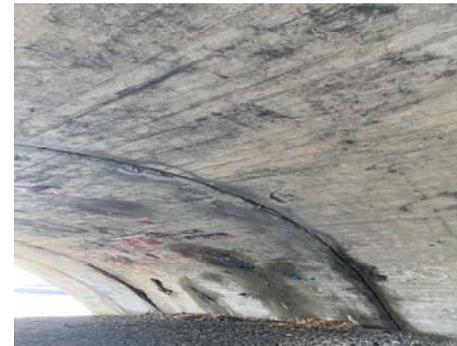
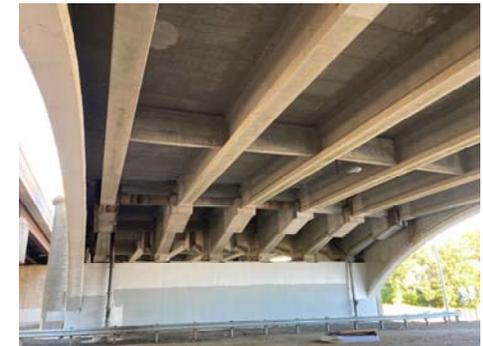
Deficiency 9

- Determine whether traditional inspection findings could be verified
 - Beades Bridge – All delaminations at least partially identified
 - Washington Bridge – 64% at least partially identified

Second Data Set – Post Processed

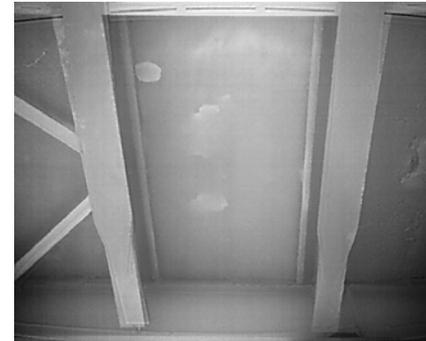
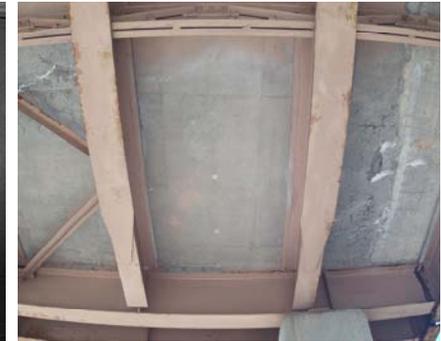
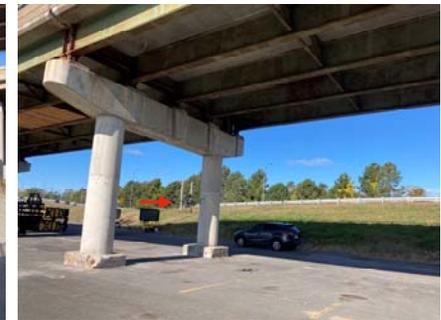
- Field tested Zenmuse XT2 mounted on DJI Matrice 210
- Two bridges
- Perform UAV-IR survey to identify delaminations for comparison to traditional rehabilitation level inspection
 - Ramp K – 78% of delaminations at least partially identified
 - Ramp B – 51% of delaminations at least partially identified
 - Both thermal surveys included false positive identifications
 - Both identified more delamination than the previous routine inspection

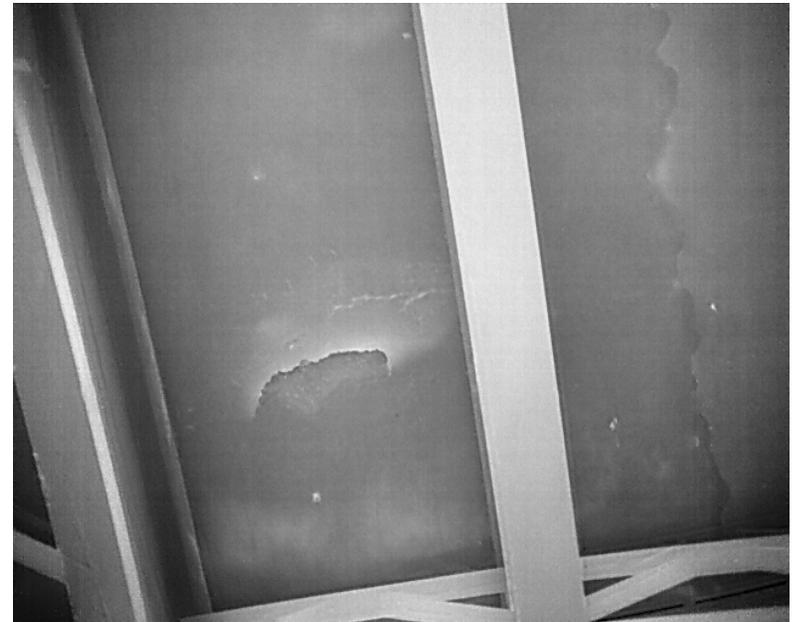
- Temperature change for the preceding 6 hours
 - 10° F for handheld
 - 15° F for drone-mounted
- Wind Speeds
 - < 30 mph for handheld
 - < 20 mph for drone-mounted
- No rain at least 48 hours prior

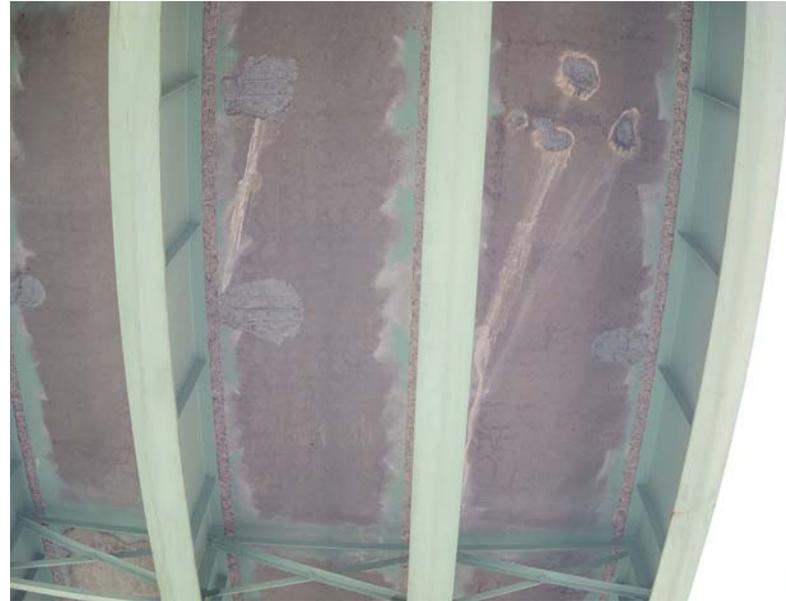
- False positive identification is possible
- Numerous factors affect temperature readings
- Cross check with visual imagery

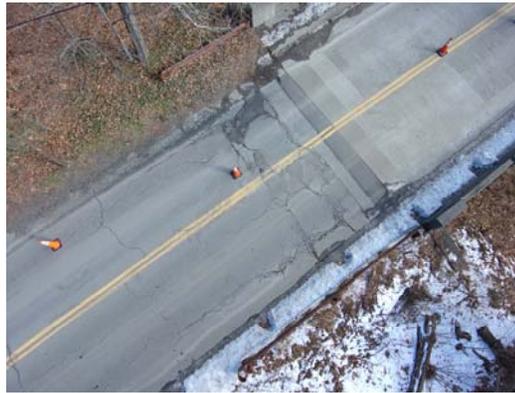
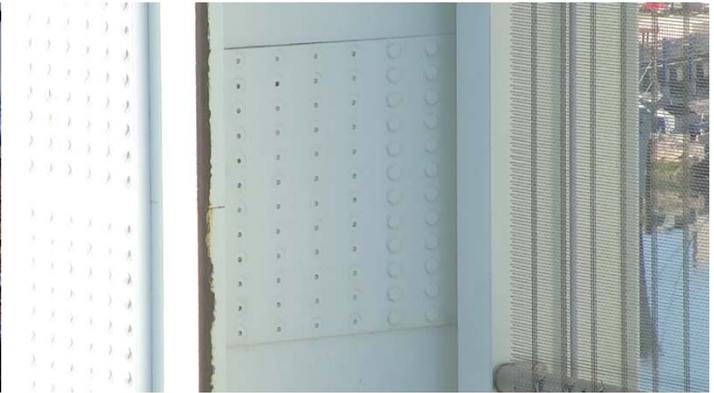
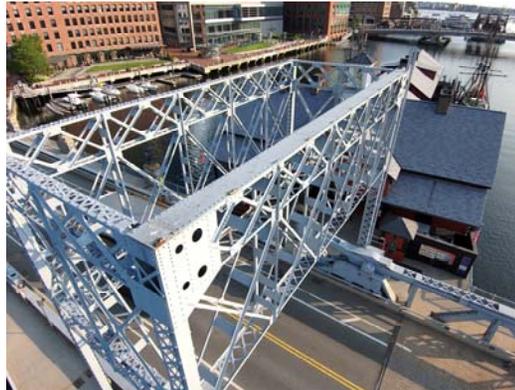
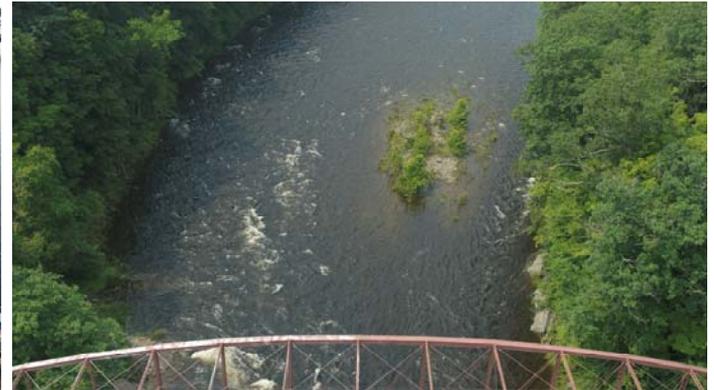
- Inventory / Record Photos
- Aerial Imagery
- Visual Screening Tool
- Channel Inspection

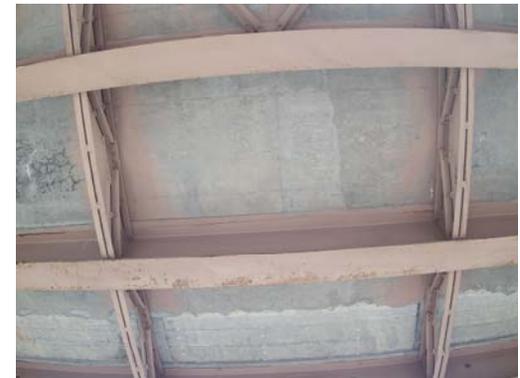
- Thermal imaging is able to detect varying degrees of delamination under the right conditions (10°-15° F temperature swing)
- Even under ideal conditions, it is possible that not all delaminations will be detected by thermal imaging
- Limits of delamination do not always line up with limits determined by traditional methods and will vary based on temperature changes
- Proper interpretation of thermal images is essential to accurately identify delaminations and avoid false positive identification
