*Development of MASH Computer Simulated Steel
Bridge Rail and Transition Details*

Prepared for: **Maine Department of Transportation**

DEVELOPMENT OF MASH COMPUTER SIMULATED STEEL BRIDGE RAIL AND TRANSITION DETAILS

**Prepared for
The New England Transportation Consortium
April 28, 2020**

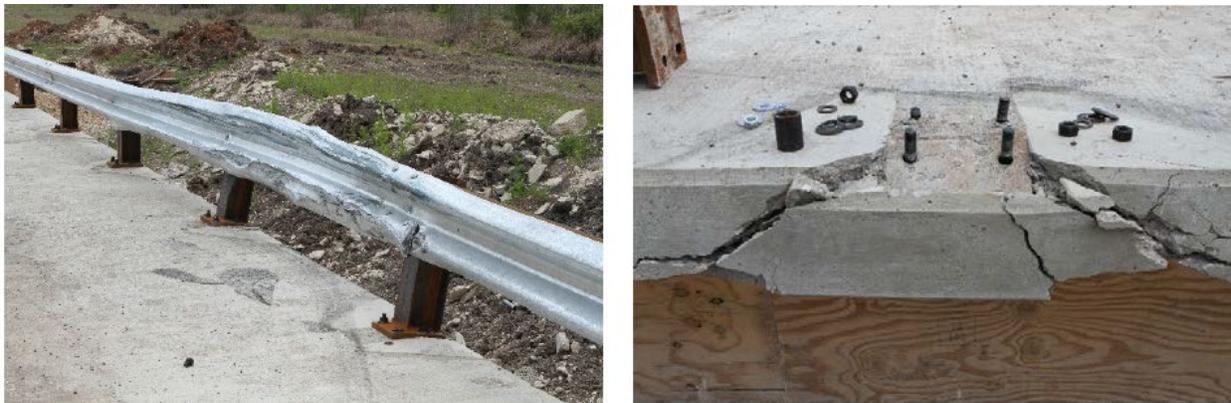
Figure 11. Concrete damage modes experienced in NCHRP Report 350 Test 3-11 on the TxDOT T77 bridge rail.

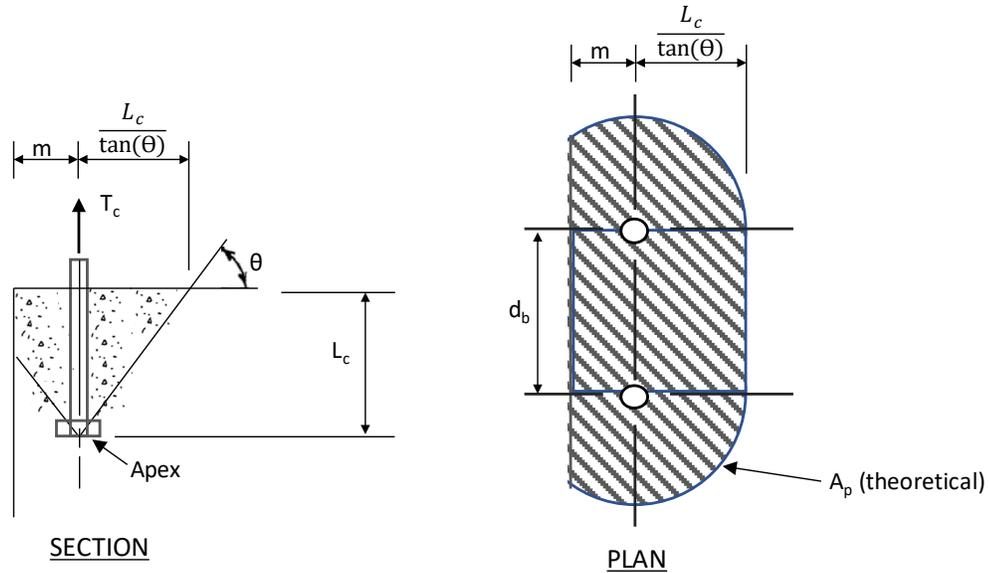
Figure 13. Theoretical failure planes for pry-out shear cone failure in concrete.

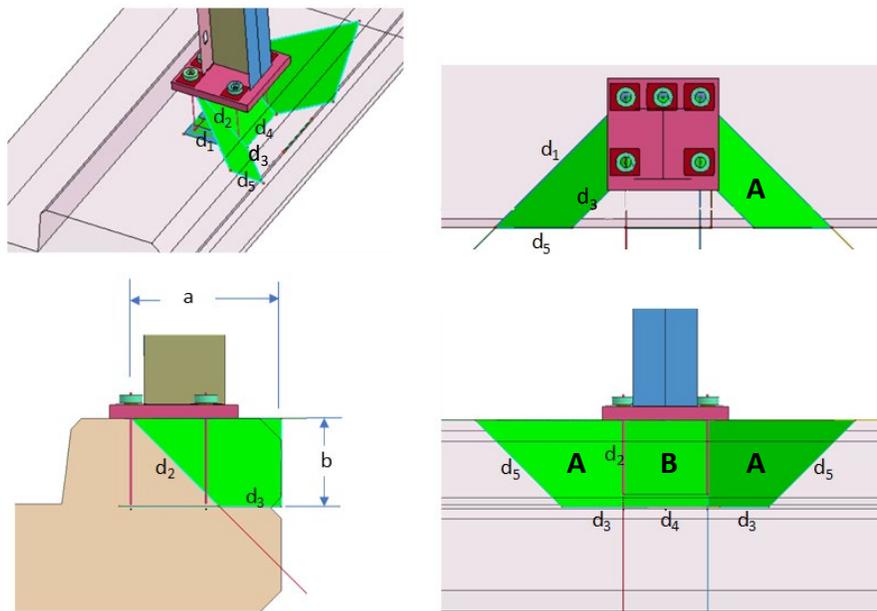
Figure 15. Approximated failure planes for push-out shear failure in concrete.

The theoretical failure area, A_p , for push-out shear, R_c , of the concrete due to shear loading on the anchor bolts is illustrated in Figure 15. It is assumed that the shear failure cracks start at the top of the concrete surface at each of the the front anchor bolts. These cracks extend at a 45 degree angle, θ , laterally across the top of the curb and downward toward the bottom of the curb/deck forming three failure plannes. The two failure surface extending outward from the baseplate are denoted in Figure 15 as Failure Plane A. The shear planes between the two anchors under the baseplate will overlap and, for simplitiy, a rectangular shear plane is approximated as a rectangular surface starting at the line between the two bolts at the surface and extending at 45 degrees downward and toward the back of the curb/deck surface. This shear plane is denoted in Figure 15 as Failure Plane B. Plane A in is shown as a trapazoid in Figure 15, since the failure plane reached the “cold joint” between the curb and deck in this example. However, if the curb were deep enough the failure plane would eventually reach the back face of the curb and form a triangular shape (refer to edge d_2 in the bottom-left image in Figure 15).

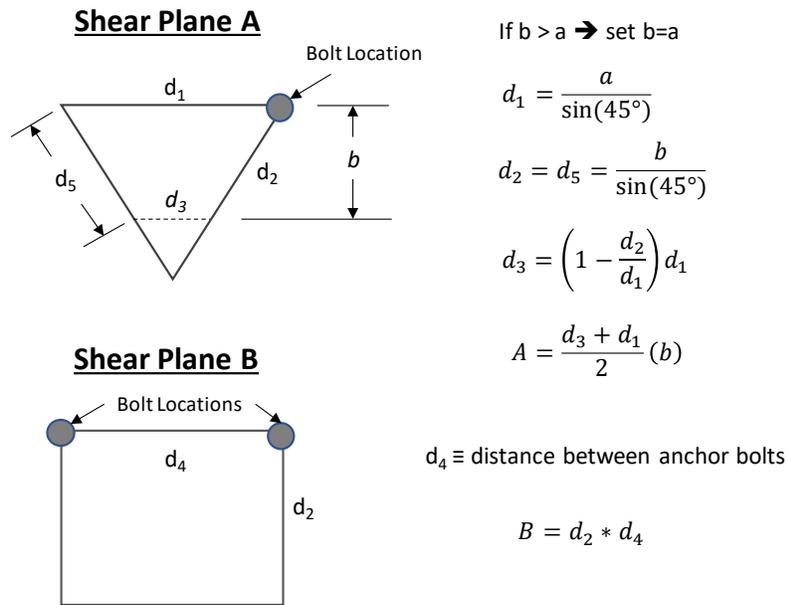
Figure 16. Calculation for Shear Planes A and B for Push-Out Shear Failure.

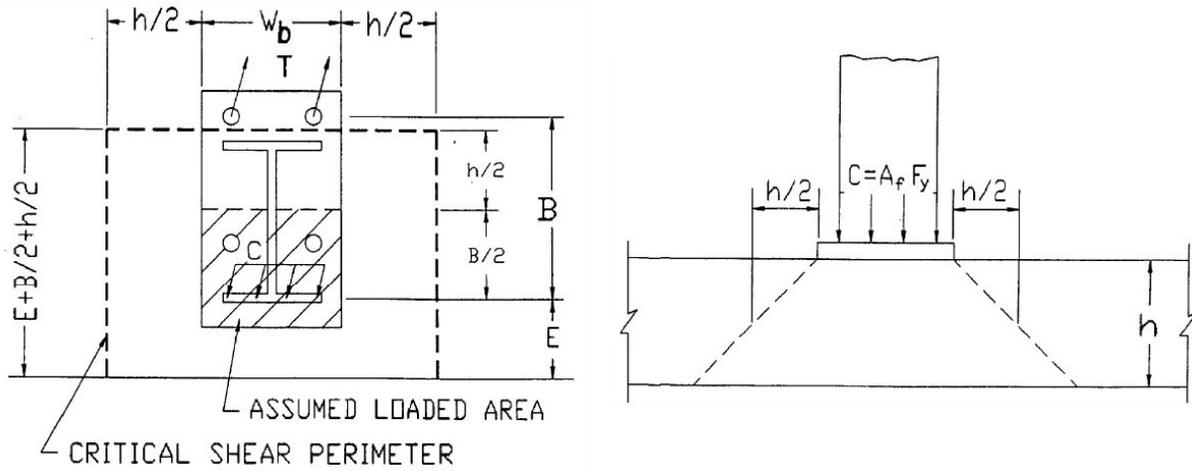
Figure 17. Punching shear failure mode (Figure A13.4.3.2-1 in 2012 LRFD)

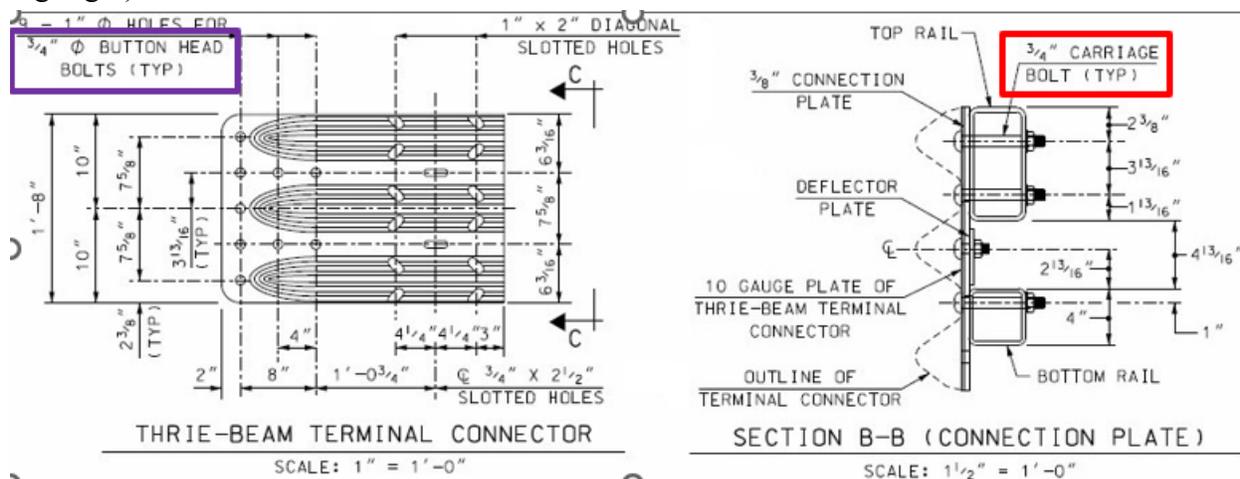
Figure 26. Terminal and connection plate detail drawings for NHDOT T2 AGT (T3 similar)

The second discrepancy found in the NHDOT T2 (and T3) drawings is also an inconsistency between bolt details. This discrepancy is highlighted in Figure 26. The clamping bolts are called out as 3/4" Ø Button Head Bolts (purple highlight) and 3/4" Carriage Bolt (red highlight).

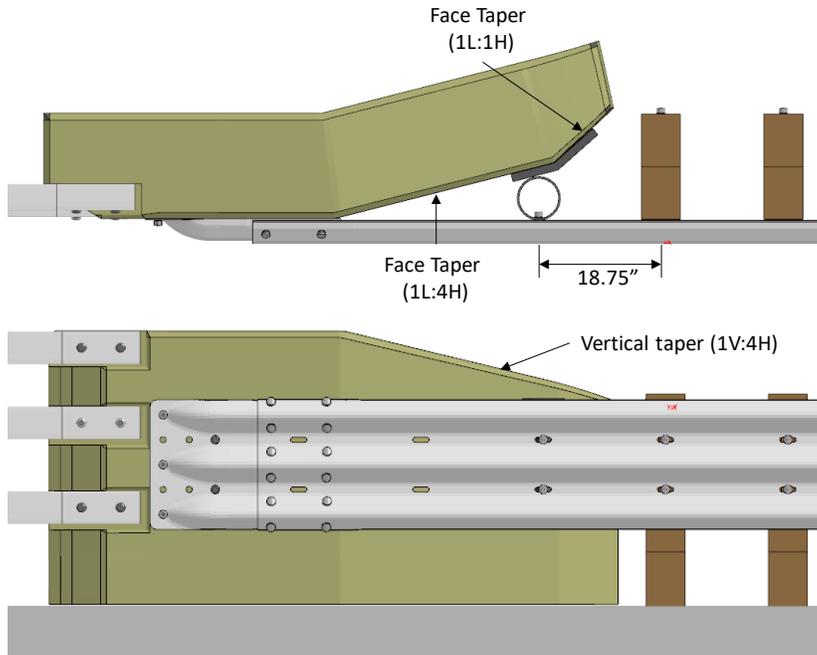
Figure 36. Plan and profile view of the shaped buttress.

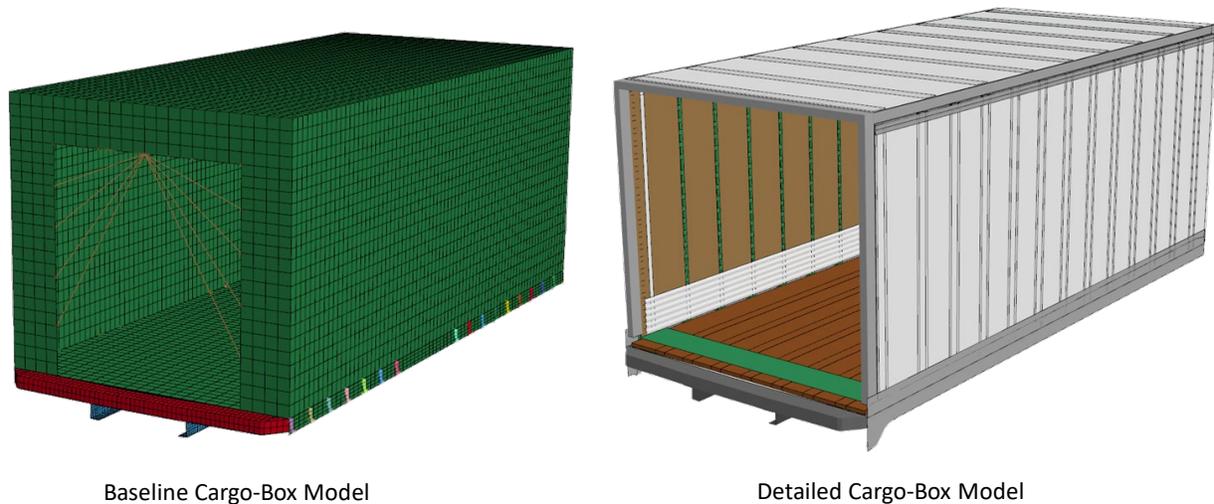
Figure 42. Images of the FEA model for the baseline and detailed cargo-box models (rear door not shown to facilitate viewing inside of cargo box).

Additional modifications to the SUT model included replacing the cargo box on the baseline model with a more detailed model with better geometric and material fidelity, as shown in Figure 42. Based on visual inspection of several single unit truck boxes, it was decided that the basic structure for the cargo box model would be adopted from an existing semitrailer model and subsequently modified to match the external dimensions of the existing baseline model. An overview of the various components that were included in the model, as well as their corresponding dimensions and material assignments can be found in [*Plaxico19*]. Further details regarding the development of this box structure can be found in the literature. [*Plaxico09; Miele10*]

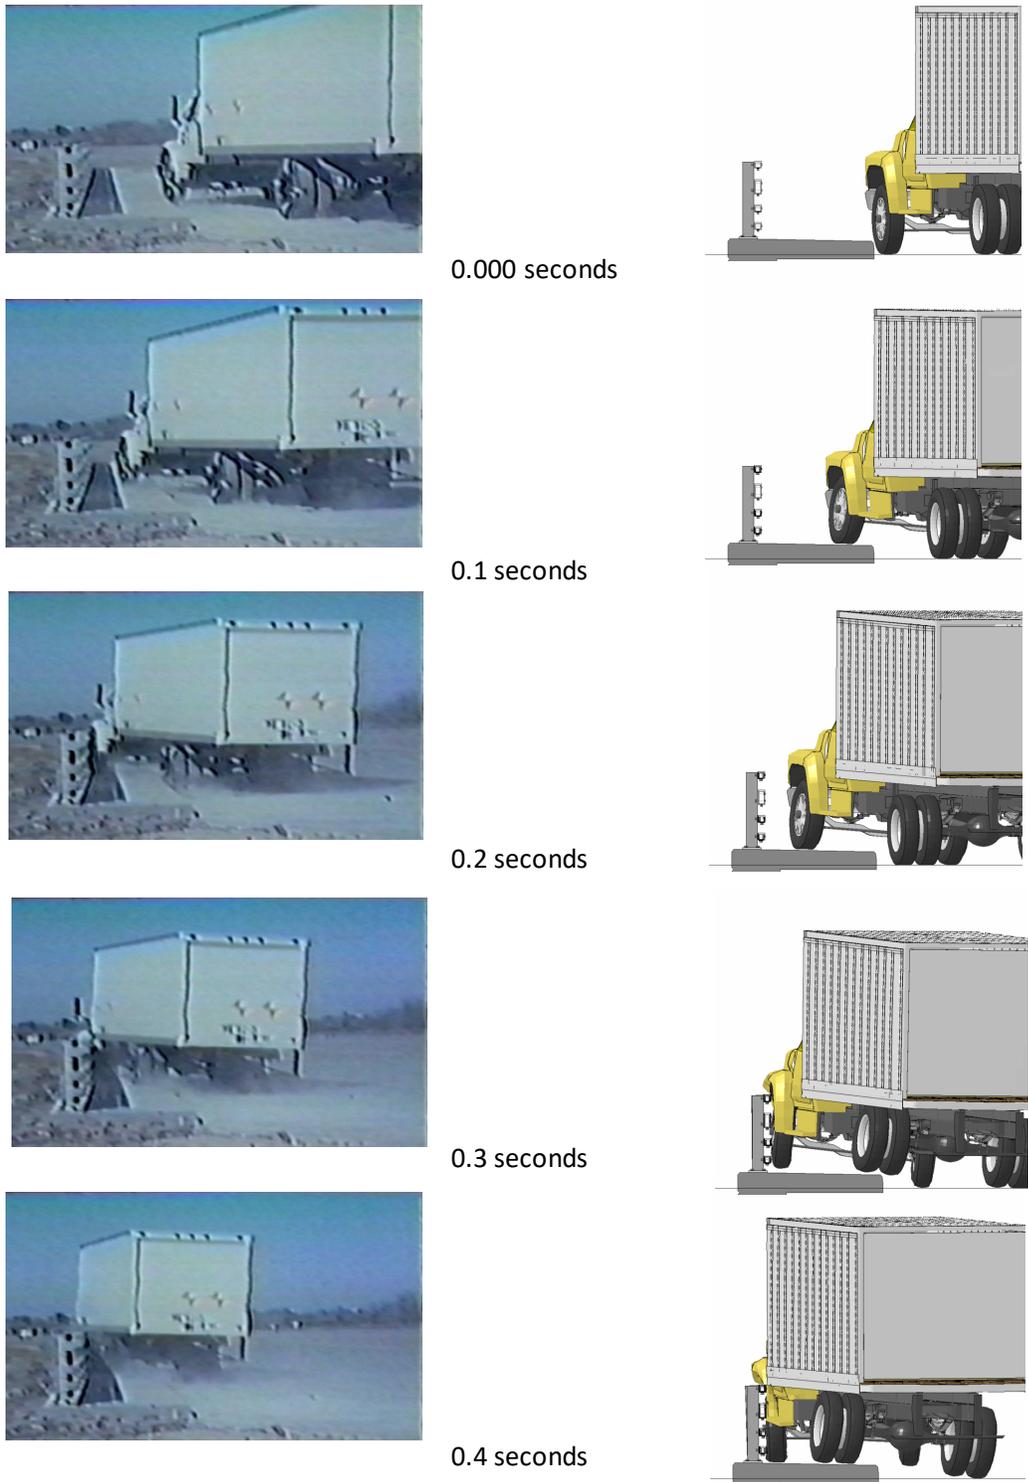
Figure 64. Sequential views of Test NETC-3 and FE analysis from upstream viewpoint.

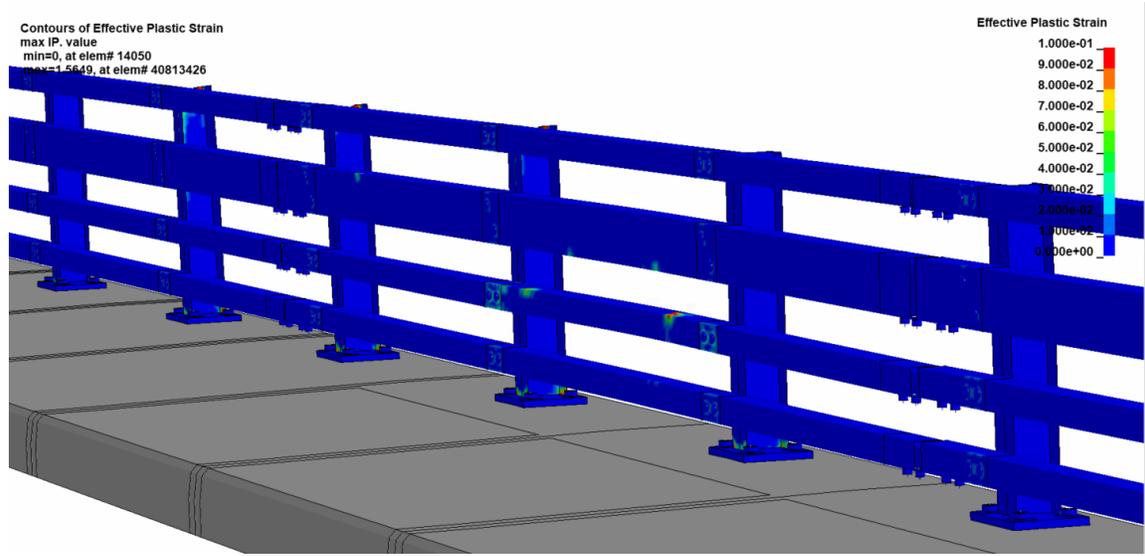
Figure 68. Contour plot of effective plastic strain showing deformations of the bridge rail model (traffic side).

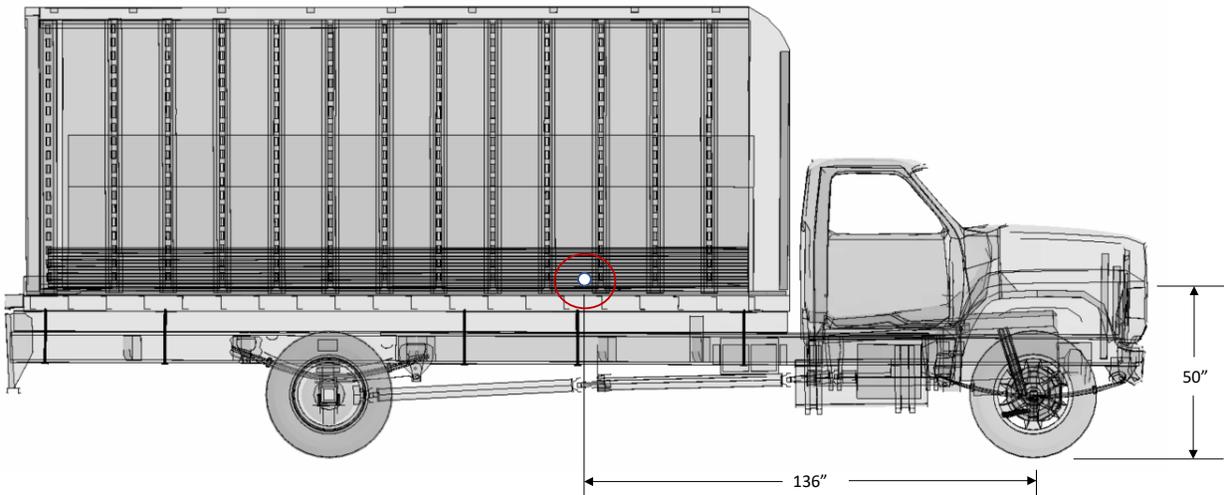
Figure 71. Location of accelerometer in FE model.

Acceleration-time histories and angular rate-time histories were collected inside the cargo box near the center of gravity of the vehicle, as illustrated in Figure 71 (compare to G and H in Figure 43). The time-history data was collected from the accelerometers in a local reference coordinate system that was fixed to the vehicle with the x-direction coincident with the forward direction of the vehicle, the local y-direction was oriented toward the right side of the vehicle and the local z-direction was oriented downward. The data was collected at a frequency of 50 kHz. Since the vehicle model struck the bridge rail from the opposite direction than the test vehicle, the “sign” for the data values collected for several of the channels was reversed for direct comparison with the test data (e.g., y-acceleration, roll-rate, and yaw-rate channels).

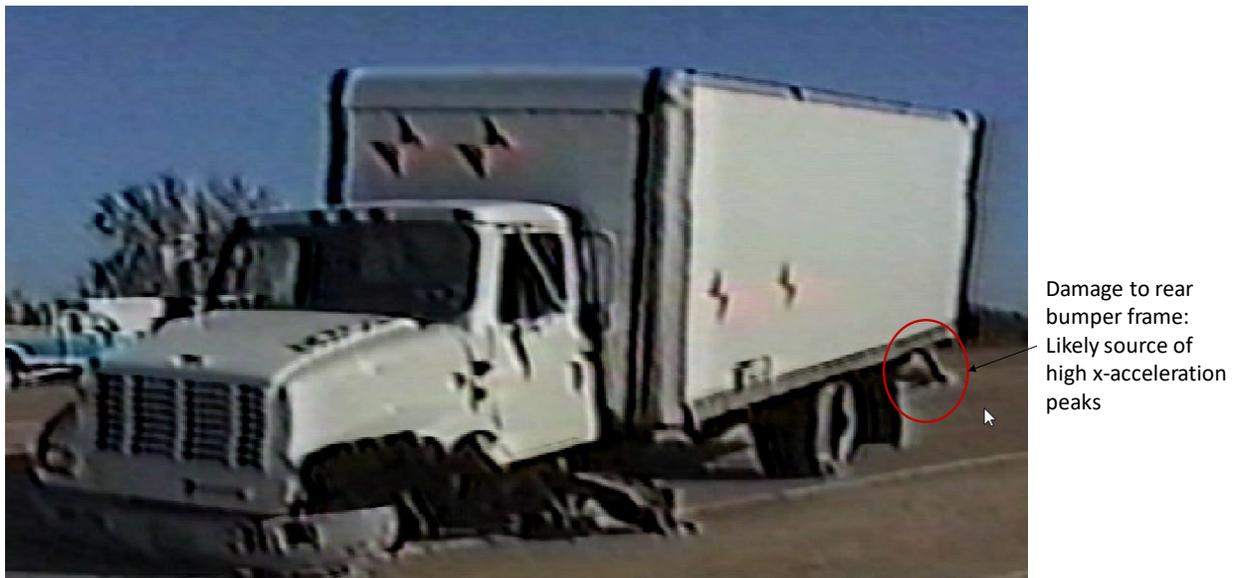
Figure 79. Post-test photo of vehicle damages.

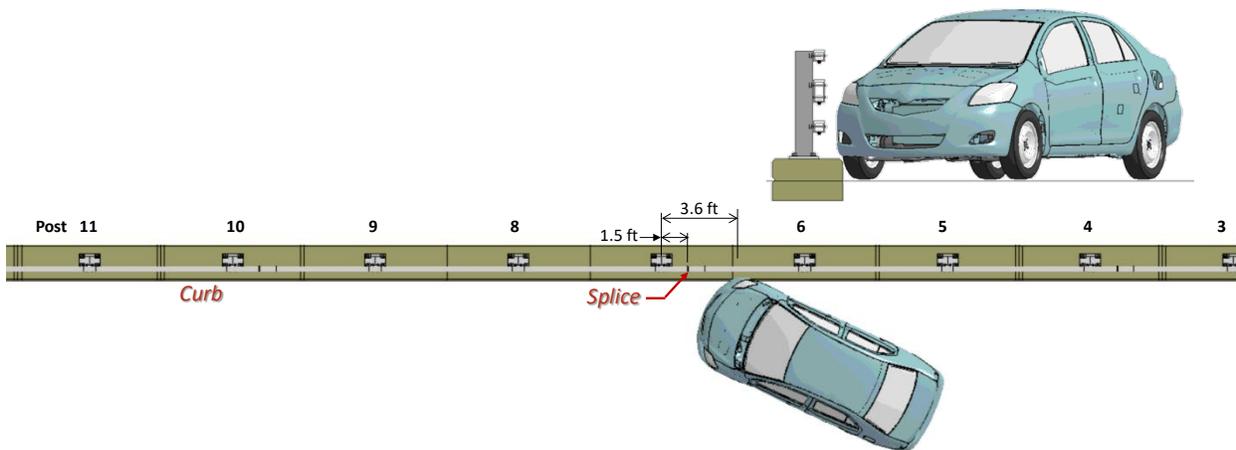
Figure 114. Impact point for Test 4-10 on the NETC 3-bar bridge rail.

The critical impact condition for Test 4-10 was selected based the *MASH* recommended CIP for rigid barrier tests (see Table 2-7 of *MASH*).[*AASHTO16*] The target impact point was 3.6 feet upstream of Post 7 and was selected to maximize potential for snagging at the post, while also providing adequate opportunity for snag at the splice connection for the tubular rails. The splice is located 1.5 feet upstream of the post. The following sections provide a summary of the results and include a commentary describing the timing and occurrence of various events during the simulated impact, time-history data evaluation, occupant risk assessments, and damages sustained by both the barrier and vehicle.

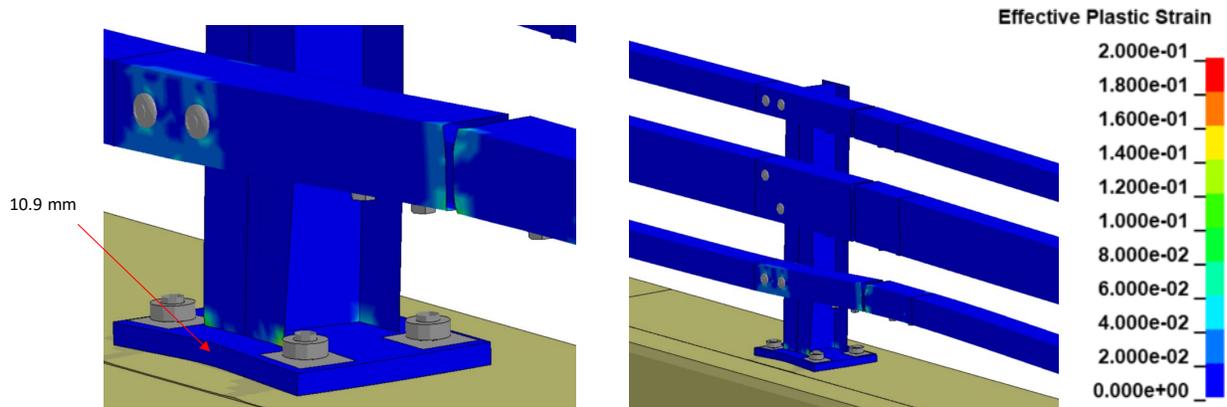
Figure 125. Contours of effective plastic strains for Test 4-10 on the NETC 3-bar bridge rail.

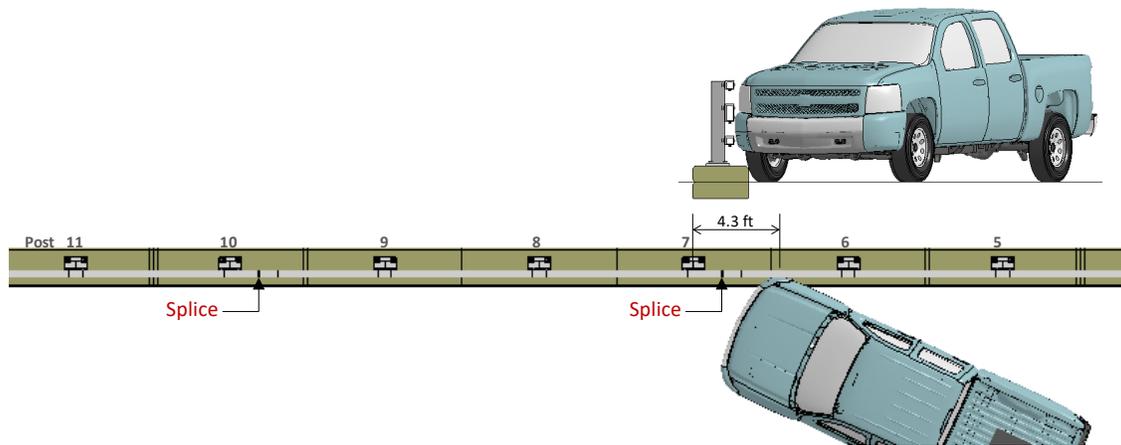
Figure 130. Impact point for Test 4-11 on the NETC 3-bar bridge rail.

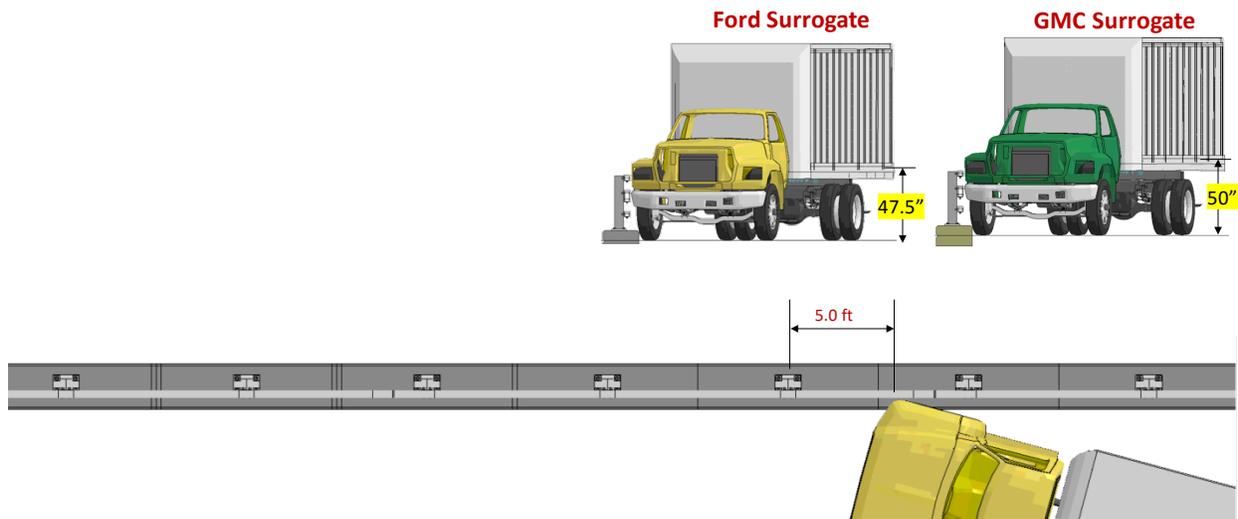
Figure 146. Impact point for Test 4-12 on the NETC 3-bar bridge rail.

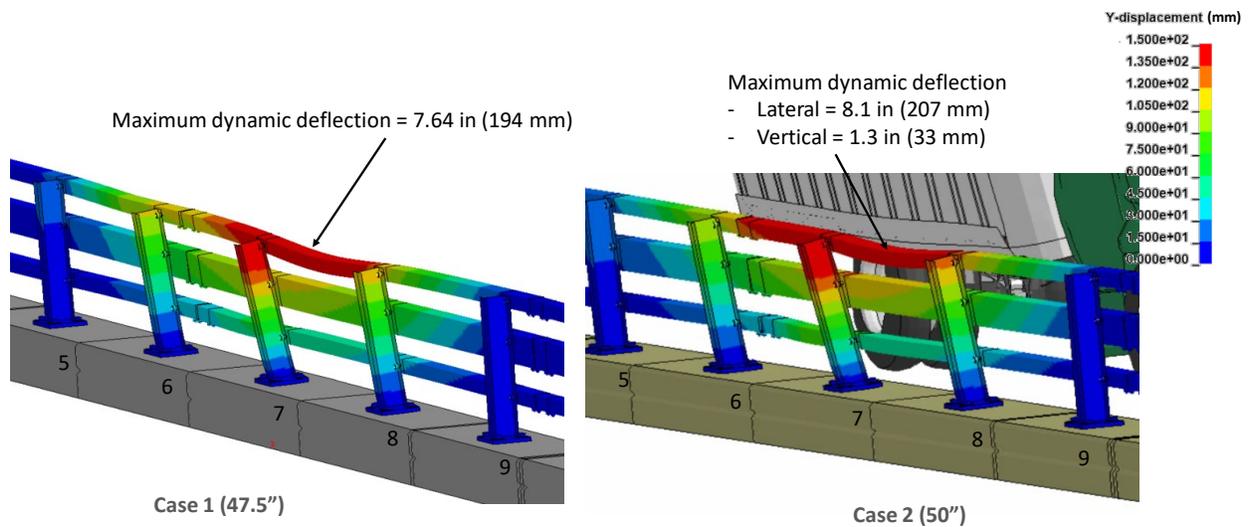
Figure 157. Contour plot of lateral displacement for the bridge rail from Test 4-12 at the time of maximum dynamic deflection for the NETC 3-bar bridge rail.

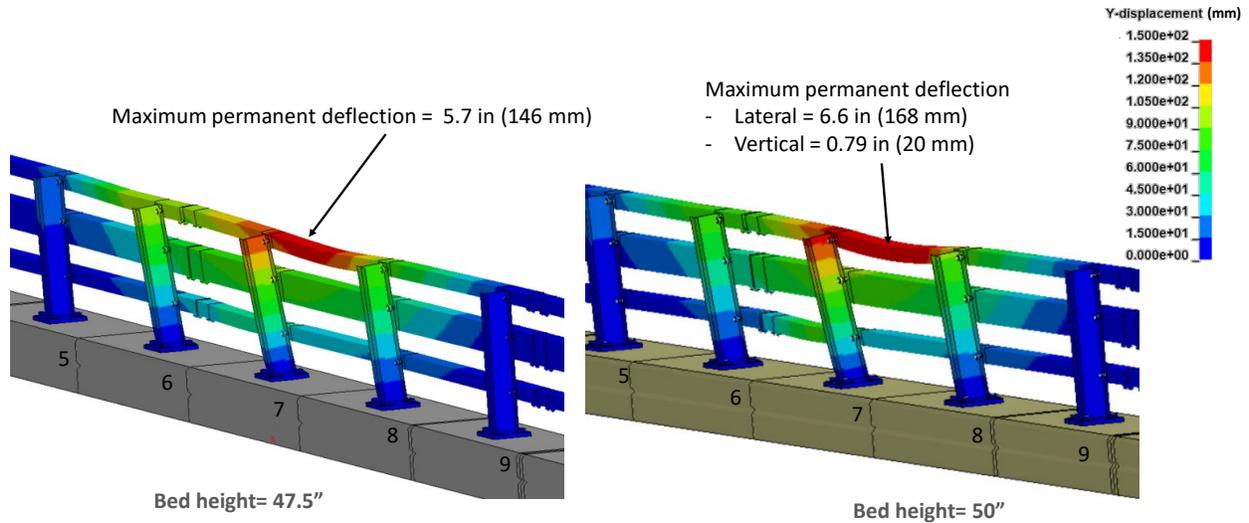
Figure 158. Contour plot of permanent deflection for the bridge rail from Test 4-12 for the NETC 3-bar bridge rail.

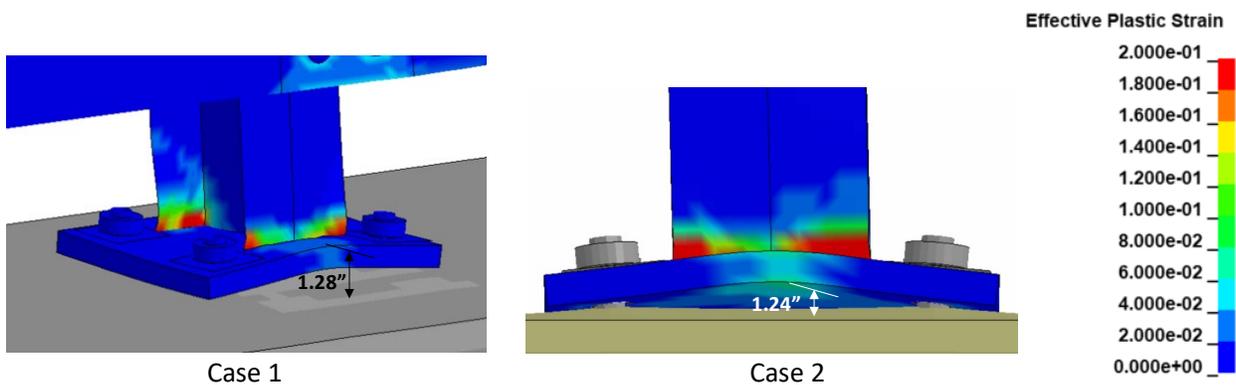
Figure 159. Contours of effective plastic strains on the critical post for Test 4-12 on the NETC 3-bar bridge rail.

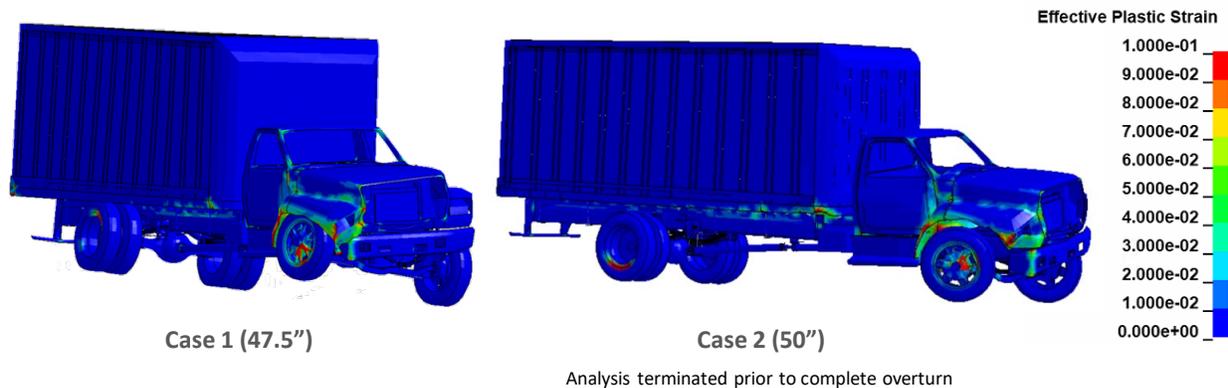
Figure 163. Damages to vehicle in Test 4-12 analysis of NETC 3-bar bridge rail for Cases 1 and 2.

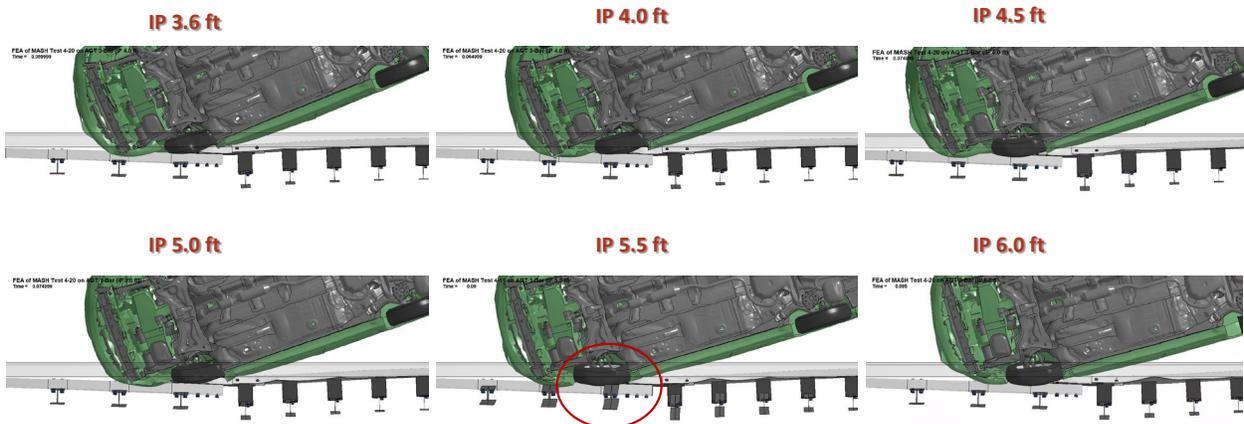
Figure 172. Results of Test 4-20 CIP evaluations for the 3-bar Transition.

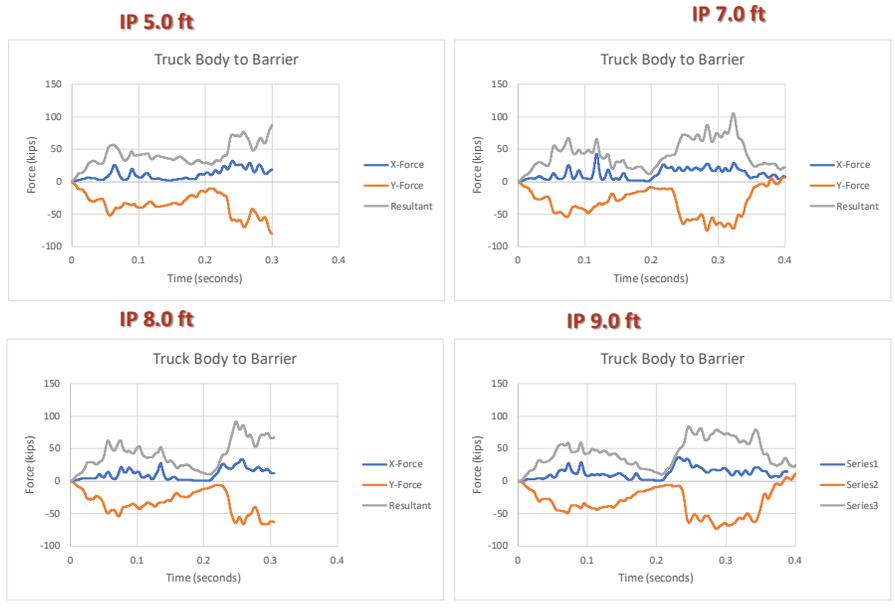
Figure 209. Longitudinal, lateral and resultant forces on barrier for each analysis case.

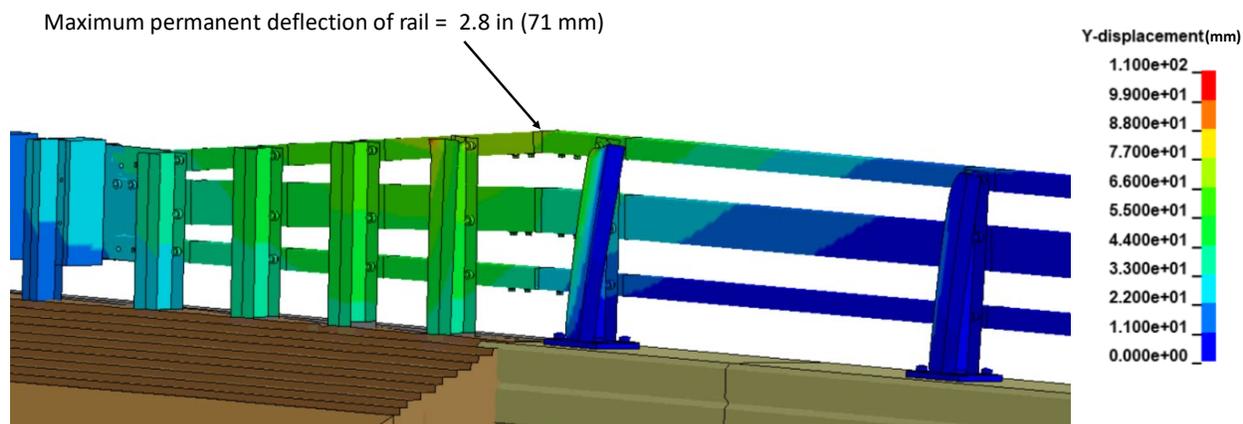
Figure 223. Contour plot of permanent deflection for the 3-bar transition for Test 4-22.

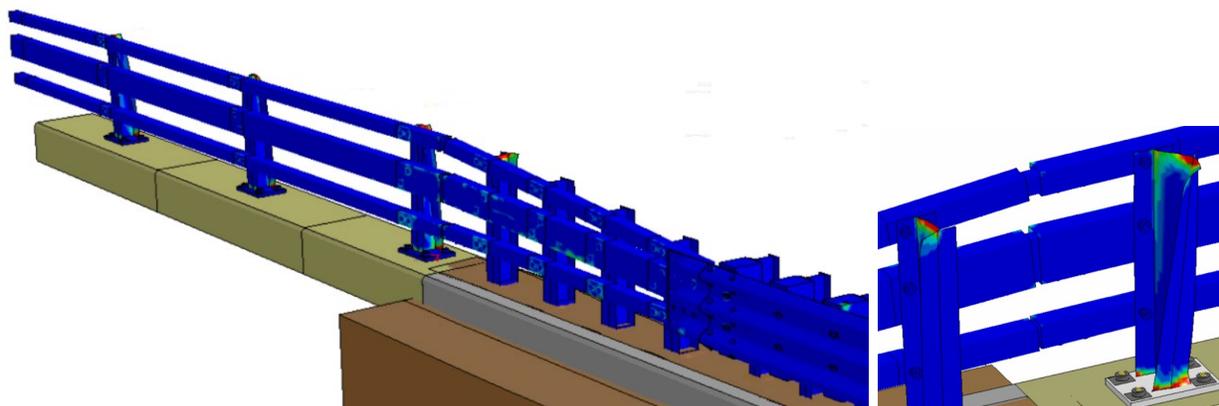
Figure 224. Contours of effective plastic strains on the transition and bridge rail for Test 4-22 on the 3-bar transition.

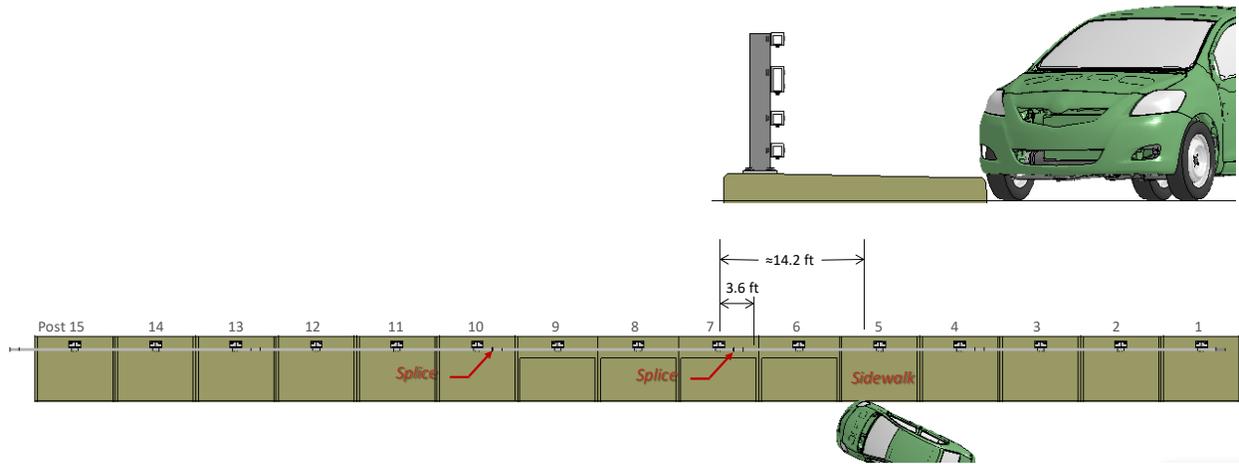
Figure 231. Initial starting point and target impact point for Test 4-10 on the NETC 4-bar bridge rail.

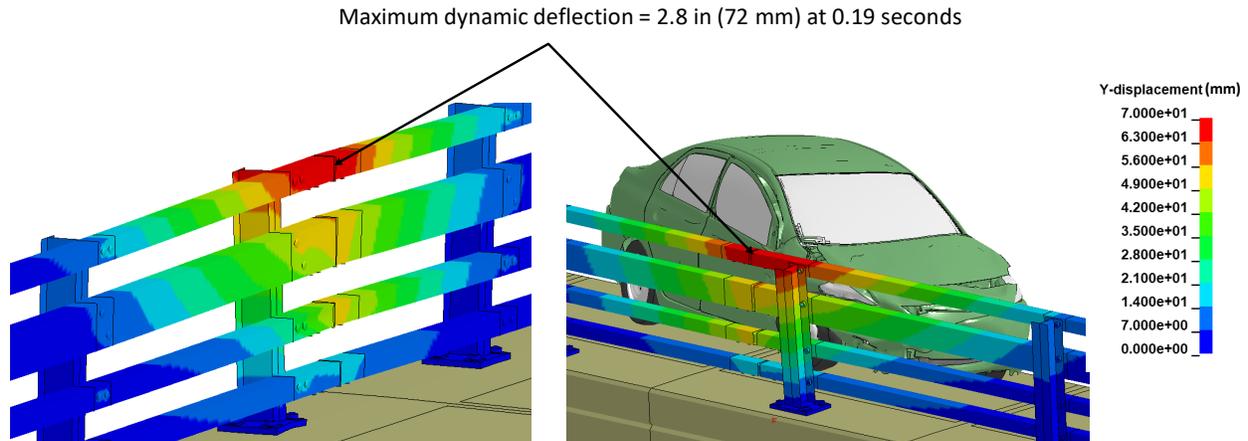
Figure 240. Contour plot of lateral displacement for the bridge rail for Test 4-10 at the time of maximum dynamic deflection.

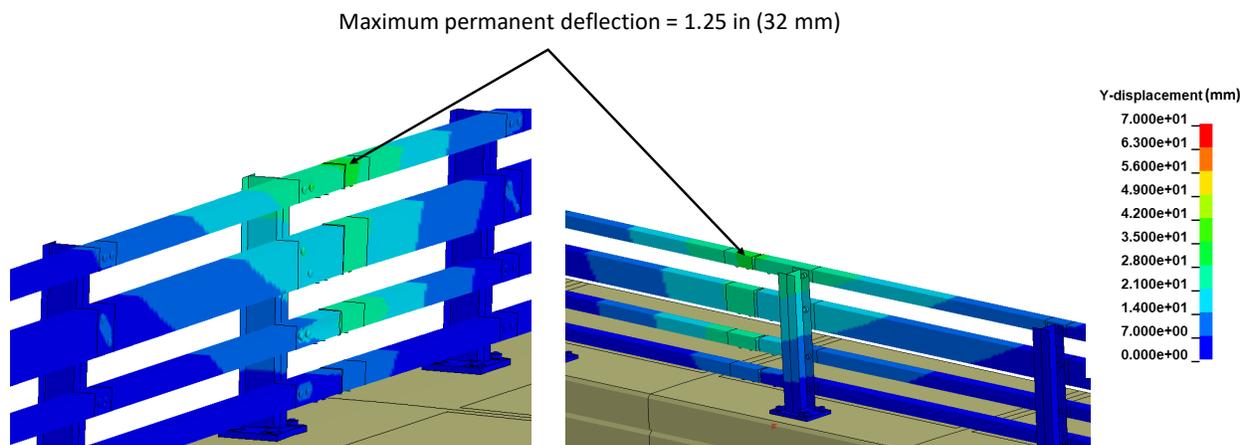
Figure 241. Contour plot of maximum permanent deflection of the bridge rail for Test 4-10.

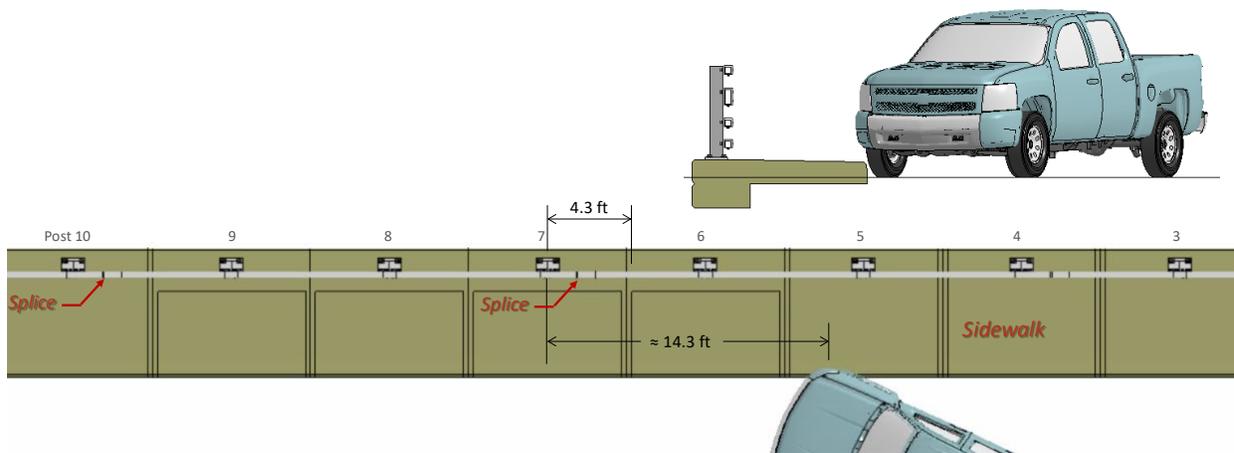
Figure 247. Initial starting point and target impact point for Test 4-11 on the NETC 4-bar bridge rail.

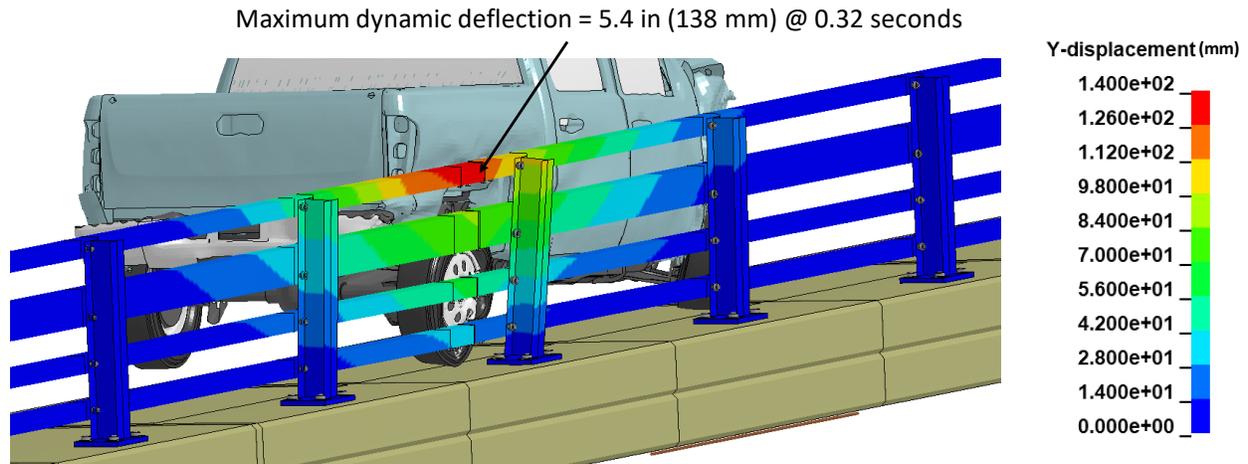
Figure 256. Contour plot of lateral displacement for the bridge rail for Test 4-11 at the time of maximum dynamic deflection.

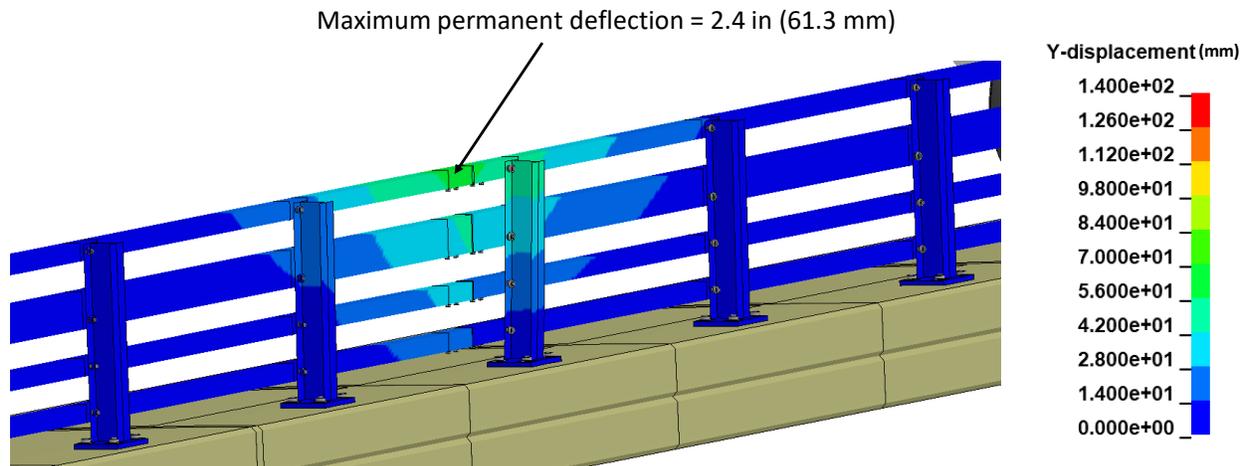
Figure 257. Contour plot of maximum permanent deflection of the bridge rail for test 4-11.

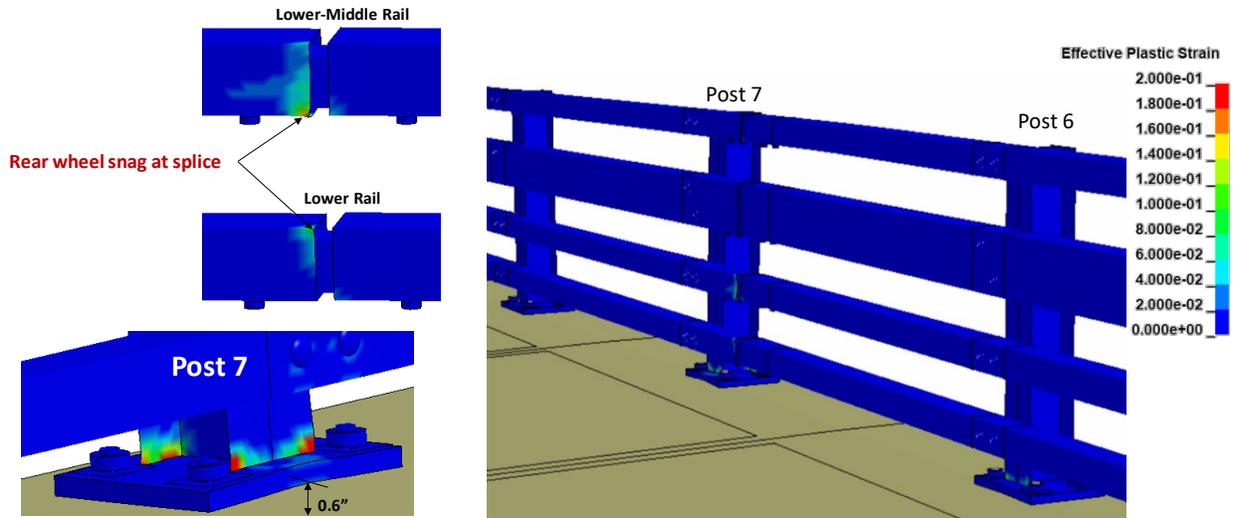
Figure 258. Contours of effective plastic strains for Test 4-11 on the NETC 4-bar bridge rail.

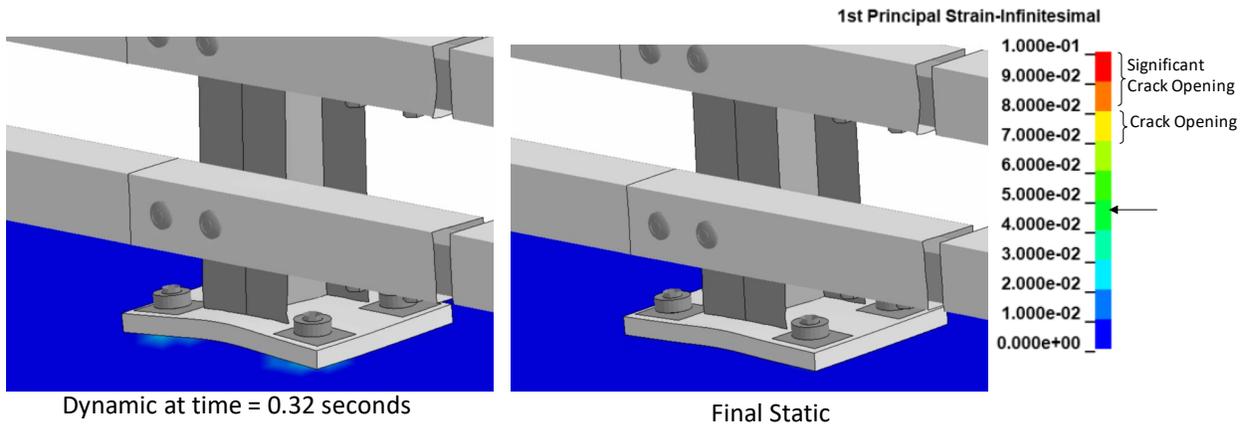
Figure 259. Contours of 1st principal strains for concrete at the critical post for Test 4-11 on the NETC 4-bar bridge rail.

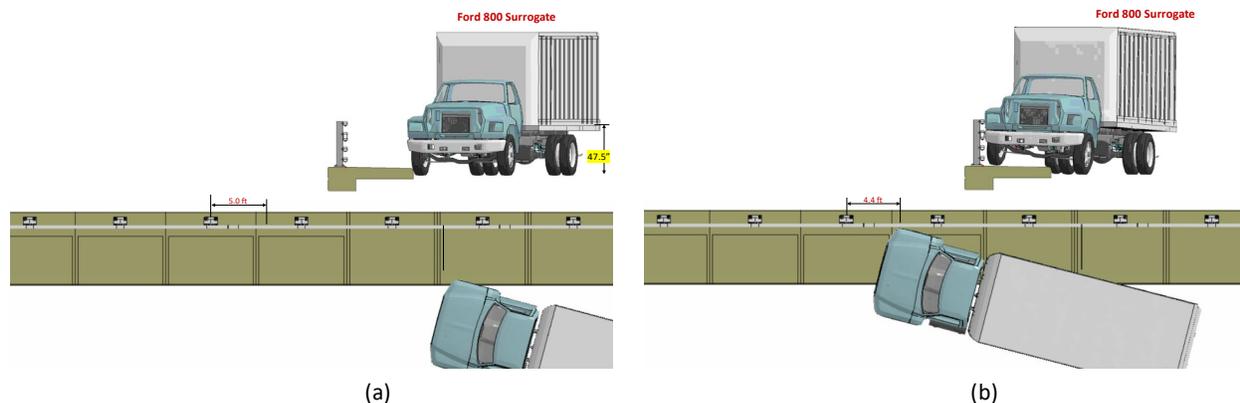
Figure 263. (a) Target and (b) actual impact point for Test 4-12 on the NETC 4-bar bridge rail.

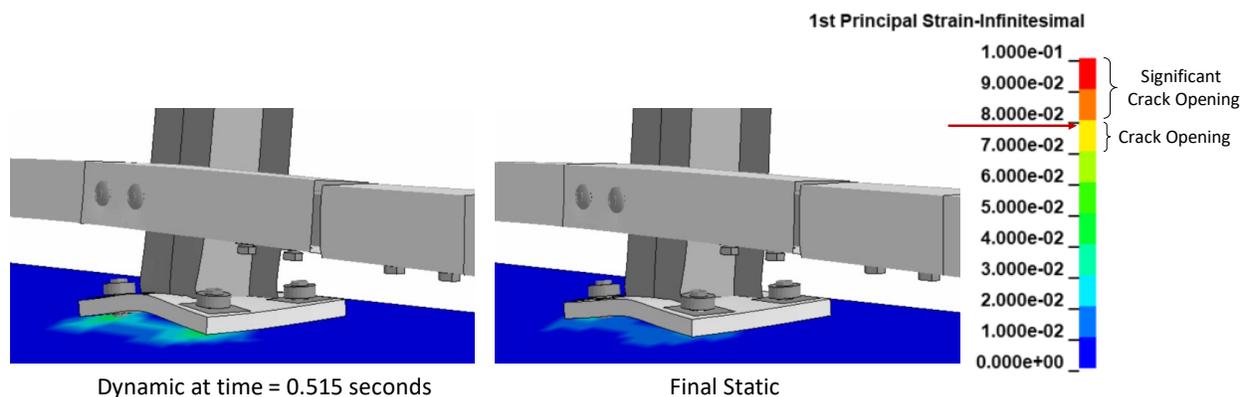
Figure 278. Contours of 1st principal strains for concrete at the critical post for Test 4-12 on the NETC 4-bar bridge rail.

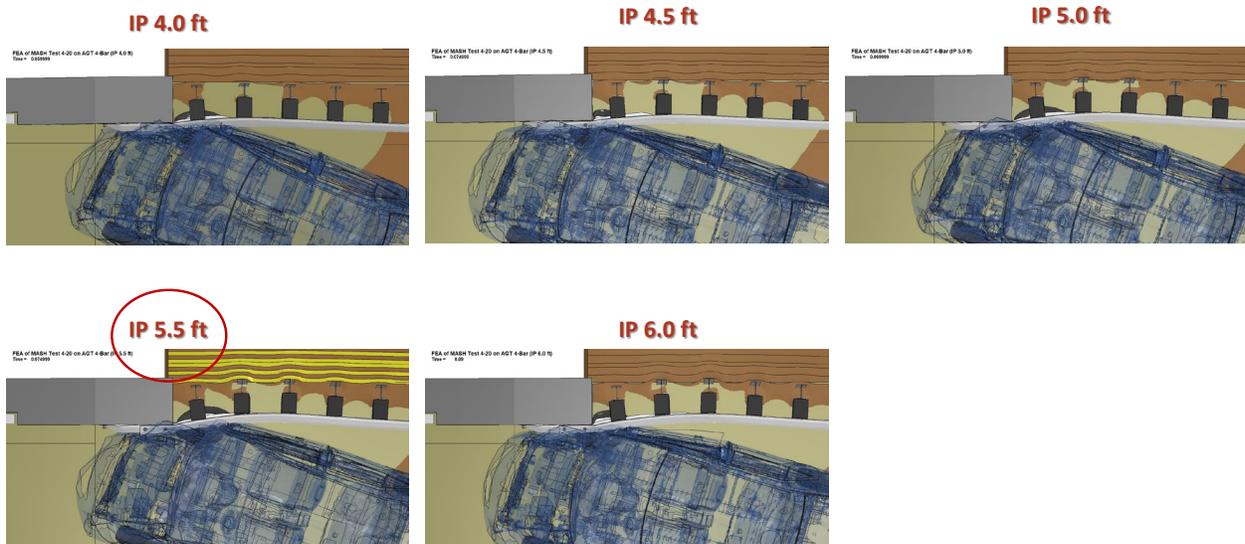
Figure 293. Results of the Test 4-20 simulations showing the deformation and position of the vehicle just before the tire impacted against the buttruss for each case.
