*Development of MASH Computer Simulated Steel
Bridge Rail and Transition Details*

Prepared for: **Maine Department of Transportation**

DEVELOPMENT OF MASH COMPUTER SIMULATED STEEL BRIDGE RAIL AND TRANSITION DETAILS

**Prepared for
The New England Transportation Consortium
April 28, 2020**

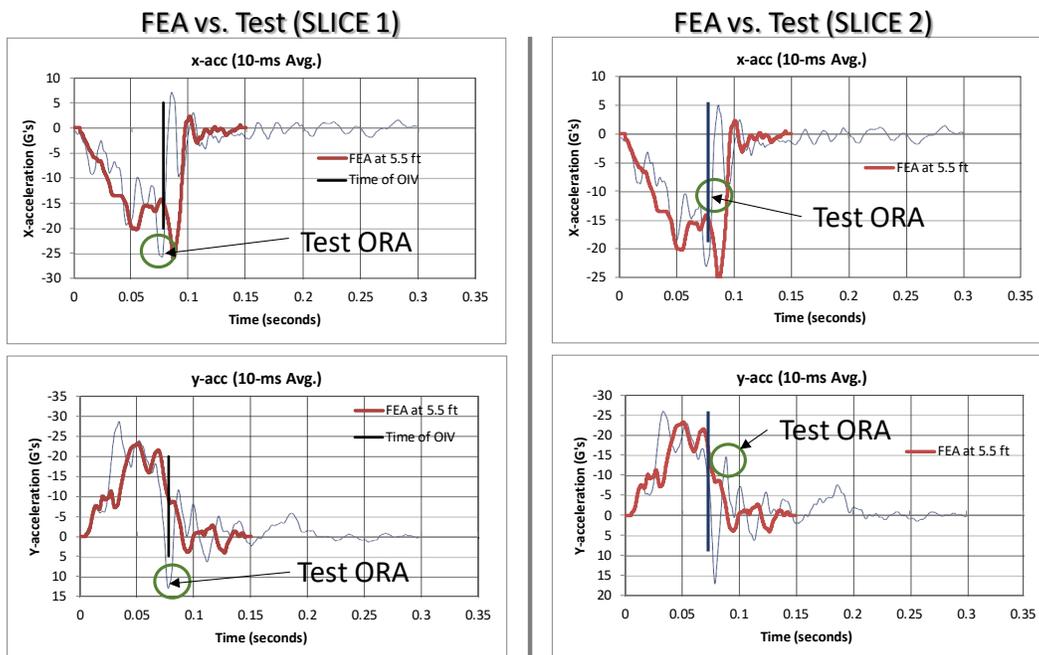
Figure 315. Overlay of acceleration-time histories for FEA and tests.

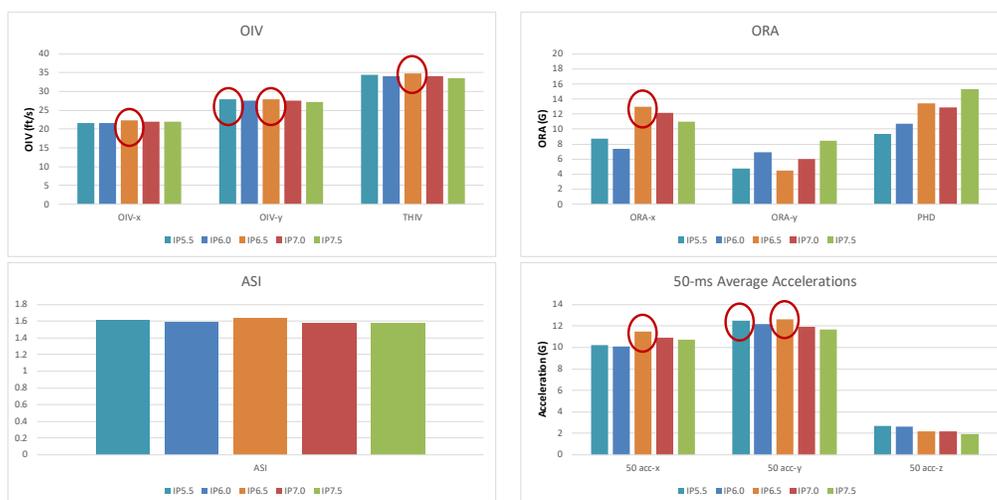
Figure 320. Comparison of occupant risk metrics computed in TRAP for Test 4-21.

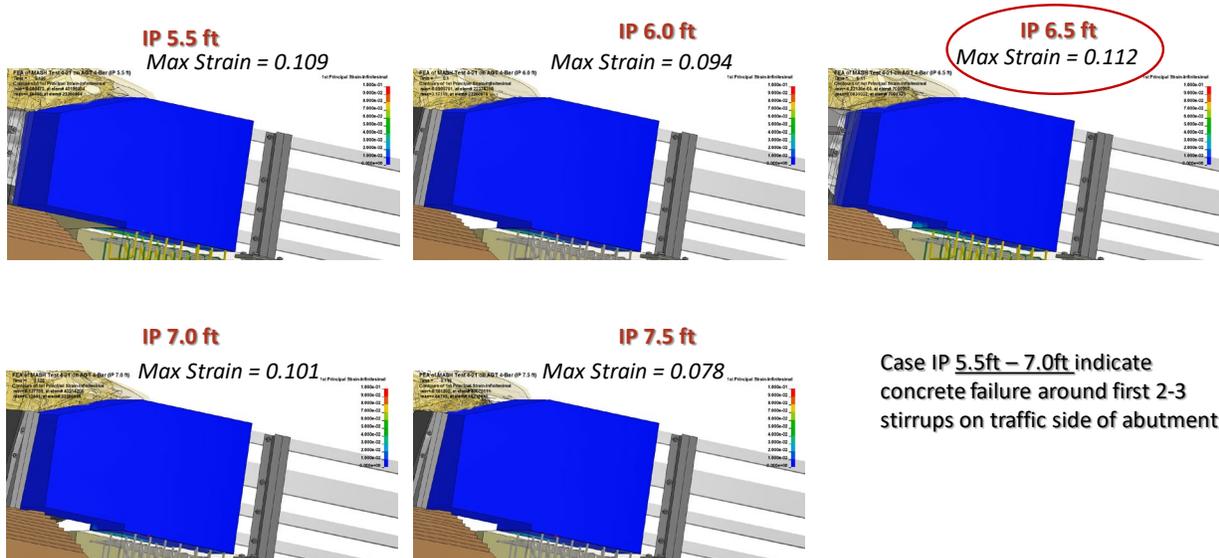
Figure 321. Contour plots of 1st principle strain for the buttress.

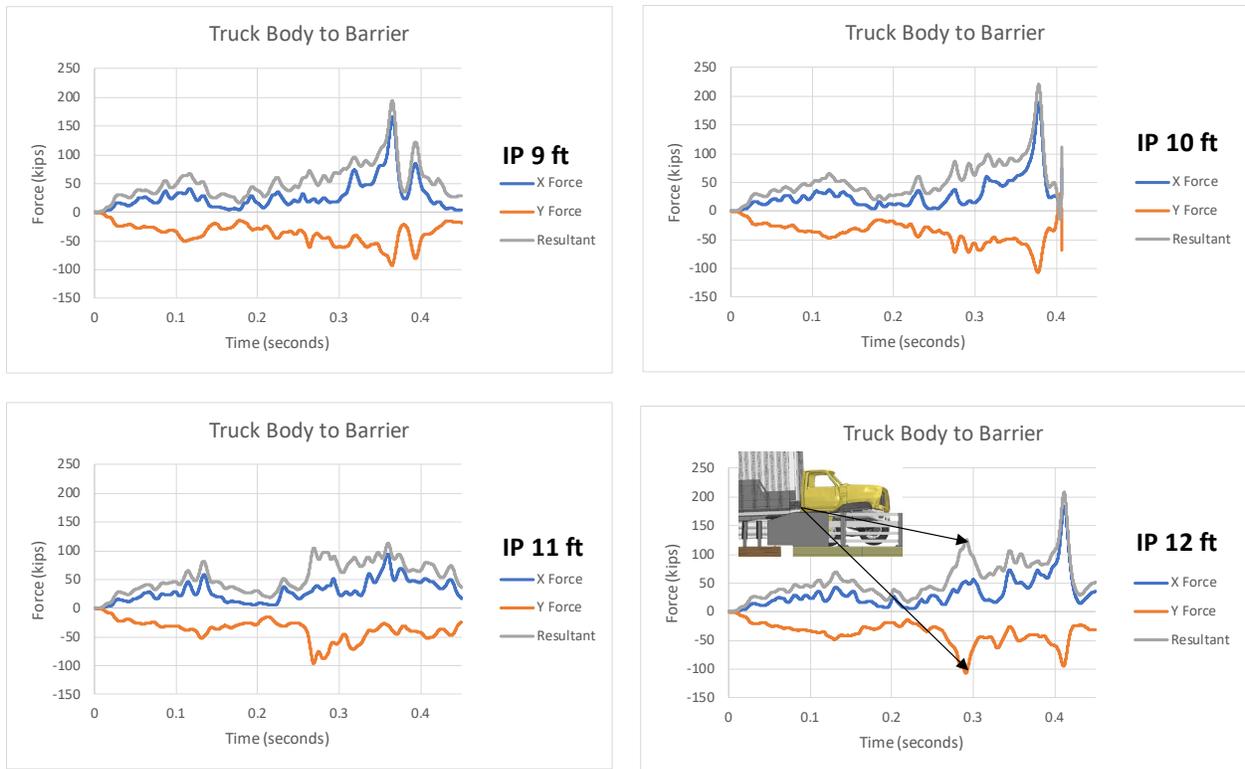
Figure 341. Longitudinal, lateral and resultant forces on barrier for each analysis case.

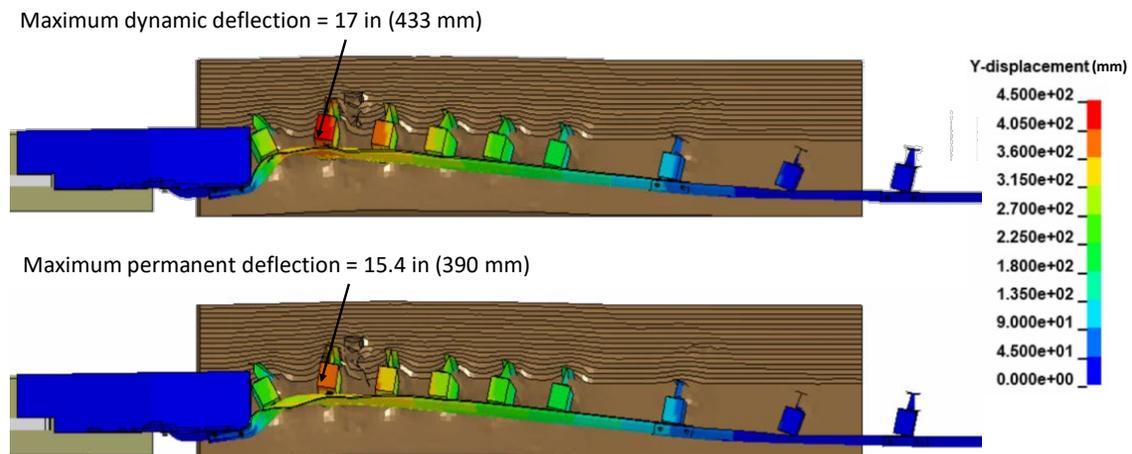
Figure 356. Contour plot of lateral displacement for the MaineDOT transition for Test 4-22 at the time of maximum dynamic deflection.

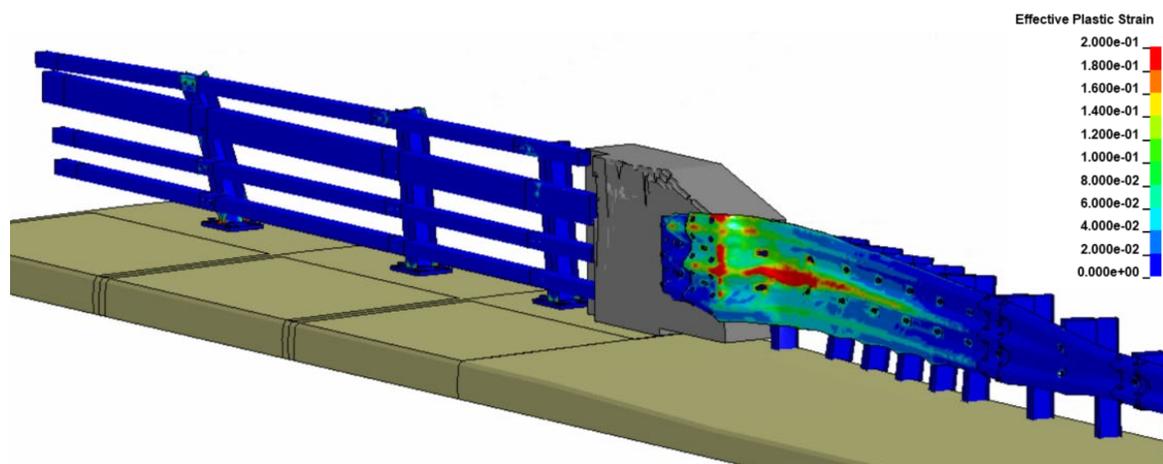
Figure 357. Contours of effective plastic strains on the transition and bridge rail for Test 4-22 on the MaineDOT transition.

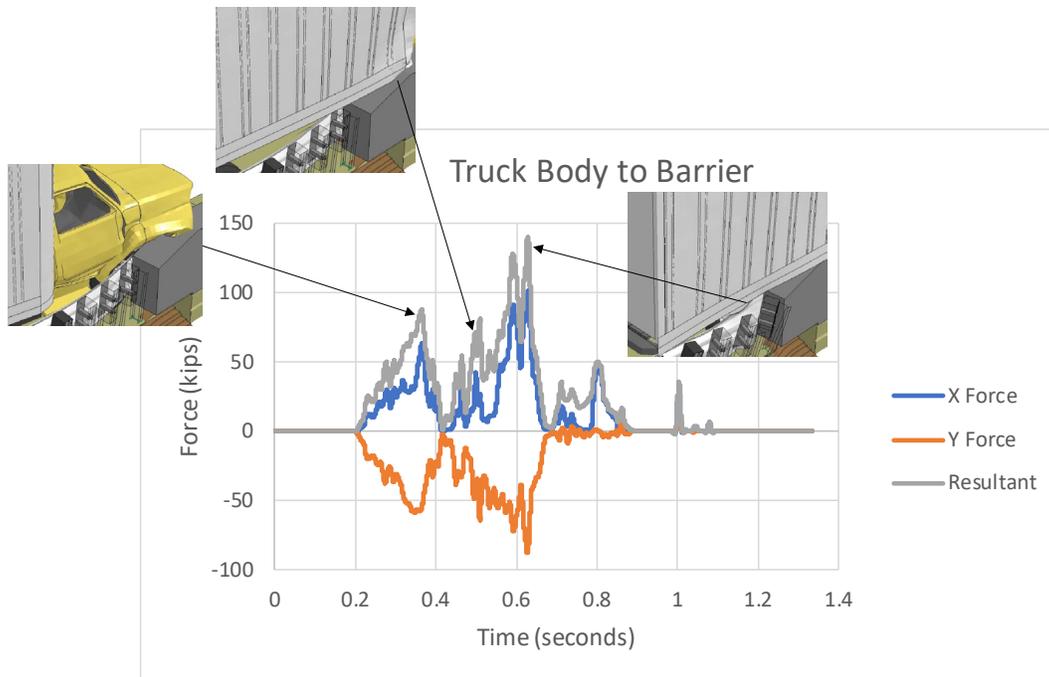
Figure 360. Longitudinal, lateral and resultant force-time history between vehicle and barrier for Test 4-22 on the MaineDOT transition.

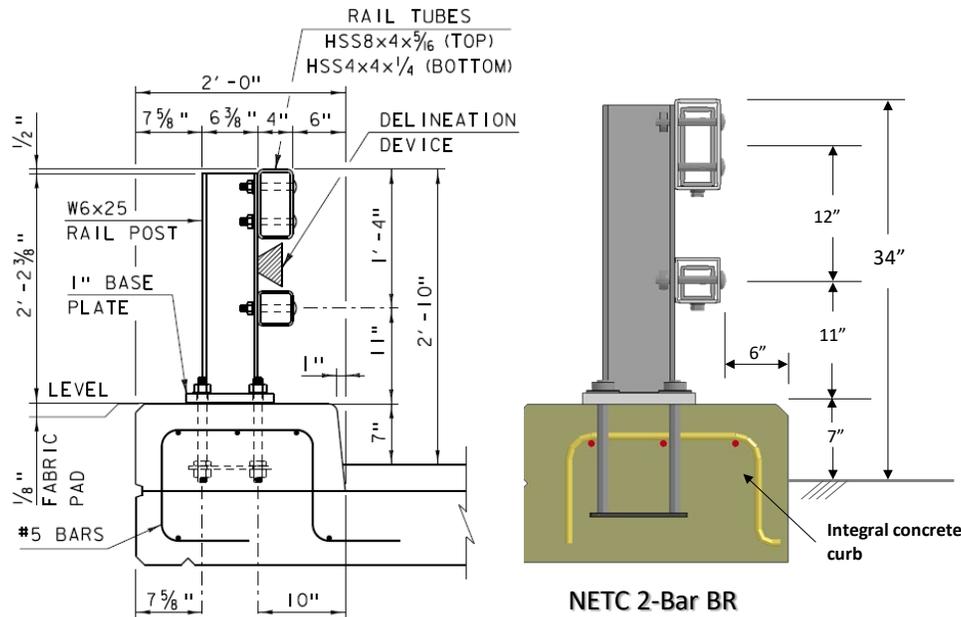
Figure 364. Section view drawing and the FEA model of the NETC 2-Bar bridge rail.

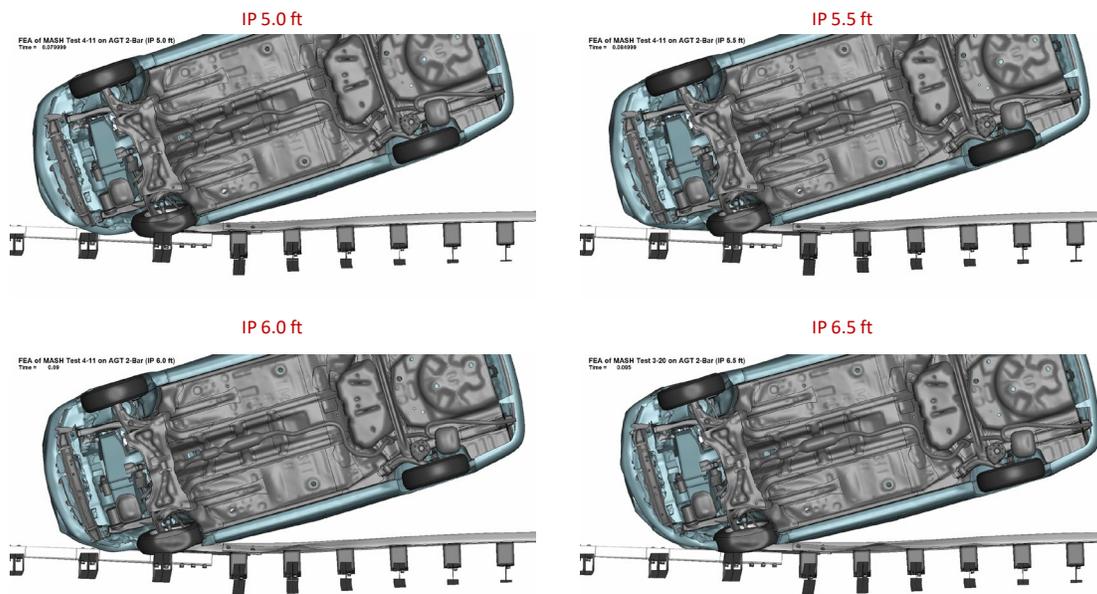
Figure 399. Results of Test 3-20 CIP evaluations for the 2-bar Transition.

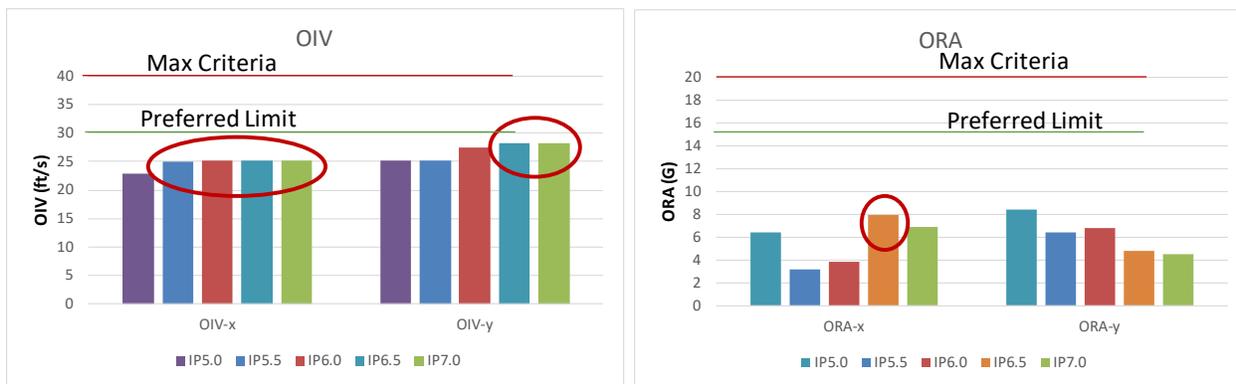
Figure 401. OIV and ORA metrics calculated for the five Test 3-20 analysis cases on the 2-bar transition.

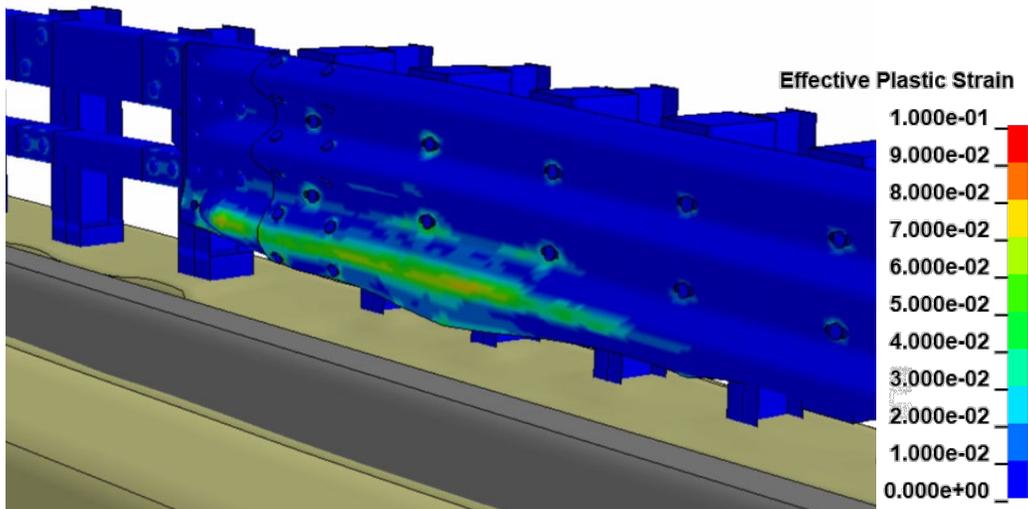
Figure 413. Contours of effective plastic strains on the steel rails and posts for 2-bar transition.

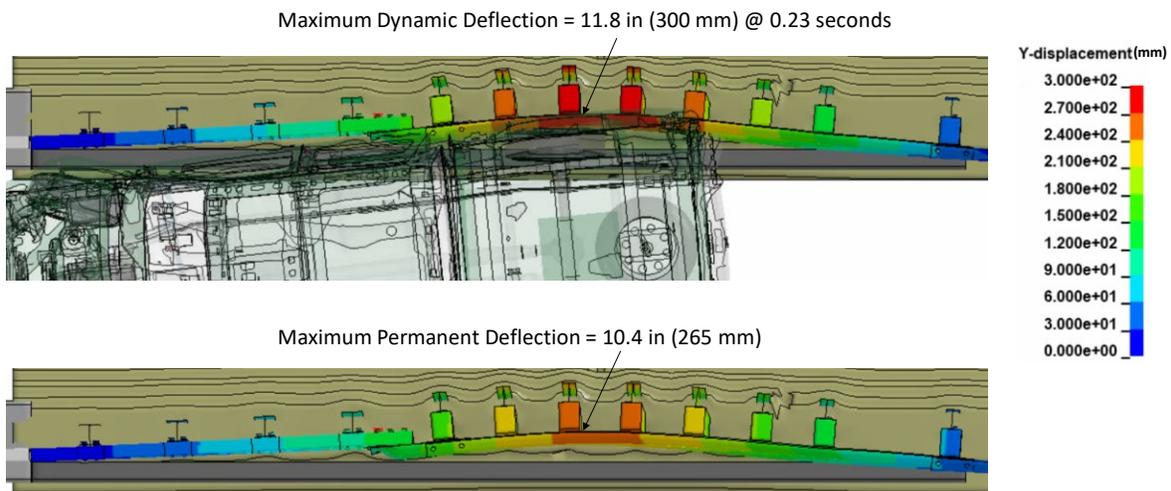
Figure 432. Contour plot of lateral displacement for Test 3-21 on the 3-bar transition at the time of maximum dynamic deflection and maximum permanent deflection.

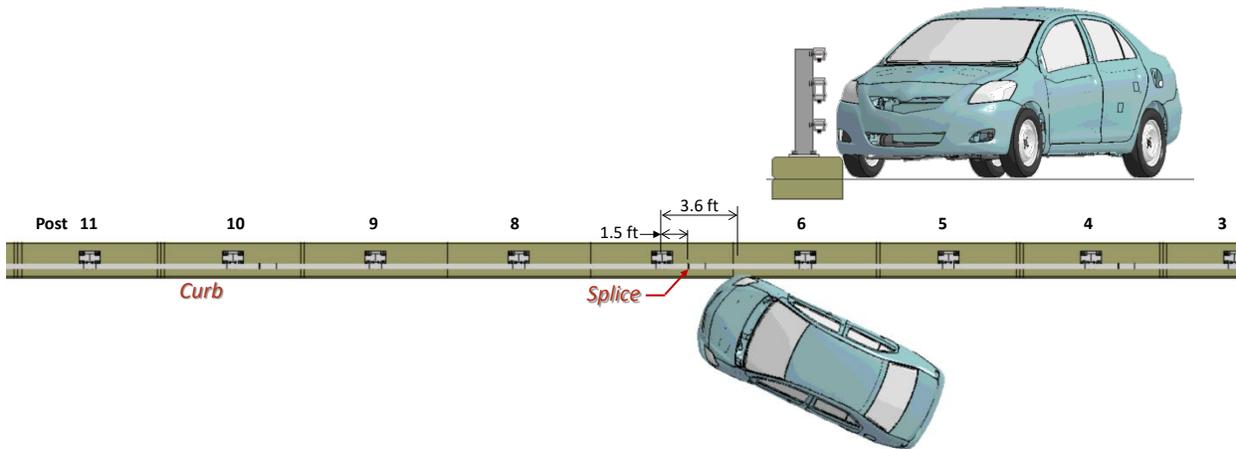
Figure 439. Impact point for Test 4-10 on the Modified NETC 3-bar bridge rail.

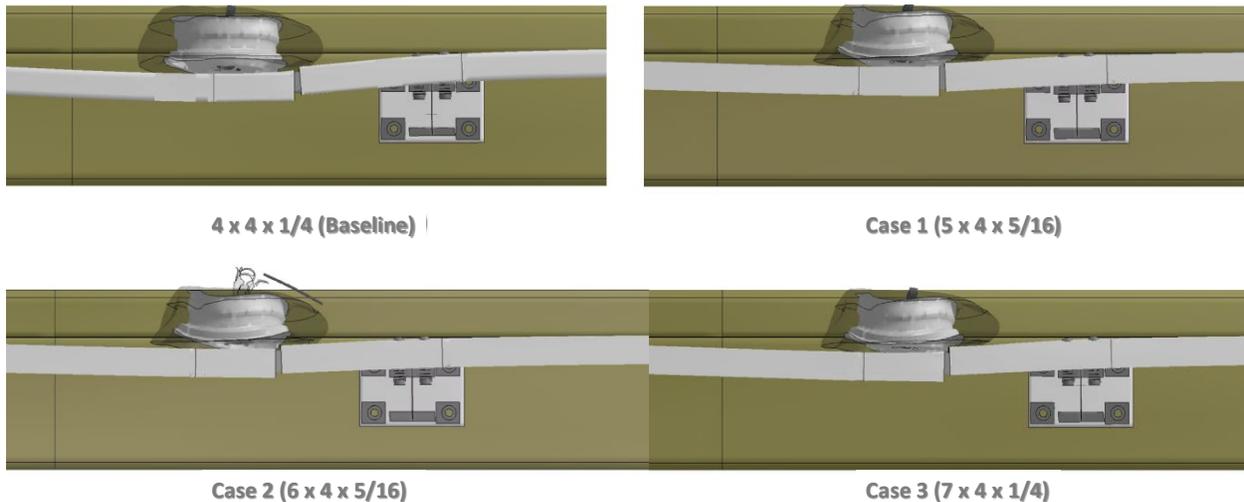
Figure 440. Overhead transparent view showing maximum deflections of the lower rail for each analysis case compared to baseline.

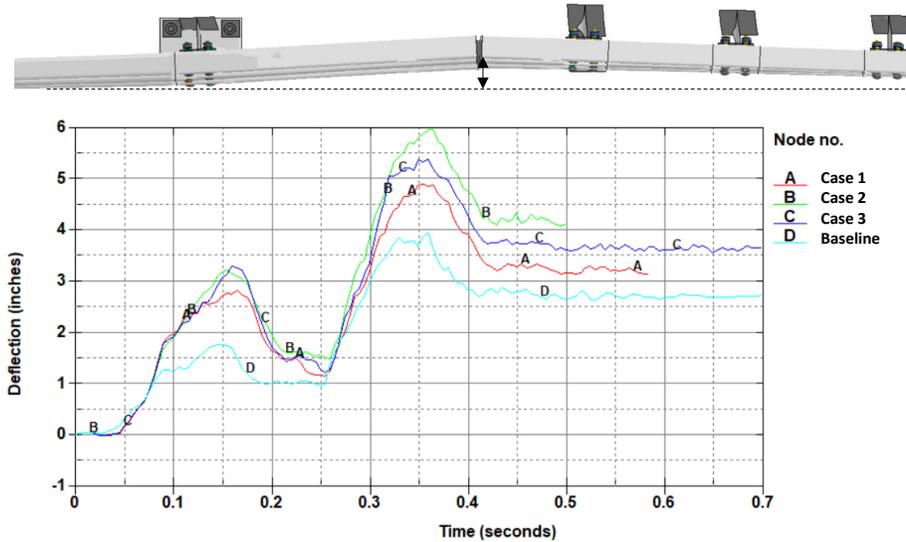
Figure 490. Deflection-time history at expansion splice for Cases 1-3 compared with baseline case.

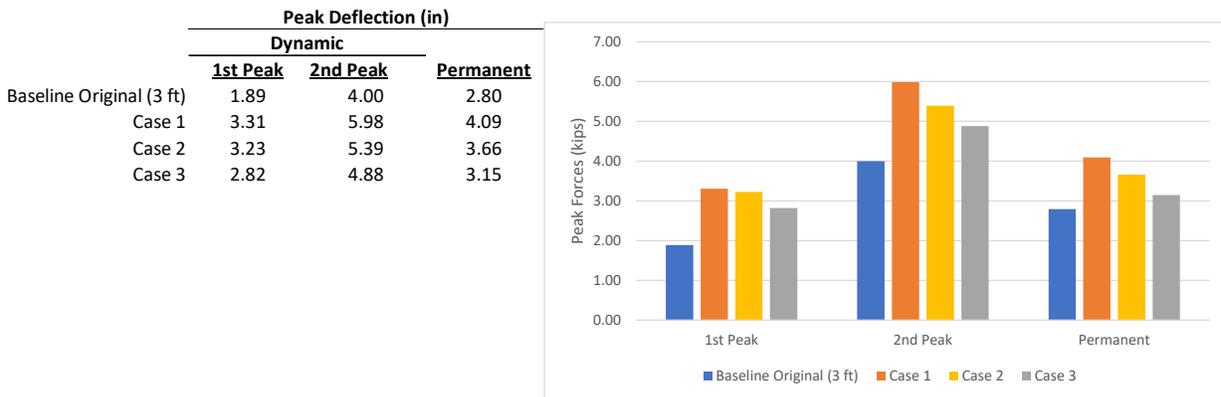
Figure 491. Peak lateral deflections of the barrier for Cases 1-3 compared with baseline case.

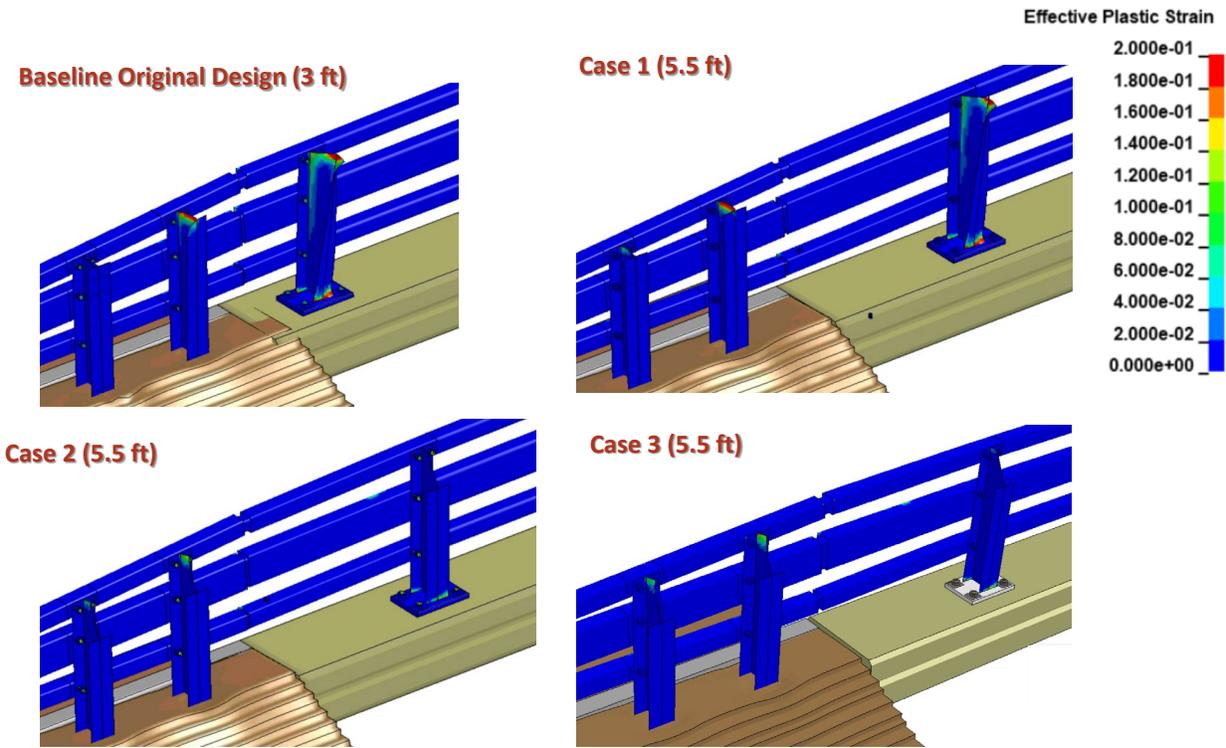
Figure 492. Contour plot of effective plastic strain for Cases 1-3 compared with baseline case.

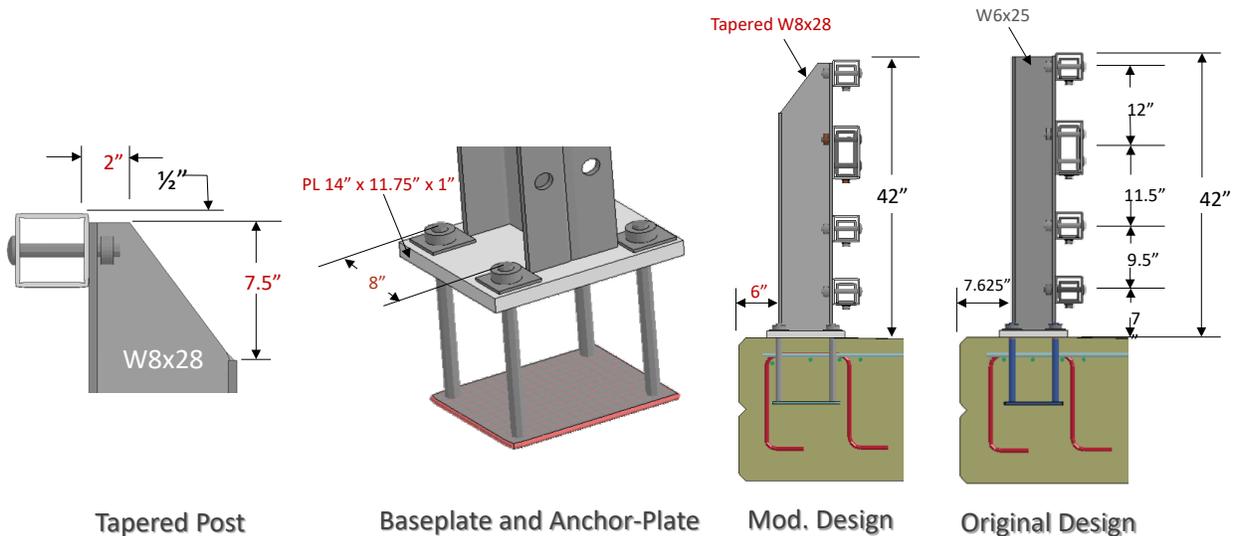
Figure 494. Design modifications for the 4-bar bridge rail.

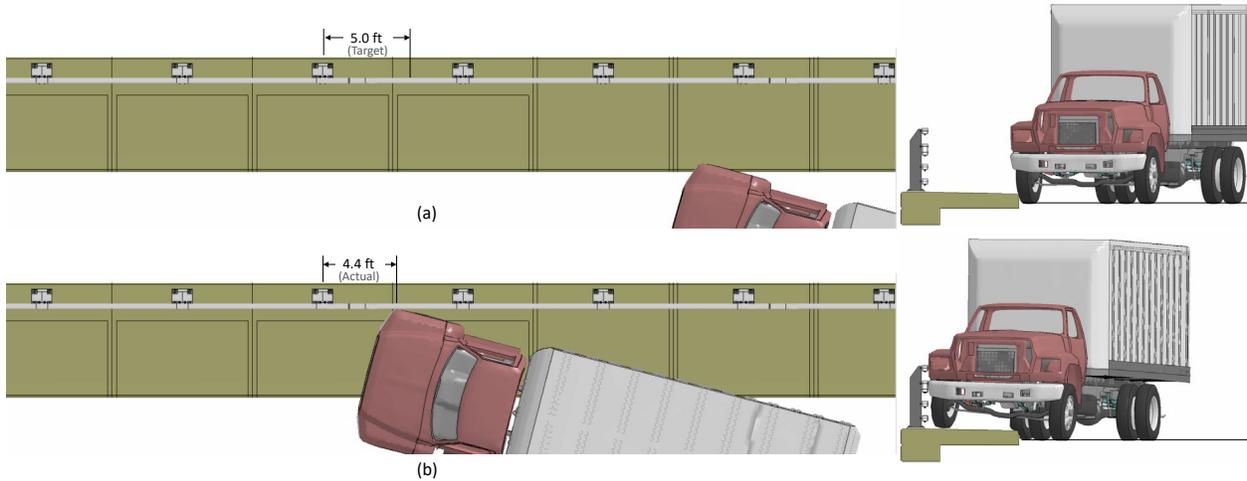
Figure 495. (a) Target and (b) actual impact point for Test 4-12 on the modified NETC 4-Bar bridge rail.

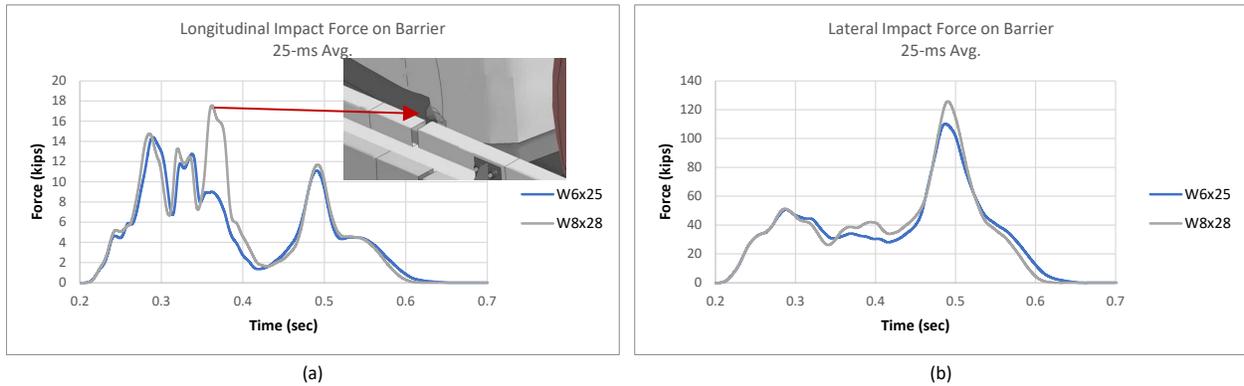
Figure 506. (a) longitudinal and (b) lateral impact force-time history for the baseline and modified design cases.

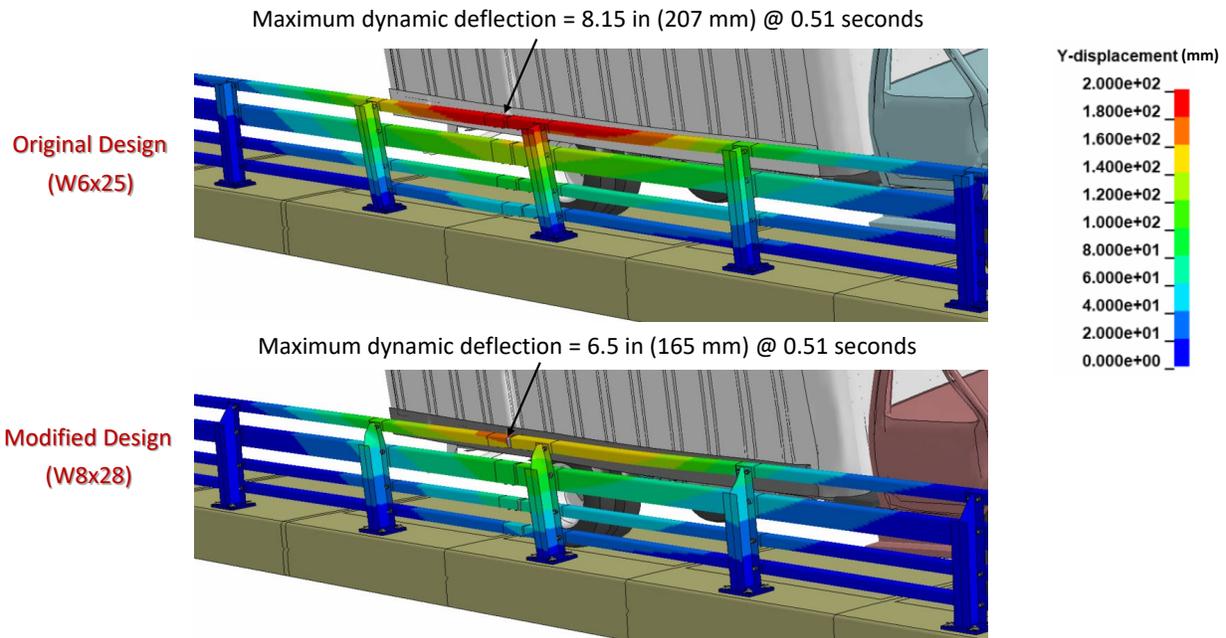
Figure 507. Contour plot of lateral displacement for the bridge rail from Test 4-12 at the time of maximum deflection for the original and modified design cases.
