Introduction to CTDOT Retaining Wall Program

NETC Topical Discussion – March 21st, 2024

Connecticut Department of Transportation Retaining Wall Inventory and Assessment Guidelines

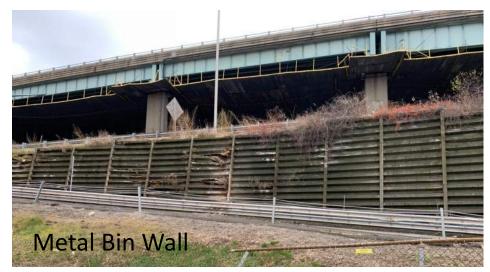
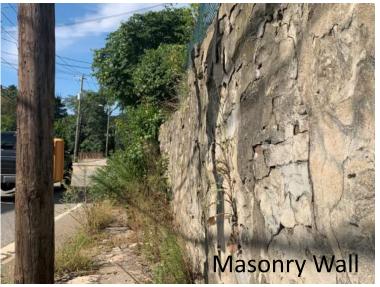
CTDOT defines the retaining walls as "structures that provide a grade separation by retaining earth and/or rock to support roadway and other structures".

NCHRP Report 903 quantifies the retaining walls as structures with vertical face inclination of 70 degrees or steeper and exposed face of 4 feet or taller.

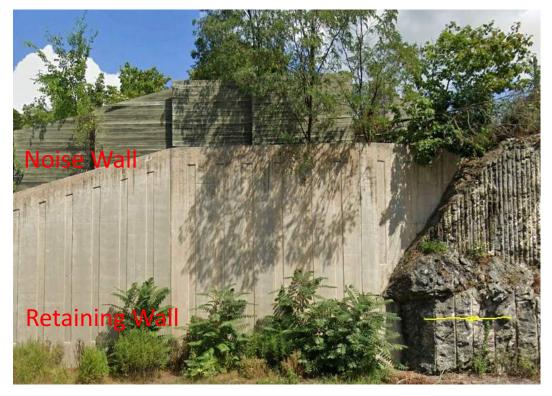
• 12 Retaining Wall Types

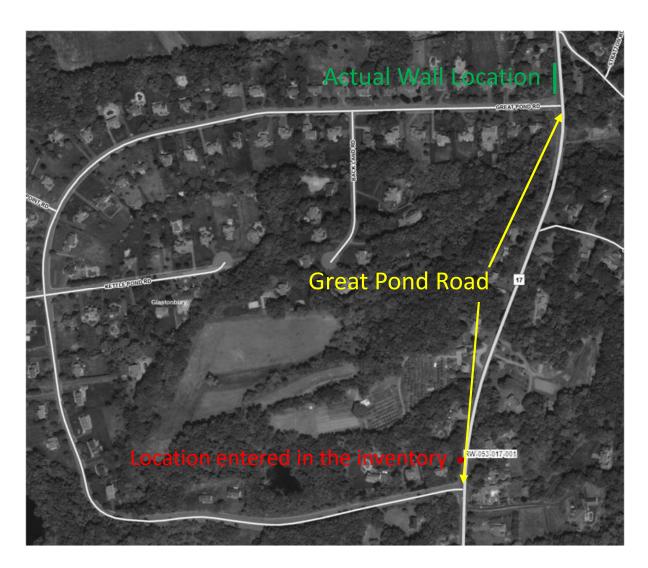
- <u>Geospatial vs. Route</u> <u>Number/Mile Point:</u>
- Wall Identified in relation to "Great Pond Road".
- Wall location misidentified in 2010s.
- Field verification in 2020s.

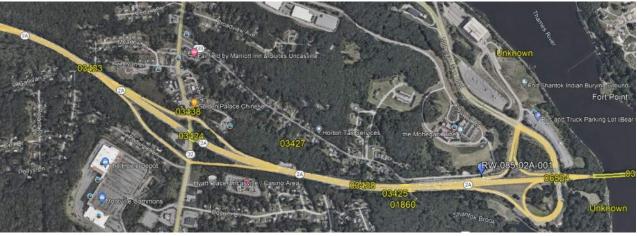
One wall was identified during field visit (2010s program)

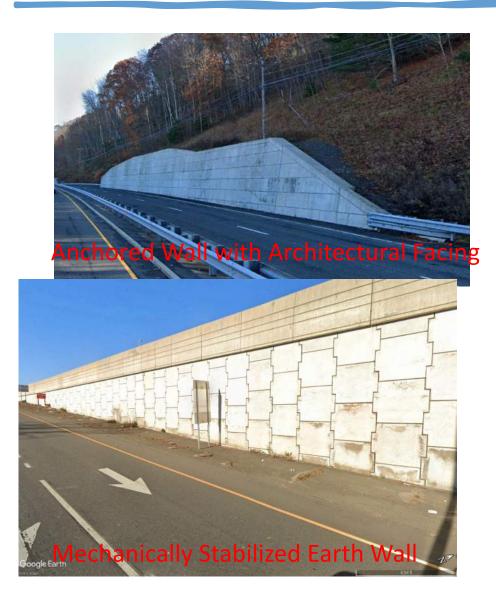
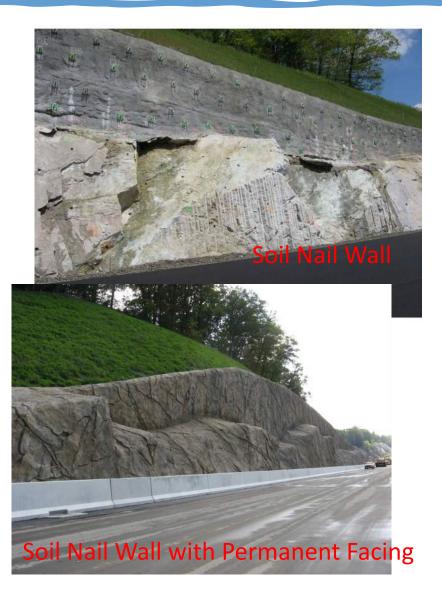
Challenges – Visual Inspection Walls with Internal Reinforcement

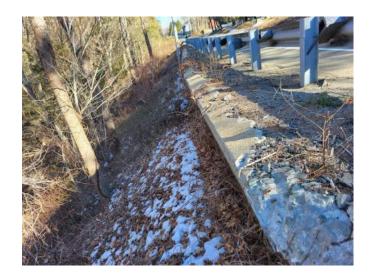
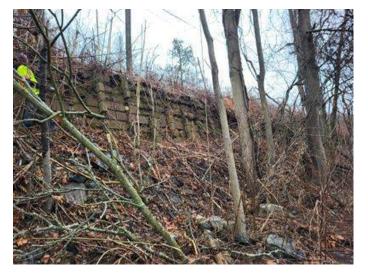
Challenges - Condition Rating

Condition Rating Criteria:

Total Condition Rating (0 to 6): sum of the three criterion

SOGR is defined as walls with total condition rating of 3 or higher.

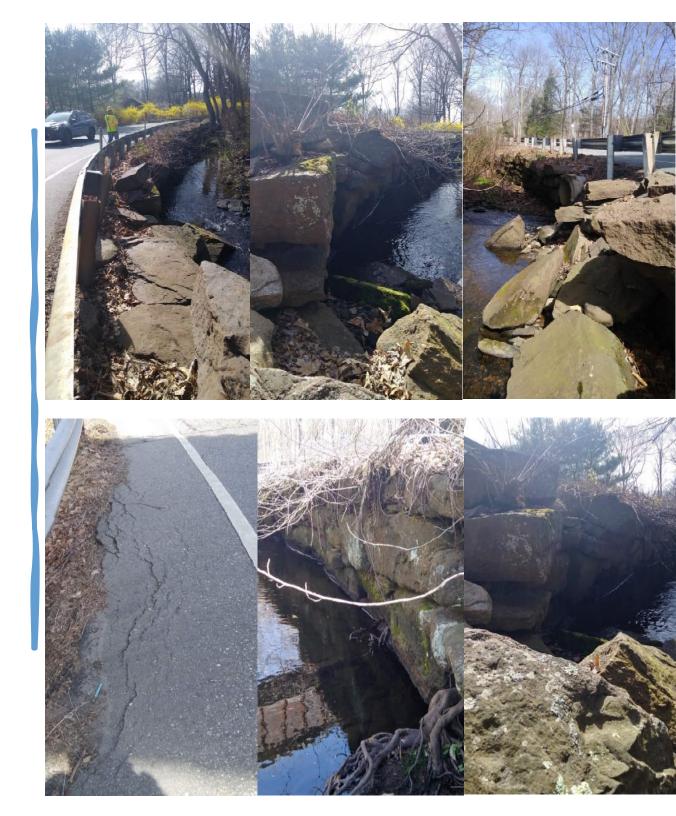
RW-081-147-001: April 2023 \rightarrow Initiate a project for immediate repairs

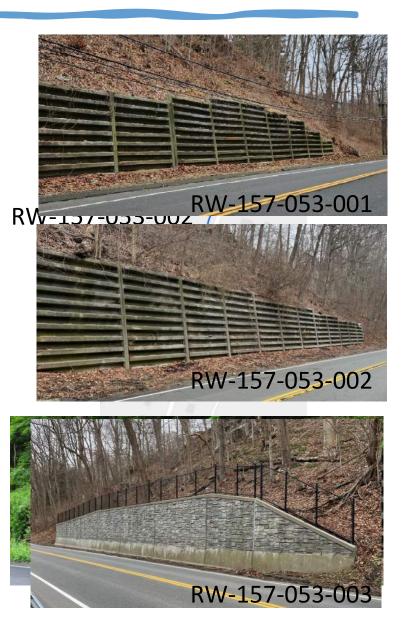
- Metal Bin Wall
- 2010s Total Condition Rating: 4
- 2020s Total Condition Rating: 3 RW-157-053-002
- Metal Bin Wall
- 2010s Total Condition Rating: 4
- 2020s Total Condition Rating: 2

A project is proposed to be initiated to replace RW-157-053-001 and RW-157-053-002

- Metal Bin Wall
- 2010s Total Condition Rating: 3
- 2019: A *concrete wall* was constructed in front of this wall.
- 2020 Total Condition Rating: 6
