189/US2 Bolton-Waterbury Wildlife Crossings

Bolton-Waterbury Study

**Bolton Waterbury STP 2709(1)
 Wildlife Connectivity Study
 Final Report**

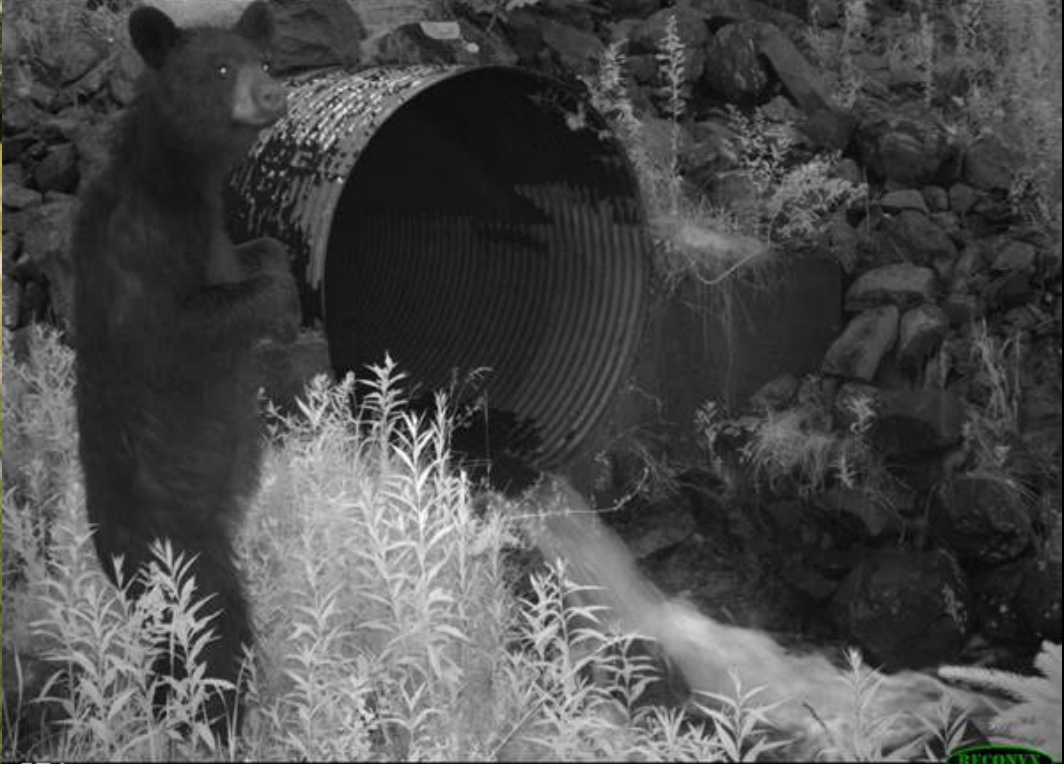
2015-07-18 7:19:08 PM M 1/3 72°F

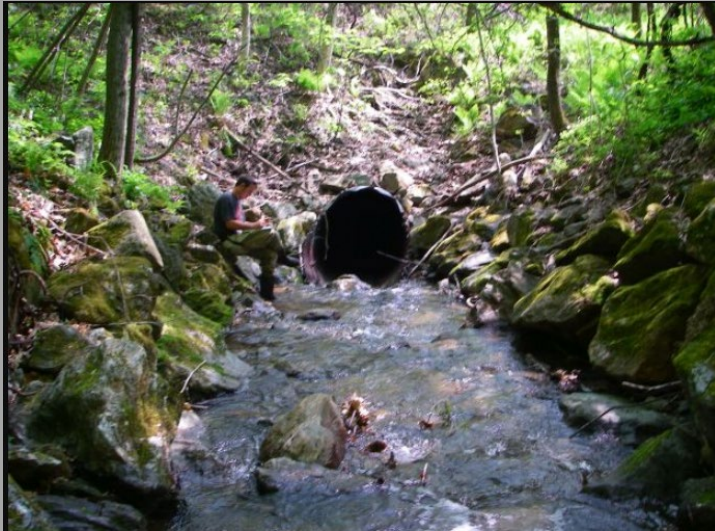
Upstream Inlet

- ▶ Structural: PID 68002, 60in Metal Pipe (385ft long), 30ft fill
- ▶ Hydraulics: 22% of Bankfull
- ▶ Wildlife: No passage available

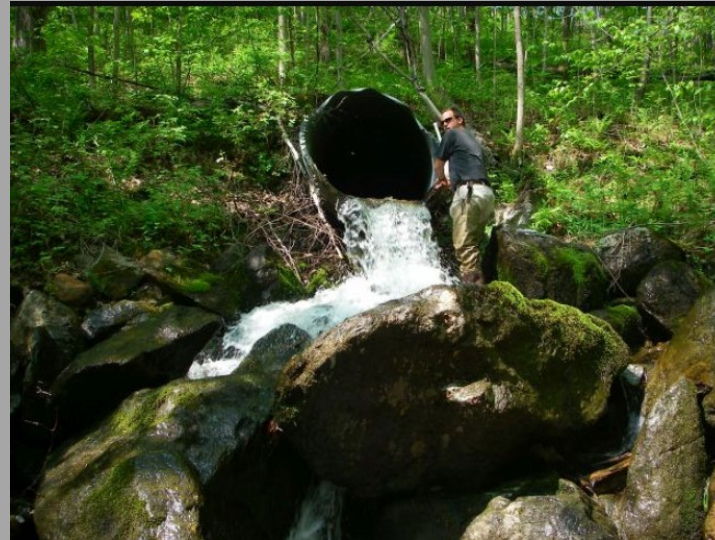
Downstream Outlet

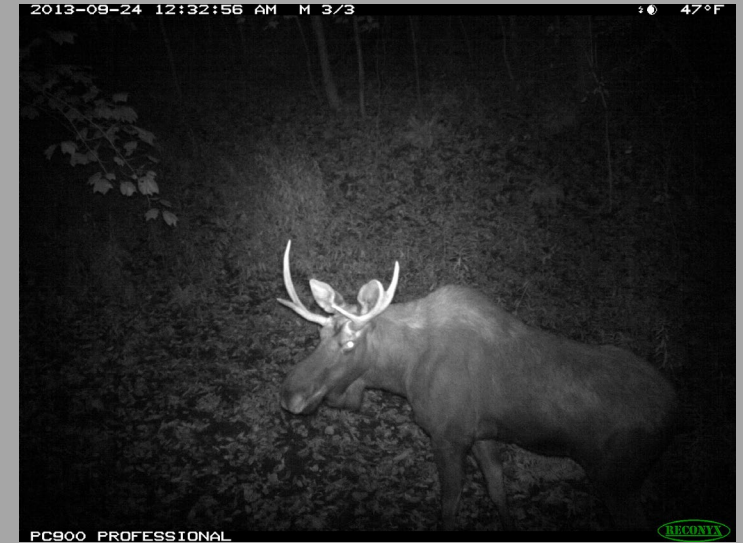
Moose walking past culvert (image from B-W study)
