Building Under-Road Wildlife Crossings for Critical Habitat Connectivity and Reduced Collisions

**PROPOSAL TO THE FEDERAL HIGHWAY ADMINISTRATION'S
2022-2023 WILDLIFE CROSSINGS PILOT PROGRAM
SUBMITTED IN PARTNERSHIP BY:**

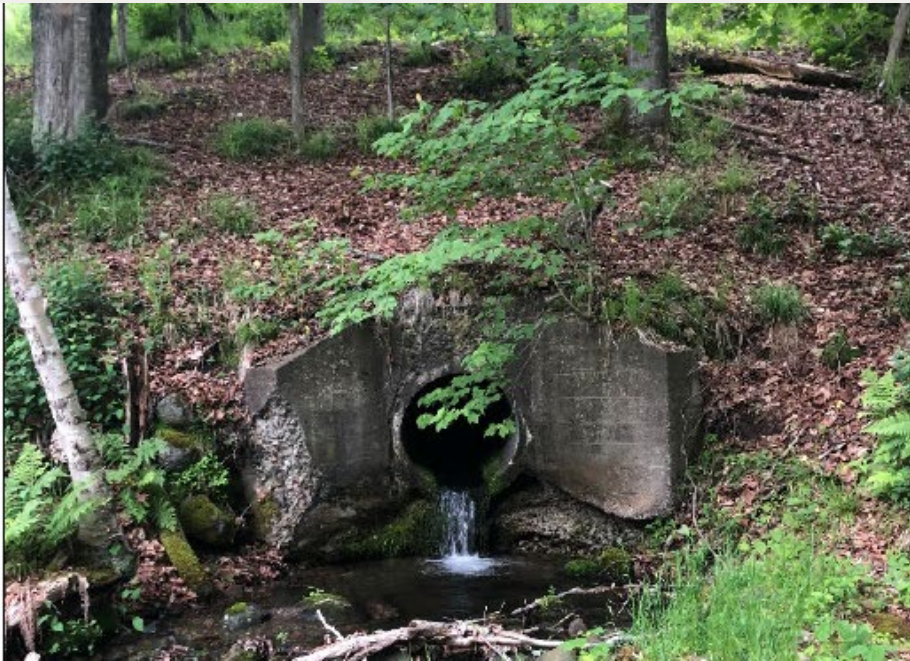
- 36” x 120’ rcp
- 18 ft of cover
- Outlet perched 15”
- Outlet headwall spalled – poor condition
- Installed 1935
- Upstream and downstream suitable for Brook Trout
- Conserved floodplain habitat to the west – large conserved forest block to east
- Deep location allows for increased height to accommodate large mammals.
- Prioritized as a NHFG wildlife corridor

Photo 1: View of existing 36" concrete pipe's outlet with an approximately 15" perch, resulting in a complete barrier for aquatic organism passage. US Route 3 is at the top of the photo. Larger wildlife use a game trail on the right side of the photo to cross US Route 3.

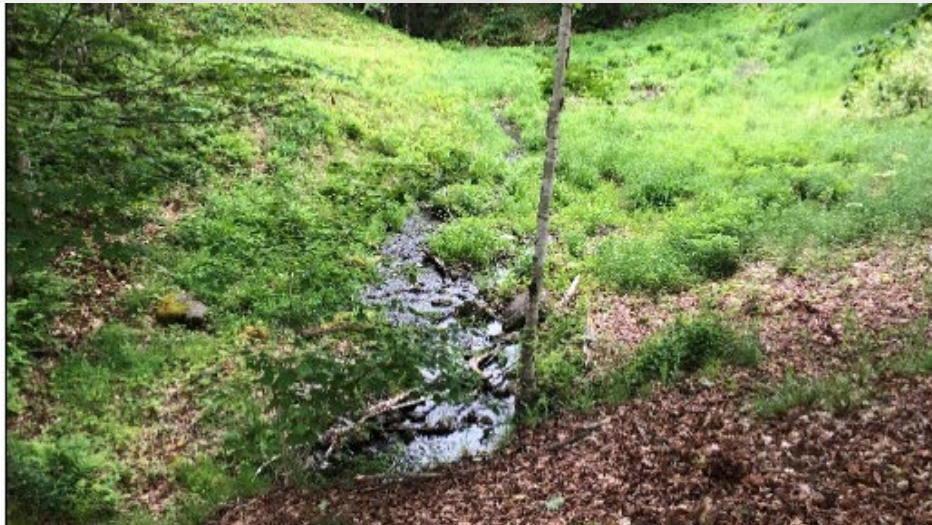
Photo 2: View looking at intact downstream habitat from atop the existing culvert. Adjacent downstream habitat provides landscape connectivity to the Connecticut River valley, including lands protected by The Nature Conservancy.

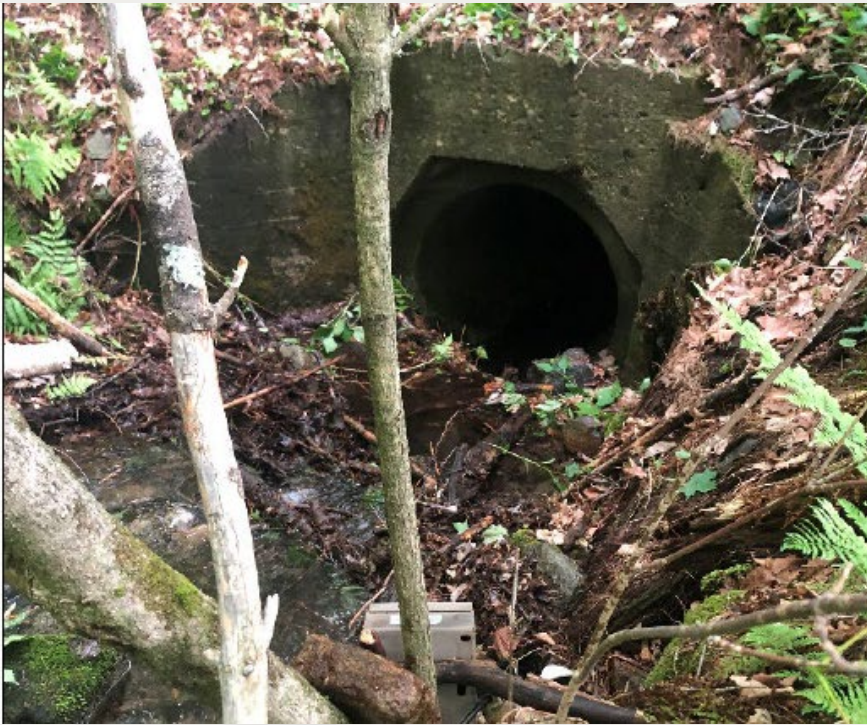
Photo 3: View of existing 36" concrete pipe's upstream inlet. Some clogging of the culvert is present because of its small size. Wildlife camera monitoring for the proposal was completed to understand existing wildlife utilization of the structure from the camera at the bottom of the photo.

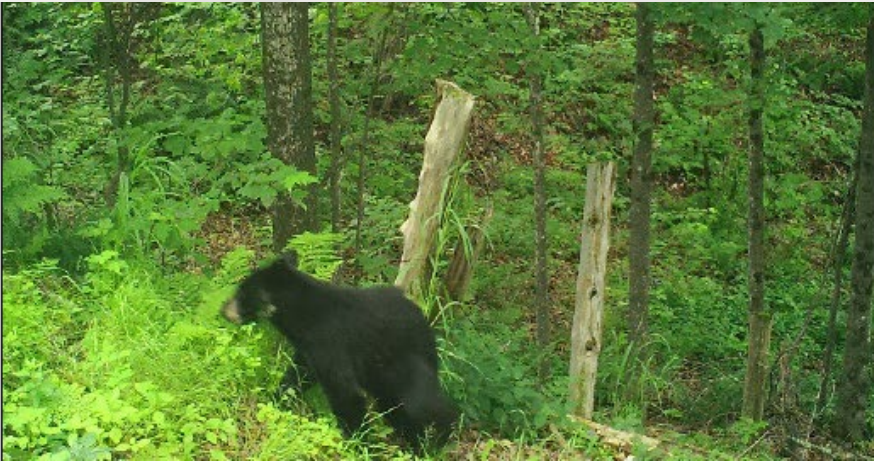
Photo 7: Wildlife camera monitoring to support this proposal observed repeated occurrences of black bear on the game trail approaching US Route 3. The replacement structure will be designed to accommodate under-road black bear passage.

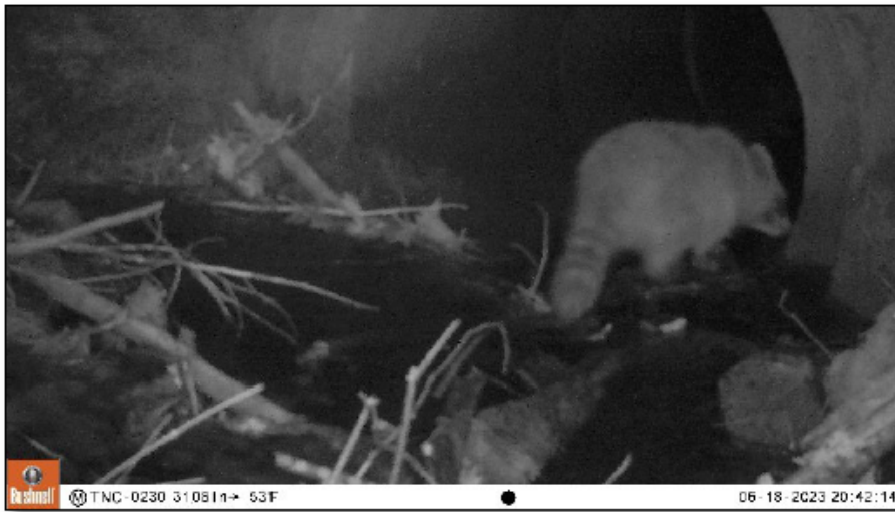
Photo 6: Wildlife camera monitoring to support this proposal observed only raccoons utilizing the existing structure for under-road passage. Based on wildlife camera monitoring at other similarly sized and situated structures, we also expect that mink, otter, and long-tailed weasel are likely to use the existing structure for passage.

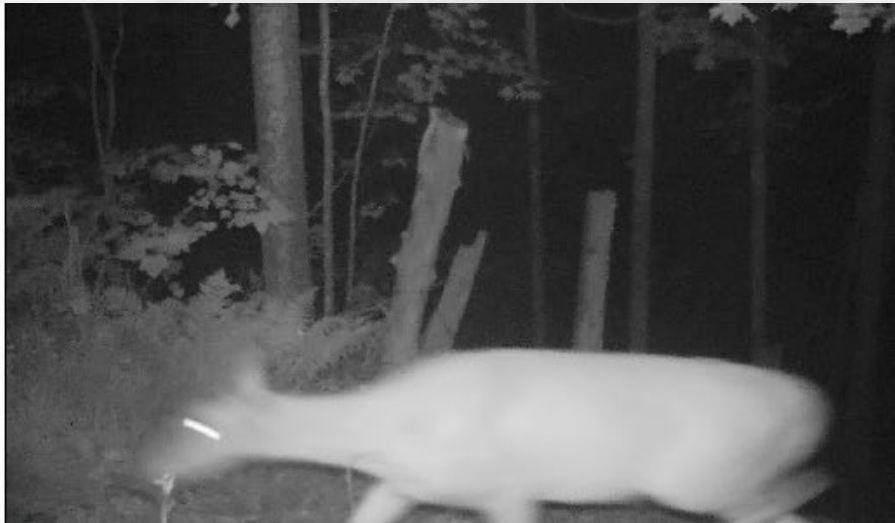
Photo 8: Wildlife camera monitoring to support this proposal observed repeated occurrences of whitetail deer on the game trail approaching US Route 3. The replacement structure will be designed to accommodate under-road whitetail deer passage.

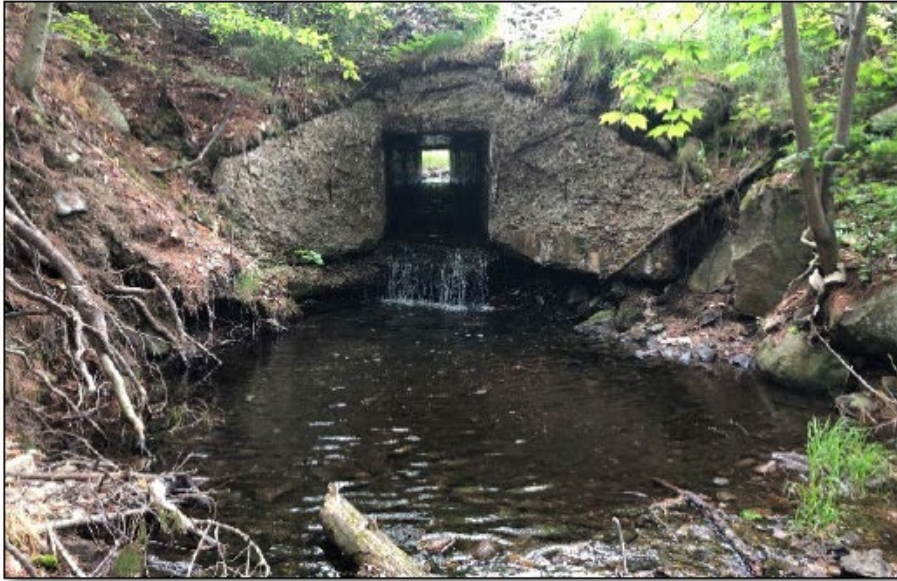
- 4' x 4' x 82' long concrete box
- 7 ft of cover
- Outlet perched 18"
- Many condition issues – overall poor
- Installed 1937
- High density of Brook trout observed in outlet pool, no sightings upstream
- Conserved floodplain habitat to the west – large conserved forest block to east
- Depth allows for increased height to accommodate large mammals.
- Long monitored history of large mammal observations
- SCI long standing priority, as well as NHFG wildlife corridor

Photo 9: View of the existing 4' by 4' concrete box culvert's outlet with an approximately 18" perch, resulting in a complete barrier for aquatic organism passage. Brook trout have been observed in high densities in the scour pool. The existing structure is in poor condition with severe concrete spalling and erosion both above and below the structure's outlet.

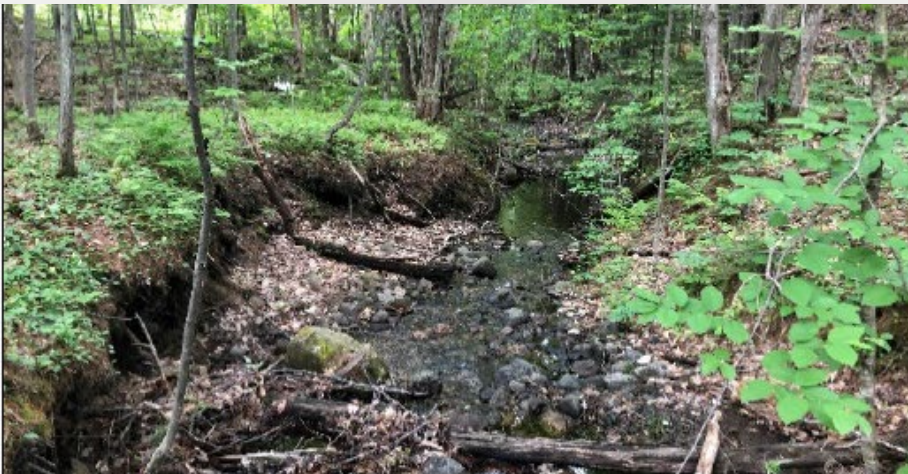
Photo 10: View looking at intact downstream habitat from just downstream of the culvert's outlet. Adjacent downstream habitat provides landscape connectivity to the Connecticut River valley.

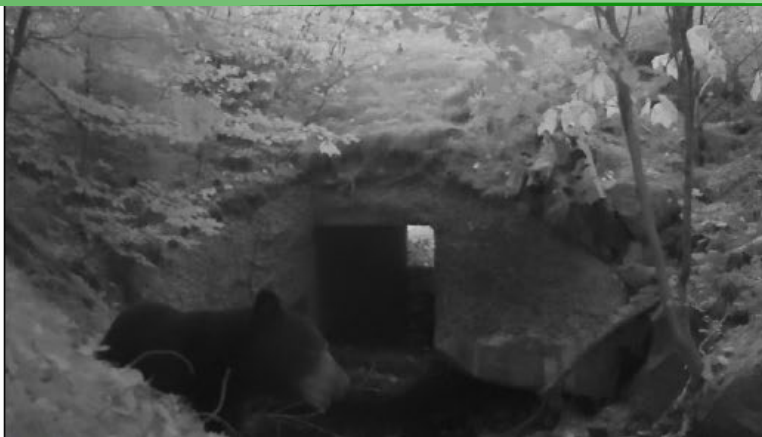
Photo 14: The Nature Conservancy monitored the existing structure for under-road wildlife passage for years. Black bear were observed at the site but never successfully crossing through the existing structure. Under-road passage is limited to small mammals such as mink, otter, and long-tailed weasel.

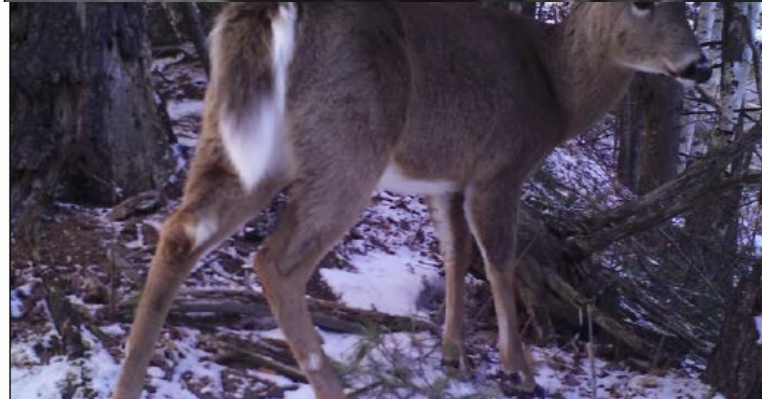
Photo 15: Whitetail deer utilize the habitat corridor associated with the riparian area, but are unable use the existing structure for under-road passage given its small size. The replacement structure will be designed to accommodate both whitetail deer and black bear.

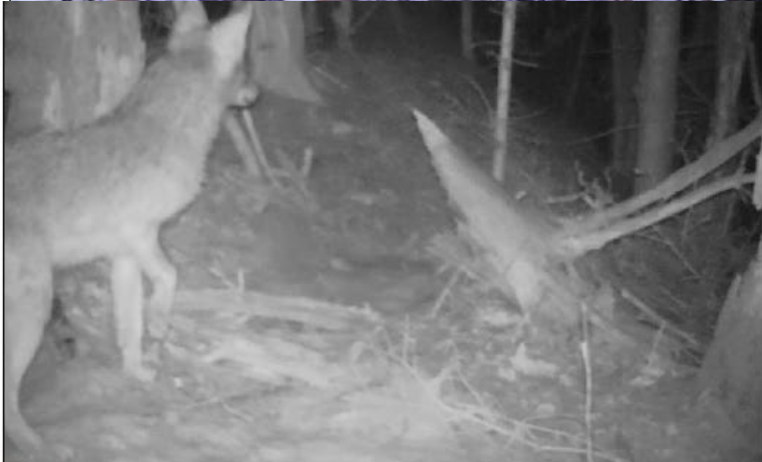
Photo 16: Eastern coyote also utilize the habitat corridor associated with the riparian area, but do not use the existing structure for under-road passage likely because of its small size and the difficult navigation associated with the downstream perch.

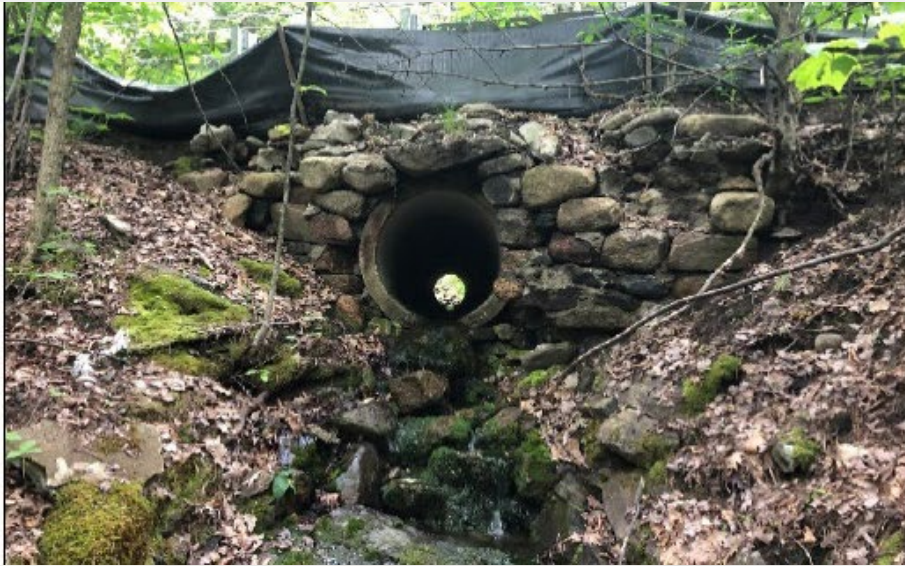
- 30” x 44 ft long rcp
- 4 ft of cover
- Outlet slope drops off steeply
- Invert is worn, exposed rebar showing
- Depth allows for some increased height to accommodate bear and some deer.
- Black bear drawn from Vt to northern red oak forest to the east.
- Prioritized as a wildlife movement zone by the SCI NEK-NNH Linkage.

Photo 17: View of the existing 30" concrete pipe's outlet. Erosion at the crossing is problematic due to the steep topography.

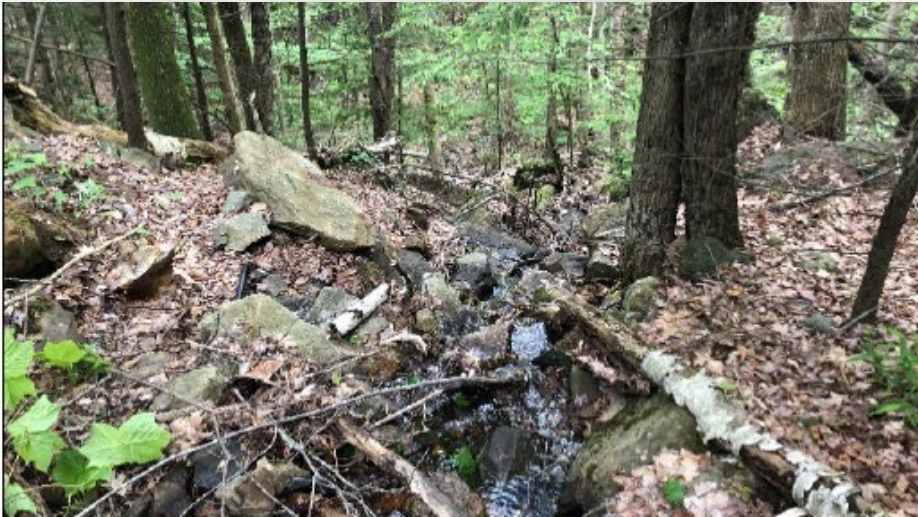
Photo 18: View looking at intact downstream habitat from just downstream of the culvert's outlet. Adjacent downstream habitat provides landscape connectivity to the Connecticut River valley.

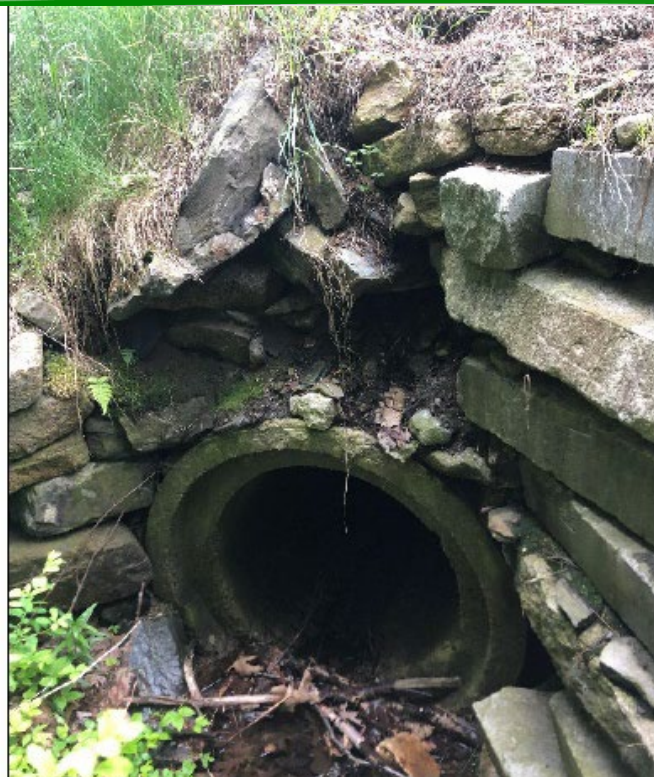
Photo 19: View of the existing 30" concrete pipe's inlet with deteriorating headwall.

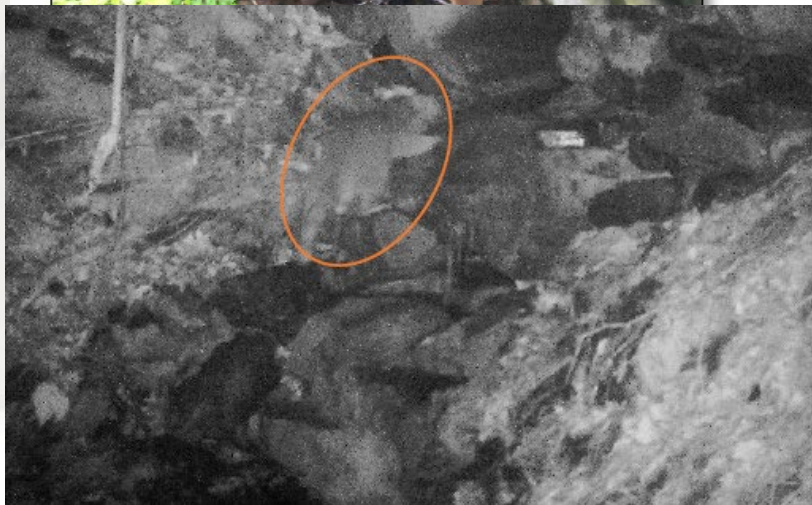
Photo 22: Wildlife camera monitoring to support this proposal observed only raccoons utilizing the existing structure for under-road passage. Based on wildlife camera monitoring at other similarly sized and situated structures, we also expect that mink, otter, and long-tailed weasel are likely to use the existing structure for passage.
