DEVELOPMENT OF MASH COMPUTER SIMULATED STEEL BRIDGE RAIL AND TRANSITION DETAILS

**Prepared for
The New England Transportation Consortium
April 28, 2020**

NETCR115

Project No. 18-1

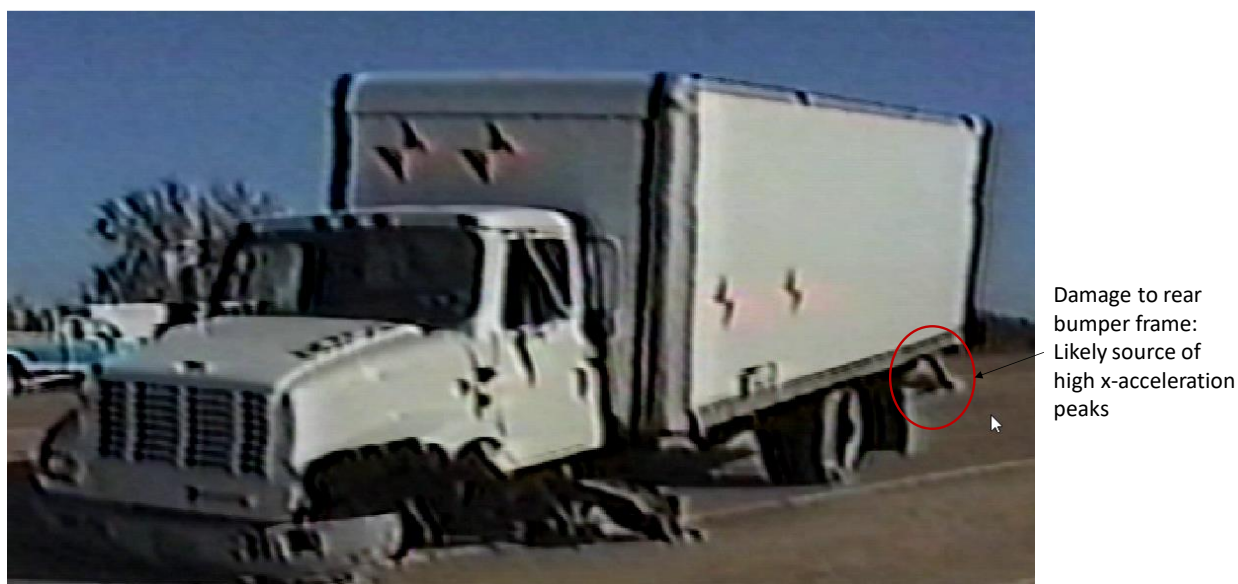
Figure 79. Post-test photo of vehicle damages.

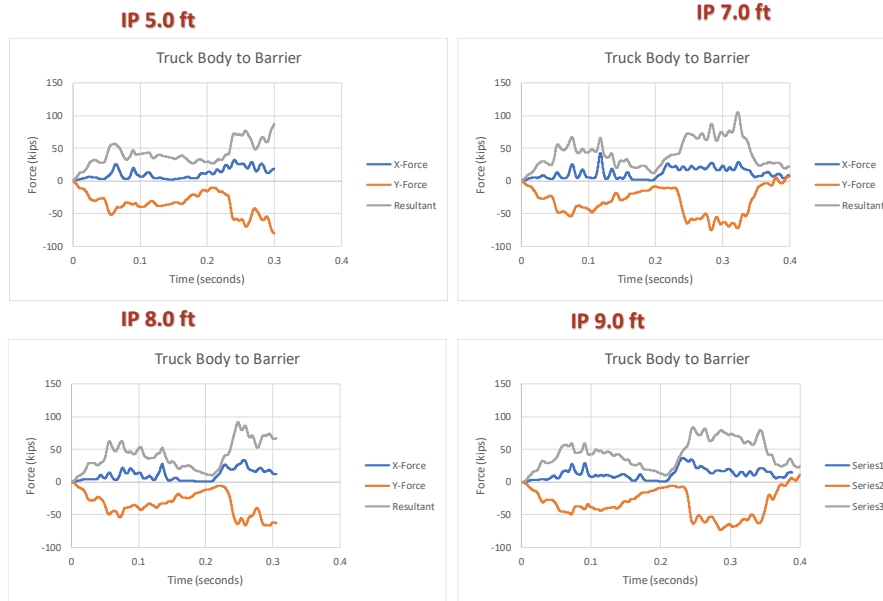
Figure 209. Longitudinal, lateral and resultant forces on barrier for each analysis case.

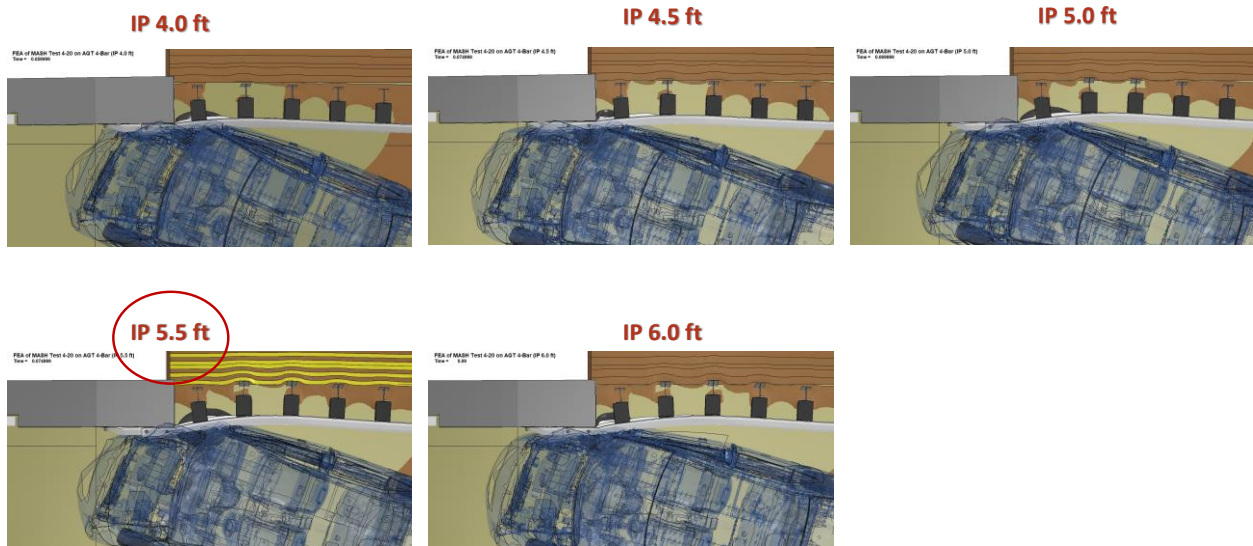
Figure 293. Results of the Test 4-20 simulations showing the deformation and position of the vehicle just before the tire impacted against the buttress for each case.
