Crash Performance Evaluation of MassDOT and NETC Steel Bridge Rail and Transition Designs

Chuck A. Plaxico, Ph.D. Roadsafe LLC

NETC Symposium June 19, 2019

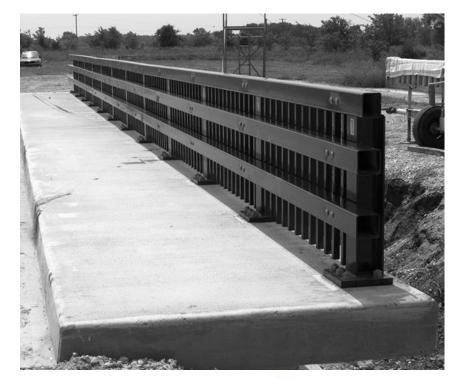
S3-TL4 Bridge Rail FEA Model

MassDOT 3-Bar Bridge Rail S3-TL4

Two design options were evaluated:

- 1. Curb-mounted option in which the bridge rail was mounted onto the top of an 8-inch tall concrete curb, and
- 2. Sidewalk-mounted option in which the bridge rail was mounted onto the top of a 5-ft wide sidewalk with an 8-inch curb face.

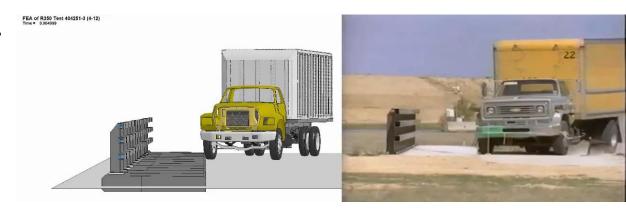
Model Validation with Previous Full-Scale Tests

- The available full-scale test data for the validation task included tests performed according to <u>NCHRP</u> <u>Report 350</u>:
 - Sidewalk-Mounted:
 - Test 404251-3 (Test 4-12): 8000-kg single unit truck (SUT) test on sidewalk-mounted system
 - Curb-Mounted:
 - Test 404251- 6 (Test 4-12): 8000-kg SUT test on curb-mounted system.

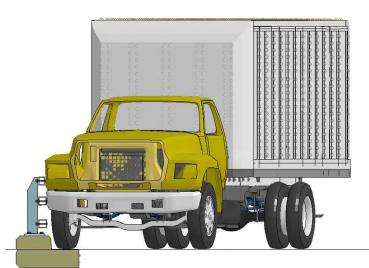
Test 4-12 (Case 3)

- Impact Speed = 56 mph
- Impact Angle = 15 degrees
- Impact Point = 5.0 ft upstream from critical Post
- Bed Height = 47.5" (e.g., Ford F800)
- Post Yield = 60 ksi

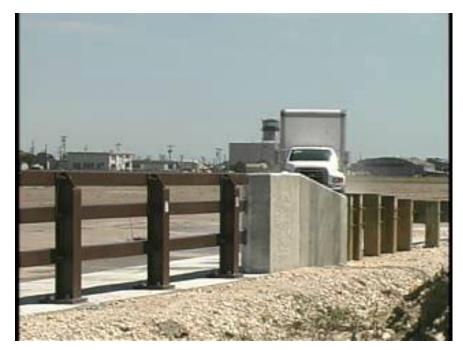
Test 401181-2 4/15/2005

MassDOT Transition

- This system was previously fullscale crash tested at the Texas Transportation Institute (TTI) under NCHRP Report 350 for TL-4, in which the system met all performance criteria.
- There have been no changes to the system's design.
- However, it was of interest to the MassDOT to determine if the system meets the strength and safety criteria of the current crash testing standards of MASH TL-4, which involve higher impact severities for each of the required test cases.

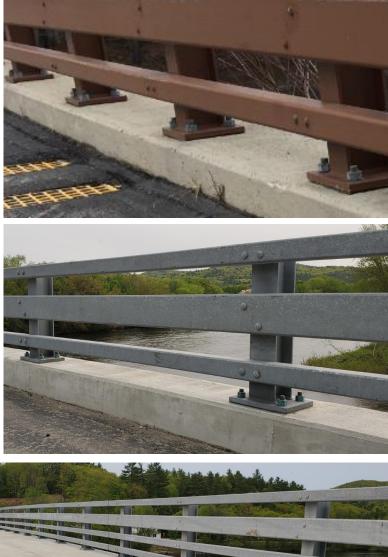
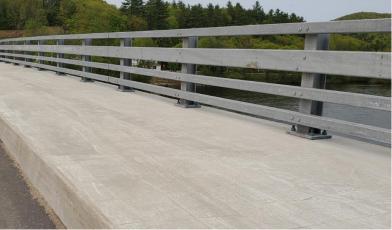
- 1. NETC curb-mounted 2-Bar Rail (TL3)
- 2. NETC curb-mounted 3-Bar Rail (TL4)
- 3. NETC sidewalk-mounted 4-Bar Rail (TL4)

Slight variations in design details depending on State

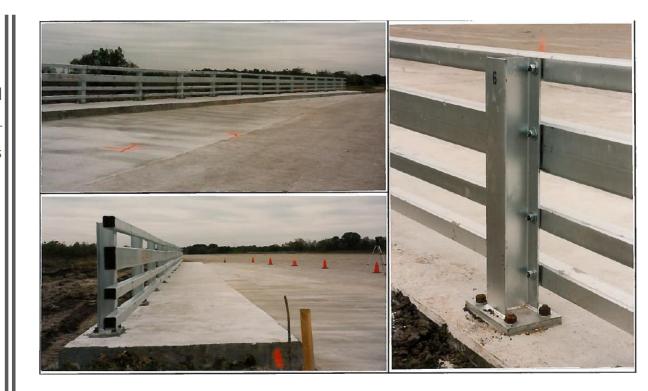
Previous Testing (SwRI)

NETC-1	NETC-2	NETC-3	
Report 350 Test No.	Test 4-10	Test 4-11	Test 4-12	
Test Vehicle	1991 Ford Festiva	1991 Ford F-250	1993 International 4600 LP	
Gross Vehicle Weight (lb)	1823	4484	17,875	
Impact Speed (mph)	62.1	62.1	49.7	
Impact Angle (deg)	20	25	15	Duefermed
Exit Speed (mph)	11.4	10.6	35.8	Preferred
Exit Angle (deg)	6.6	8.2	4.1	Limits
Occupant Impact Velocity				
Longitudinal (ft/s)	*	13.1	5.41	< 30 ft/s
Lateral (ft/s)	*	*	9.48	
Ridedown Accel				
Longitudinal (g's)	*	2.55	8.95	< 15 G
Lateral (g's)	*	*	14.3	2 2 J 5 G
Maximum 50 msec Avg Accel				
Longitudinal (g's)	-	-	2.7	
Lateral (g's)	-	-	5.8	
Max Deflection (in)	0	1	1	
Vehicle Trajectory				
Maximum YawAngle (deg)	34	*	*	
Maximum Roll Angle (deg)	10	20	20	} < 75°
Maximum Pitch Angle (deg)	5	15	5	
NCHRP Report 350 Evaluation				
Structural Adequacy	Pass	Pass	Pass	
Ocupant Risk	*	Pass	Pass	
Vehicle Trajectory	Pass	Pass	Pass

* No occupant risk data - lateral accelerometer malfunctioned during test.

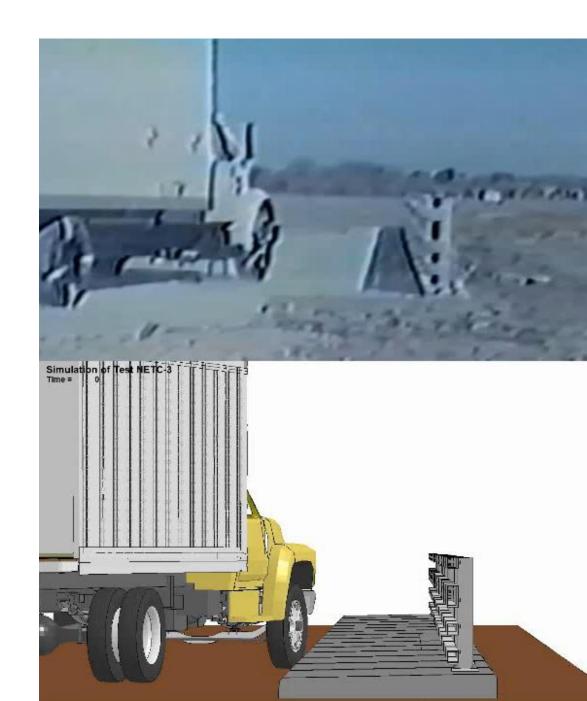
NETC 4-Bar

- Test No. NETC-3 on the bridge rail was performed by SwRI on 12/18/1997.
- Total length of bridge rail was 108 feet.
- Impact conditions:
 - Mass = 17,875 lb (8,108 kg)
 - Speed = 49.8 mph (80.1 km/hr)
 - Angle = 15 deg.
 - Impact point = 2 ft (0.61 m) upstream of Post 6.

- The maximum dynamic deflection of the bridge rail model occurred at the top rail at the splice connection between posts 6 and 7.
 - FEA = 1.77 in (45 mm)
 - Test = 1.00 in (25 mm)
- The resulting permanent deflection at this location was:
 - FEA = 0.7 in (17.5 mm)
 - Test = 0.5 in (13 mm).
- Posts 6 and 7 were tilted back and the base plates of both posts were raised upward at the center:
 - FEA: <u>Dynamic</u> = 0.28 in (7 mm) ; <u>Permanent</u> = 0.11 in (2.75 mm)
 - Test: <u>Dynamic</u> = (not reported) ; <u>Permanent</u> = 0.14 in (3.5 mm).

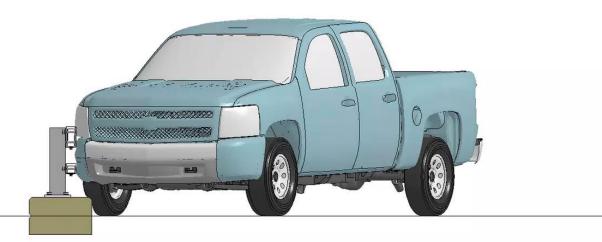
FEA of MASH Test 3-11 on NETC 2-Bar (curb) Time = 0.004999

Assessment of Potential Vehicle Contact with Post

- The front fender made slight contact with the post.
- The contact between the front tire and post was moderate.
 - Tire deflation was not included in the model, so an accurate assessment on the potential for wheel rim snag on the post could not be made; however, a moderate snag is possible.

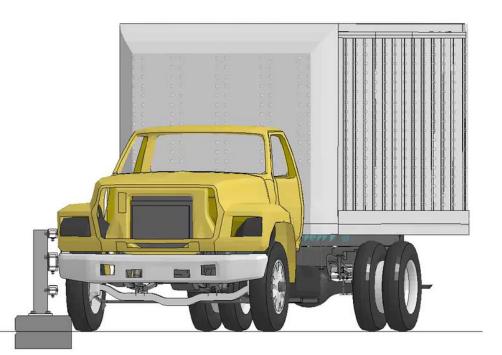
NETC 3-Bar BR (MASH Test 4-12) Time = 0.004999

- Impact Speed = 56 mph
- Impact Angle = 15 degrees
- Impact Point = 5.0 ft upstream from critical Post
- Bed Height = 47.5" (e.g., Ford F800)

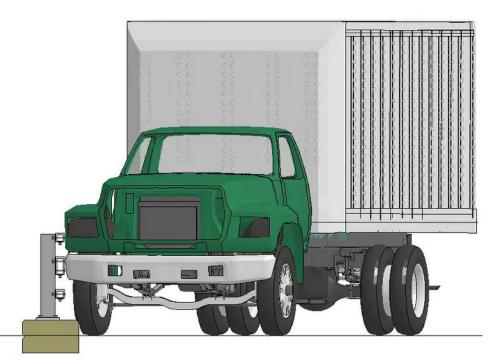
NETC 3-Bar BR (MASH Test 4-12 w/ Raised Truck) Time = 0.004999

Test 4-12 (Case 2)

- Impact Speed = 56 mph
- Impact Angle = 15 degrees
- Impact Point = 5.0 ft upstream from critical Post
- Bed Height = 50" (e.g., GMC)

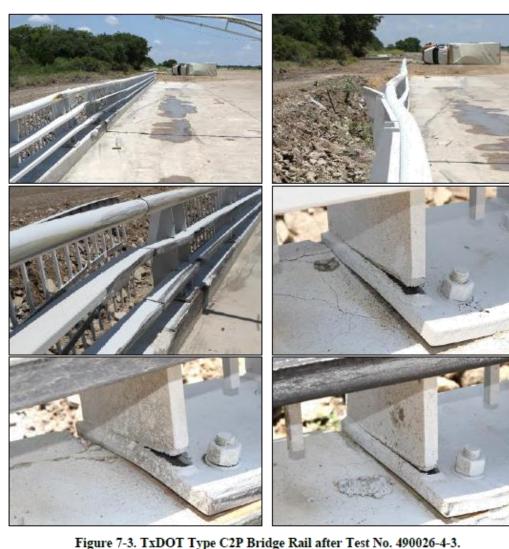
7.5 DAMAGE TO TEST INSTALLATION

Figure 7-3 shows the damage to the TxDOT Type C2P Bridge Rail. The welds failed at the base plates of post 5, 6, and 7. It was determined that the welds were not constructed correctly by the fabricator. After the welds failed at Posts 5, 6, and 7, the post plates rotated toward the field side 10 degrees, 13 degrees, and 7 degrees, respectively. The picket section between posts 5 and 6 released at the center and downstream locations but remained attached to the rail. Cracks radiated through the curb at posts 3 and 4, through the curb and deck at posts 5, 6, and 7, and through the curb at post 8. Working width was 62.3 inches. Maximum dynamic deflection during the test was 11.4 inches. Maximum permanent deformation as 7.25 inches at the joint between posts 5 and 6.

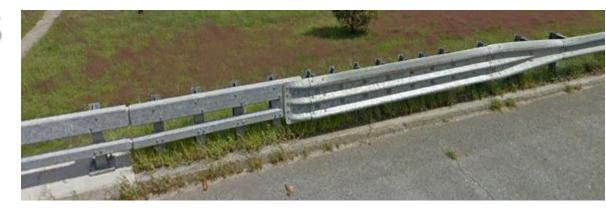
NETC Transition Systems

- Three design options are being evaluated:
 - 1. NETC Style 2-Bar Rail and Thrie Beam (TL3) (NHDOT steel rail transition)
 - NETC Style 3-Bar Rail and Thrie Beam (TL4) (NHDOT steel rail transition)
 - 3. Concrete Transition Barrier and Thrie Beam (TL4) (MaineDOT standard detail)

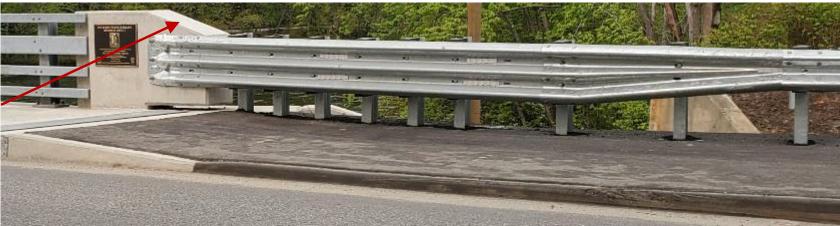
- Single taper on top
- No face taper

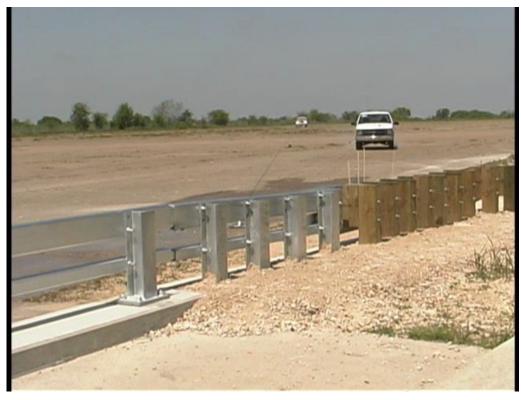
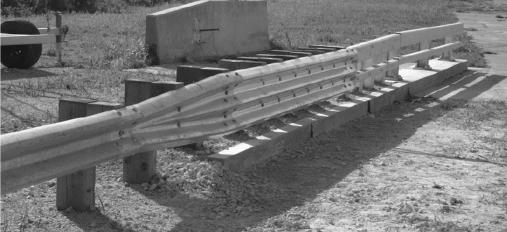
NETC 2-Bar to Thrie-Beam AGT

Report 350 Test Level 3

401181-1	
Test Designation	Test 3-21	
Test Vehicle	2000 Chevrolet 2500	
Gross Vehicle Weight (lb)	4,706	
Impact Speed (mph)	63.6	
Impact Angle (deg)	24.9	
Exit Speed (mph)	52.9	Preferred
Exit Angle (deg)	11.7	Limits
Occupant Impact Velocity		
Longitudinal (ft/s)	17.1	< 30 ft/s
Lateral (ft/s)	24.6	
Ridedown Accel		
Longitudinal (g's)	8.3	< 15 G
Lateral (g's)	10	
Maximum 50 msec Avg Accel		2
Longitudinal (g's)	8.1	
Lateral (g's)	13.5	
Max Deflection (in)	7.87	
Vehicle Trajectory		
Maximum YawAngle (deg)	56	L.
Maximum Roll Angle (deg)	14	< 75°
Maximum Pitch Angle (deg)	19	
NCHRP Report 350 Evaluation		-
Structural Adequacy	Pass	
Ocupant Risk	Pass	
Vehicle Trajectory	Pass

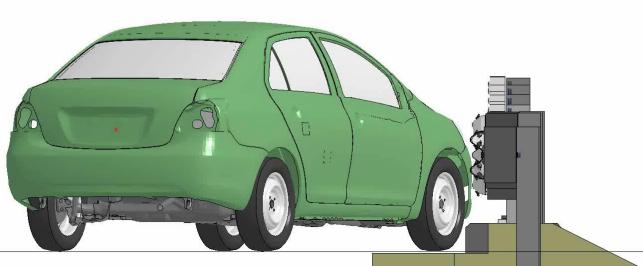
FEA of MASH Test 4-11 on AGT 3-Bar (IP 5.5 ft) Time = 0

- Impact Speed = 62.1 mph
- Impact Angle = 25 degrees
- Impact Point = 5.5 ft upstream from critical Post

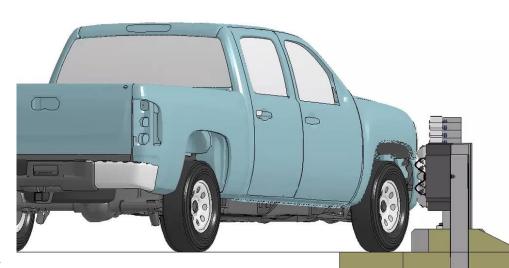
FEA of MASH Test 4-21 on AGT 3-Bar (IP 6.2 ft) Time = 0.004999

<u>Test 4-21</u>

- Impact Speed = 62.1 mph
- Impact Angle = 25 degrees
- Impact Point = 6.2 ft upstream from end of tube rail

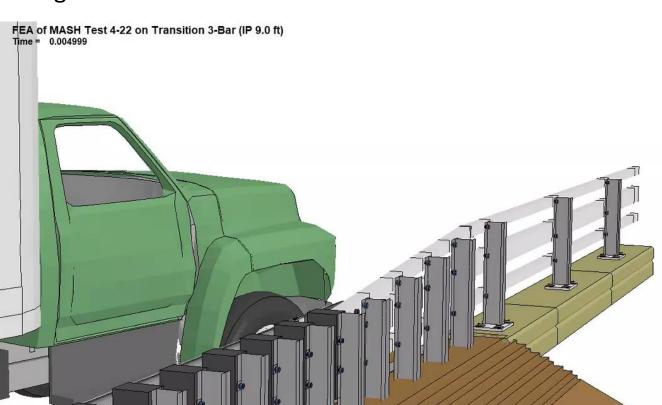
• Impact Conditions

- Mass = 22,061 lb
- Impact Speed = 56 mph (90 km/hr)
- Impact Angle = 15 degrees
- Impact Point = 9 ft upstream of Bridge Rail tube ends

Barrier Damage

- Plastic deformations of the steel components were primarily to the top of Post 1 of the transition and to all three (3) bridge rail posts.
- There was some plastic deformation of the transition rail elements.
- The damage to the posts were due to the bottom of the cargo-box snagging on the top of the posts. This caused torque rotation and longitudinal deformation of the posts.
- The vehicle was in contact with the barrier from the point of contact until the truck box slid off the end of the bridge rail at 0.55 seconds.
- The maximum working width prior to exiting the barrier was 3.9 ft resulting from the top of the cargo box extending over the bridge rail.
