Development of MASH Computer Simulated Steel Bridge Rail and Transition Details

Task 5 – NETC 4-Bar MASH TL4

Project # : NETC 18-1

Task 5 – MASH TL-4 Evaluation of NETC 4-Bar Bridge Rail

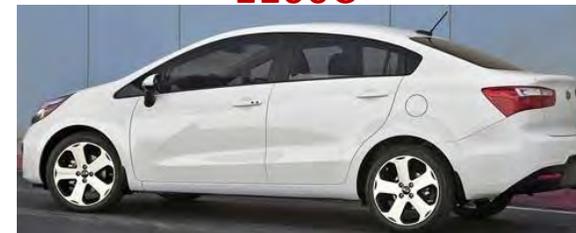
1100C

- *MASH* specifies three (3) tests for assessing TL-4 crash performance for bridge rails and transitions:
 - **Test 4-10/4-20:** Involves a 2425-lb passenger car (**1100C vehicle**) impacting the critical impact point at a nominal speed and angle of **62 mph** and **25 degrees**. Test optional for transitions.
 - **Test 4-11/4-21:** Involves a 5,000-lb ½-ton quad-cab pickup truck (**2270P vehicle**) impacting the critical impact point at a nominal speed and angle of **62 mph** and **25 degrees**.
 - **Test 4-12/4-22:** Involves a 22,000-lb single unit truck (SUT) (**10,000S vehicle**) impacting the critical impact point at a nominal speed and angle of **56 mph** and **15 degrees**.

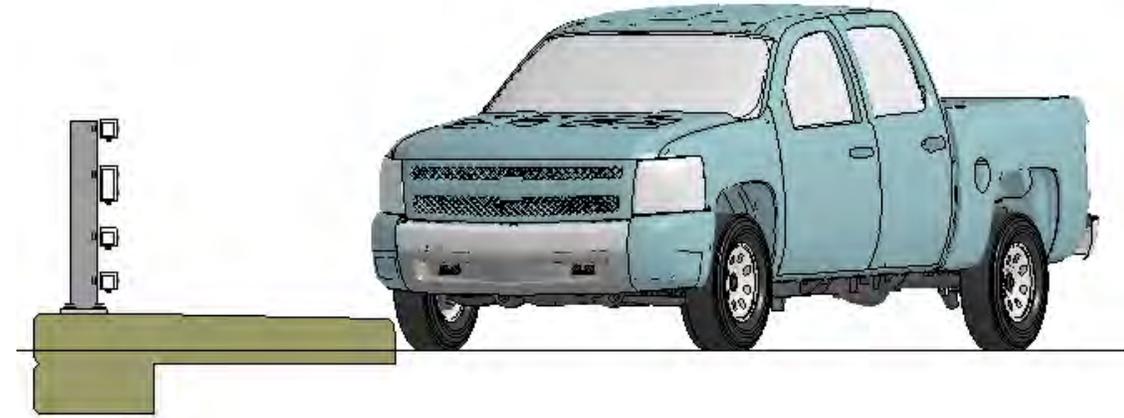
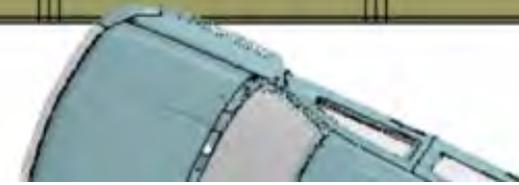
- Vehicle Model

- SilveradoC_V3a_V180201_TireRS_35psi.k
- Vehicle Mass = 2,268 kg (5,001 lb)

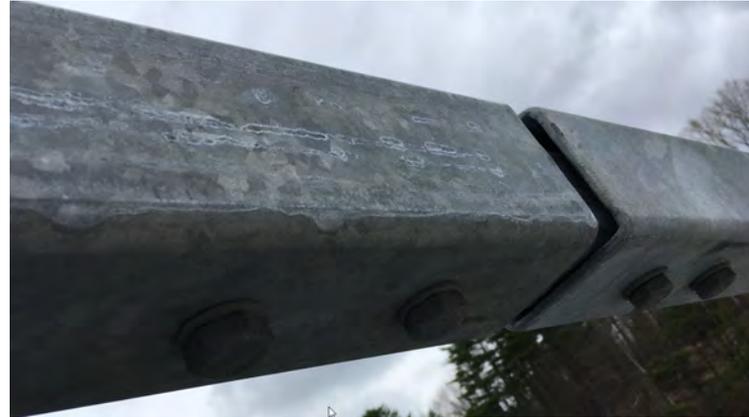
Photos of Splice Connection

- PFC Buddy Wendell McLain Memorial Bridge in Dixfield, ME

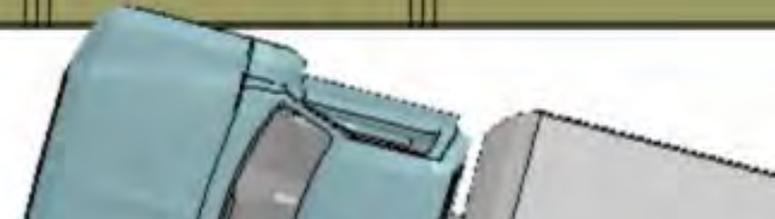
Ford 800 Surrogate

- F800_No-Box_181114_UboltF0p17.k
- TruckBox_181114.k
- F800-SuspenStress_FRONT_35N.k
- F800-SuspenStress_REAR_60N.k
- Vehicle Mass = 10,000 kg (22,046 lb)

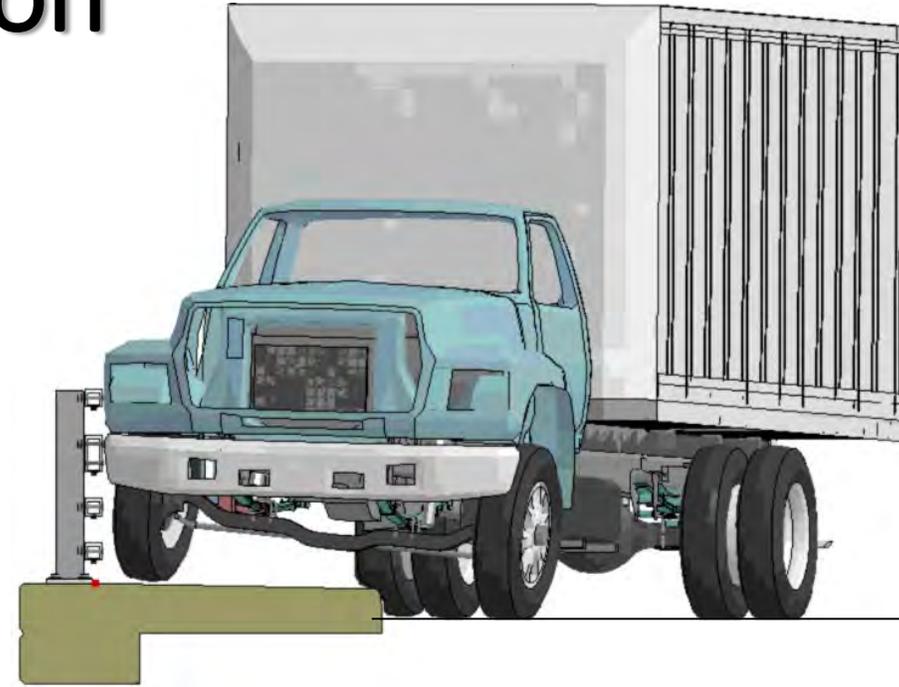
Ford 800 Surrogate

- **Vehicle Model**

- F800_No-Box_181114_UboltF0p17.k
- TruckBox_181114.k
- F800-SuspenStress_FRONT_35N.k
- F800-SuspenStress_REAR_60N.k
- Vehicle Mass = 10,000 kg (22,046 lb)
