Development of MASH Computer Simulated Steel Bridge Rail and Transition Details

Task 8: Transition for 2-Bar BR MASH TL3

Project # : <u>NETC 18-1</u> Federal Project No. : <u>2343018</u>

Task 8 – MASH TL-3 Evaluation of NETC 2-Bar Transition

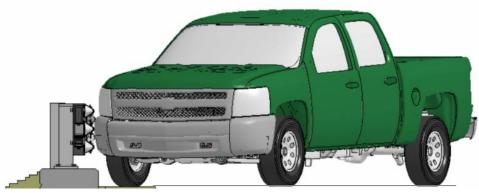
- Impact Conditions
 - Impact Speed = 62.1 mph (100 km/hr)
 - Impact Angle = 25 degrees
 - Impact Point = 9 ft upstream from end of tube-rail

- Vehicle Model
 - SilveradoC_V3a_V180201_TireRS_35psi.k
 - Vehicle Mass = 2,268 kg (5,001 lb)
