New England Transportation Consortium (NETC) NETC 20-3

Investigating Thermal Imaging Technologies and Unmanned Aerial Vehicles to Improve Bridge Inspections

Task 2 Interim Report

Field Demonstration and Data Analysis

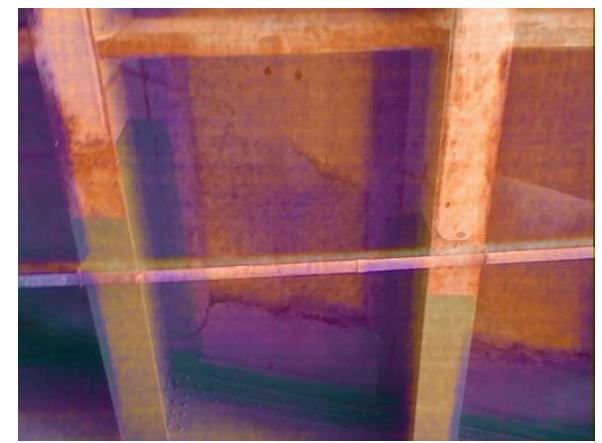
Figure 29 - Misalignment of Seek Fusion

The user of the thermal camera should be aware that the thermal and visual blended imagery has the potential for misalignment as separate cameras are being used to develop these. Depending on the manufacturer and specific product, the alignment can be adjusted automatically by the camera or manually by the user. For products with interchangeable lenses, like the Flir E86 and E96, the lens needs to be calibrated properly or the misalignment is unable to be corrected. While these misalignments will cause the blended images to be improperly aligned, the misalignment will not affect the quality of the thermal data. Refer to Figures 28 and 29 for examples of misalignment.

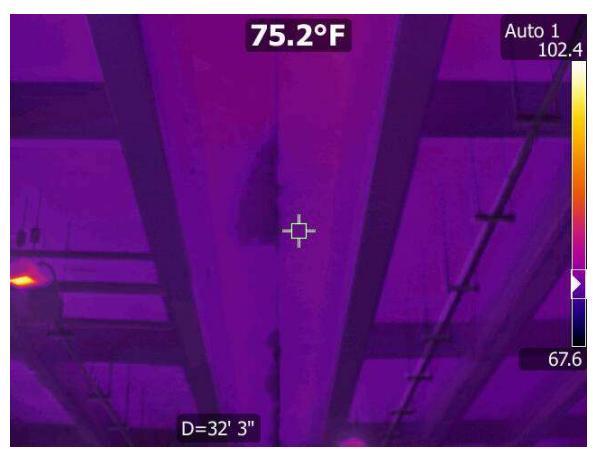
Figure 32 - Lighting Fixture affecting Thermal Span

Figure 35 - Visible Sky affecting Thermal Span
In order to avoid potential issues with an automatic temperature span, the thermal cameras should be set to use manual temperature spans wherever possible. However, this is not possible for some thermal cameras. Additional guidance will be provided in the Task 3 Interim Report.

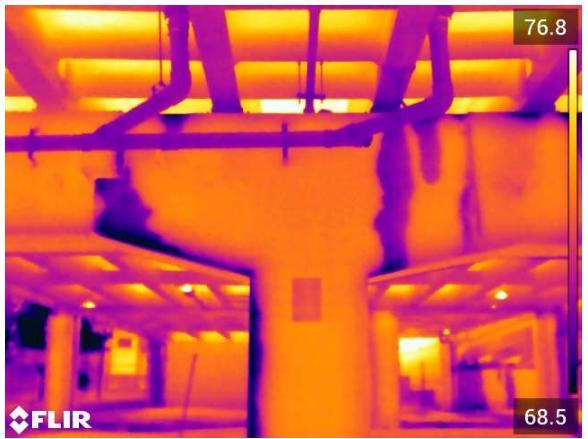
Figure 34 - Water Leakage affecting Thermal Span

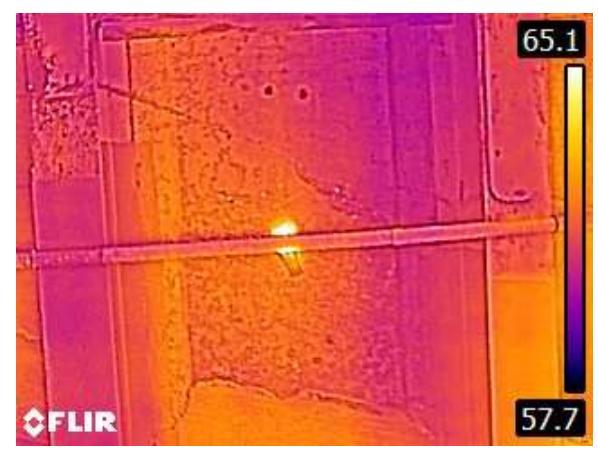
Figure 33 - Pigeon affecting Thermal Span

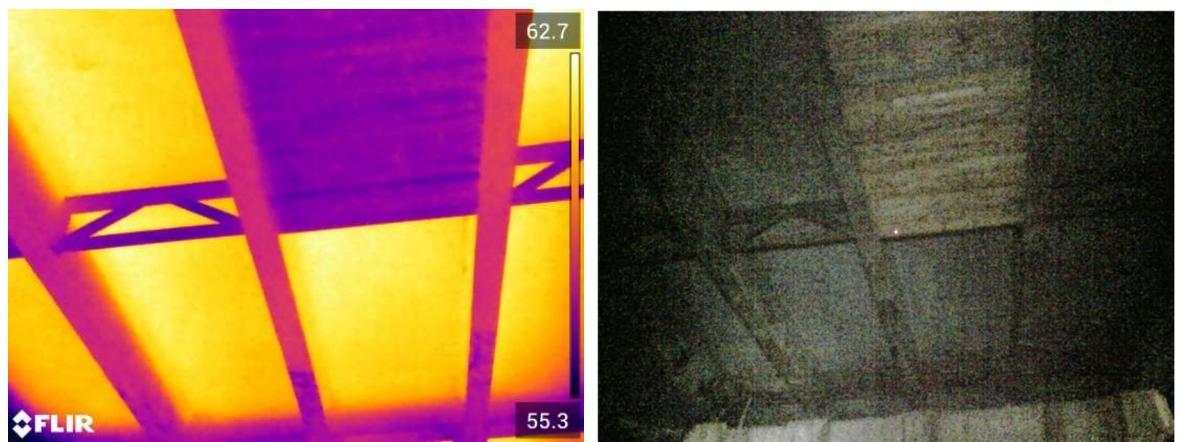
Figure 36 - Concrete, Steel, and Timber along Underside of Bridge Deck

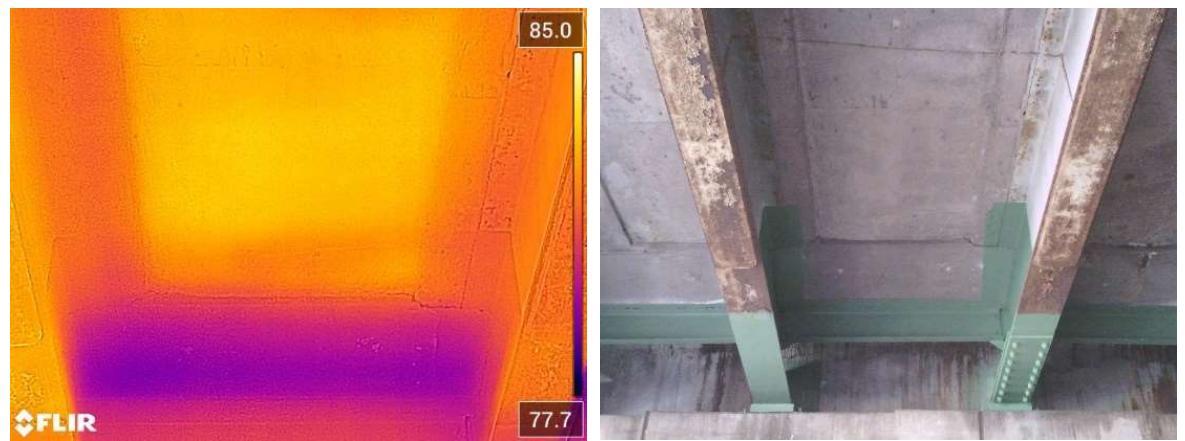
Figure 37 – Temperature Differentials along Girders and Abutment

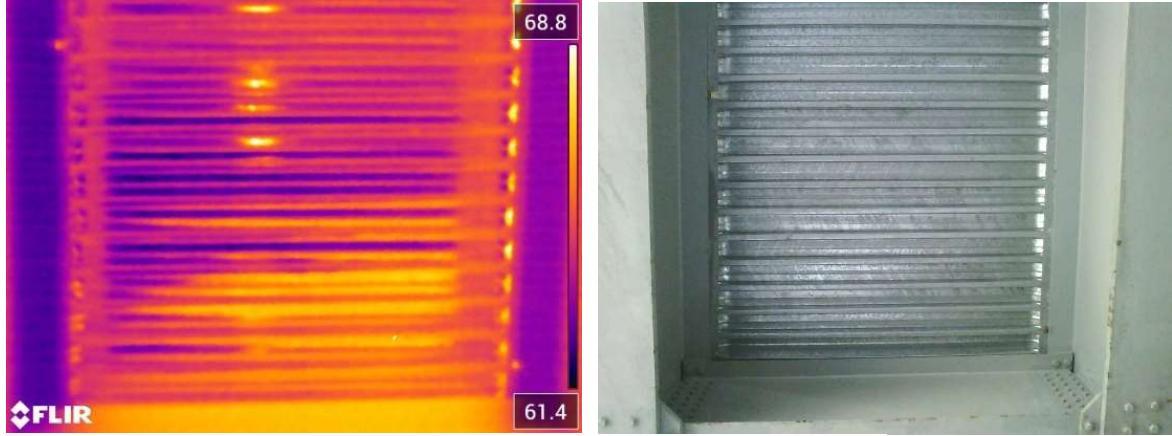
Figure 38 – Temperature Differential due to Reflection in SIP Forms

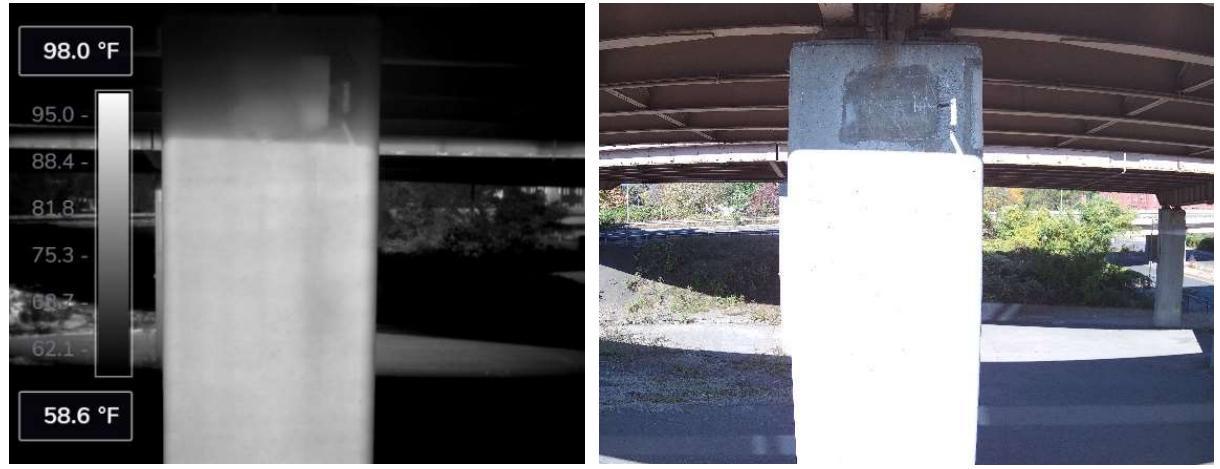
Figure 43 – Temperature Differential caused by Shadow

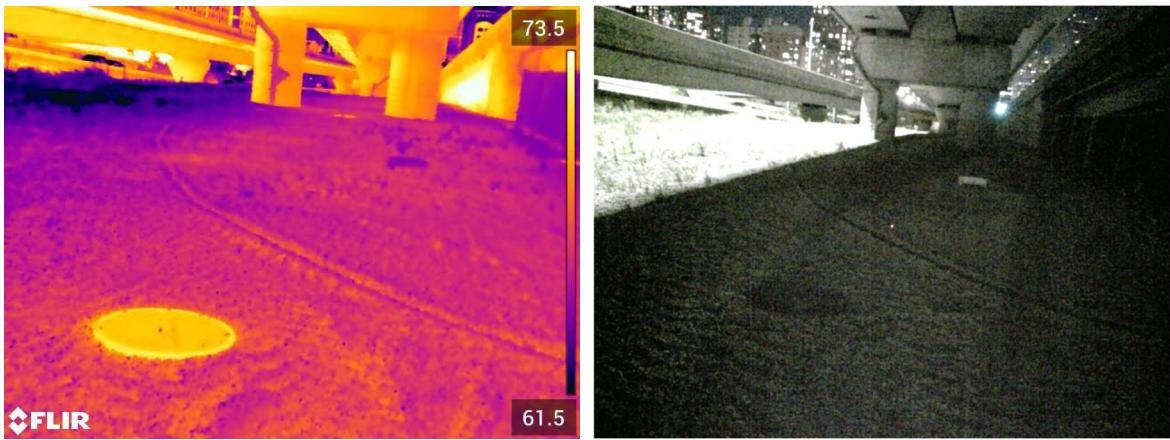
Figure 44 – Temperature Differential caused by Texture of Gravel

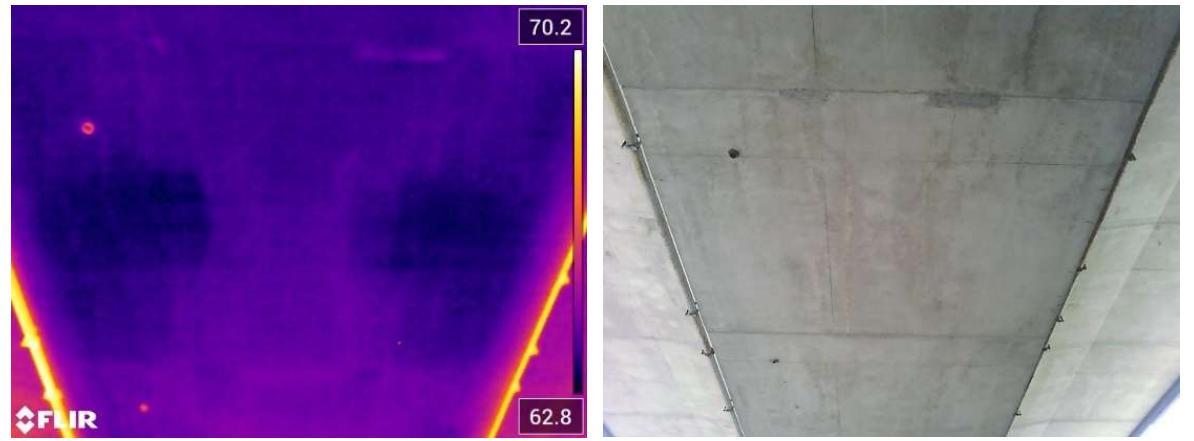
Figure 46 - Temperature Differentials caused by Internal Deviation Blocks and Drain Pipes)

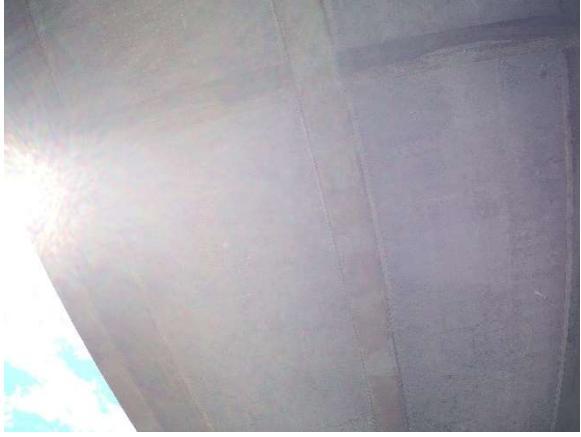
However, there were still limitations for this visual cross check, especially near the edges of the deck. Depending on the conditions, the visual image of the deck could be washed out from sun glare (Figure 48) or under exposed due to the adjacent sky (Figure 49). Contrast caused by shadows can also result in overexposure of portions of the visible image removing needed detail (Figure 50).

Figure 48 - Sun Glare obscuring Deck

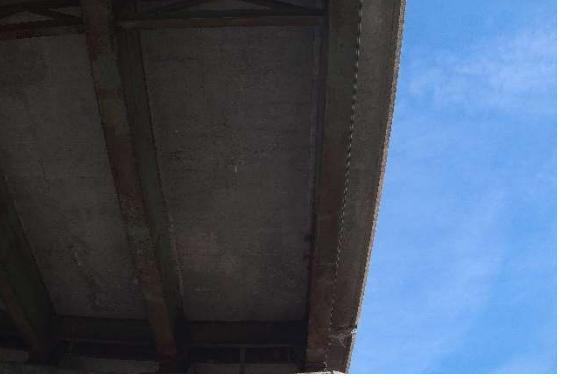
Figure 49 - Underexposed Deck

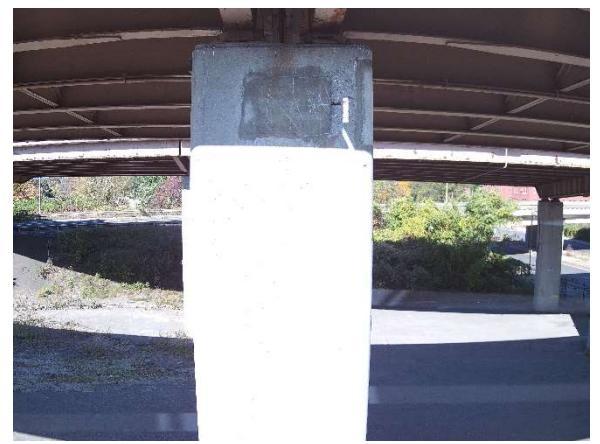
Figure 50 - Overexposed Surface Removing Detail

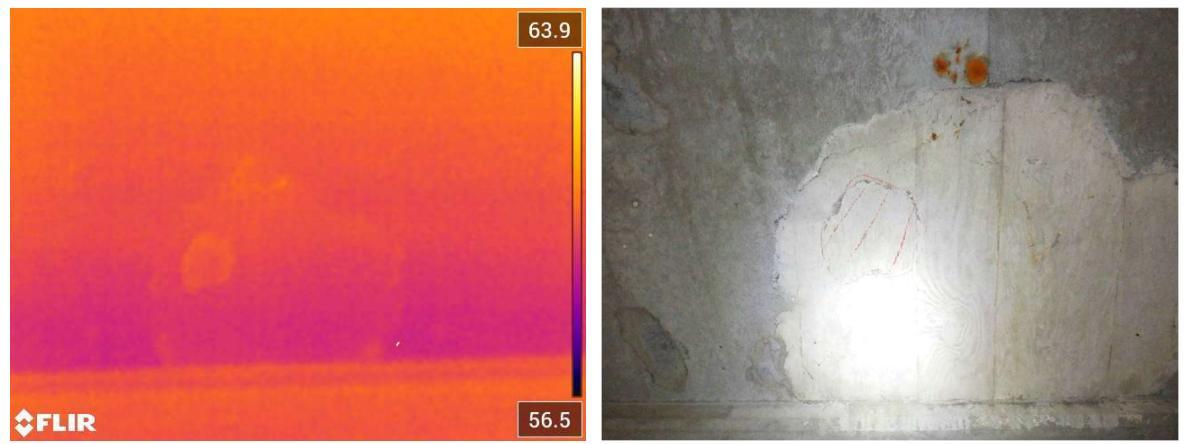
Figure 58 - Delamination within Otherwise Sound Patch

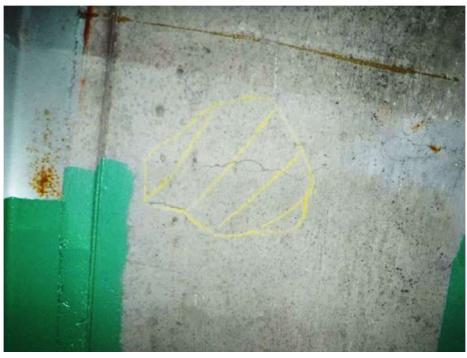
Figure 61 - Hatched Delamination

was not sounded 100% and that the bridge inspector used experience and judgement for the inspection. Identified areas were marked with an outline and hatch marks with lumber crayon (Figure 61). These areas were then documented onto a framing plan of the span. Twenty-six deficiencies consisting of delamination and/or spalling were identified within this span, (Figure 62). The full deficiencies and measurements for the traditional inspection findings sketch can be found in Appendix A-1. The traditional inspection of this span took approximately 2 hours.

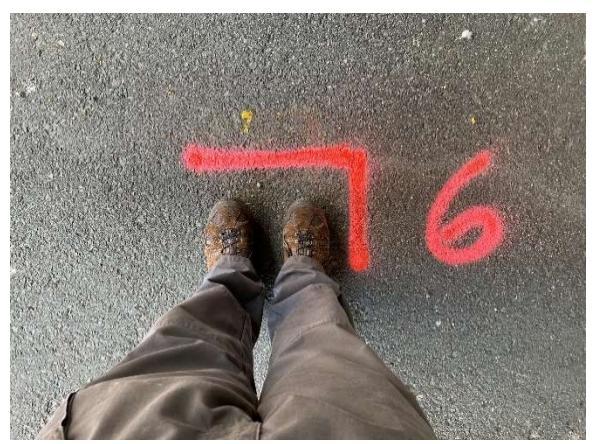
Additionally, the inspectors reviewed the 2020 Routine Inspection report to identify previously identified deficiencies along the underside of the deck outside of Span L-M that could be used for repeated thermal data capture. The list was initially surveyed on foot to eliminate locations that did not include delamination or were directly above or adjacent to the roadways below. The remaining spots received a hands-on inspection using the bucket truck to identify the limits of delamination. The identified delaminations were also marked with an outline and hatch marks and the inspector updated the existing deficiency text description and dimensions.

Figure 63 - Marked Location for Repeated Data Collection

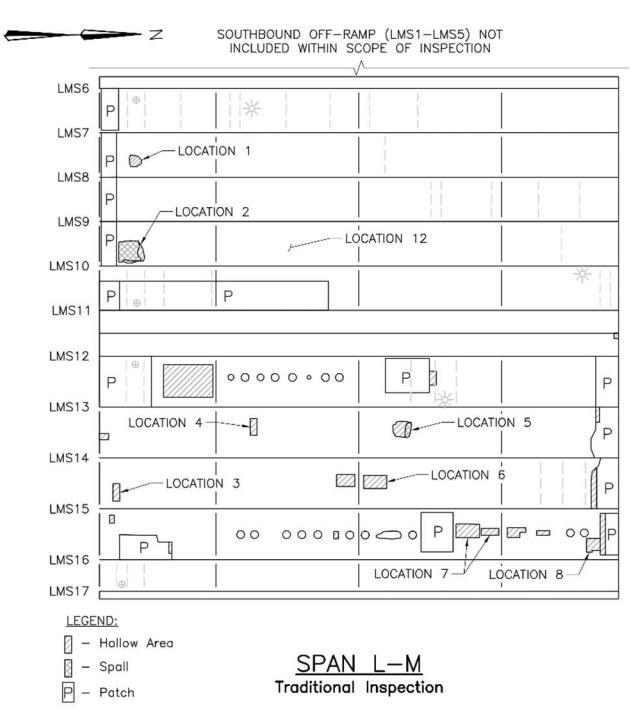
Figure 64 - Span L-M Locations for Data Collection

Location	Span	Вау	Brief Description	
1	L-M	7	Hollow sounding area	
2	L-M	9	Spall with adjacent hollow sounding area	
3	L-M	14	Minor hollow sounding area	
4	L-M	13	Hollow sounding area	
5	L-M	13	Spall with adjacent hollow sounding area	
6	L-M	14	Minor hollow sounding area	
7	L-M	15	Hollow sounding area containing hollow patches	
8	L-M	15	Hollow sounding area and hollow sounding previous repair	
9	P-R	13	Spall with adjacent hollow sounding area	
10	R-S	13	Hollow sounding area	
11	S-T	11	Hollow sounding area	
12	L-M	9	None

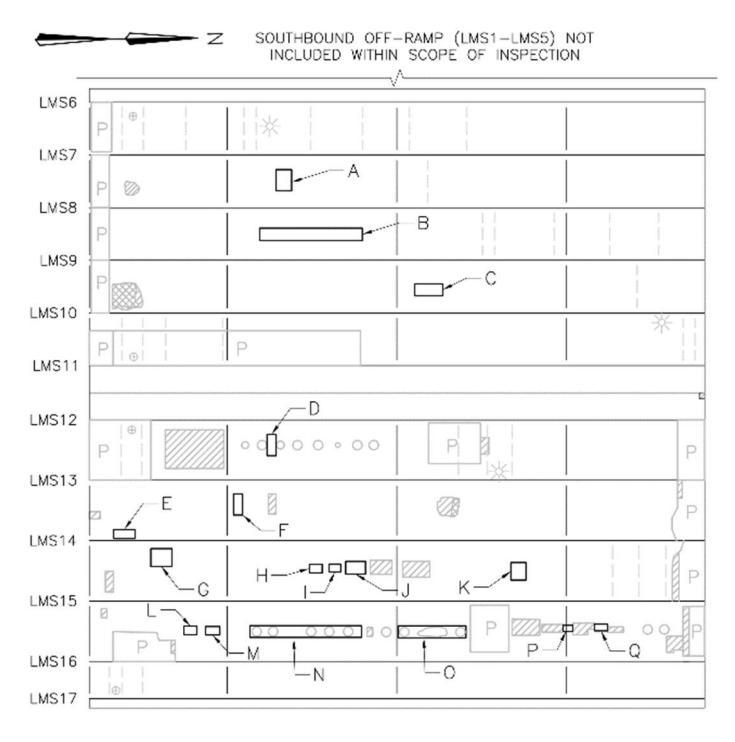
<u>SPAN L-M</u> Thermal Survey and Follow up Inspection Figure 65 - Areas of Interest from Thermal Survey

Area of Interest	Follow up Insp. Description	Comment(s)
A	No Delamination Found	No apparent cause for differential
В	No Delamination Found	No apparent cause for differential
С	No Delamination Found	No apparent cause for differential
D	Minor delamination	
E	Delamination in deck and haunch	
F	No Delamination Found	No apparent cause for differential
G	No Delamination Found	Minor discoloration of deck at location
Н	No Delamination Found	Discoloration and poor consolidation at location
I	No Delamination Found	Discoloration and poor consolidation at location
J	Minor delamination	
К	Minor delamination	
L	No Delamination Found	Patches, discoloration, and poor consolidation at location
М	No Delamination Found	Patches, discoloration, and poor consolidation at location
N	Minor delamination with hollow	
	sounding patches	
0	Minor delamination	
Р	Minor delamination	
Q	Minor delamination

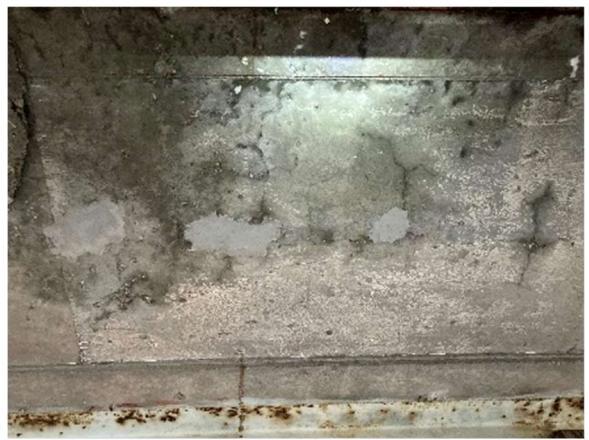
Nine of the areas of interest were false positives with no delamination present; some of these temperature differentials may have been caused by discoloration and poor consolidation of the concrete but not all false positives had an obvious cause (Figure 66). Seven areas of interest were minor delaminations that were hard to distinguish by sounding. Some of these areas may not have been true delaminations caused by corrosion of rebar but caused by poor quality repairs as several were located adjacent to patches, contained hollow sounding patches, and/or had poor consolidation (Figure 67). One location, area of interest E, was a delamination that likely should have been identified during the traditional inspection (Figure 68). The initial traditional inspection and follow up inspection findings are compiled in Appendix A-8-3. The compiled findings have thirty-five deficiencies, which is an increase from the twenty-six identified during the initial traditional inspection.

Figure 66 - False Positive from Thermal Survey

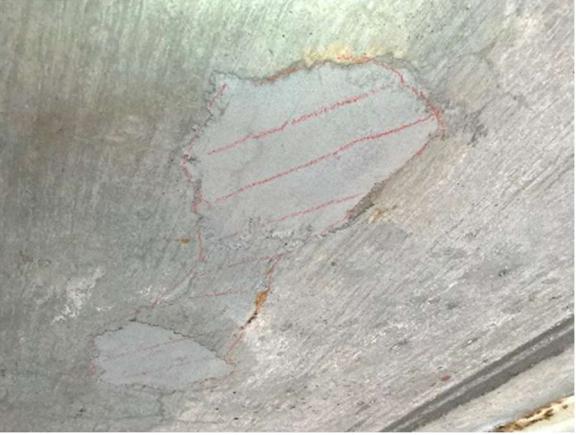
Figure 67 - Minor Delamination from Thermal Survey

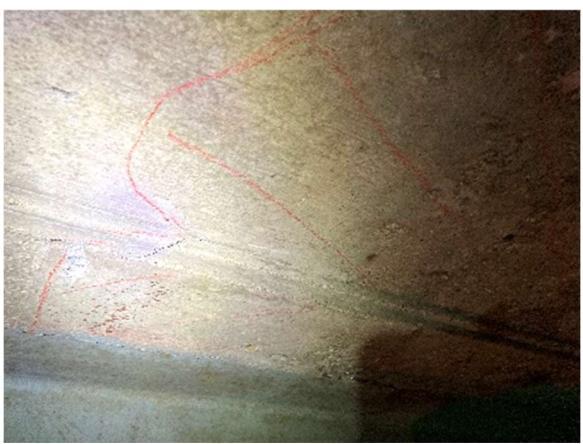
Figure 68 - Delamination from Thermal Survey

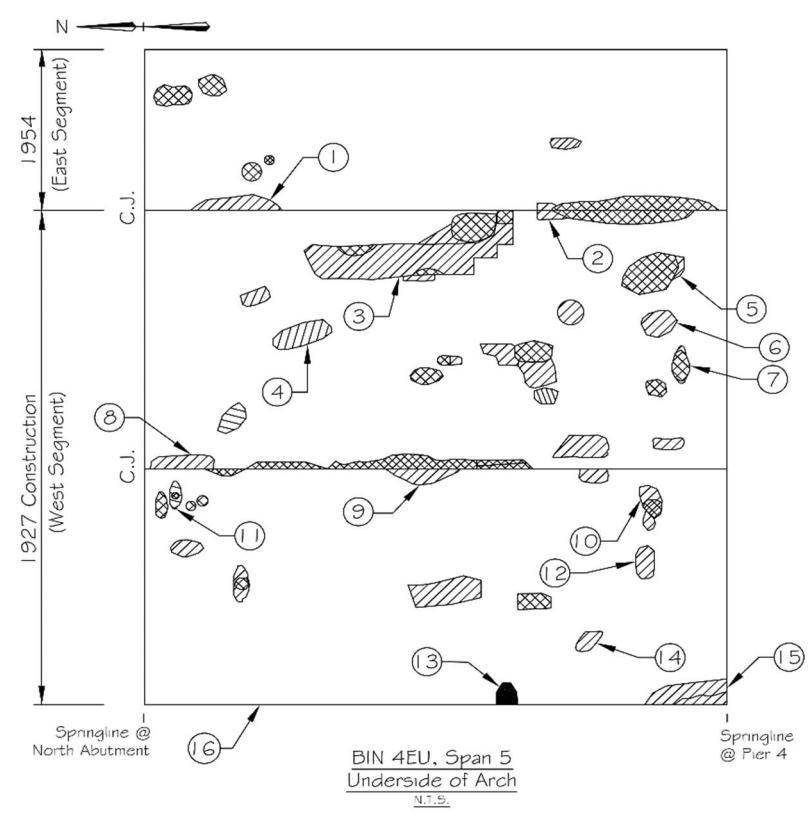
Figure 71 - Underside of Arch for Span 5

The existing underside of arch sketch for span 5 from the 2019 routine inspection report was used as a starting point in the field. Existing deficiencies were reviewed to establish locations for the collection of thermal data. Sixteen locations of delamination were chosen for data collection (Figure 71).

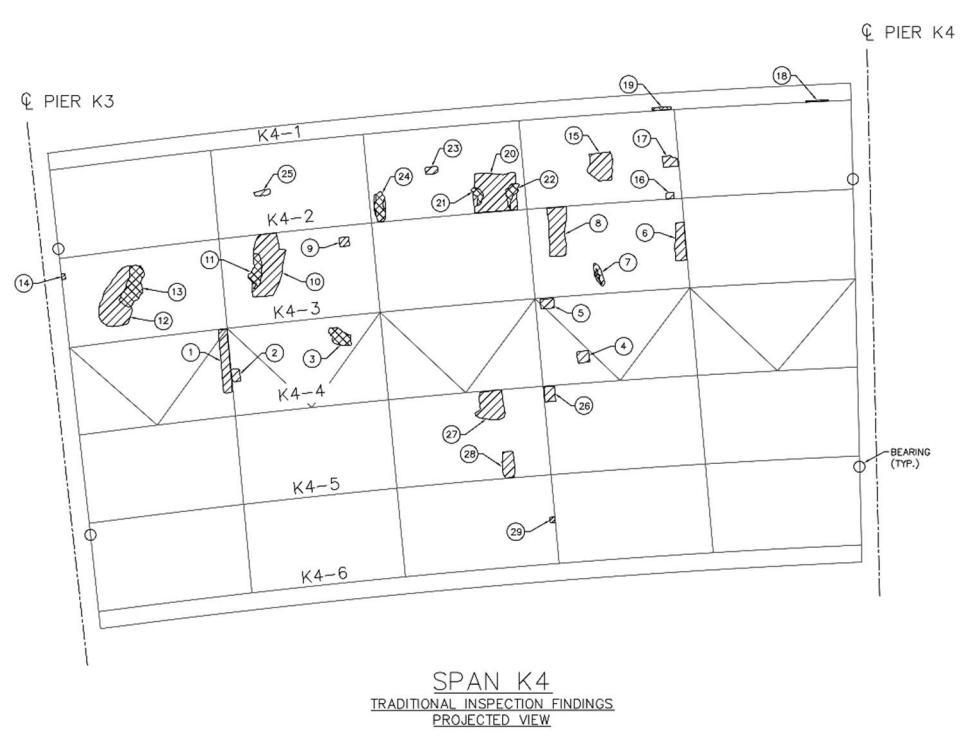
Figure 81 - Span K4 Traditional Inspection Findings

The traditional inspection findings were compared against the thermal data that was collected. Figures 81 through 86 on the following pages provide the abridge Traditional Inspection Finding Sketches and UAV-IR Survey Finding Sketches. It should be noted that the traditional inspection sketches include locations of spalling, which were not captured as part of the UAV-IR surveys.

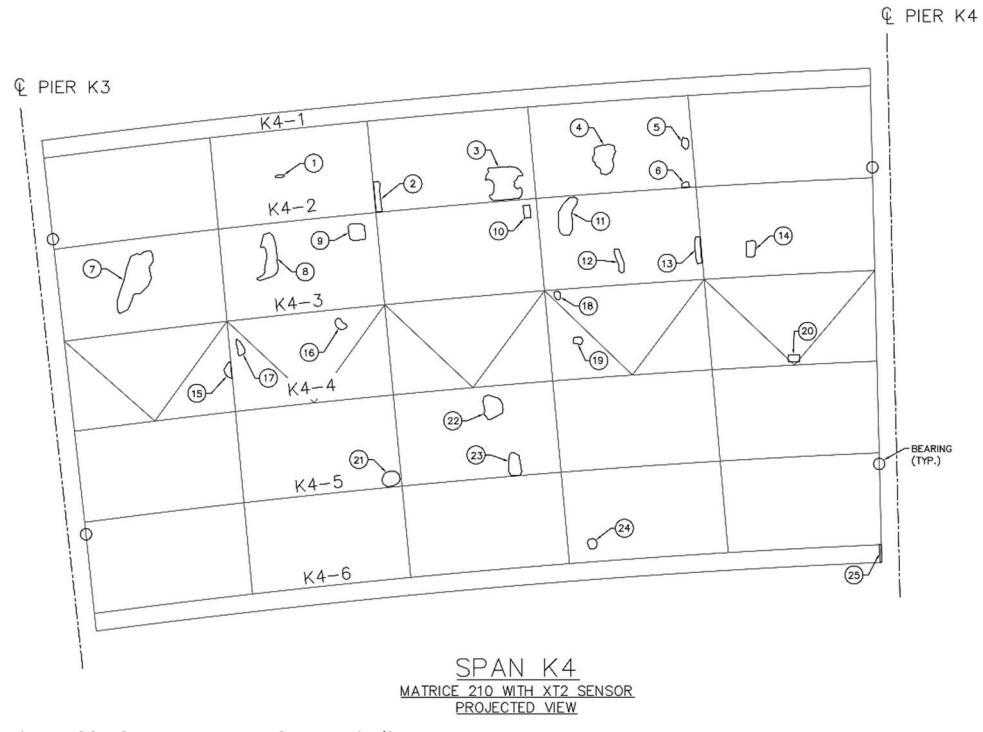
Figure 82 - Span K4 UAV-IR Survey Findings

Table 36 – 114: Span K4, Traditional Inspection versus Thermal Data

Traditional Inspection Deficiency Number*	Type of Deficiency	Delamination Identified with Thermal?	Thermal Sketch Number**	IR Image #	Comment(s)
1	HSA	Partially	15	676	
2	HSA	No	None	-	
3	Spall	Misidentified	16	680	Spall misidentified as delamination
4	HSA	Yes	19	694	
5	HSA	Yes	18	694	
6	HSA	Partially	13	696	
7	HSA & Spall	Yes	12	696	
8	HSA	Yes	11	696	
9	HSA	Yes	9	682	
10	HSA	Yes	8	682	
11	Spall	n/a	-	-	
12	HSA	Yes	7	674	
13	Spall	n/a	-	-	
14	HSA	No	None	-	
15	HSA	Yes	4	696	
16	HSA	Yes	6	696	
17	HSA	Yes	5	696	
18	Spall	n/a	-	-	
19	Spall	n/a	-	-	
20	HSA	Yes	3	684	
21	Spall	n/a	-	-	
22	Spall	n/a	-	-	
23	HSA	No	None	-	
24	HSA & Spall	Yes	2	684	
25	HSA	Yes	1	682	
26	HSA	No	None	-	
27	HSA	Yes	22	688	
28	HSA	Yes	23	688	
29	HSA	No	None	-	
None		False Positive	17	680	Paint overspray
None	_	False Positive	10	686	Paint overspray
None	-	False Positive	14	700	Discoloration of deck
None	-	False Positive	20	702	Discoloration of deck
None	-	False Positive	21	678	Paint overspray, discoloration of deck

None	-	False Positive	24	692	Discoloration of deck
None	-	False Positive	25	704

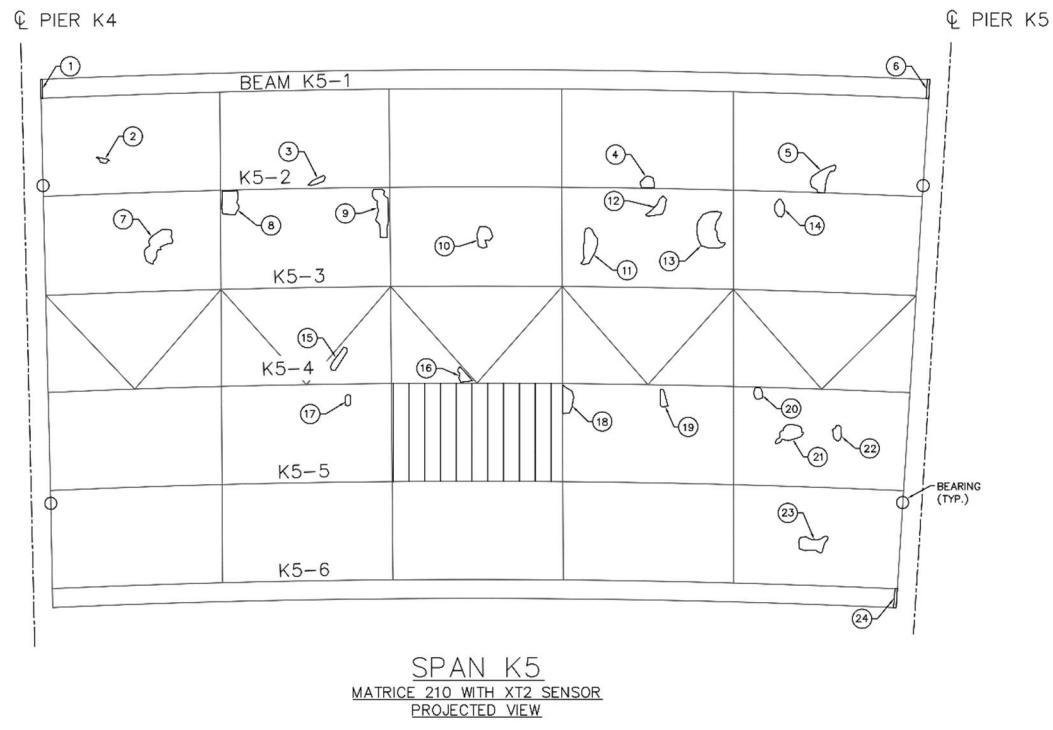
Figure 83 - Span K5 UAV-IR Survey Findings

Traditional Inspection Deficiency Number*	Type of Deficiency	Delamination Identified with Thermal?	Thermal Sketch Number**	IR Image #	Comment(s)
1	HSA	No	None	-	
2	Spall	n/a	-	-	
3	HSA	Yes	23	163	
4	HSA	Yes	22	161	
5	HSA	Partially	21	161	Thermal shows 5 & 6 as one larger combined area
6	HSA	Partially	21	161	Thermal shows 5 & 6 as one larger combined area
7	HSA	Yes	20	161	
8	HSA	Yes	19	167	
9	Spall	n/a	-	-	
10	HSA	Partially	18	167	
11	n/a	n/a	-	-	
12	HSA	Yes	7	189	
13	Spall	n/a	-	-	
14	Spall	n/a	-	-	
15	HSA	Yes	2	187	
16	HSA	No	None	-	
17	Spall	n/a	-	-	
18	HSA	Yes	3	183	
19	HSA	No	None	-	
20	HSA	Yes	4	171	
21	Spall	n/a	-	-	
22	Spall	n/a	-	-	
23	HSA	Yes	5	157	
24	HSA	Yes	14	159	
25	Spall	n/a	-	-	
26	HSA	Yes	12	169	Thermal area is larger than actual
27	HSA	Yes	13	169	
28	Spall	n/a	-	-	
29	HSA & Spall	Yes	11	169	
30	HSA	Yes	8	181	
31	HSA	Yes	9	181	Thermal area is larger than actual
32	Spall	n/a	-	-	
33	HSA	Partially	10	173	
34	HSA	Yes	16	175

None	-	False Positive	1	185	
None	-	False Positive	6	155	
None	-	False Positive	15	179	Paint overspray
None	-	False Positive	17	177	
None	-	False Positive	24	165

Table 37 – 114: Span K5, Traditional Inspection versus Thermal Data

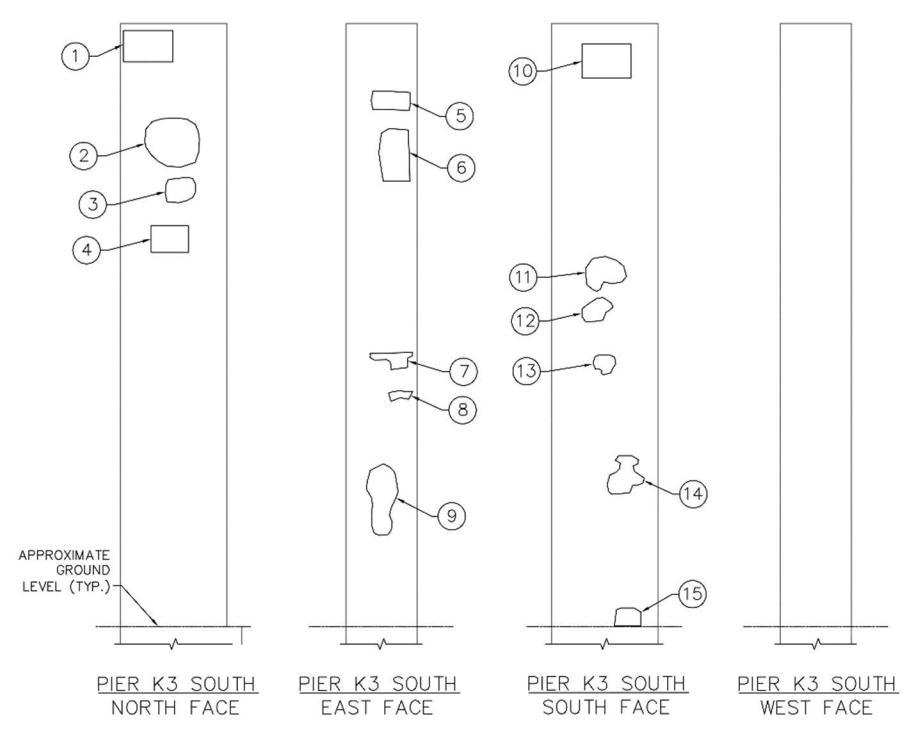
Figure 86 - Pier K3 South Column UAV-IR Survey Findings

Table 38 – 114: Pier K3	South Column.	Traditional Inspe	ction versus Therm	al Data
10010 00 111110110	South conunny	in a antion an inspec		ar D'ata

Traditional Inspection Deficiency Number*	Type of Deficiency	Delamination Identified with Thermal?	Thermal Sketch Number**	IR Image #	Comment(s)
1	HS Patch	Yes	1	736	
2	HSA	Yes	2, 3	736	
3	Sound patch	Misidentified	4	736	Patch at location
4	Sound patch	n/a	-	736	
5	Sound patch	Misidentified	5	730	Patch at location
6	HS Patch	Partially	6	730	
7	HS Patch	No	None	732	
8	HSA	Yes	7	732	
9	Spall	n/a	-	732	
10	HSA & Spall	Partially	8	8	
11	HSA	Yes	9	734	
12	HS Patch	Yes	10	722	
13	HSA & Spall	No	None	722	
14	HSA	Yes	11, 12	724	
15	HSA	Yes	13	724, 726	
16	HSA	Yes	14	726	
None	-	False Positive	15	728

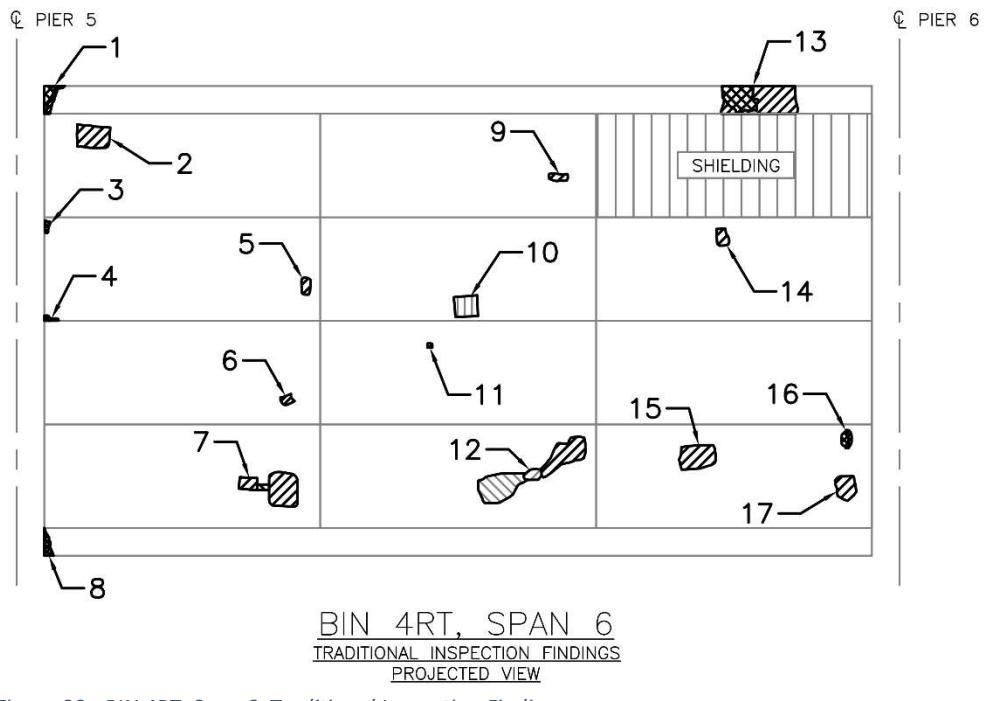
Figure 90 - BIN 4RT, Span 6, Traditional Inspection Findings

The traditional inspection findings were compared against the thermal data that was collected. Figures 90 through 93 on the following pages provide the UAV-IR Survey Finding Sketches and abridged Traditional Inspection Sketches. It should be noted that the traditional inspection sketches include locations of spalling, which were not captured as part of the UAV-IR surveys.

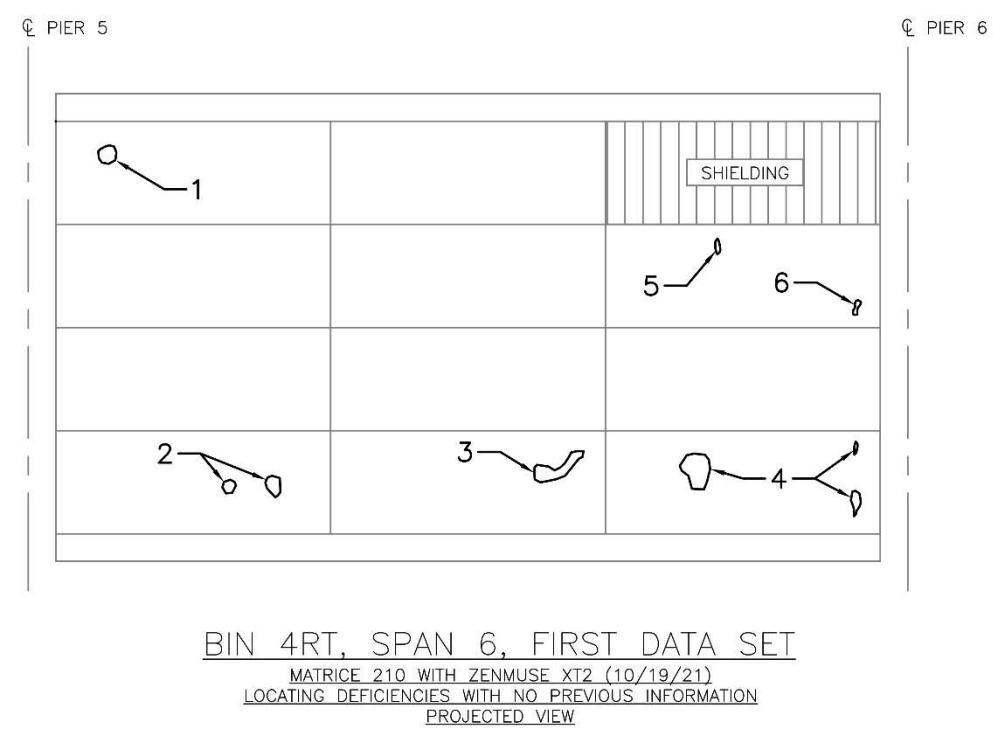
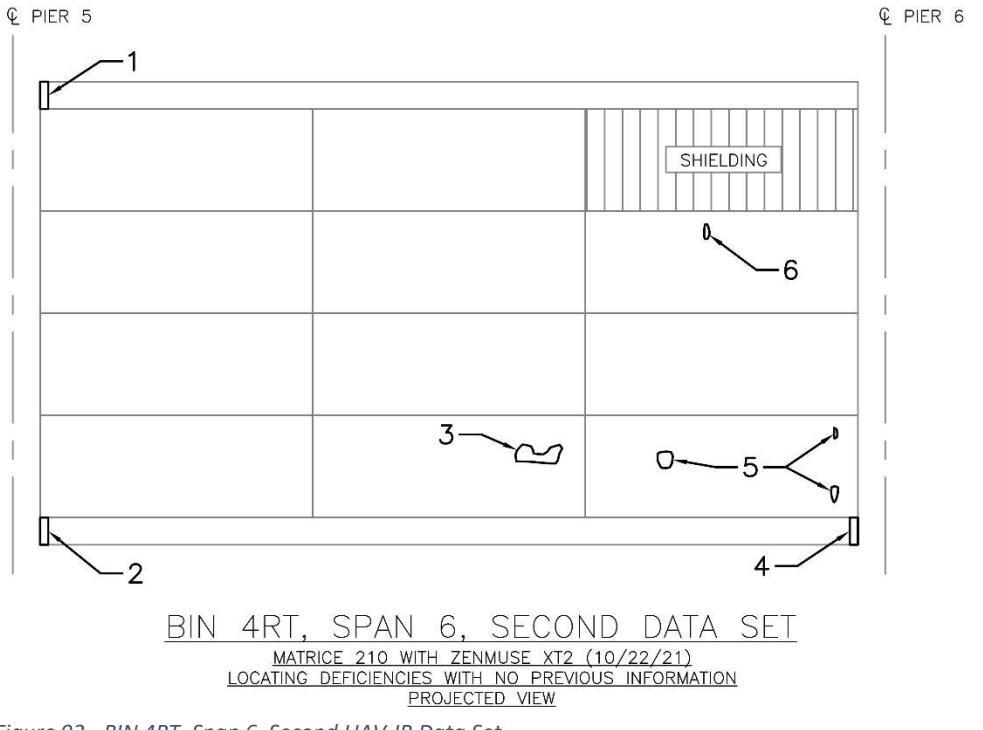
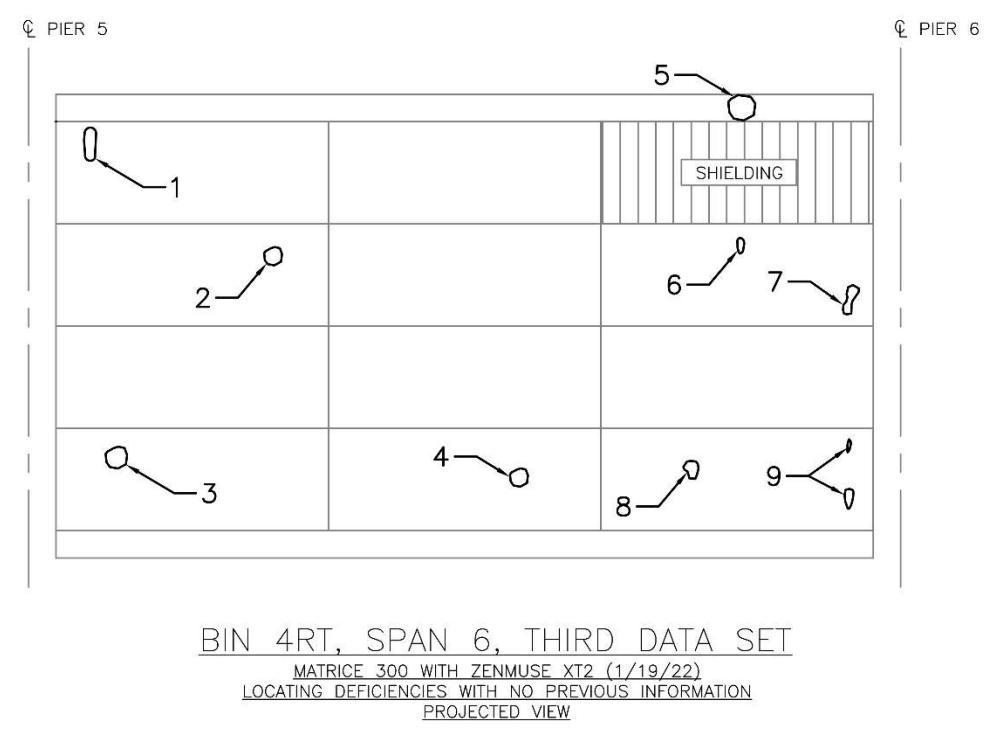
Tue ditie and		First Data Set (10/19/2021)		Second Data Set (10/22/2021)			Third Data Set (1/19/2022)			
Iraditional Inspection Deficiency Number*	Type of Deficiency	Delam. Identified with Thermal?	Thermal Sketch Number **	Comment(s)	Delam. Identified with Thermal?	Thermal Sketch Number **	Comment(s)	Delam. Identified with Thermal?	Thermal Sketch Number **	Comment(s)
1	HSA & Spall	No	-		Yes	1		No	-	
2	HSA	Yes	1		No	-		Partial	1	
3	Spall	n/a	-		n/a	-		n/a	-	
4	Spall	n/a	-		n/a	-		n/a	-	
5	HSA	No	-		No	-		No	-	
6	HSA	No	-		No	-		No	-	
7	HSA	Partial	2		No	-		No	-	
8	Spall	n/a	-		Mis- identified	2	Spall identified as delam	No	-	
9	HSA	No	-		No	-		No	-	
10	n/a	n/a	-		n/a	-		n/a	-	
11	HSA	No	-		No	-		No	-	
12	HSA	Partial	3		Yes	3		Partial	4	
13	HSA & Spall	No	-		No	-		Yes	5	
14	HSA	Yes	5		Yes	6		Yes	6	
15	HSA	Yes	4		Yes	5		Partial	8	
16	HSA & Spall	Yes	4		Yes	5		Yes	9	
17	HSA	Yes	4		Yes	5		Yes	9	
None	-	False Positive	2		False Positive	4		False Positive	2

It should be noted that the majority of the delaminations along the span that was field tested were relatively minor and small which may have contributed to the limited detection. While thermal imaging was unable to identify all of the delaminations along the portions of the bridge selected for field testing, it did identify more locations of delamination than were specifically identified in the most recent NBIS Routine inspection. However, the Routine Inspection general deficiency description for the deck indicated that that area numerous delaminations throughout the bridge. Table 44 provides the number of identified deficiencies (spalls and delaminations) and delaminations for each inspection.

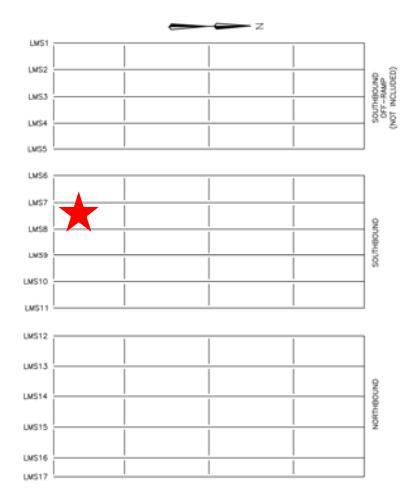
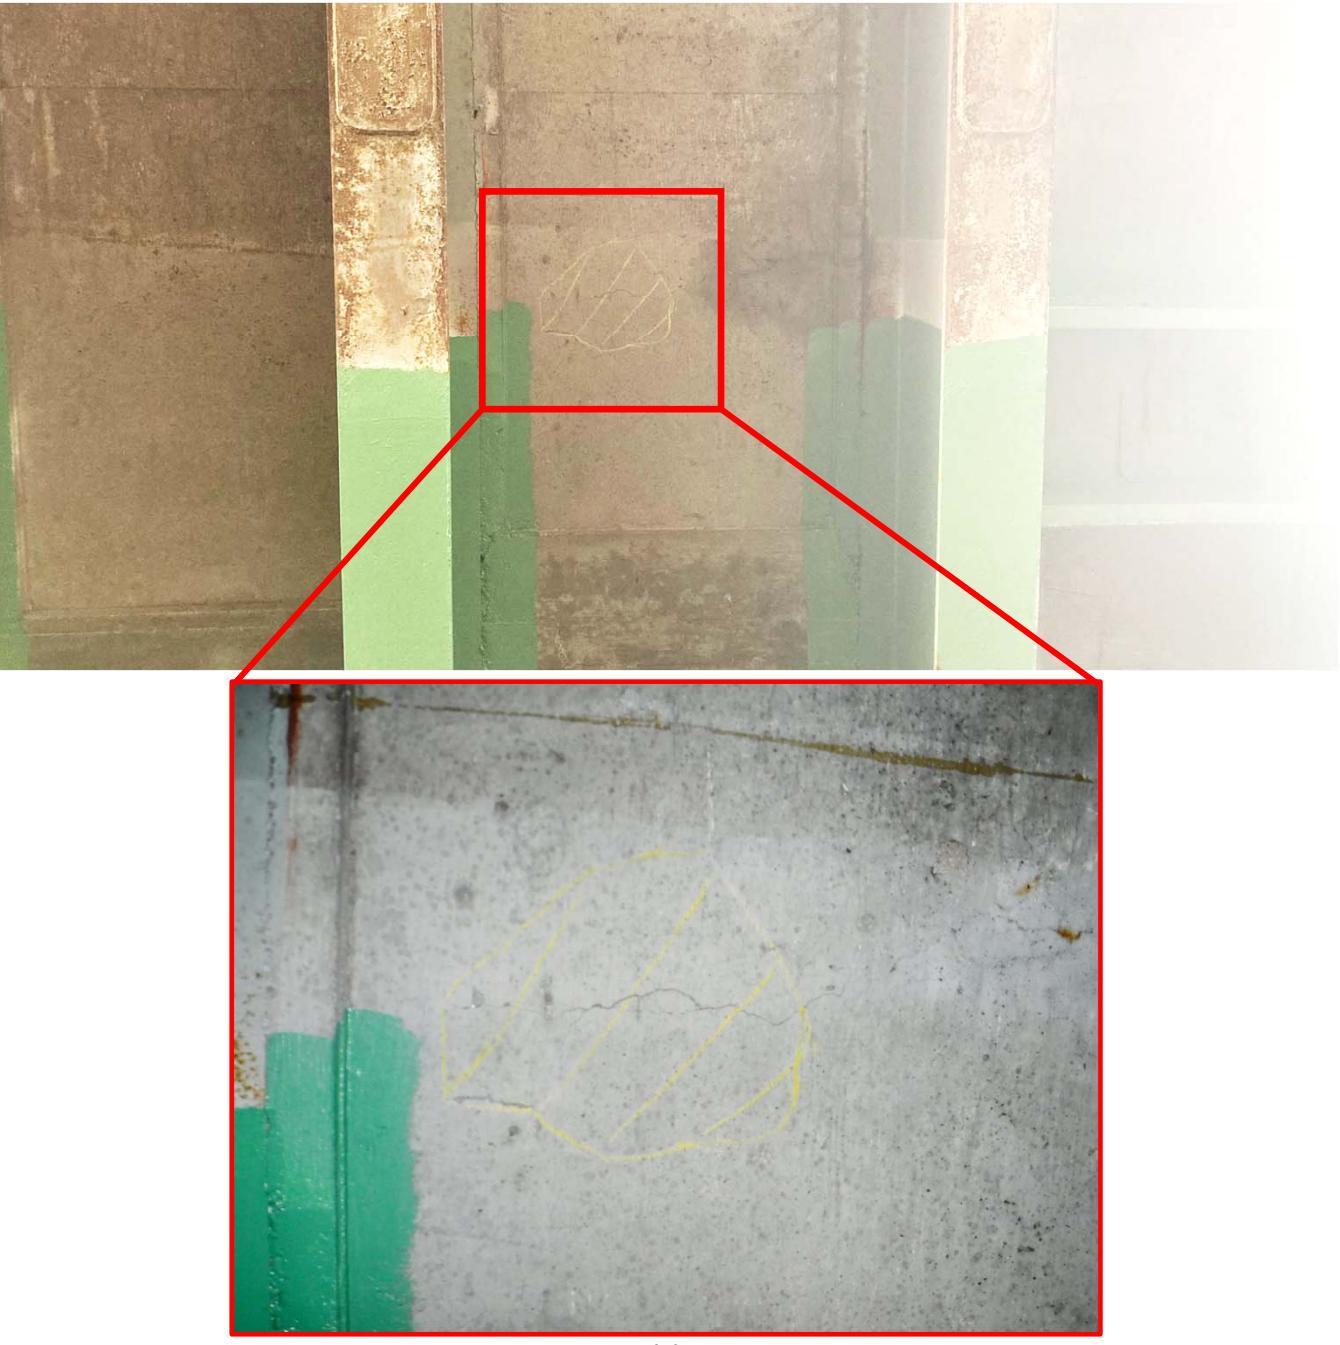
Visually Identifiable as Delamination?

No, the crack could suggest delamination but hammer sounding was necessary to confirm.

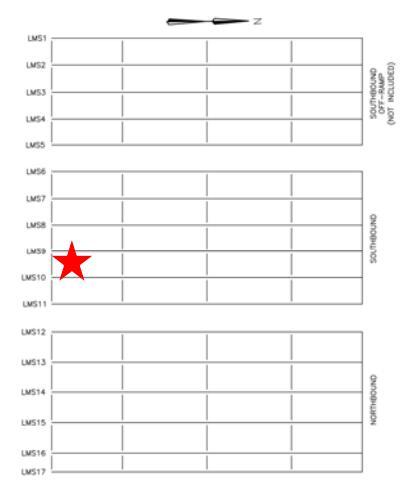
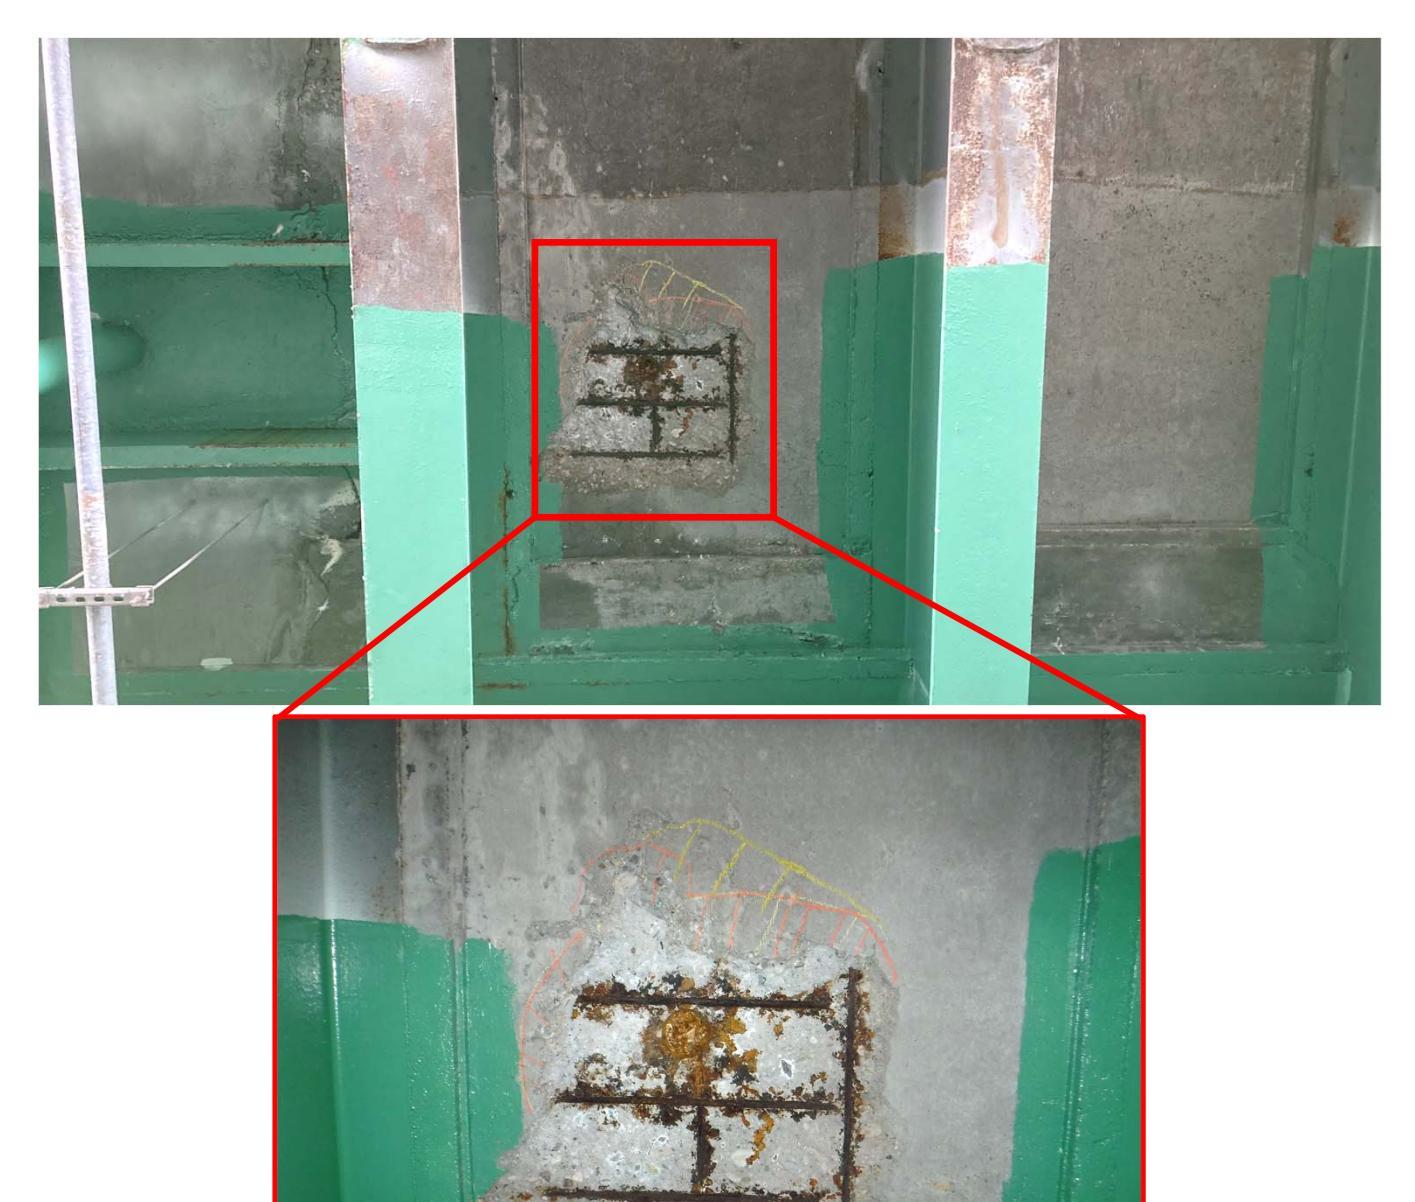
4E5, Location 2

Visually Identifiable as Delamination?

No, adjacent spalling suggested delamination but hammer sounding was necessary to confirm.
