New England Transportation Consortium (NETC) NETC 20-3

Investigating Thermal Imaging Technologies and Unmanned Aerial Vehicles to Improve Bridge Inspections

Task 2 Interim Report

Field Demonstration and Data Analysis

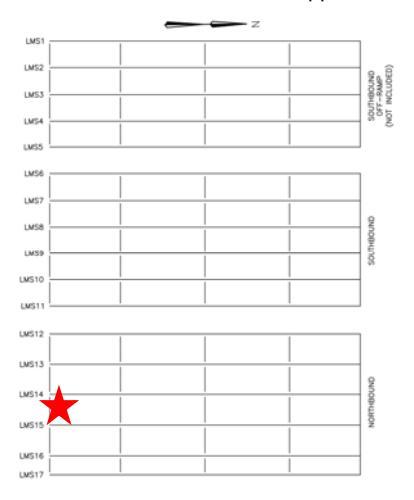
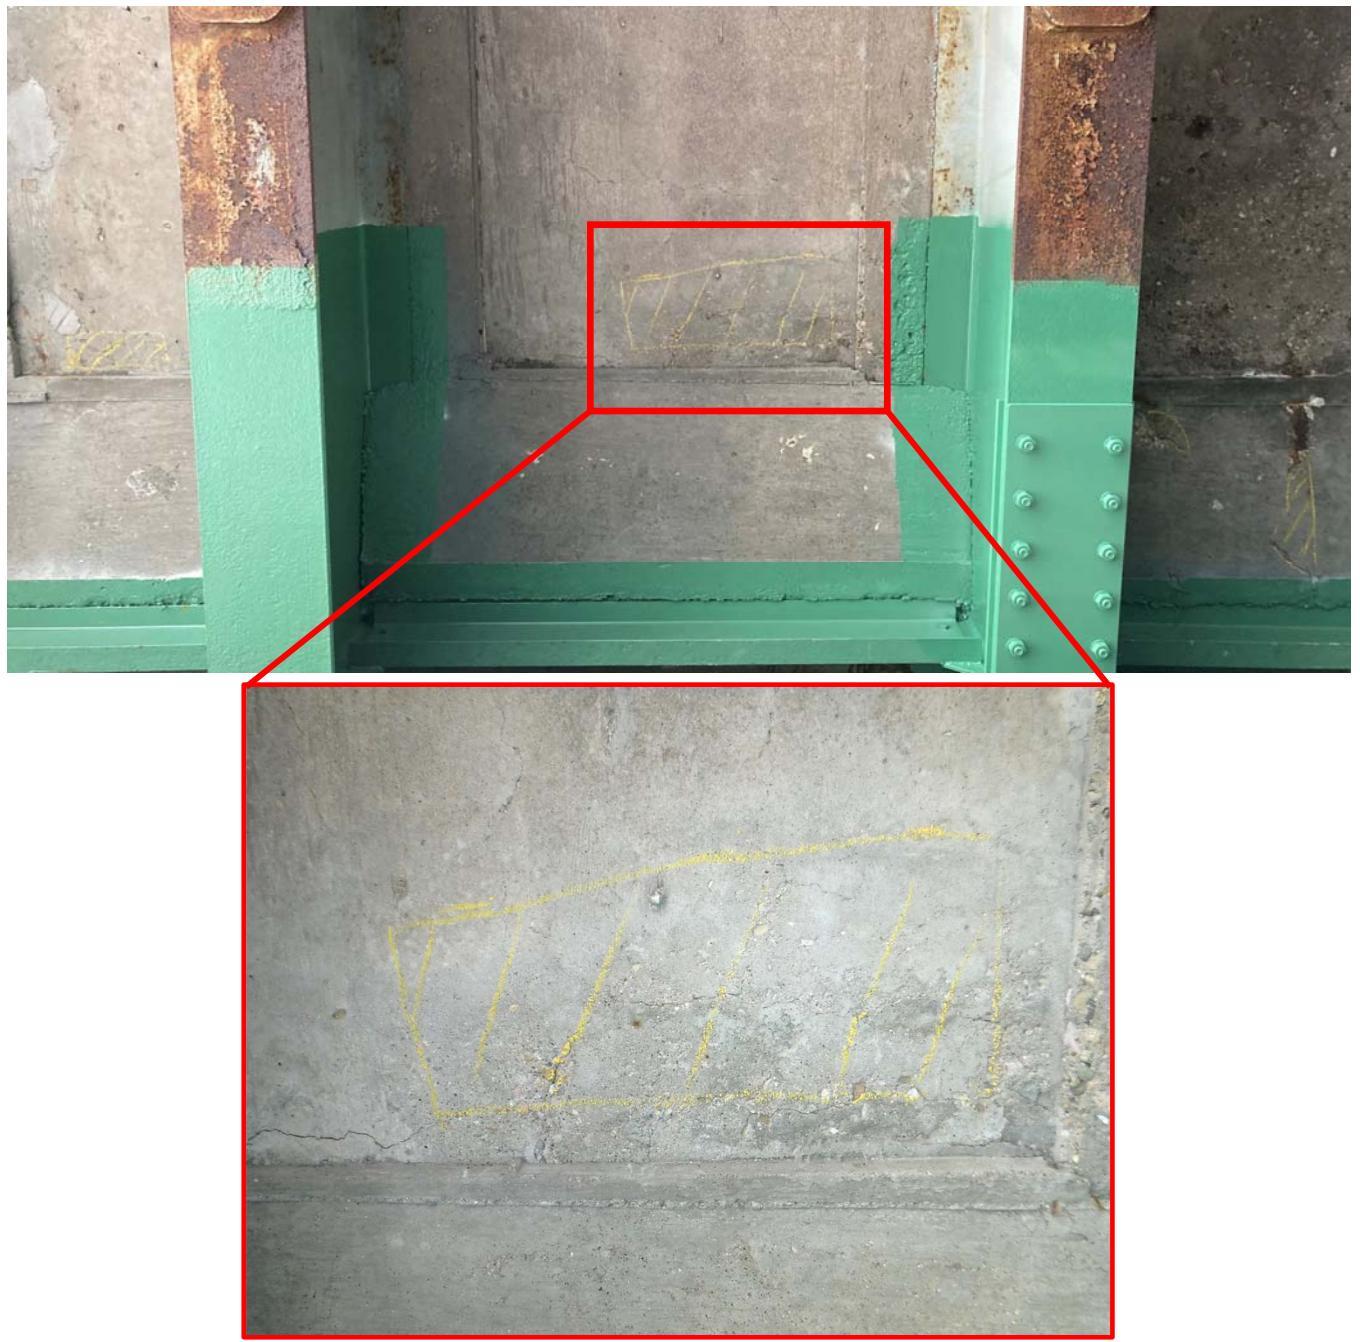
4E5, Location 3

Visually Identifiable as Delamination?

No, this location was only identified through random hammer sounding of the deck.

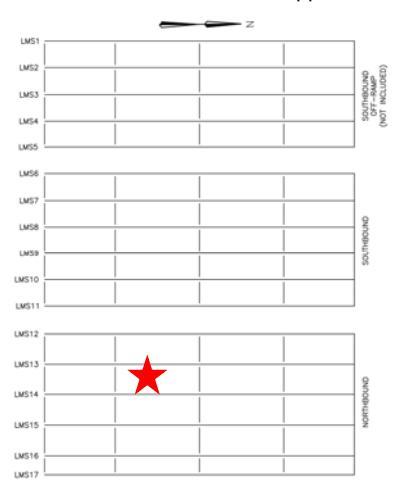
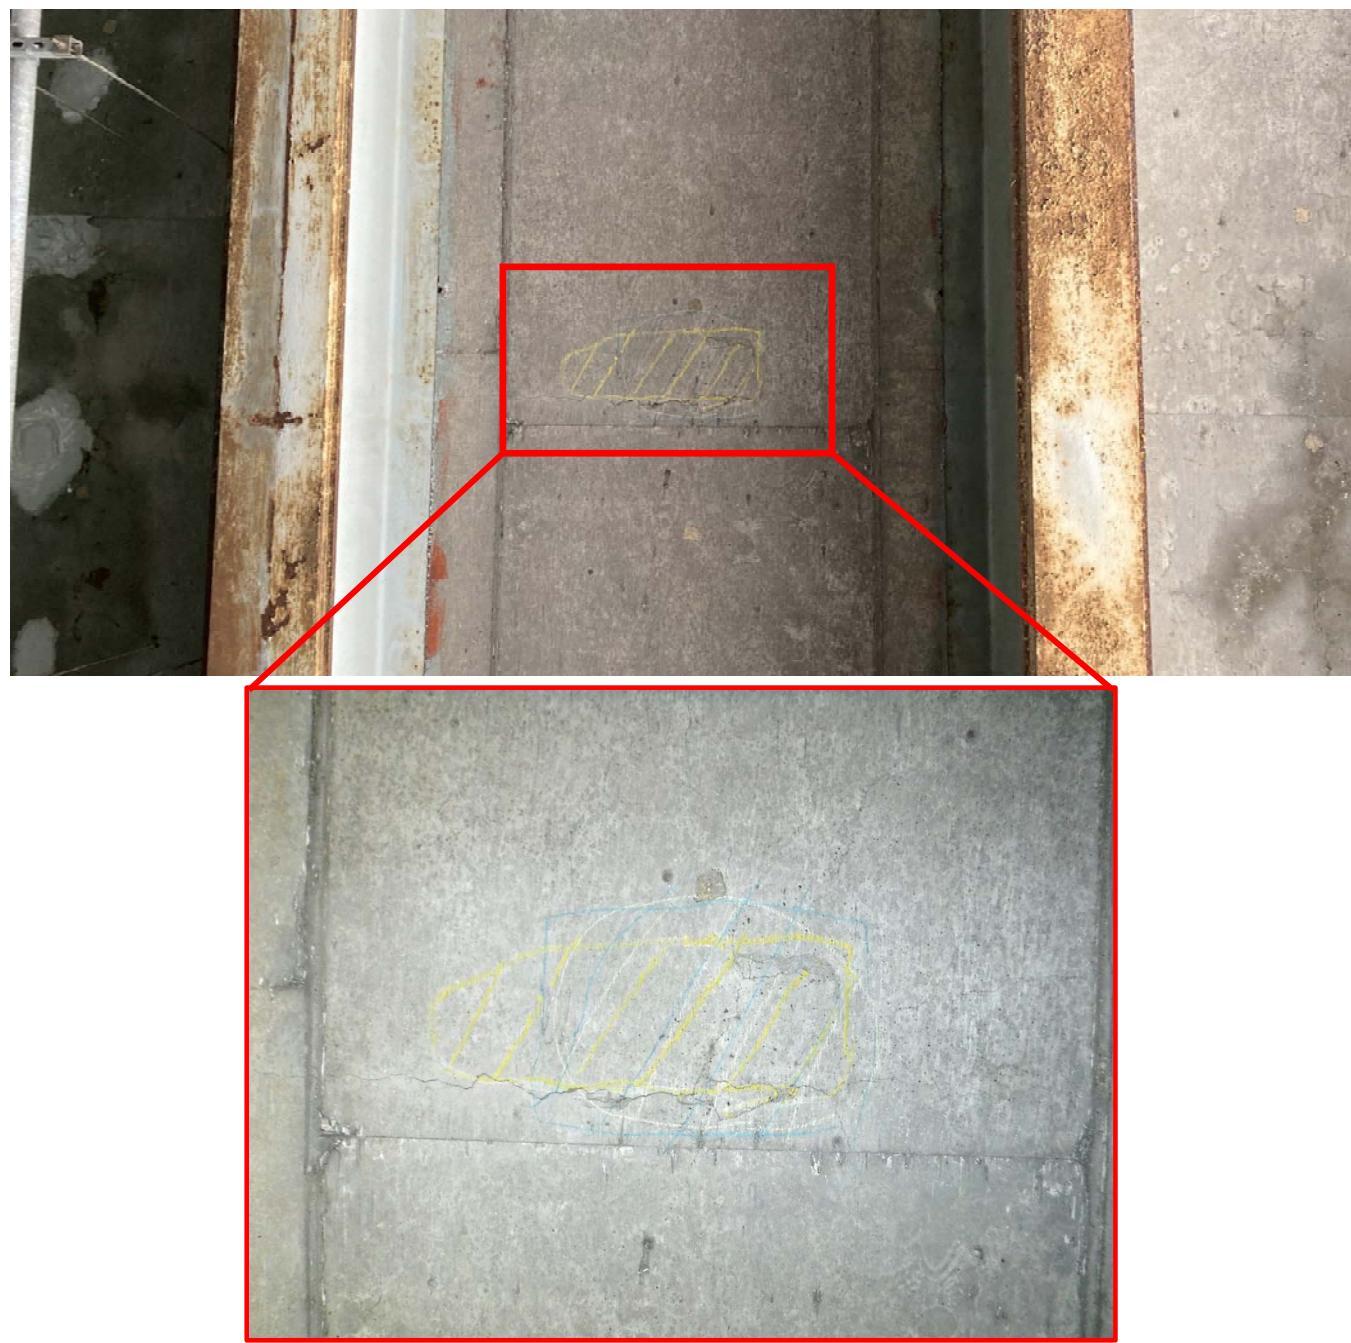
4E5, Location 4

Visually Identifiable as Delamination?

No, the crack could suggest delamination but hammer sounding is necessary to confirm.

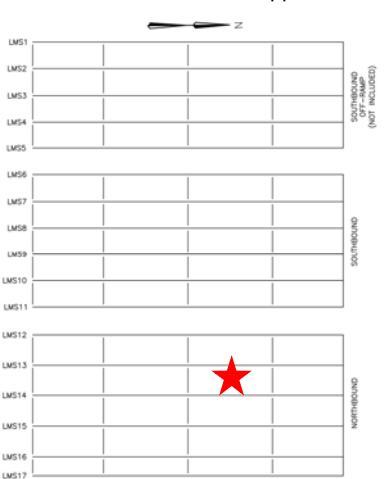
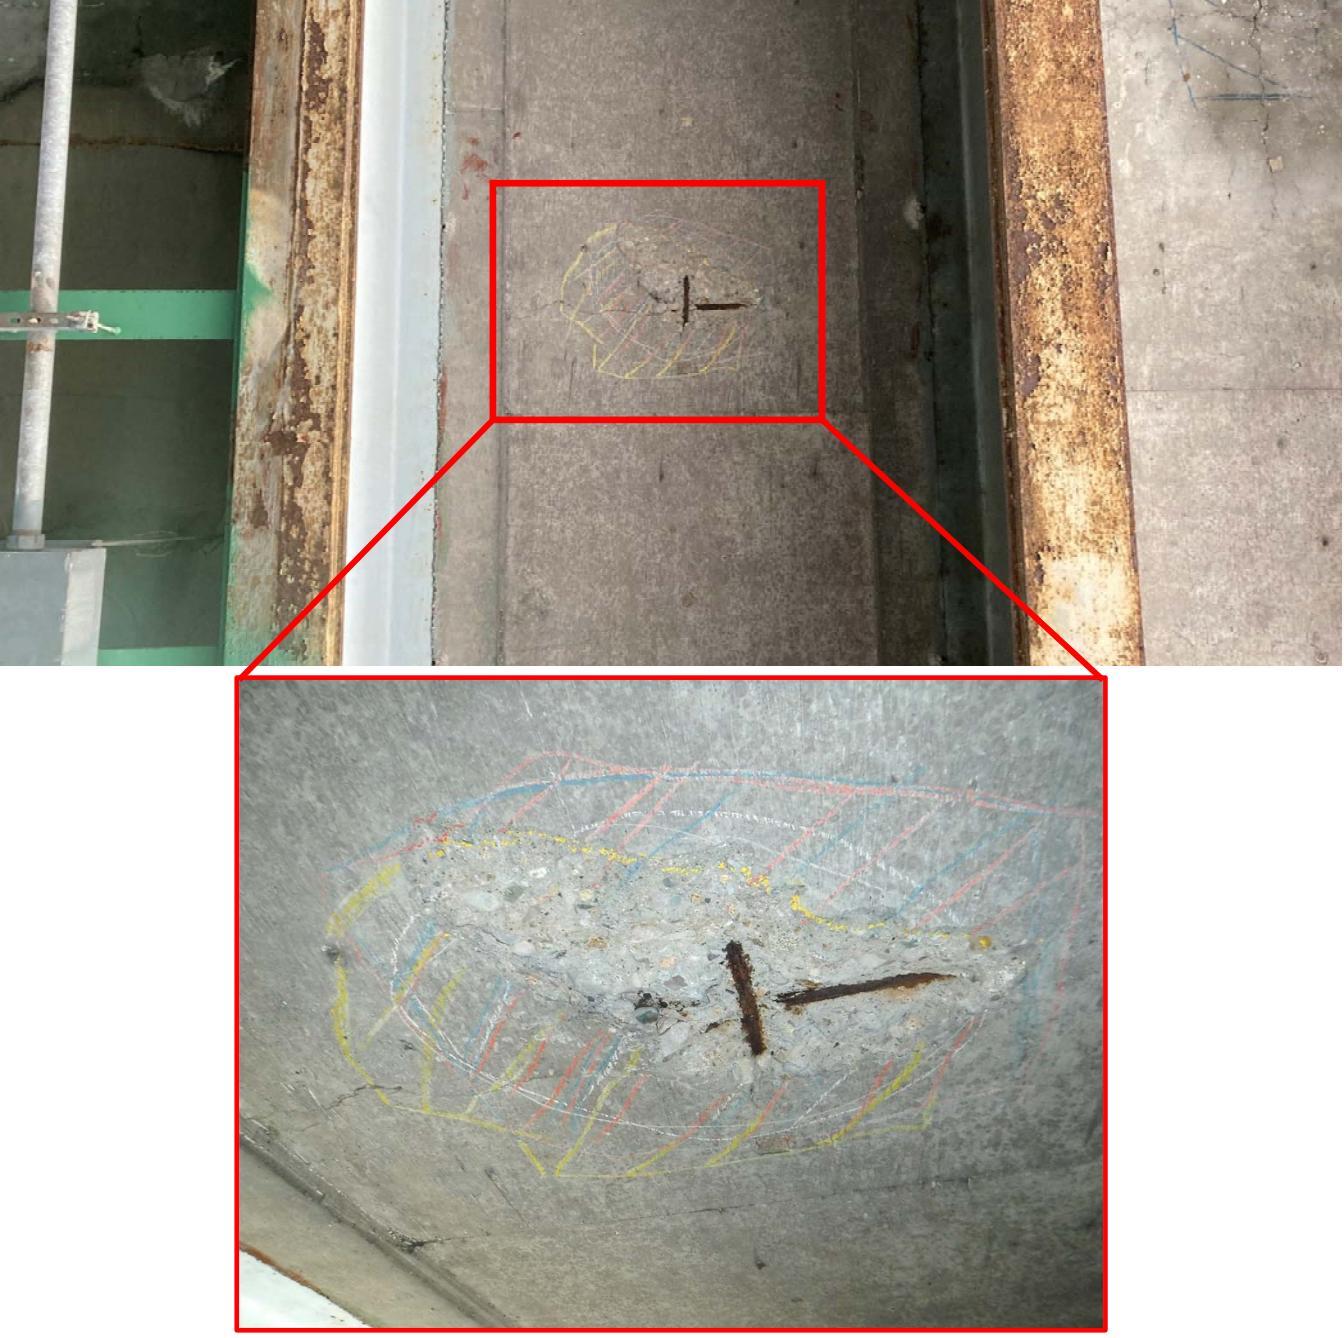
4E5, Location 5

Visually Identifiable as Delamination?

Yes, there is separation cracking that is visible although the limits of the delamination required hammer sounding to determine.

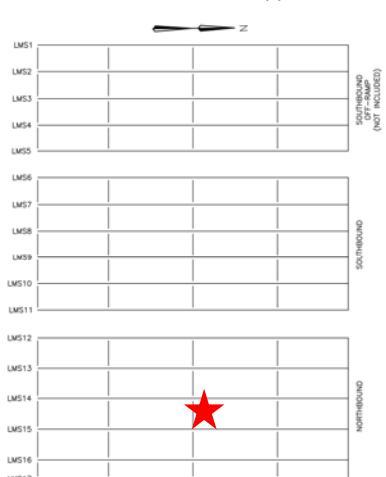
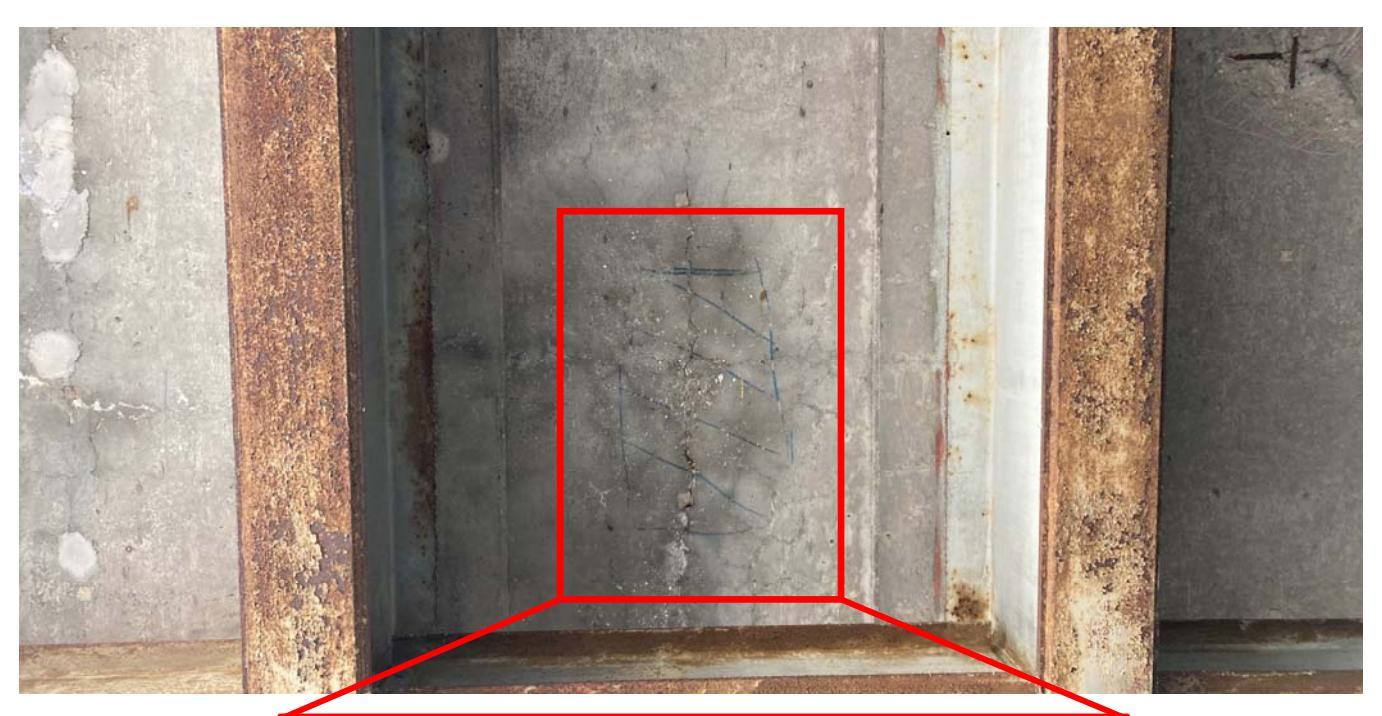
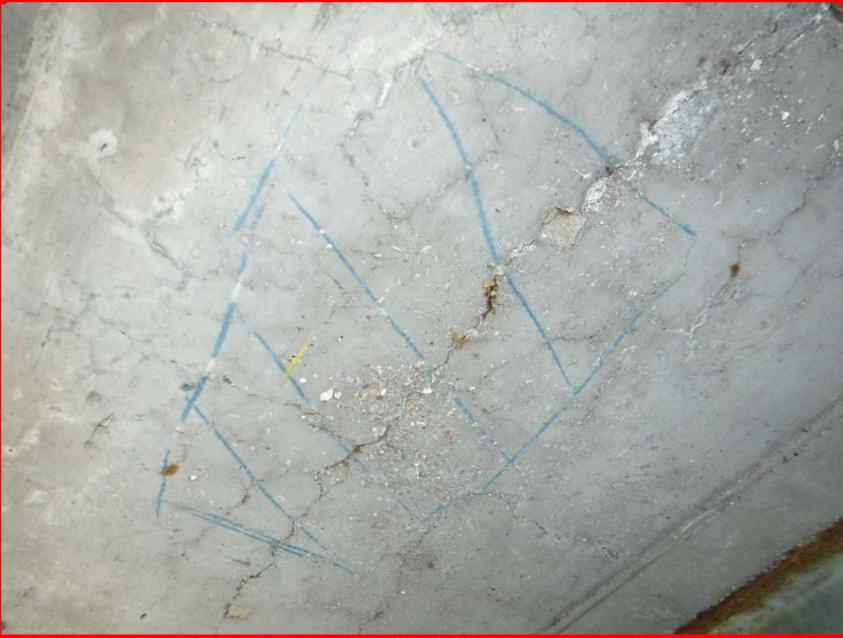
4E5, Location 6

Visually Identifiable as Delamination?

No, cracking and poor consolidation can suggest delamination but hammer sounding was necessary to confirm. Additionally, the delamination was very minor and might not be noted by all inspectors due to the atypical tone produced when sounding.

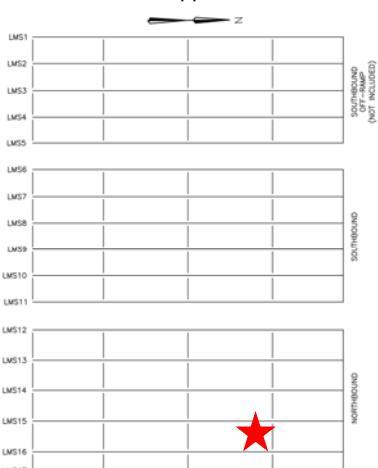
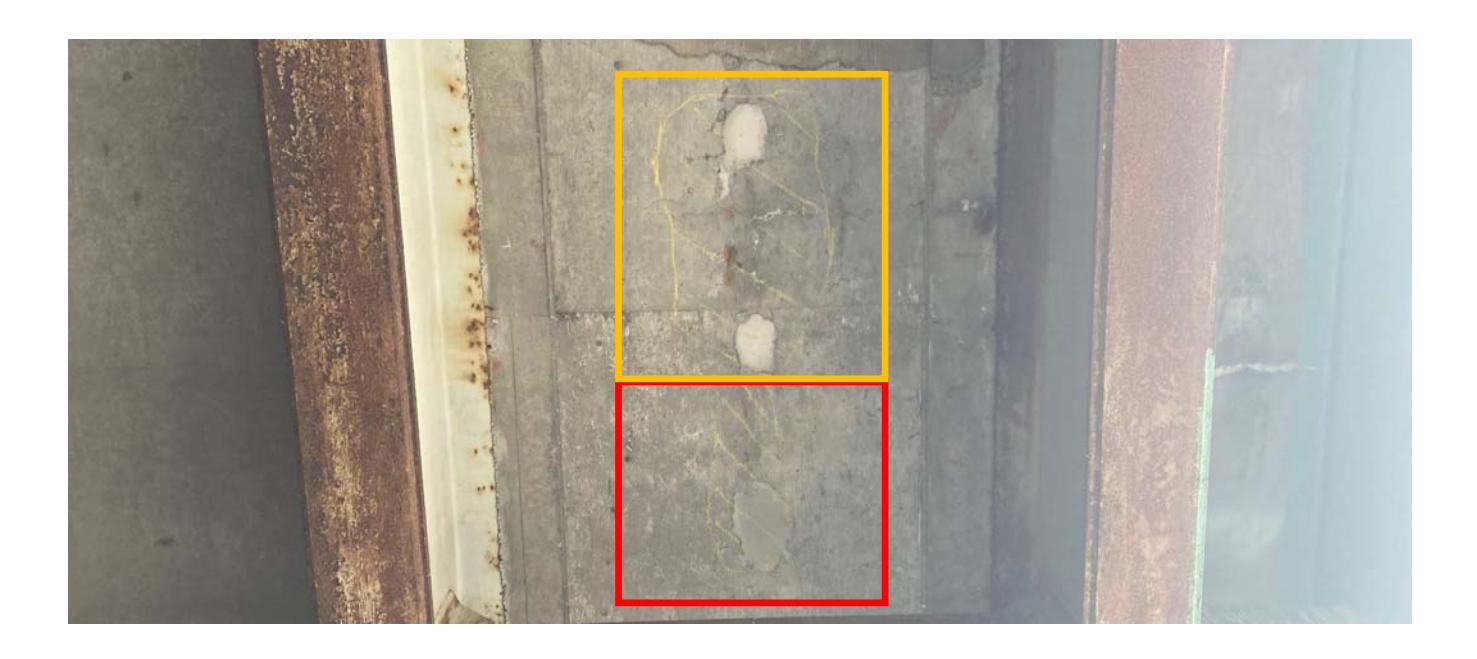
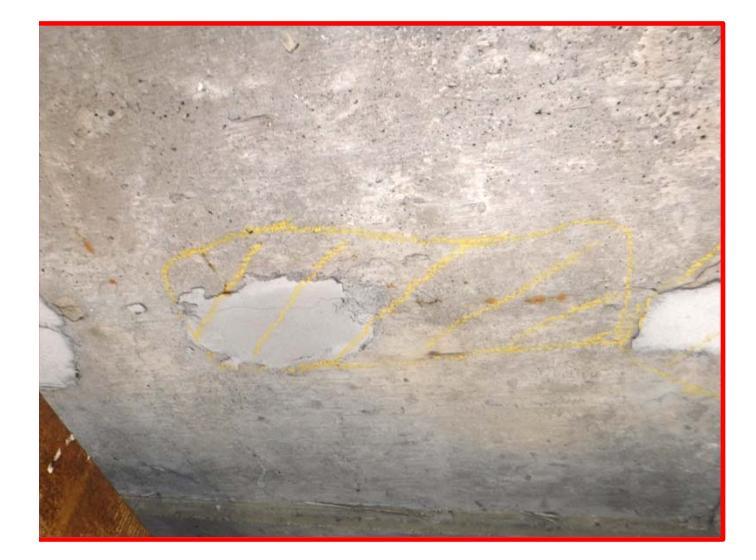
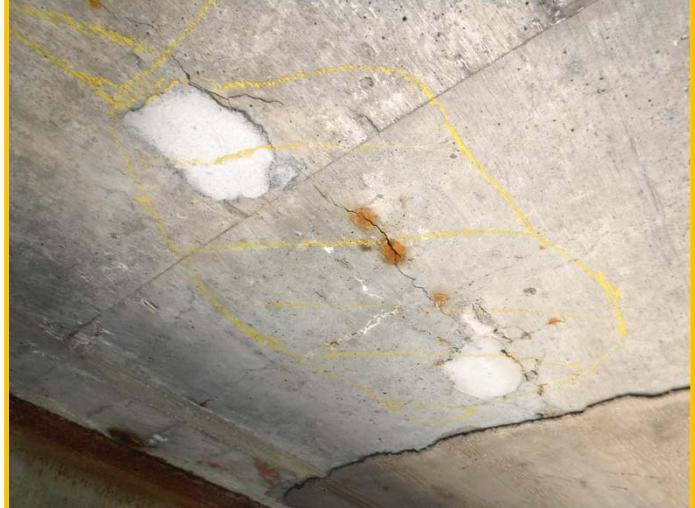
4E5, Location 7

Visually Identifiable as Delamination?

No, rust staining, cracking, and patches suggest possible delamination but hammer sounding was necessary to confirm.

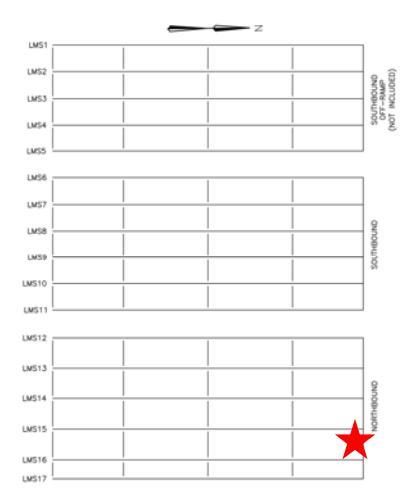
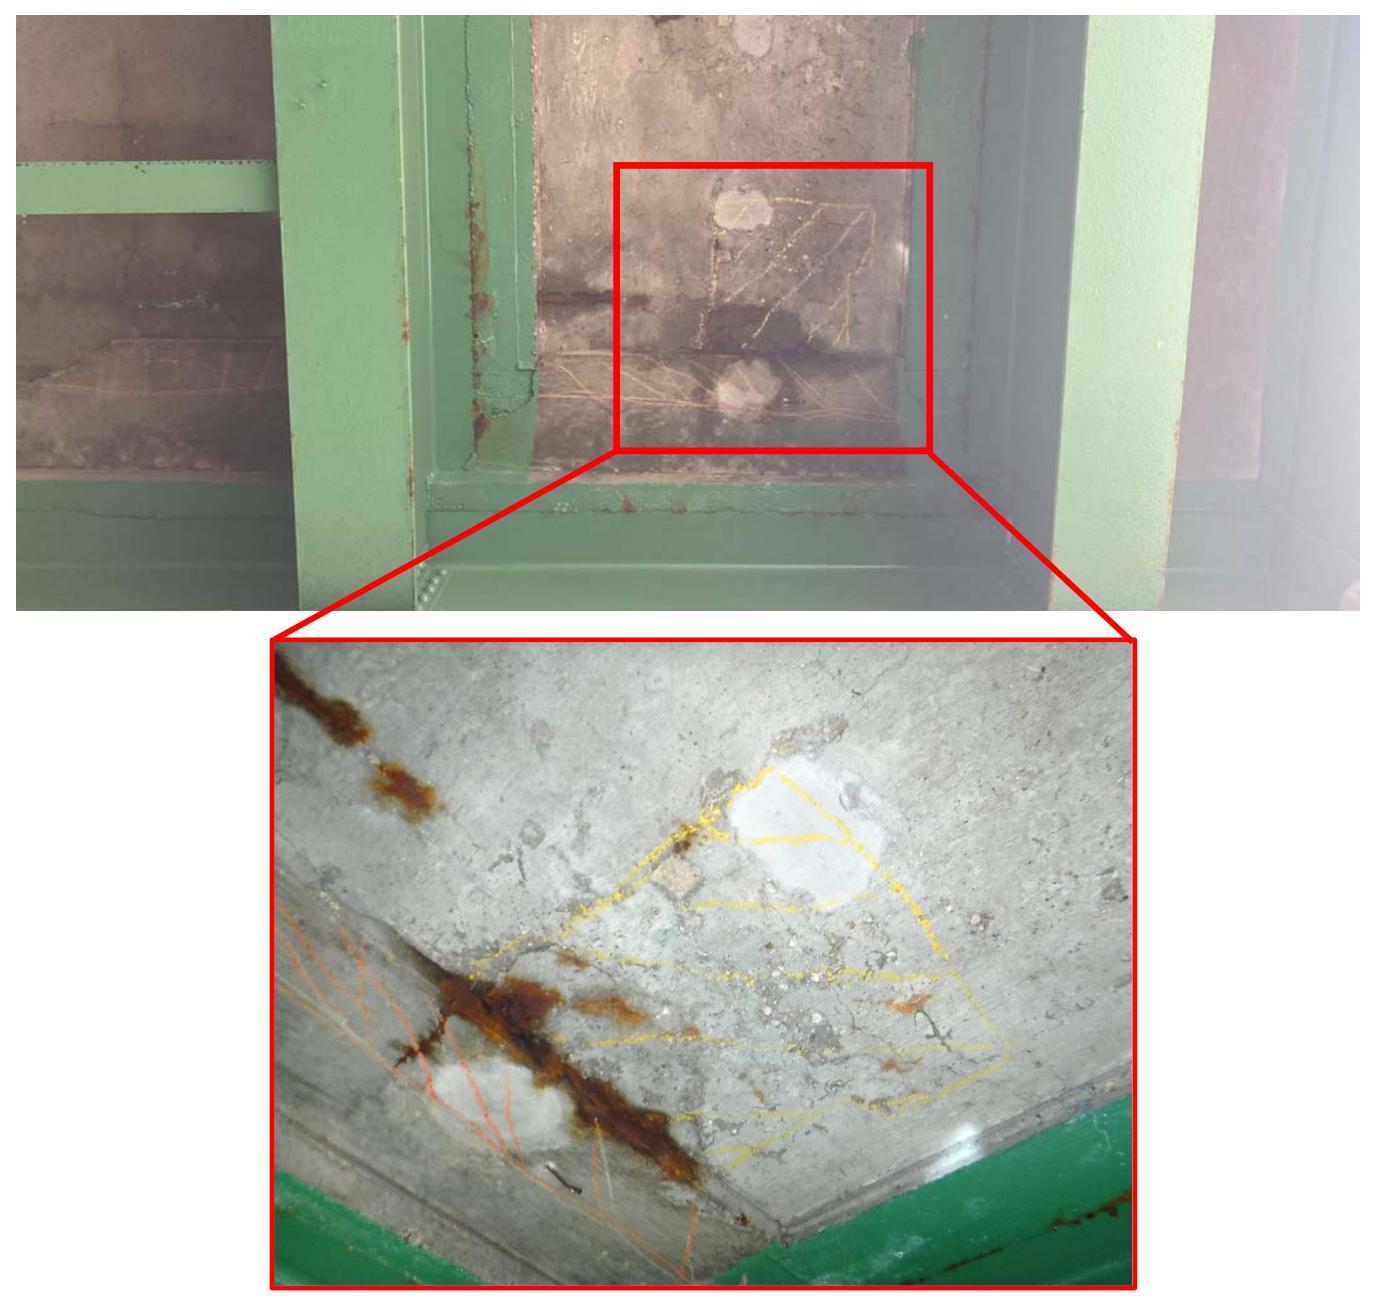
Visually Identifiable as Delamination?

No, rust staining and cracking suggest delamination but hammer sounding is necessary to confirm.

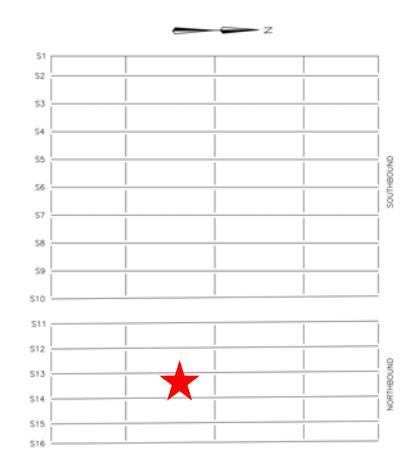
4E5, Location 9

Visually Identifiable as Delamination?

Yes, there is separation cracking that is visible although the limits of the delamination required hammer sounding to determine.

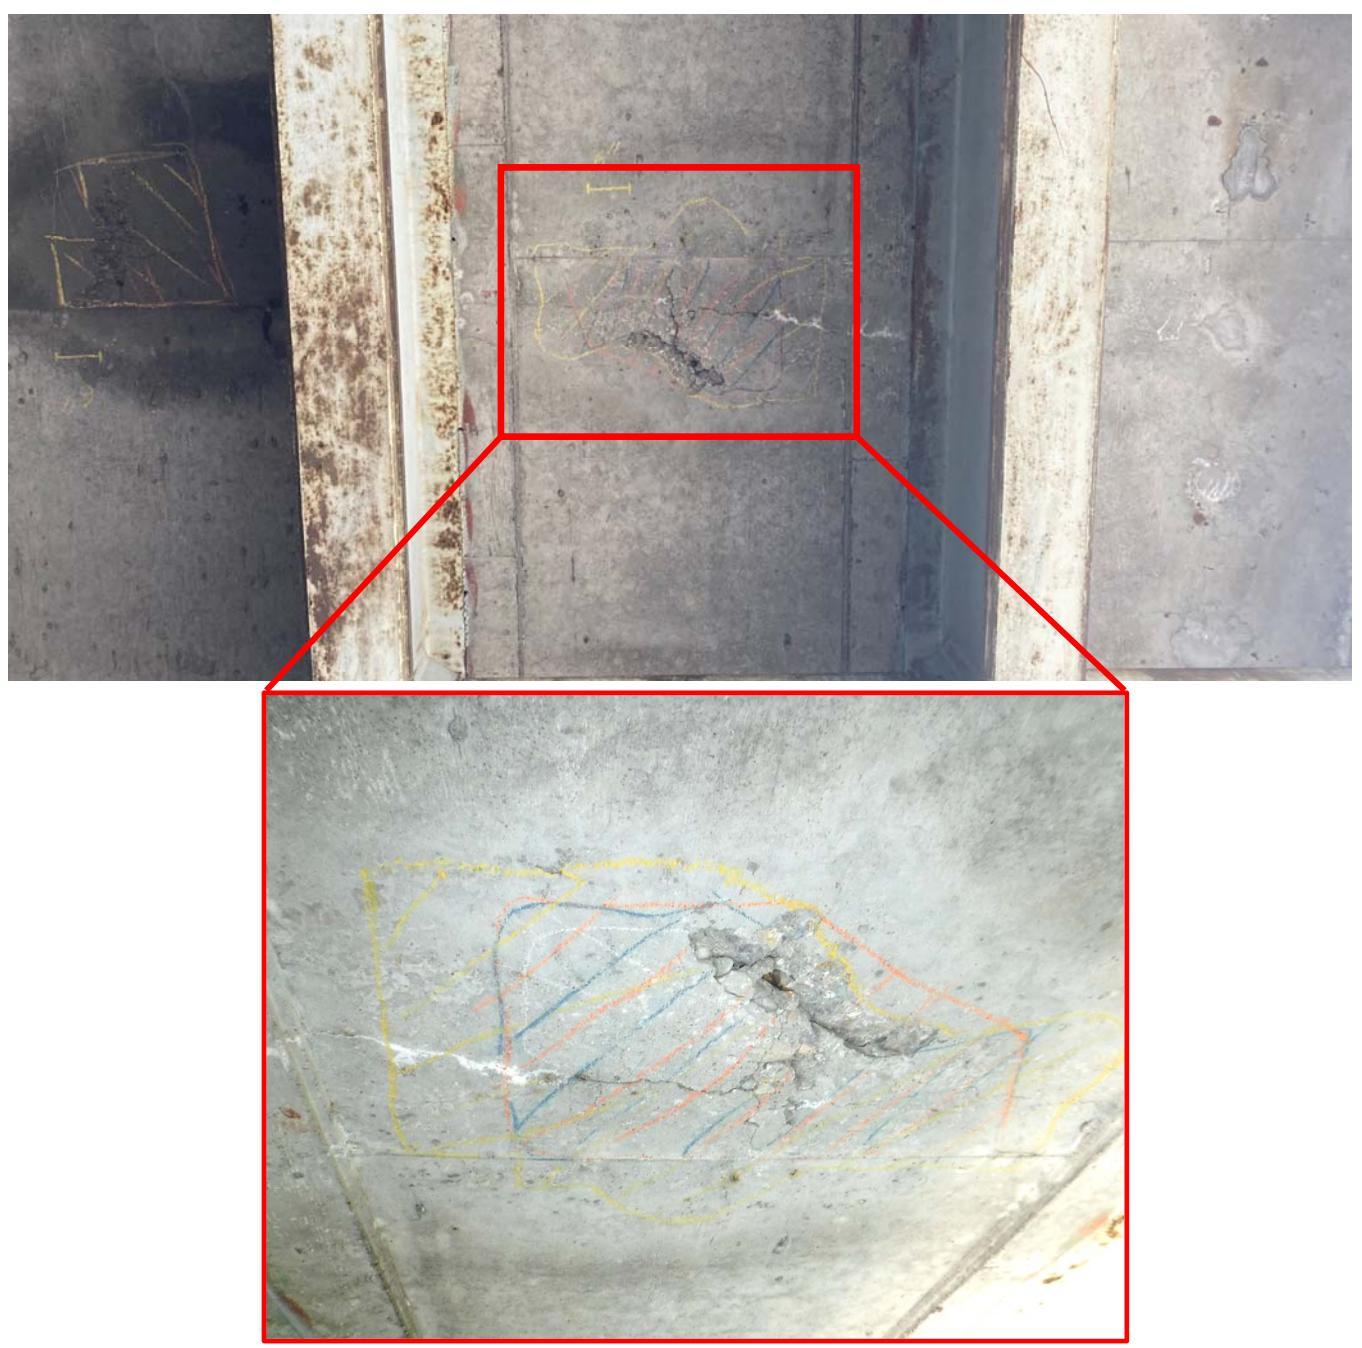
4E5, Location 10

No, discoloration and efflorescence could suggest delamination but hammer sounding was necessary to confirm.

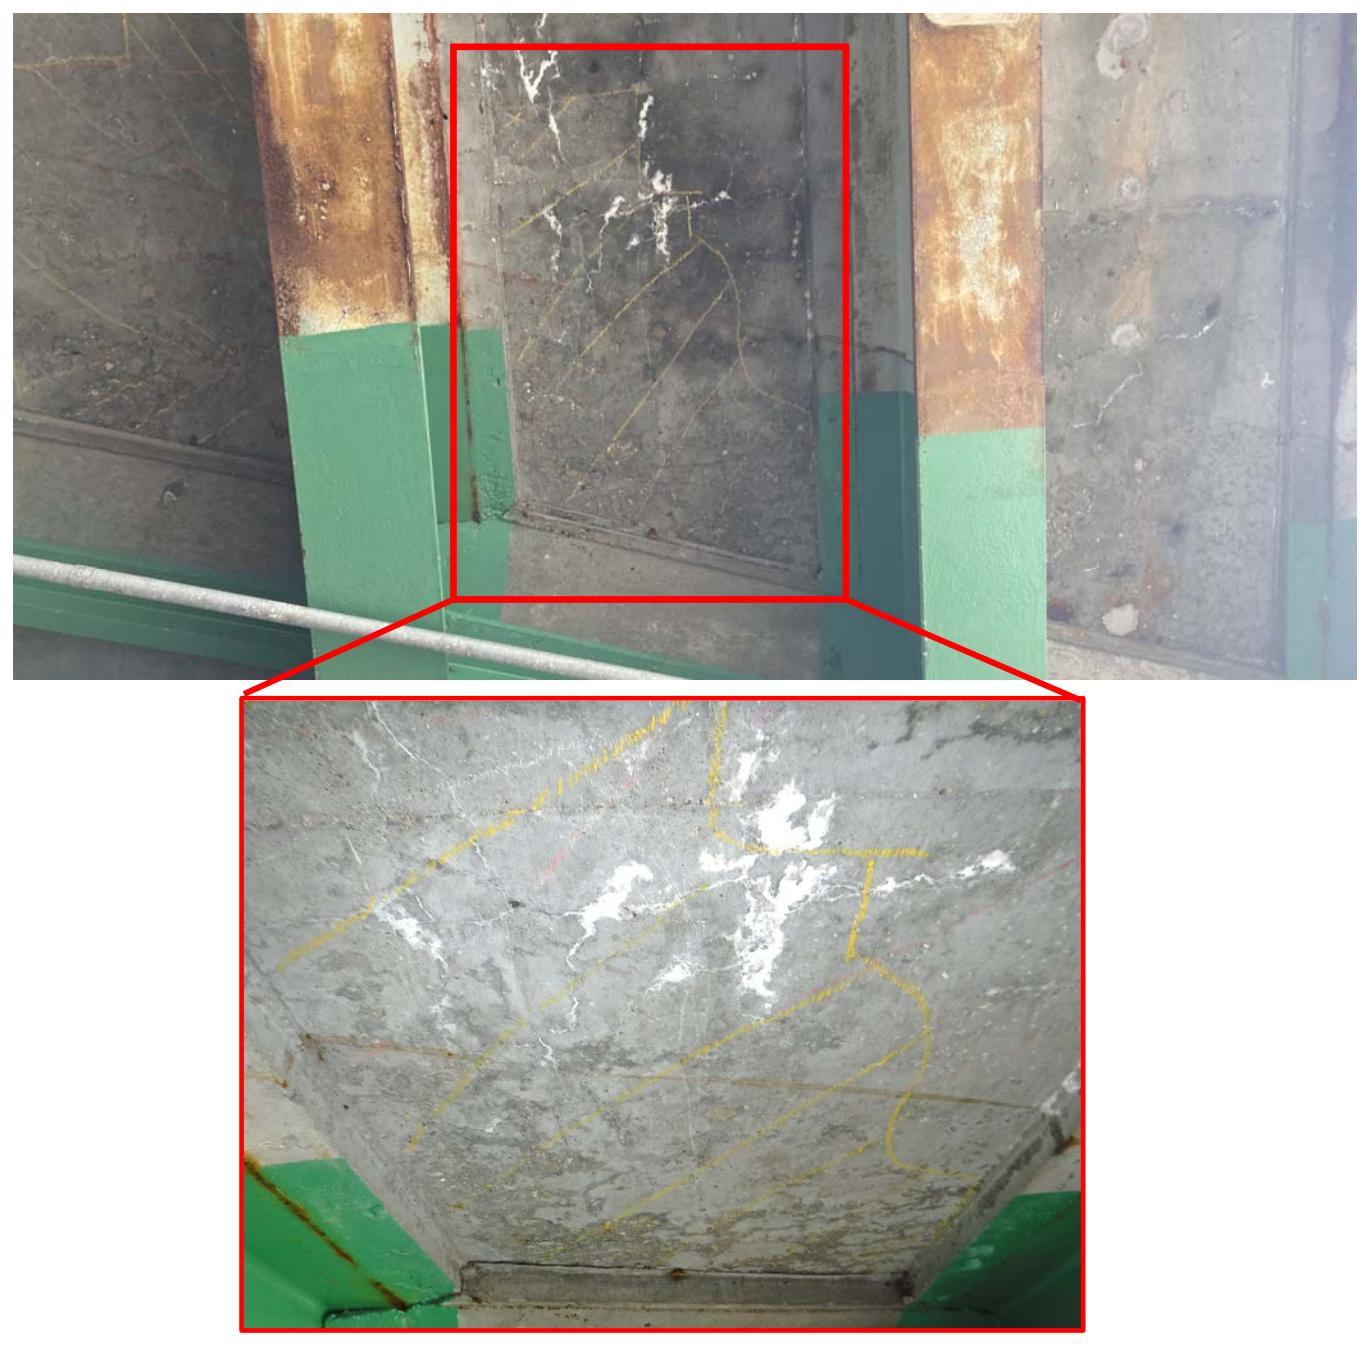
4E5, Location 11

Hollow sounding area measuring up to 60" long x 48" wide with adjacent spalling measuring up to 6" wide x 25" long and dampness

No, discoloration and efflorescence could suggest delamination but hammer sounding was necessary to confirm.

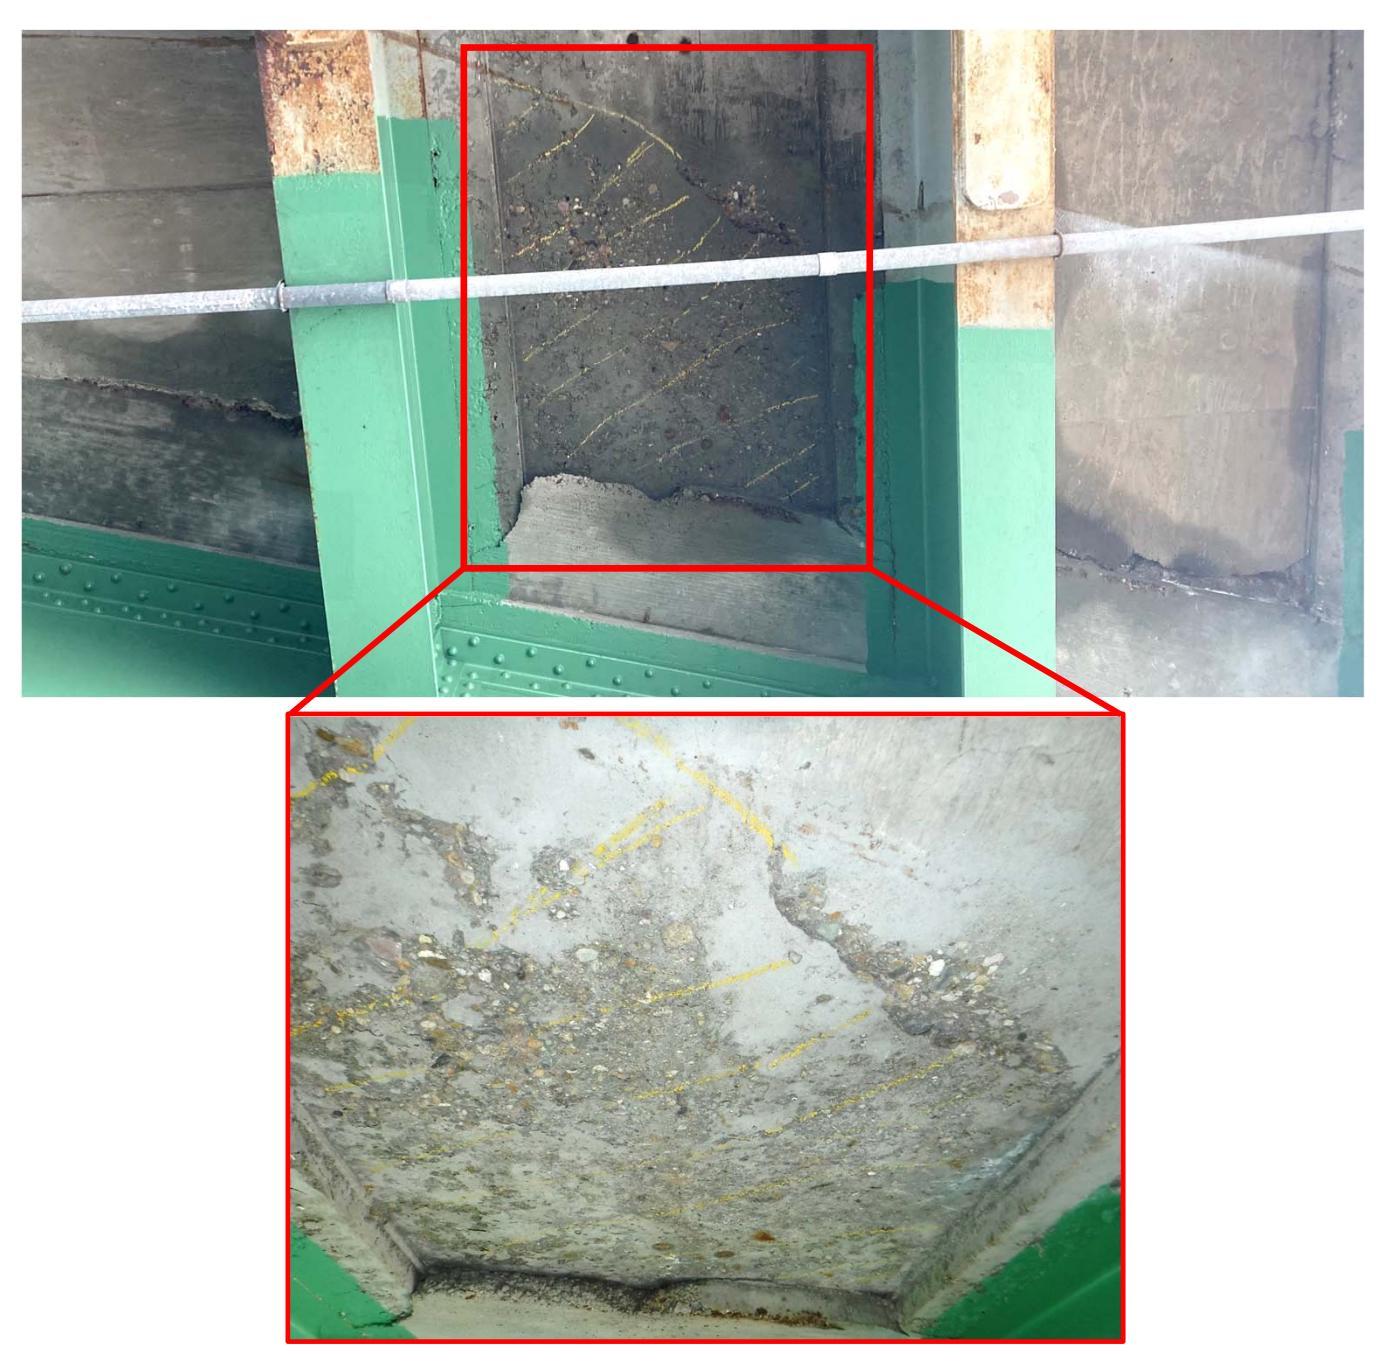
4E5, Location 12

Deficiency Description: None

This location is intended to serve as a control for thermal imagery at a location with no delamination that was detected by hammer sounding.

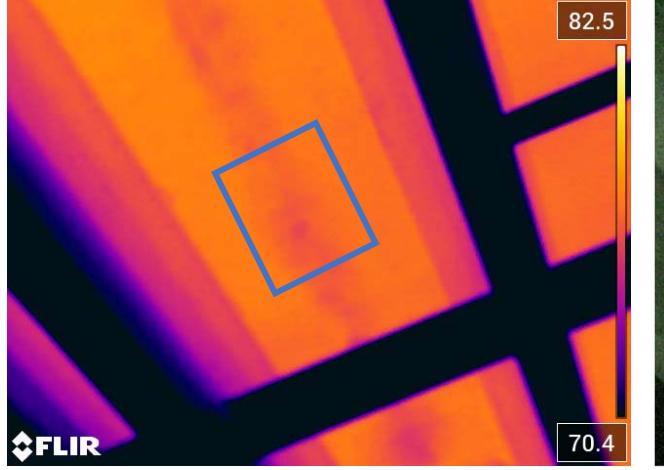
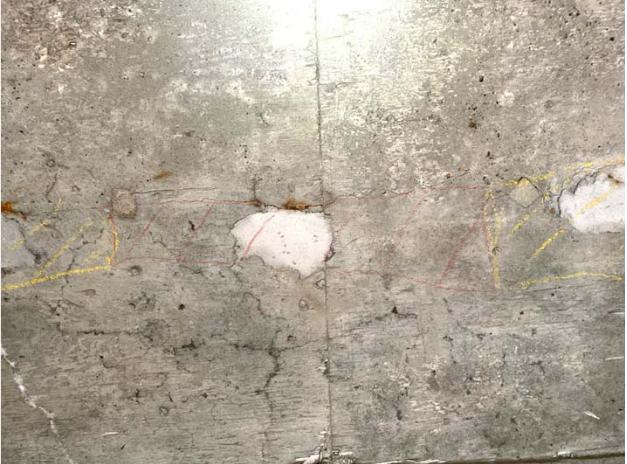
Location Q, Follow Up Insp. Image 5111

L	2749	NO DELAMINATION FOUND	5108	PATCHES, DISCOLORATION AND POOR CONSOLIDATION AT LOCATION
м	2749	NO DELAMINATION FOUND	5108	PATCHES, DISCOLORATION AND POOR CONSOLIDATION AT LOCATION
N	2747	MINOR DELAMINATION INCLUDING HOLLOW SOUNDING PATCHES MEASURING 31"L x UP TO 9" w AT SOUTH END; 7"W x UP TO 10"L HOLLOW SOUNDING PATCH AT CENTER; AND 7"W x UP TO 5"L HOLLOW SOUNDING PATCH AT NORTH END	5115	
0	2745	MINOR DELAMINATION BETWEEN HOLLOW SOUNDING PATCHES MEASURING 56"L X UP TO 9"W	5117	POTENTIALLY CAUSED BY POOR QUALITY REPAIR / POOR CONSOLIDATION
Р	2743	MINOR DELAMINATION MEASURING 8"W	5112	POTENTIALLY CAUSED BY POOR QUALITY REPAIR / POOR CONSOLIDATION
Q	2743	MINOR DELAMINATION MEASURING UP TO 8" W x 29" L	5111	POTENTIALLY CAUSED BY POOR QUALITY REPAIR / POOR CONSOLIDATION

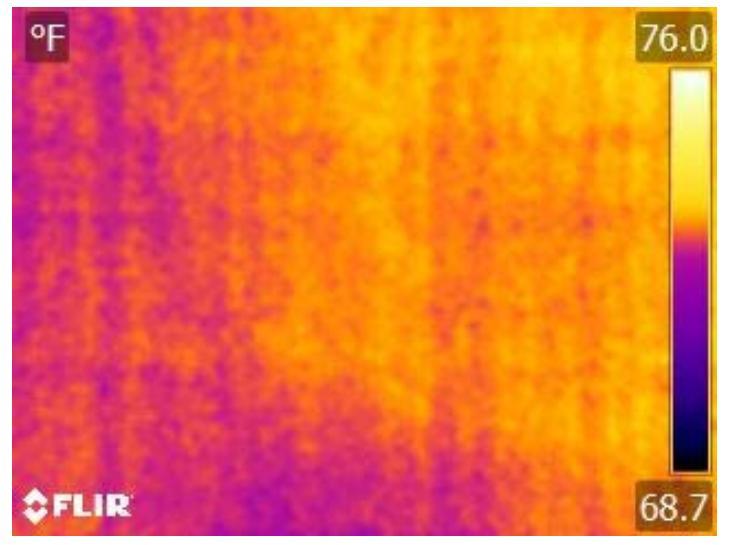
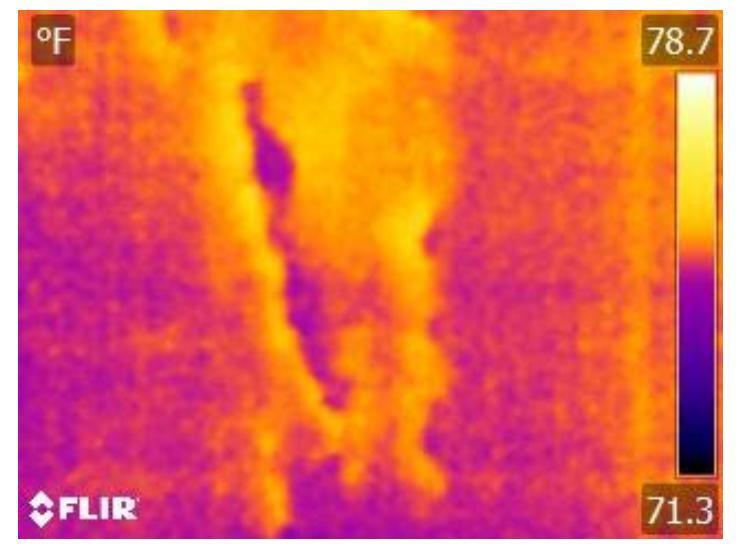
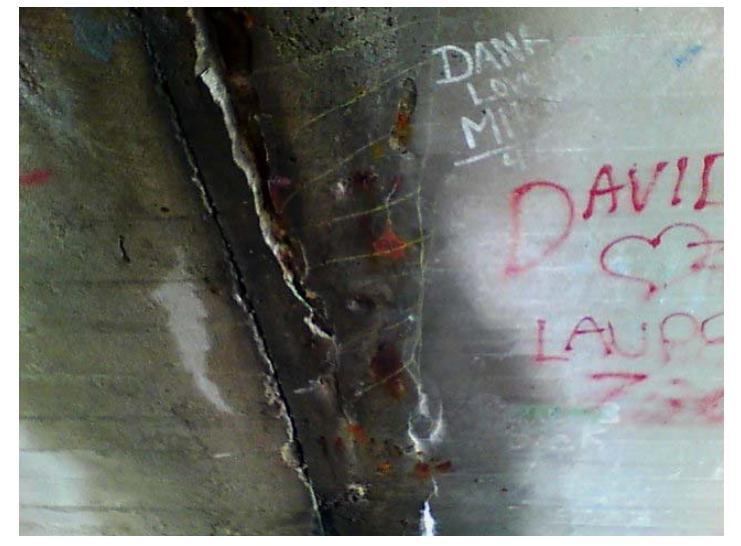
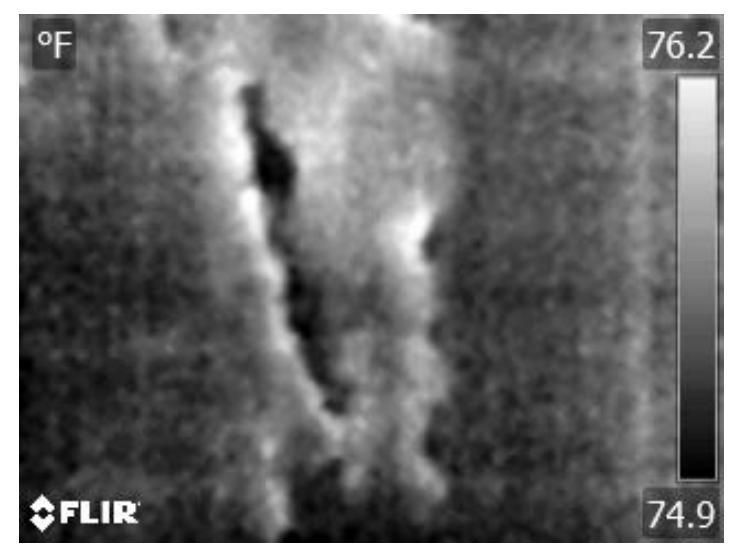
Deficiency 1

- 1. 16" long x up to 19" wide hollow area (18" wide at south end, 8" wide at north end).
- 2'-1" long (avg.) x 2'-9" wide spall exposed rebar and adjacent up to 10" long (6" avg) x 18" wide hollow area and 14" long x 4" wide hollow area.

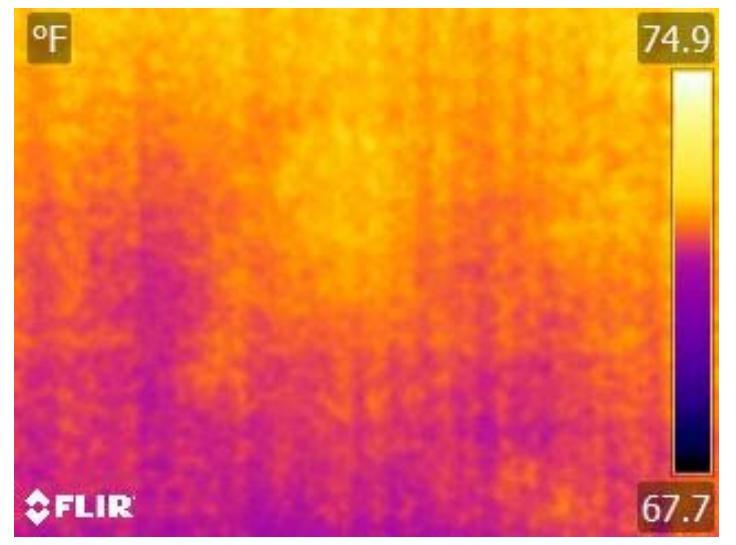
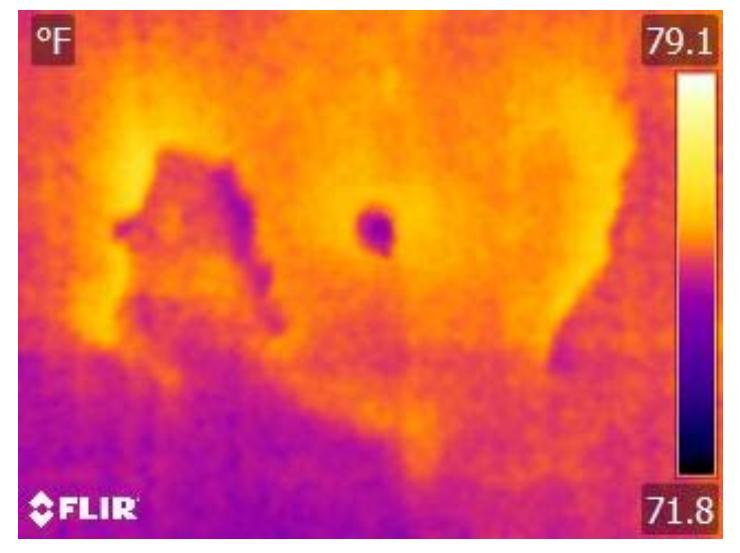
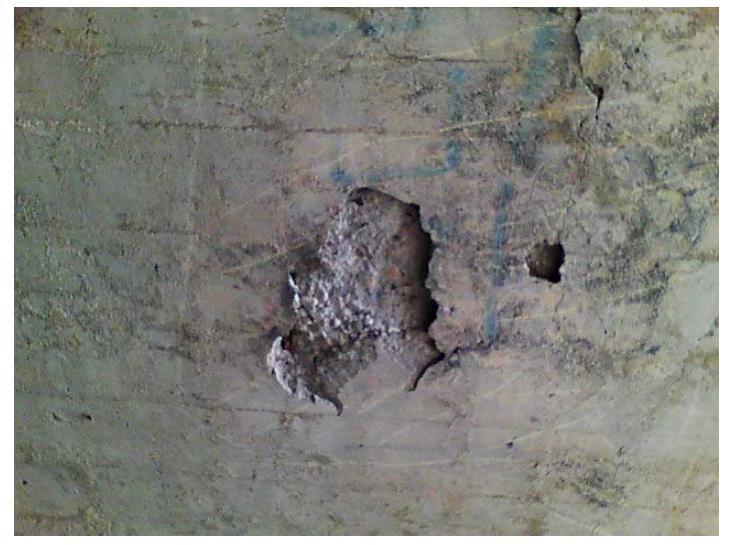
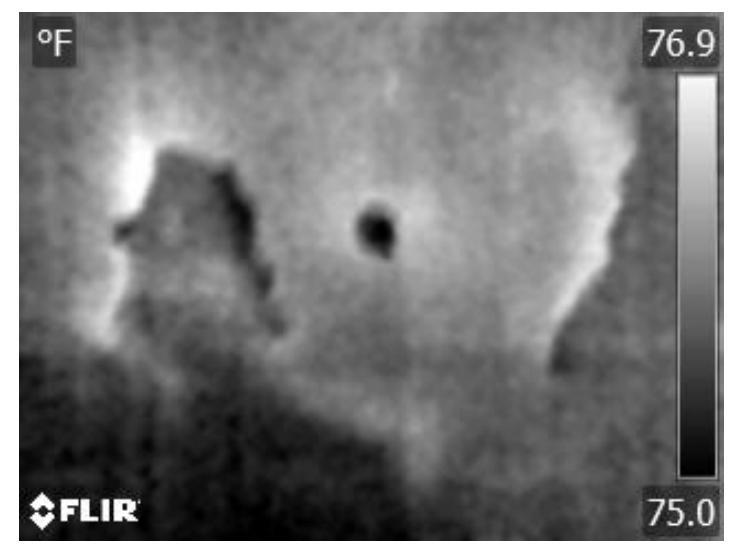
Deficiency 3

- 3. Hollow sounding area with moderate efflorescence, honey combing, cracking, and discoloration.
- 4. Two hollow areas in sloped portion; 7" long x 3" wide and 14" long x up to 5" wide (3" wide avg).
