New England Transportation Consortium (NETC) NETC 20-3

Investigating Thermal Imaging Technologies and Unmanned Aerial Vehicles to Improve Bridge Inspections

Task 2 Interim Report

Field Demonstration and Data Analysis

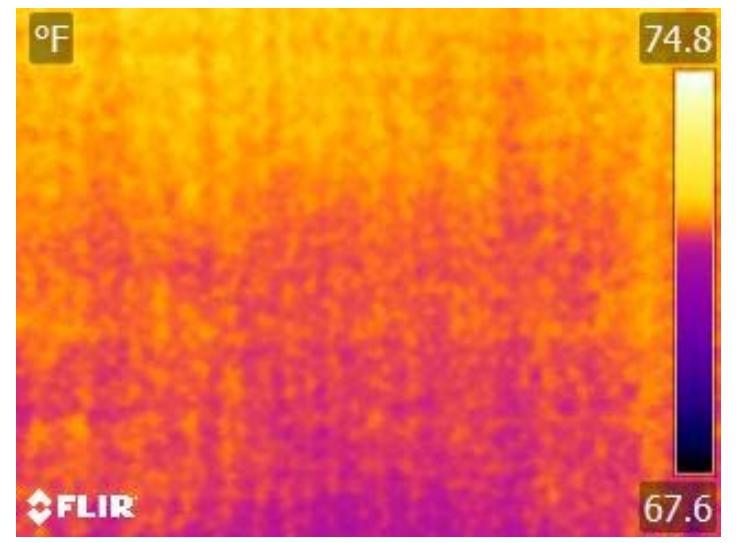
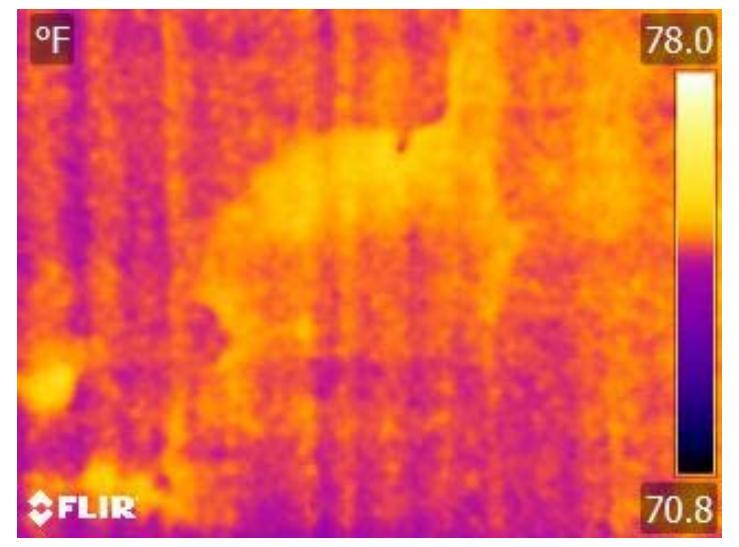
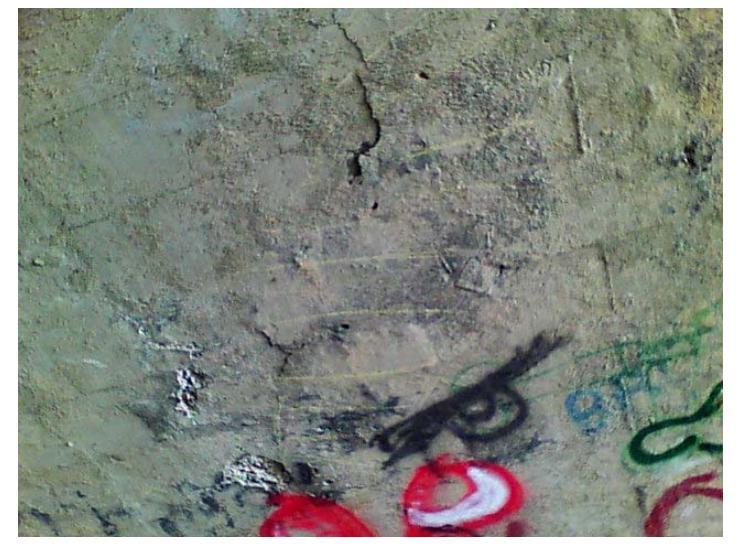
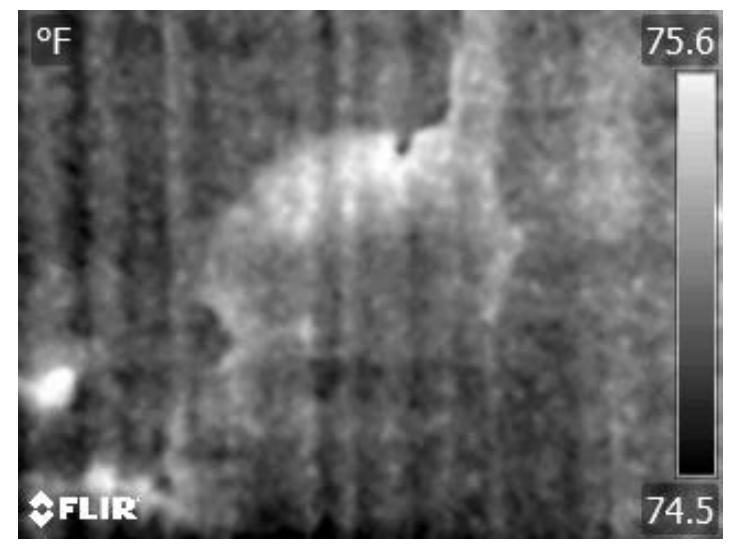
Deficiency 4

- 3. Hollow sounding area with moderate efflorescence, honey combing, cracking, and discoloration.
- 4. Two hollow areas in sloped portion; 7" long x 3" wide and 14" long x up to 5" wide (3" wide avg).

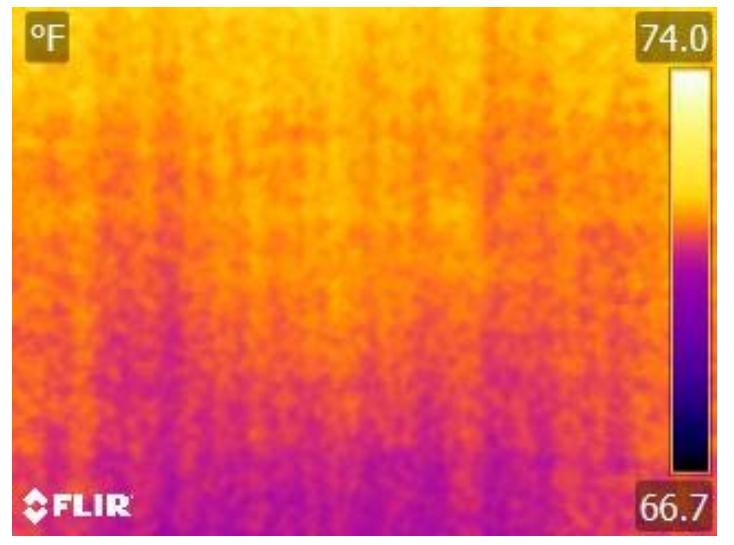
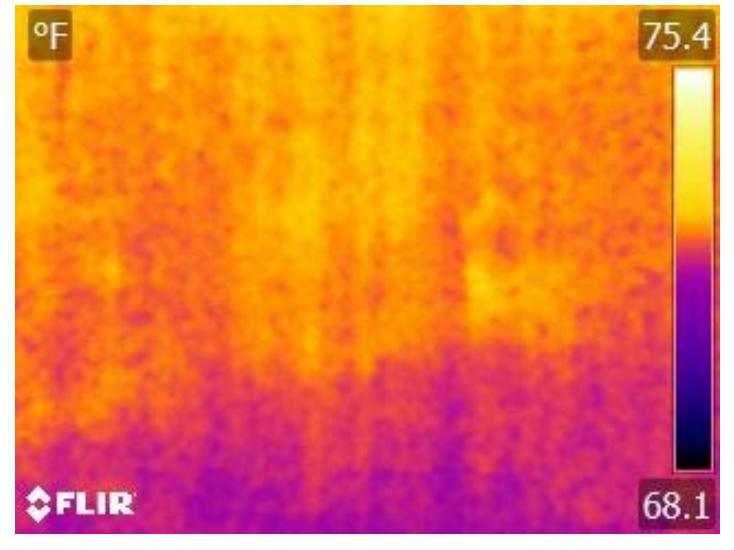
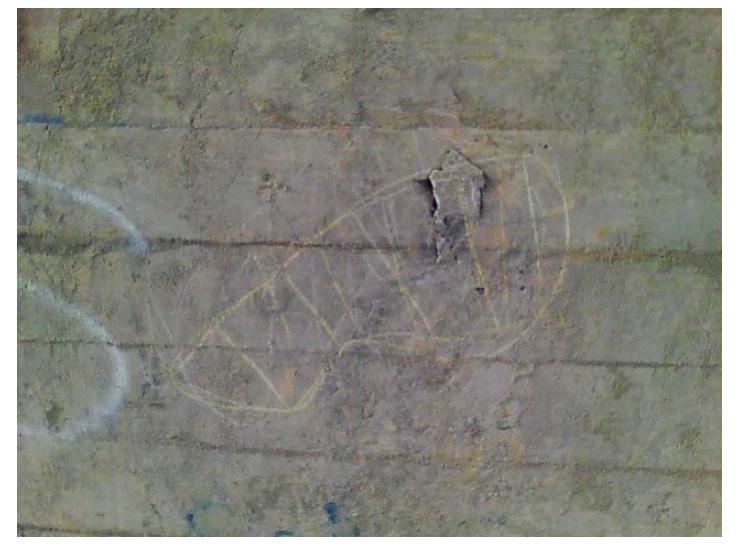
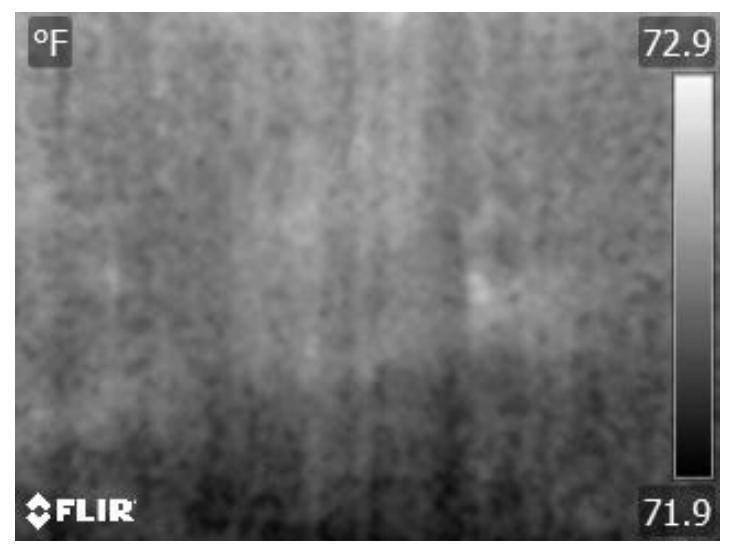
Deficiency 12

- 12. 2" long x 6" wide hollow area.
- 13. 10" long x 23" wide spall with exposed rebar and adjacent 20" long x 18" wide hollow area.
- 14. 2'-11" long x 20" wide hollow area.

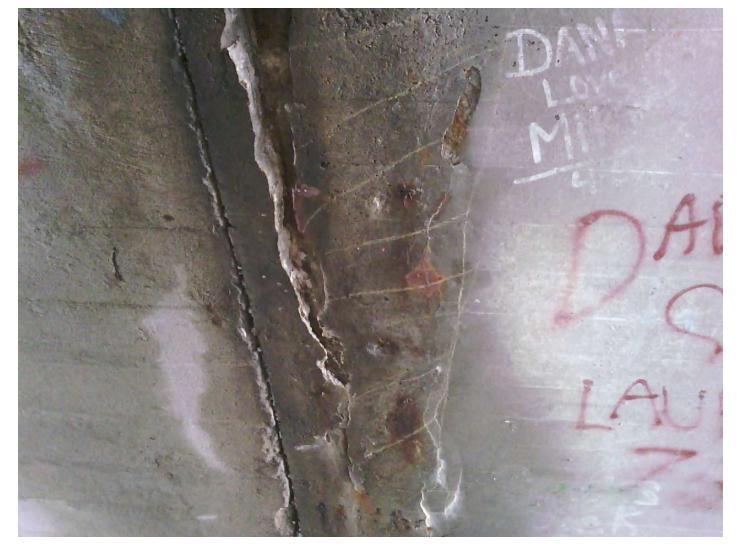
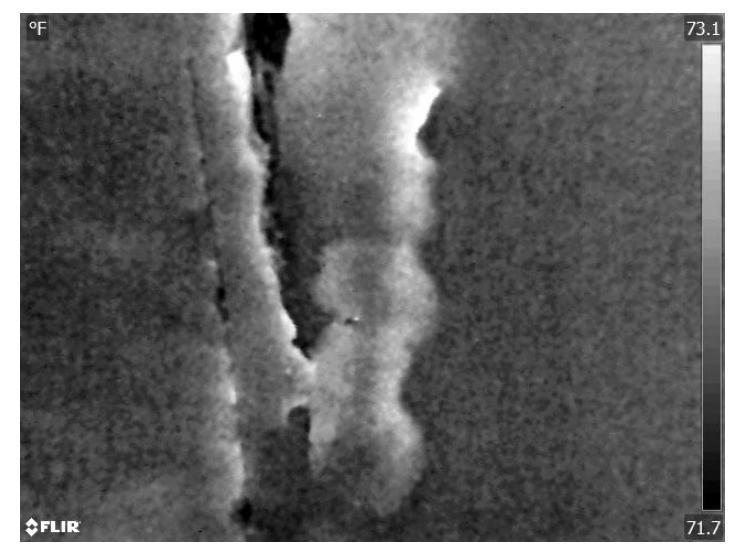
E96_02_01_IR_FLIR1749

Visual of Delamination

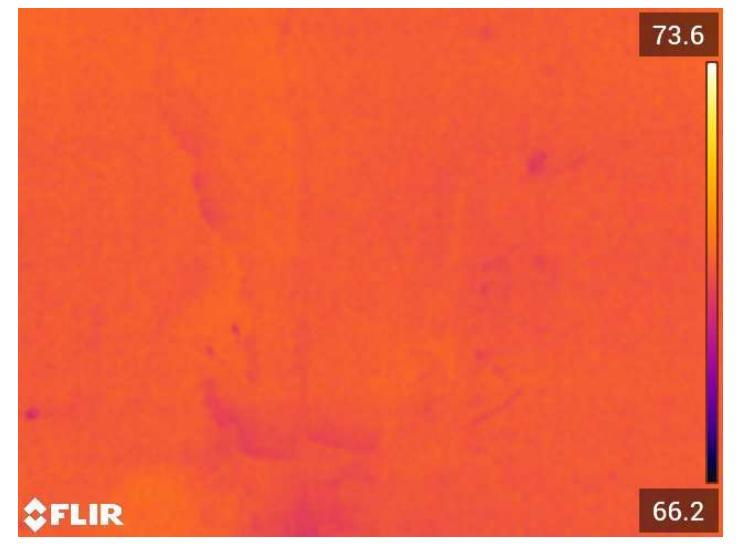
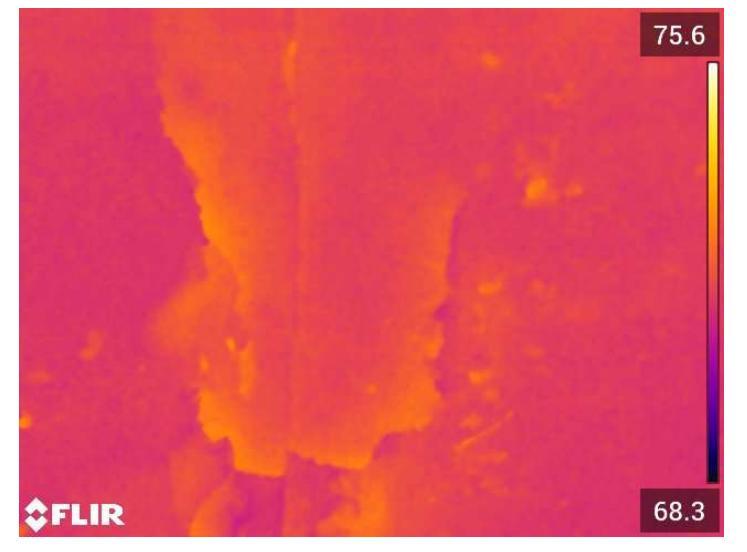
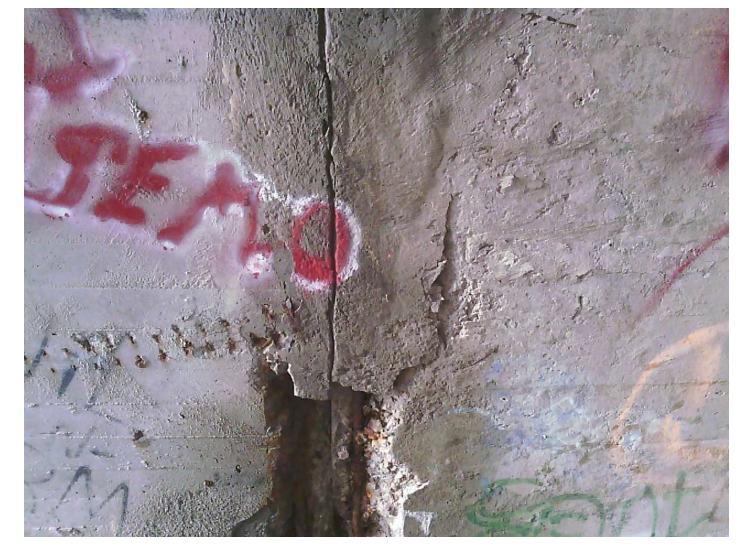
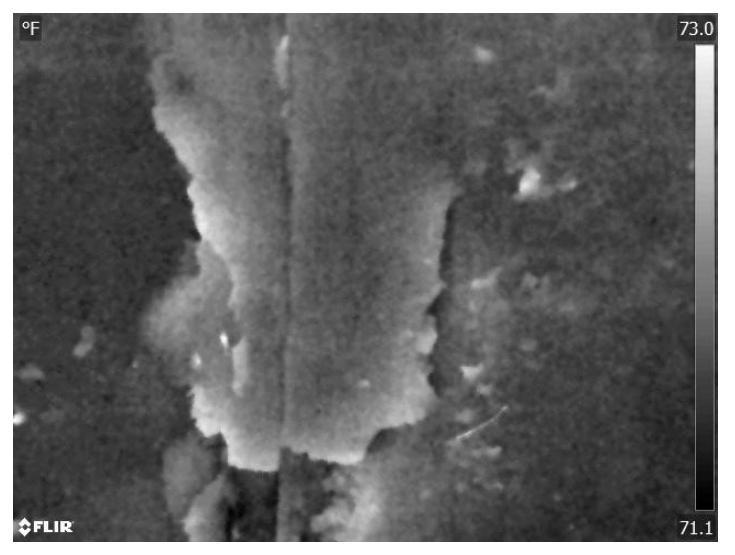
Deficiency 2

Visual of Delamination

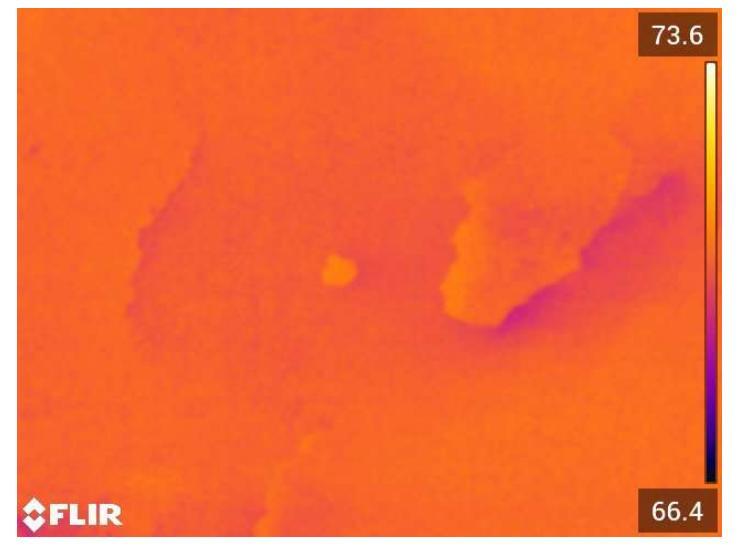
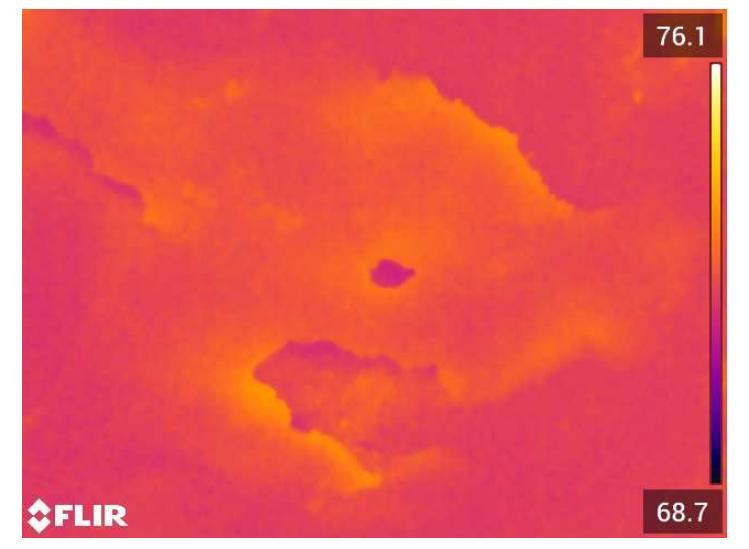
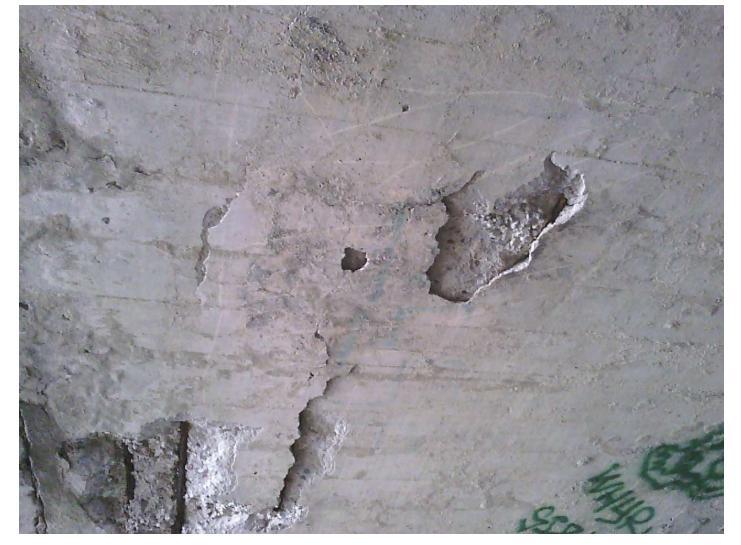
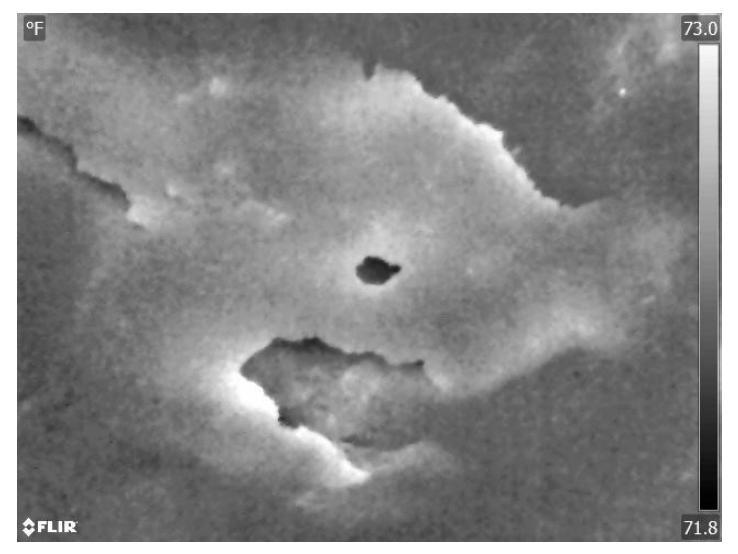
Deficiency 3

Visual of Delamination

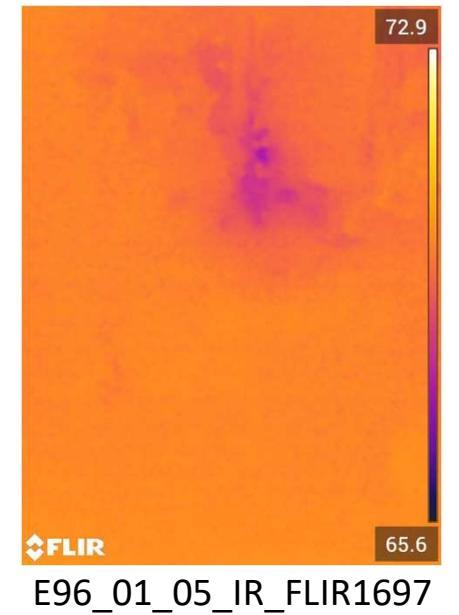
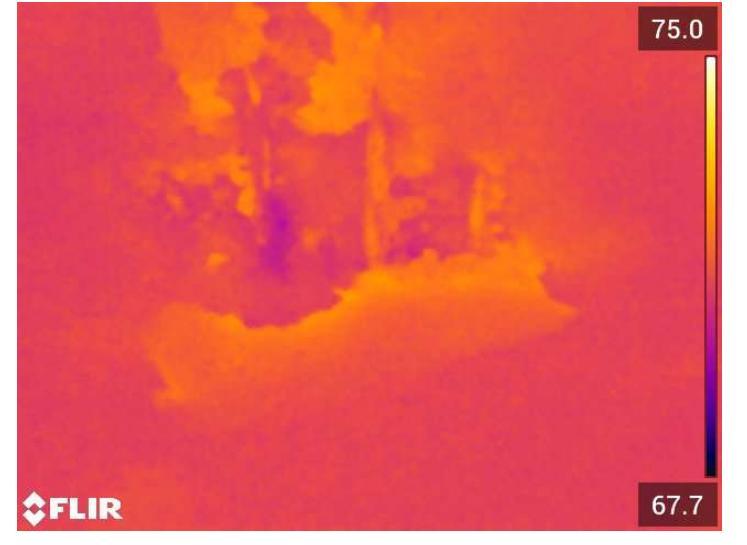
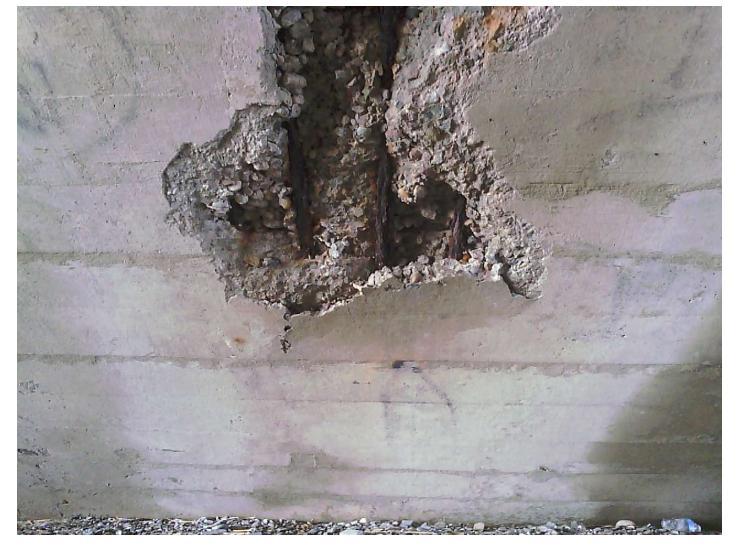
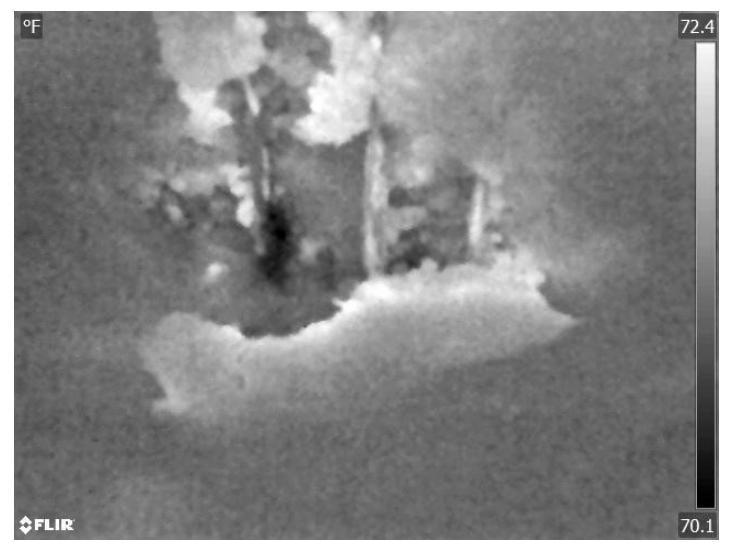
Deficiency 5

Visual of Delamination

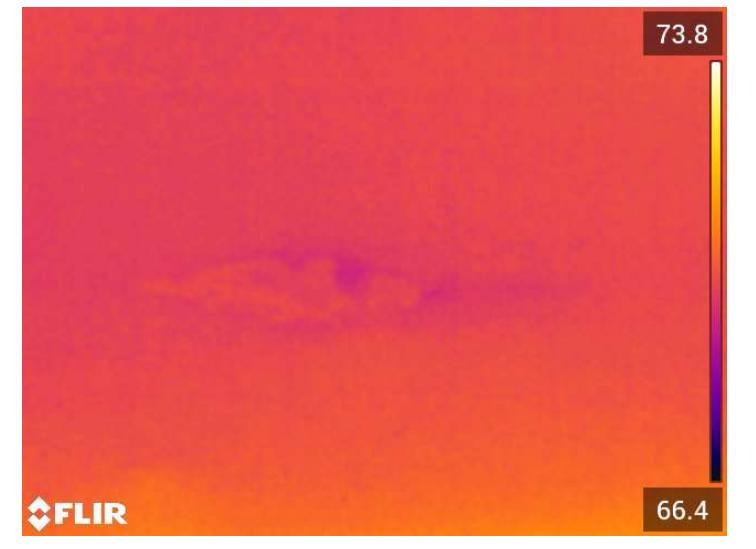
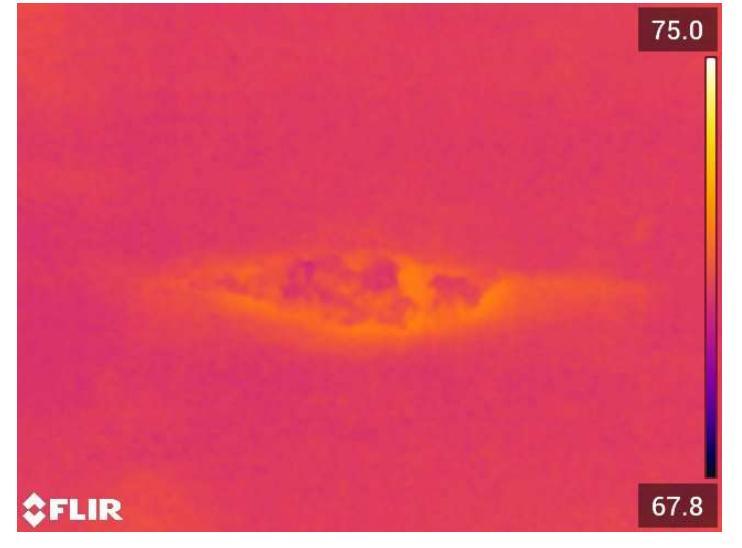
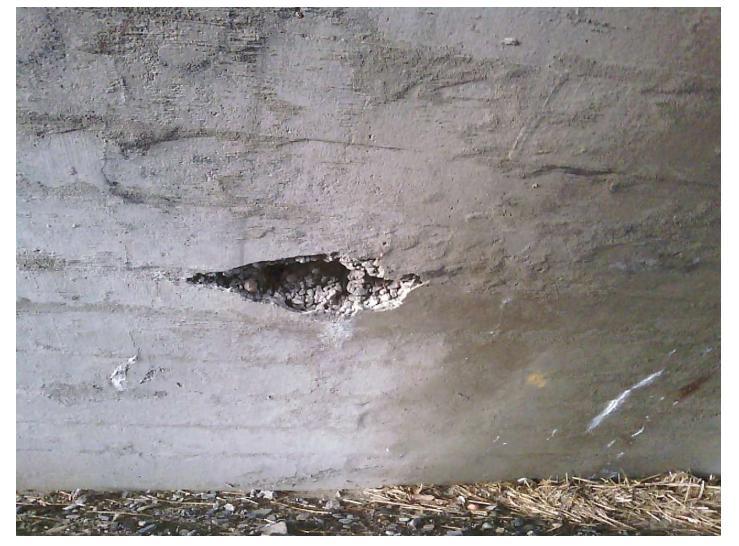
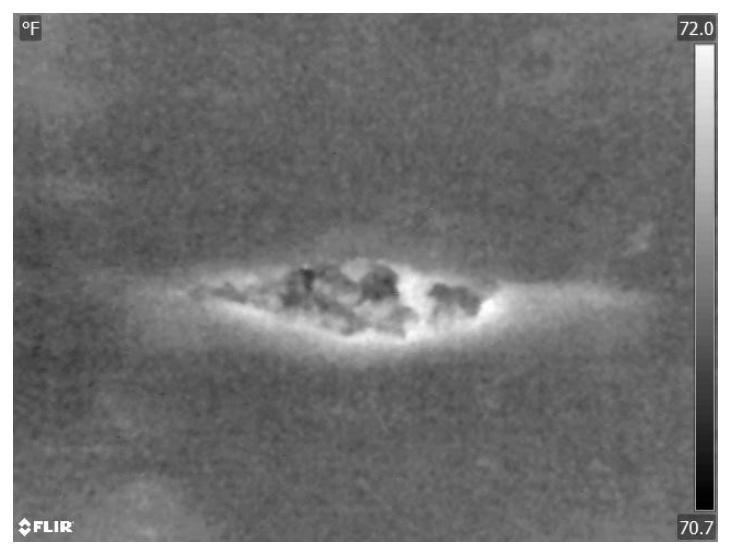
Deficiency 7

Visual of Delamination

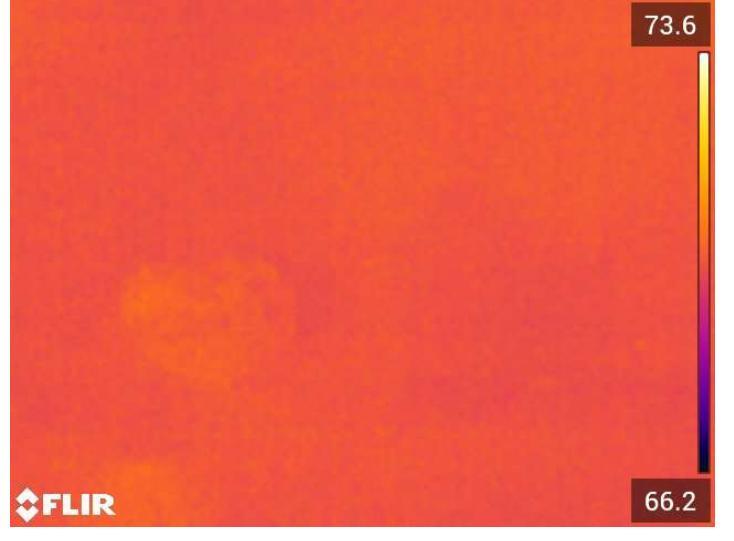
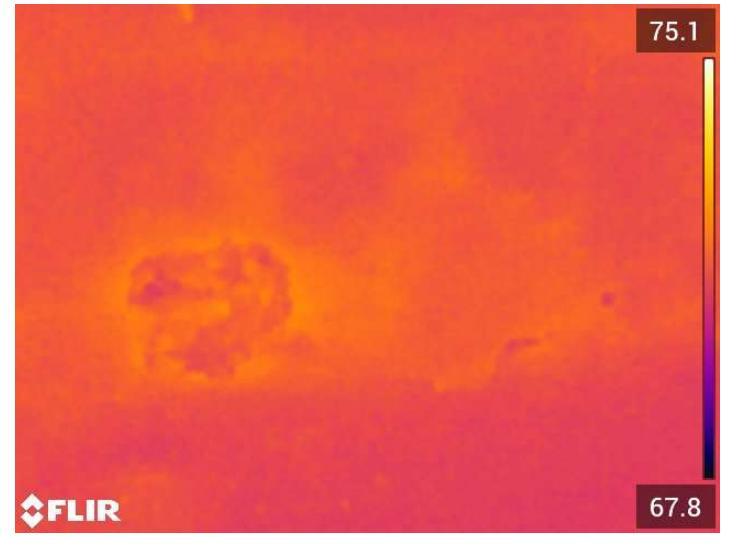
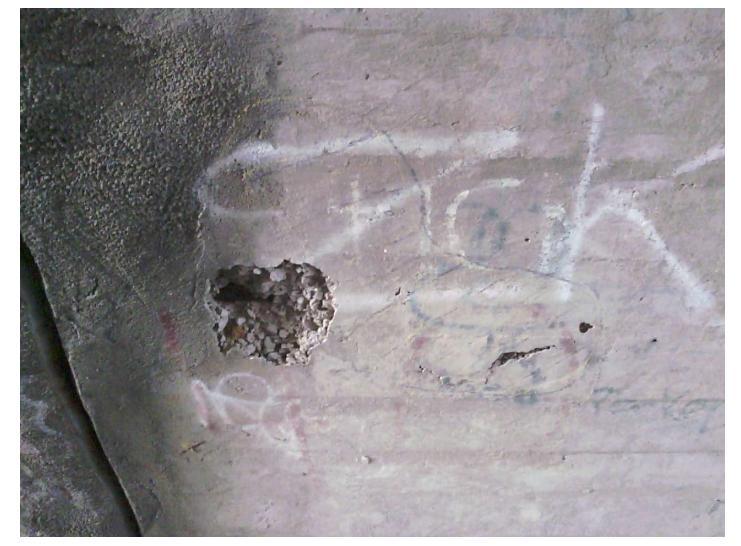
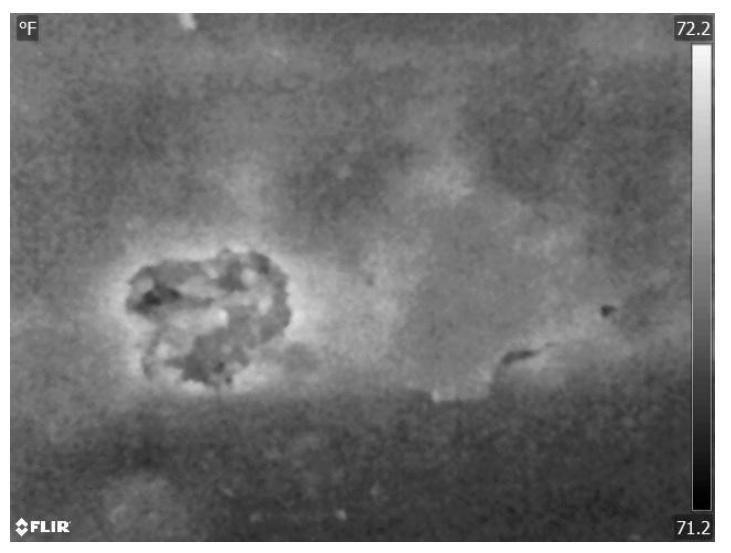
Deficiency 10

Visual of Delamination

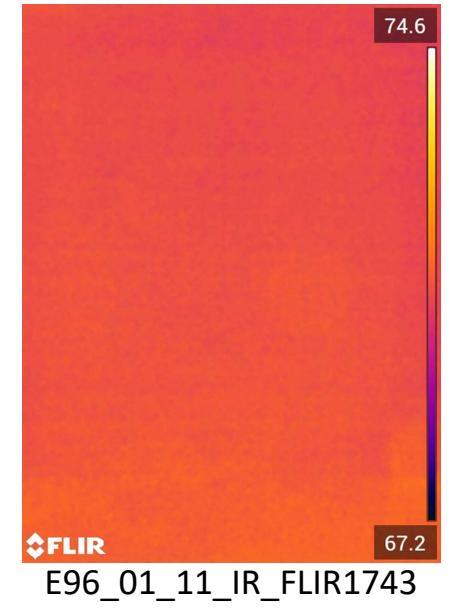
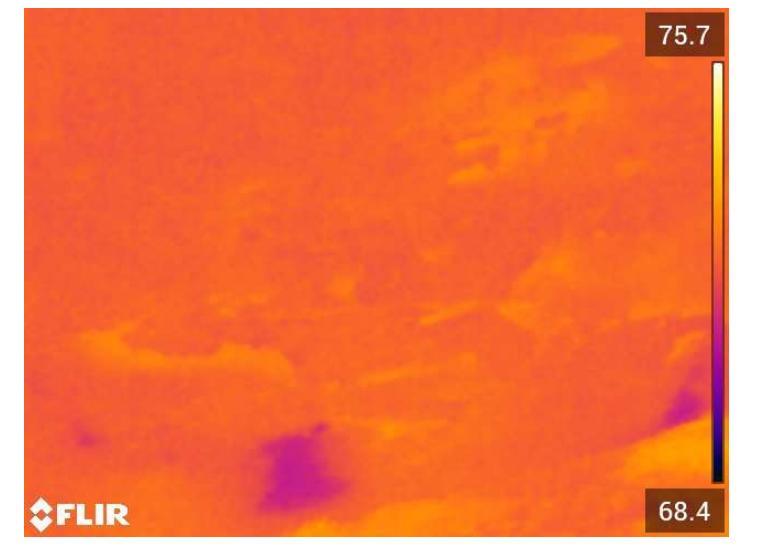
Deficiency 11

Visual of Delamination

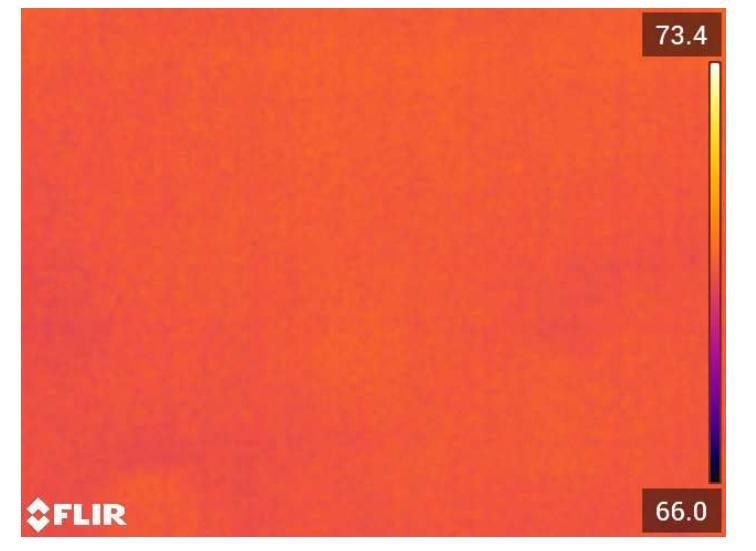
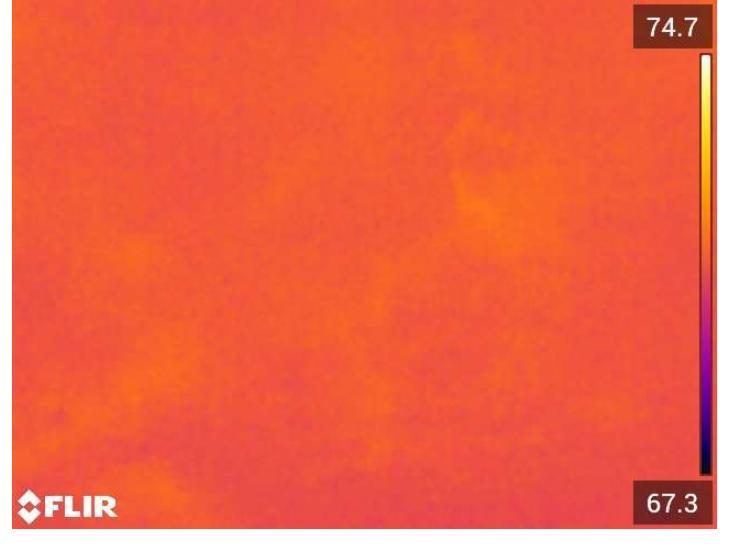
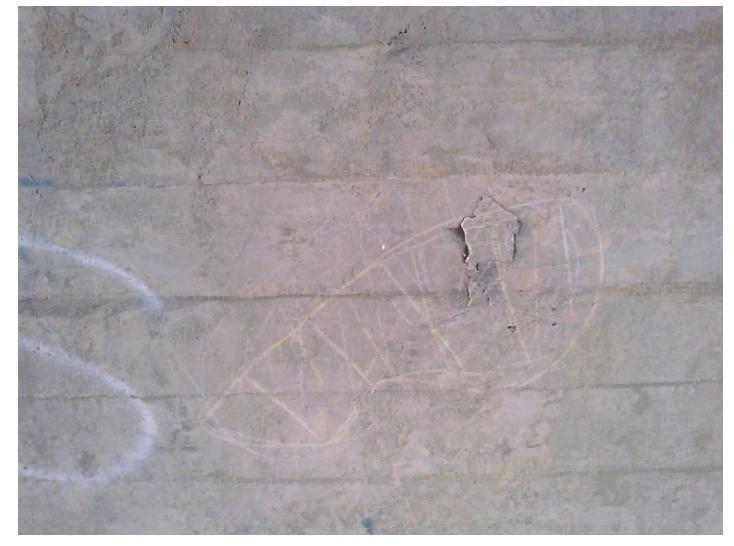
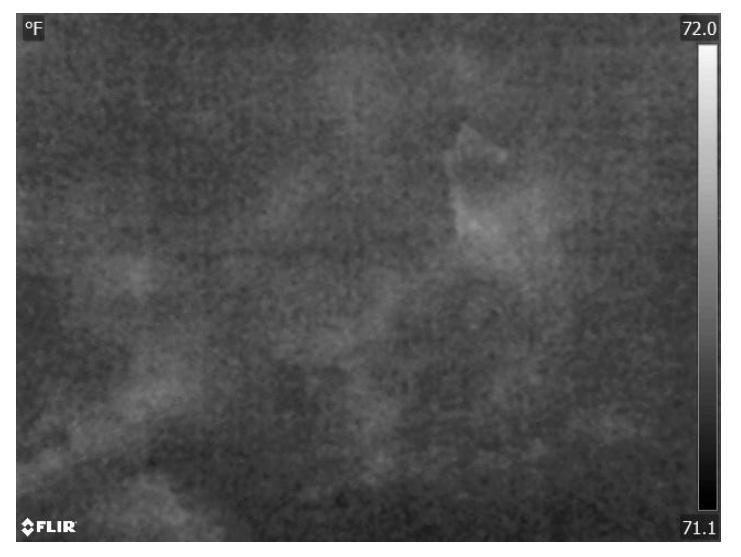
Deficiency 12

С	Corbel C	East Corbel, Underside	South edge - 18"L x 1'-2"W hollow area and 5"L x 10"W hollow area		Y	11					
D	Deck	West of West Corbel	2-8"W x up to 8"L hollow area adjacent to previous repair		Y	12

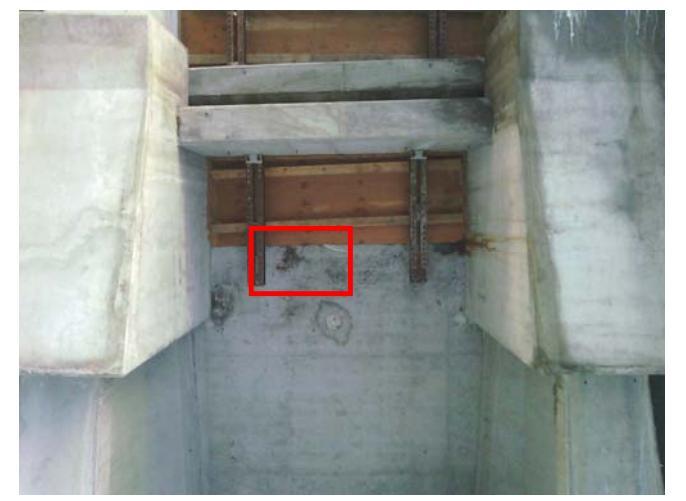
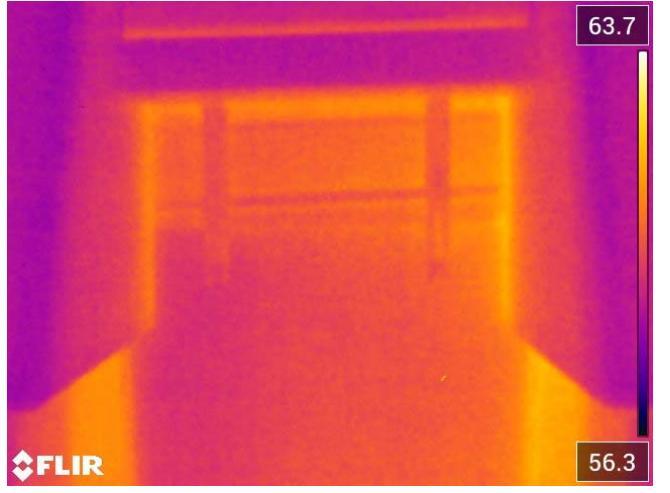
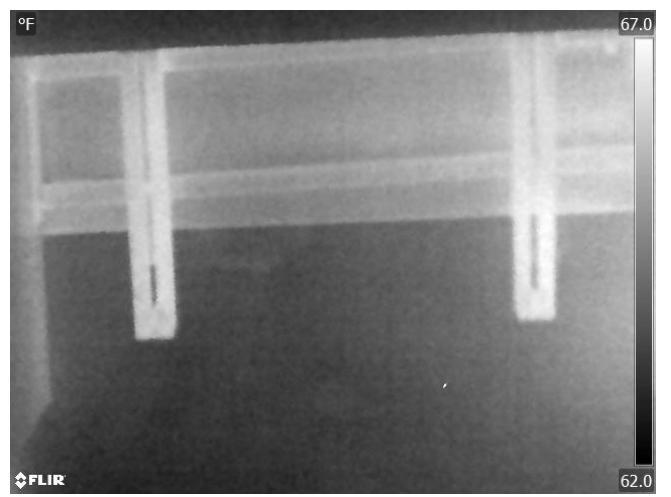
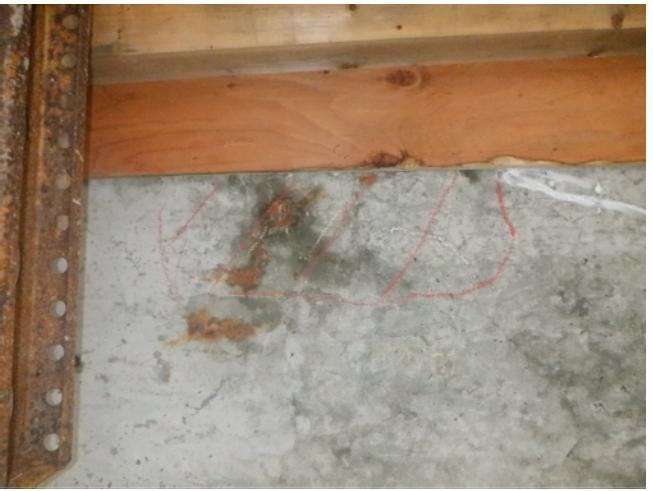
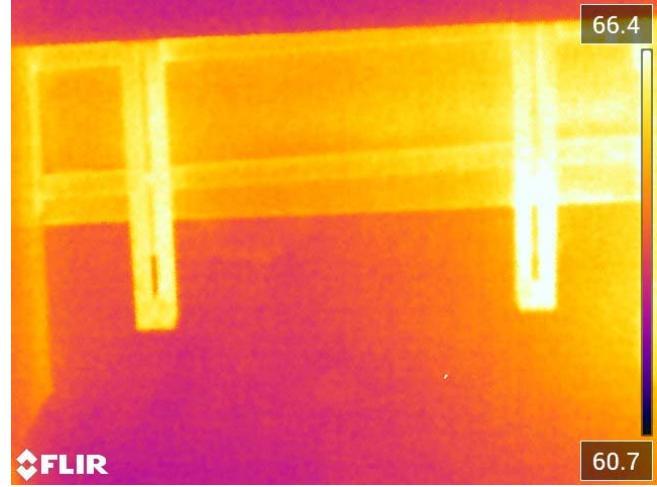
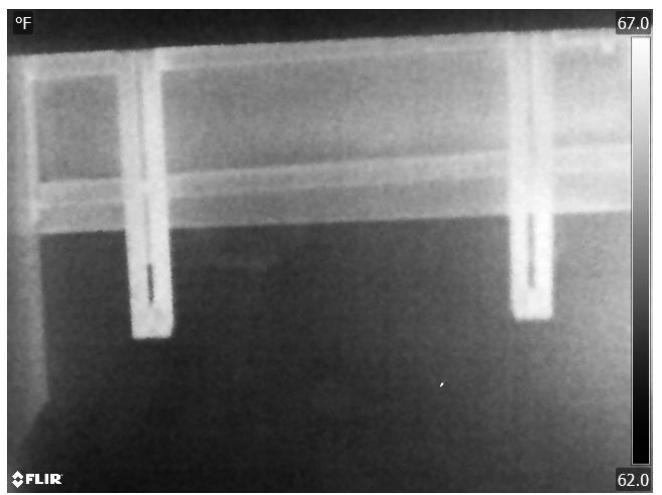
Deficiency 1

Washington Bridge (07001), Span 2, Traditional Inspection Findings											
Bay / Corbel / Beam	Element (Deck, Beam, Corbel, or Cant.)	Location	Deficiencies	Comment(s)	Use for Thermal Testing (Yes / No)	Deficiency # for Thermal Chart					
North Overhang	Deck	Over West Corbel	Active deck joint leakage	Leakage, not included as part of thermal testing	N	-					
A	Deck	West of West Corbel	1'-8"W x 8"L hollow area adjacent to repair		Y	1					
A	Corbel A	West Corbel, East Face	Upper section, north side - 1'W x 2'H hollow area	Not visible from ground due to bridge geometry	N	-					
A	Corbel A	West Corbel, East Face	Lower section, north side - 1'W x 1'-4"H hollow area		Y	2					
A	Beam A	West Corbel, North Face	Web at beam end - Up to 2'L x 1'-11"H hollow area with 8"L x 1'-2"H x 3"D spall with exposed rebar	Not visible from ground due to bridge geometry	N	-					
A	Deck	East of West Corbel	1'W x up to 8"L (5"L avg) minor hollow area with minor rust/leakage staining		Y	3

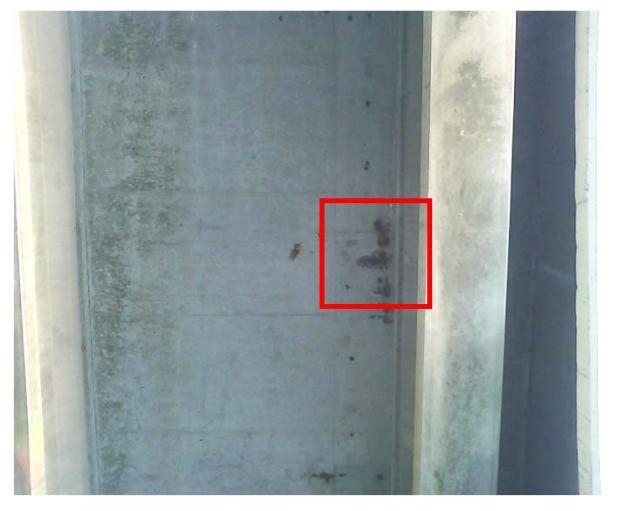
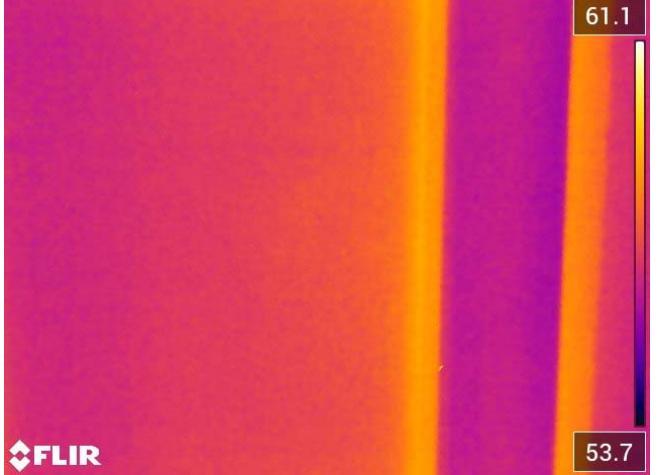
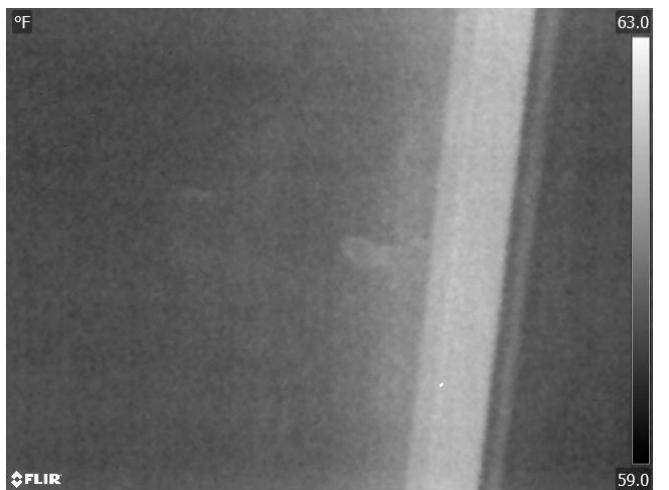
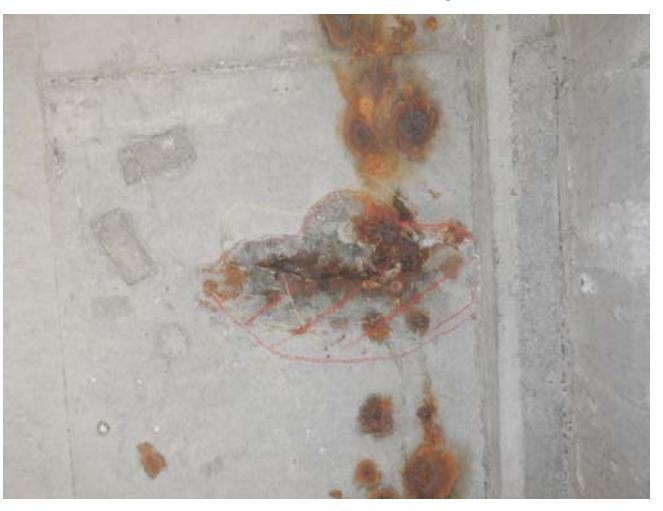
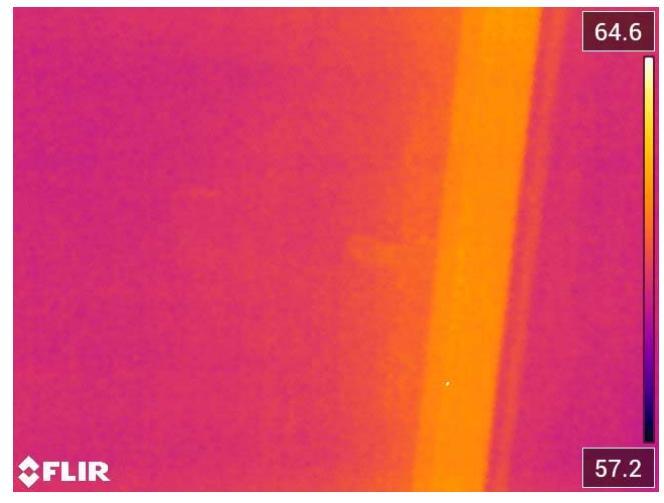
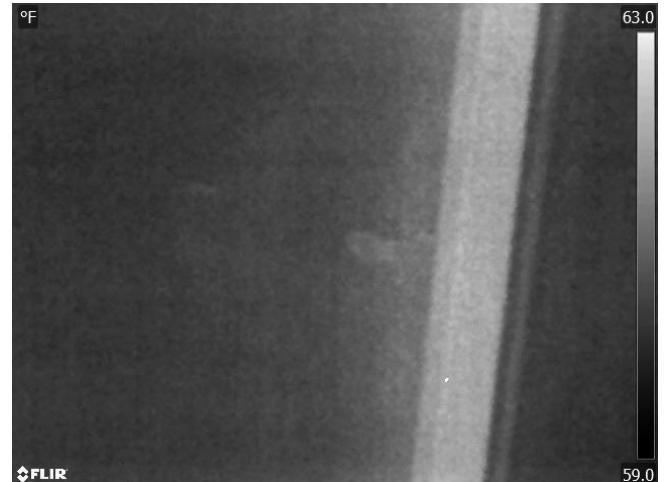
A	Deck	West of Midspan	1'-2"W x 4"L avg hollow area with adjacent 10"W x up to 5"L x 1/2"D spall with rust staining		Y	4					
A	Deck	West of Midspan	Adjacent to beam B - 1'-2"W x 4"L hollow area		Y	5					
A	Deck	East of Midspan	4"L x 1'W hollow area with adjacent 1"L x 1'W spall	Red hatching for limits of delamination, yellow is incorrect	Y	6					
A	Beam A	North Face at East Corbel	Web at beam dapped end - 17"H x 16"W x 1"D spall with exposed rebar	Not visible from ground due to bridge geometry	N	-					
A	Beam A	North Face at East Corbel	Hidden by steel repair plate - Previously noted as web over bearing - full height x 7"L hollow area and a 1'L x 1'-2"H 'L-shaped' hollow area	Hidden	N	-					
A	Corbel A	East Corbel, West Face	Hidden by steel repair plate - Previously noted as lower section, north side - 27"H x 1'W x 2"D spall with exposed rebar	Hidden	N	-					
A	Corbel A	East Corbel, West Face	Hidden by steel repair plate - Previously noted as lower section, south side - Patched - 1'-2"H x 1'-2"W x 1-1/2"D spall with exposed anchor plate	Hldden	N	-

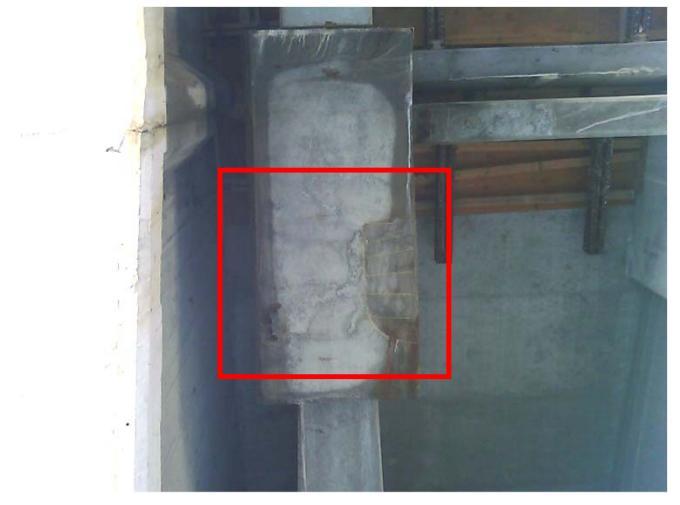
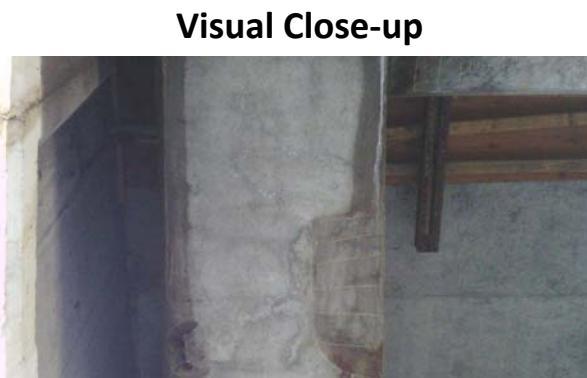
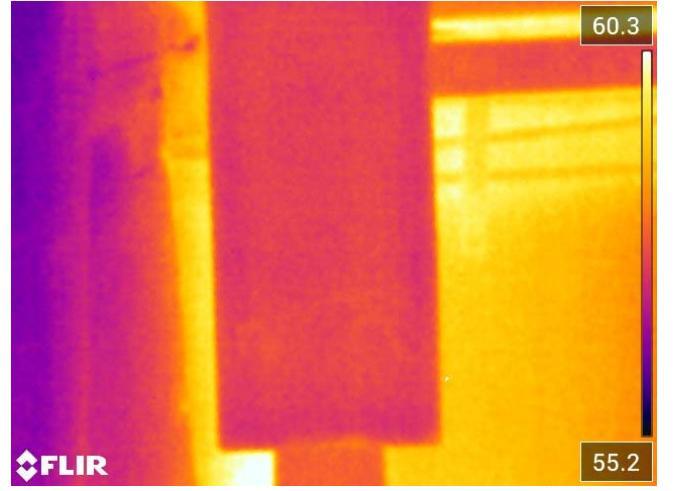
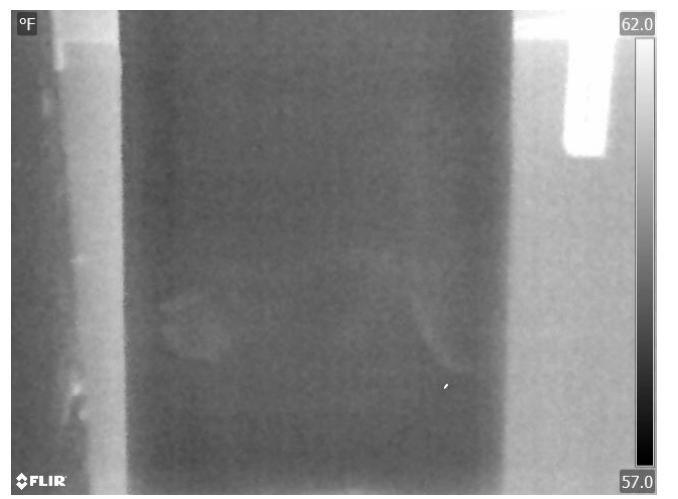
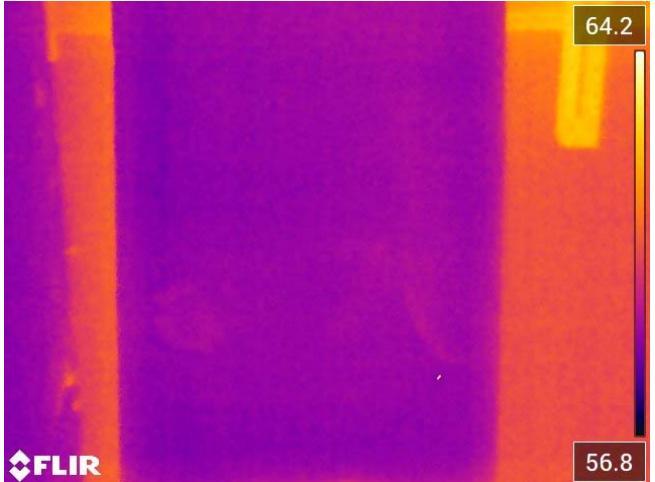
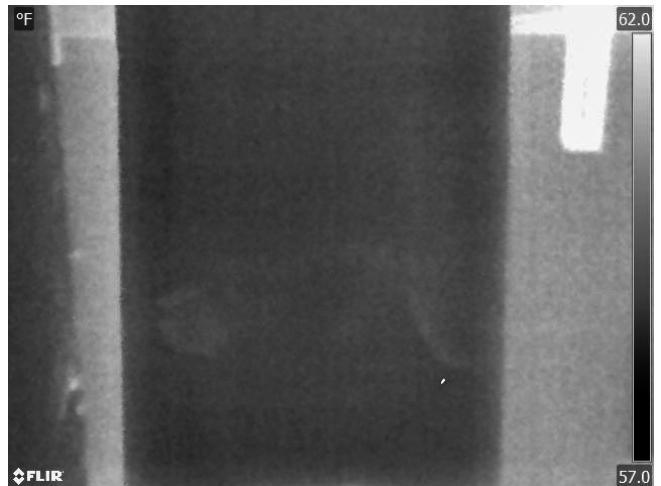
Deficiencies 7,8

A	Corbel A	East Corbel, Underside	North end - 8"L x 5"W hollow area with 10"L x 3"W spall		Y	7					
A	Corbel A	East Corbel, Underside	South end - 2'-8"L x 1'-2"W hollow area extending up to 1'-2"H onto south face		Y	8					
В	Corbel B	West Corbel, East Face	Lower section, north side - 1'-1"W x 10"H minor hollow area		Y	9					
С	Corbel C	West Corbel, East Face	Hidden by steel repair plate - Previously noted as 1'-8"W x 1'H x 1"D spall with exposed anchor plate	Hidden	N	-					
С	Beam C	North Face at East Corbel	Web at beam end - 8"W x 6"H x 1"D spall with exposed rebar	Spall, not included as part of thermal testing	N	-					
С	Corbel C	East Corbel, West Face	North side - 1'-2"W x 1'H spall	Spall, not included as part of thermal testing	N	-					
С	Corbel C	East Corbel, West Face	Lower section, south side - 1'-2"L x 1'-3"W spall on west with 1'H x 5"W hollow area on south		Ŷ	10					
С	Corbel C	East Corbel, South Face	South side - 16"L hairline vertical crack	Crack, not included as part of thermal testing	N	-
