New England Transportation Consortium (NETC) NETC 20-3

Investigating Thermal Imaging Technologies and Unmanned Aerial Vehicles to Improve Bridge Inspections

Task 2 Interim Report

Field Demonstration and Data Analysis

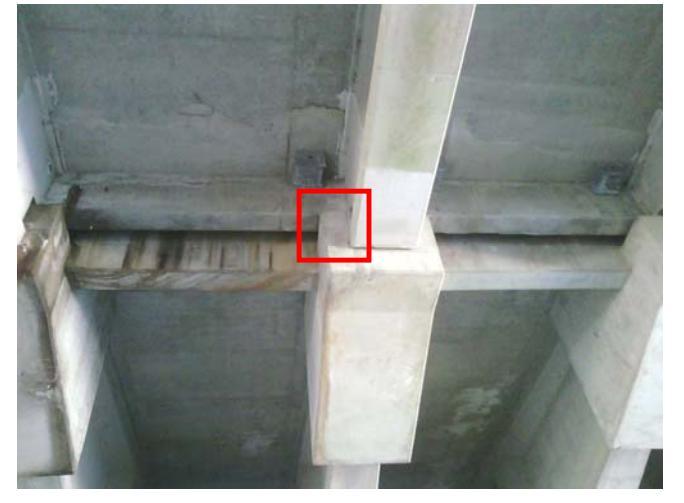
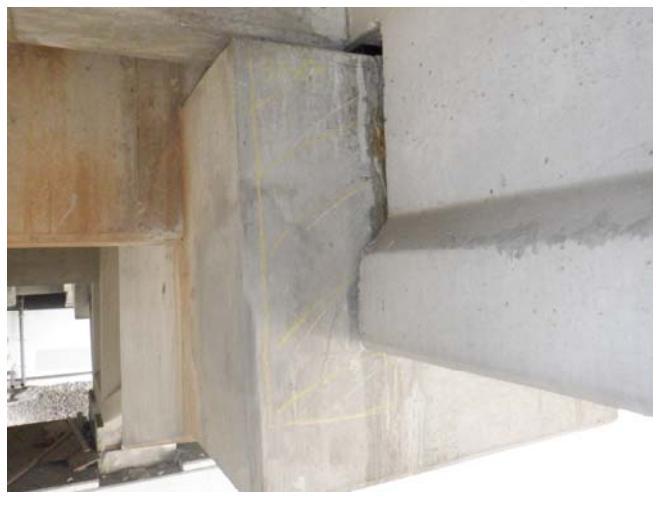
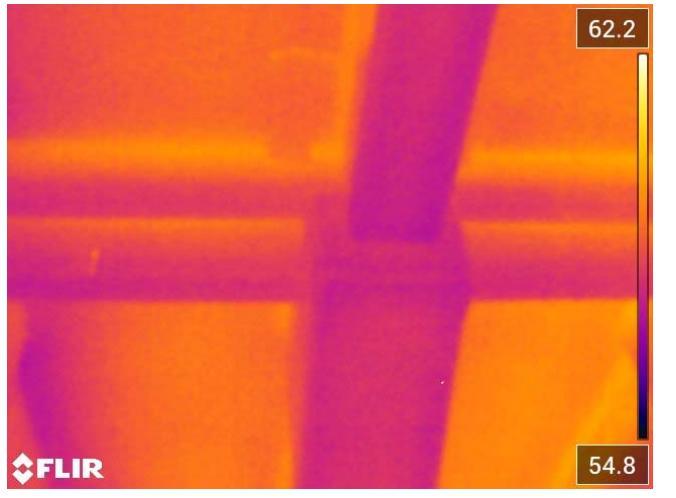
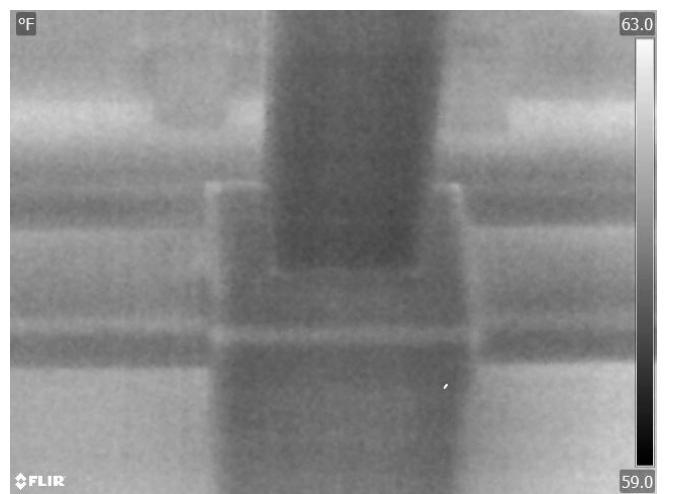
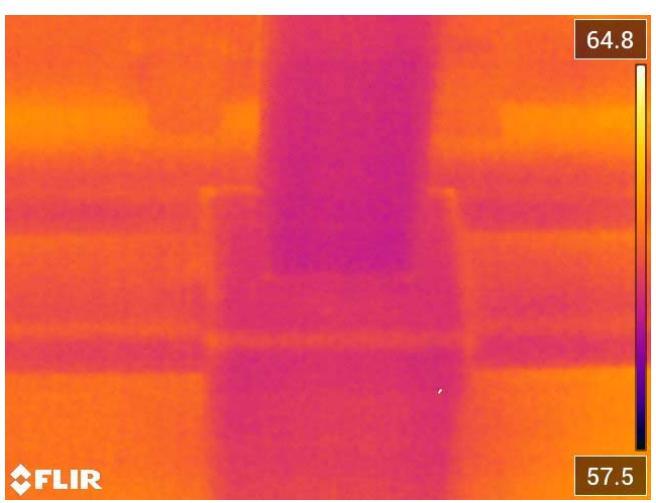
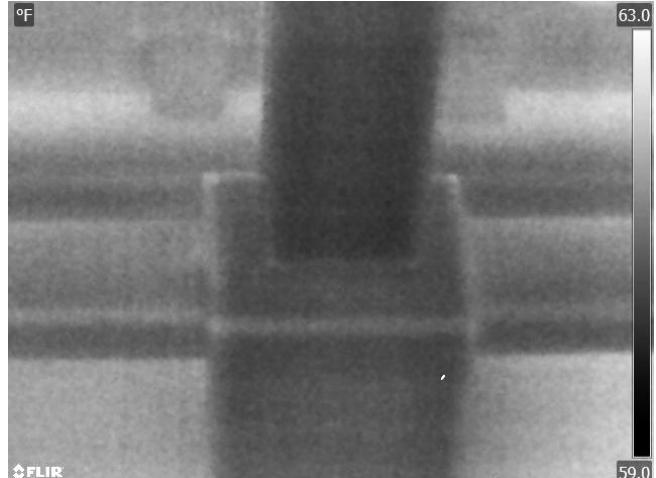
Deficiency 14

Washington Bridge (07001), Span 2, Traditional Inspection Findings										
Bay / Corbel / Beam	Element (Deck, Beam, Corbel, or Cant.)	Location	Deficiencies	Comment(s)	Use for Thermal Testing (Yes / No)	Deficiency # for Thermal Chart				
D	Corbel D	West Corbel, East Face	Behind drop-in beam, north side - 1'W x 8"H x 5"D spall that extends up to the bearing pad edge	Not visible from ground due to bridge geometry	Ν	-				
D	Deck	West of East Corbel	1'-10"W x 7"L hollow patch		Y	13				
D	Corbel D	East Corbel, West Face	North side - 32"W x up to 1'H spall that extends 2" onto the north face	Spall, not included as part of thermal testing	N	-				
D	Corbel D	East Corbel, West Face	Upper section, north side - 2'W x 2'H spall/hollow area with 1/8"W boundary cracks, efflorescence, and rust staining	Not visible from ground due to bridge geometry	Ν	-				
E	Corbel E	West Corbel, East Face	Top of lower section, south side - $1'-3"W \times 8"H \times 1"D$ spall in front of bearing with an adjacent 2'-6"H x 1'W hollow area on south lower face	Partially hidden by beam	Y	14

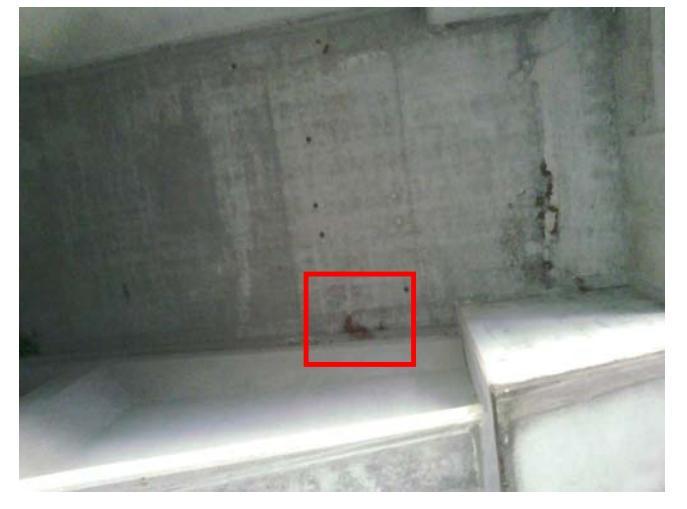
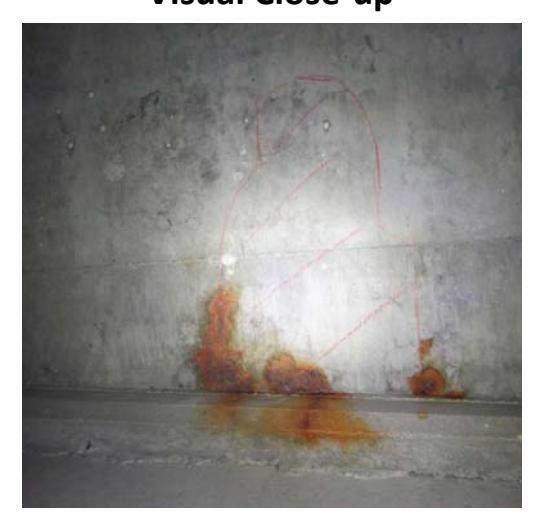
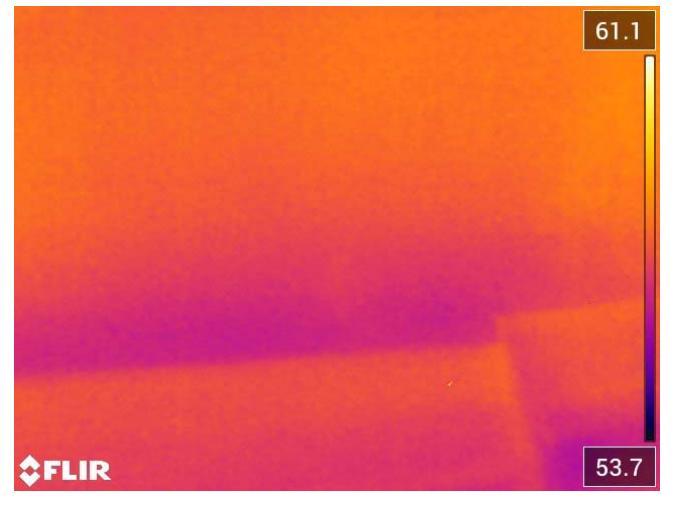
E	Corbel E	West Corbel, Underside	Upper section, south side - 1'-8"W x 24"H hollow area.	Not visible due to geometry	N	-				
Ш	Beam E	West Quarter Point	6"L x 3"H x 1/2"D spall	Spall, not included as part of thermal testing	Ν	-				
E	Deck	East Quarter Point	Patch with 1" diameter hollow area		Y	15				
E	Deck	East of Midspan	1'-8"L x 1'-1"W hollow area		Y	16				
Ш	Corbel E	East Corbel, West Face	North side, behind diaphragm - 1'W x 8"H hollow area	Not visible from ground due to bridge geometry	Ν	-				
E	Corbel E	East Corbel, West Face	South side, behind diaphragm - 1'W x 8"H hollow area	Not visible from ground due to bridge geometry	Ν	-				
Ш	Corbel E	East Corbel, West Face	North end - 1'W x 1'H hollow area		Y	17				
E	Corbel E	East Corbel, West Face	South end - 1'W x 1'H spall	Spall, not included as part of thermal testing	Ν	-				
E	Deck	East of East Corbel	1'L x 1'-7"W hollow area with rust staining along cantilever F		Y	18

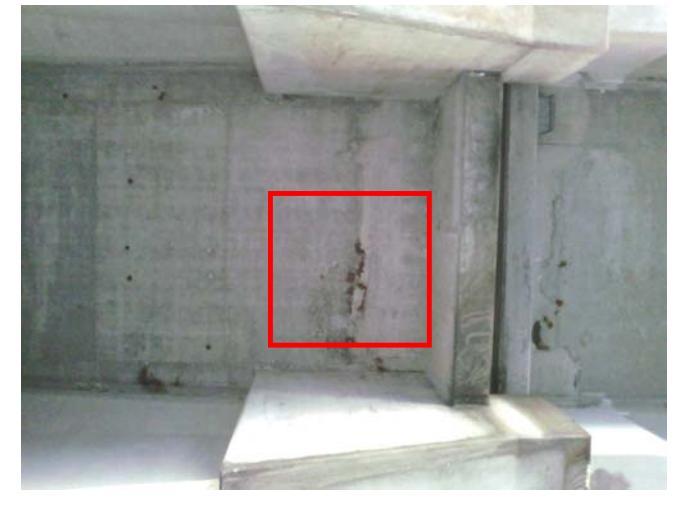
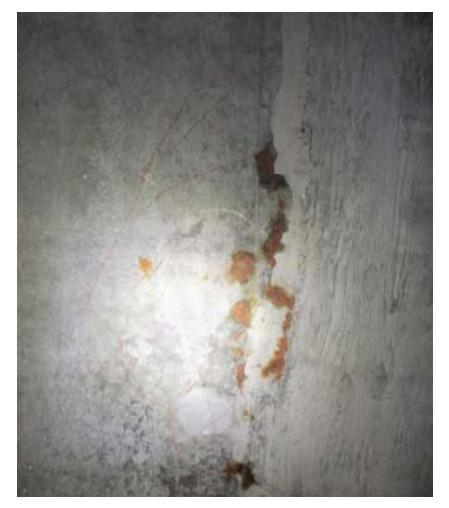
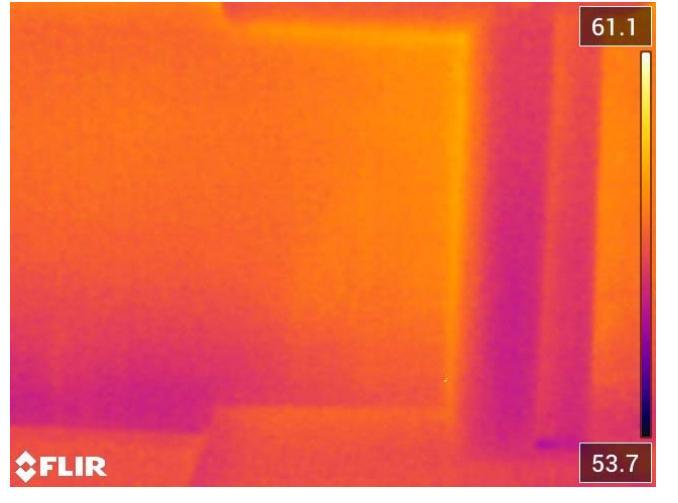
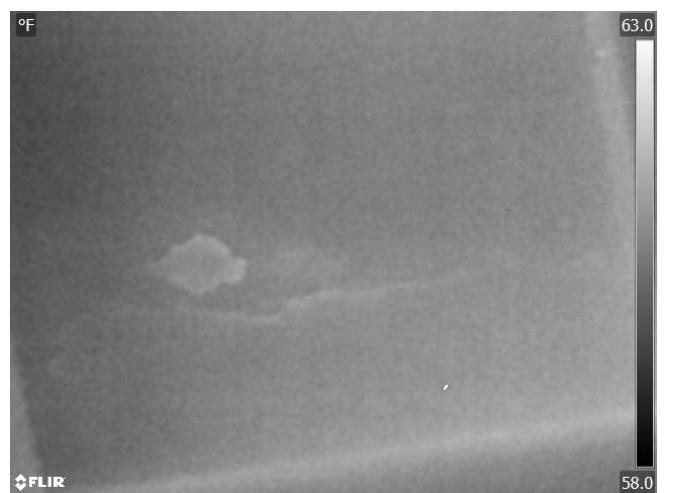
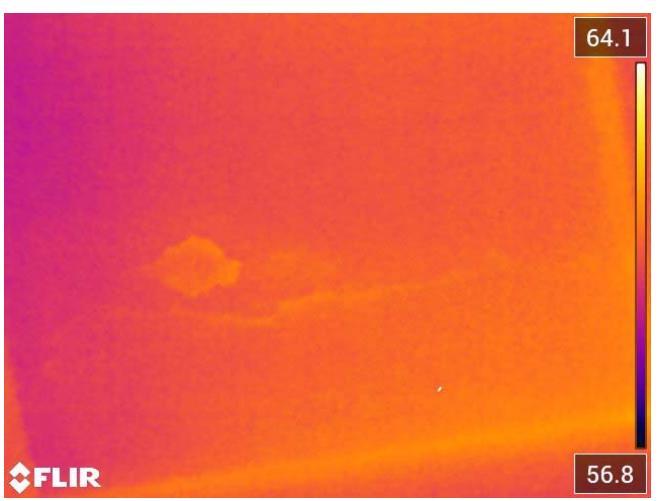
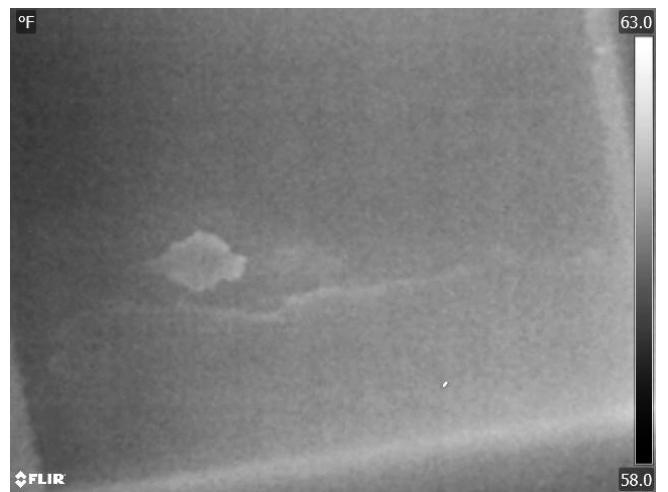
Visual of Delamination

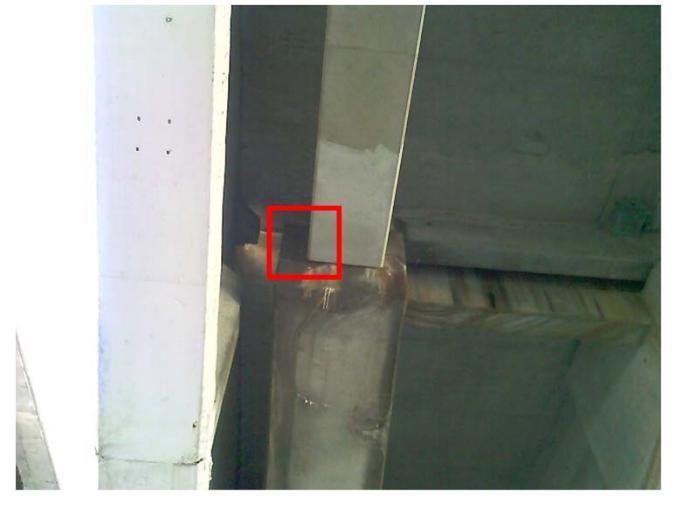
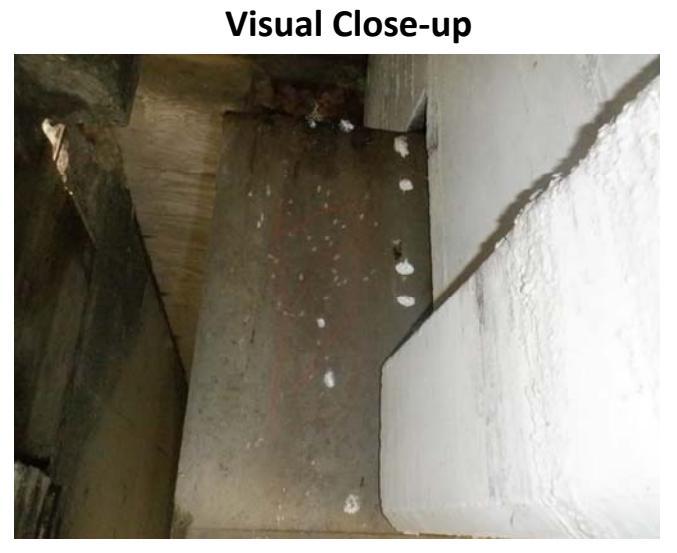
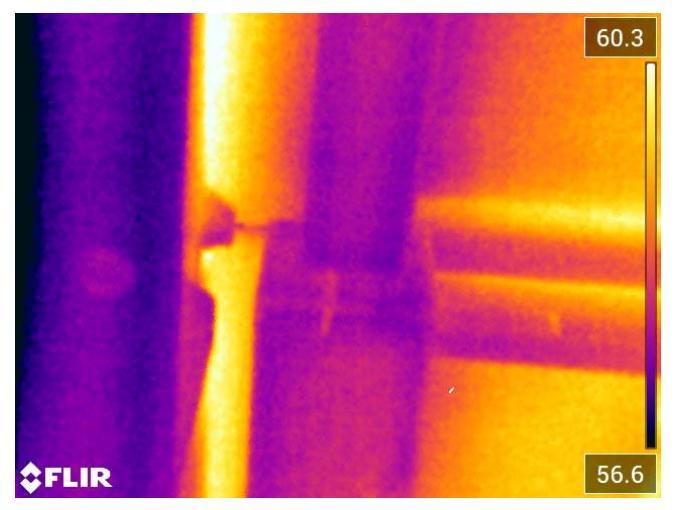
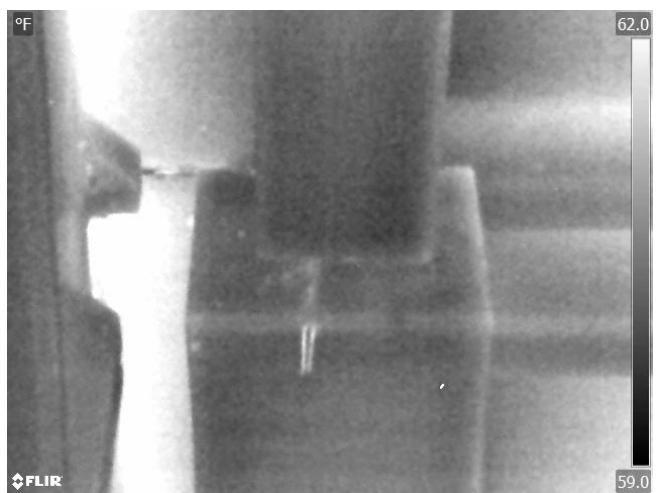
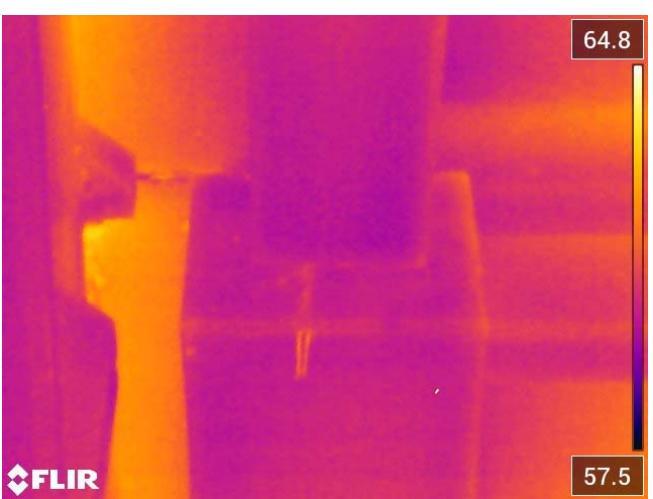
Visual of Delamination

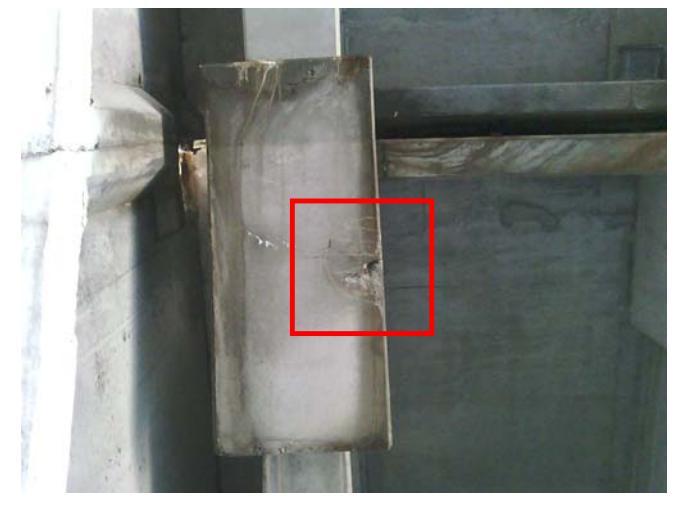
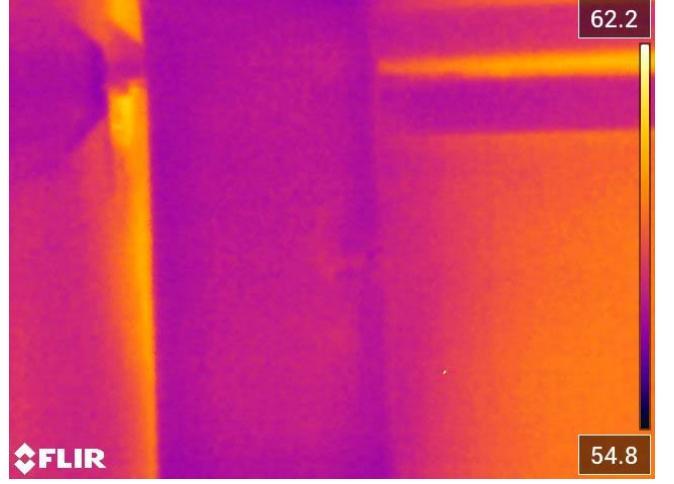
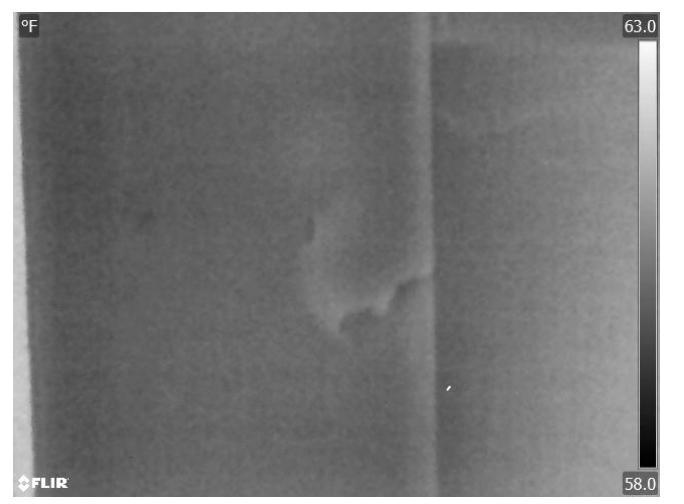
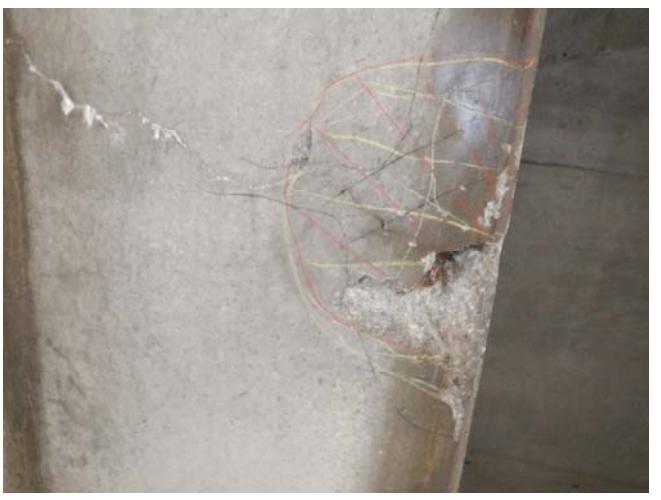
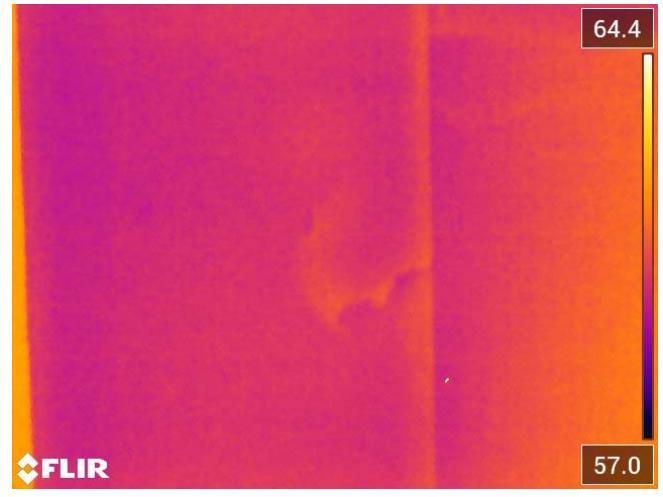
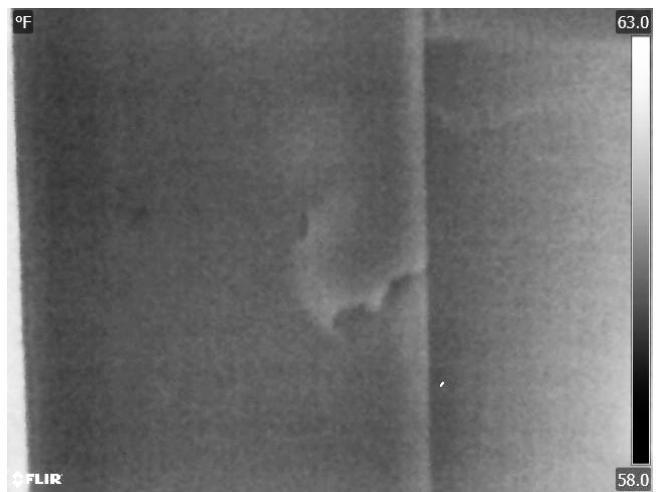
Deficiency 21

Visual of Delamination

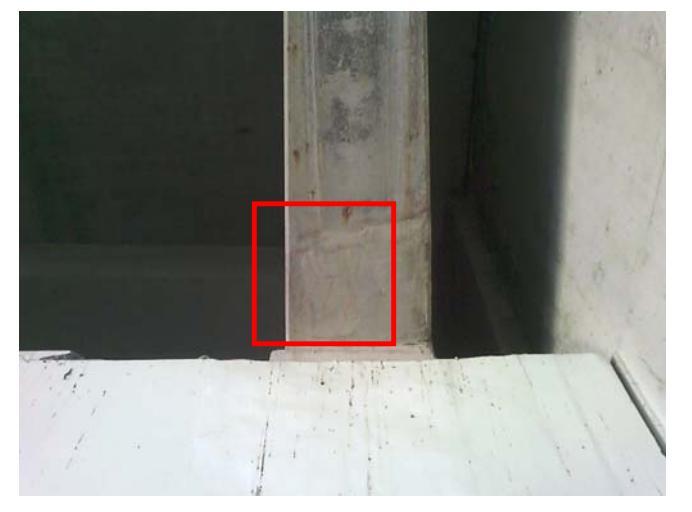
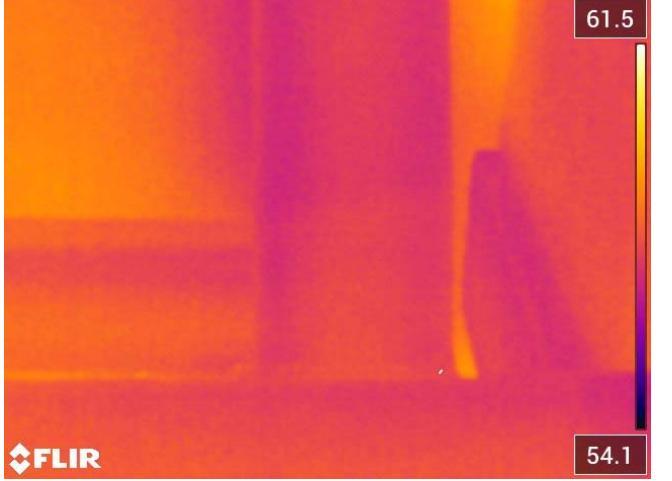
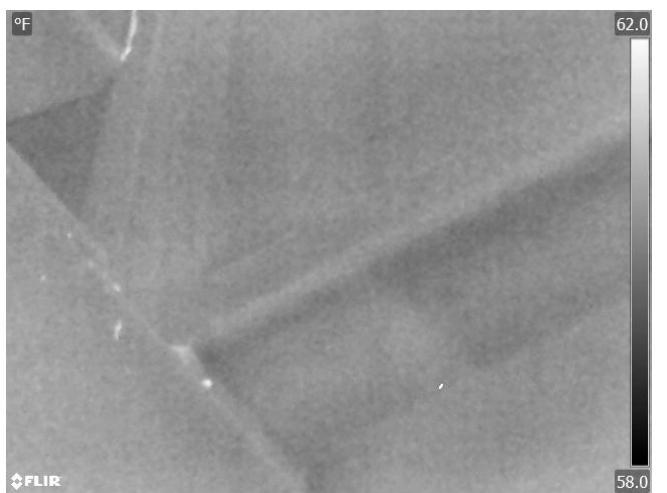
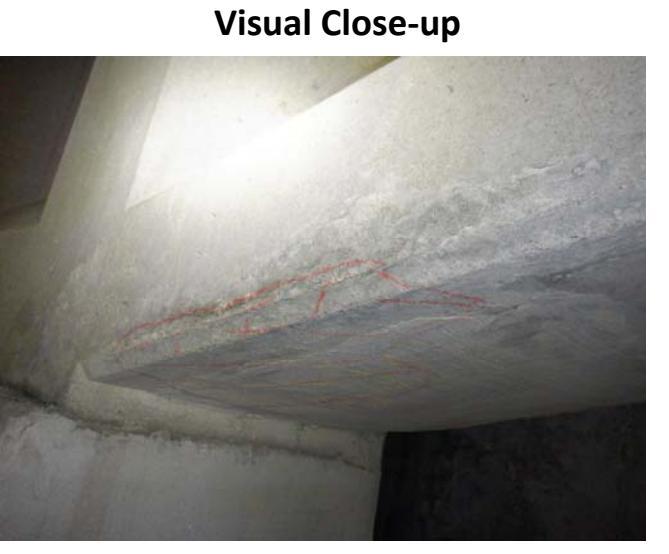
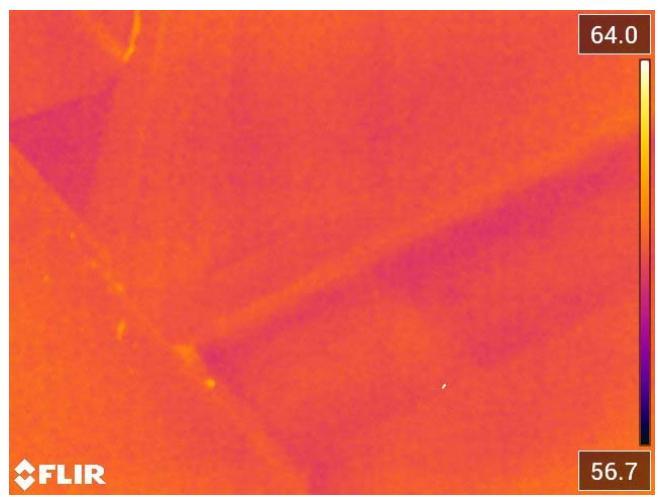
Deficiency 22

Visual of Delamination

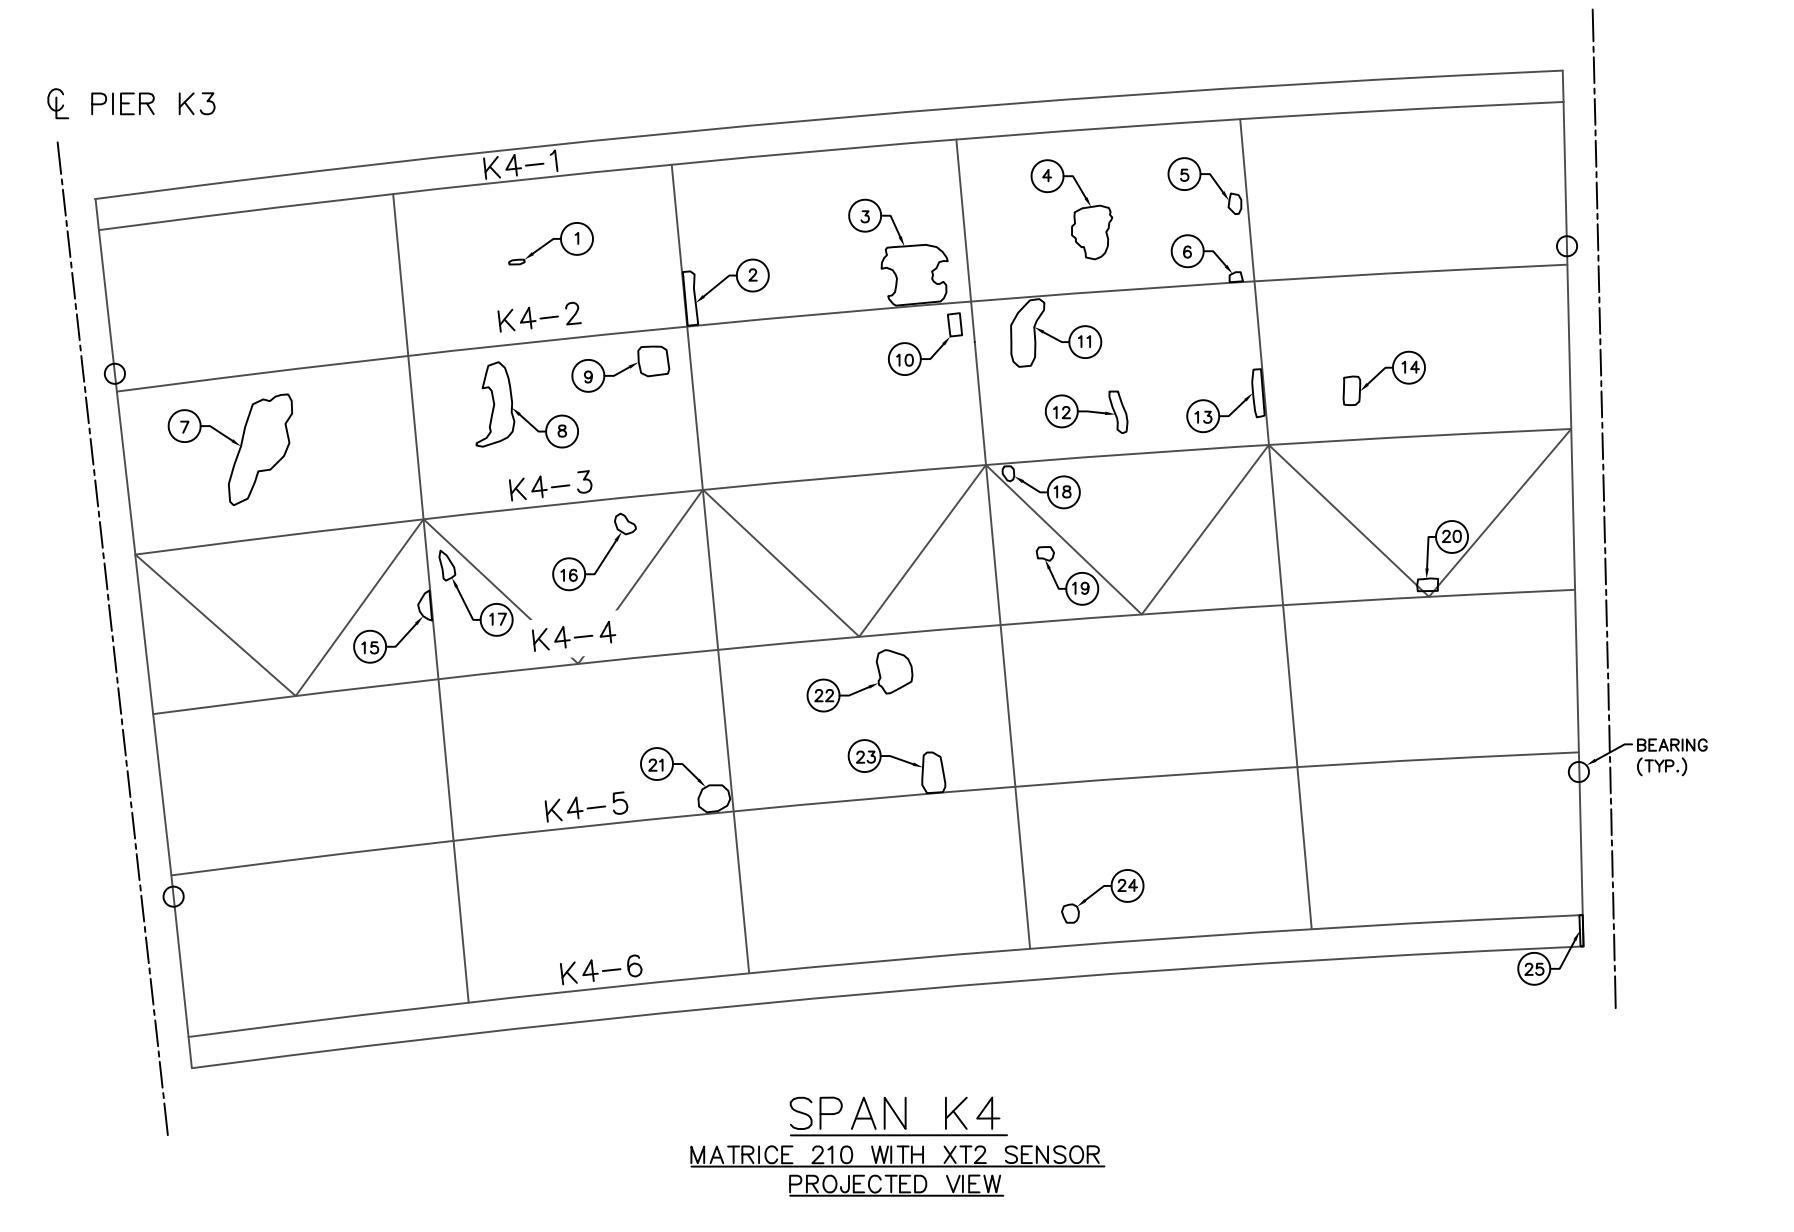
- 1. 66" wide x 9" long hollow sounding area (HSA)
- 2. 9" wide x 13" long HSA
- 3. 26" wide x 30" long spall
- 4. 12" wide x 12" long HSA
- 5. 14" wide x 10" long HSA
- 6. 45" wide x 9" long HSA
- 7. 24" wide x 4" long HSA with adjacent $2\frac{1}{2}$ " wide x 16" long spall
- 8. 50" wide x 21" long (18" long average) minor HSA
- 9. $9\frac{1}{2}$ wide x 10" long minor HSA
- 10. $6\overline{1}$ " wide x up to $2\overline{3}$ " long spall
- 11. 33" wide x 14" long HSA
- 12. 60" wide x up to 34" long HSA
- 13. 41" wide x 22" long spall
- 14. 6" wide x 4" high HSA in haunch
- 15. 30" wide x up to 27" long HSA
- 16. 6" wide x 10" long minor HSA
- 17. 13" wide x 14" long HSA

- 18. $1\frac{1}{2}$ wide x 14 long spall
- 19. Up to 3" wide x 20" long spall
- 20. 38" wide x 46" long HSA
- 21. 21" wide x 12" long spall
- 22. 18" wide x 9" long spall
- 23. 7" wide x 14" long HSA
- 24. 30" wide x 10" long spall with two adjacent HSA measuring 14" wide x 3" long and 20" wide x up to 5" long
- 25. 6" wide x 17" long HSA
- 26. 16" wide x 11" long HSA
- 27. 28" wide x up to 31" long HSA
- 28. 25" wide x 13" long HSA
- 29. 5" wide x 6" long HSA

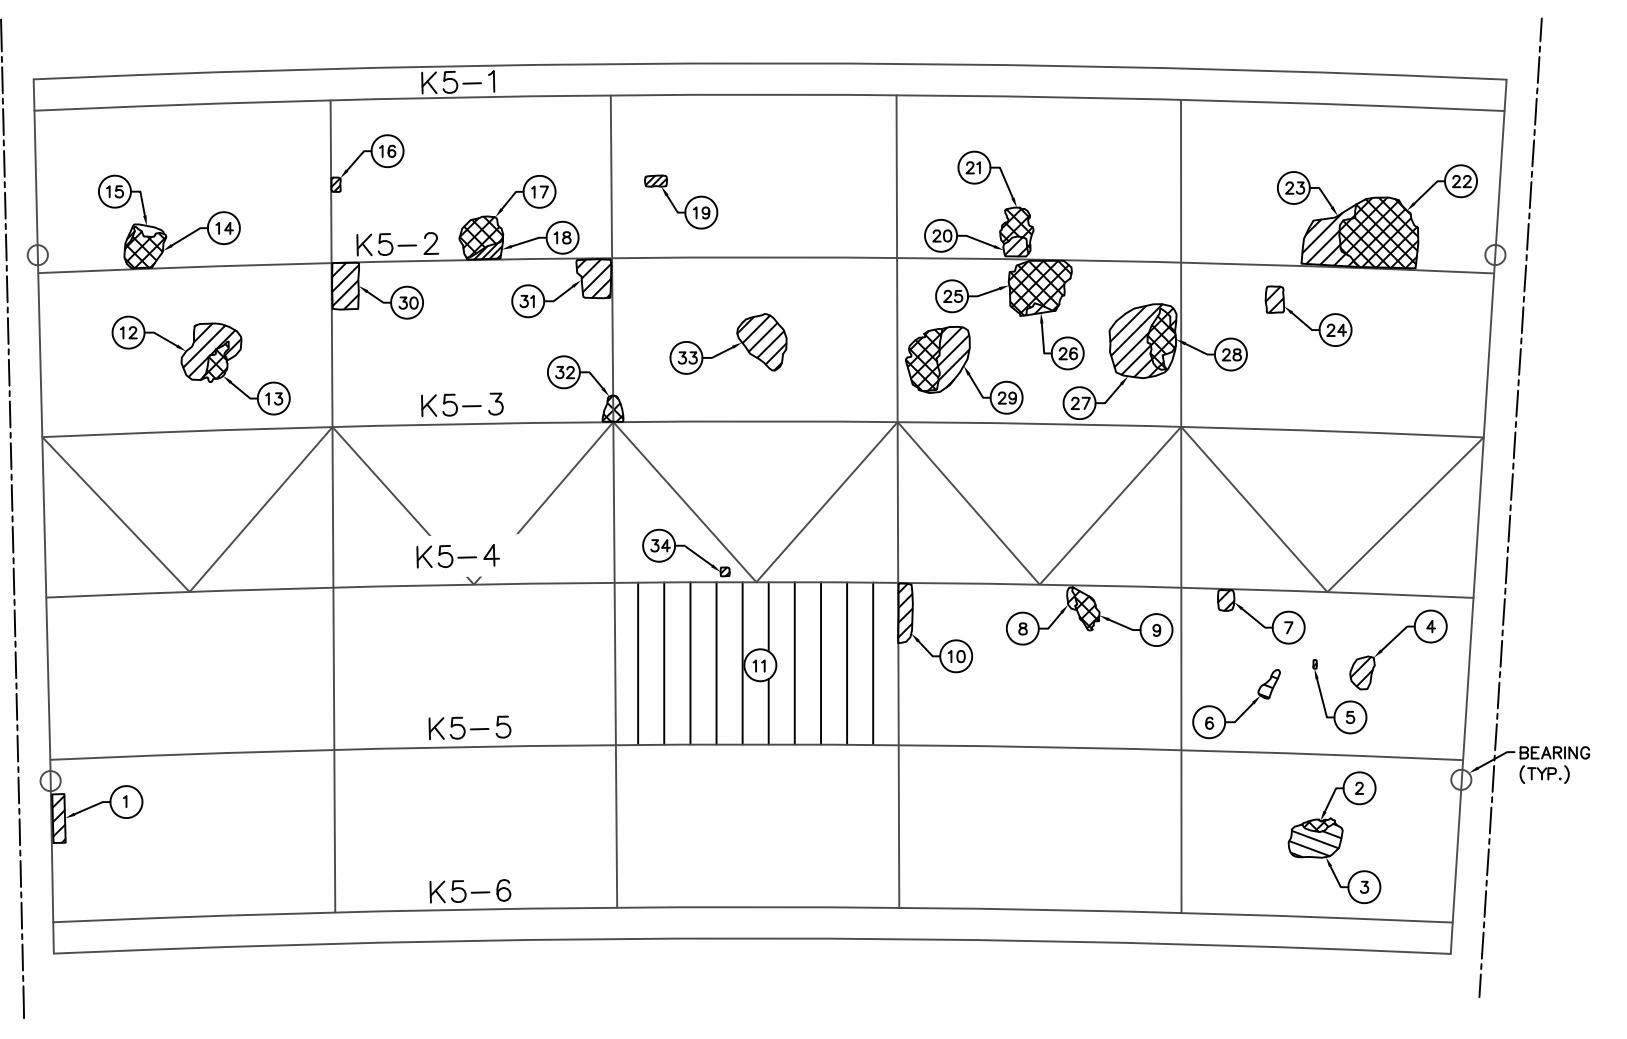
SPAN K5 TRADITIONAL INSPECTION FINDINGS PROJECTED VIEW

- 1. 28" wide x up to 7" long hollow sounding area (HSA)
- 2. 7" wide x 26" long spall
- 3. 20" wide x 30" long HSA
- 4. 20" wide x 12" long HSA
- 5. 5" wide x 2" long HSA
- 6. 8" wide x 18" long HSA
- 7. 12" wide x 9" long HSA
- 8. 26" wide x 12" long spall
- 9. 14" wide x 4" long HSA
- 10. 34" wide x 8" long HSA extending into shielded area
- 11. Shielded area (area not inspected)
- 12. 32" wide x up to 28" long HSA
- 13. 20" wide x 11" long spall
- 14. 22" wide x 22" long spall
- 15. 6" wide x 15" long HSA
- 16. 8" wide x 5" long HSA
- 17. Up to 22" wide x 24" long spall
- 18. Up to 9" wide x 19" long HSA
- 19. 6" wide x 12" long HSA (overpour)

20. 12" wide x 14" long HSA 21. 26" wide x 18" long spall 22. 38" wide x 42" long spall 23. 25" wide x up to 30" long HSA 24. 15" wide x 10" long HSA 25. 32" wide x 32" long spall 26. 6" wide x 8" long HSA 27. 40" wide x 23" long HSA 28. 34" wide x 14" long spall 29. 38" wide x 18" long spall with adjacent 17" long x 36" wide HSA 30. 26" wide x 15" long HSA 31. 22" wide x up to 20" long HSA 32. 15" wide x 12" long spall 33. 27" wide x up to 26" long HSA 34. 5" wide x 5" long HSA

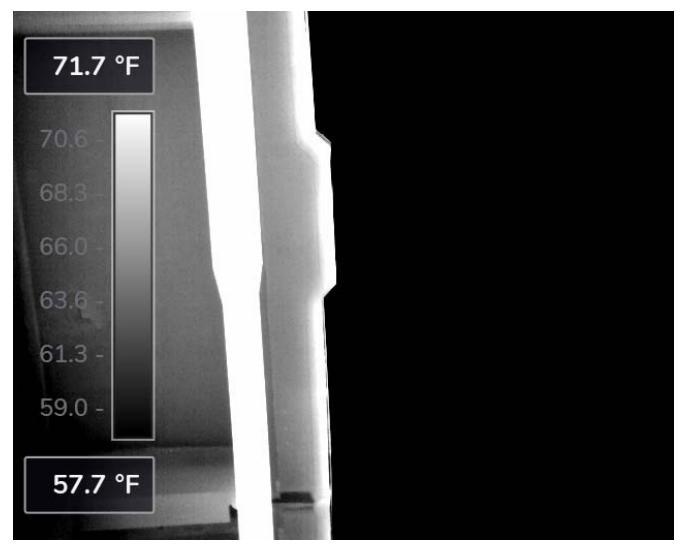
114_Sp5_Def01_RGB_DJI_0186

Thermal Deficiency 1

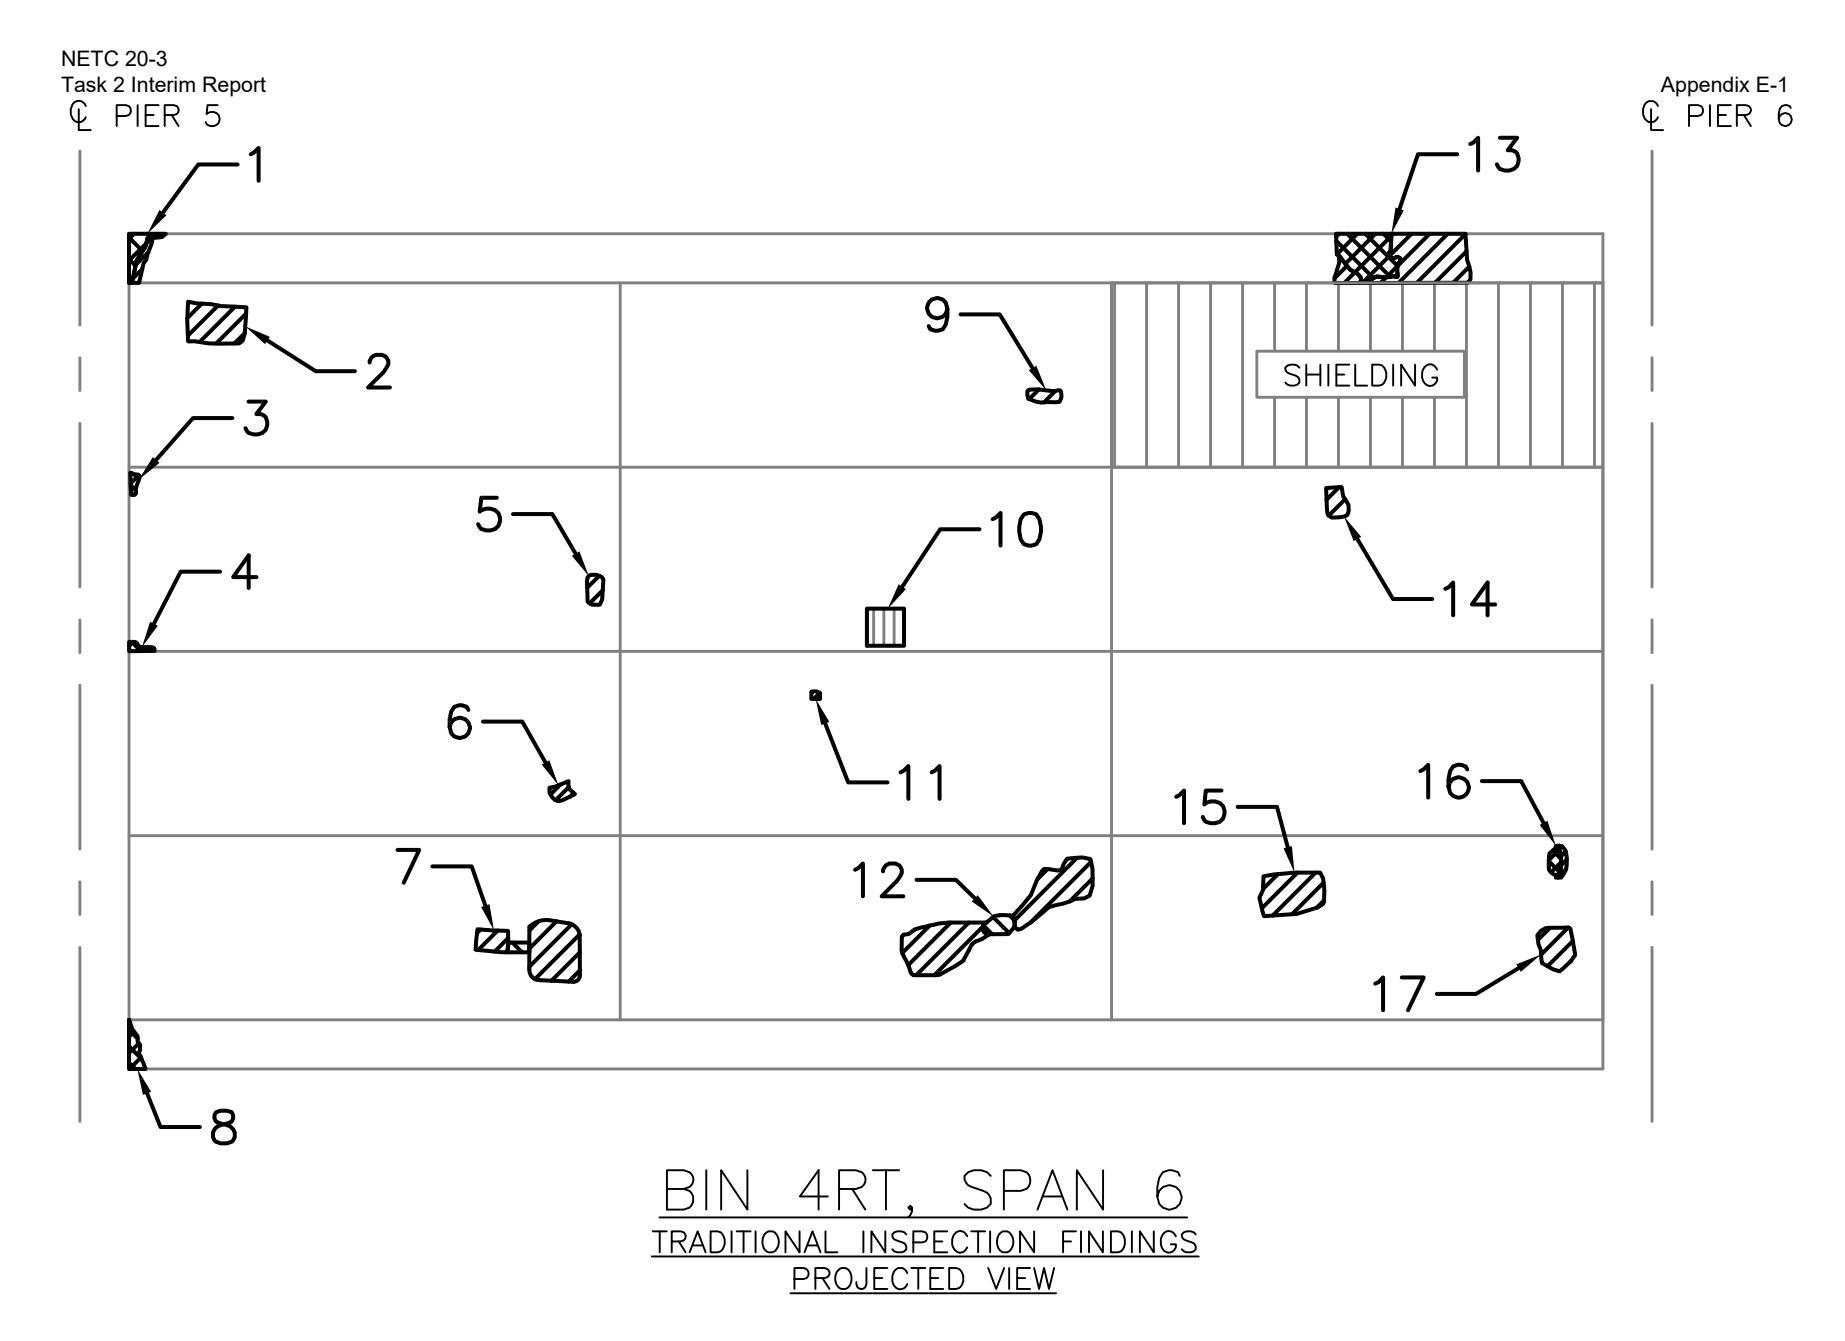
B-16-369 (BIN 4RT)

- 13" long x full width x 3" deep spall with rebar and full width x 4" long hollow sounding area (HSA).
- 2. 29" long x 19" wide HSA
- 3. 1" wide x 4" long x 1" deep spall.
- 4. 13" long x 4" wide x 2" deep spall.
- 5. 15" long x 7" wide HSA.
- 6. 10" long x 8" wide HSA.
- 7. 17" long x 11" wide HSA, 12" long x 5" wide HSA, 29" long x 25" wide HSA.
- 8. 8" long x full depth x full width spall.
- 9. 19" long x 7" wide HSA.
- 10. Formwork left in place.

- 11. 4" x 4" HSA.
- 12. Up to 36" long x 19" wide HSA, 10" long x 7" wide HSA, 38" long x up to 20" wide HSA.
- 13. 24" long x full width x 1" deep spall with two HSA's measuring 9" long x full width and 38" long x full width
- 14. 16" long x 16" wide HSA.
- 15. 30" long x 20" wide HSA.
- 16. 16" wide x 5" long HSA with a 16" wide x 5" long spall.
- 17. 17" long x 20" wide HSA.

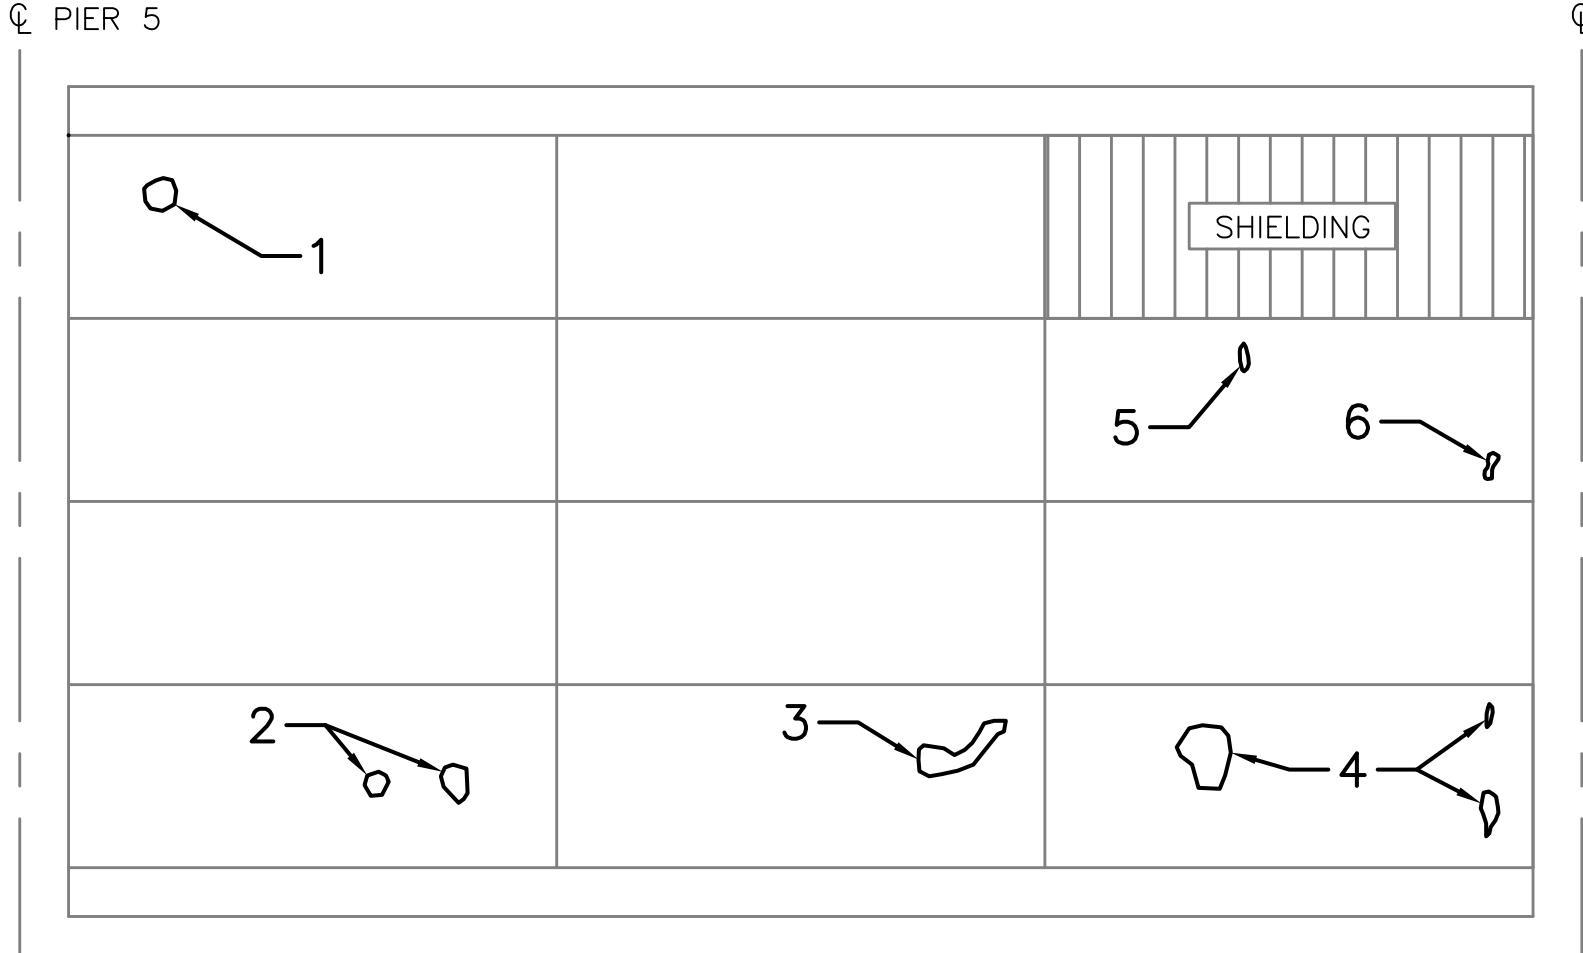
BIN 4RT, SPAN 6, FIRST DATA SET

- 1. AREAS INDICATED ON THIS SKETCH ARE TEMPERATURE DIFFERENTIALS BELIEVED TO BE DELAMINATIONS ALONG THE UNDERSIDE OF THE BRIDGE DECK. LOCATIONS, SIZES, AND SHAPES ARE APPROXIMATED BASED ON THE THERMAL IMAGERY.
- 2. TEMPERATURE DIFFERENTIALS WERE CROSS CHECKED WITH VISUAL IMAGERY TO REMOVE FALSE POSITIVES DURING DATA COLLECTION.

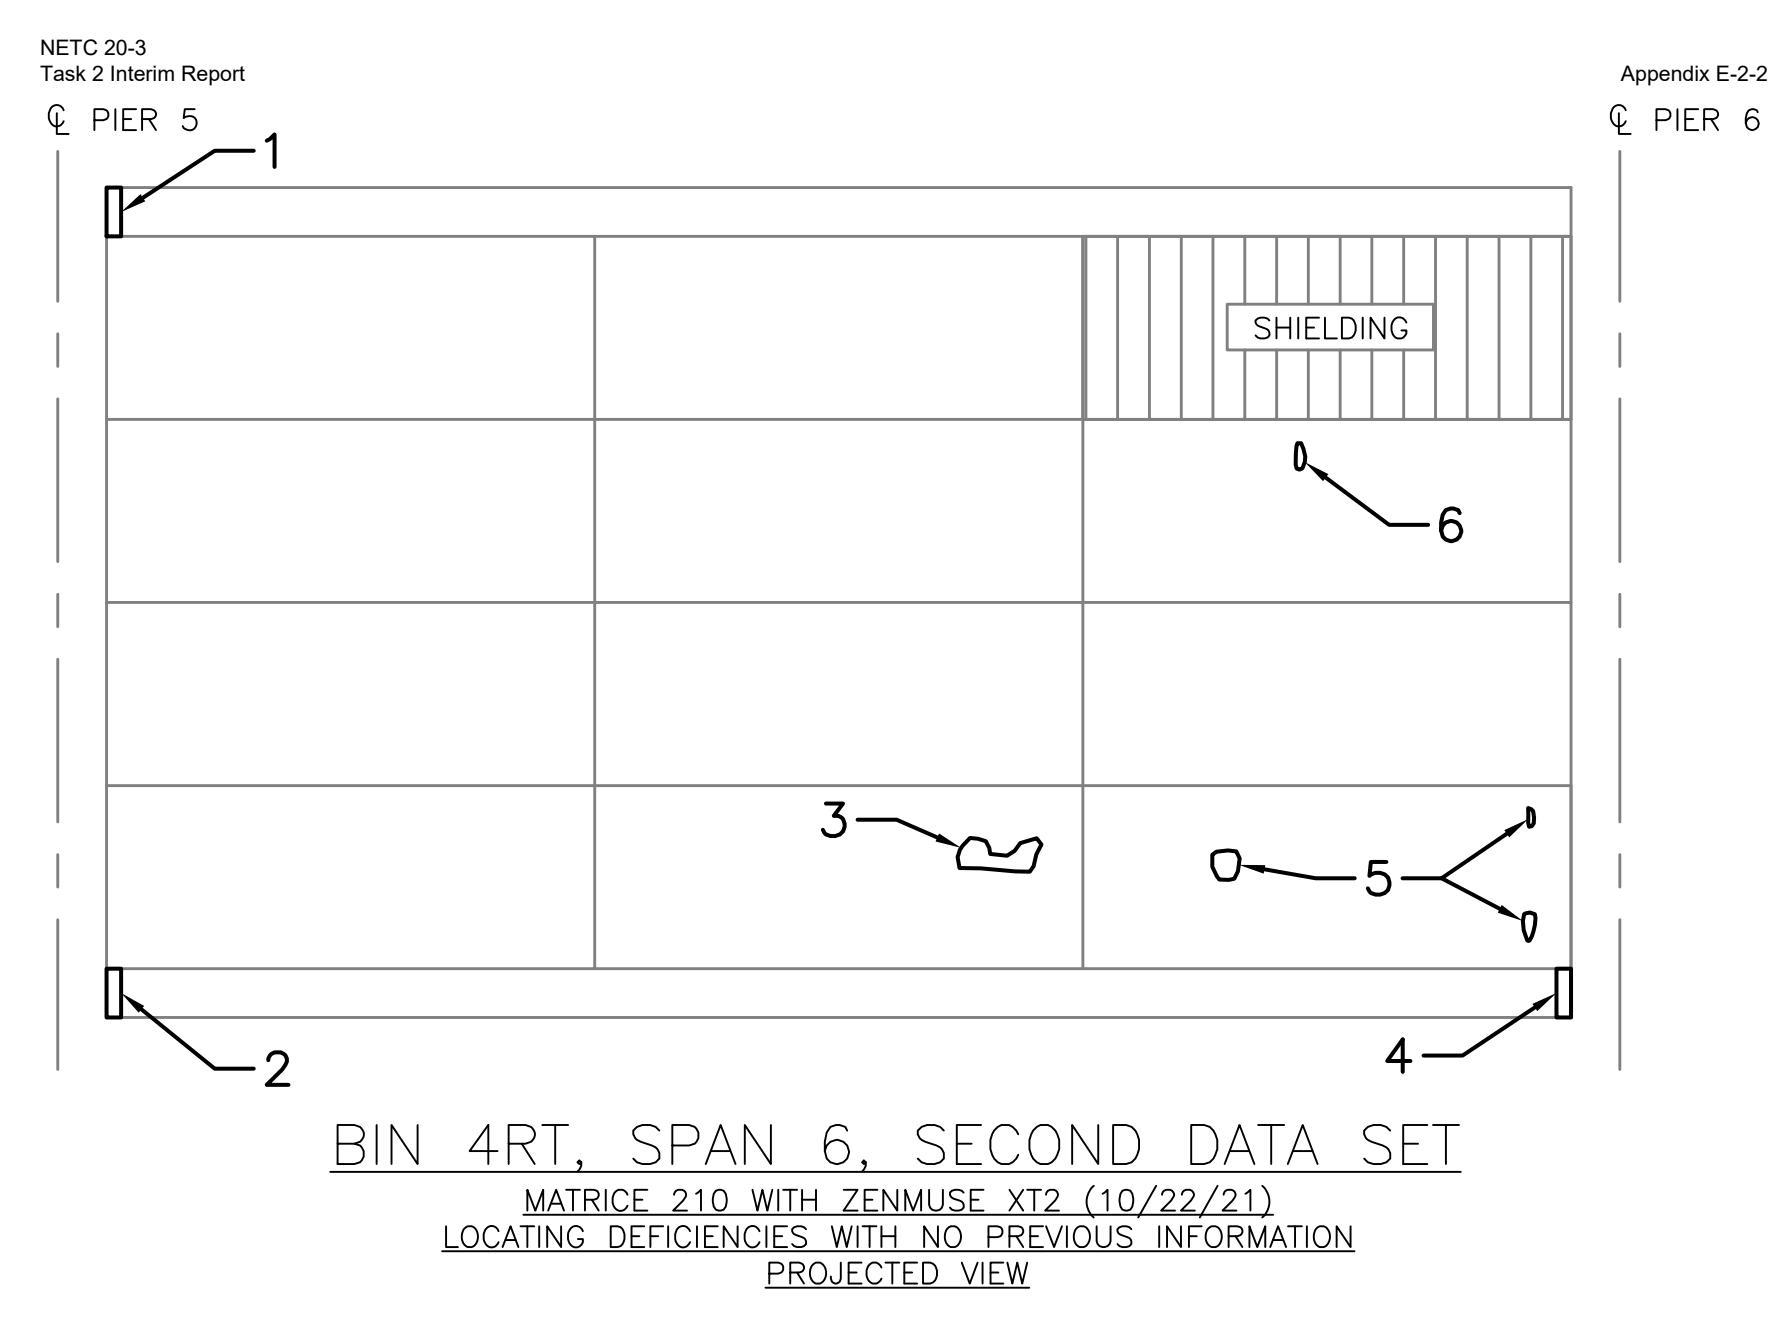
- 1. AREAS INDICATED ON THIS SKETCH ARE TEMPERATURE DIFFERENTIALS BELIEVED TO BE DELAMINATIONS ALONG THE UNDERSIDE OF THE BRIDGE DECK. LOCATIONS, SIZES, AND SHAPES ARE APPROXIMATED BASED ON THE THERMAL IMAGERY.
- 2. TEMPERATURE DIFFERENTIALS WERE CROSS CHECKED WITH VISUAL IMAGERY TO REMOVE FALSE POSITIVES DURING DATA COLLECTION.
