New England Transportation Consortium (NETC) NETC 20-3

Investigating Thermal Imaging Technologies and Unmanned Aerial Vehicles to Improve Bridge Inspections

Task 2 Interim Report

Field Demonstration and Data Analysis

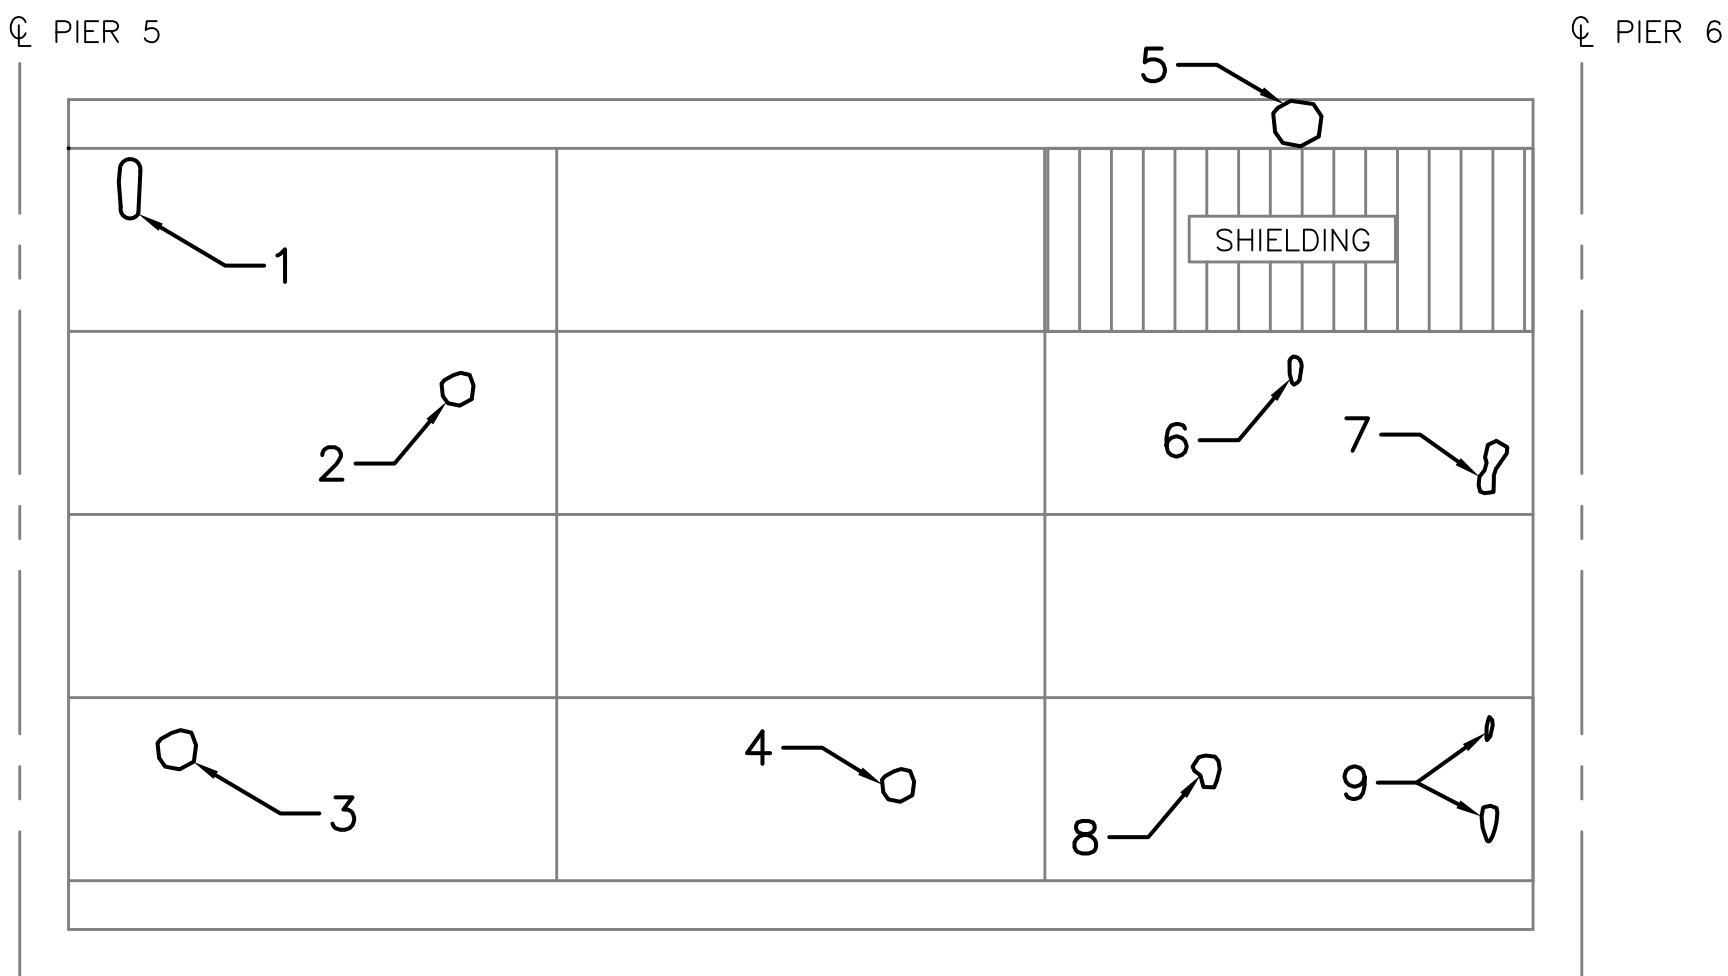
BIN 4RT, SPAN 6, THIRD DATA SET

- 1. AREAS INDICATED ON THIS SKETCH ARE TEMPERATURE DIFFERENTIALS BELIEVED TO BE DELAMINATIONS ALONG THE UNDERSIDE OF THE BRIDGE DECK. LOCATIONS, SIZES, AND SHAPES ARE APPROXIMATED BASED ON THE THERMAL IMAGERY.
- 2. TEMPERATURE DIFFERENTIALS WERE CROSS CHECKED WITH VISUAL IMAGERY TO REMOVE FALSE POSITIVES DURING DATA COLLECTION.

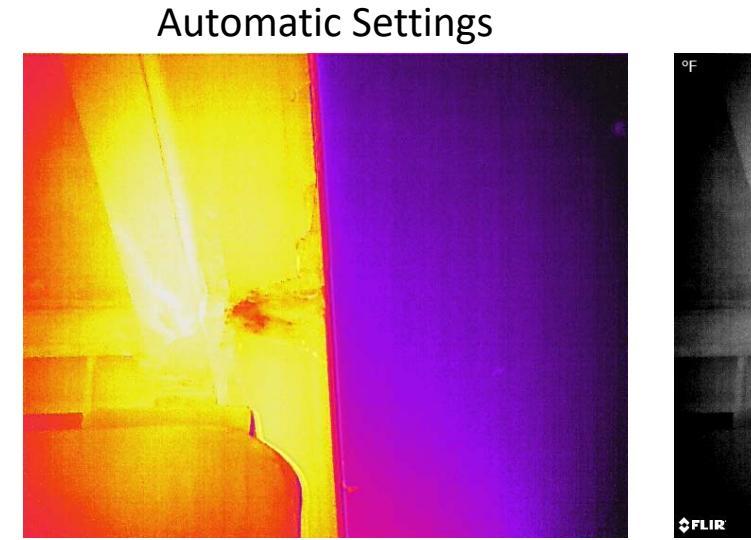
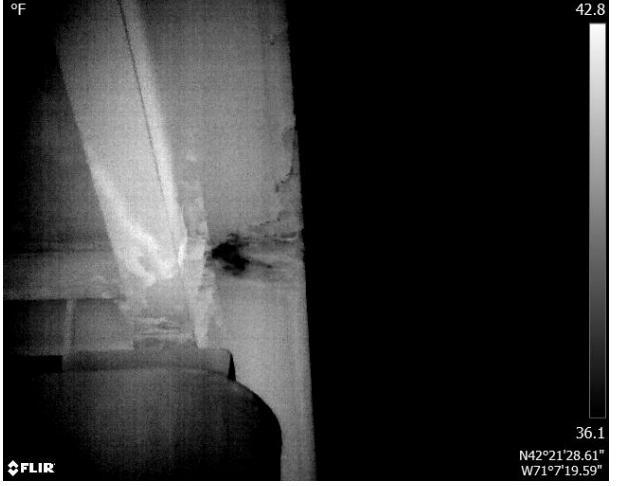
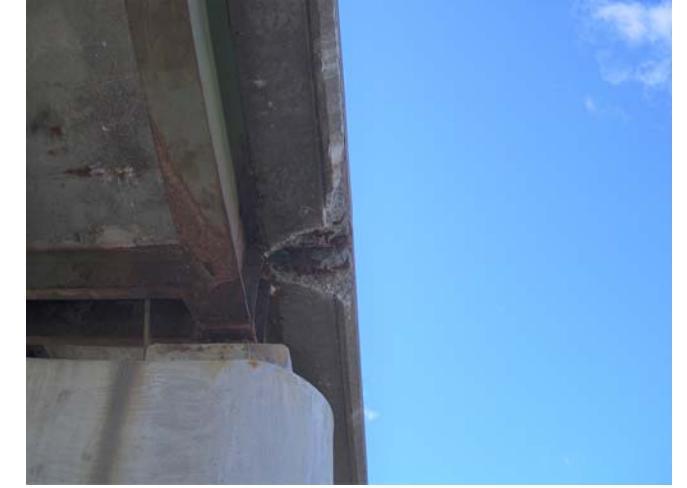
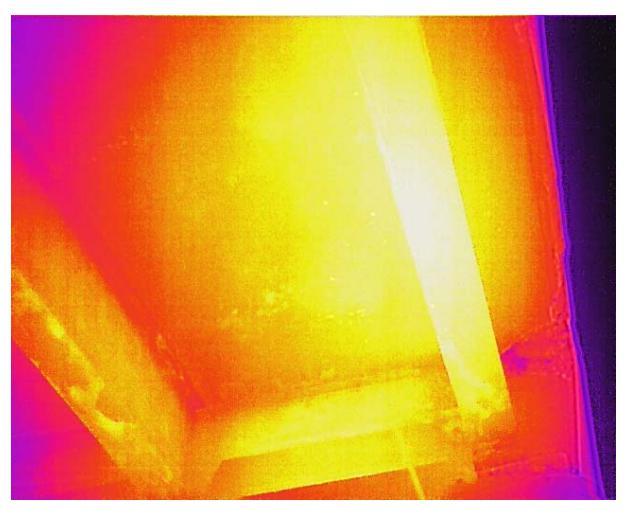
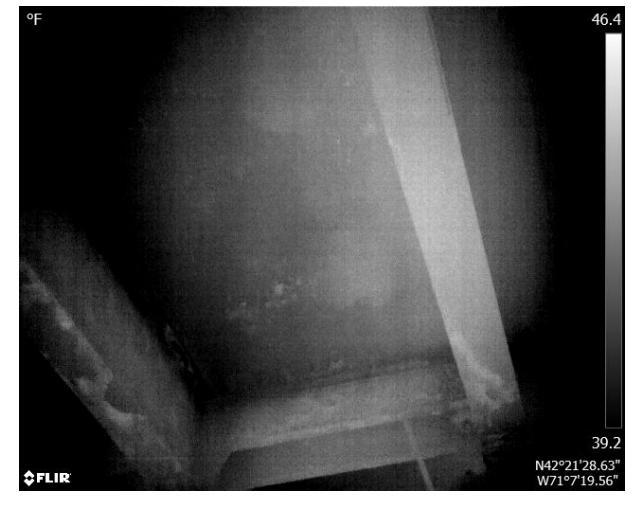
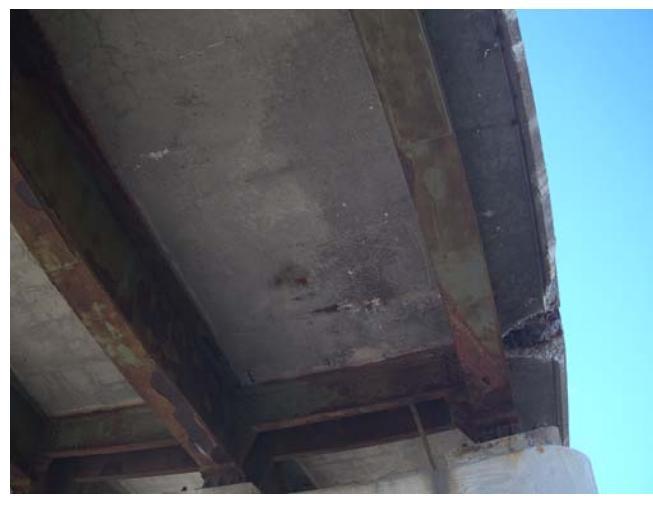
Deficiencies 1, 2

4RT, IR of Delaminations, First Data Set (10/19/21)

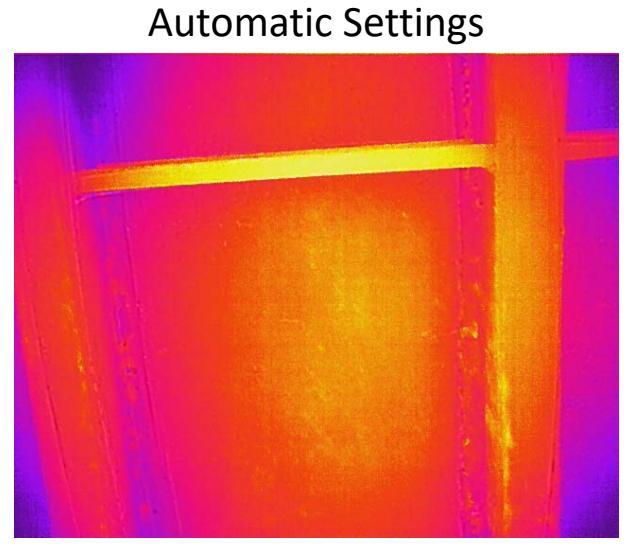
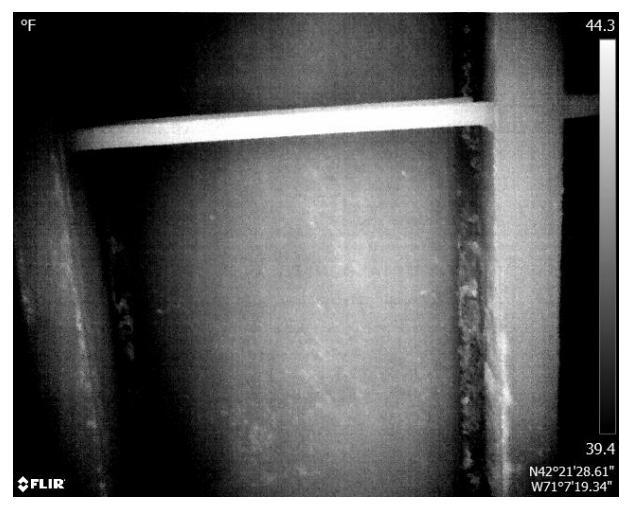
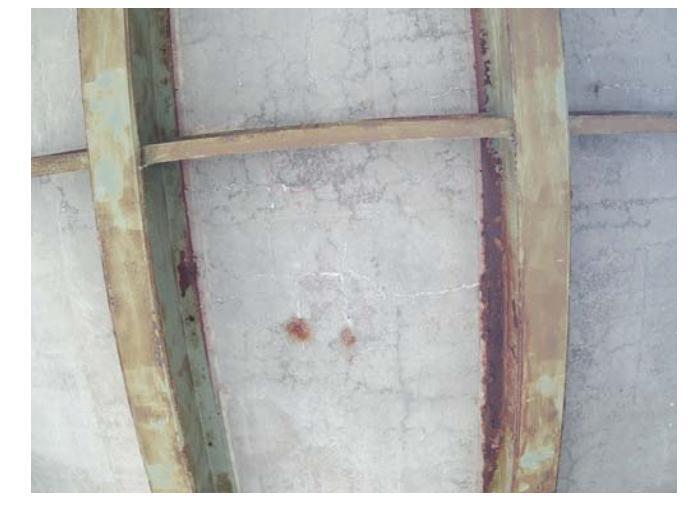
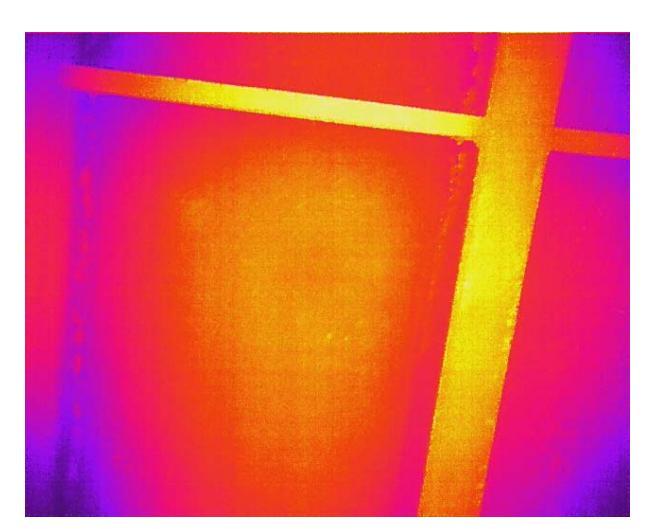
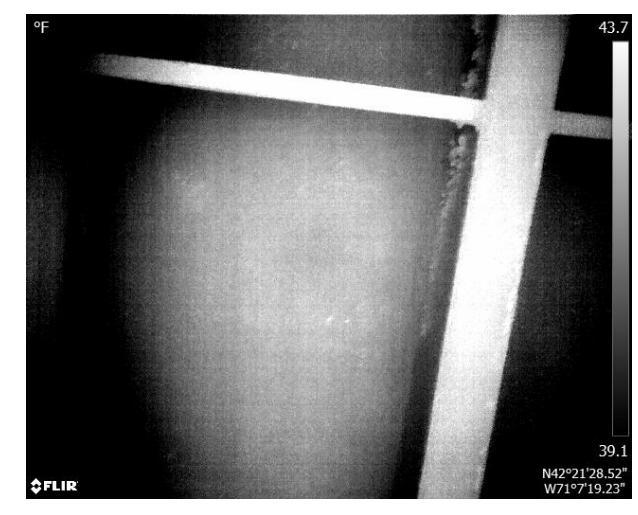
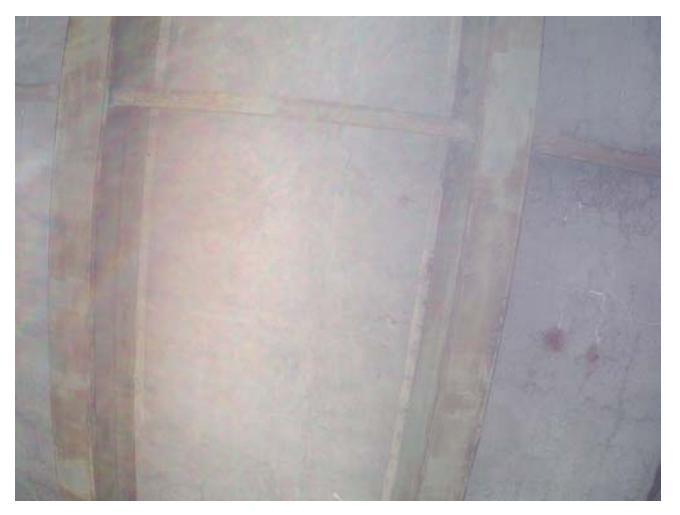
Deficiencies 5, 6

4RT, IR of Delaminations, First Data Set (10/19/21)

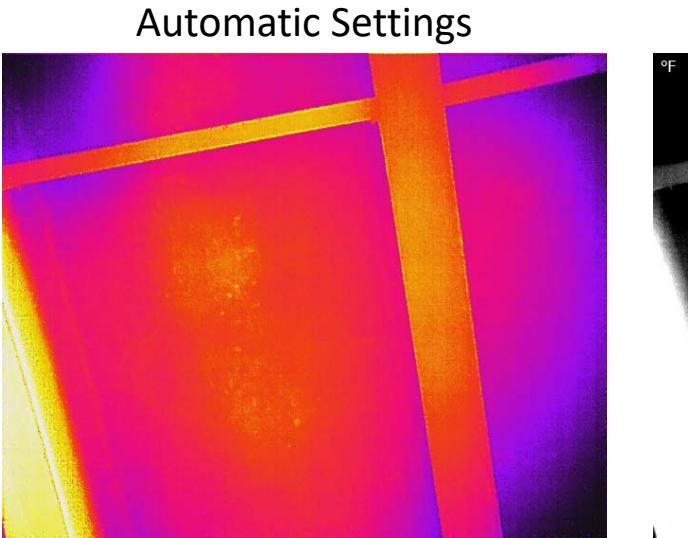
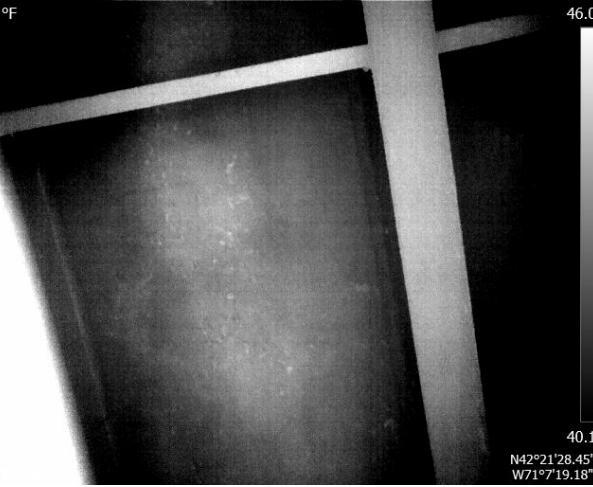
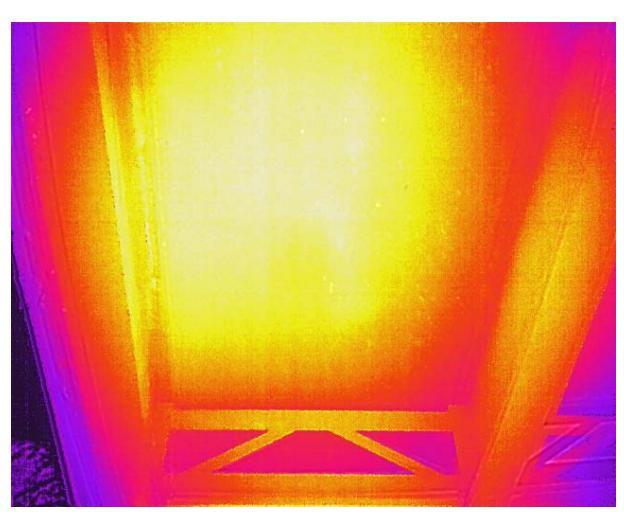
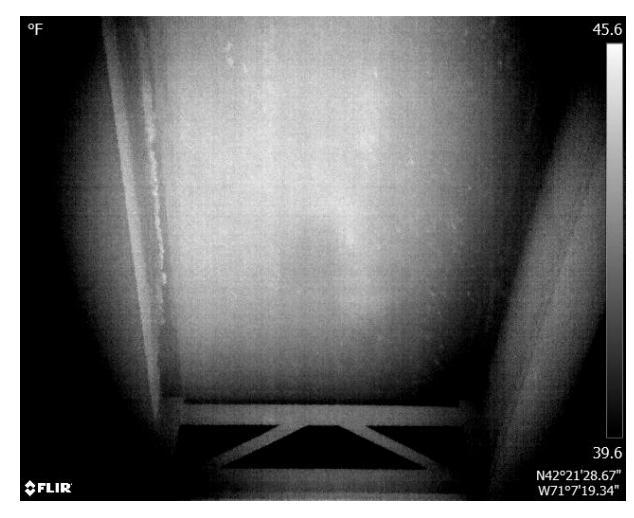
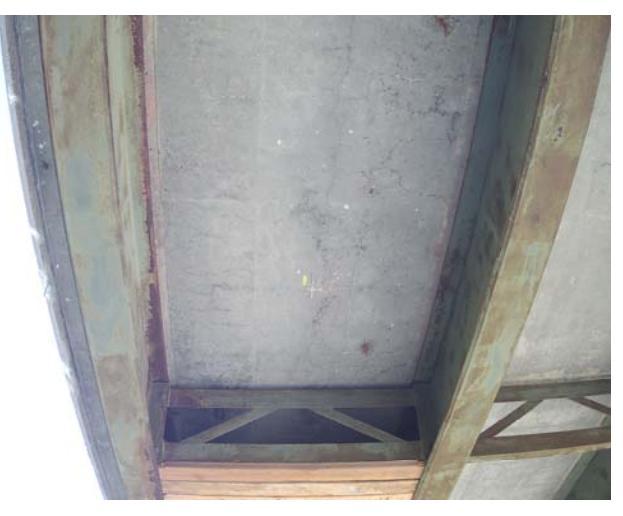
Deficiencies 7, 9

4RT, IR of Delaminations, First Data Set (10/19/21)

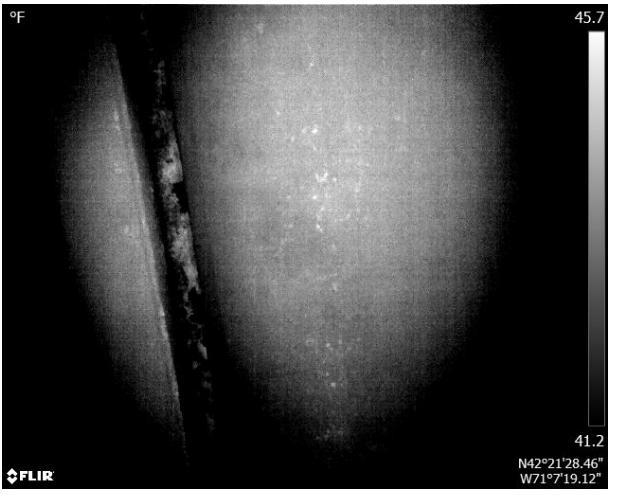
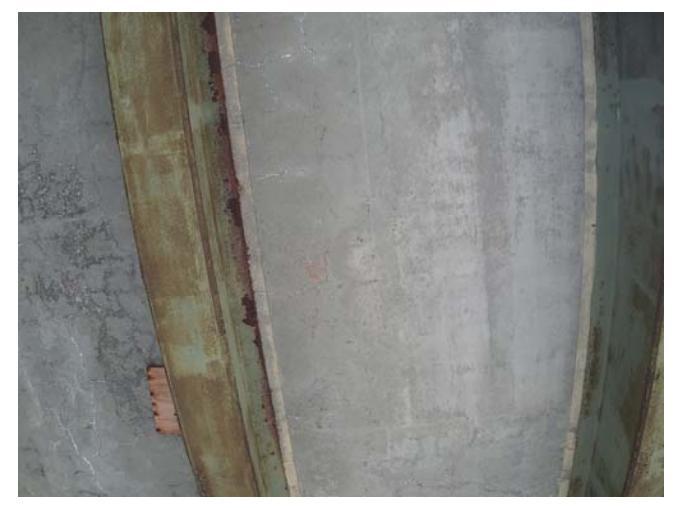
Deficiencies 11, 12

4RT, IR of Delaminations, First Data Set (10/19/21)
