**CRASH TESTING AND EVALUATION OF THE
NETC 2-BAR CURB-MOUNTED BRIDGE RAIL**

NETCR-10

Prepared by:
Texas Transportation Institute
The Texas A & M University System
College Station, Texas

**VOLUME IX: APPENDIX H -
CRASH TESTING AND EVALUATION OF THE
NETC PL-2 BRIDGE RAIL DESIGN**

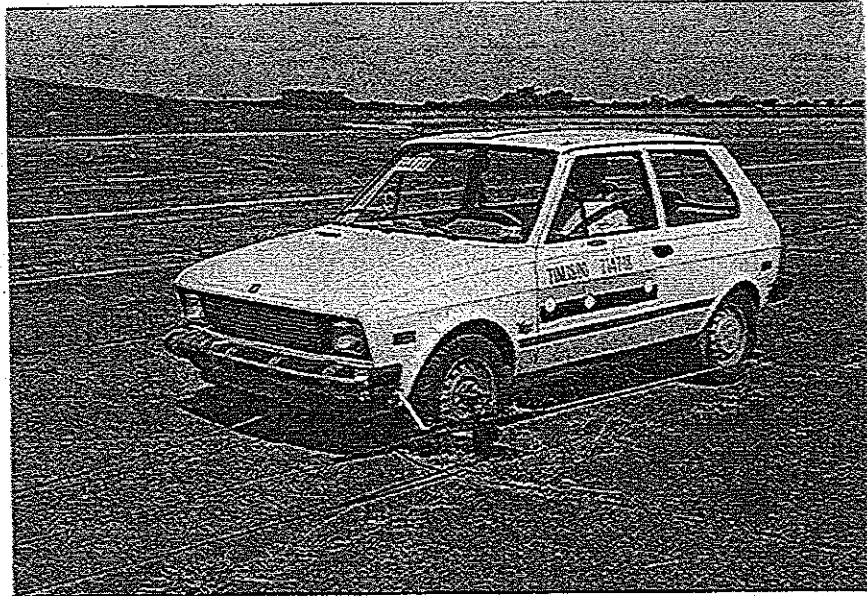
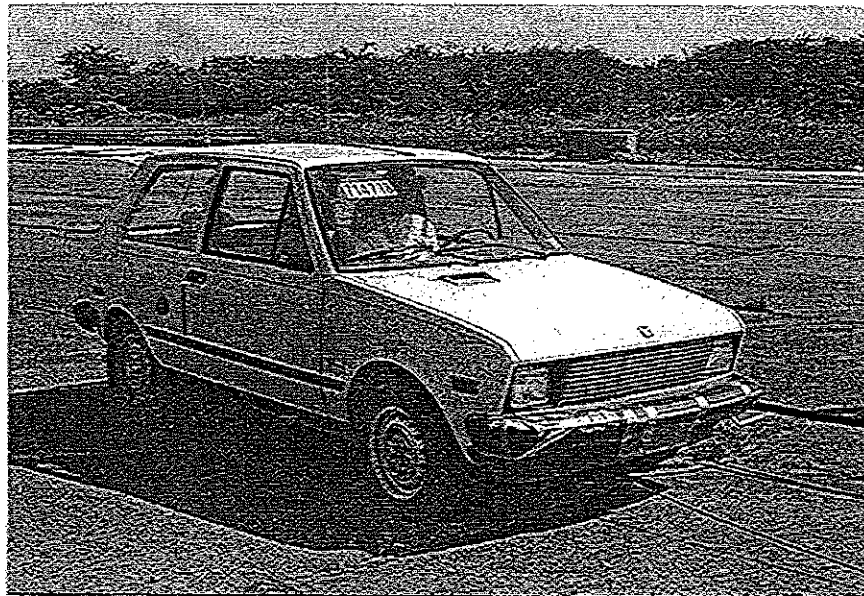
Figure 5. Vehicle before test 471470-18.

A 1986 Yugo GV (figure 5) was used for the crash test. Test inertia mass of the vehicle was 817 kg (1800 lb) and its gross static mass was 894 kg (1970 lb). The height to the lower edge of the vehicle bumper was 238 mm (9.4 in) and it was 465 mm (18.3 in) to the top of the bumper. Additional dimensions and information on the test vehicle are given in figure 6. The position of the vehicle relative to the bridge railing prior to impact is shown in figure 7. The vehicle was directed into the bridge railing using the cable reverse tow and guidance system, and was released to be free-wheeling and unrestrained just prior to impact.

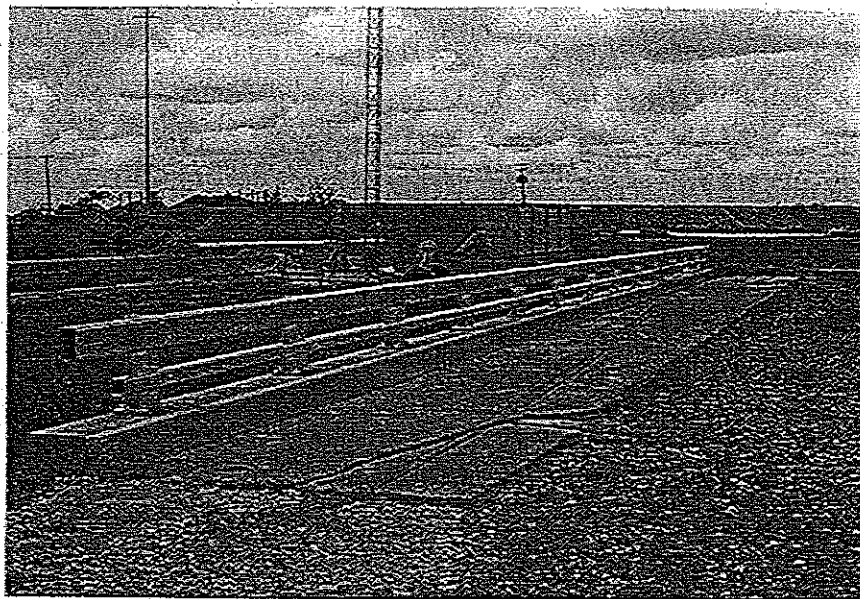
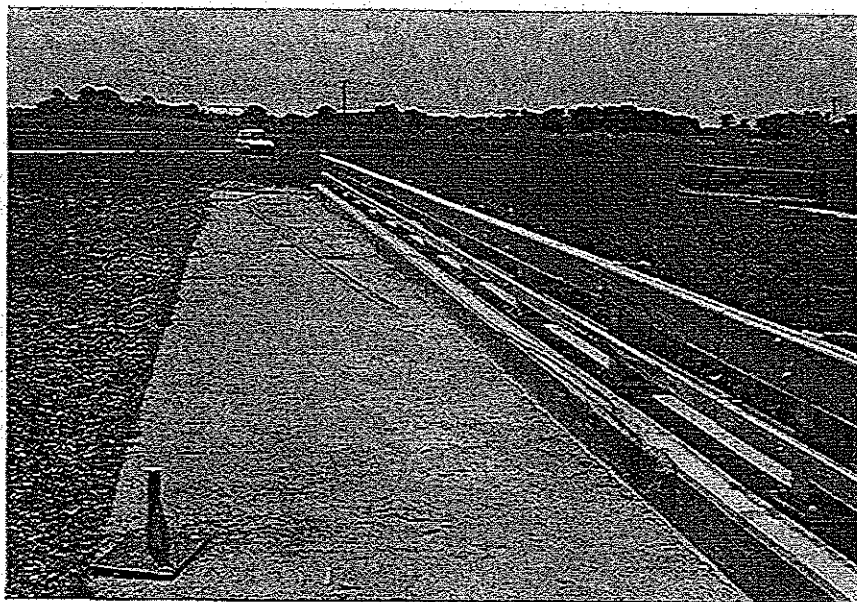
Figure 11. Test site after test 471470-18.

bridge railing for a total length of 4.0 m (13.2 ft). Shown in figure 11 are photographs of the post-test vehicle trajectory.
