GUARDRAIL TESTING – MODIFIED ECCENTRIC
LOADER TERMINAL (MELT) AT NCHRP 350 TL-2

Prepared for
The New England Transportation Consortium

July 2002

NETCR 35

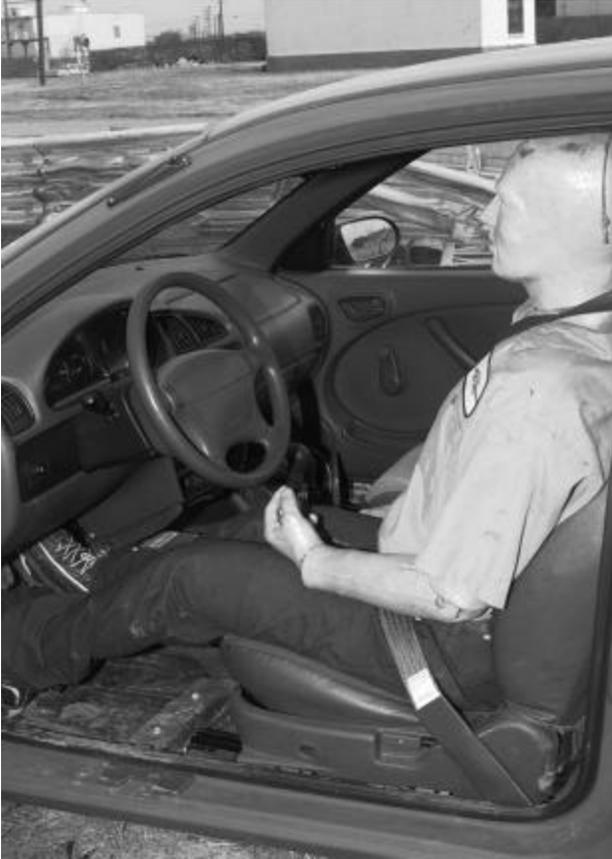
Before Test

The vehicle sustained damage to the front as shown in figure 9. Structural damage was imparted to the right front strut, right front mount, and right front axle, and the firewall and floor pan were deformed. Also damaged were the front bumper, hood, fan, radiator, radiator support, right and left front quarter panels, left front tire and wheel rim, and the left rear tire. The right door was jammed and the windshield sustained stress cracking. Maximum exterior crush to the vehicle was 400 mm at the right front quarter point near bumper height. Maximum occupant compartment deformation was 37 mm just to the right of the center firewall area. Photographs of the interior of the vehicle are shown in figure 10. Exterior vehicle crush and occupant compartment measurements are shown in appendix B, tables 3 and 4.

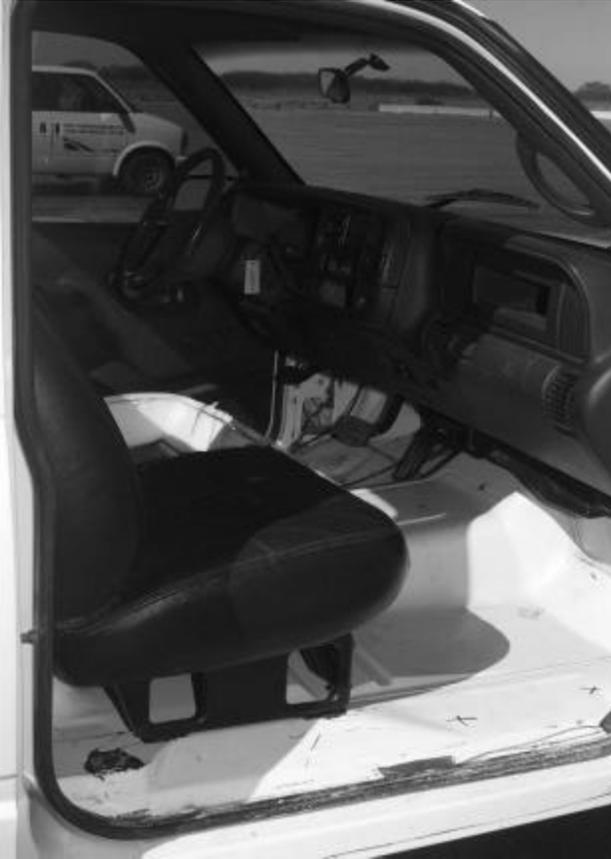
Before Test

Damage to the vehicle was restricted to the front of the vehicle, as shown in figure 16. The stabilizer bar and the left and right front of the frame were deformed. Also damaged were the front bumper, fan, and radiator. Maximum exterior crush to the vehicle was 340 mm at the center front at bumper height. No deformation of the occupant compartment occurred. Photographs of the interior of the vehicle are shown in figure 17. Exterior vehicle crush and occupant compartment measurements are shown in appendix B, tables 5 and 6.

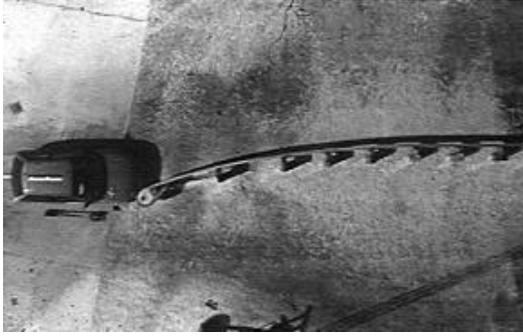
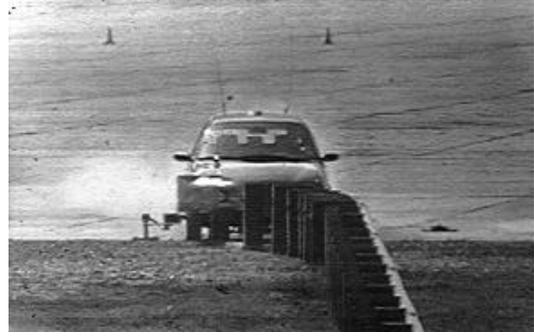
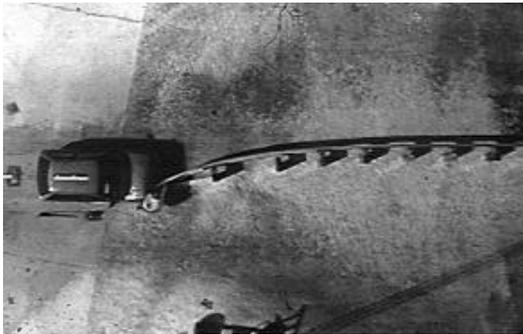
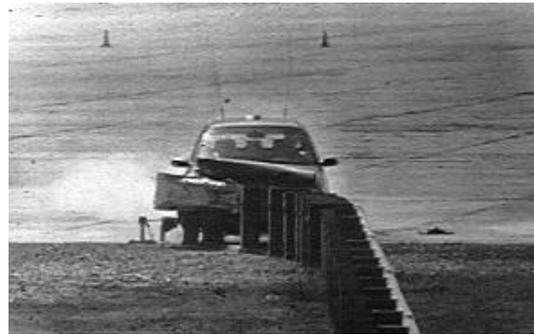
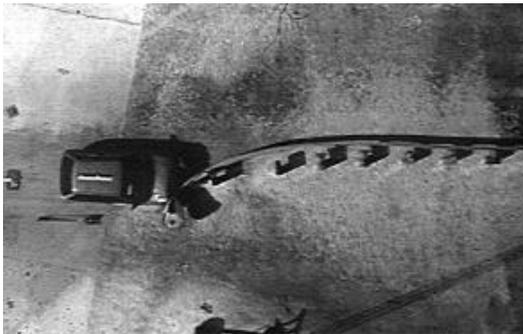
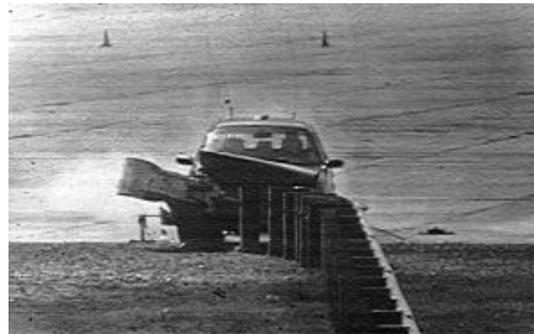
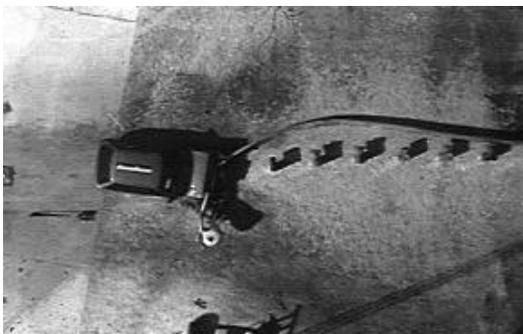
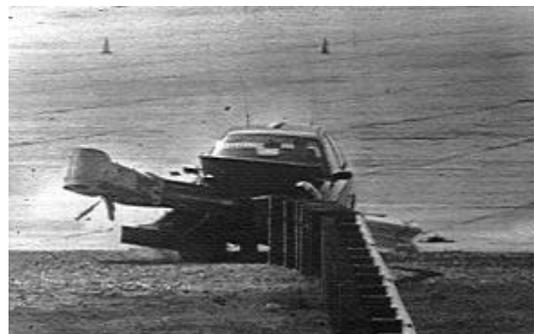
Figure 21. Sequential photographs for test 400401-1 (overhead and frontal views).

At approximately 0.027 s after impact, post 1 began to move and, at 0.030 s, the rail element at post 3 moved toward traffic lanes. The rail element moved away (toward traffic lanes) from posts 4, 2, 5, and 6 at 0.034 s, 0.041 s, 0.048 s, and 0.050 s, respectively. The vehicle began to redirect at 0.059 s. At 0.088 s, post 1 fractured at ground level and, at 0.093 s and 0.109 s, respectively, the rail element at posts 7 and 8 moved toward traffic lanes. The first elbow (at 490 mm from the beginning of the rail element) formed at 0.113 s, and the second elbow (2040 mm from the beginning of the rail element) formed at 0.115 s. At 0.142 s, post 2 began to move and, at 0.192 s, the third elbow (at 1310 mm from the center of the first rail splice) formed. Post 2 fractured at ground level at 0.195 s and post 3 began to move at 0.295 s. At 0.357 s, post 3 fractured at ground level and, at 0.411 s, the blockout at post 3 separated from the post and rail element. Post 4 moved at 0.0446 s and then fractured at ground level at 0.480 s. At 0.692 s, the third elbow contacted the lower frame rail of the vehicle, at which time the vehicle was traveling at a speed of 23.3 km/h.

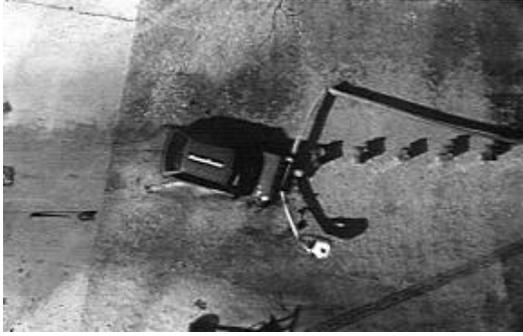
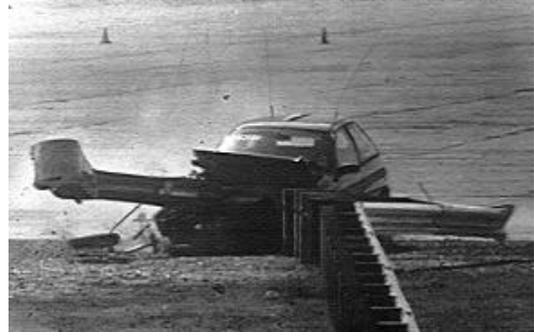
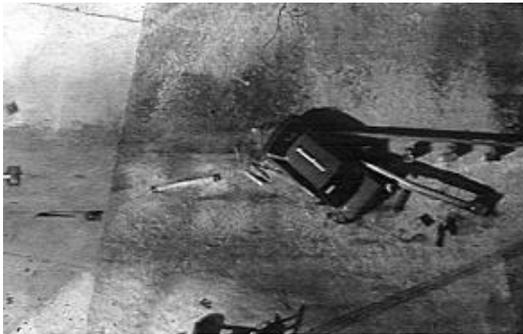
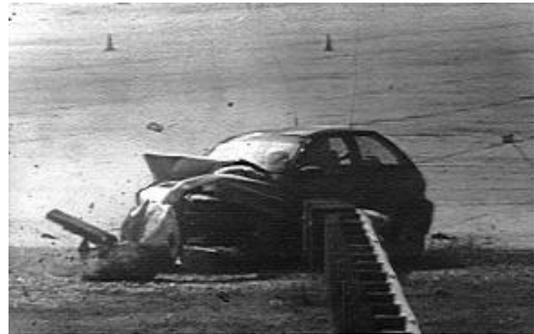
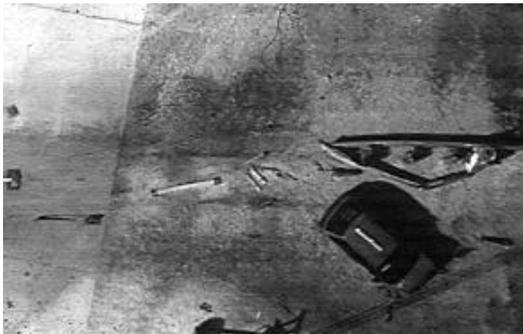
Figure 21. Sequential photographs for test 400401-1 (overhead and frontal views) (continued).

At 0.983 s, the vehicle lost contact with the rail element and was traveling at a speed of 15.5 km/h and an exit angle of 37.6 degrees clockwise to the tangent of the length of need. Brakes on the vehicle were not applied. At 2.975 s, the vehicle subsequently came to rest 4.58 m behind post 6 and 7 (7.75 m downstream of impact) and was oriented at 62.3 degrees clockwise of the tangent of the length of need. Sequential photographs of the test period are shown in appendix C, figures 21 and 22.
