Improved Load Rating Procedures for Deteriorated Unstiffened Steel Beam Ends

Prepared For:
New England Transportation Consortium
January 2024

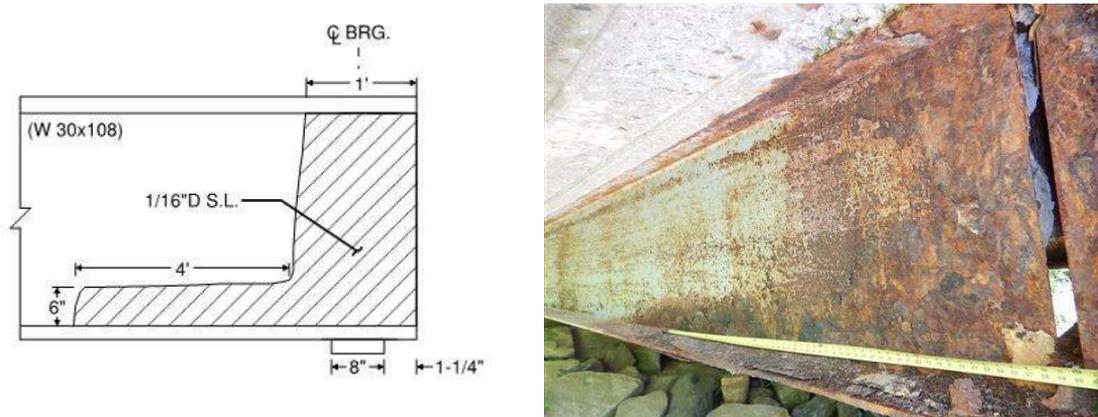
Figure 2: Sketch (Left) and Photography (Right) of corrosion damage

Much of the corrosion information gathered to meet the goals of this task was found by compiling the notes of inspection data, sketches, and the pictures. Figure 2 below depicts a corrosion scenario described by a sketch and by a photograph presented in an inspection report from the State of Connecticut.

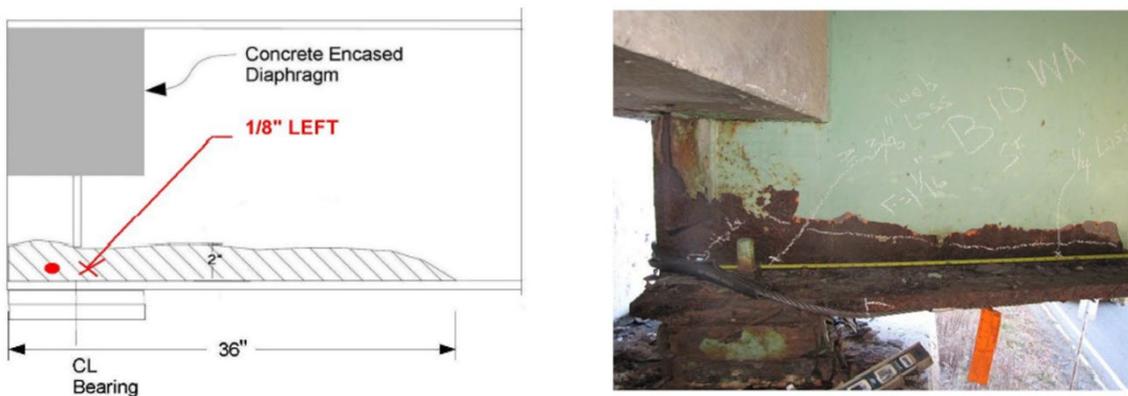
**Figure 4 : The same beam, as was described by sketch (left) and by photograph (right).
Adopted from W46010-3RY-DOT-NBI (district 5, City of Wrentham)**

The “Photos” section contains several pictures from the bridge inspection, which often include a detailed description. Additionally, the inspection notes reference the photographs often, aiming to illustrate what is being described by text. The combination of sketches, photos and inspection notes represent the major source of corrosion data. Figure 4 depicts an example of a sketch and a picture illustrating corrosion damage taken from the records of MassDOT.

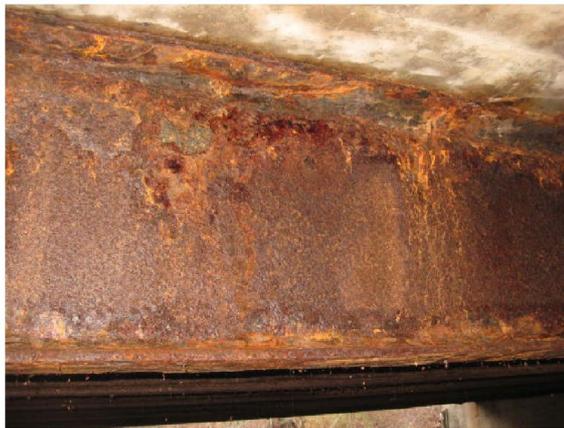
Monday, November 13, 2017
BEAM #8 ON SOUTH END
1/2" REMAINING ON
BOTTOM FLANGE EIGHT
FEET IN LENGTH LIGHT
SECTION LOSS. MRL

Figure 7: Example of corrosion damage taken from the records of a bridge from NHDOT

It is crucial to note that a “photos” section was not provided in the reports but was reported in a separate file by NHDOT. Every photograph was labeled, but they are often not referenced in the text. While photos from the inspections are provided, no sketches regarding corrosion damage are found on the photographic records. Figure 7 depicts an example of corrosion damage taken from the records of a bridge from NHDOT.

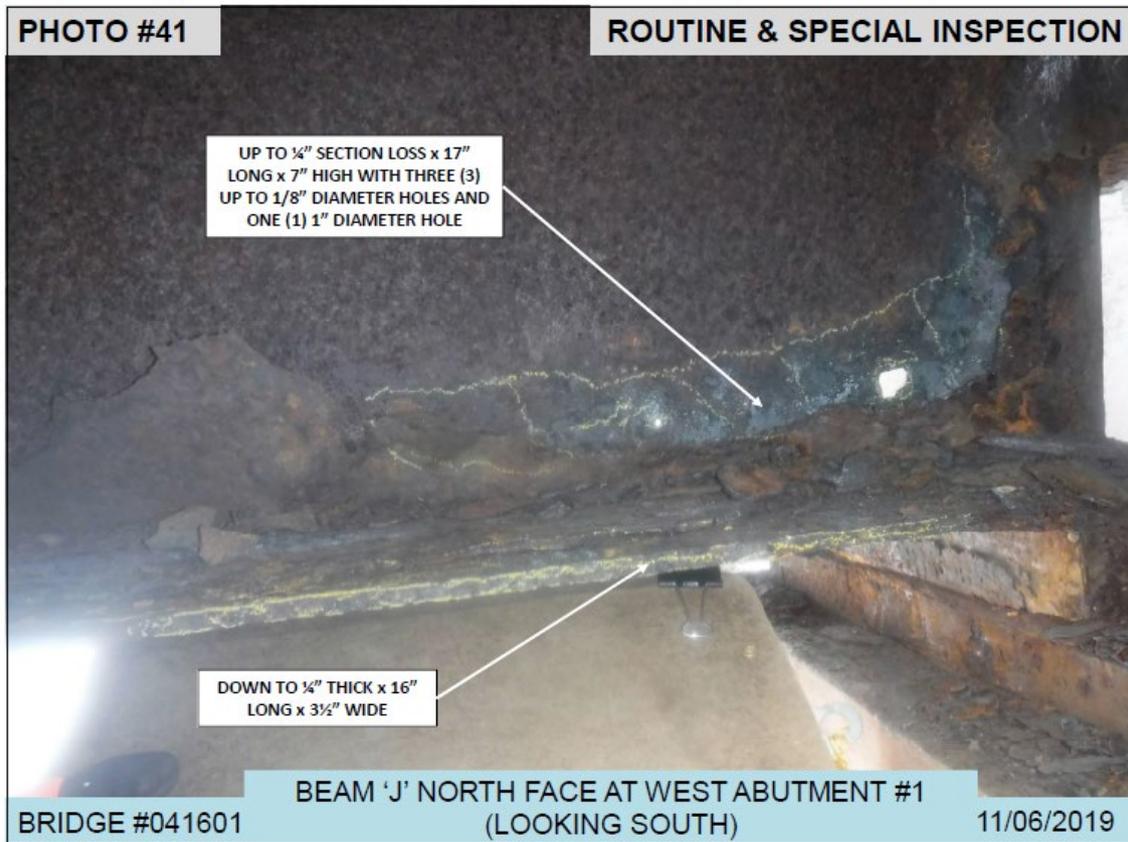
Figure 9: An example of picture provided by RIDOT

While the RIDOT reports do not present a section containing photos, all reports provided are accompanied with photographic records. The photographs are labeled with comments and measurements provided, as depicted in Figure 9. For some reports and bridges, more documentation on corrosion damage was provided. Among the outstanding documents, section loss calculations and corrosion damage sketches were provided.

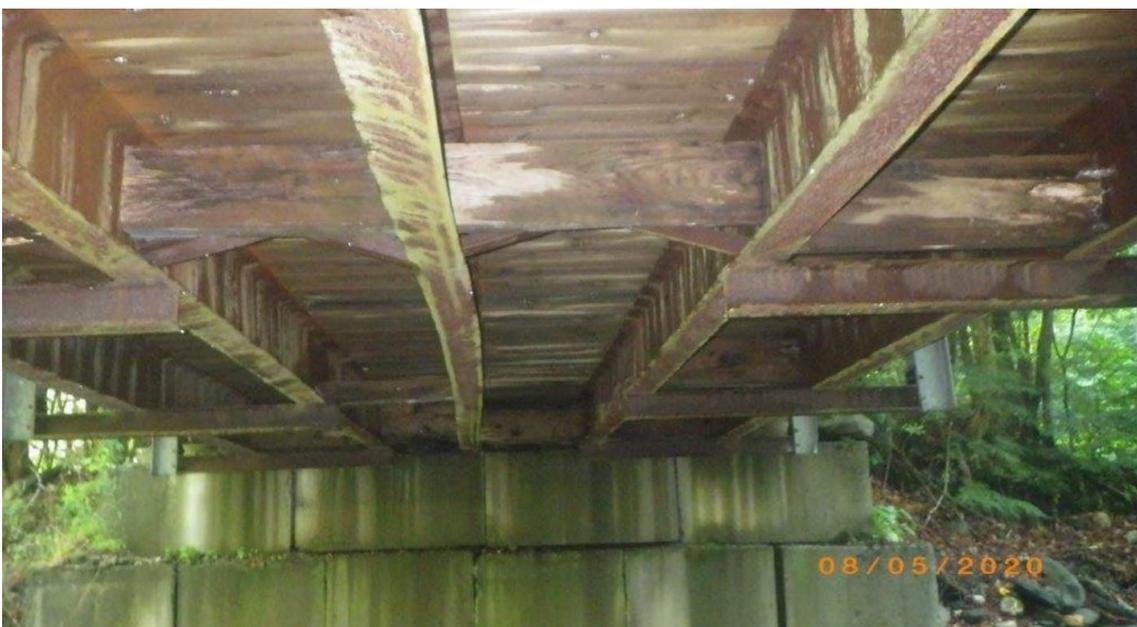
Figure 10: Example of photo of a buckled beam found in VTrans web-portal

The reports do not depict photographic records, as this type of data can be found for all bridges in the VTrans web-portal. Not all pictures are labeled, and the text does not often reference the photographs. No sketches regarding corrosion are provided along with the photographs or the inspection reports. Figure 10 depicts an example of photo which can be found in VTrans web-portal.

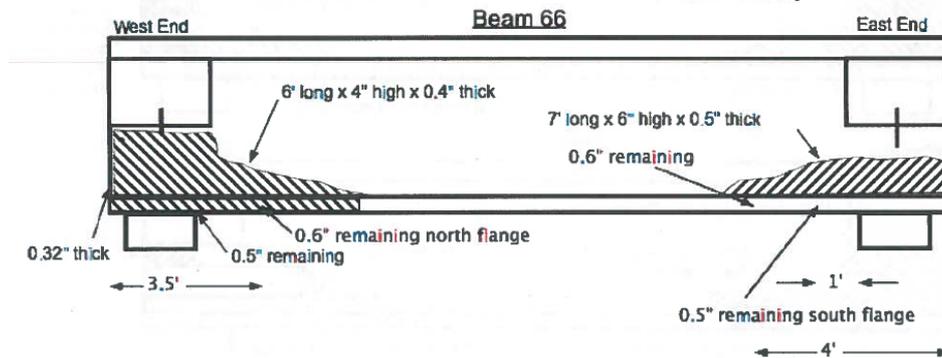
Figure 15: Typical inspection report sketch not in scale. Adapted from N19059-101-DOT-NBI (Northampton, MA)

While there is visual inspection, many reports from the Southern New England States (Group 2) provide sketches regarding corrosion information. It is important to note that many of these sketches are not to scale and are depicted in Figures 15, Figure 16 and Figure 17.

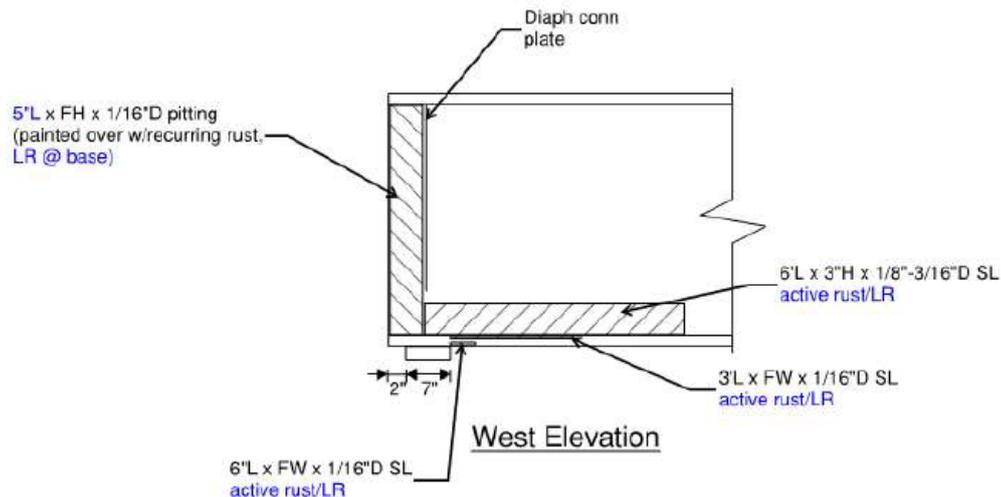
Figure 16: Typical inspection report sketch (not to scale). Adapted from Br. #00297 (Plainfield, CT)

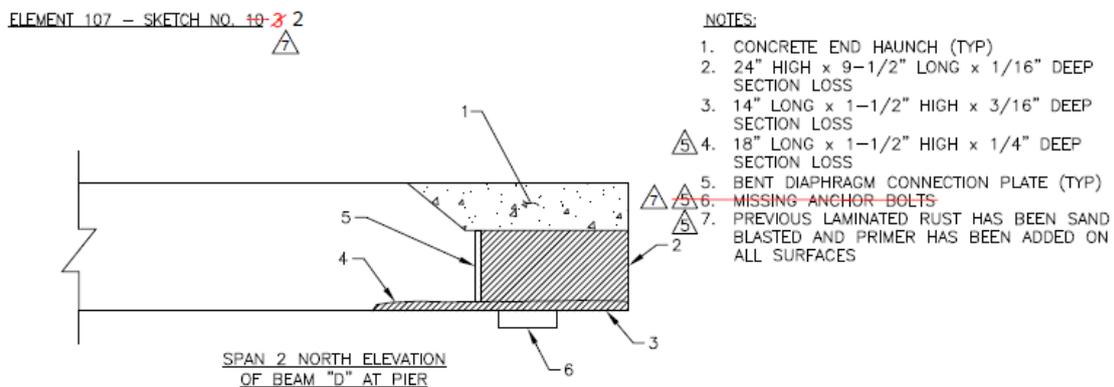
Figure 17: Typical inspection report sketch not to scale (Adapted from Br. #042501, RI)

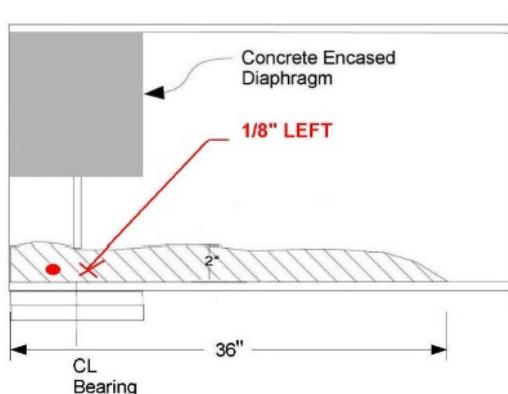
Figure 18: Corroded area described by only one thickness value. Adapted from W46010-3RY-DOT-NBI (Wrentham, MA)

The reports from all states that contain information about corrosion most often include a single data point of web thickness measurement. This is a gross simplification of the corrosion region since it is likely that web thickness will vary within a corroded region of the beam. The corrosion damage is considered uniform within the corroded region, and the given measurement is assumed to be the maximum thickness loss. The sparsity of thickness measurements is critical to note and consider here, as the average thickness of the beam is an important parameter of capacity load equations. Figure 18, Figure 19, and Figure 20 show the variation in how some of the New England States report this critical section loss parameter. The inspection reports from Massachusetts, Connecticut, and Rhode Island are where diagrams like these can be found.

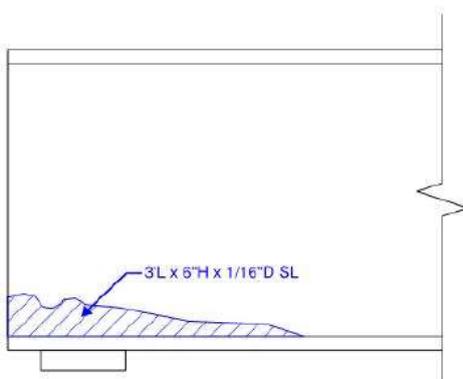
Figure 19: Corroded area described by only one thickness value. Adapted from bridge 00501 (Killingly, CT)

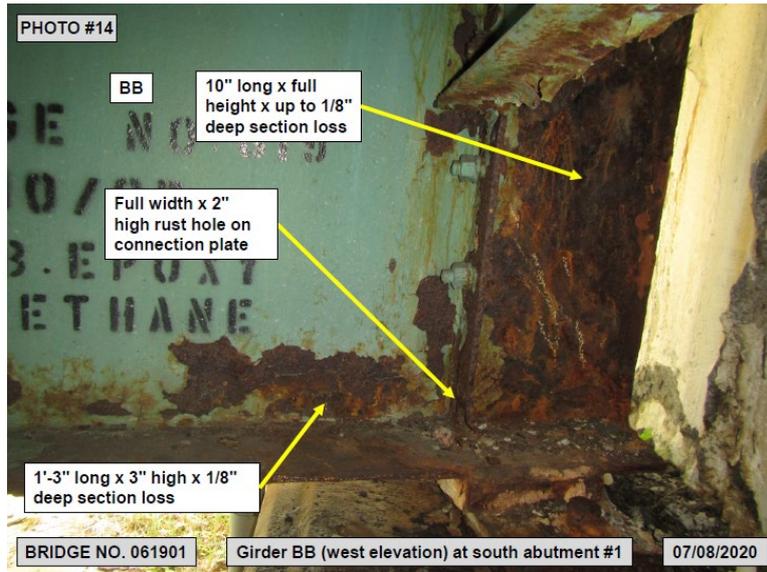
Figure 20: Corroded areas described by only one thickness value. Adapted from bridge 061901(RI)

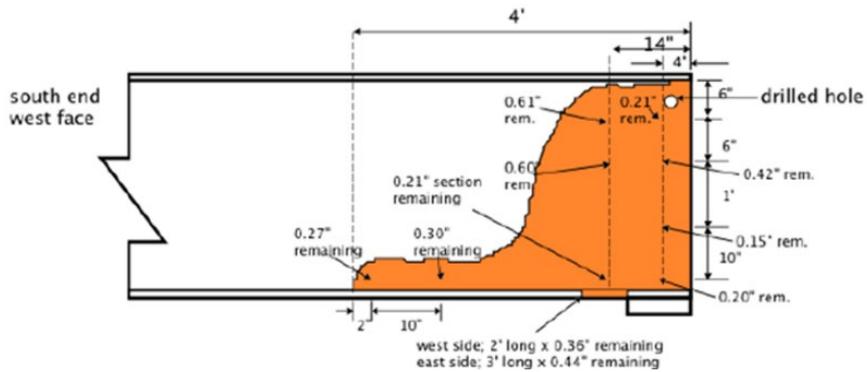
Figure 21: Corroded area described by multiple thickness loss values. Sketch adopted from H08003-18J-MUN-NBI (District 2, Town of Hardwick, MA)

There are also cases, where multiple thickness measurements are provided in an effort of the inspector to provide higher accuracy, as shown in Figure 21. It is worthwhile to note that the thickness measurement and its variation throughout the corroded region are important parameters needed when assessing the load capacity of the beams.

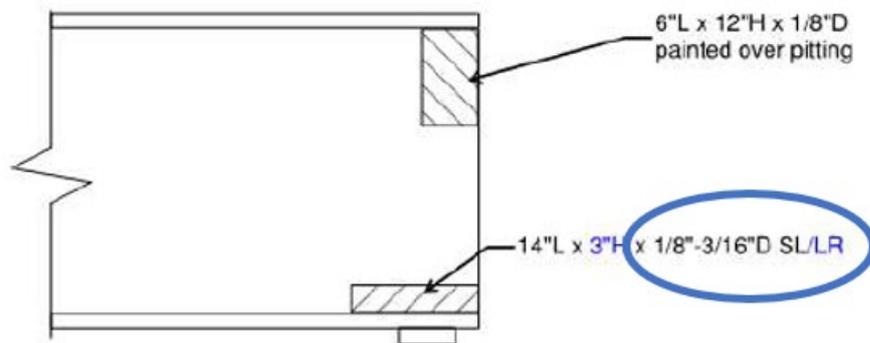
Figure 22: No indication of where the section loss occurs. Adapted from Br. #00297 (Plainfield, CT)

There are sketches that provide an interval of section loss over a particular area. While this interval is depicted in a given area, they do not often indicate where the maximum and minimum loss occurs, as depicted in Figure 22.

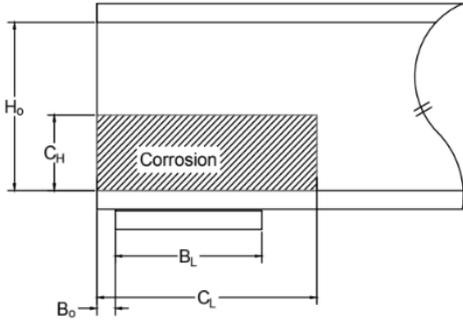
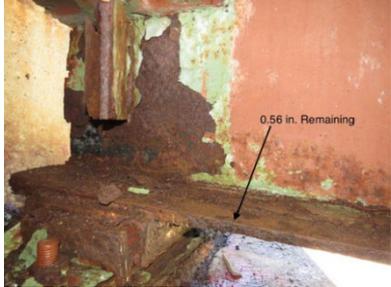
Table 3: Web corrosion pattern W1

<p data-bbox="940 1079 1433 1171">Adopted from H-23-011-1UQ-DOT-NBI (District 3, Town of Hopkinton)</p>
	<p data-bbox="384 1211 1437 1391">Short description: W1 is a rectangular shape corrosion pattern which appears at the beam end above the bearing. The dimensions of the damaged area are C_H for the depth of the damaged area and C_L for the length. B_L is the bearing width and B_o is the length of the free end of the beam beyond the bearing. The photograph on the right shows a case of W1 for which the C_H is equal to the depth of the beam web H_o.</p>

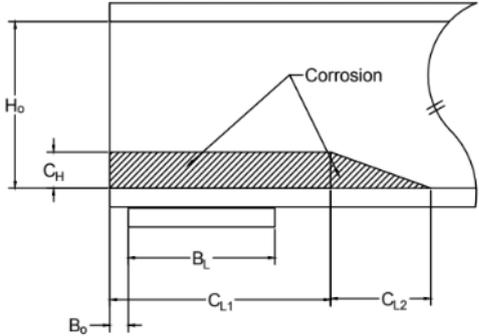
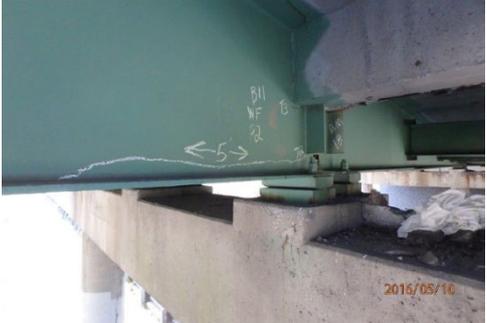
Table 4: Web corrosion pattern W2

<p data-bbox="930 741 1417 831">Adopted from N-06-015-3WR-DOT-NBI (District 5, Town of New Bedford)</p>
<p>Short description: W2 is similar to W1 with the addition of a triangular shaped corrosion area at the end of the rectangular shape. For W2, C_H is the depth of the damaged area, while C_{L1} is the length of the rectangular part of the corrosion. C_{L2} is the length of the triangular damage. B_L is the bearing width and B_0 is the length of the free end of the beam beyond the bearing. The photograph on the right shows a typical case of W2.</p>

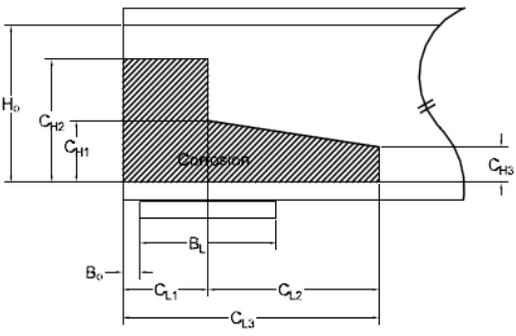
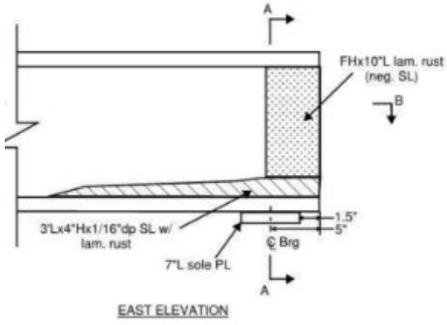
Table 5: Web corrosion pattern W3

<p data-bbox="930 1682 1417 1809">Adapted from Bridge 00162, Girder G1, Span 2, Pier 2 West Haven, Connecticut</p>
<p>Short description: W3 is a more complex shape than W1 and W2. It can be described by the three areas as shown at the sketch above (left). For W3, the depth of the corroded area is described using C_{H1}, C_{H2} and C_{H3}. Similarly, C_{L1} and C_{L2} are used to provide the length of the corroded area. B_L is the bearing width and B_0 is the length of the free end of the beam beyond the bearing. The photograph on the right shows a typical case of W3.</p>

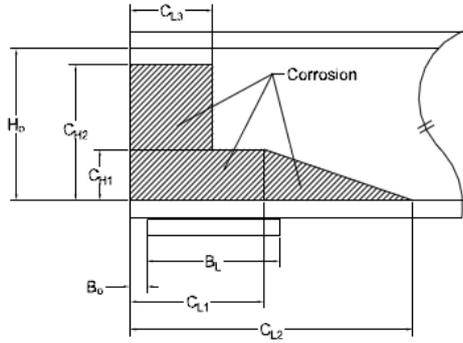
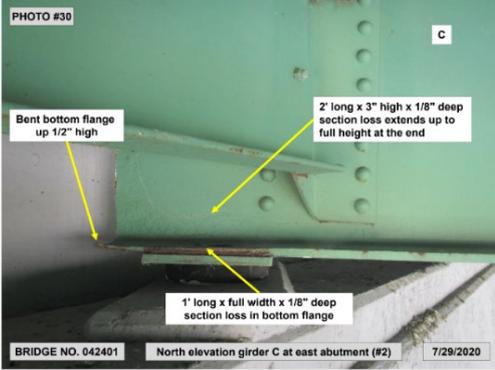
Table 6: Web corrosion pattern W4

<p>Adapted from Bridge 042401, Girder C, Abutment 2 New London Ave, Rhode Island</p>
<p>Short description: W4 is a slight modification of W3 to include the bottom left rectangular shape. The depth of the corroded area is described using C_{H1} and C_{H2}. Similarly, C_{L1}, C_{L2} and C_{L3} are used to provide the length of the corroded area. B_L is the bearing width and B_0 is the length of the free end of the beam beyond the bearing. The photograph on the right shows a typical case of W4.</p>

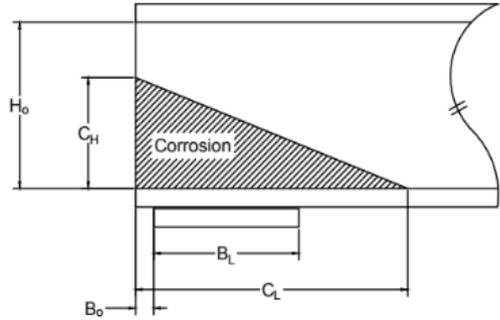
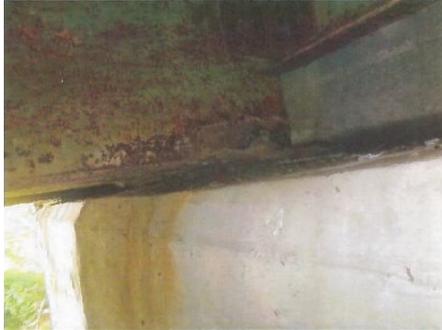
Table 7: Web corrosion pattern W5

<p>Adapted from W-05-024-0T4-MUN-NBI (District 2, Town of Ware)</p>
<p>Short description: W5 is a simple triangular shape corroded area described by C_H which is the height of the triangle and C_L which is the length of the triangle. B_L is the bearing</p>

width and B_o is the length of the free end of the beam beyond the bearing. The photograph on the right shows a typical case of W5.

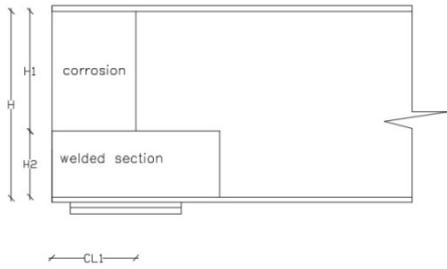
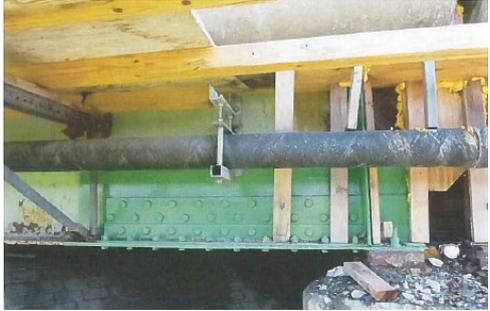
Table 8: Web corrosion pattern W6.

<p>Adapted from N-19-064-10C-DOT-NBI (District 2, City of Northampton, Massachusetts)</p>
	<p>Short description: W6 is a rare case but it is included here for the sake of completeness. It involves a plate at the bottom side of the web. The corrosion extends above the repaired section as shown in the graph above (left). For this case, H_1 is the height of the corroded area, C_{L1} is the length of the corroded area, and H_2 is the height of the repair plate. The photograph on the right shows a typical case of W6.</p>

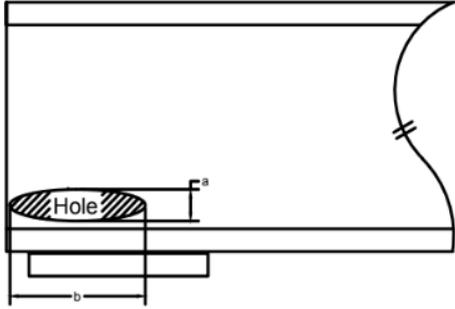
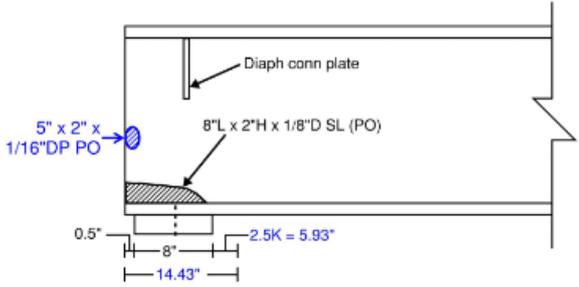
Table 9: Web hole pattern M1

<p style="text-align: center;">G2 WEST ELEVATION</p> <p style="text-align: center;">Adapted from Bridge 00636, Girder 2, Span 2, Pier 2 Middletown, Connecticut</p>
<p>Short description: M1 is a case where a hole appears at the lower part of the web and extends longitudinally over the bearing. For this case, a is the height of the hole and b is the length of the hole. The photograph on the right shows a typical case of M1.</p>

Much like the web corrosion patterns, no new web hole corrosion patterns were created as the existing patterns described more than 95% of the beam ends. Table 9 through Table 12 depict the web hole corrosion patterns considered. These tables provide a label for the pattern, a diagram, a real inspection report example, and a brief description.

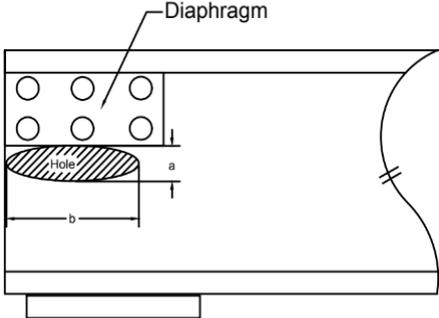
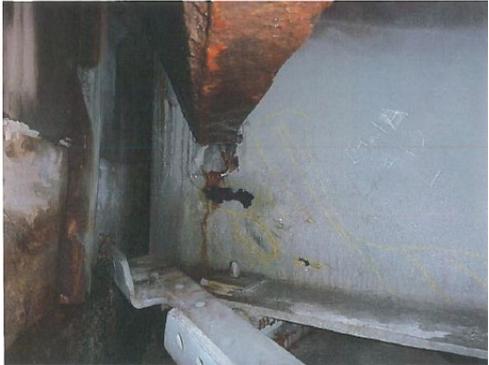
Table 10: Web hole pattern M2

<p style="text-align: center;">Adapted from S-24-017-14K-DOT-634 (District 2, City of Springfield, Massachusetts)</p>
<p>Short description: M2 is a case where the beams have a diaphragm and the hole appears just below the diaphragm. For this case, a is the height of the hole and b is the length of the hole. The photograph on the right shows a typical case of M2.</p>

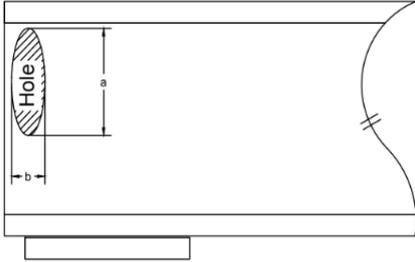
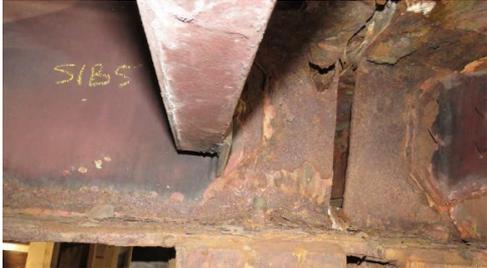
Table 11: Web hole pattern M3

<p>Adapted from F-04-017-23N-DOT-634 (District 3, City of Fitchburg, Massachusetts)</p>
<p>Short description: M3 is a case where a hole appears at the top part of the beam. For this case, a is the height of the hole and b is the length of the hole. The photograph on the right shows a typical case of M3.</p>

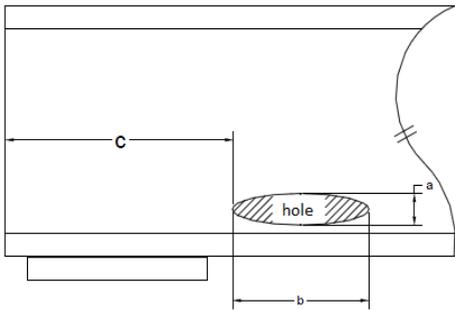
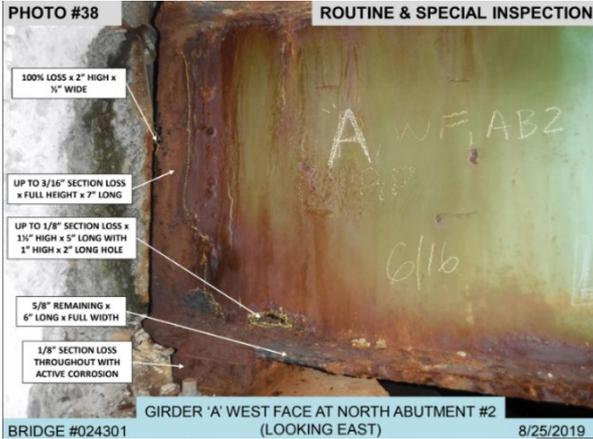
Table 12: Web hole pattern M4

<p>Adapted from Bridge 024301, Girder A West Face, North Abutment 2 Lafayette RR, Rhode Island</p> <p>Short description: M4 is a case where a hole appears away from the bearing at the lower part of the beam. For this case, a is the height of the hole, b is the length of the hole, and c is the distance of the end of the hole from the end of the beam. The photograph on the right shows a typical case of M4.</p>

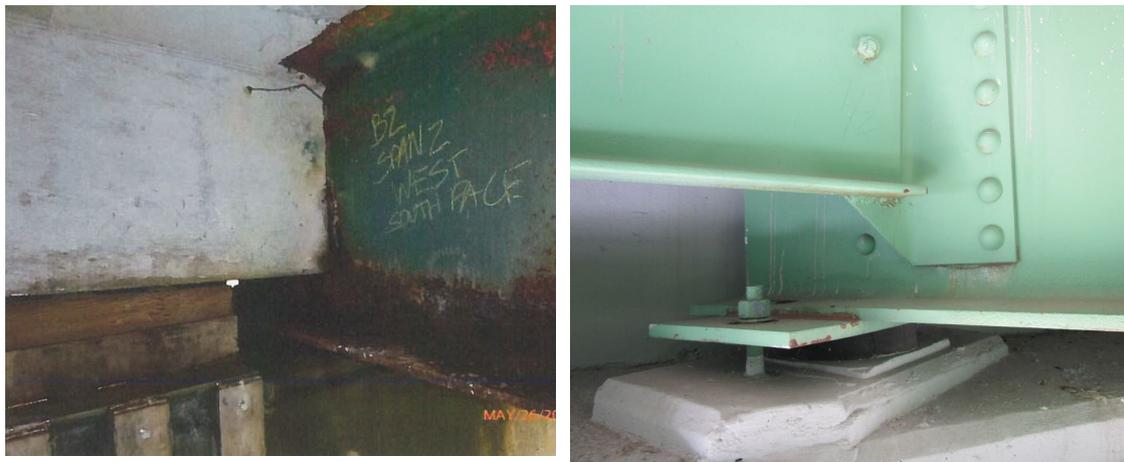
Figure 26: To the left is P-01-005 (Massachusetts) and the right structure is 042401 (Rhode Island)

Additionally, with the division of results by states, the results were further divided into two categories; to address structures that had diaphragms and structures that did not. It is imperative to distinguish that a structure was considered to have “diaphragms” for either concrete diaphragms or for cases in which the connection plate of the metallic diaphragm occupied a significant area of the web, as depicted in Figure 26.

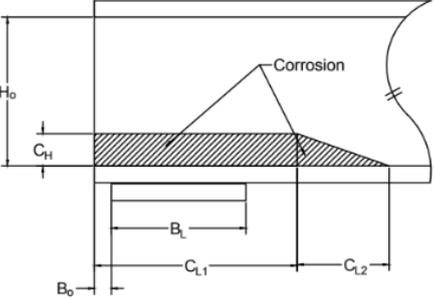
Table 17: Final corrosion patterns for W1 and W2 without holes (beam ends without a diaphragm) - CTDOT

Based on the 317 appearances of W1 and W2 without a diaphragm system, our team was able to determine the most common cases regarding web and flange corrosion for both patterns and the most common interaction between the parameters of a pattern. Table 17, Table 18, and Table 19 depict the most common trends observed in the compiled data. The graphs which allowed the team to observe these behaviors are found in the Appendices of this report.

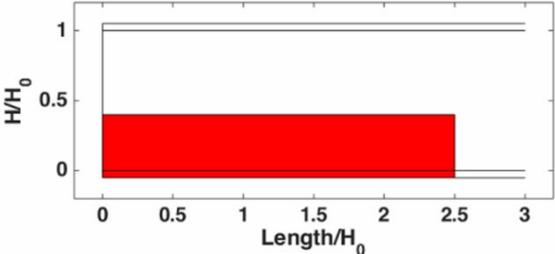
Description	Pattern W1
<p>Case A</p> $0 < CH_1 < 0.4H_0, 0 < CL_1 < 2.5H_0$ $0 < \frac{t_{loss}}{t_{web}} \leq 0.4$ $1 \leq \frac{C_f}{C_l} \leq 3, \text{ with } 0.1 \leq \frac{t_{loss}}{t_{flange}} \leq 0.7$

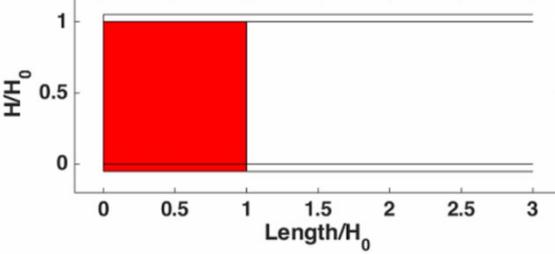
<p>Case B</p> $0 < CH_1 < 1H_0, 0 < CL_1 < 1H_0$ $0 < \frac{t_{loss}}{t_{web}} \leq 0.4$ $1 \leq \frac{C_f}{C_l} \leq 2.5, \text{ with}$ $\frac{t_{loss}}{t_{flange}} \text{ taking values of } 0.2, 0.4, 0.6, 1$

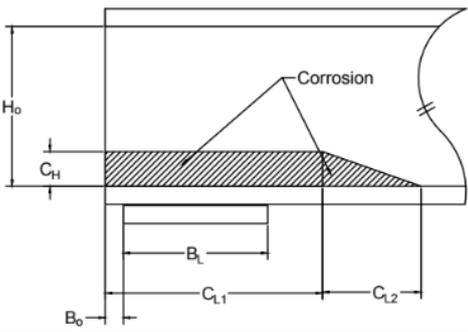
Table 20: Final corrosion patterns for W1 and W2 without holes (beam ends with a diaphragm) - CTDOT

From the results, it was observed that beam ends with a diaphragm have two main trends. It was found that in both cases, CL2 is equal to 0. Additionally, the corrosion height was found either to be the full height or up to 40% of H0, as depicted in Table 20.

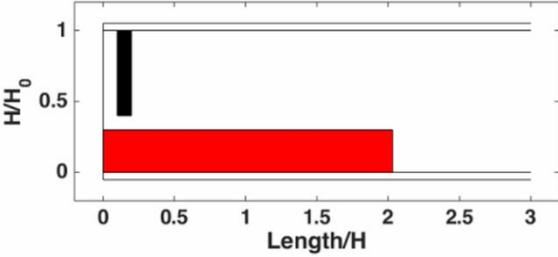
<p>Description</p> <p>Case A (Report 01807, CT, Span 1, G4, Pier 1) $0.1H_0 < CH_1 < 0.3H_0, 0 < CL_1 < 2.5H_0$ $0 < \frac{t_{loss}}{t_{web}} \leq 0.3$ $1 \leq \frac{c_f}{c_l} \leq 3, \text{ with } 0.1 \leq \frac{t_{loss}}{t_{flange}} \leq 0.4$</p>	<p>Pattern W1</p>

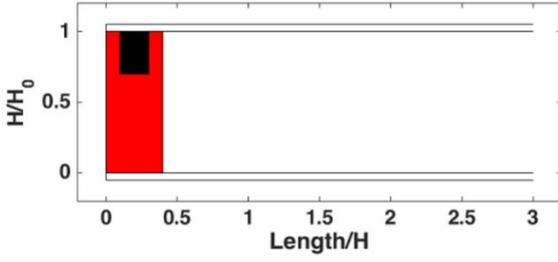
<p>Case B (01732, CT, Span 3, G6, Pier 2) $0 < CH_1 < 1H_0, 0.2H_0 < CL_1 < 0.4H_0$ $0.2 \leq \frac{t_{loss}}{t_{web}} \leq 0.4$ $0 < \frac{c_f}{c_l} \leq 1, \text{ with}$ $\frac{t_{loss}}{t_{flange}}$ takes values of 0.2, 0.4</p>

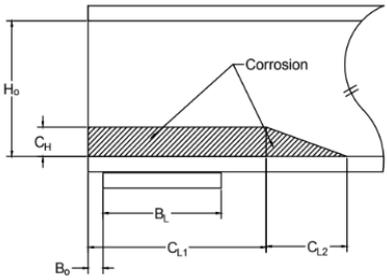
Table 27: Final corrosion patterns for W1 and W2 without holes (beam ends without a diaphragm) - MassDOT

Description	W1 and W2 pattern
<p>Helpful sketch</p>

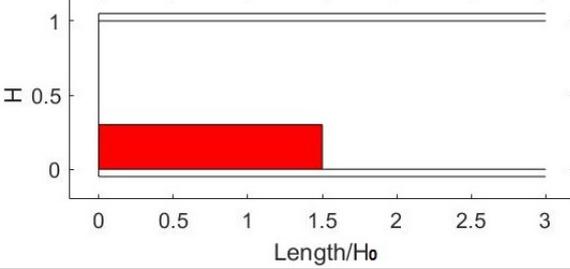
<p>Case A: $0 < CH_1 \leq 0.3H_o$, $0 < CL_1 \leq 1.5H_o$ and $\frac{t_{loss}}{t_{web}}$ takes values of {0.2, 0.4, 0.6, 0.8} $1 \leq \frac{C_f}{C_l} \leq 2$, with $\frac{t_{loss}}{t_{flange}}$ taking values of {0.2, 0.4, 0.6, 0.8}</p>

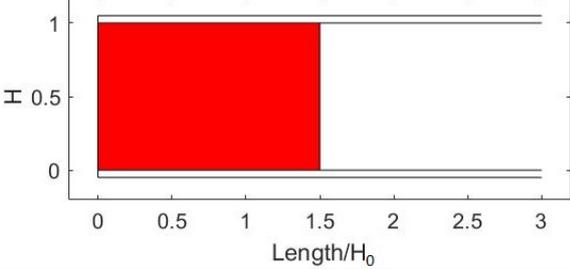
<p>Case B: $CH_1 = H_o$, $0 < CL_1 \leq 1.5H_o$ and $\frac{t_{loss}}{t_{web}}$ takes values of {0.2, 0.8} $1 \leq \frac{C_f}{C_l} \leq 2$, with $\frac{t_{loss}}{t_{flange}}$ taking values of {0.45, 0.65}</p>

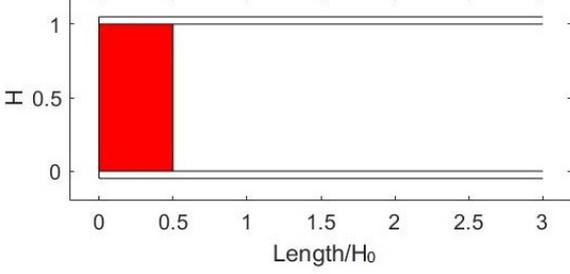
<p>Case C: $CH_1 = H_o$, $0 < CL_1 \leq 0.5H_o$ and $\frac{t_{loss}}{t_{web}}$ takes values {0.2, 0.8} $1 \leq \frac{C_f}{C_l} \leq 2$, with $\frac{t_{loss}}{t_{flange}}$ taking values of {0.45, 0.65}</p>

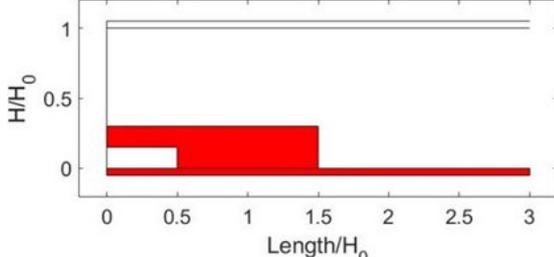
Table 28: Final corrosion patterns for W1 and W2 with holes (beam ends without a diaphragm) - MassDOT

<p data-bbox="240 813 707 880">The extreme scenario is projected on the W1 and W2 Case C:</p> <p data-bbox="240 880 746 947">The extreme hole scenario was found on W2, with $a=0.15$ and $b=0.5$.</p>

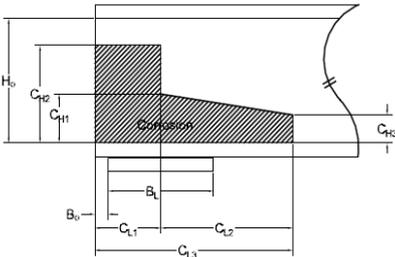
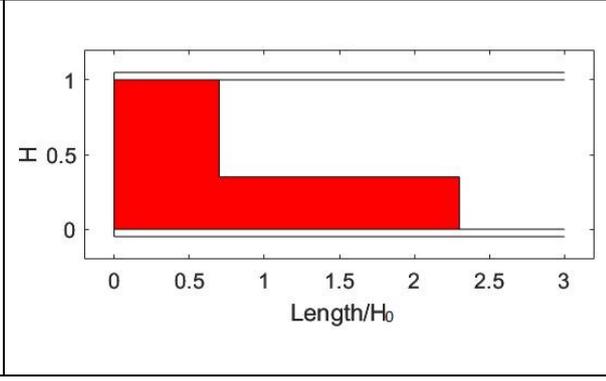
Table 29: Final corrosion patterns for W3 and W4 without holes (beam ends without a diaphragm) - MassDOT

The extreme scenario is:
 $0 < CH_1 \leq 0.35H_o$, $0 < CH_3 \leq 0.35H_o$
 $0.05H_o < CL_1 \leq 0.7H_o$, $0.5H_o < CL_3 \leq 2.3H_o$
 $\frac{t_{loss}}{t_{web}}$ taking values of {0.1,0.2,0.3,0.4,0.5,0.6,0.7,0.8}
 $\frac{C_f}{C_{L3}} = 1$, with
 $\frac{t_{loss}}{t_{flange}}$ taking values of {0.4, 0.6, 0.8}

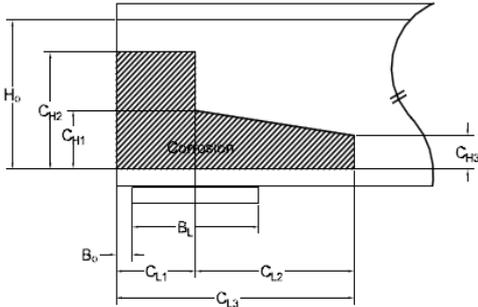
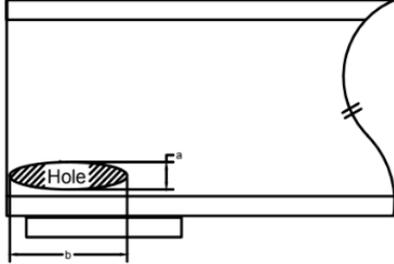
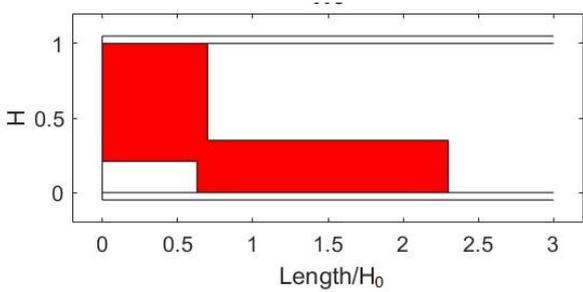
Table 30: Final corrosion patterns for W3 and W4 with holes (beam ends without a diaphragm) - MassDOT

<p>The extreme scenario is: Holes seem to be mainly thin and long across the web, with the extreme case $a=0.21H_0$ and $b=0.63H_0$.</p>

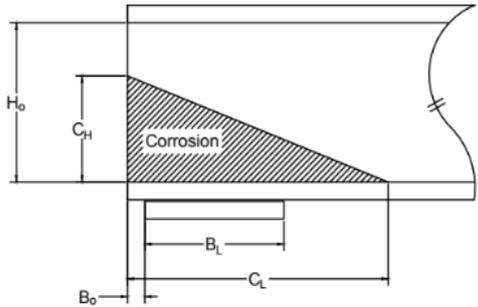
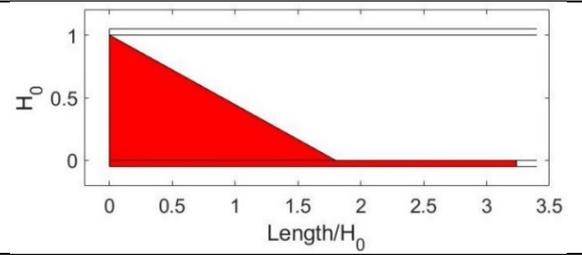
Table 31: Final corrosion patterns for W5 without holes (beam ends without a diaphragm) - MassDOT

The extreme scenario is:

$$0.15H_o \leq CH_1 \leq 1H_o, \quad 0 < CL_1 \leq 0.35H_o$$

1.8, with

$$\frac{t_{loss}}{t_{flange}} \text{ taking values of } \{0.1, 0.8\}$$

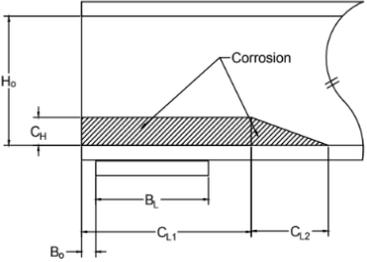
Table 32: Final corrosion patterns for W1 and W2 without holes (beam ends with a diaphragm) - MassDOT

Description	W1 and W2 pattern
<p>Helpful sketch</p>

Case A is the first extreme corrosion scenario in the web and flange, with full height corrosion and length up to 35% of H_0 . The corroded area is often located before the diaphragm, which is illustrated with black in the figures of this report. Case B is the second extreme corrosion scenario in the web and flange. The corroded area extends longitudinally in the web above the flange. Case C is the third extreme corrosion scenario in the web and flange.

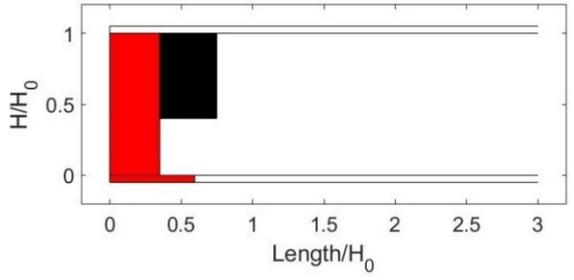
<p>Case A: $0 < CL_1 \leq 0.35H_0$, $\frac{t_{loss}}{t_{web}}$ taking values of {0.2,0.4,0.6,0.8} Flange: $0.15 < \frac{t_{loss}}{t_{flange}} \leq 0.45$, $1 \leq \frac{Cf}{Cl} \leq 1.7$</p>

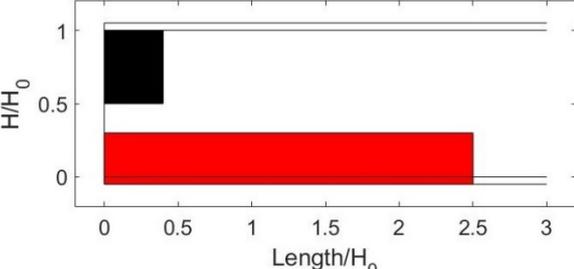
<p>Case B: $0 < CL_1 \leq 2.5H_0$, $\frac{t_{loss}}{t_{web}}$ taking values of {0.2,0.4,0.6,0.8} Flange: $0 \leq \frac{Cf}{Cl} \leq 1$, $\frac{t_{loss}}{t_{flange}}$ taking values of {0.2,0.4,0.6,0.8}</p>

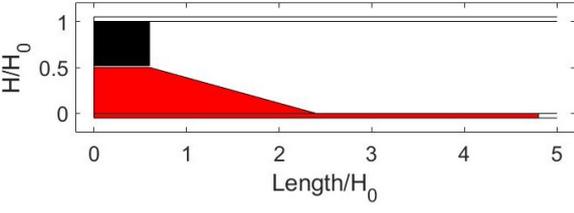
<p>Case C: $0 < CH_1 \leq 0.5H_0$, $0 < CL_1 \leq 0.6H_0$ $0 < CL_2 \leq 1.8H_0$, $\frac{t_{loss}}{t_{web}}$ taking values of {0.2,0.4,0.6,0.8} $1 < \frac{Cf}{Cl} \leq 2$, $\frac{t_{loss}}{t_{flange}}$ taking values of {0.2,0.4,0.6,0.8}</p>

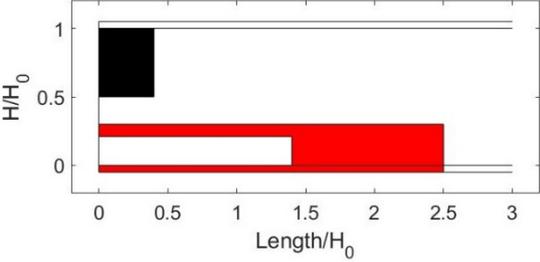
Table 33: Final corrosion patterns for W1 and W2 with holes (beam ends with a diaphragm) - MassDOT

<p data-bbox="240 719 783 887">M1 holes were equally distributed between web corrosion scenarios CASE A and CASE B, with maximum length $1.4H_0$ and height $0.21H_0$. M2 mainly appeared in the third scenario.</p>

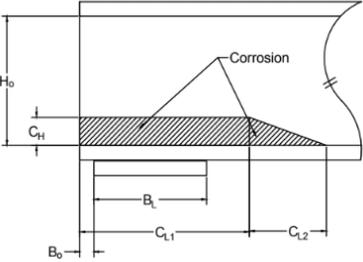
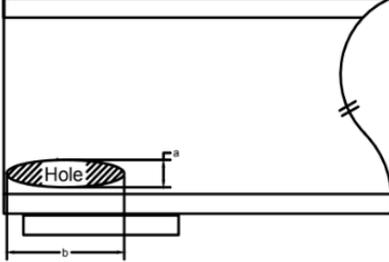
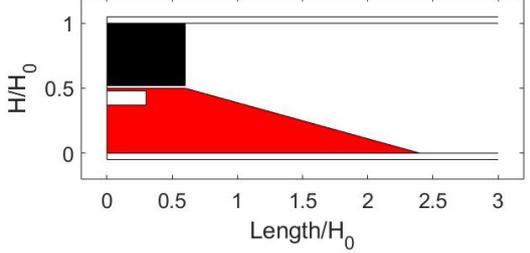
Table 34: Final corrosion patterns for W1 and W2 with holes (beam ends with a diaphragm) - MassDOT

<p data-bbox="240 1715 778 1850">M2 hole pattern projected on the extreme third web corrosion pattern. With black color the diaphragm is illustrated in a possible configuration, with $a \leq 0.11$, and $b \leq 0.3$.</p>

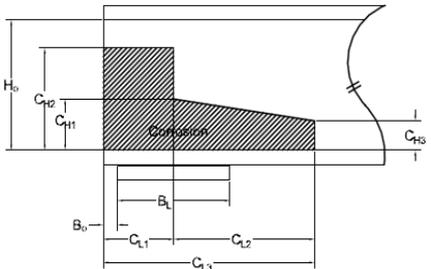
Table 35: Final corrosion patterns for W3 and W4 without holes (beam ends with a diaphragm) - MassDOT

As discussed earlier in the report, W3 and W4 were merged for analysis. However, in this case, both patterns were examined separately, and three extreme scenarios were identified. It was noticed that extreme scenarios of W3 are the most critical. Following this, two main trends were found: a) full height corrosion, or b) corrosion up to 30% of H_0 .

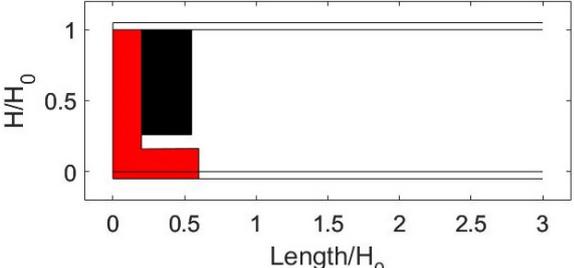
<p>Case A: $0.25H_0 < CL_3 \leq 0.6H_0$, $0.1H_0 < CL_1 \leq 0.2H_0$ $0.06H_0 < CH_1 = CH_3 \leq 0.16H_0$, $\frac{t_{loss}}{t_{web}}$ takes values of {0.4,0.6} $\frac{Cf}{Cl} = 1.2$ and $\frac{t_{loss}}{t_{flange}}$ takes values of {0.3, 0.6}</p>

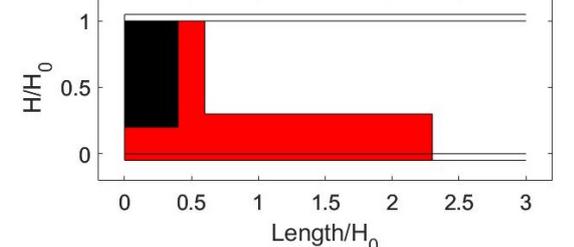
<p>Case B: $0.6H_0 < CL_3 \leq 2.3H_0$, $0.2 < CL_1 \leq 0.6H_0$ $0.05 < CH_1 = CH_3 \leq 0.30H_0$, $\frac{t_{loss}}{t_{web}}$ takes values of {0.4,0.6,0.8}, $\frac{Cf}{Cl} = 1$ and, $\frac{t_{loss}}{t_{flange}}$ takes the value of {0.65}</p>

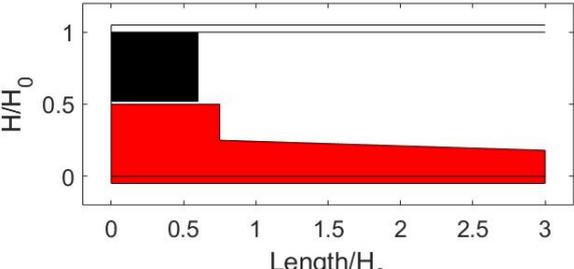
<p>Case C: $0.5H_0 < CL_3 \leq 3H_0$, $0.1H_0 < CL_1 \leq 0.75H_0$ $0.05H_0 < CH_1 \leq 0.25H_0$, $0.05H_0 < CH_3 \leq 0.18H_0$, $\frac{t_{loss}}{t_{web}}$ takes values of {0.4,0.6,0.8} $\frac{Cf}{Cl} = 1$ and $\frac{t_{loss}}{t_{flange}}$ takes values of {0.3, 0.6, 0.8}</p>

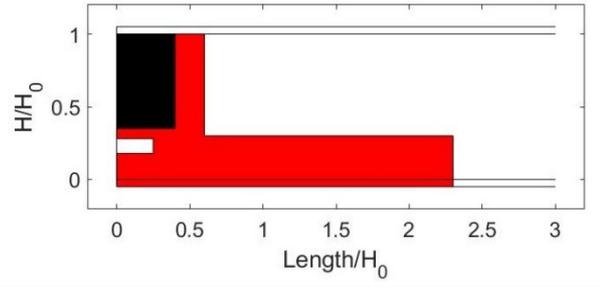
Table 37: Final corrosion patterns for W3 and W4 with holes (beam ends with a diaphragm) - MassDOT

M2 holes were examined together for both patterns W3 and W4 because there were found only 7 times. The extreme hole scenario with $a \leq 0.1$ and $b \leq 0.25$ is projected on the Case B extreme web corrosion scenario.

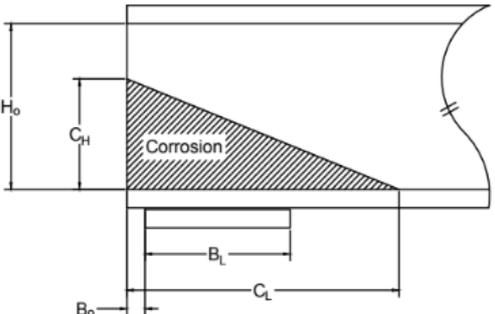
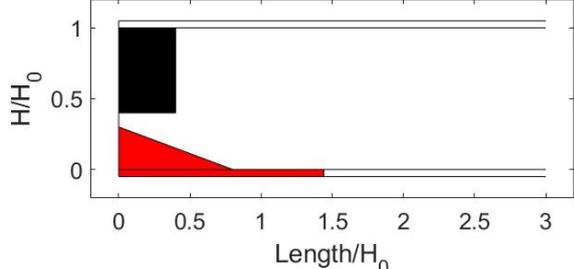
Table 38: Final corrosion patterns for W5 with holes (beam ends with a diaphragm) - MassDOT

<p>$0.3H_0 \leq CL_1 \leq 0.85H_0$, $0.15H_0 < CH_1 \leq 0.30H_0$</p> <p>$\frac{t_{loss}}{t_{web}}$ takes the value {0.35}</p> <p>$\frac{t_{loss}}{t_{flange}}$ takes the values {0.3,0.6,0.8} with C_f taking the values of {1, 1.6}</p> <p>C_l</p>

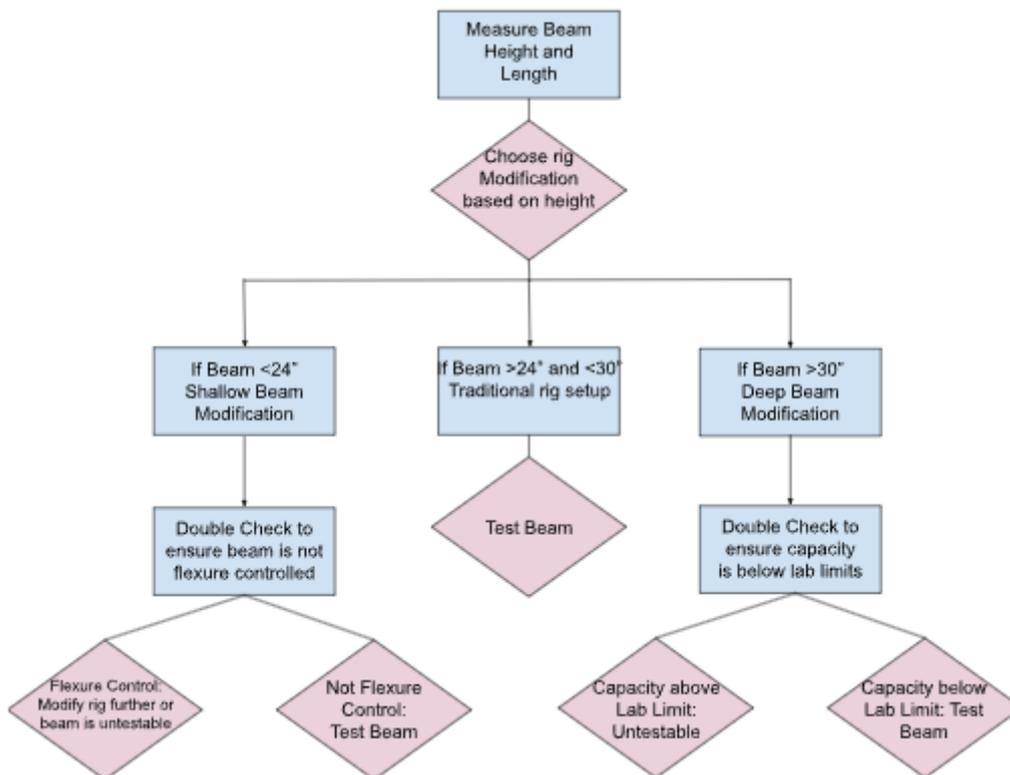
Figure 38. Structural Rig Flow Chart

Once delivered to the university, the research team took measurements to compare to the documentation provided by the states. This was a check performed as there are instances where the beams on a bridge structure do not match the as-built drawing callouts. Additionally, these initial measurements were important for selecting the correct arrangement of the structural testing rig. The outline of this process can be found in the flowchart in Figure 38 below.

The outcome of the flow chart above would determine if the original structural testing rig needed modification. The original rig components were designed for the corroded beam

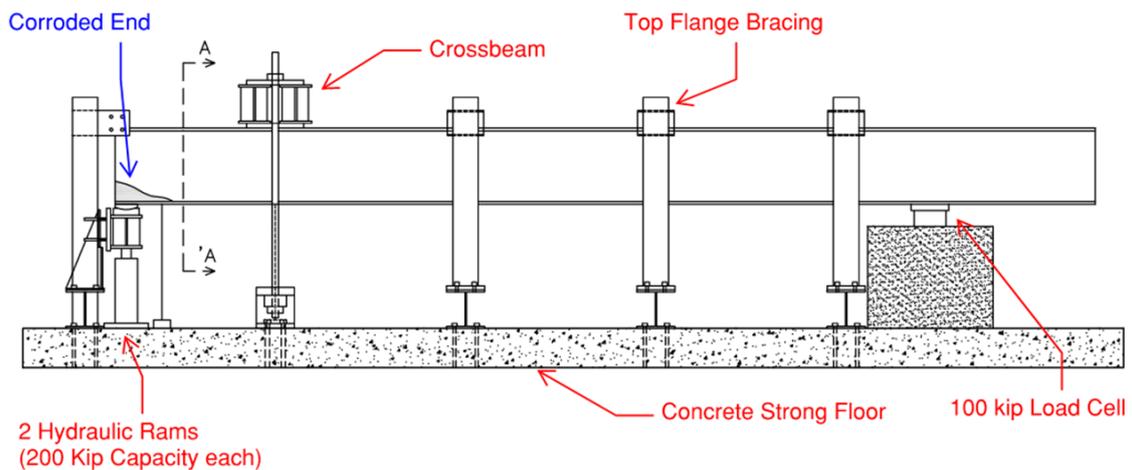
Figure 39. Structural Rig

ends project conducted by Tzortzinis in [28]. In this project, the corroded specimens were loaded from the top of the beam specimen [28]. This rig was then modified which allowed for a higher loading to be applied via direct loading/shear application. Corroded beams specimens are loaded from the bottom at the corroded end. This is to ensure that a shear failure mode and the true capacity of the end is reached and that undesirable failure modes, such as flexure, are avoided. Additionally, there are C-channels which were welded to threaded rods connected to W12x40s which stand vertically along the length of the beam. These C-channels have an attached low friction plastic attached to the outside of their webs. Ultimately, these channels face the beam with the plastic almost touching the edge of the top flange. This is to ensure bracing to prevent lateral torsional buckling modes and the beam from dangerously falling out of the testing rig while also allowing for ease of vertical movement for the beam specimen. The back support was a steel plate that rested on the 100 kip load cell. Both the crossbeam and the corroded end were grouted on the flange, this was to ensure continuity in the loading process and a flat, leveled loading surface as to not introduce eccentricity. A key component that was utilized in the first two experiments was a roller support under the corroded end, courtesy of MassDOT. For the modifications made for the larger beam specimens from Maine (experiments three through twelve), the roller had to be removed. The corroded end in experiments three through twelve sat directly on the load beam above the hydraulic rams. The hydraulic rams had caps that allowed for movement to mimic a roller when the MassDOT roller was not utilized. Below the beam specimen, two linear string potentiometers were used for displacement measuring in the loading process, one located close to the area of loading, and one located below the crossbeam. A rack of six linear rod potentiometers was also utilized in the experiments. This rack was placed so the potentiometers could measure the out of plane web displacement along the height of the web throughout the loading process until buckling occurred. The base rig used for this project is shown below in Figure 39 and Figure 40.

The load beam above the hydraulic rams is a W10x77 with 4-1/2"x1/2" stiffener plates. The crossbeam is composed of two W12x58 with three 12"x18"x1-1/2" plates on the top and bottom and 4"x 1/4" plates used for stiffeners. There are two threaded rods connecting the crossbeam to anchor blocks in the strong floor. The anchor blocks are composed of a 16"x12"x2-1/2" top plate, a 16"x12"x1-1/2" bottom plate, 1-1/2" thick side plates.

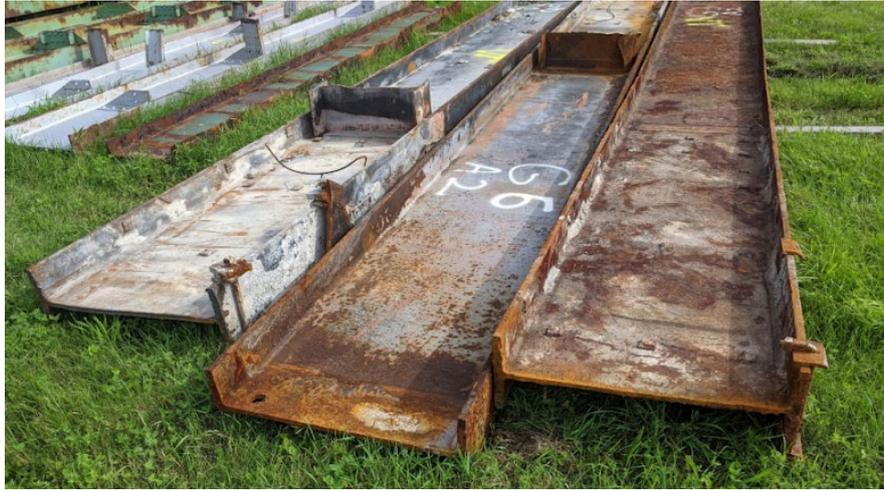
Figure 41. Limited Damage Steel Beams

Beams that were flagged with the limited damage criterion were done via visual inspection. The beams that fell under this labelling exhibited little to no damage at the end. This would mean that the team may observe a different failure mode of the beam rather than a beam end failure. Thus, the beam end capacity would not accurately be captured. Additionally, the beams that we received that had limited beam end deterioration were often too strong, having a capacity too large to induce failure with our current equipment.

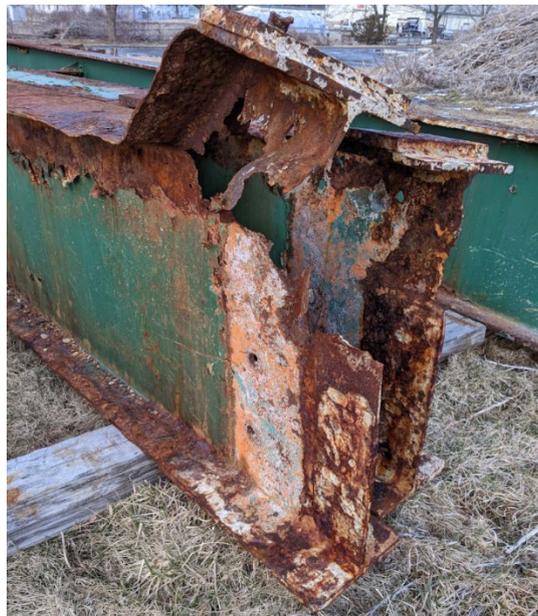
Figure 42. Extreme Damage Criterion, Vermont Beams

Beams that were flagged with the extreme damage criterion were done via visual inspection. The beams that fell under this labelling exhibited excessive damage at the end. In many of these cases, the beams under this criterion could not be properly placed into the testing rig and were too damaged to accurately estimate residual capacity. This damage could have been due purely to environmental conditions, but in the case of Figure 42, the extreme corrosion was present then the beam end was destroyed in the demolition process. There are many other beam specimens that the research team investigated where one beam had two corroded ends. There are instances where one corroded end was deemed untestable, but the specimen was kept to test the other end which was deemed testable via our protocol. This was the case for many of the New Hampshire beam specimens received and pictured in Figure 43.
