Improved Load Rating Procedures for Deteriorated Unstiffened Steel Beam Ends

Prepared For:
New England Transportation Consortium
January 2024

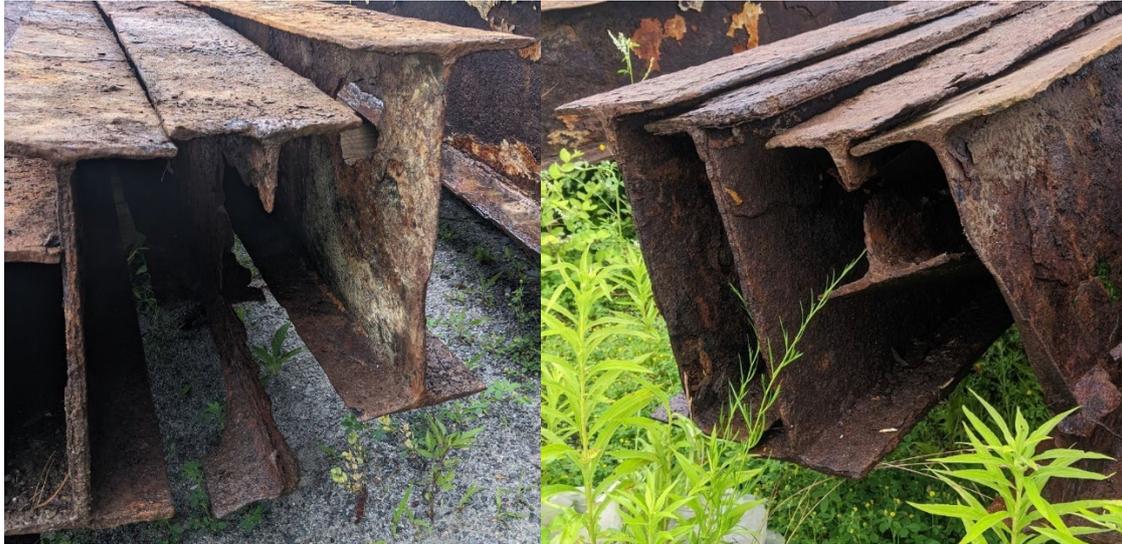
Figure 43. Extreme Damage Criterion, New Hampshire Beams

Beams that were flagged with the extreme damage criterion were done via visual inspection. The beams that fell under this labelling exhibited excessive damage at the end. In many of these cases, the beams under this criterion could not be properly placed into the testing rig and were too damaged to accurately estimate residual capacity. This damage could have been due purely to environmental conditions, but in the case of Figure 42, the extreme corrosion was present then the beam end was destroyed in the demolition process. There are many other beam specimens that the research team investigated where one beam had two corroded ends. There are instances where one corroded end was deemed untestable, but the specimen was kept to test the other end which was deemed testable via our protocol. This was the case for many of the New Hampshire beam specimens received and pictured in Figure 43.

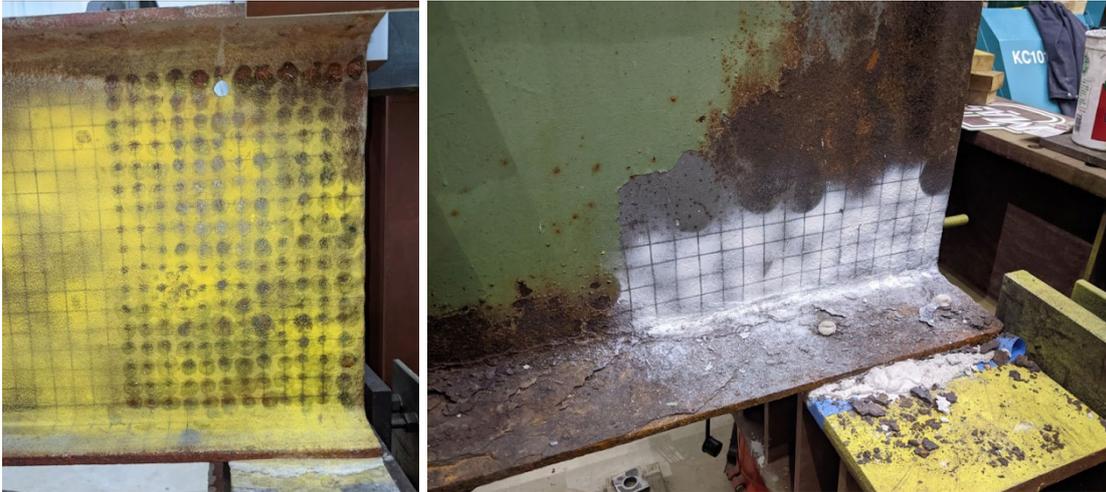
Figure 44. Measurement Grids

For the first six experiments, the research team utilized the PocketMIKE ultrasonic thickness gauge for thickness measurements on the corroded end [50]. This tool, or an equivalent ultrasonic thickness d-meter, is typically utilized by inspectors for an on-site bridge inspection of corroded ends when a thickness reading is necessary. Following the cleaning of the corroded end, the team devised a grid on the web for measurements to be taken. This grid was constructed by attaching chicken wire via magnets and spray painting over it. While it is typical to take one or a few thickness measurements in the field, many of which are at the discretion of the inspector based on visual inspection rather than a prescribed location. The researchers took very thorough measurements, particularly at the base of the web where capacity is governed. A figure depicting this measurement grid can be seen below in Figure 44. The team found the PocketMIKE's reliability and accuracy very challenging even in a laboratory environment which prevented the team from getting accurate measurements in pitted regions. The use of LiDAR and 3D Scanning however, was able to accurately measure this phenomenon and the entire section loss observed at the beam end.

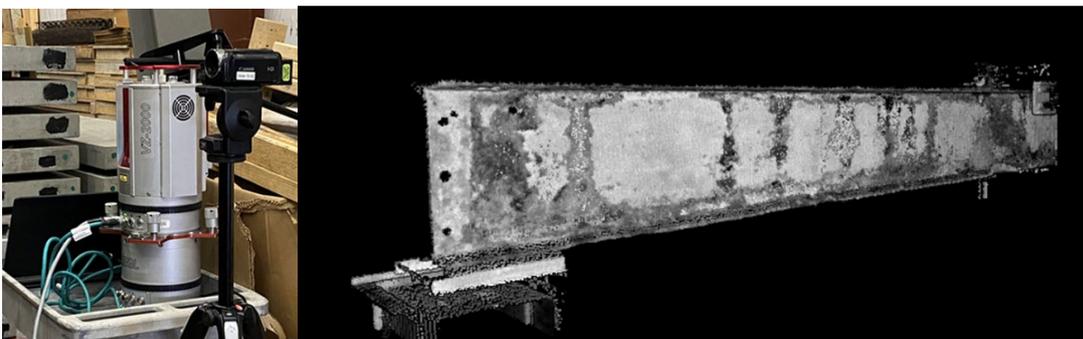
Figure 45. REIGL VZ-2000 Terrestrial Scanner and Corroded Beam Point Cloud

Experiments one through six were scanned using the RIEGL VZ2000 terrestrial LiDAR scanner [52, 53]. Because the terrestrial scanner remains stationary during the scanning process, the team had to utilize target points to align multiple scans. For the terrestrial scanner, target points were placed around the beam specimen in the lab. For these targets, the research team utilized a checkerboard pattern that could be easily placed around the beam specimen. Along with these reference points, the team could use points already present around the Brack Structural Testing Facility, such as a corner point on the steel testing rig. The alignment of point clouds followed the protocol that was devised by the research team and utilized methods of Tzortzinis in [29]. Using the open-source platform CloudCompare [51], these point clouds were aligned using the references above. Once aligned, the two sides of the corroded web can be compared, and a distance measurement can be calculated. Utilizing this data and codes designed by our research team in MATLAB, contour maps depicting the section loss of the beam end can be created. These contour maps were cross checked with measurements taken by the Pocket Mike ultrasonic thickness gauge to ensure an accurate representation of the corroded end [50]. The finalized contour was used as a representation of the section loss and was ultimately incorporated into the finite element simulations of the experiments via Python in the finite element analysis program ABAQUS [49].

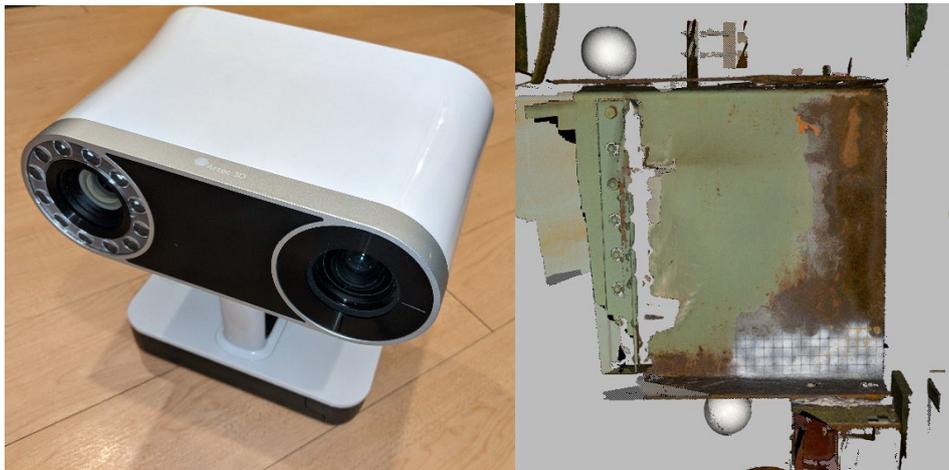
Figure 46. Artec Leo Scanner and sample scan with setup

Experiments seven through twelve were scanned using the Artec LEO 3D Scanner. With this technology, target surfaces, lettering, magnetic spheres, were primarily used along with supplemental target checkerboards and lettering. Unlike the RIEGL Scanner, the Artec LEO encourages constant movement, and its small size allowed the research team to capture multiple types of scans. This included the two-sided scan like the RIEGL had done but also what the team refers to as “closed loop scans”, where both sides of the beam specimen are captured without the need of alignment. If scans were performed using a multiple scan, two-sided method, the team utilized its created methods of alignment using point picking and the auto-alignment features of Artec Studio [52]. The Artec Leo scanner with a sample scan using the sphere targets can be seen in Figure 46.

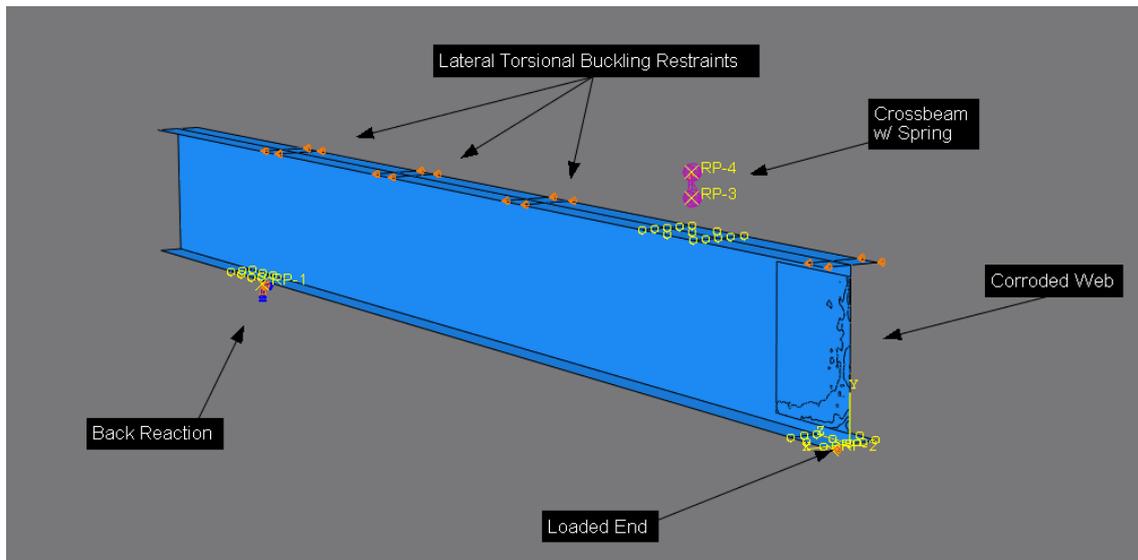
Figure 47. Finite Element Model

The beam model contained several boundary conditions which pertained and were used to simulate the real conditions within the laboratory experiments. The back reaction was assumed to be a “pinned” reaction and the crossbeam and threaded rods were modeled as a spring. The spring stiffness was assumed to be 593.855 kip/in as a baseline from experiments conducted by Tzortzinis in [29] but was then tailored and fine-tuned (reduced or increased) based on experimental results if necessary. For the loaded end, the boundary conditions were selected to simulate a “roller” as the team felt it was the best representation of the roller support provided by MassDOT and could also simulate the load beam which was free to behave as a roller support when the MassDOT support was not used. Finally, the lateral torsional buckling supports were applied as constraints directly on the beam’s top flange in the locations for which they were present in the laboratory experiment. Additionally, it is important to note that experiments three through twelve all had plates attached as a bracing system for the bridge, these bolted/riveted plates were not considered in the simulation or the capacity estimation process as they were not attached to the flanges of the beam, spanned most of the web but not the entirety, and did not lie within the lengths for which average thickness was taken. While the plates’ presence here could influence the stiffness of the system, they would not add capacity to

the corroded end. A diagram of the finite element simulation model can be found in Figure 47.

The beam components were all created using shell elements. These shell elements would be assigned thickness values pertaining to the thickness of the beam section, such as flange thickness and web thickness. For corroded sections, the levels of the corrosion contour maps would be used as the thickness inputs. All of the shell thicknesses use a middle surface assignment to avoid any possible unexpected problems with eccentric loading or displacement. Each model was composed of S3 and S4R shell elements to accommodate the nonuniformity of the corrosion patterns present at the beam end. These elements are typical shell elements, S3 is a three sided shell element while the S4R is a four sided shell element. The team performed mesh convergence for models of this type previously through models made in [28, 29].

Each specimen had an eigenvalue analysis performed where the team could analyze the potential failure modes and what would be entered into the static model as an initial imperfection. The eigenmode chosen for this imperfection was based on two features: the failure mode of the beam and the measured initial web deviation of the beam. This initial web deviation was measured in accordance with Tzortzinis and MassDOT in [28,47]. The research team utilized a combination of straightedges, laser levels, and caliper measurements to accurately estimate the initial web deviation, or initial imperfection, present on the beam. This estimation and measurement ultimately guided the team as to what mode and how much deviation was implemented into the static analysis.

The static analysis was a two-step process, the first for the application of self-weight and the weight of the crossbeam, and the second for the loading to induce beam end buckling. The self-weight for each beam was assumed based on inspection reports, lab measurements of the beam geometry, and engineering judgement. A load for the crossbeam was also applied in this step. In the second step where the beam end was loaded until failure, a vertical displacement was applied to a reference point below the corroded end. This point was connected to the entire bearing surface below the corroded end, so the model distributed load in the same way as the laboratory tests.

There were many key assumptions made in the modelling of the beam specimens. The first key piece of the model is the contour maps used to describe the corrosion profile present on the beam. Contour maps have been used by the research team in previous projects with MassDOT to describe the remaining thickness of corroded ends; with this there is an assumption that each level of the remaining thickness contour map takes a particular value of “thickness” based on the bounds of the contour. Other key assumptions that were made in the modelling process were averaging flange thicknesses for beams that have varying thicknesses and averaging the corroded thickness of the flange in the area of the bearing. The intact flange measurements were based on lab measurements and

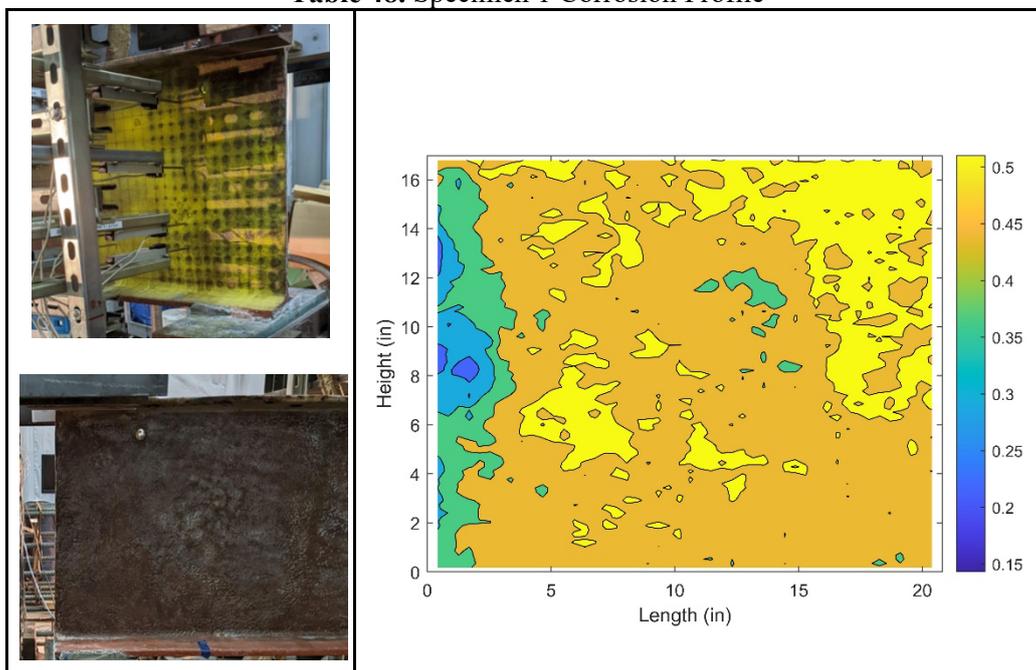
Table 48. Specimen 1 Corrosion Profile

Specimen 1 was assumed to be a 20” deep American Standard from the 02929 bridge on Route 80 in Deep River, Connecticut. This beam type was assumed based on the structural drawings, our own in-lab measurements, and engineering judgment. The beam was used as an addition in efforts to rehabilitate the structure. It came from another structure before being placed on the 02929 bridge. The section loss profile was created using the RIEGL VZ-2000. This profile can be found in Table 48. The section loss profile was one that the research team had not observed before and had a semi-circular profile with heavy corrosion at mid-height. The corrosion length was taken to be 3 inches. The experimental capacity of the corroded end was 129.8 kips. The experimental and finite element load-displacement curves can be found in Table 49.

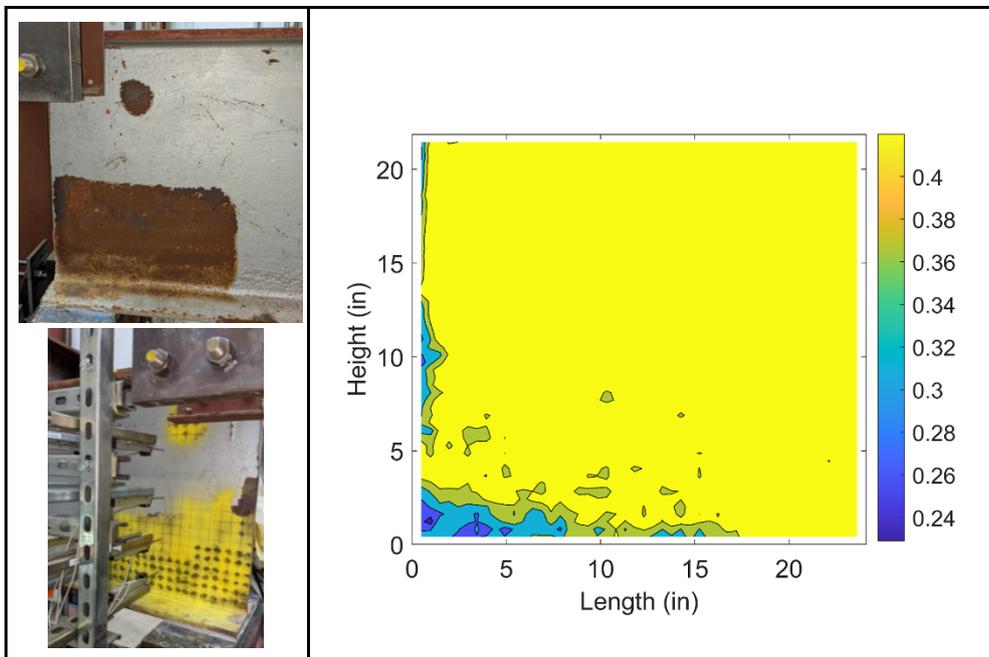
Table 50. Specimen 2 Corrosion Profile

Specimen 2 was assumed to be a 24” deep CB 241-19 from the 02929 bridge on Route 80 in Deep River, Connecticut. This beam type was assumed based on the structural drawings, our own in-lab measurements, and engineering judgment. The beam was used as an addition in efforts to rehabilitate the structure. It came from another structure before being placed on the 02929 bridge. The section loss profile shown in Table 50 was created using the RIEGL VZ-2000. The corrosion length was taken to be 11.8 inches. The experimental capacity of the corroded end was 113.3 kips. One can observe in the experimental loading a sudden jump down in displacement at around 90 kips applied, this is likely due to settling in the system during a loading pause and slipping of the string potentiometers which were hooked below the specimen. The experimental and finite element load-displacement curves can be found in Table 51.

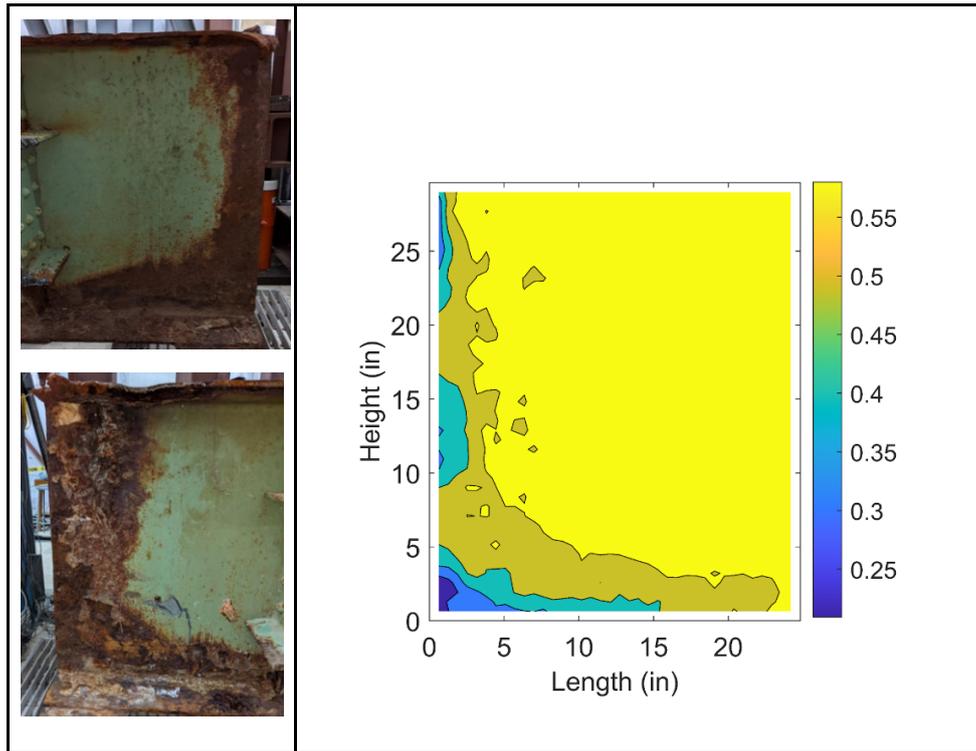
Table 52. Specimen 3 Corrosion Profile

Specimen 3 was assumed to be a B33x132 from the 3801 bridge in Jay, Maine. This beam type was assumed based on the structural drawings, our own in-lab measurements, and engineering judgment. The section loss profile shown in Table 52 was created using the RIEGL VZ-2000. The corrosion length was taken to be 13.315 inches. The experimental capacity of the corroded end was 199.8 kips. The experimental and finite element load-displacement curves can be found in Table 53.

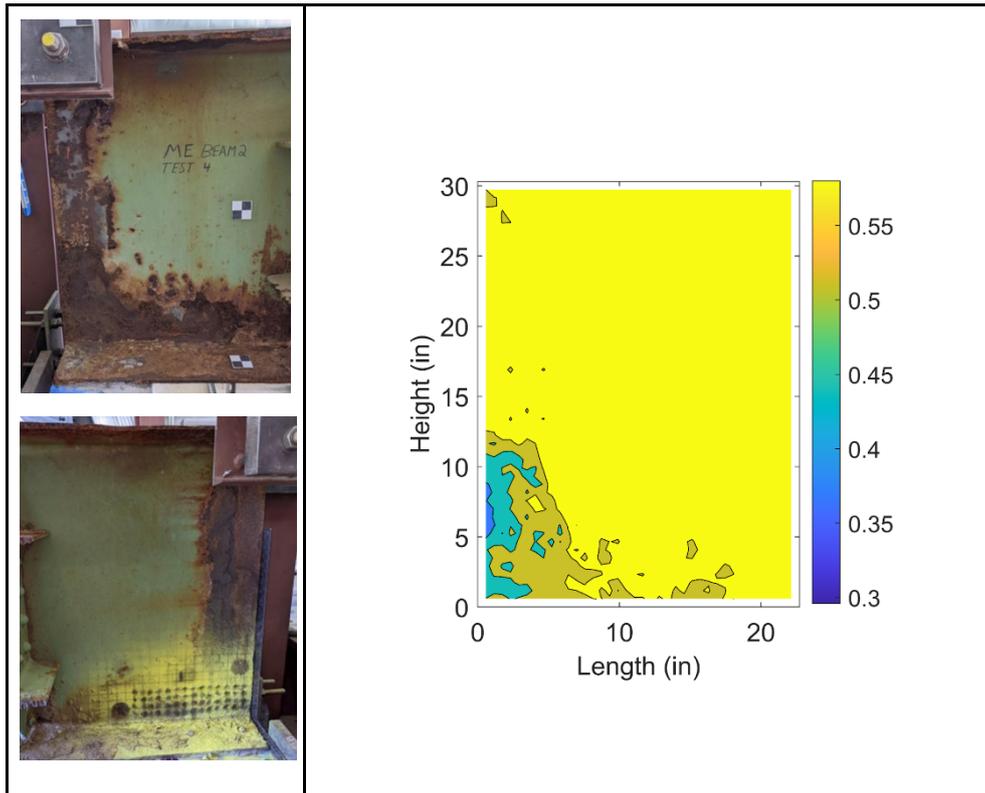
Table 54. Specimen 4 Corrosion Profile

Specimen 4 was assumed to be a B33x132 from the 3801 bridge in Jay, Maine. This beam type was assumed based on the structural drawings, our own in-lab measurements, and engineering judgment. The section loss profile shown in Table 54 was created using the RIEGL VZ-2000. The corrosion length was taken to be 13.315 inches. The experimental capacity of the corroded end was 284.5 kips. The experimental and finite element load-displacement curves can be found in Table 55.

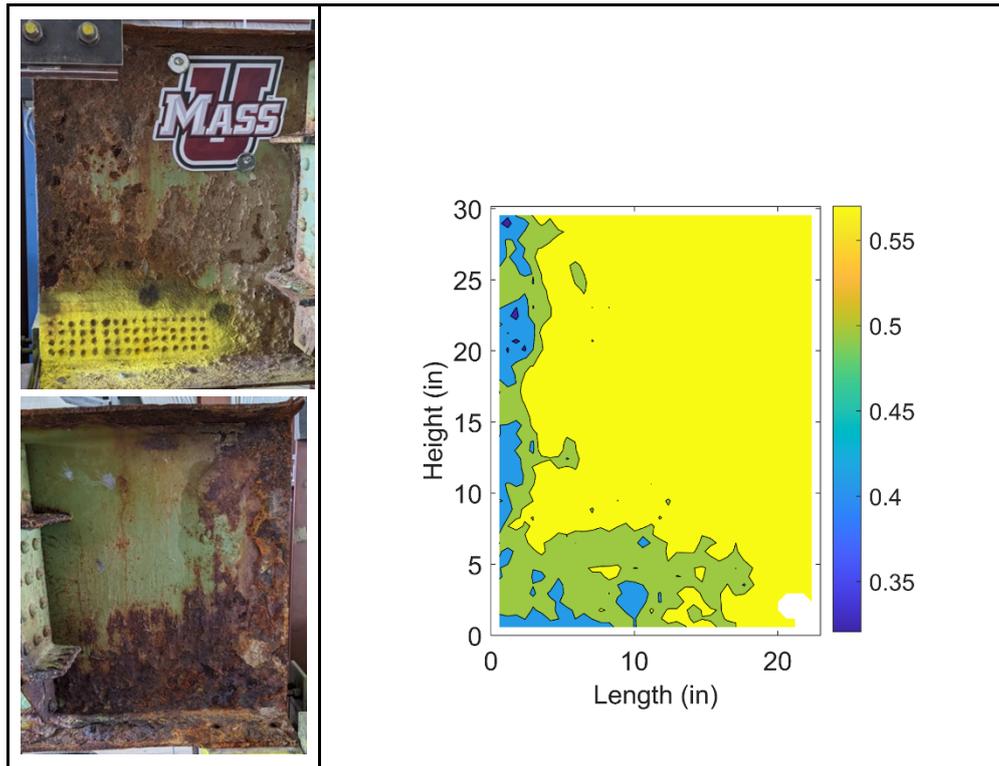
Table 56. Specimen 5 Corrosion Profile

Specimen 5 was assumed to be a B33x132 from the 3801 bridge in Jay, Maine. This beam type was assumed based on the structural drawings, our own in-lab measurements, and engineering judgment. The section loss profile shown in Table 56 was created using the RIEGL VZ-2000. The corrosion length was taken to be 11 inches. The experimental capacity of the corroded end was 224.1 kips. The experimental and finite element load-displacement curves can be found in Table 57.

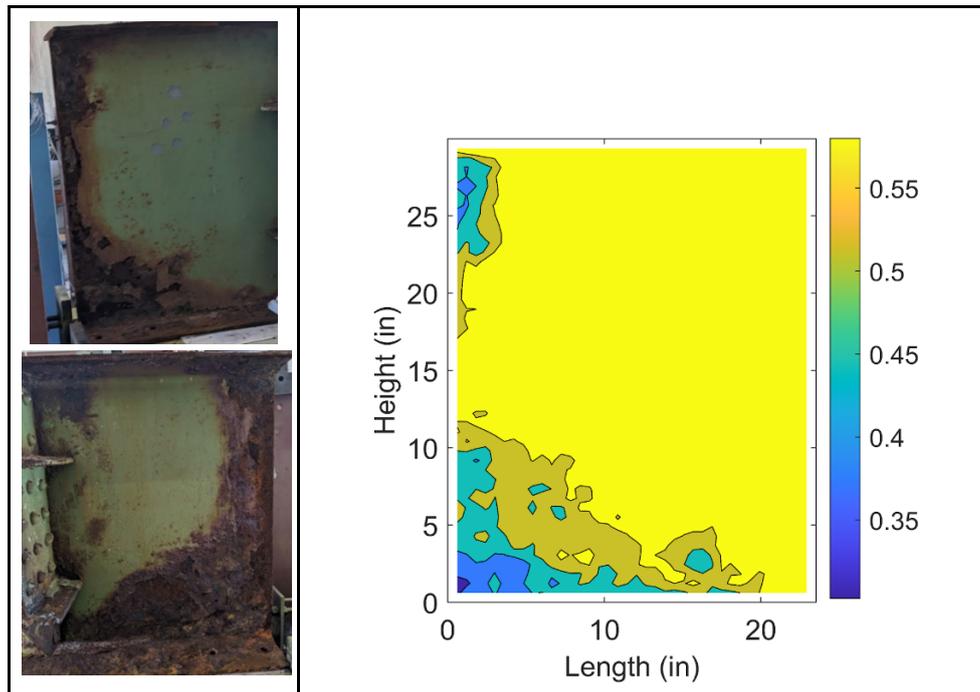
Table 58. Specimen 6 Corrosion Profile

Specimen 6 was assumed to be a B33x132 from the 3801 bridge in Jay, Maine. This beam type was assumed based on the structural drawings, our own in-lab measurements, and engineering judgment. The section loss profile shown in Table 58 was created using the RIEGL VZ-2000. The corrosion length was taken to be 12 inches. The experimental capacity of the corroded end was 211.1 kips. One can observe in the experimental loading a sudden jump down in displacement at around 10 kips applied, this is likely due to settling in the system during an initial loading pause. The experimental and finite element load-displacement curves can be found in Table 59.

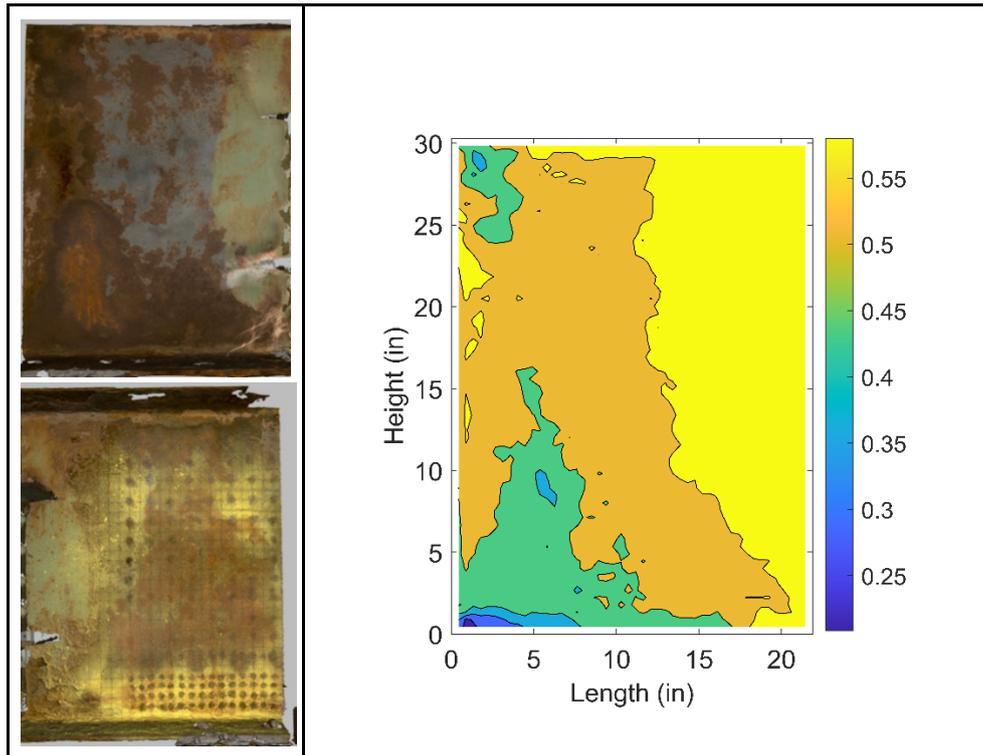
Table 60. Specimen 7 Corrosion Profile

Specimen 7 was assumed to be a B33x132 from the 3801 bridge in Jay, Maine. This beam type was assumed based on the structural drawings, our own in-lab measurements, and engineering judgment. The section loss profile shown in Table 60 was created using the Artec Leo. The corrosion length was taken to be 13.315 inches. The experimental capacity of the corroded end was 230.1 kips. The experimental and finite element load-displacement curves can be found in Table 61.

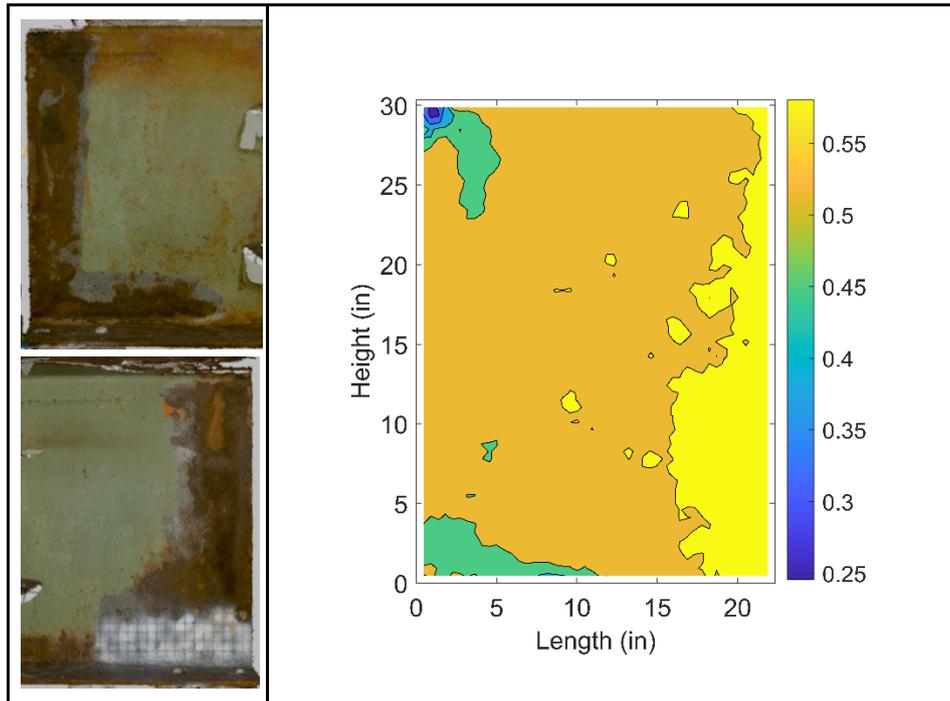
Table 62. Specimen 8 Corrosion Profile

Specimen 8 was assumed to be a B33x132 from the 3801 bridge in Jay, Maine. This beam type was assumed based on the structural drawings, our own in-lab measurements, and engineering judgment. The section loss profile shown in Table 62 was created using the Artec Leo. The corrosion length was taken to be 11.39 inches. The experimental capacity of the corroded end was 253.2 kips. The experimental and finite element load-displacement curves can be found in Table 63.

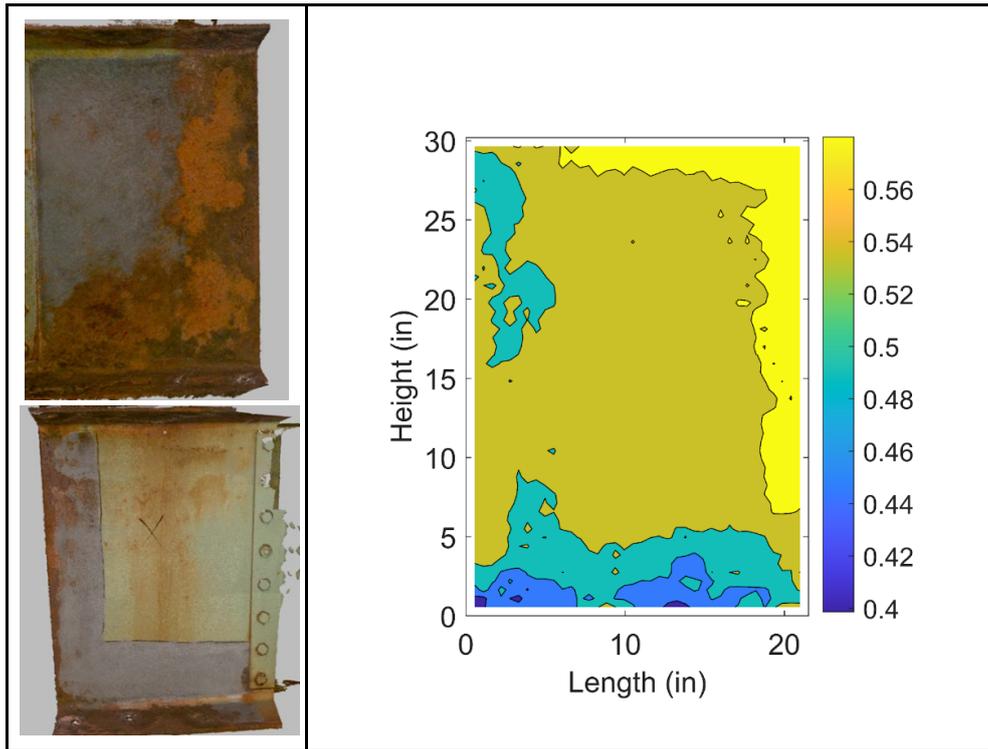
Table 64. Specimen 9 Corrosion Profile

Specimen 9 was assumed to be a B33x132 from the 3801 bridge in Jay, Maine. This beam type was assumed based on the structural drawings, our own in-lab measurements, and engineering judgment. The section loss profile shown in Table 64 was created using the Artec Leo. The corrosion length was taken to be 13.315 inches. The experimental capacity of the corroded end was 257.3 kips. The experimental and finite element load-displacement curves can be found in Table 65.

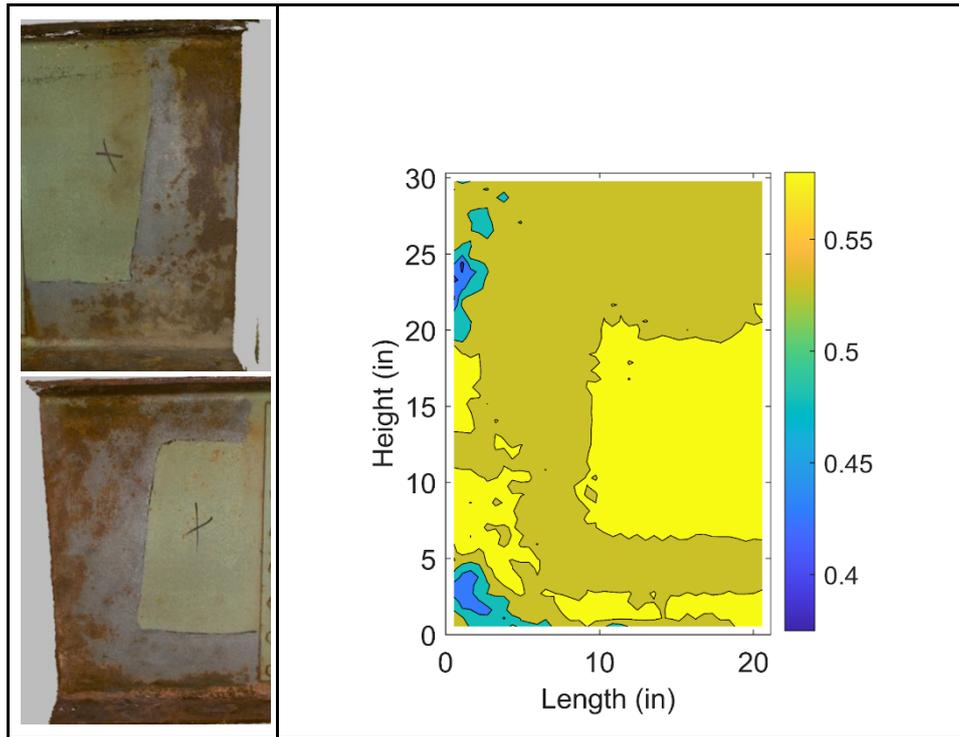
Table 66. Specimen 10 Corrosion Profile

Specimen 10 was assumed to be a B33x132 from the 3801 bridge in Jay, Maine. This beam type was assumed based on the structural drawings, our own in-lab measurements, and engineering judgment. The section loss profile shown in Table 66 was created using the Artec Leo. The corrosion length was taken to be 13.315 inches. The experimental capacity of the corroded end was 297.6 kips. The experimental and finite element load-displacement curves can be found in Table 67.

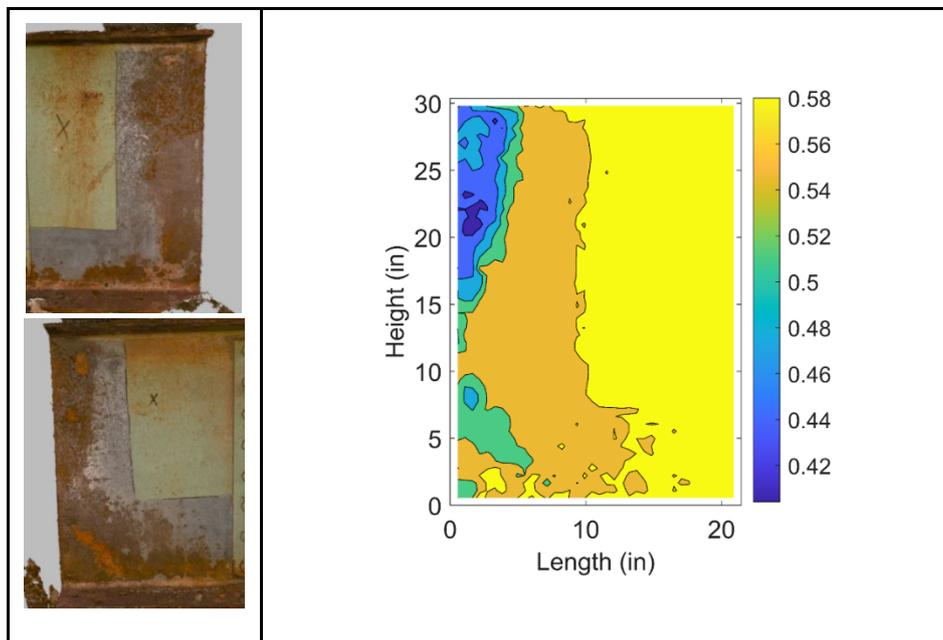
Table 68. Specimen 11 Corrosion Profile

Specimen 11 was assumed to be a B33x132 from the 3801 bridge in Jay, Maine. This beam type was assumed based on the structural drawings, our own in-lab measurements, and engineering judgment. The section loss profile shown in Table 68 was created using the Artec Leo. It is important to note there was a calibration error that occurred in one of the linear string potentiometers for displacement measurements, so this specimen only considers displacement closest to the crossbeam and not the difference between the two linear displacement measurements. The experimental capacity of the corroded end was 267.1 kips. The experimental and finite element load-displacement curves can be found in Table 69.

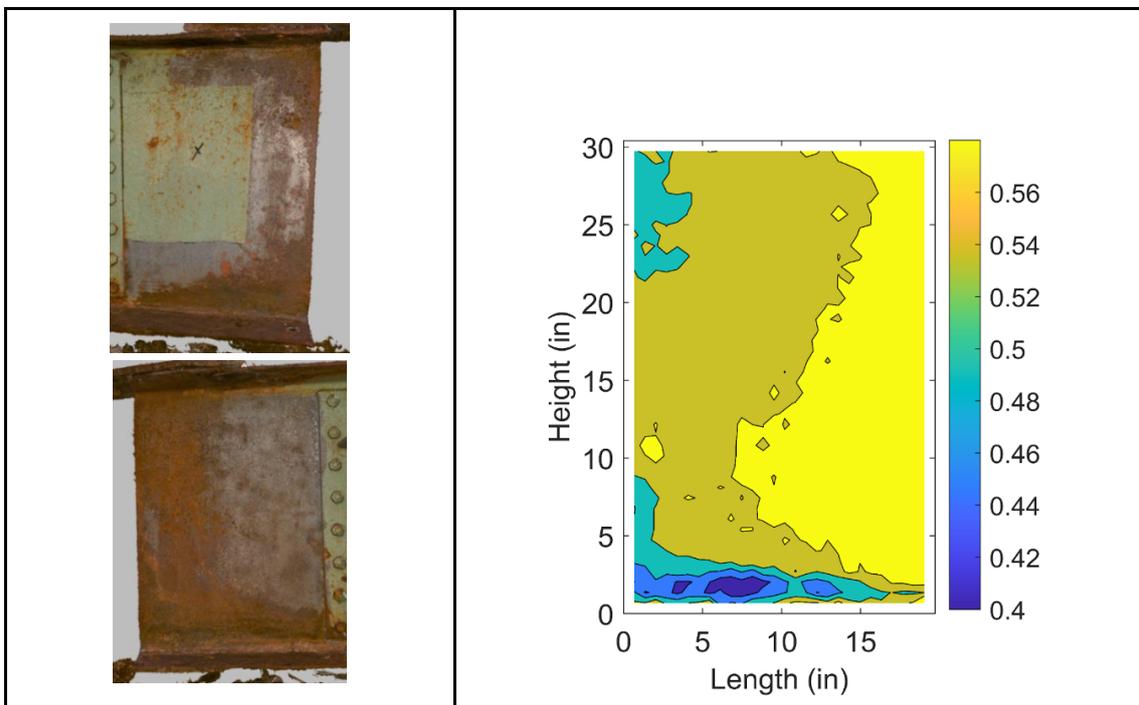
Table 70. Specimen 12 Corrosion Profile

Specimen 12 was assumed to be a B33x132 from the 3801 bridge in Jay, Maine. This beam type was assumed based on the structural drawings, our own in-lab measurements, and engineering judgment. The section loss profile was created using the Artec Leo and can be found in Table 70. The corrosion length was taken to be 13.315 inches. The experimental capacity of the corroded end was 232.3 kips. The experimental and finite element load-displacement curves can be found in Table 71. It is important to note there was a calibration error that occurred in one of the linear string potentiometers for displacement measurements, so this specimen only considers displacement closest to the beam end and not the difference between the two linear displacement measurements.

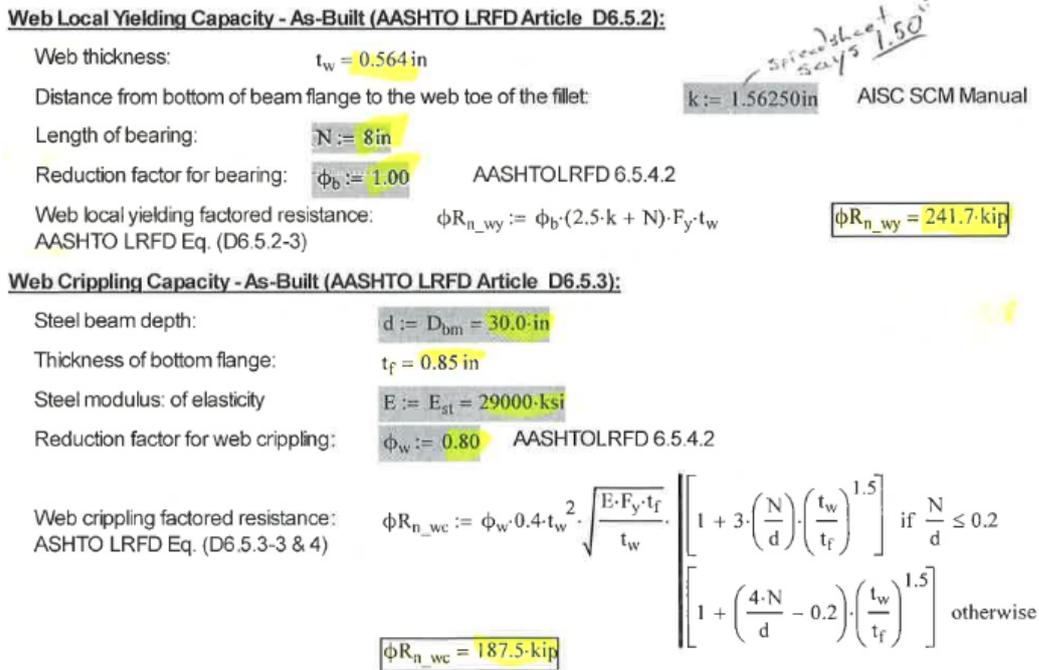
done over the length $2.5k+N$, where N is the bearing length and k is length of the web toe fillet plus the flange thickness. The average web thickness for crippling was assumed to be taken over the bearing length N based on what was stated in the examples and provisions. The research team only considered the unfactored capacities as the results would be compared to other state procedures and the real experimental tests. An example of the equations used by NHDOT [25] for capacity estimations can be found in Figure 51.

Figure 51. New Hampshire Corroded End Capacity Estimation Example, Adapted from New Hampshire Load Rating Frankestown 142-160 [25]

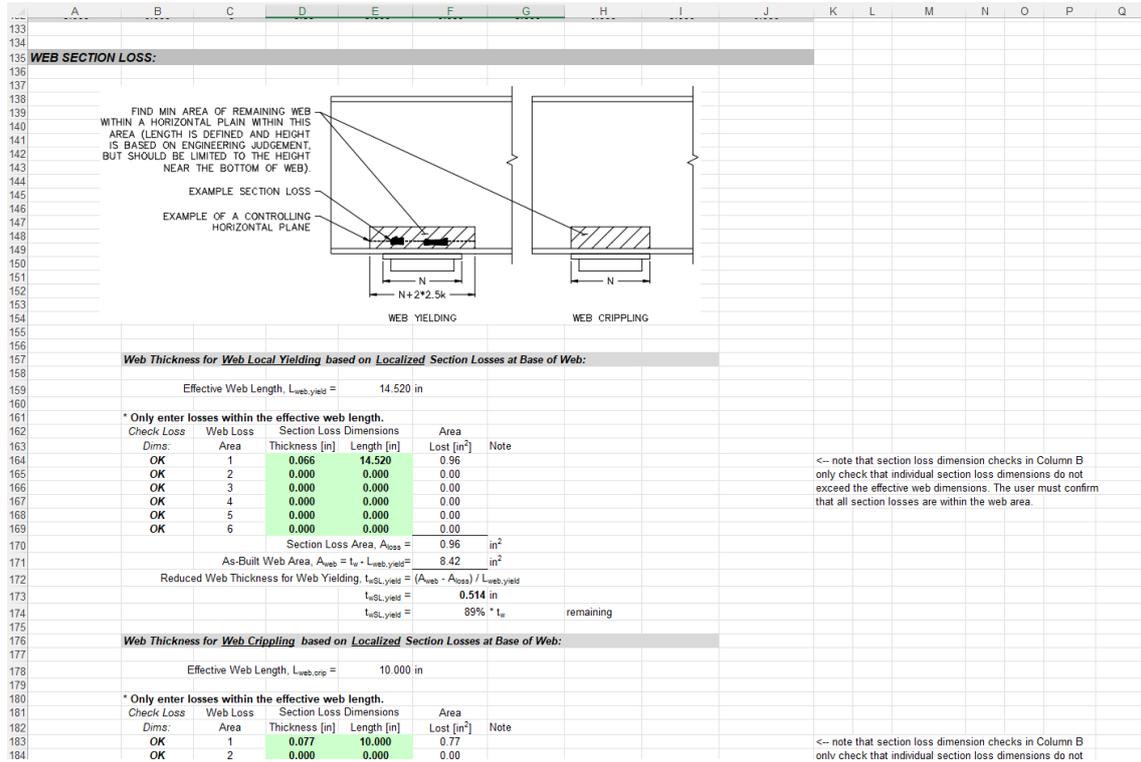
results would be compared to other state procedures and the real experimental tests. An example of the spreadsheet pages used from RIDOT [26] are found in Figure 52.

Figure 52. RIDOT Spreadsheet Example, adapted from RIDOT Load Rating Spreadsheet [26]

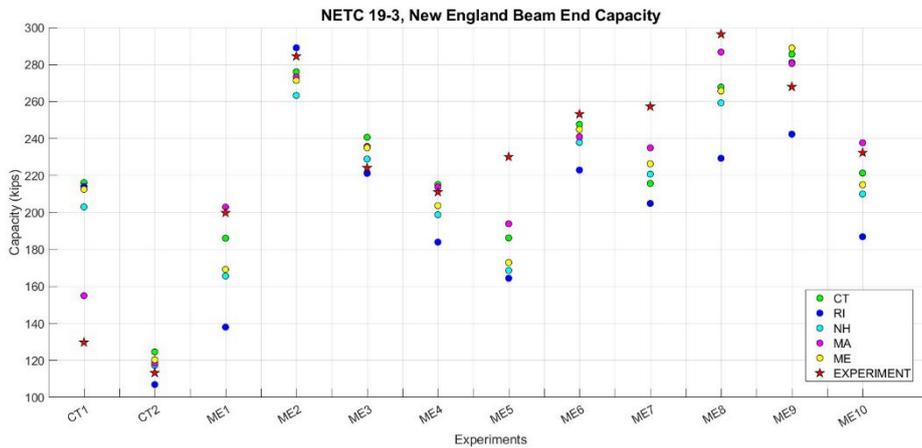
The capacity evaluation using each state’s provisions was conducted on each specimen and compiled into graphs shown in Figure 53 and Figure 54. Figure 53 shows the true capacity found in the experiment with the corresponding predictions from the state provisions. Figure 54 shows the same capacity and predictions normalized to the experimental capacity. The summarized values pictured in Figure 53 along with the peak loads from the Finite Element Simulations can be found in Table 73. The summarized percent differences between the evaluation methods and the experimental peak loads can be found in Table 74.

Figure 53. New England Beam End Capacity

There are several critical observations that can be drawn from the beam end capacity provision comparison. In most cases, the prediction for every state is conservative or a close estimation, however there are cases that this is not true (CT1, CT2, ME3, ME9).

As stated in Section 8.2, the CL parameter defines the corrosion length for which the average thickness is taken. This corrosion length is bounded from $N/2$ to $N+md$, the bearing length plus the beam depth multiplied by a parameter "m" which is dependent on web deviation. In the crippling capacity equations of [47], if the length of corrosion is not taken to be the full $N+md$ length, then a knockdown of the capacity takes place to account for the influence of the average thickness via the factor $(CL/N+md)^{0.15}$ found in the equation of Figure 49 via the MassDOT Bridge Manual (under review) [47]. Web deviation imperfections create major knockdowns in remaining capacity and have proven to have great influence on the beam webs. With the web of the beam behaving much like a column, the larger the initial out of plane deformation, the larger the influence in reducing the buckling capacity. The parameter CL provides a limit and range to where the average thickness of the end can be estimated. This parameter allows the inspector to quantify the average web thickness but also utilize engineering judgement in measuring and estimating the length over which the major section loss occurs. Finally, alongside the encompassing provisions, it is clear that the performance and accuracy of the equations is quite high and consistent across different beam types and section loss quantities. This can be best seen in Section 7, Figure 53 and Figure 54 as well as Table 73 and Table 74.

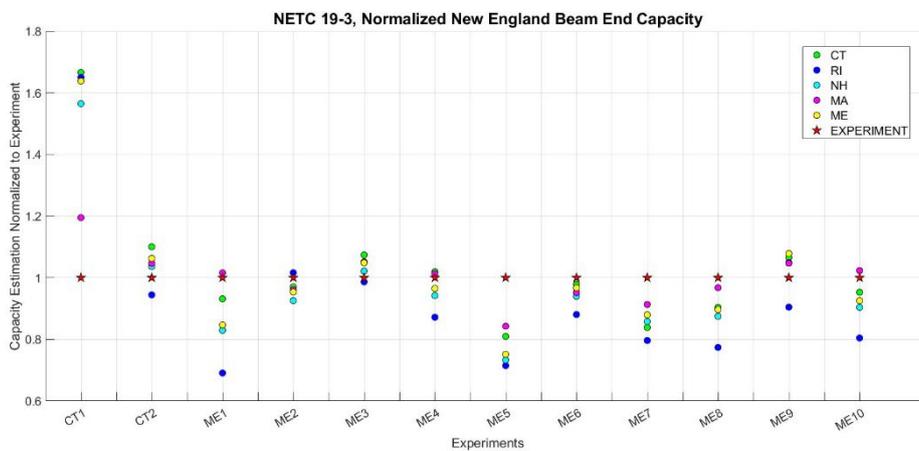
Figure 54. Normalized New England Beam End Capacity

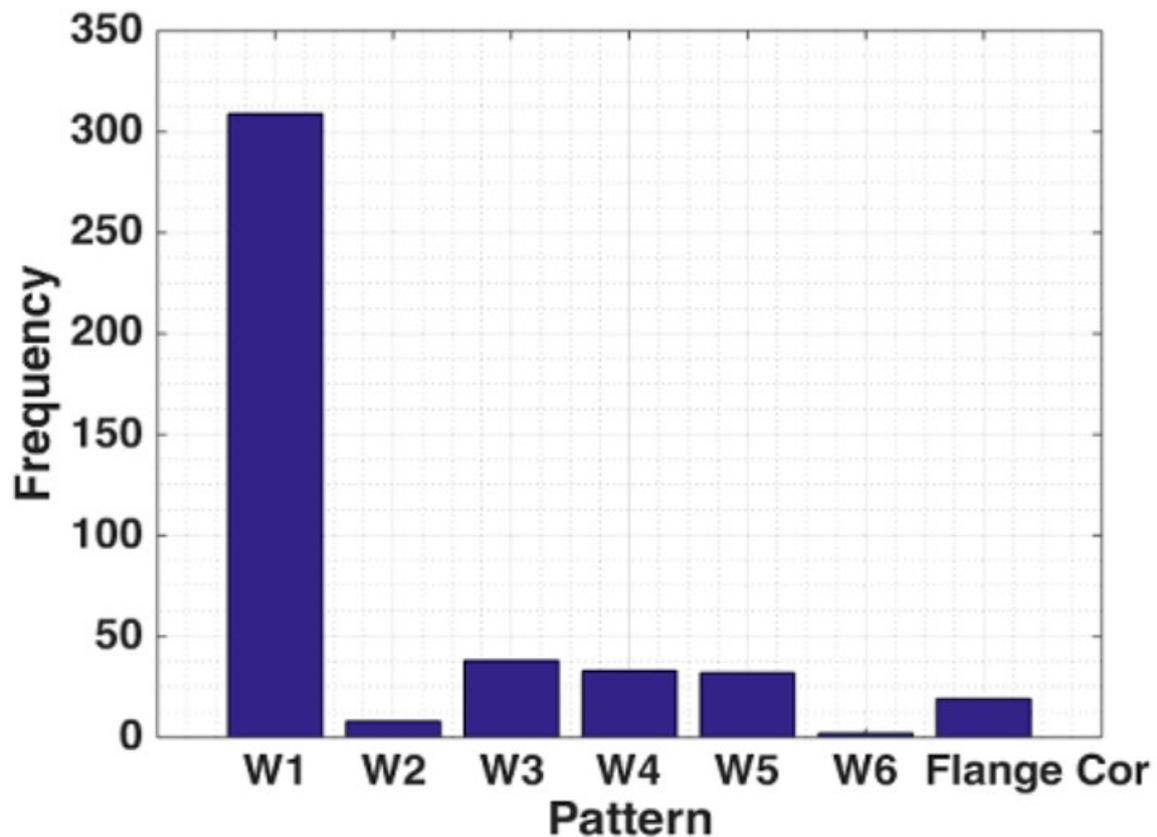
Figure 55 depicts the frequency of patterns obtained for beam ends without diaphragm from the reports provided by CTDOT.

Figure 55: Web corrosion patterns distribution for beams ends without a diaphragm – CTDOT

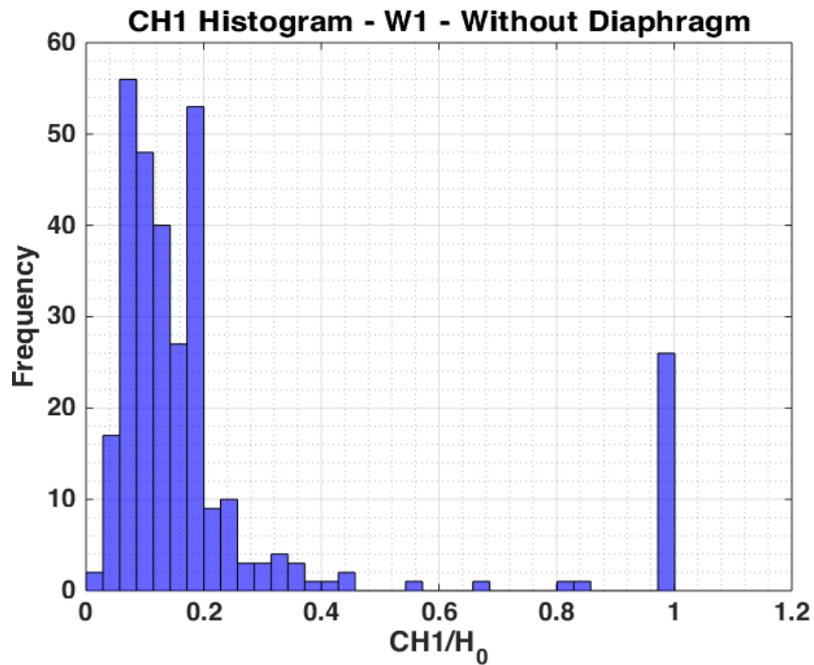
The distribution of CH_1 for this pattern is depicted in Figure 56. From Figure 56 two dominant trends can be seen: (i) full height corrosion, or (ii) corrosion up to 40% of the web, which can be written as:

$$0 < CH_1 \leq 0.4H \text{ and } 0.9H \leq CH_1 \leq 1H$$

Figure 56: CH_1 distribution of W1 pattern for beams without a diaphragm - CTDOT

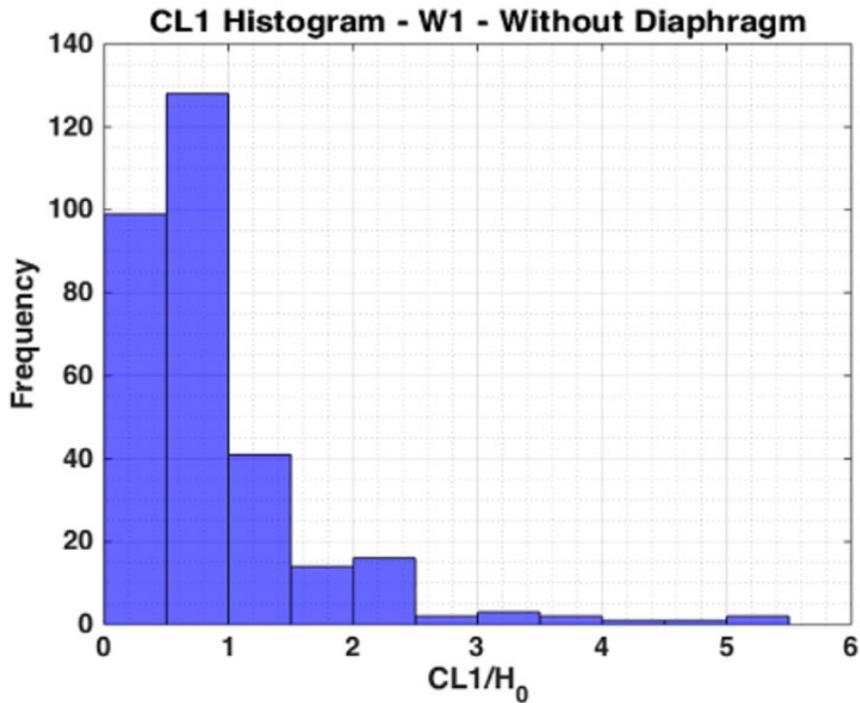
Figure 57: CL1 distribution of W1 pattern for beams without a diaphragm – CTDOT

Upon investigation of Figure 57, no major trend could be found. While no dominant trend could be seen, it is reasonable to state that the corrosion present for W1 is dominated by values smaller than 2.5H₀.

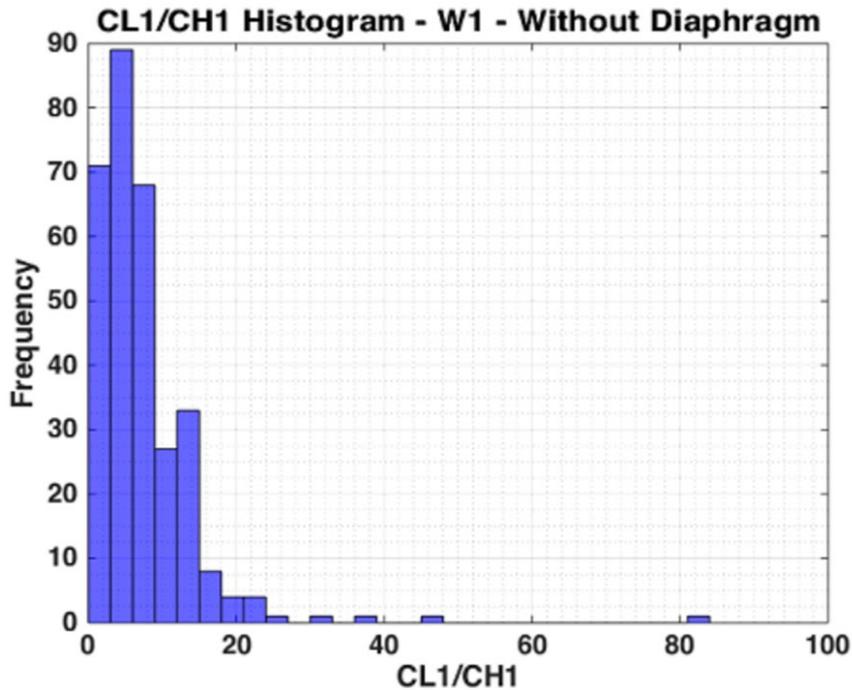
Aiming to compare the length and height of corrosion, Figure 58 depicts the ratio between the length and height of corrosion. It is possible to observe that the length is usually several times greater than the height.

Figure 58: Ratio of corrosion length (CL1) to corrosion height (CH1) of W1 pattern for beams without a diaphragm - CTDOT
