Improved Load Rating Procedures for Deteriorated Unstiffened Steel Beam Ends

Prepared For:
New England Transportation Consortium
January 2024

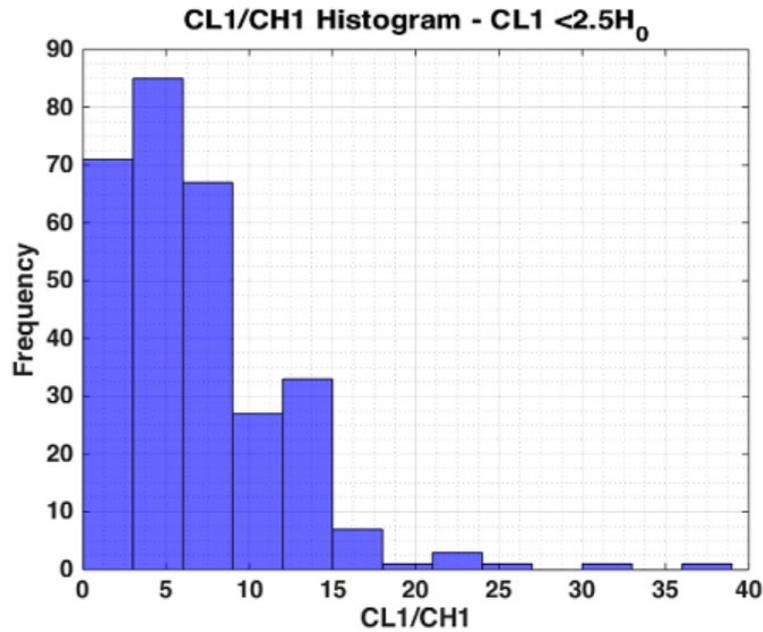
As many lengths are less than $2.5H$, our team was able to check the ratio for beams ends where $CL1 < 2.5H$. The resulting histogram is depicted in Figure 59.

Figure 59: Ratio of corrosion length (CL1) to corrosion height (CH1) for $CL1 < 2.5H_0$ - CTDOT

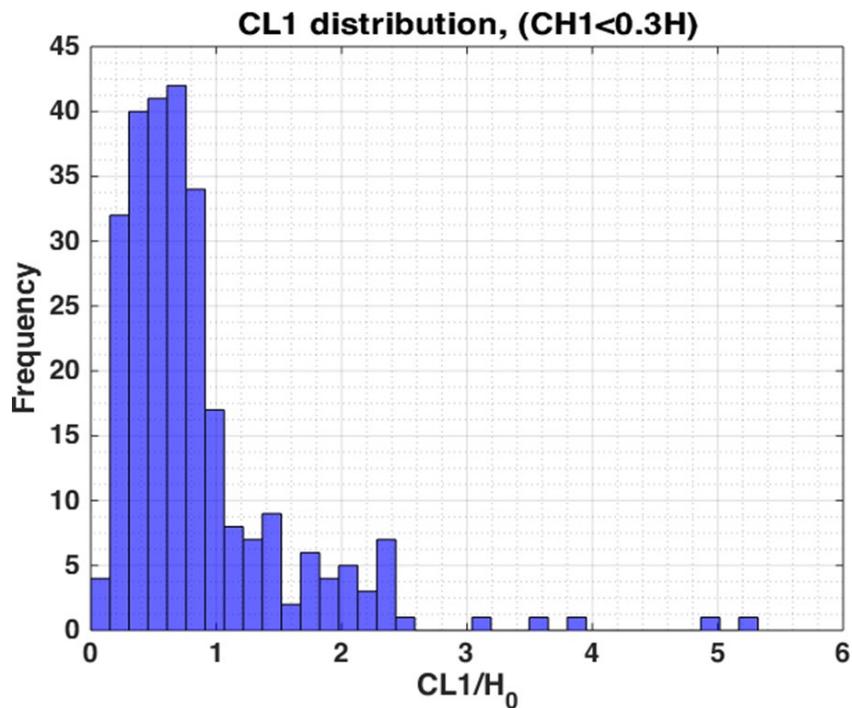
Beyond this, to deepen the understanding regarding the interaction between CH1 and CL1, our team could isolate trends depicted in the CH1 distribution. As a result, our team could plot the length of corrosion for $CH1 < 0.3H_0$. Figure 60 depicts the final distribution of CL1 for this case.

Figure 60: CL1 distribution for $CH1 < 0.3H$ - CTDOT

When comparing Figure 60 to Figure 61, it is apparent that when the corrosion height is large, the corrosion length is often smaller. On the other hand, for small heights of corrosion, the corrosion length tends to be greater than the corrosion height.

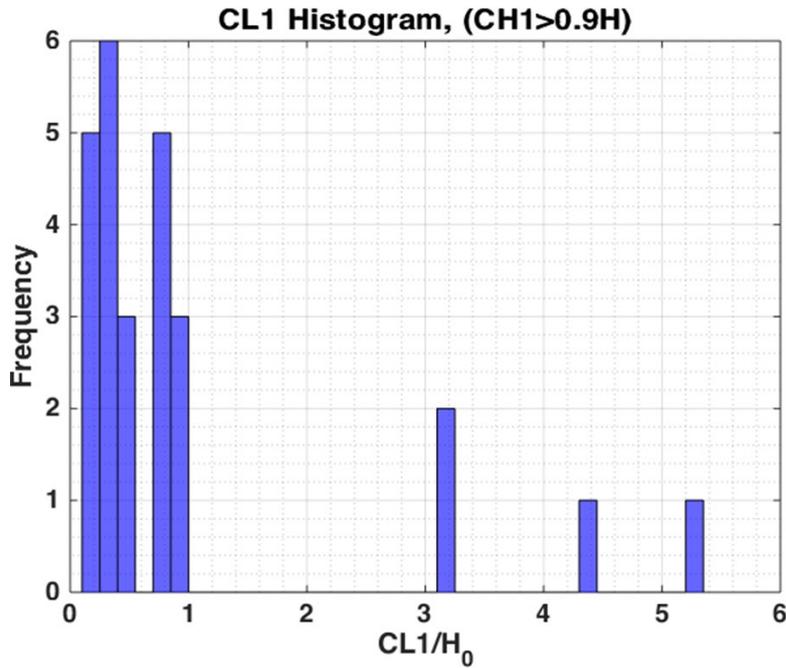
A similar study to the $CH1 < 0.3H0$ case, our team conducted a study on the case where $CH1 > 0.9H$. Figure 61 below depicts the final distribution for this case.

Figure 61: CL1 distribution for $CH1 > 0.9H$ - CTDOT

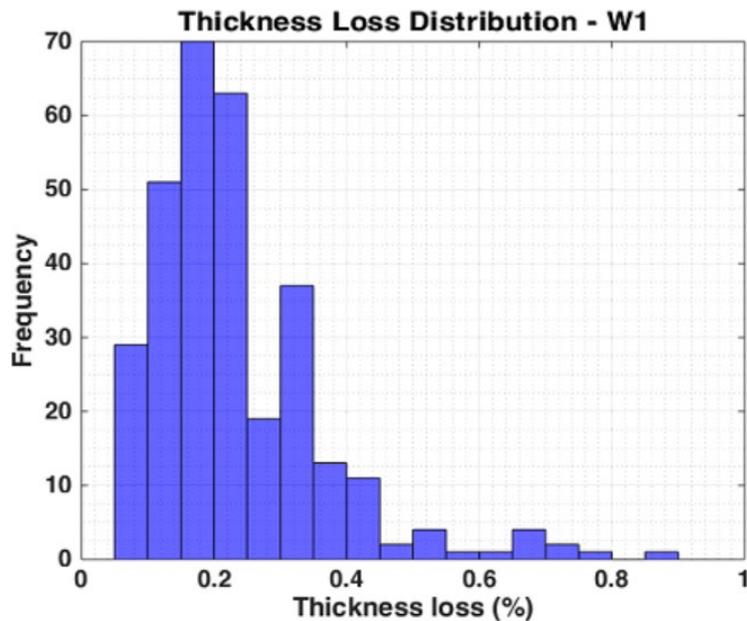
Figure 62 depicts the distribution of web thickness loss for pattern W1. It is noticeable that much of the thickness loss for the W1 case is no greater than 50%.

Figure 62: Web thickness loss distribution for pattern W1 - CTDOT

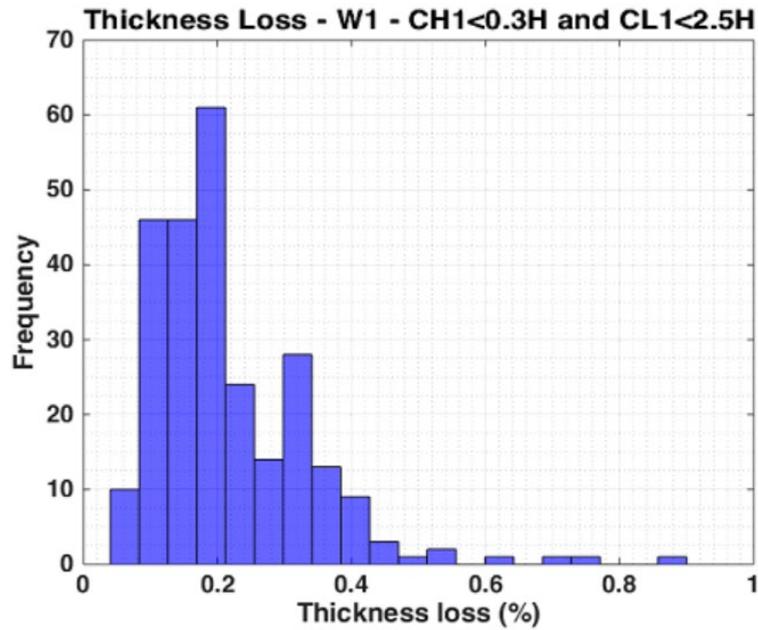
Similar to the analysis conducted for corrosion length, our team was able to study the thickness loss for the two main trends detected previously. The resulting distributions are depicted in the Figure 63 and Figure 64.

Figure 63: Web thickness loss distribution for CH1<0.3H and CL1<2.5H - CTDOT

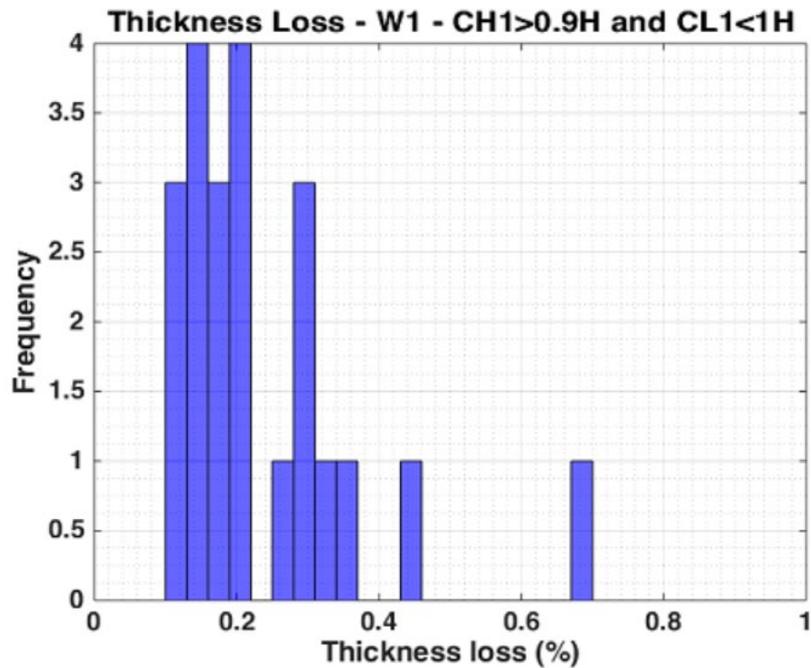
Figure 64: Web thickness loss distribution for Ch1<0.9H and CL1<1H - CTDOT

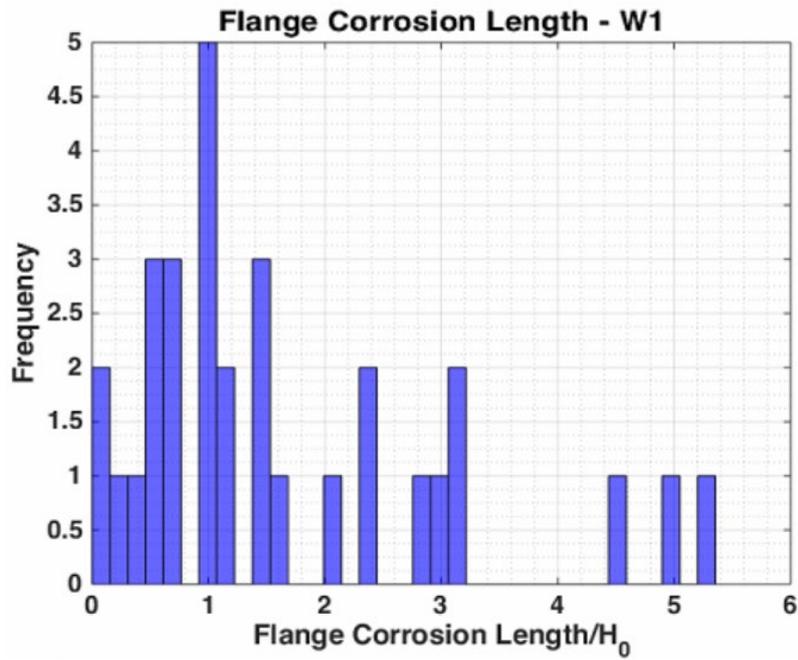
Figure 65 depicts the length of corrosion in the flanges. It is worthwhile in recognizing that there is significantly less information regarding flange corrosion.

Figure 65: Distribution of corrosion length for pattern W1 - CTDOT

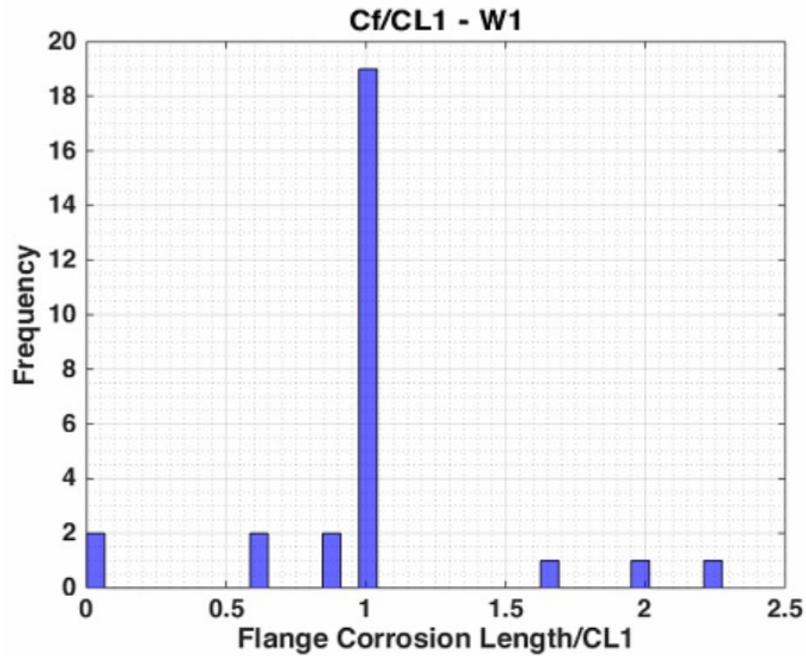
To compare the length of corrosion in the flanges with the length of corrosion in the web, Figure 66 was created. Here, the graph depicts the ratio of C_f/C_l , where C_f is the length of corrosion in the flanges and C_l is the web length corrosion.

Figure 66: Ratio between flange corrosion length for pattern W1 - CTDOT

From Figure 66, it was valid to assume that the length of corrosion is the same for both web and flange. Therefore, for trends previously identified, our team assumed that the length of corrosion in the flange was equal to the corrosion in the web.

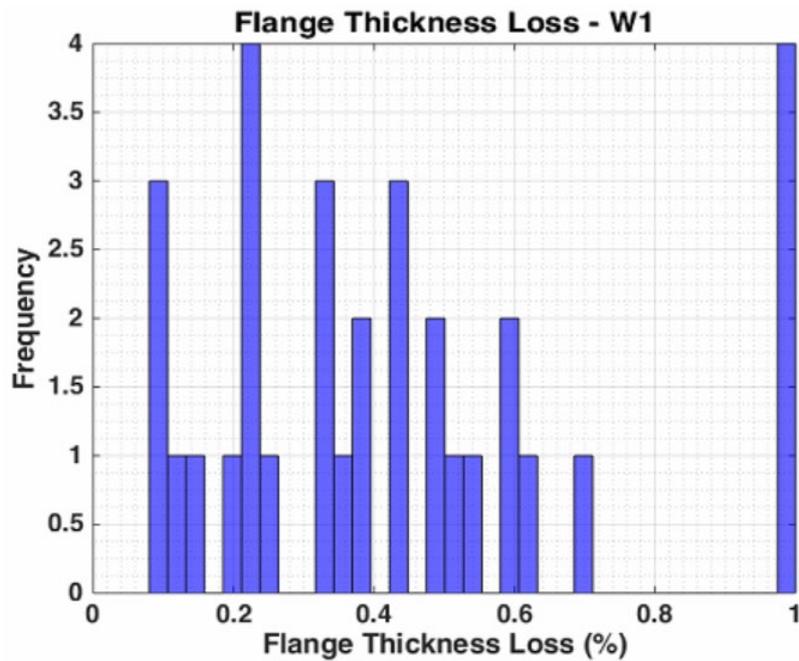
Regarding the thickness loss of the flanges, the research team was able to plot the distribution depicted in Figure 67.

Figure 67: Flange thickness Loss for pattern W1 - CTDOT

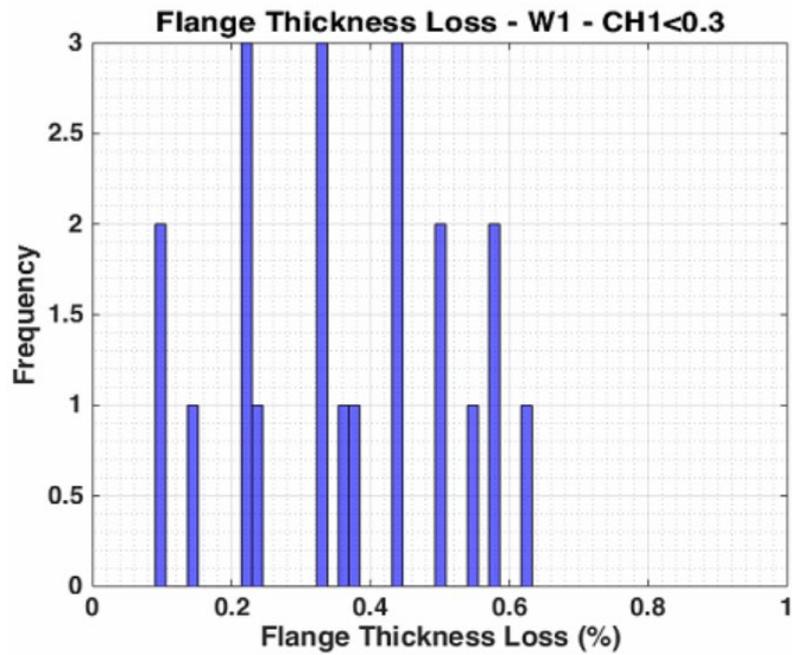
Similarly, our team was able to isolate the thickness loss for either trends found previously, as depicted in Figure 68 and Figure 69.

Figure 68: Flange thickness loss distribution for CH1<0.3 - CTDOT

For beam ends which CH1 is less than 0.3H, the thickness loss on the flanges tended to be small. This was different for cases which CH1 is greater than 0.9H, which resulted in a thickness loss of almost 100%. This allowed our team to assume the beams described by W1 patterns present the two patterns described in Table 75.

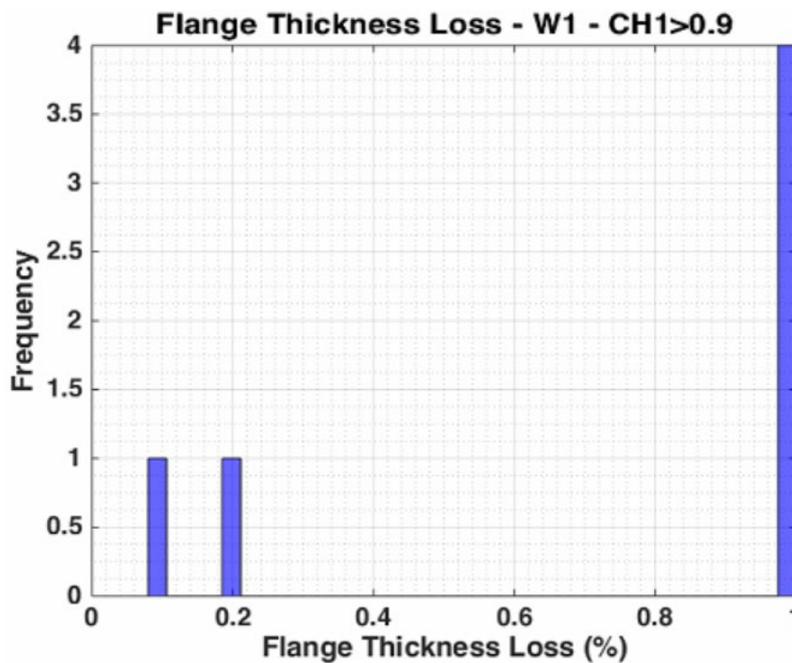
Figure 69: Flange thickness loss distribution for CH1>0.9 - CTDOT

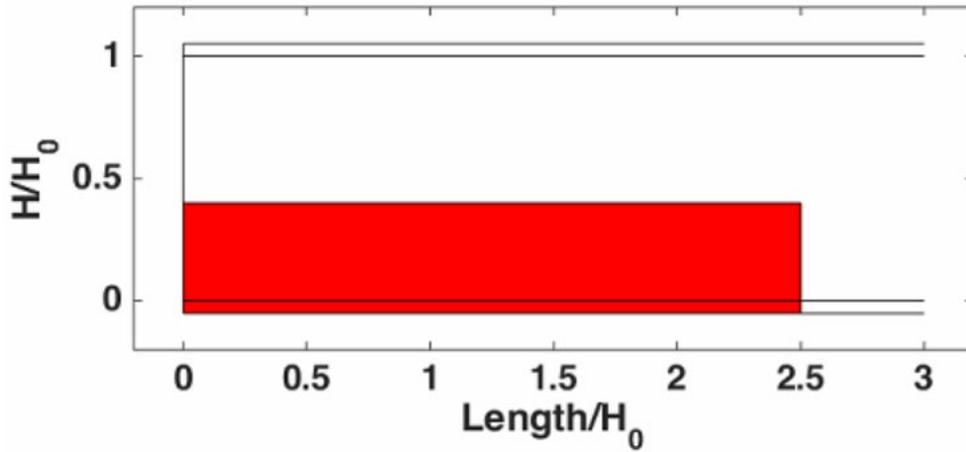
Based on Table 75, our team was able to plot the extreme corrosion scenarios for pattern W1.

Figure 70: Extreme scenario for pattern W1 - CTDOT

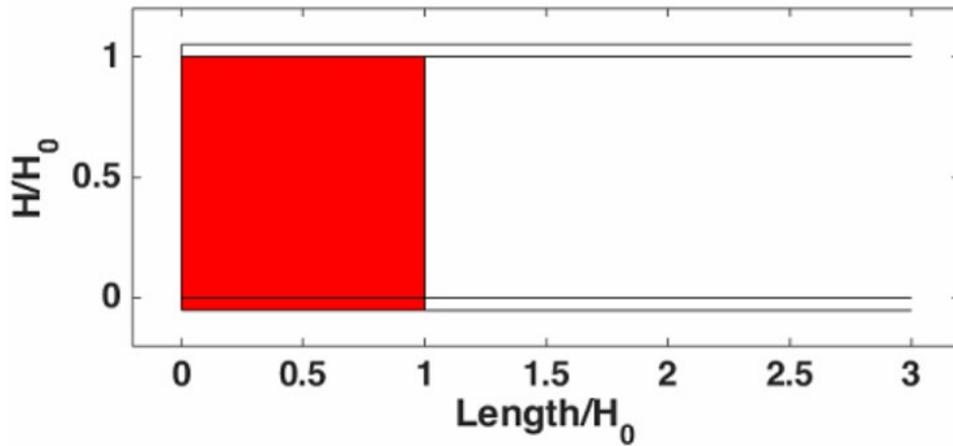
Figure 71: Extreme scenario for pattern W1 - CTDOT

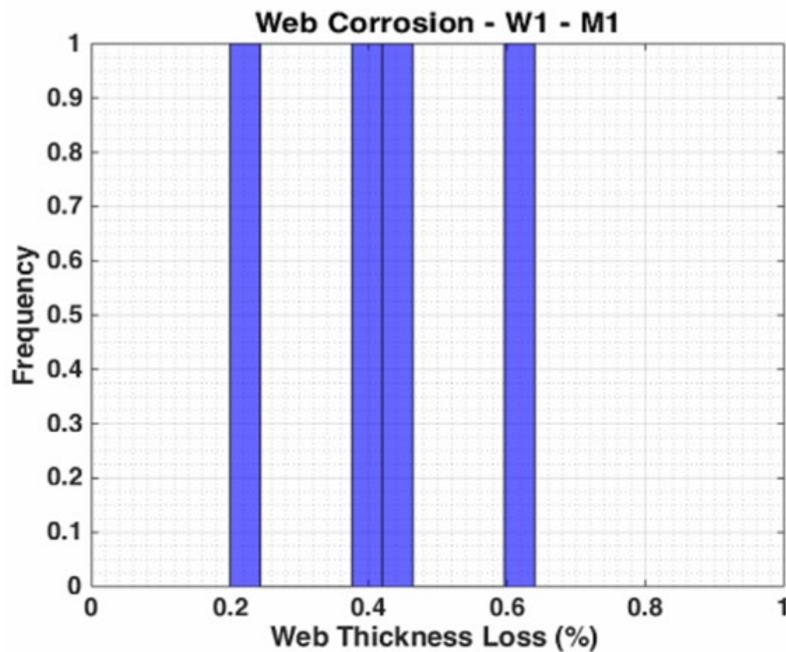
The web thickness loss distribution for beam ends with M1 holes is:

Figure 72: Web thickness loss for beam ends with M1 holes - CTDOT

From Figure 72, Figure 73, Figure 74, and Figure 75 is not possible to determine the thickness in which the holes will appear. While this is a clear observation, the figures hint that corrosion holes can appear even for cases in which the thickness loss is not extreme. As a result of this, and due to the small amount of data regarding corrosion holes, it is not possible to define any trend or try to make any prediction of what causes the holes to appear.

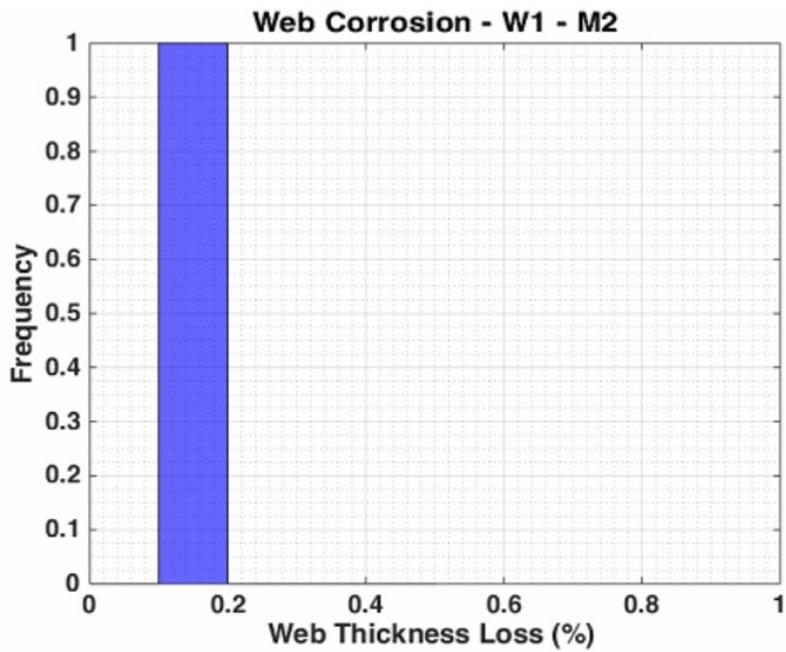
The web thickness loss distribution for beam ends with M2 holes is:

Figure 73: Web thickness loss for beam ends with M2 holes - CTDOT

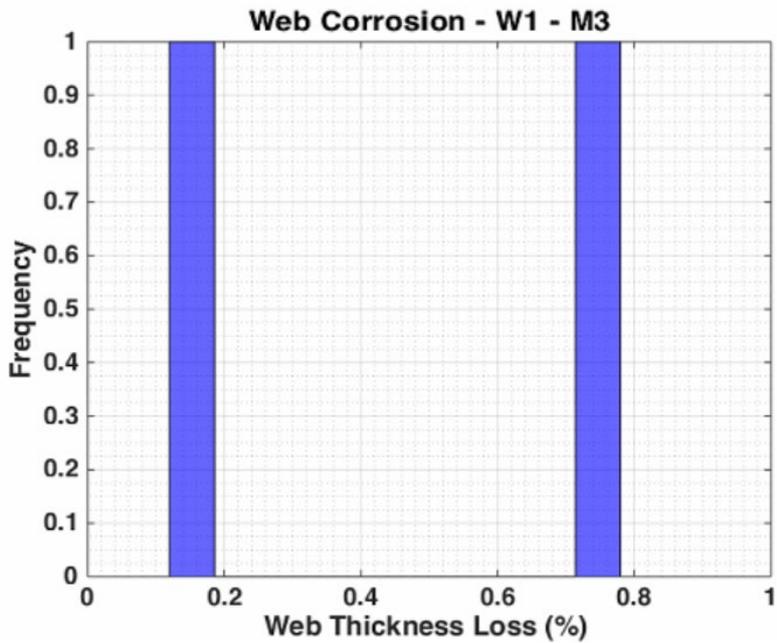
The web thickness loss distribution for beam ends with M3 holes is:

Figure 74: Web thickness loss for beam ends with M3 holes - CTDOT

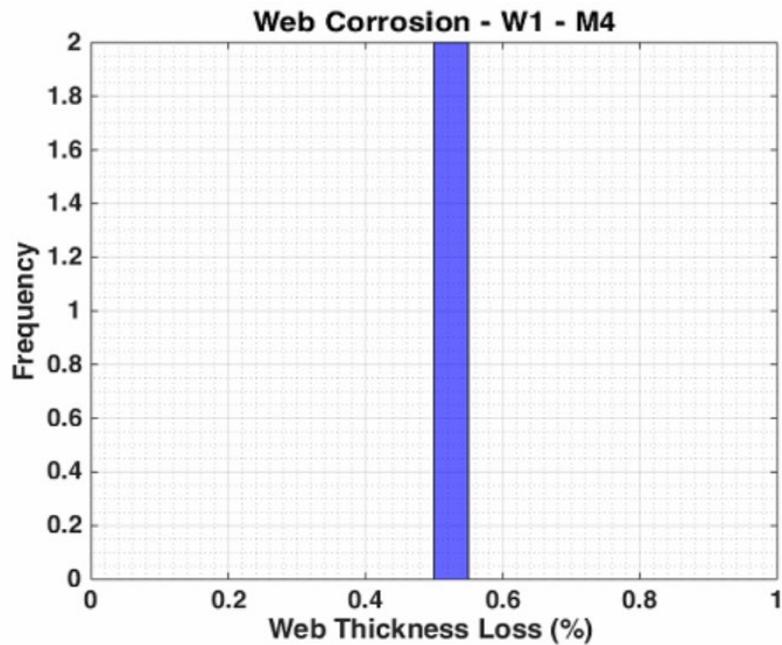
The web thickness loss distribution for beam ends with M4 holes is:

Figure 75: Web thickness loss for beam ends with M4 holes - CTDOT

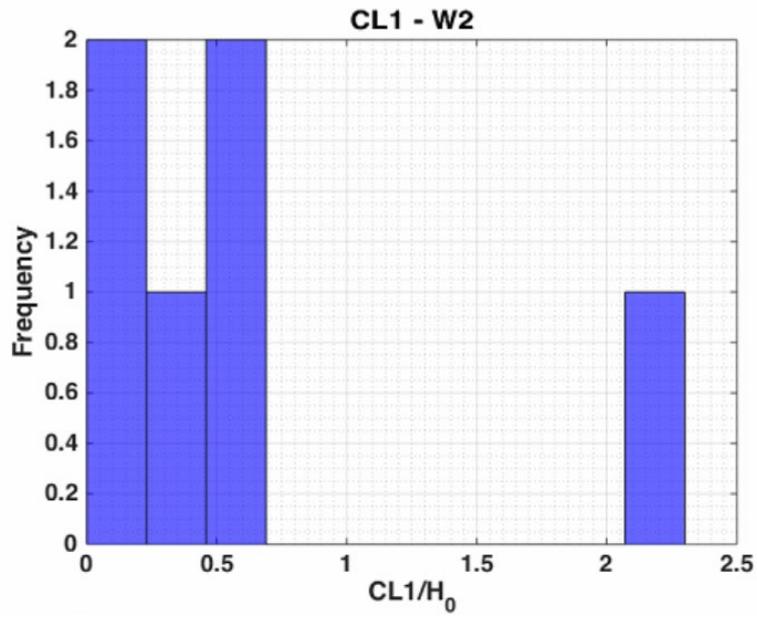
The W2 corrosion pattern was observed only six times throughout the reports from the state of Connecticut. In a similar way to how W1 was recorded, the measurements for the W2 pattern provided in the reports were normalized by H0. Figure 76, Figure 77 and Figure 78 depict the distribution of the parameters of pattern W2. The parameters for the corrosion patterns can be found with corresponding diagrams in Section 1.5 *Corrosion Patterns* of this report.

Figure 76: CL1 distribution for W2 pattern - CTDOT

From Figure 76, there is a trend present regarding CL1, as $CL1 < 0.6H0$ for most of the beam ends reported. This allowed our team to analyze the behavior of the other parameters given that $CL1 < 0.6H0$.

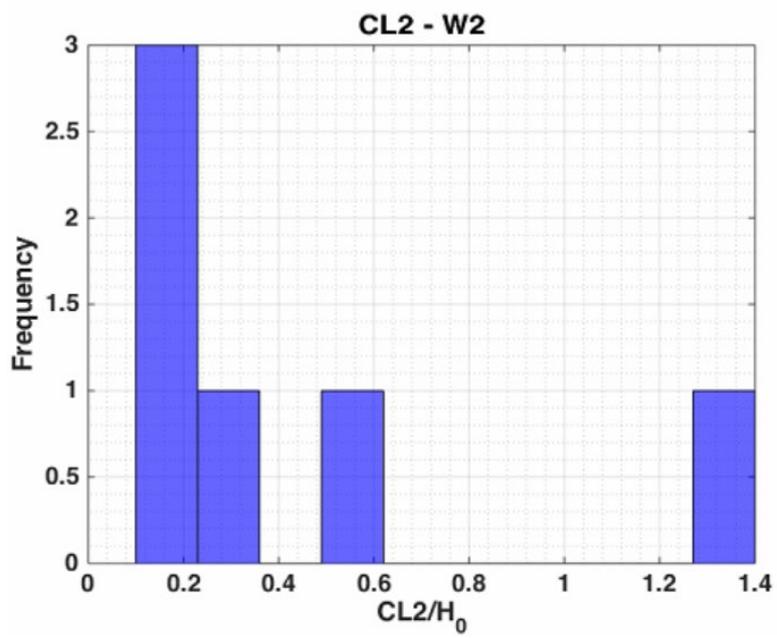
Figure 77: CL2 distribution for W2 pattern - CTDOT

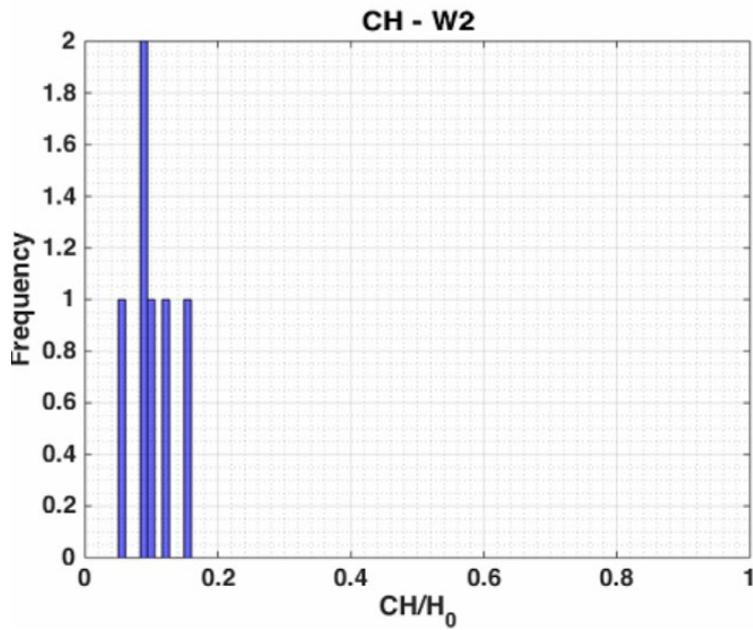
Figure 78: CH distribution for W2 pattern - CTDOT

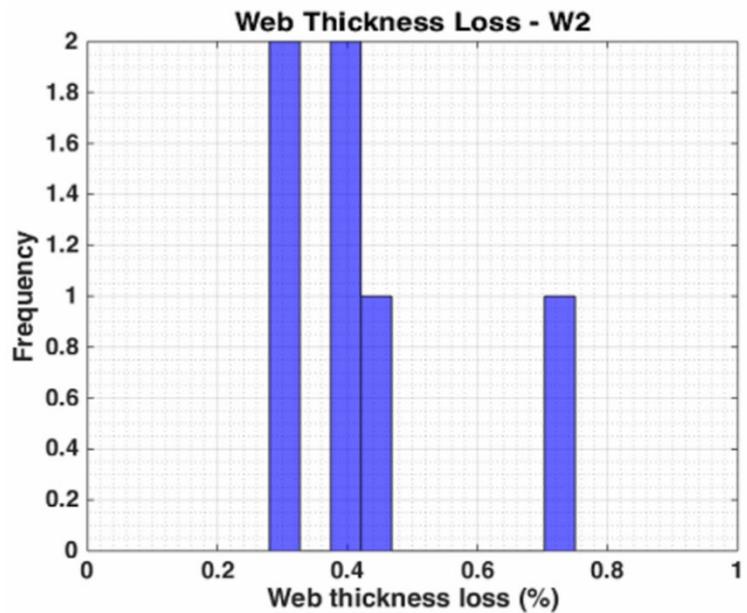
The distribution of web thickness loss depicted in Figure 79.

Figure 79: Web thickness loss for W2 pattern - CTDOT

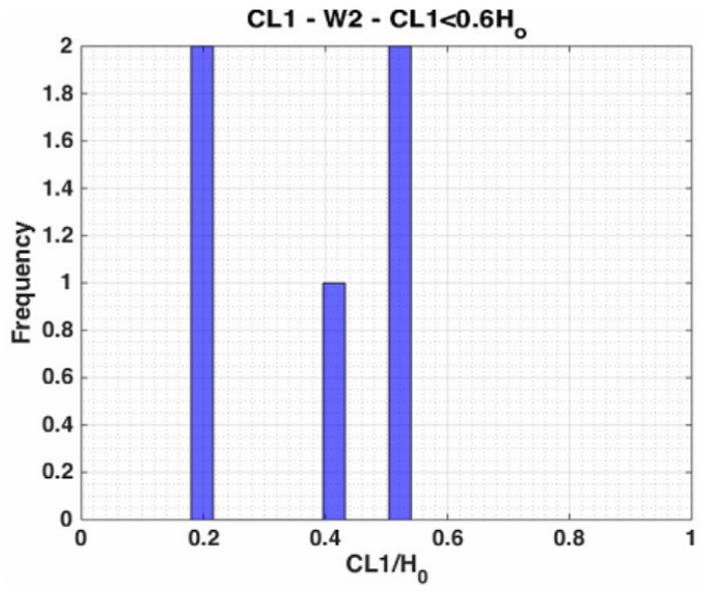
Figure 80: CL1 distribution for W2 pattern and CL1<0.6H - CTDOT

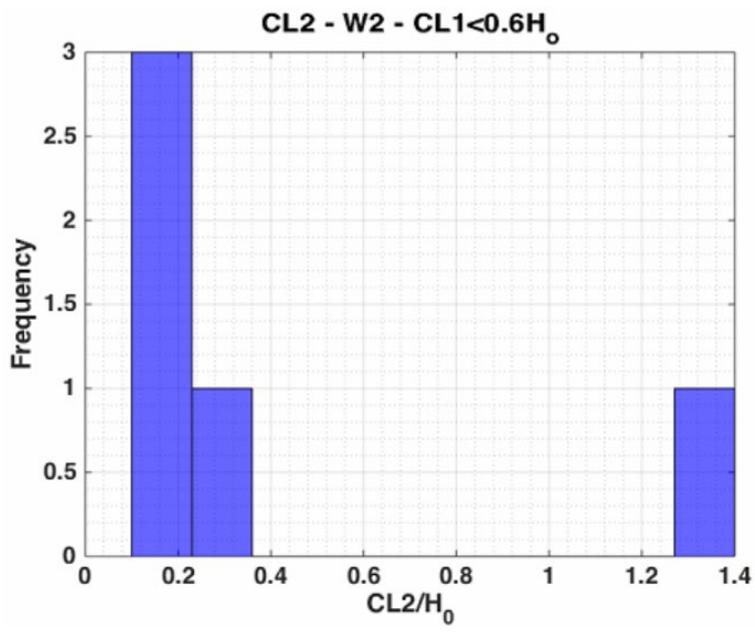
Figure 81: CL2 distribution for W2 pattern and CL1<0.6H - CTDOT

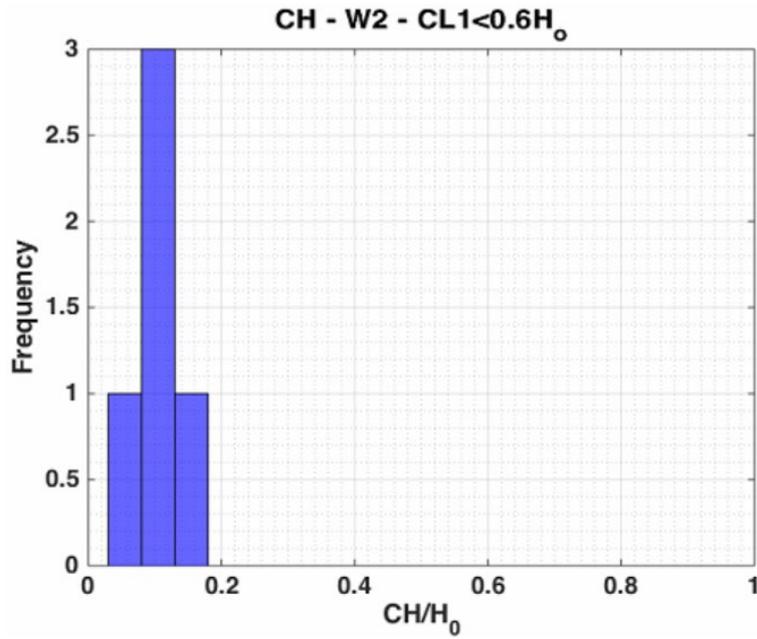
Figure 82: CH distribution for W2 pattern and CL1<0.6H - CTDOT

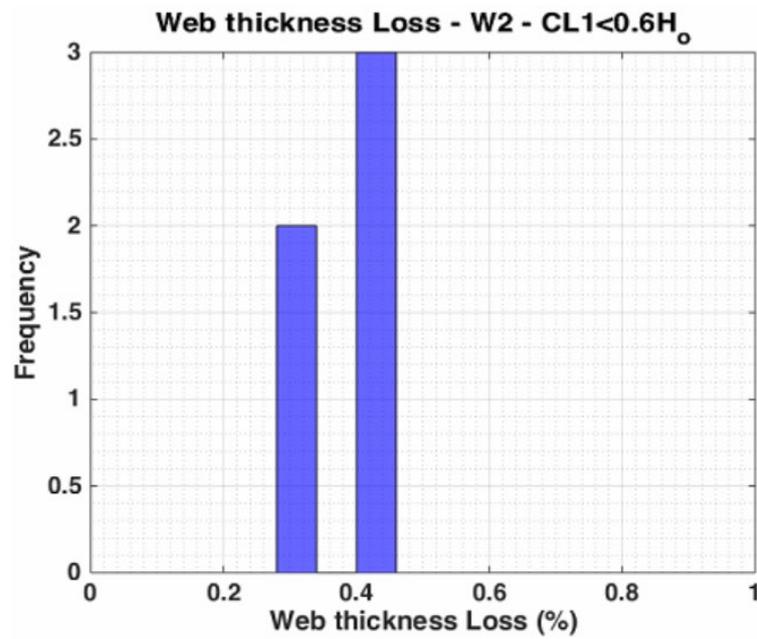
Figure 83: Web thickness loss for W2 pattern and CL1<0.6H - CTDOT

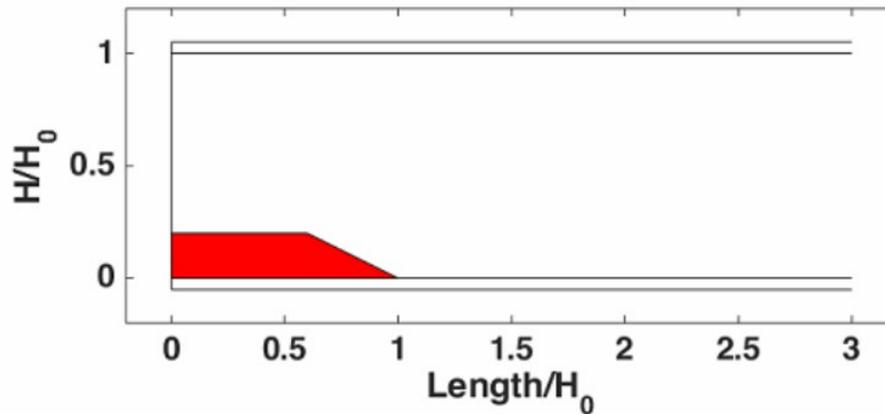
Therefore, it is valid to assume that $0 < CL_1 \leq 0.6 H_0$, $0.1H_0 \leq CL_2 \leq 0.4H_0$, $0 < CH \leq 0.2H_0$ and $0.3 \leq \frac{t_{loss}}{t_{web}} \leq 0.45$. The extreme scenario for W2 is depicted in Figure 84.

Figure 84: Extreme corrosion scenario for pattern W2 - CTDOT

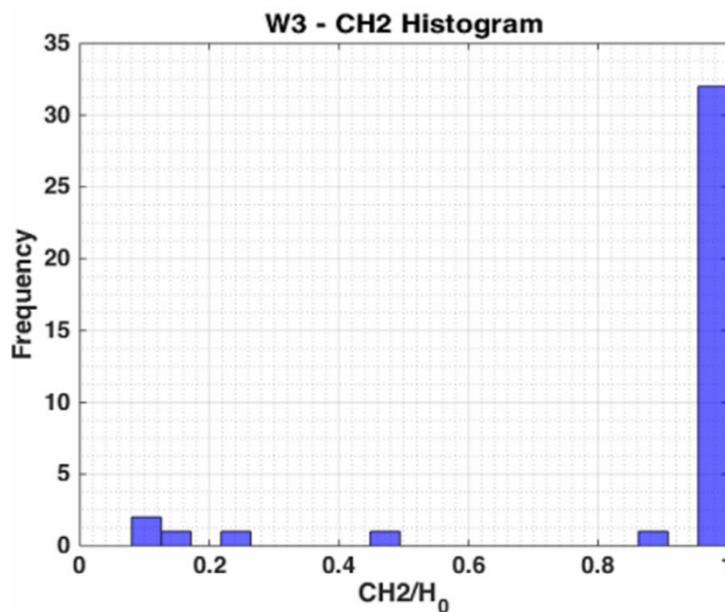
The analysis began by studying the distribution of CH2, depicted in Figure 85. The parameters for the corrosion patterns can be found with corresponding diagrams in Section 1.5 *Corrosion Patterns* of this report.

Figure 85: CH2 distribution for W3 pattern - CTDOT

A single trend for when $CH_2 > 0.9H_0$ is clearly observed in Figure 85. Given that $CH_2 > 0.9H_0$, our team could plot the distribution of the other parameters of the corrosion pattern given that $CH_2 > 0.9H_0$. This is shown in the following figures.

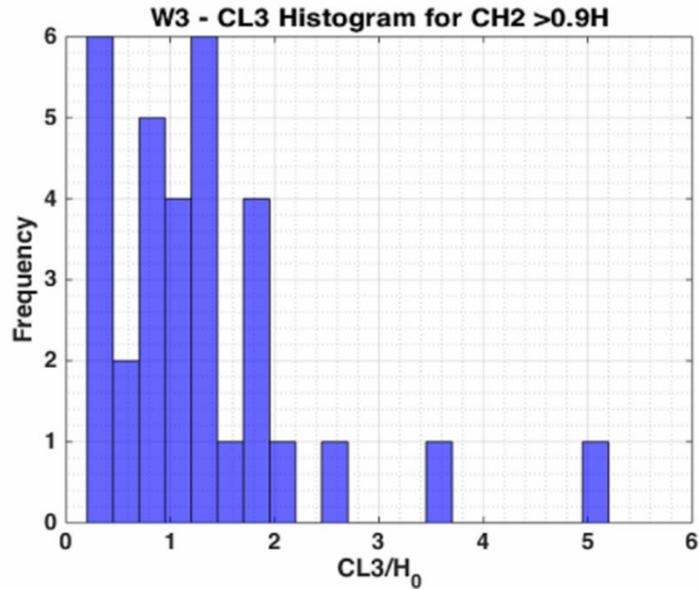
Figure 86: CL3 distribution for W3 pattern - CTDOT

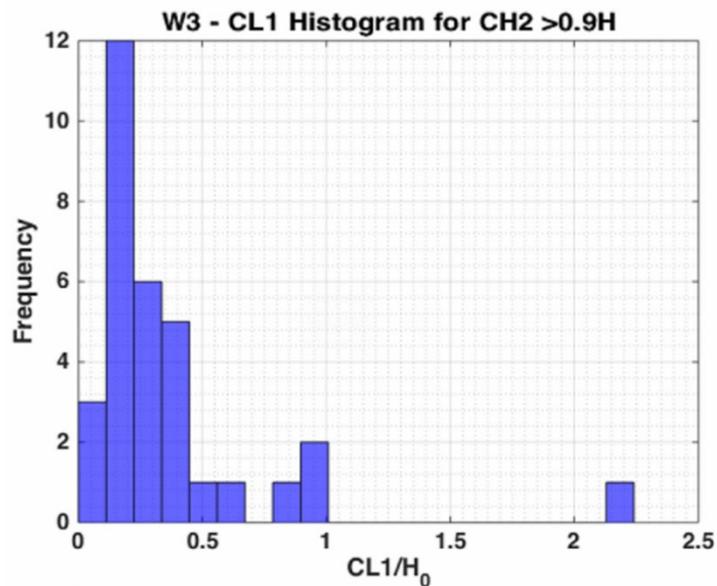
Figure 87: CL1 distribution for W3 pattern and $CH_2 > 0.9H$ - CTDOT

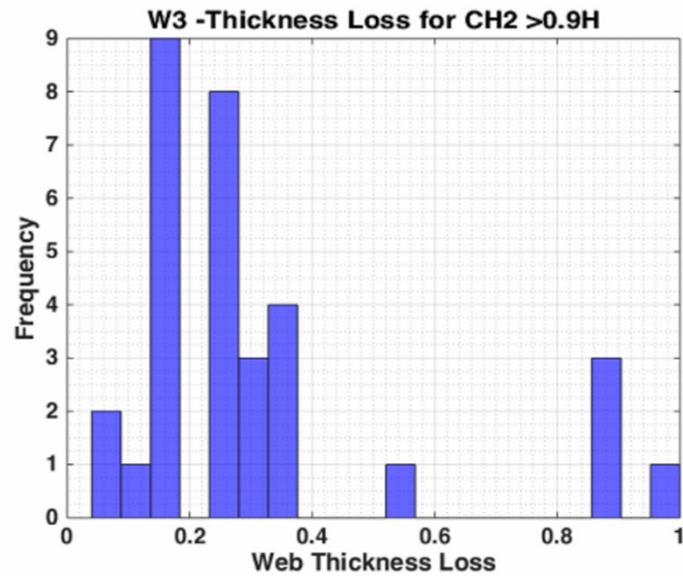
Figure 88: Web thickness loss distribution for W3 pattern and CH2>0.9H - CTDOT

From the last figures, our team was able to conclude that:

$$\begin{aligned}
 0 < CH_1 &\leq 0.4H_0 \\
 0.9H_0 &\leq CH_2 \leq 1H_0 \\
 0 < CH_3 &\leq 0.4H_0 \\
 0 < CL_1 &\leq 1H_0 \\
 0 < CL_2 &\leq 1.5H_0 \\
 0 < CL_3 &\leq 2.5H_0 \\
 0 < \frac{t_{loss}}{t_{web}} &\leq 0.4
 \end{aligned}$$

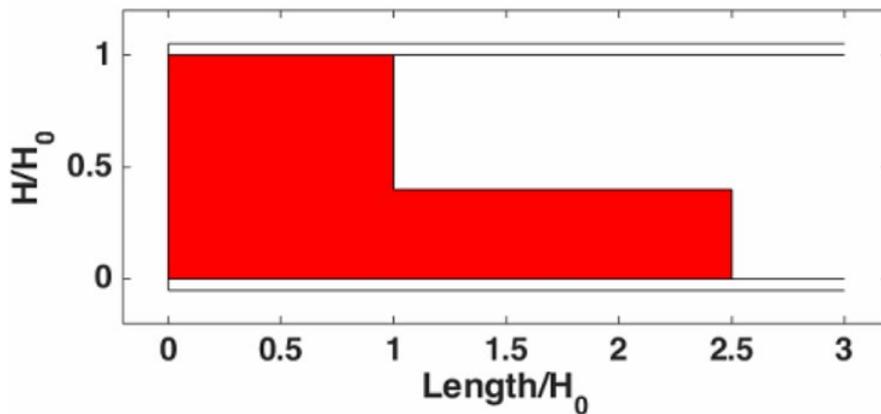
This resulted in the extreme scenario for pattern W3:

Figure 89: Extreme corrosion scenario for W3 pattern – CTDOT

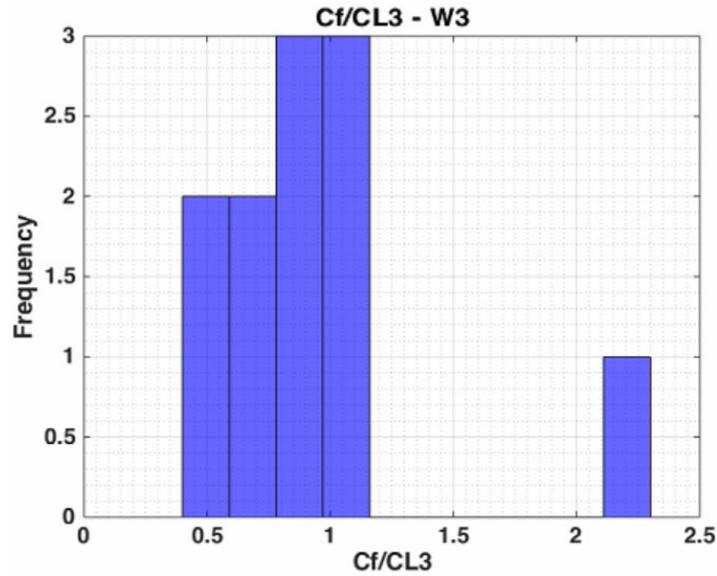
Figure 90: Ratio between corrosion length in the flanges and CL3 for W3 pattern - CTDOT

The ratio between the length of corrosion in the flanges and the total corroded length (CL3) is depicted in Figure 90. Figure 91 depicts the raw corrosion length in the flange.

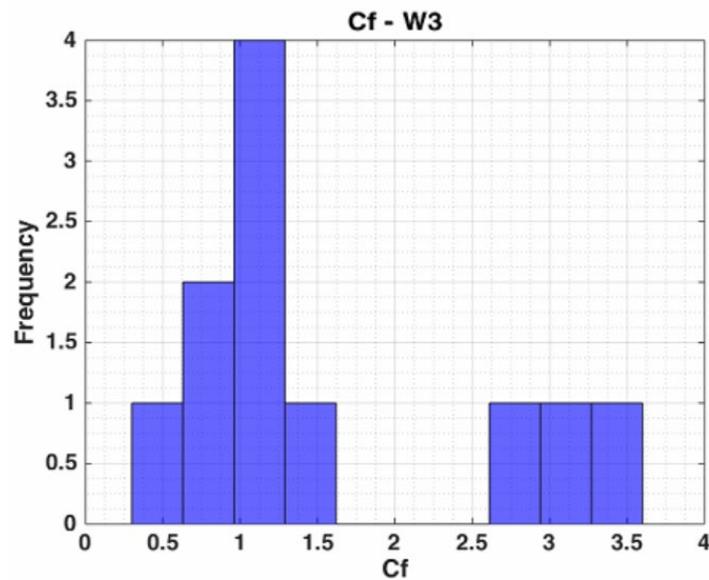
Figure 91: Raw corrosion length in the flanges for W3 pattern - CTDOT

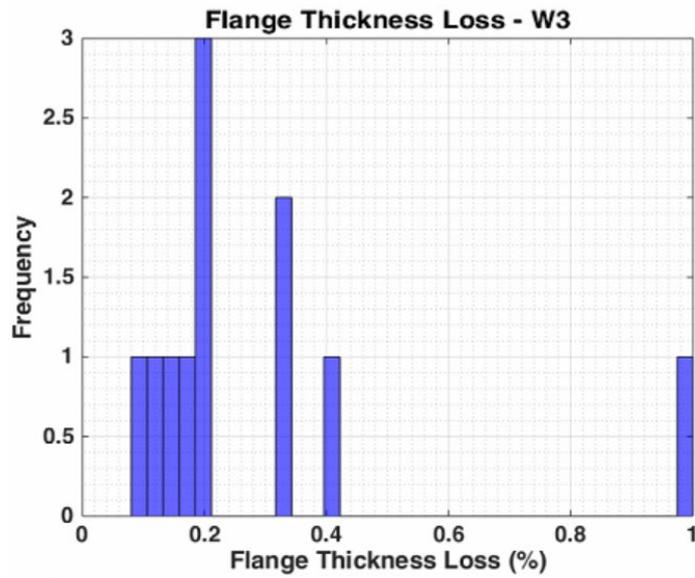
Figure 92: Flange thickness loss for W3 pattern - CTDOT

Figure 92 depicts the distribution of the thickness loss in the flanges. Similar to the previous sections, our team could assess the distribution of thickness loss for $CH_2 > 0.9$. This case is depicted on Figure 93.

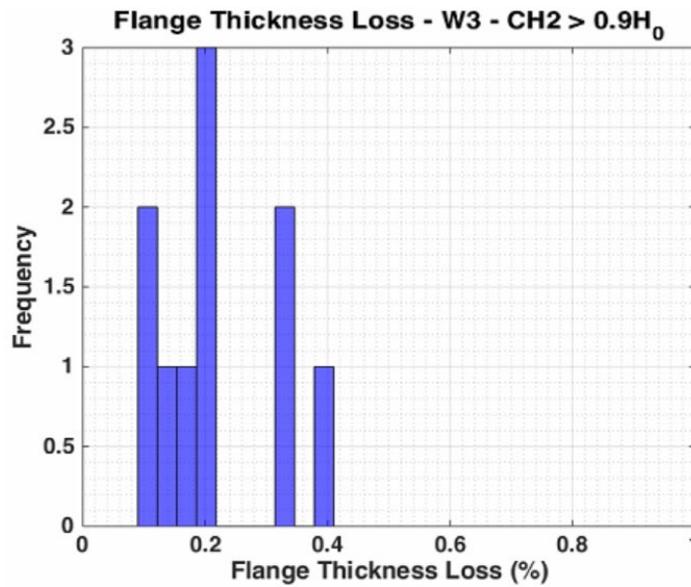
Figure 93: Flange thickness loss for W3 pattern and CH2>0.9H - CTDOT

As a result, for the case of CH2>0.9H0, our team assumed that $0.1 < \frac{t_{loss}}{t_{flange}} < 0.4$.

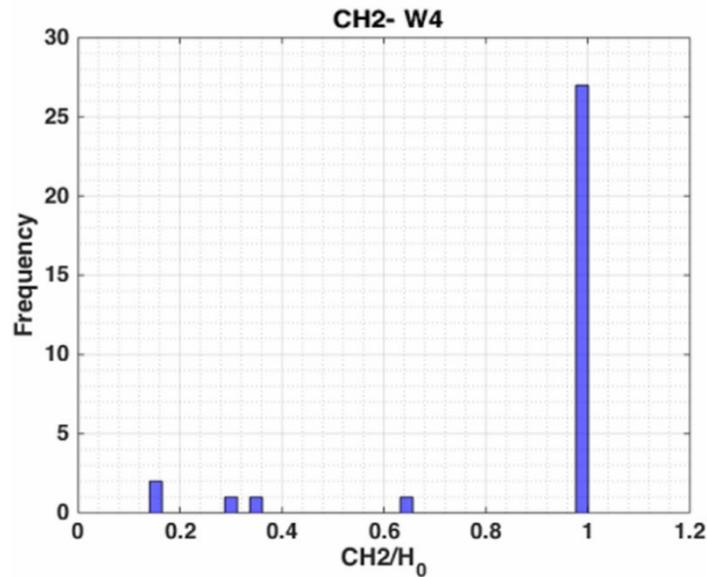
Figure 94: CH2 distribution for W4 pattern - CTDOT

Like the other studies conducted, this study started by analyzing CH2, depicted in Figure 94. The parameters for the corrosion patterns can be found with corresponding diagrams in Section 1.5 *Corrosion Patterns* of this report.

Figure 94 clearly depicts that CH2 is equal to 1 for most beam ends reported. Using this information, our team was able to further analyze the other parameters for CH2>0.9H0. The following figures depict the behavior of the other parameters for CH2>0.9H0.

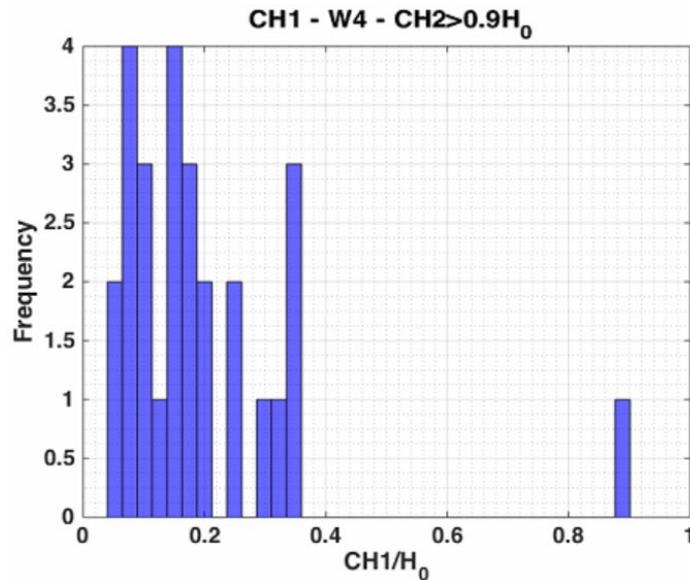
Figure 95: CH1 distribution for W4 pattern and CH2>0.9H - CTDOT

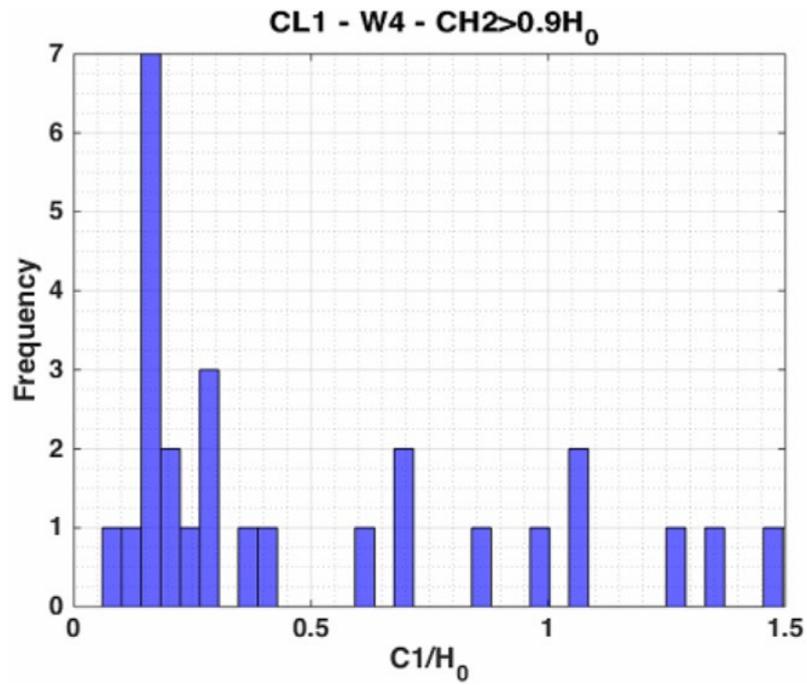
Figure 96: CL1 distribution for W4 pattern and CH2>0.9H - CTDOT

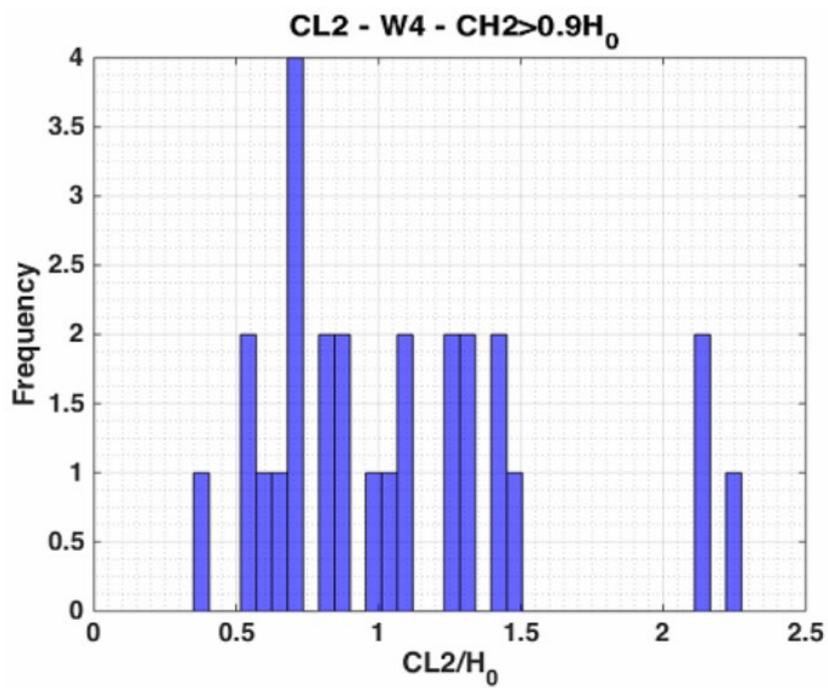
Figure 97: CL2 distribution for W4 pattern and CH2>0.9H - CTDOT

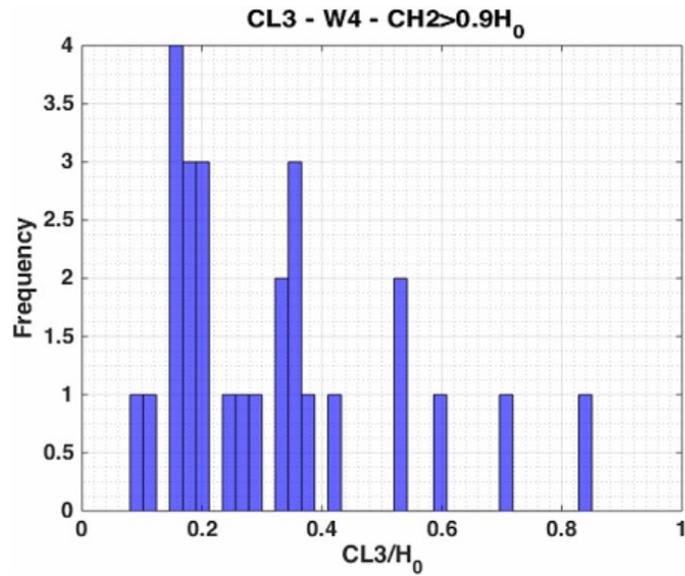
Figure 98: CL3 distribution for W4 pattern and CH₂>0.9H - CTDOT

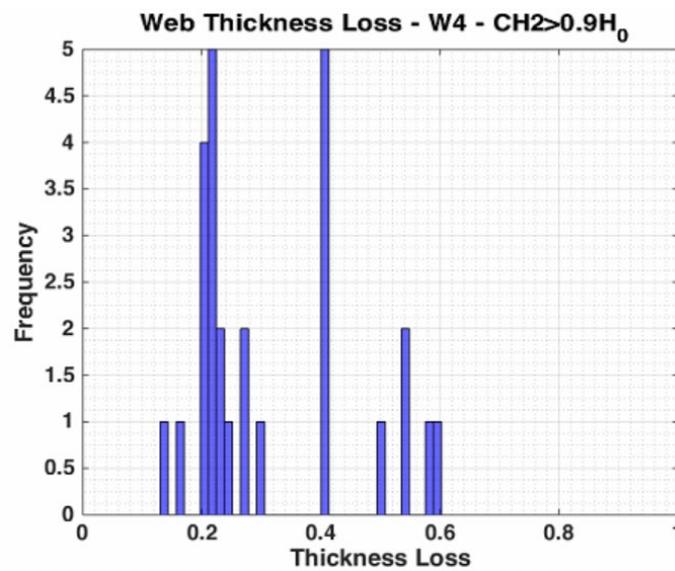
Figure 99: Web thickness loss distribution for W4 pattern and CH₂>0.9H - CTDOT

$$\begin{aligned}
 0 < CH_1 &\leq 0.4H_0 \\
 0.9H_0 &\leq CH_2 \leq 1H_0 \\
 0 < CL_1 &\leq 1H_0 \\
 0.5H_0 < CL_2 &\leq 1.5H_0 \\
 0.1H_0 < CL_3 &\leq 0.5H_0 \\
 0.1 \leq \frac{t_{loss}}{t_{web}} &\leq 0.6
 \end{aligned}$$

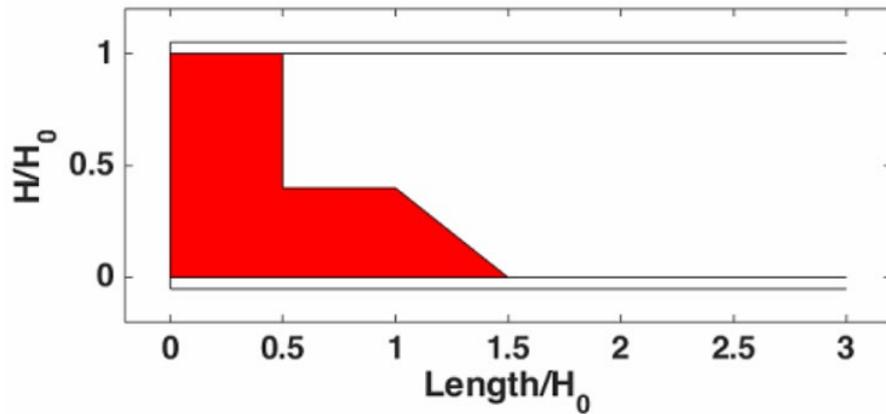
Thus, the extreme scenario for pattern W4 is:

Figure 100: Extreme corrosion scenario for W4 pattern - CTDOT

According to the table above, the W2 corrosion pattern is combined once with the M1 hole corrosion pattern and 4 times with the M2 hole corrosion pattern. As it was already mentioned W2 and W1 will be combined and used as one pattern. Thus, for the M1 hole corrosion pattern our team checked if the dimensions of the unique hole belong in the range of the W1 pattern and M1 pattern combination. The unique hole with $a=0.089H_0$ and $b=0.31H_0$ satisfies the limits of Figure 100.

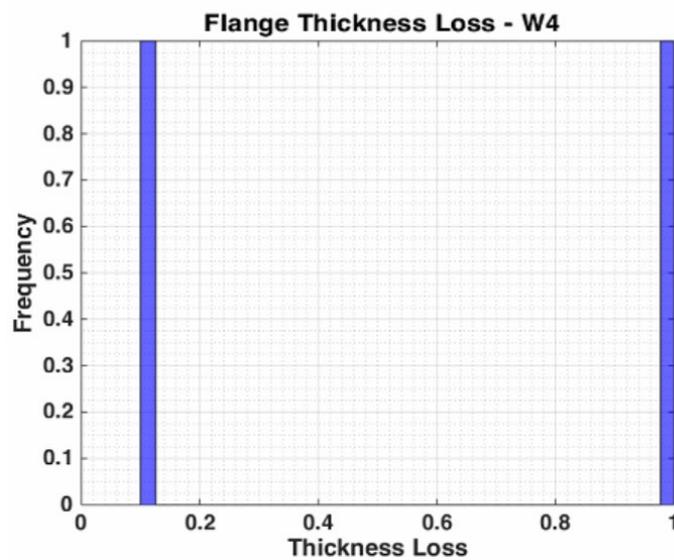
Figure 101: Flange thickness loss for W4 pattern - CTDOT

The information regarding flange corrosion combined with the W4 corrosion pattern was rarely observed in the reports analyzed from CTDOT. For this reason, the research team was not able to draw any conclusion nor trends from the available data. The histogram of the two observed flange corrosion scenarios can be found in Figure 101.

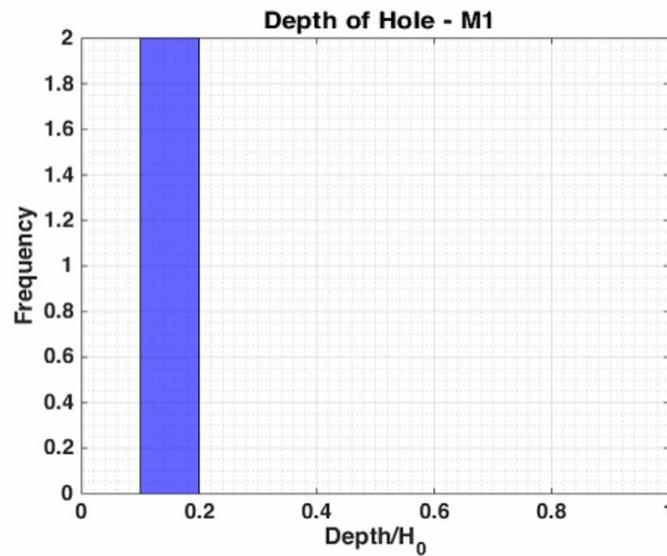
Figure 102: Depth of hole M1 combined with W4 pattern - CTDOT

For the corrosion combination of W4 with holes, only three holes were observed with the W4 pattern. It is important to note that the data here is not enough in order to draw conclusions via the histograms in Figure 102, Figure 103, Figure 104, and Figure 105. These depict the dimensions of the holes observed.
