Improved Load Rating Procedures for Deteriorated Unstiffened Steel Beam Ends

Prepared For:
New England Transportation Consortium
January 2024

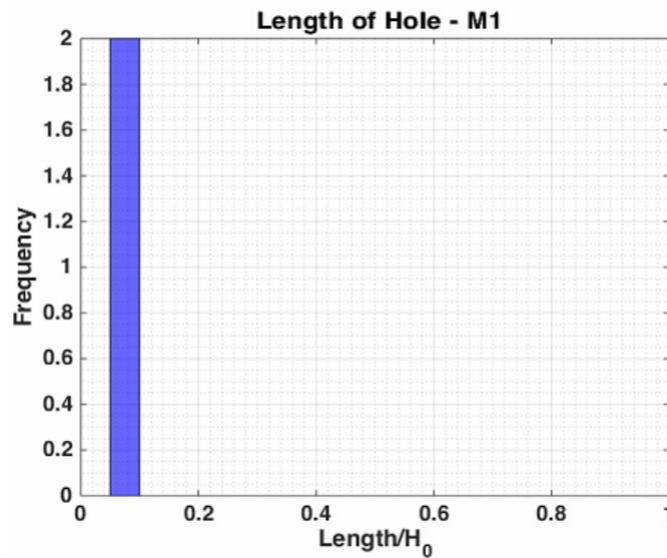
Figure 103: Length of hole M1 combined with W4 pattern - CTDOT

For the corrosion combination of W4 with holes, only three holes were observed with the W4 pattern. It is important to note that the data here is not enough in order to draw conclusions via the histograms in Figure 102, Figure 103, Figure 104, and Figure 105. These depict the dimensions of the holes observed.

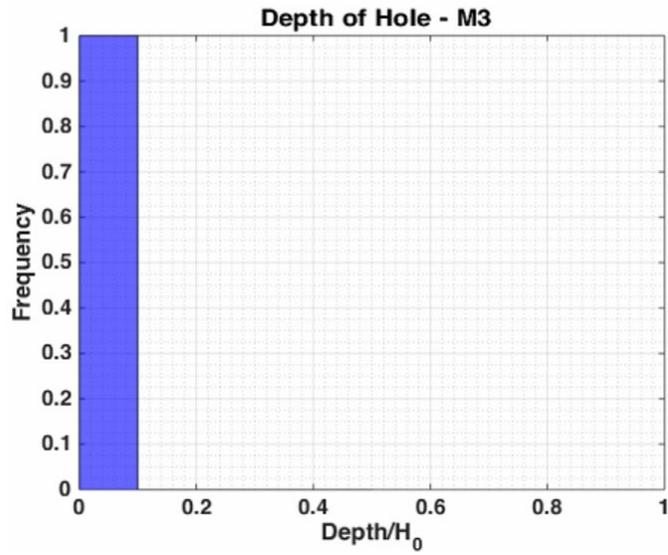
Figure 104: Depth of hole M3 combined with W4 pattern - CTDOT

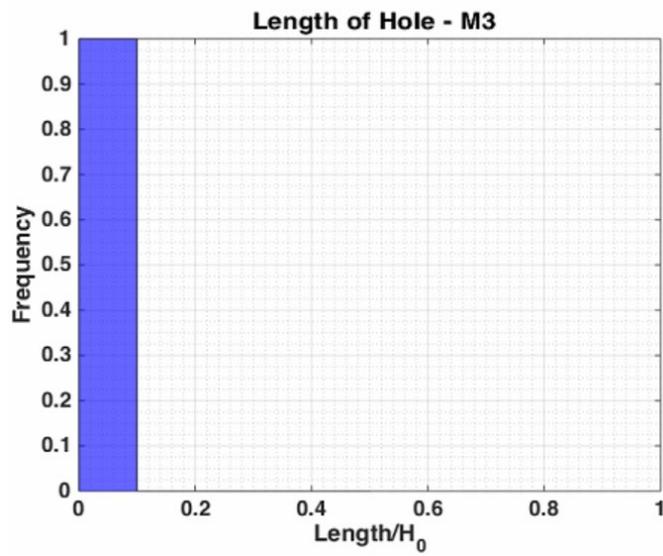
Figure 105: Length of hole M3 combined with W4 pattern - CTDOT

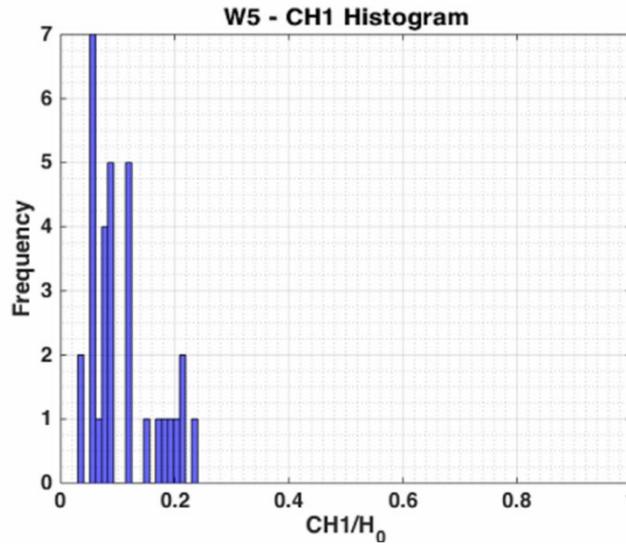
Figure 106: CH1 distribution of W5 pattern for beams without a diaphragm – CTDOT

The study began by analyzing the height of corrosion. Figure 106 depicts the distribution of CH1 for pattern W5. The parameters for the corrosion patterns can be found with corresponding diagrams in Section 1.5 *Corrosion Patterns* of this report.

Figure 106 clearly depicts that CH1 tends to be smaller than 0.2H0. This means that when analyzing the behavior of CL1 for when CH1 < 0.2H0, we found:

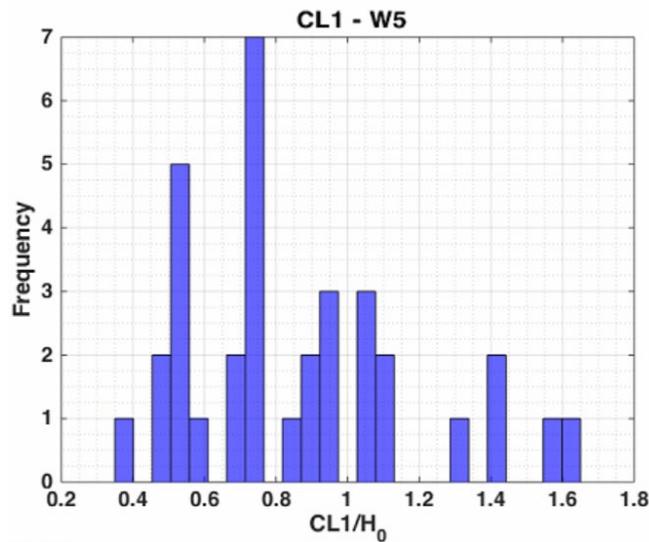
Figure 107: CL1 distribution of W5 pattern for beams without a diaphragm – CTDOT

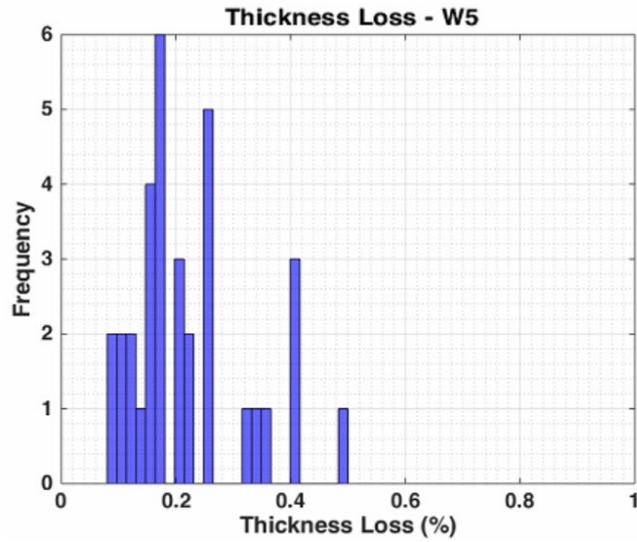
Figure 108: Web thickness loss distribution of W5 pattern for beams without a diaphragm – CTDOT

Figure 108 depicts the web thickness loss for $CH_2 > 0.9H_0$:

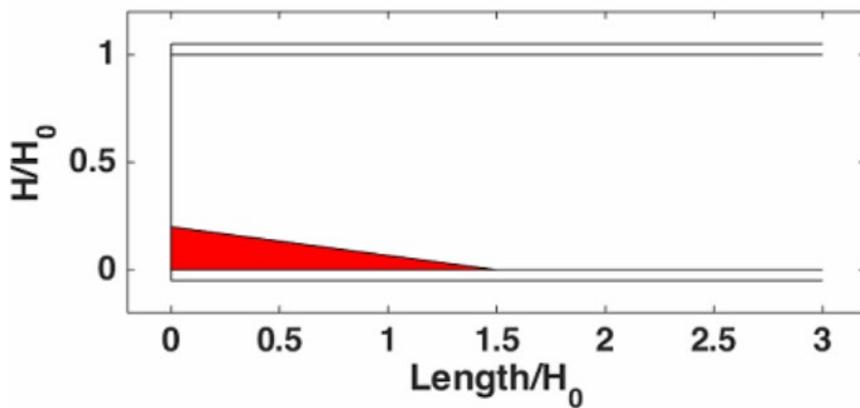
The extreme scenario for W5 pattern is:

Figure 109: Extreme corrosion scenario for pattern W5 - CTDOT

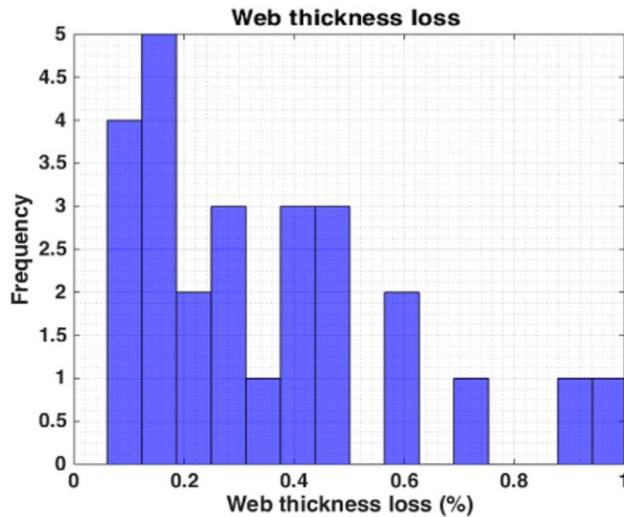
Figure 110: Web thickness loss histogram from the beam ends compiled - MaineDOT

Most of the reports presented information regarding web thickness loss. The information is provided without specifically referring to a beam. Figure 110 depicts the histogram of web thickness loss for the beams ends provided by MaineDOT.

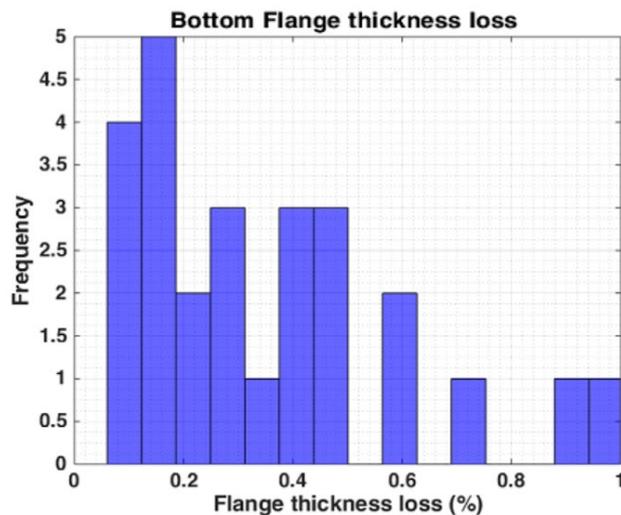
Figure 111: Bottom flange thickness loss histogram from the beam ends compiled - MaineDOT

Most of the reports that contained information regarding the web thickness loss also included information regarding flange thickness loss. More precisely, 29 out of the 39 beam ends compiled presented information regarding corrosion in the flanges. Figure 111 and Figure 112 depict the flange thickness loss for the bottom and top flanges, respectively.

The comparison between Figure 111 and Figure 112 clearly shows that the thickness loss of top flanges is smaller than the thickness loss of the bottom flanges. This is likely a result of how ice and water flow to the bottom flanges.

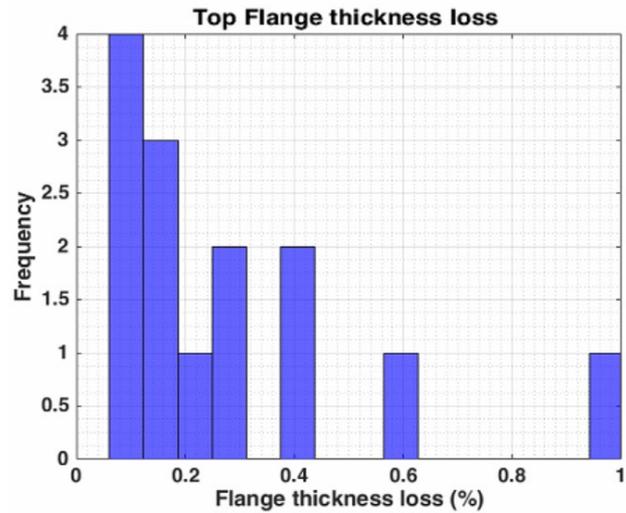
Figure 112: Top flange thickness loss histogram from the beam ends compiled - MaineDOT

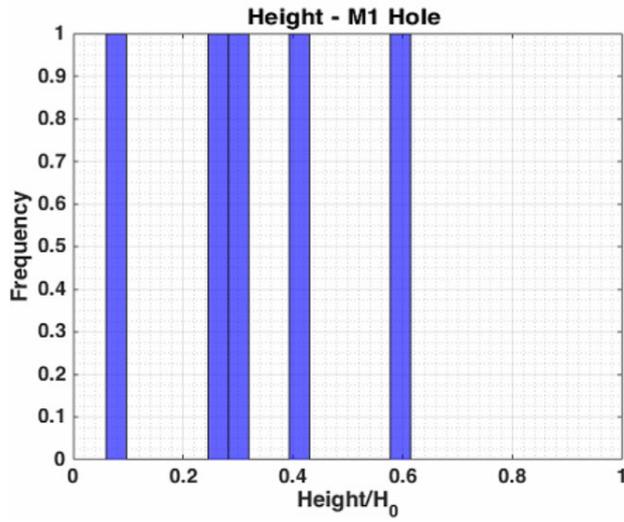
Figure 113: M1 web hole's height distribution of W1 web corrosion pattern for beams without a diaphragm - MaineDOT

All five holes observed in the reports are M1. Additionally, Figure 113 and Figure 114 depict the dimensions of the holes observed in the bridge inspection reports from MaineDOT.

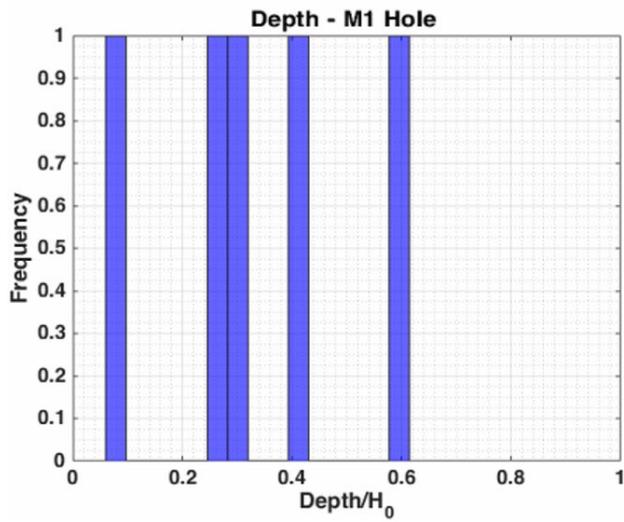
Figure 114: M1 web hole's depth distribution of W1 web corrosion pattern for beams without a diaphragm - MaineDOT

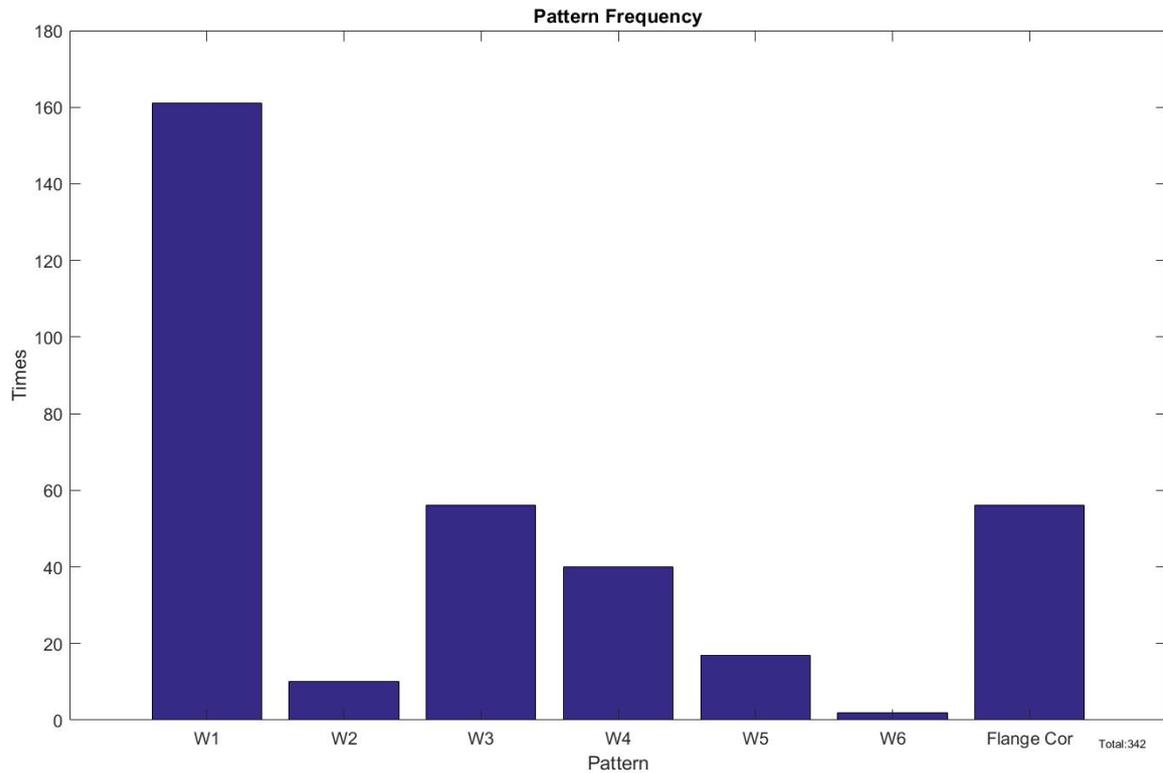
Figure 115: Web corrosion patterns distribution for beams without a diaphragm - MassDOT

The data for Massachusetts was divided in two main categories, beams ends with a diaphragm and without a diaphragm. All the graphs in this part of the document represent the second case. Figure 115 contains the frequency of each of the defined corrosion patterns (the total amount of times each pattern appears in the reports).

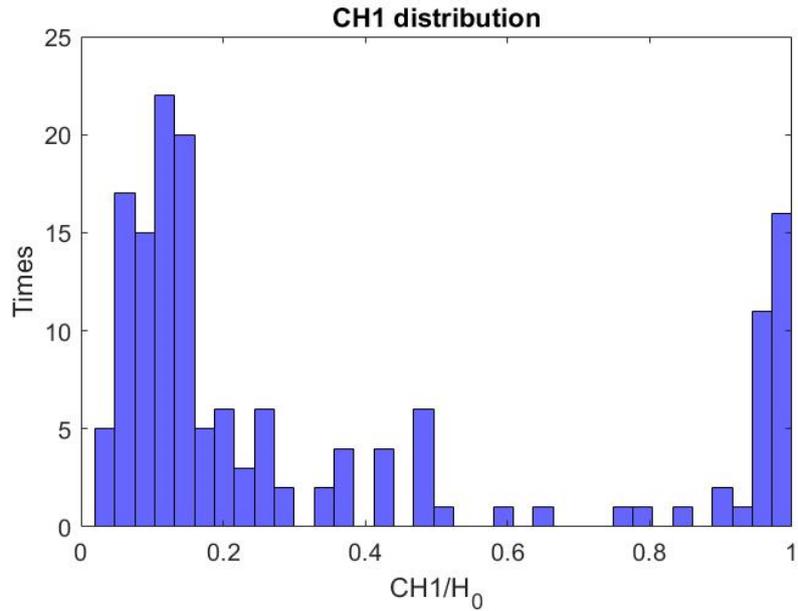
Figure 116: CH₁ distribution of W1 pattern for beams without a diaphragm - MassDOT

The distribution of CH_1 is shown in Figure 116. From this histogram, 2 main trends are noticed: either a) full height corrosion, or b) corrosion up to 30% of H_0 . The parameters for the corrosion patterns can be found with corresponding diagrams in Section 1.5 *Corrosion Patterns* of this report.

$$0 < CH_1 \leq 0.3H \text{ and } 0.9H \leq CH_1 \leq H$$

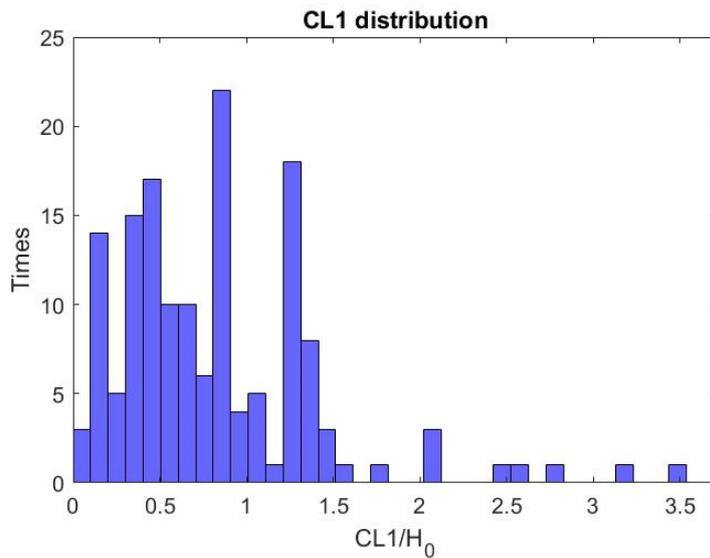
Figure 117: CL₁ distribution of W1 pattern for beams without a diaphragm - MassDOT

Similarly, the CL₁ distribution is shown in Figure 117. From this histogram, it is valid to say that most of the web corrosion length is up to 1.5 times the H₀.

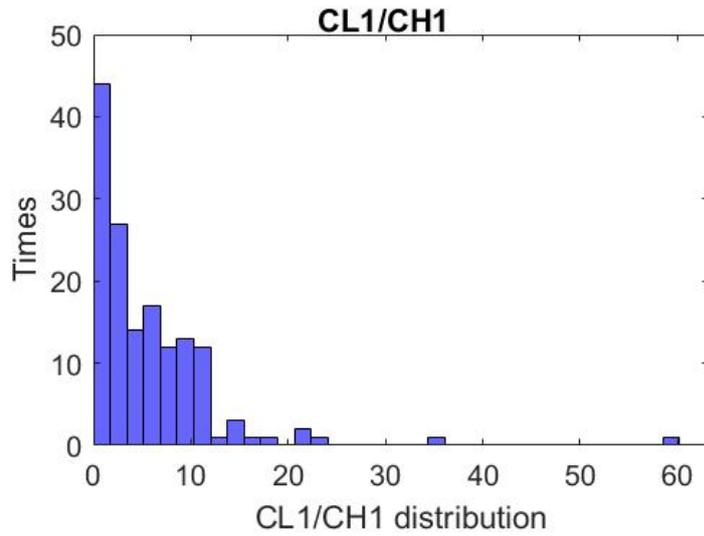
Figure 118: Ratio of corrosion length (CL_1) to corrosion height (CH_1) of W1 pattern for beams without a diaphragm - MassDOT

Figure 118 shows the ratio of CL₁/CH₁ which indicates that in general, the length of the corroded area is bigger than its height. Figure 119 focuses on the range 0-15 for the same distribution.

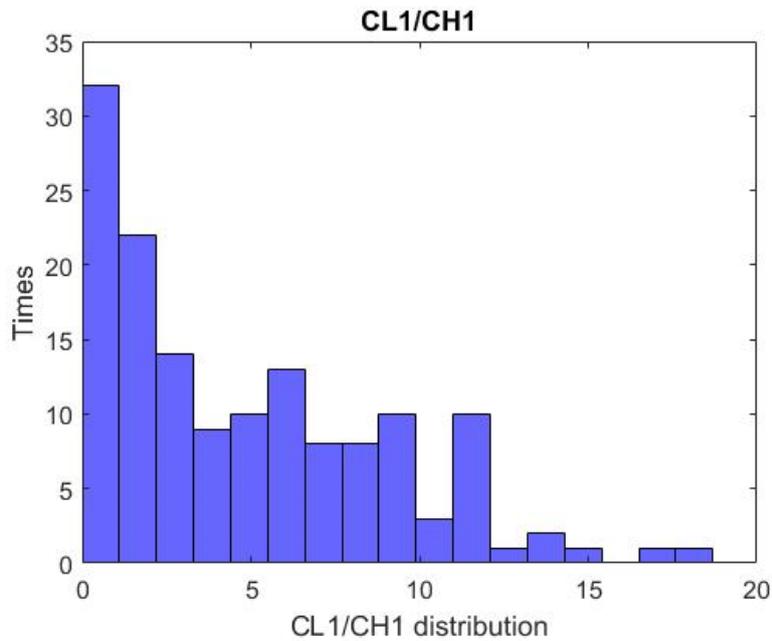
Figure 119: Ratio of corrosion length (CL_1) to corrosion height (CH_1) of W1 pattern for beams without a diaphragm (range 0-15) - MassDOT

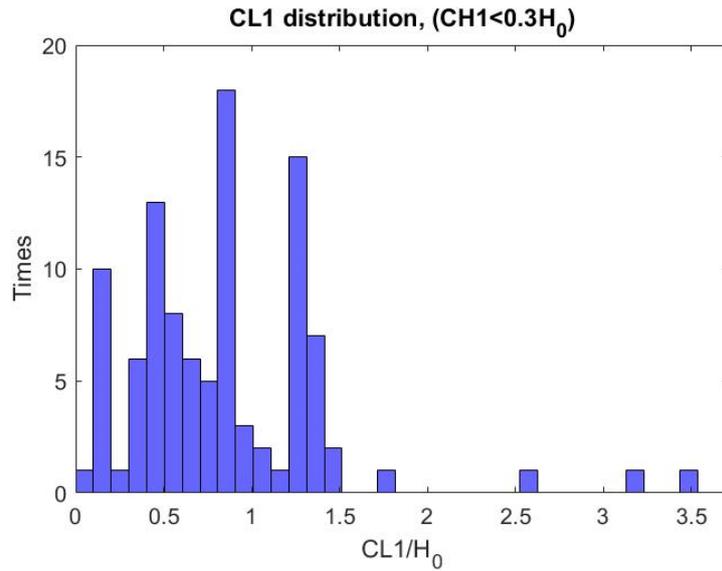
Figure 120: CL1 distribution of W1 web corrosion pattern, with corrosion height up to 30% of H₀ for beams without a diaphragm - MassDOT

As an additional step, the corrosion length and the web thickness loss distribution for each of the two cases of CH_1 were plotted, a) for $CH_1 < 0.3H_0$ (Figure 120) and b) for $CH_1 > 0.9H_0$ (Figure 121).

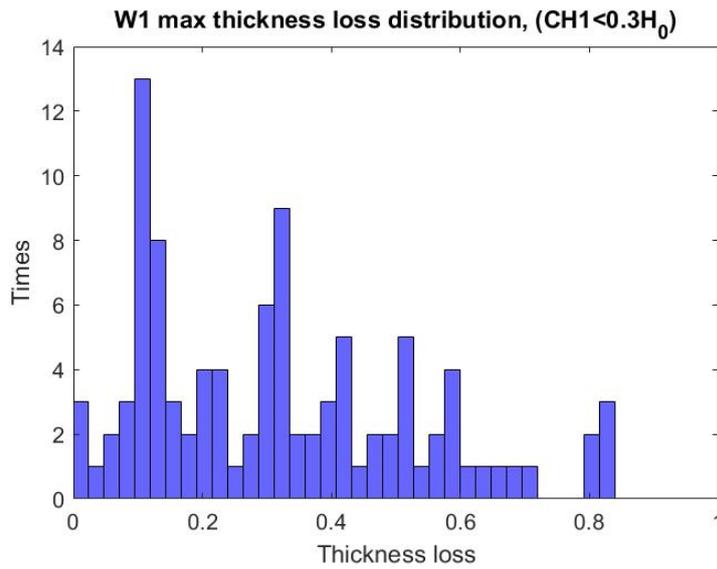
Figure 121: Max thickness loss distribution of W1 web corrosion pattern, with corrosion height up to 30% of H₀ for beams without a diaphragm - MassDOT

Based on Figure 121, we can define as extreme case the following, which covers 103 out of the 161 beam ends that demonstrate a W1 corrosion pattern without diaphragms:

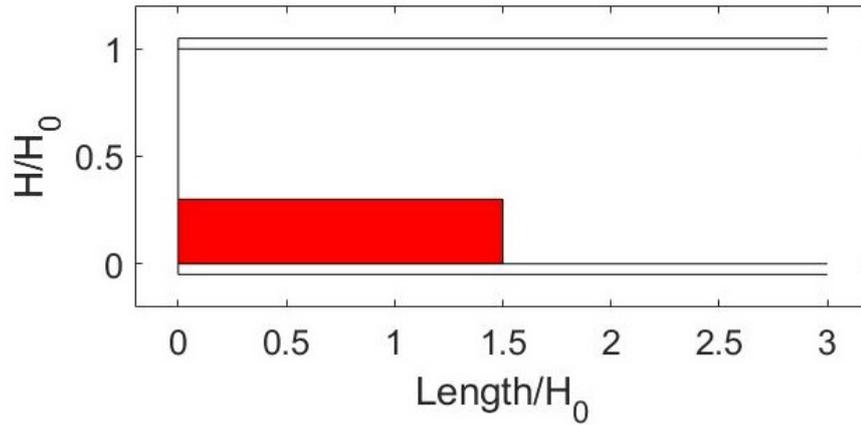
Figure 122: First extreme W1 web corrosion pattern, with corrosion height up to 30% of H0 for beams without a diaphragm - MassDOT

Based on Figure 122, the values for the web thickness loss are: $\frac{t_{loss}}{t_{web}}$ take values of {0.2,0.4,0.6,0.8}

For each of the three cases (Figure 122, Figure 125, Figure 126) the ratio of the length of the corroded flange over the length of the corroded web was plotted (figure Figure 127, Figure 128, Figure 129).

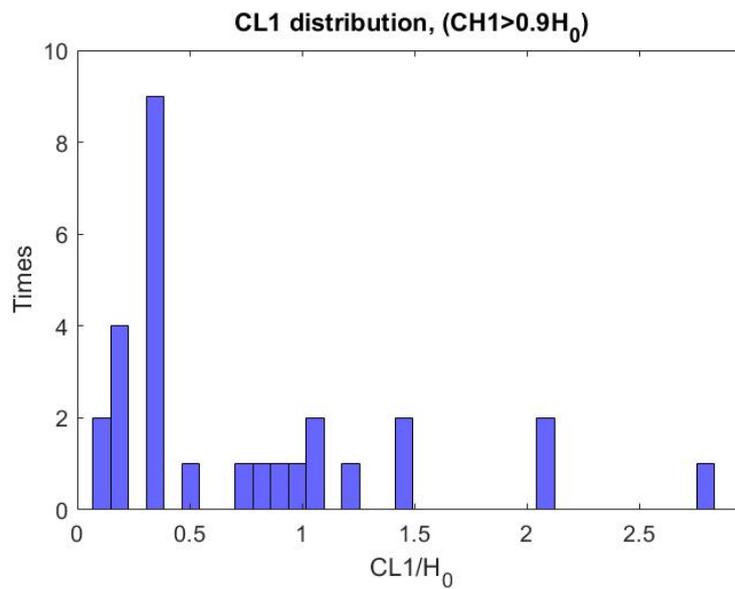
Figure 123: CL1 distribution of W1 web corrosion pattern with corrosion greater than 90% of H0 for beams without a diaphragm - MassDOT

Figure 123 shows the distribution of CL1 for the case when $CH_1 > 0.9H_0$.

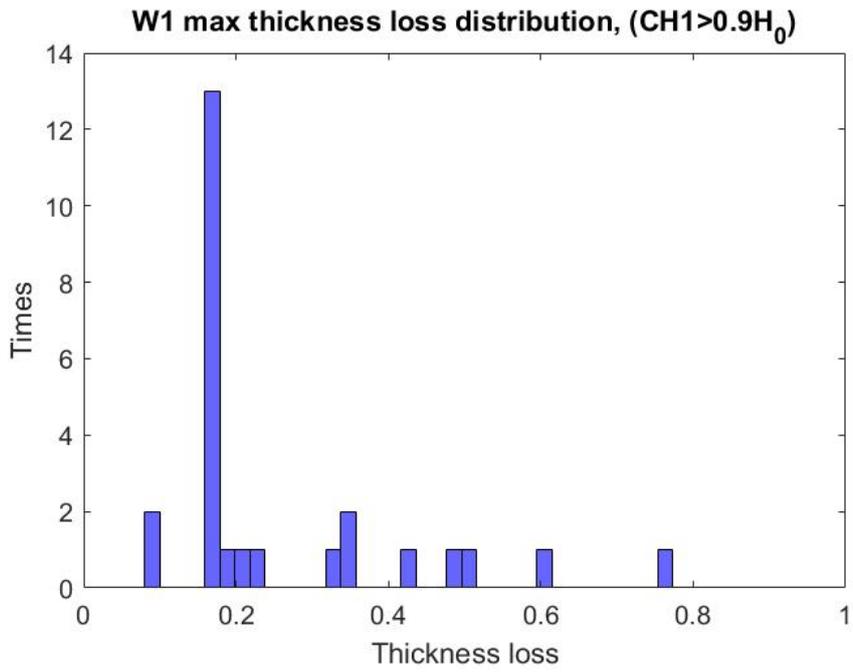
Figure 124: Max thickness loss distribution of W1 web corrosion pattern with corrosion height greater than 90% of H_0 for beams without a diaphragm - MassDOT

Figure 124 shows the maximum thickness loss distribution for the same groups of beams. Therefore, for the full height corrosion ($>0.9H_0$), two different cases are identified as shown in Figure 125 and Figure 126.

From Figure 124 we can conclude that the web thickness loss for this case is:

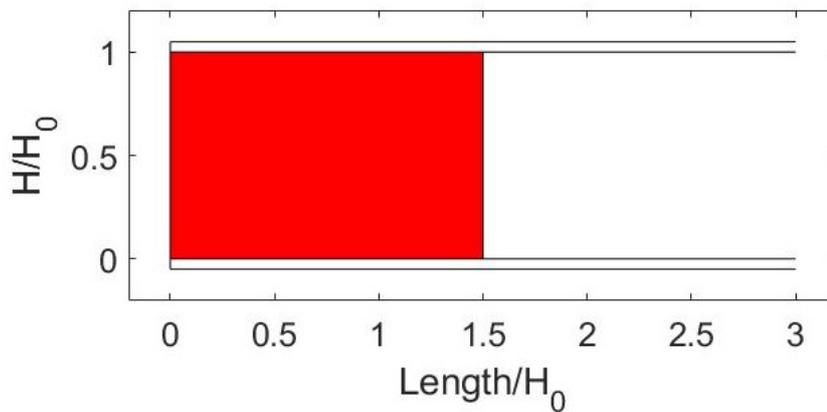
Figure 125: Second extreme W1 web corrosion pattern, with corrosion height greater than 90% of H_0 for beams without a diaphragm - MassDOT

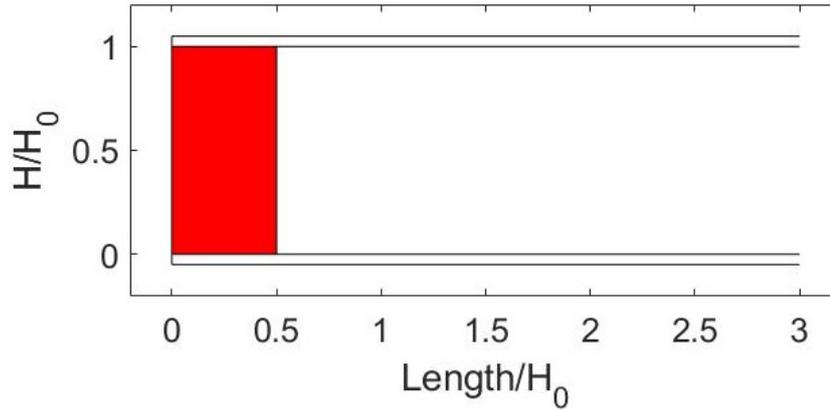
Figure 126: Third extreme W1 web corrosion pattern, with corrosion height greater than 90% of H_0 for beams without a diaphragm - MassDOT

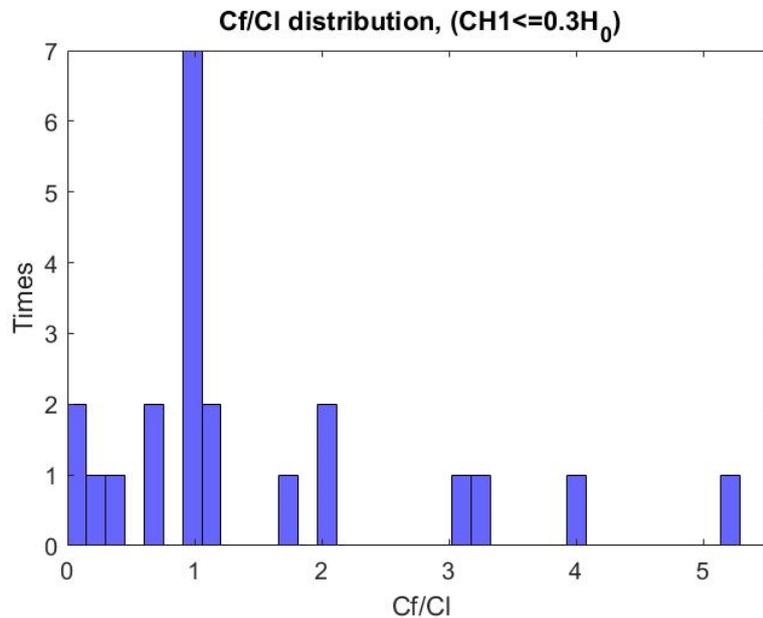
Figure 127: Ratio of flange to web corrosion length distribution of W1 web corrosion pattern with corrosion height up to 30% of H_0 for beams without a diaphragm - MassDOT

For all cases $1 \leq \frac{c_f}{c_l} \leq 2$ (Figure 127, Figure 128, Figure 129).

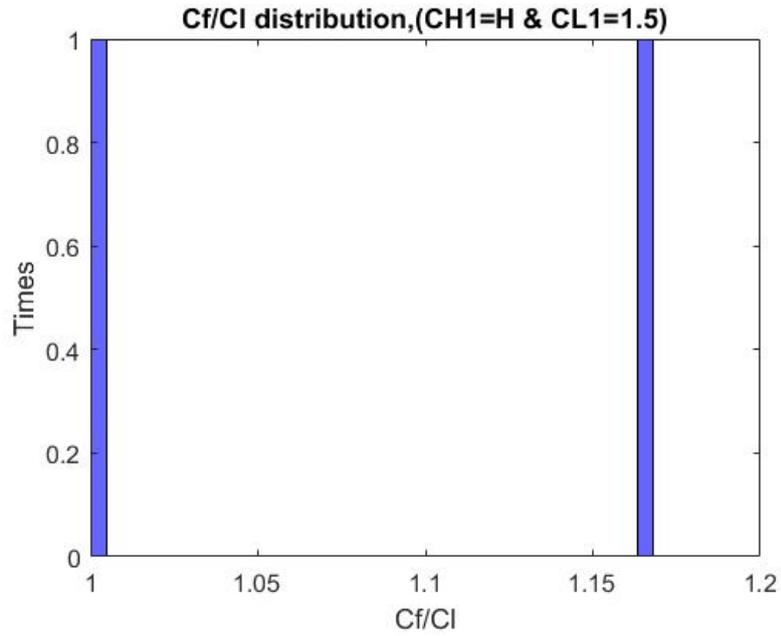
Figure 128: Ratio of flange to web corrosion length distribution of W1 web corrosion pattern for extreme scenario CASE B for beams without a diaphragm - MassDOT

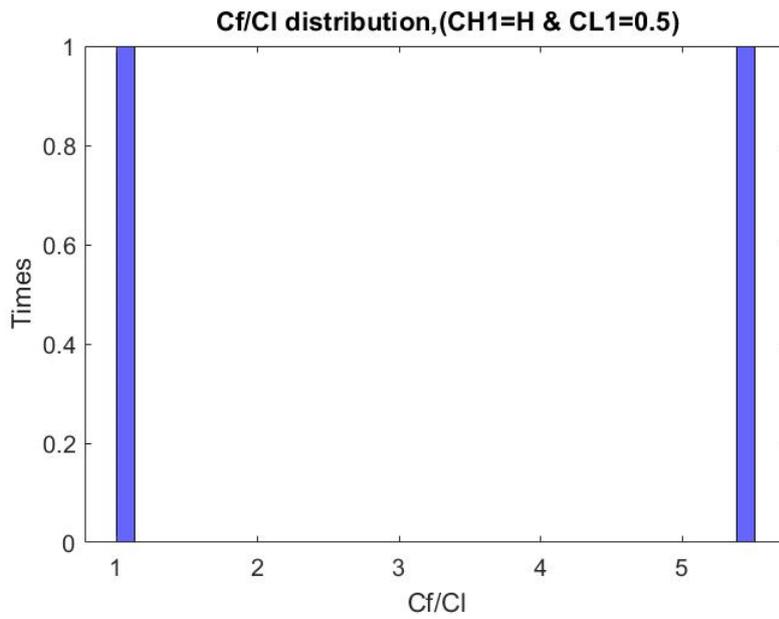
Figure 129: Ratio of flange to web corrosion length distribution of W1 web corrosion pattern for extreme scenario CASE C for beams without a diaphragm - MassDOT

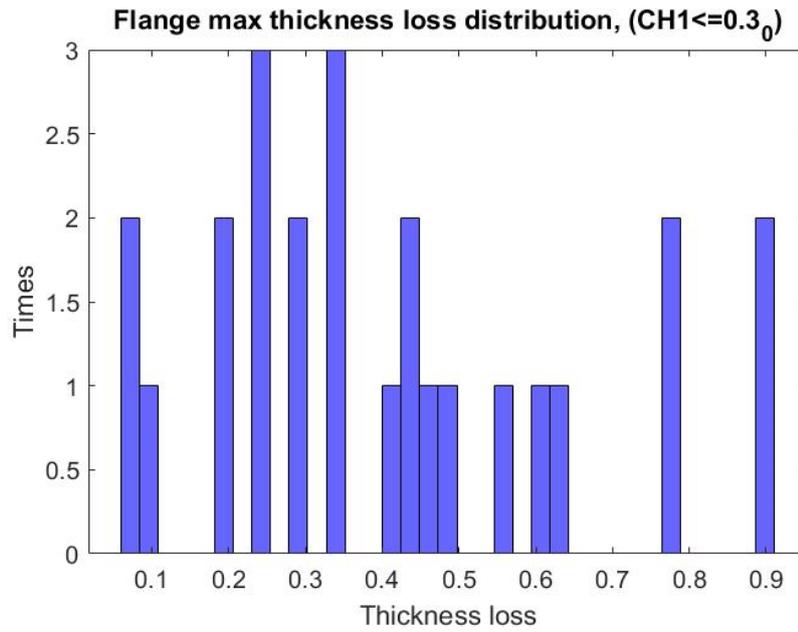
The flange thickness loss is plotted in Figure 130:

Figure 130: Max flange thickness loss distribution of W1 web corrosion pattern with corrosion height up to 30% of H₀ for beams without a diaphragm - MassDOT

Thus, for Case A: $\frac{t_{loss}}{t_{flange}}$ takes values of {0.2,0.4,0.6,0.8} (Figure 130) and for Cases B and

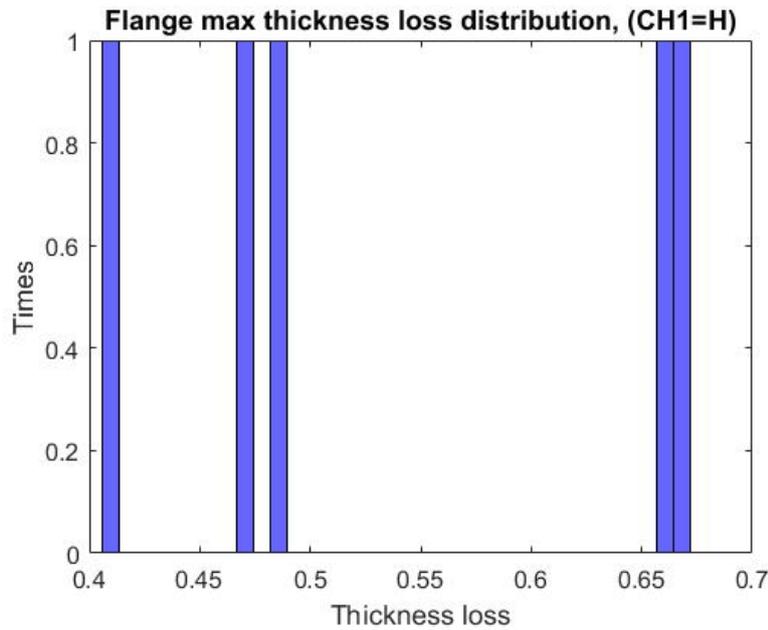
Figure 131: Max flange thickness loss distribution of W1 web corrosion pattern with full height corrosion for beams without a diaphragm - MassDOT

C: $\frac{t_{loss}}{t_{flange}}$ takes values of {0.45,0.65} (Figure 131).

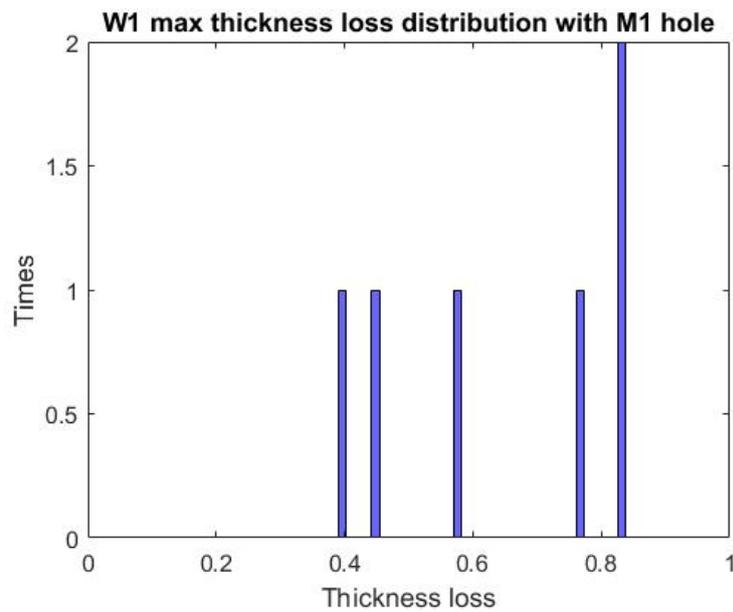
According to the table, the W1 pattern is combined 9 times with the M1 hole pattern (not all cases provide data). The web thickness loss at these cases is given as shown in Figure 132:

Figure 132: Max thickness loss distribution for W1 web corrosion patterns and M1 hole for beams without a diaphragm - MassDOT

Thus, we could say that the holes appear when the web thickness loss exceeds 40%. The distribution of the holes dimensions is shown below:

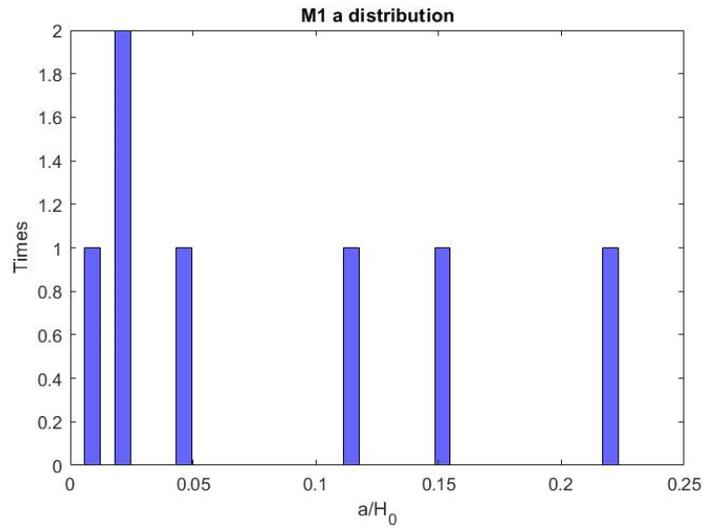
Figure 133: M1 web hole's pattern height distribution of W1 web corrosion pattern for beams without a diaphragm - MassDOT

Observing Figure 133 and Figure 134, our team decided that M1 appears in the form of pit holes (very small dimensions) or in a rectangular shape with the long side parallel to flange. Due to the small number of the available data for the holes, dimensions are not investigated for each case A, B, C separately.

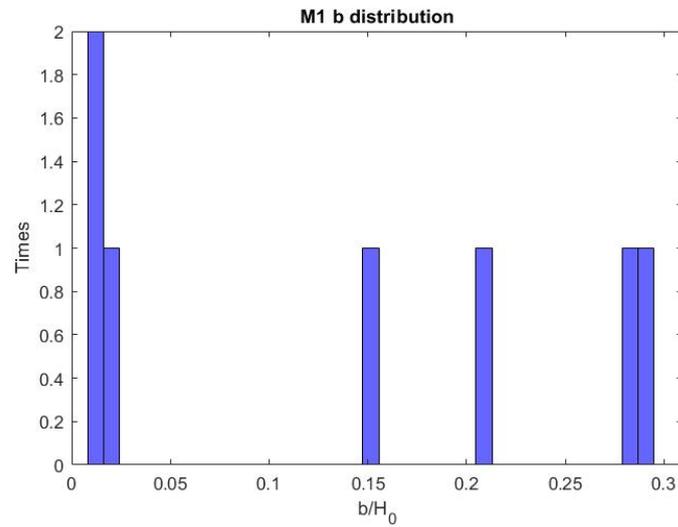
Figure 134: M1 web hole's pattern length distribution of W1 web corrosion pattern for beams without a diaphragm - MassDOT

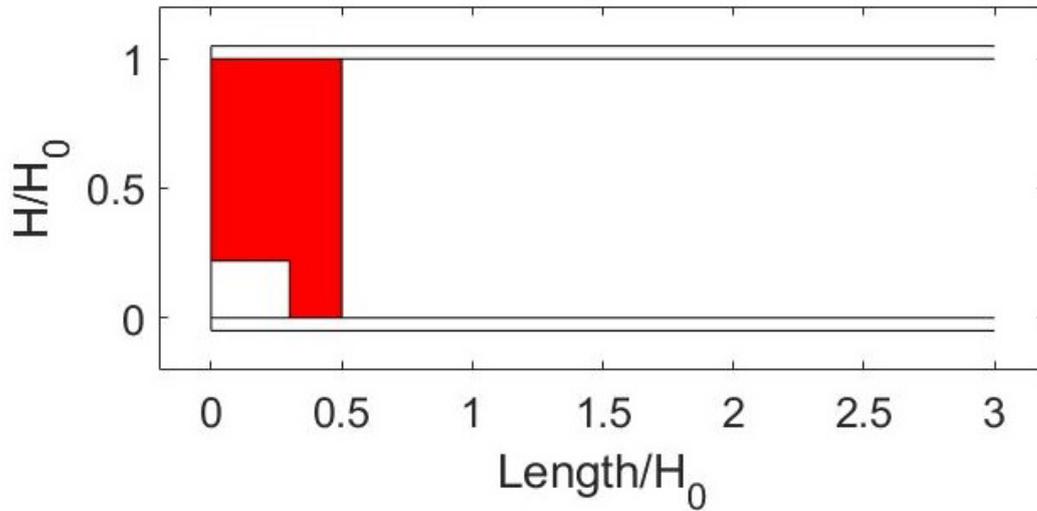
The extreme scenario, projected on the W1 corrosion pattern Case C with $a=0.22H$ and $b=0.3H_0$ is presented below:

Figure 135: M1 extreme web hole pattern scenario of W1 web corrosion pattern, projected on W1 CASE A, for beams without a diaphragm - MassDOT

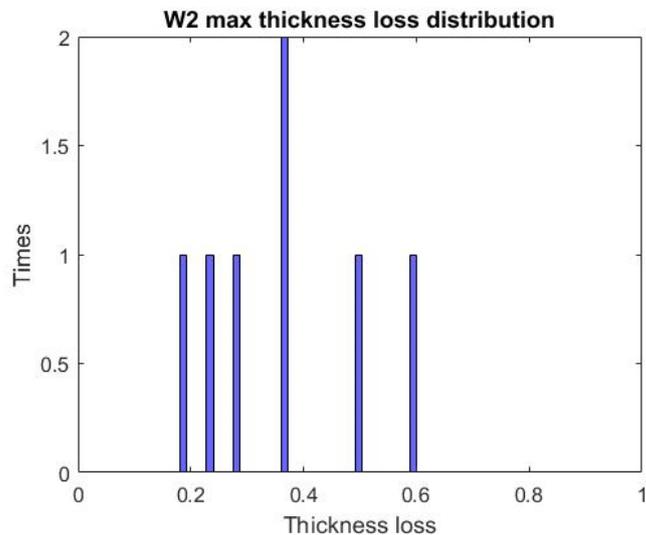
Figure 136: Web thickness loss distribution of W2 pattern for beams without a diaphragm - MassDOT

The blue area indicates the Case A of W1 pattern, and with red the extreme W2 pattern scenario. Since the rest of W2 cases fit in the blue shadowed area, W1 case A can be merged with W2. According to Figure 136 the thickness loss for W2 is in the Case A-W1 range.

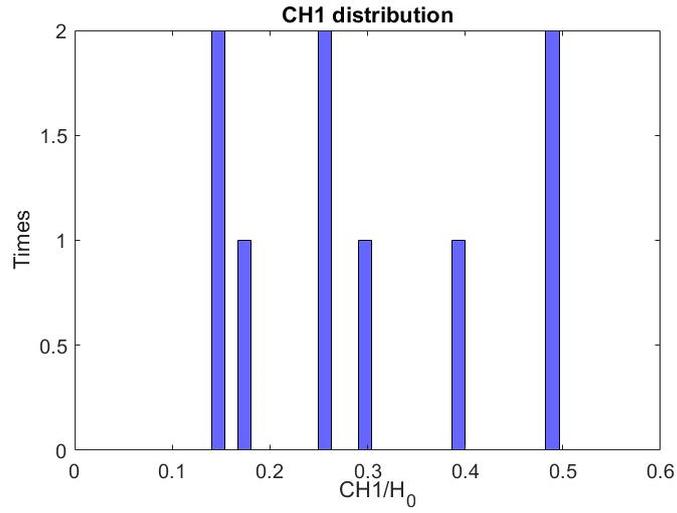
Figure 137: CH₁ distribution of W2 pattern for beams without a diaphragm - MassDOT

From Figure 137, for 6 out of 9 cases, the corrosion height is up to 0.3 H. For these cases, the web corrosion height, length and web thickness loss are presented below:

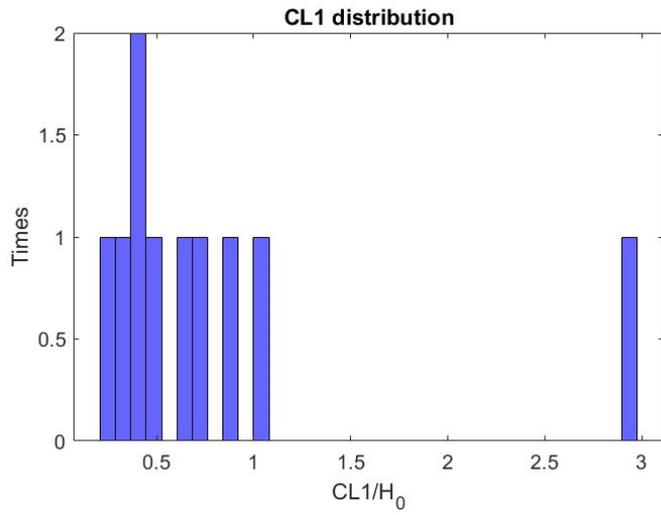
Figure 138: CL₁ distribution of W2 pattern for beams without a diaphragm - MassDOT

From Figure 138 and Figure 139: $0.5 < CL_1 \leq 1.1H$, $0.25 < CL_2 \leq 1.2H$, where the extreme scenario is illustrated as:

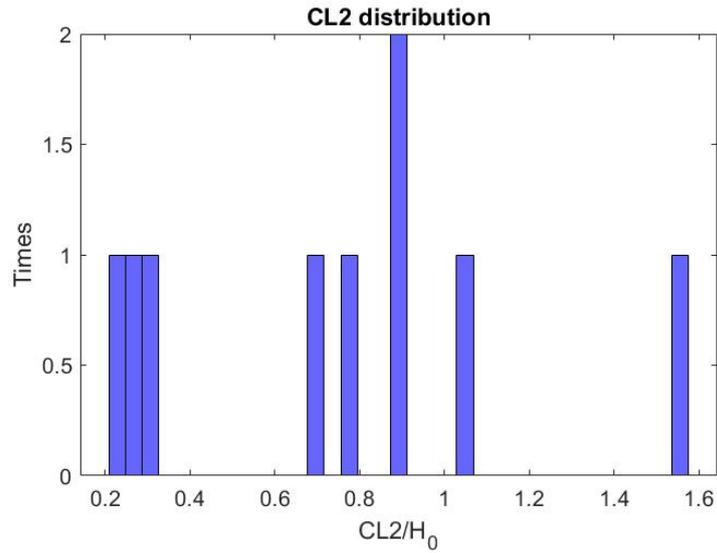
Figure 139: CL₂ distribution of W2 pattern for beams without a diaphragm - MassDOT

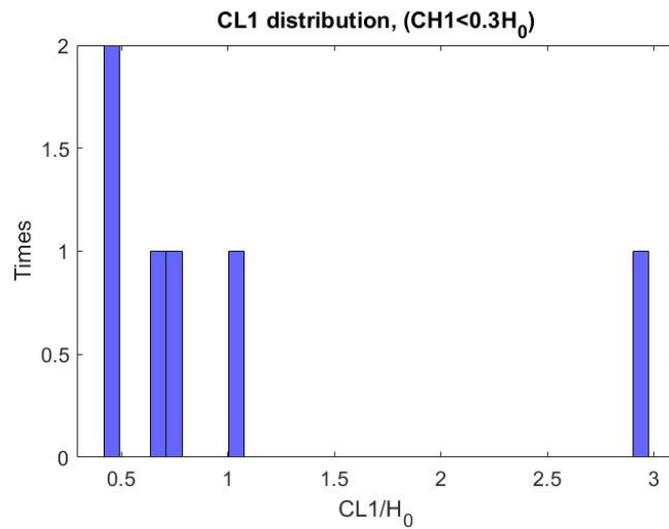
Figure 140: CL₁ distribution of W2 web corrosion pattern corroded up to 30% of H₀ for beams without a diaphragm - MassDOT

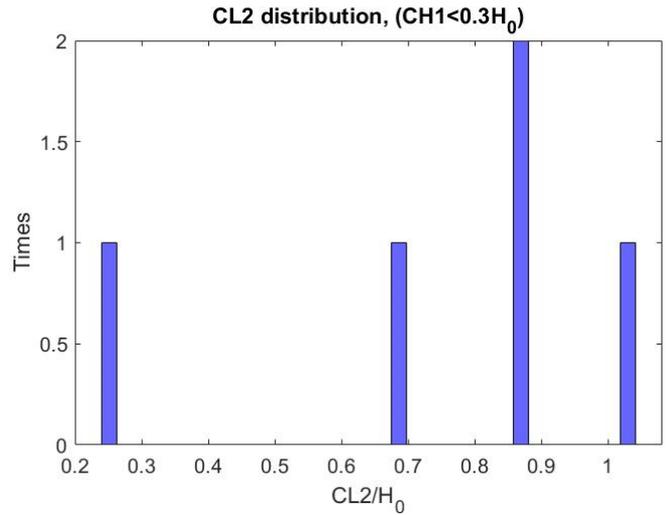
Figure 141: CL2 distribution of W2 web corrosion pattern corroded up to 30% of H0 for beams without a diaphragm - MassDOT

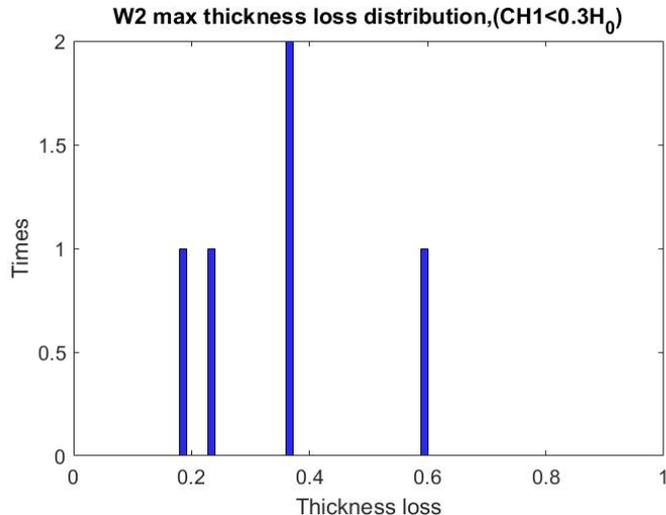
Figure 142: Max thickness loss distribution of W2 web corrosion pattern corroded up to 30% of H0 for beams without a diaphragm - MassDOT

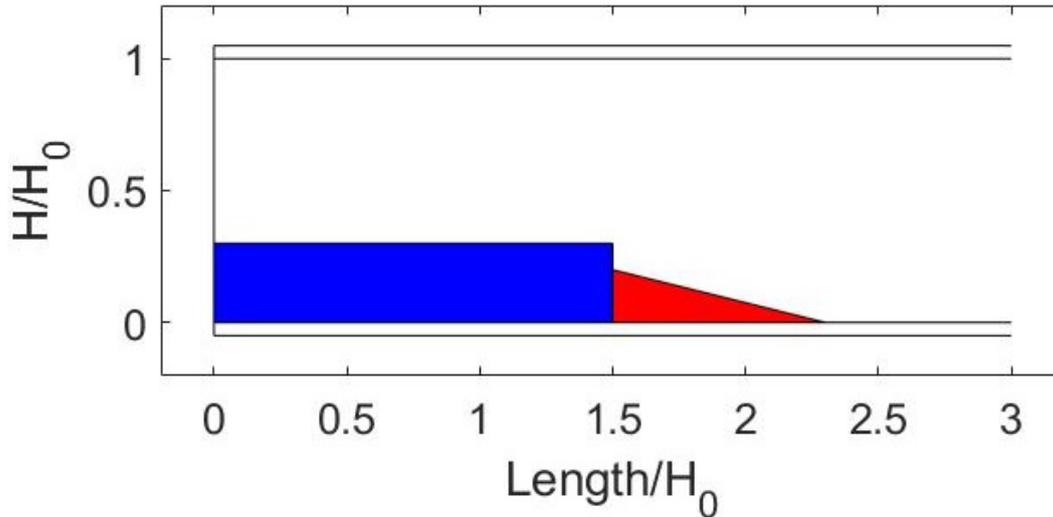
Figure 143: W1 Case A extreme web corrosion scenario projected over W2 extreme web corrosion scenario - MassDOT

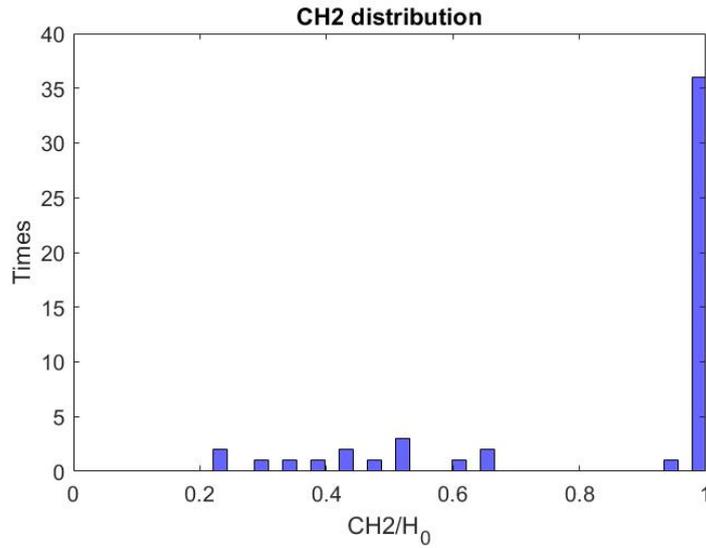
Figure 144: CH₂ distribution of W3 web corrosion pattern for beams without a diaphragm - MassDOT

From Figure 144, it is obvious that the dominant scenario is the full height corroded web case. For CH₂=H₀ the dimension and thickness distributions are presented.

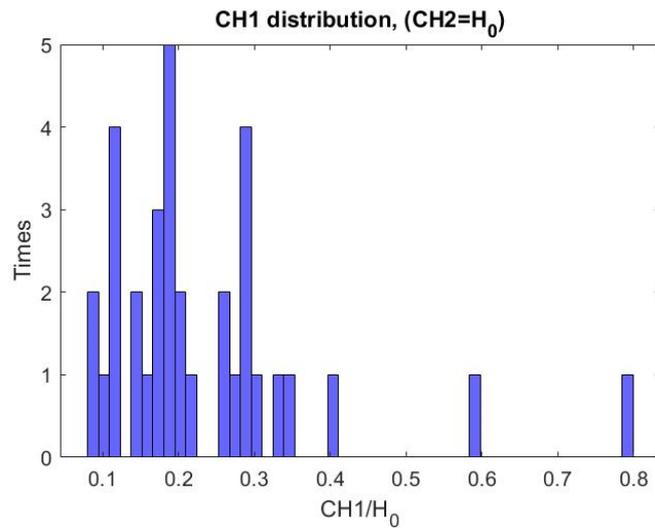
Figure 145: CH₁ distribution of W3 web corrosion pattern with full height corrosion for beams without a diaphragm - MassDOT

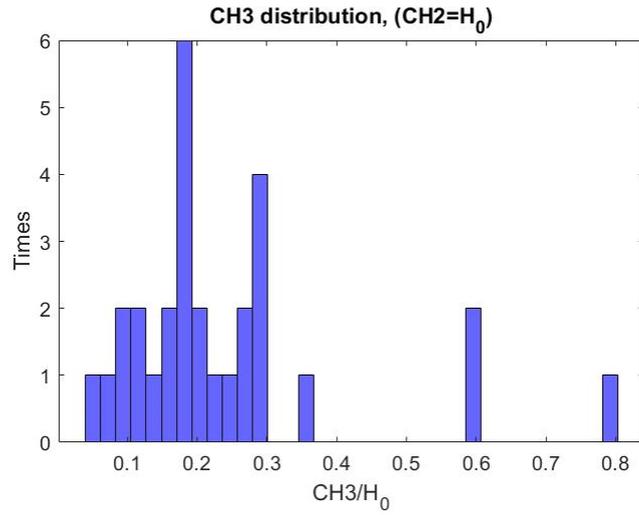
Figure 146: CH₃ distribution of W3 web corrosion pattern with full height corrosion for beams without a diaphragm - MassDOT

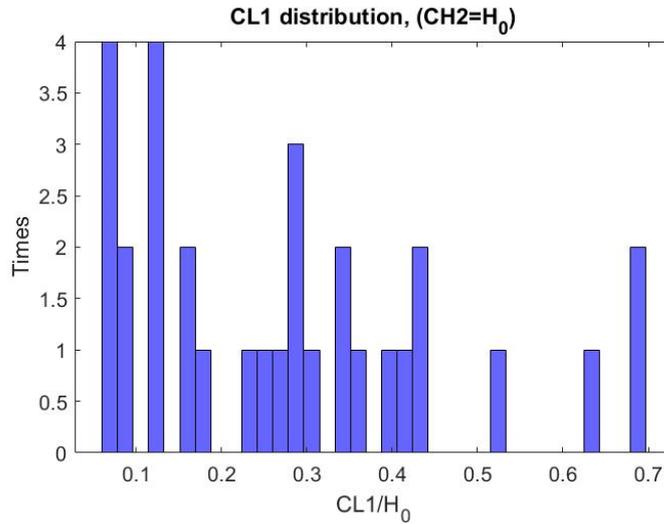
Figure 147: CL1 distribution of W3 web corrosion pattern with full height corrosion for beams without a diaphragm - MassDOT

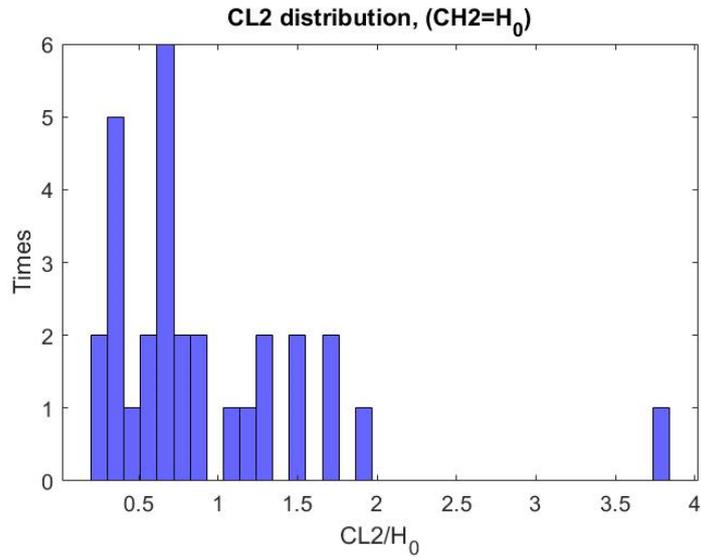
Figure 148: CL₂ distribution of W3 web corrosion pattern with full height corrosion for beams without a diaphragm - MassDOT

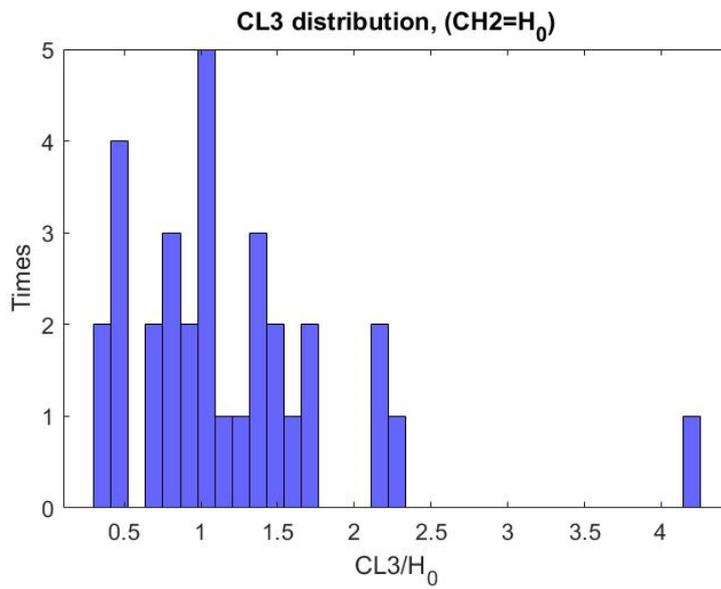
Figure 149: CL₃ distribution of W3 web corrosion pattern with full height corrosion for beams without a diaphragm - MassDOT

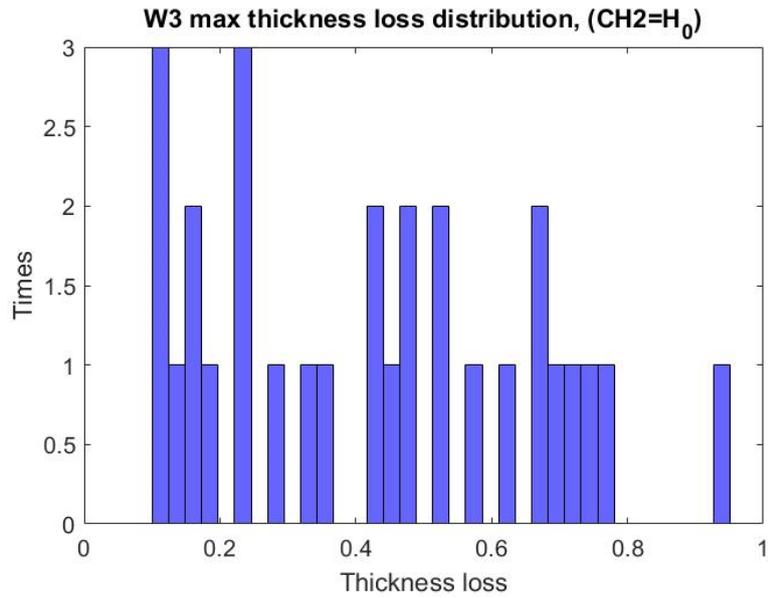
Figure 150: Max web thickness loss distribution of W3 web corrosion pattern with full height corrosion for beams without a diaphragm - MassDOT

$$\frac{t_{loss}}{t_{web}} \text{ takes values of } \{0.1, 0.2, 0.3, 0.4, 0.5, 0.6, 0.7, 0.8\}$$

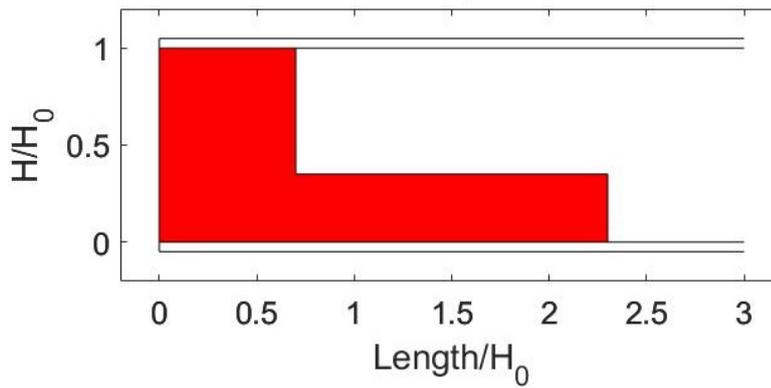
Figure 151: Extreme W3 web corrosion scenario for beams without a diaphragm - MassDOT
