Improved Load Rating Procedures for Deteriorated Unstiffened Steel Beam Ends

Prepared For:
New England Transportation Consortium
January 2024

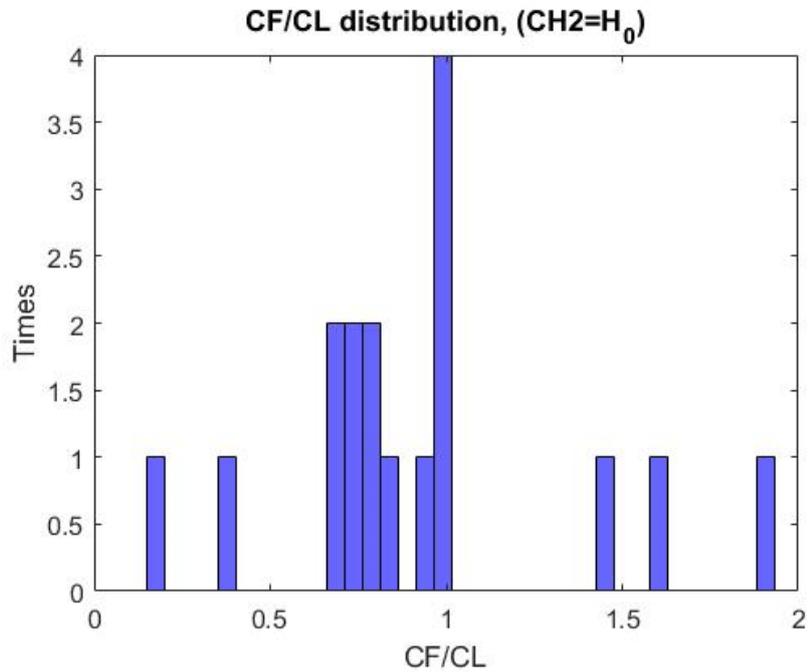
Figure 152: Ratio of flange to web corrosion length distribution of W3 web corrosion pattern with full height corrosion for beams without a diaphragm - MassDOT

Based on Figure 152, the parameter CF is considered equal to parameter CL.

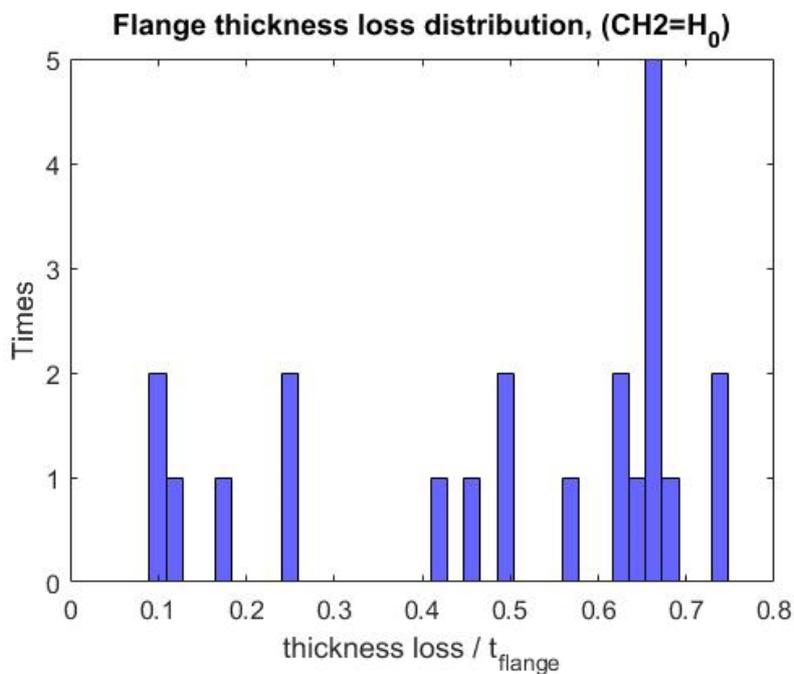
Figure 153: Max flange loss thickness distribution of W3 web corrosion pattern with full height corrosion for beams without a diaphragm - MassDOT

$$\frac{t_{loss}}{t_{flange}} \text{ takes values of } \{0.4, 0.6, 0.8\}$$

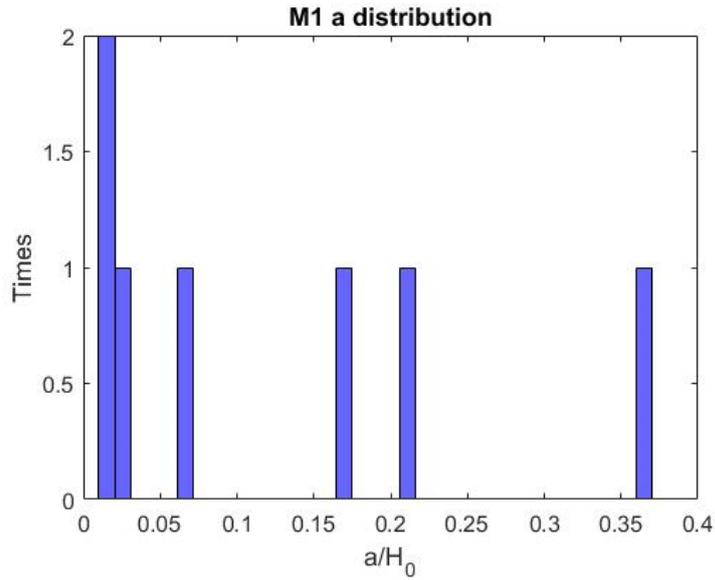
Figure 154: M1 web hole's pattern height distribution of W3 web corrosion pattern for beams without a diaphragm - MassDOT

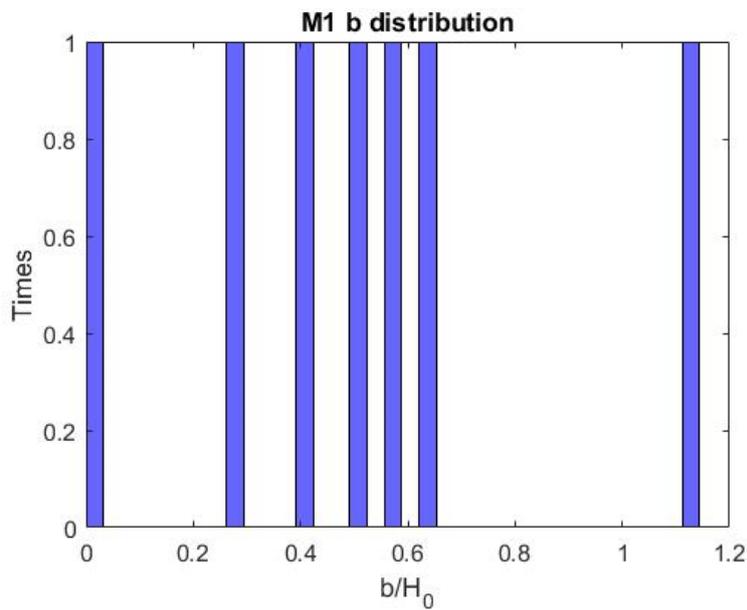
Figure 155: M1 web hole's pattern length distribution of W1 web corrosion pattern for beams without a diaphragm - MassDOT

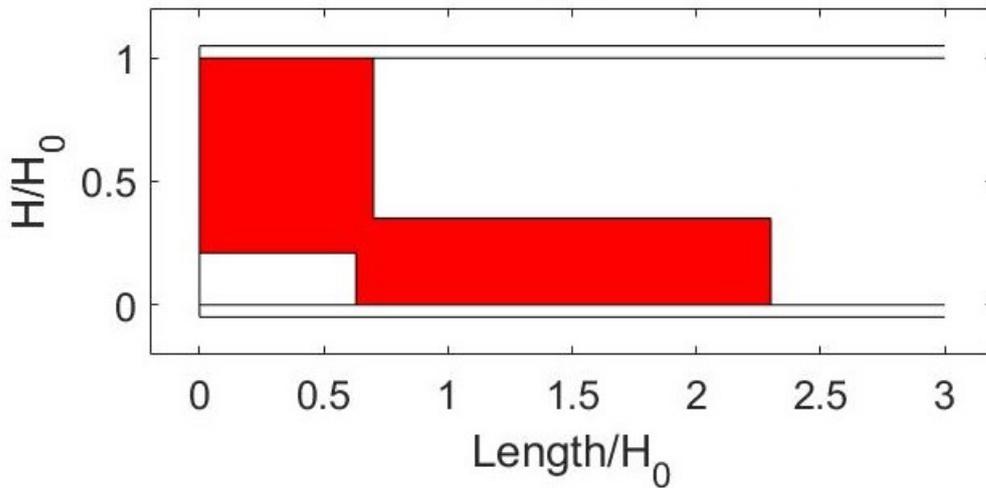
The extreme corrosion hole scenario with parameters $a=0.21$ and $b=0.63$ are presented below. This extreme case is projected on the W3 pattern corroded area:

Figure 156: M1 extreme web hole pattern scenario of W1 web corrosion pattern, projected on W3 extreme corrosion scenario, for beams without a diaphragm - MassDOT

The extreme hole corrosion cases belong in the range of the W3 pattern with M1 pattern holes (Figure 156).

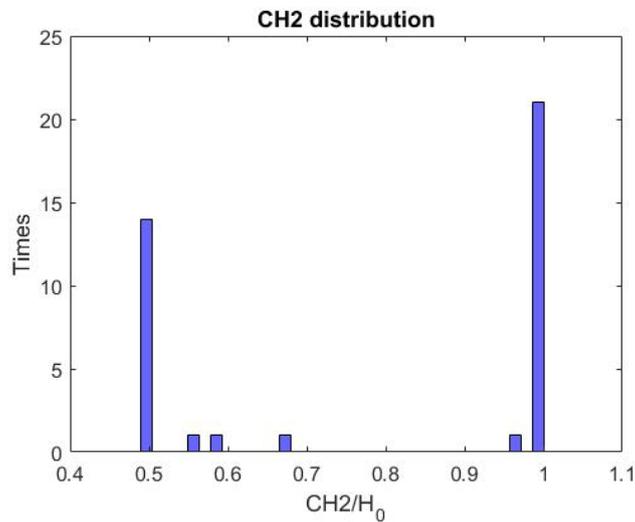
Figure 157: CH2 distribution of W4 web corrosion pattern for beams without a diaphragm - MassDOT

From the CH2 histogram (Figure 157), two main trends were noticed: either a) full height corrosion, or b) corrosion up to 50% of H_0 . As an additional step, the corrosion dimensions (CH1, CL1, CL2, CL3) and the web thickness loss distribution for each of the two cases of CH1 were plotted, a) for $CH1=0.5H_0$ and b) for $CH1=H_0$.

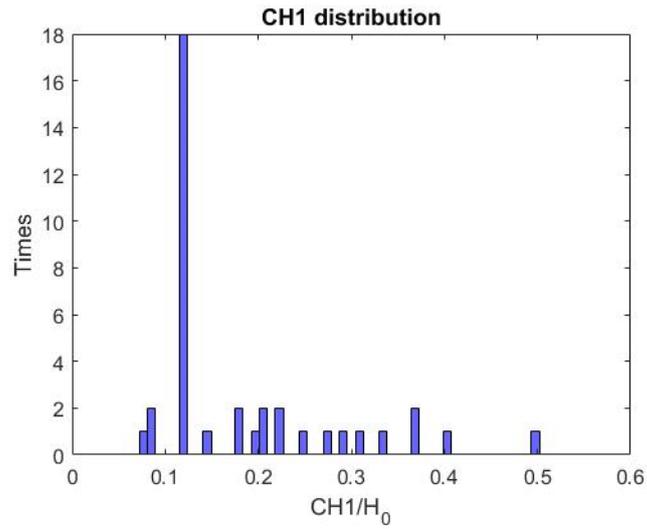
Figure 158: CH1 distribution of W4 web corrosion pattern for beams without a diaphragm - MassDOT

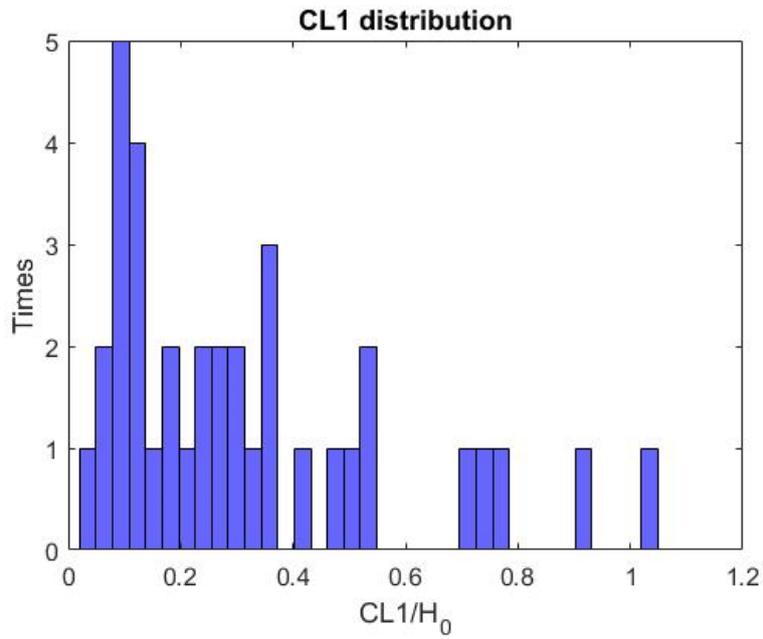
Figure 159: CL1 distribution of W4 web corrosion pattern for beams without a diaphragm - MassDOT

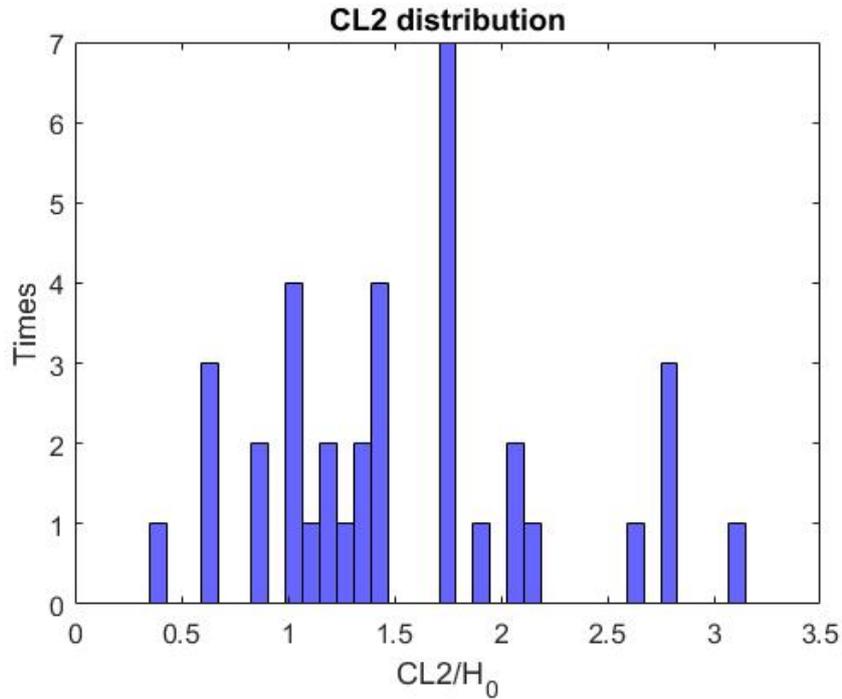
Figure 160: CL2 distribution of W4 web corrosion pattern for beams without a diaphragm - MassDOT

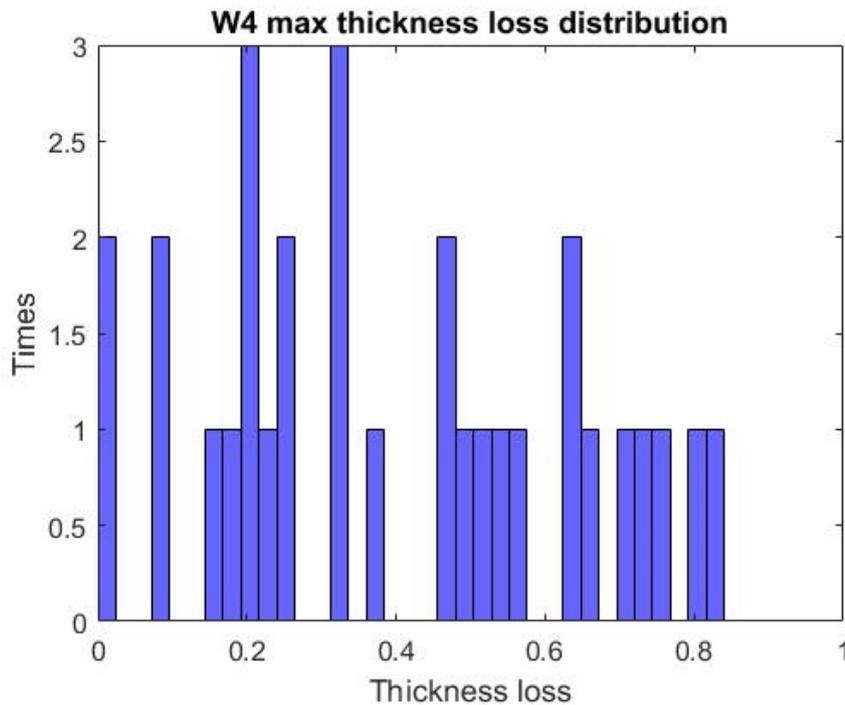
Figure 161: Max web thickness loss distribution of W4 web corrosion pattern for beams without a diaphragm - MassDOT

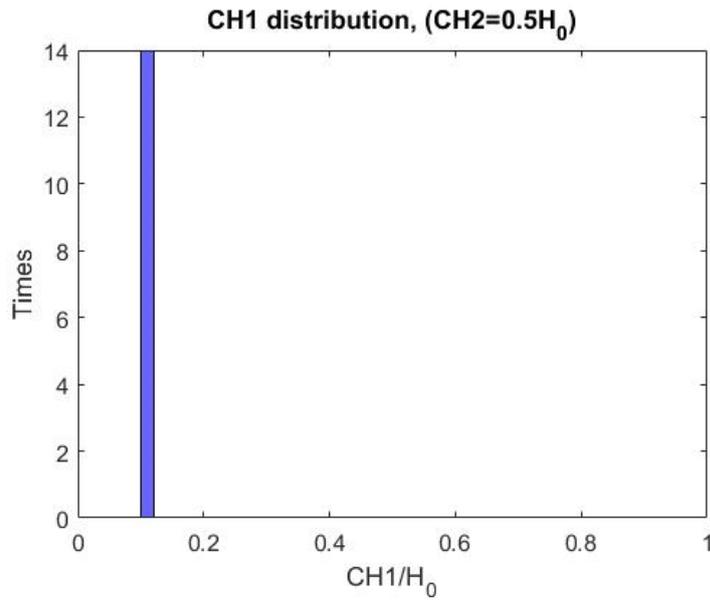
Figure 162 : CH1 distribution of W4 web corrosion pattern, with corrosion height up to 50% of H₀ for beams without a diaphragm - MassDOT

Based on Figure 162, Figure 163, Figure 164, Figure 165, Figure 166:

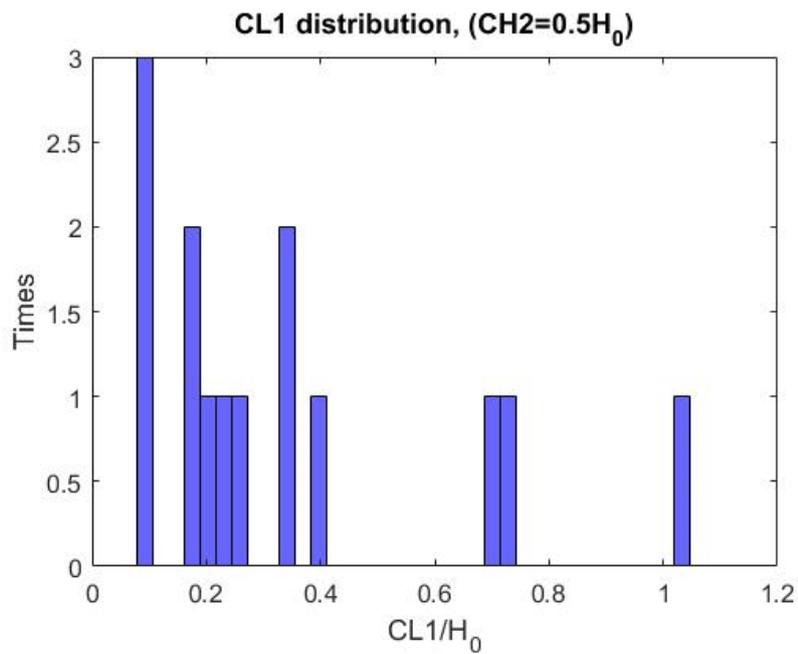
Figure 163: CL1 distribution of W4 web corrosion pattern, with corrosion height up to 50% of H₀ for beams without a diaphragm - MassDOT

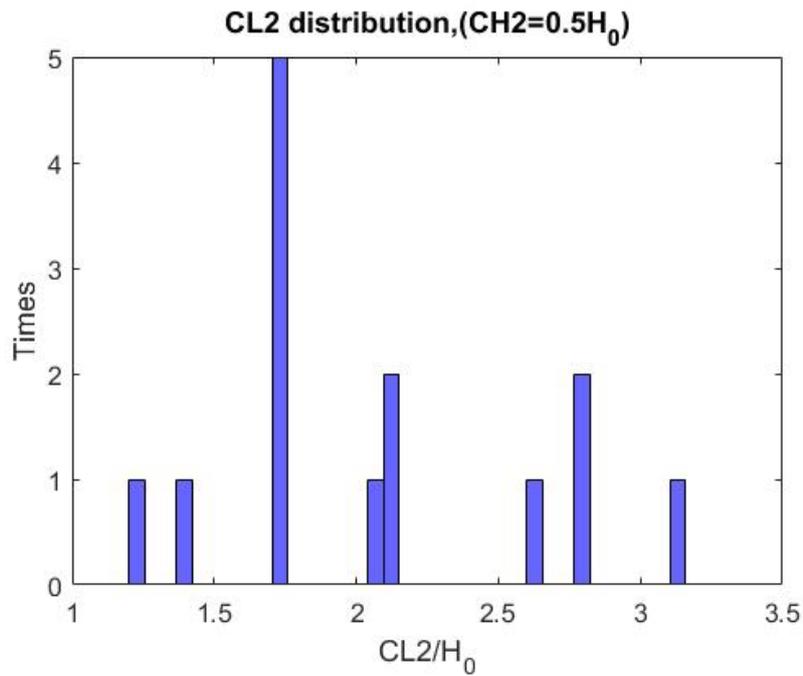
Figure 164: CL2 distribution of W4 web corrosion pattern, with corrosion height up to 50% of H₀ for beams without a diaphragm - MassDOT

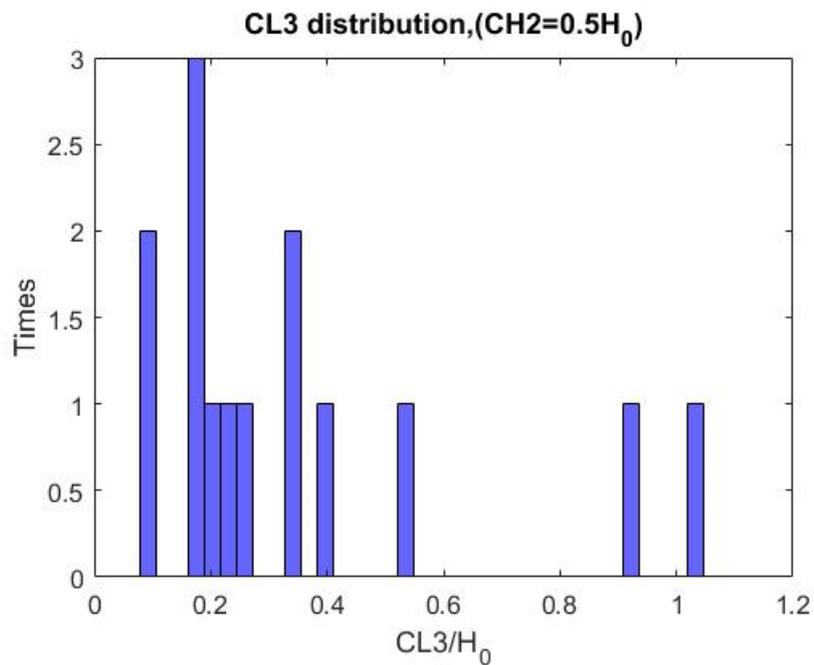
Figure 165: CL3 distribution of W4 web corrosion pattern, with corrosion height up to 50% of H₀ for beams without a diaphragm - MassDOT

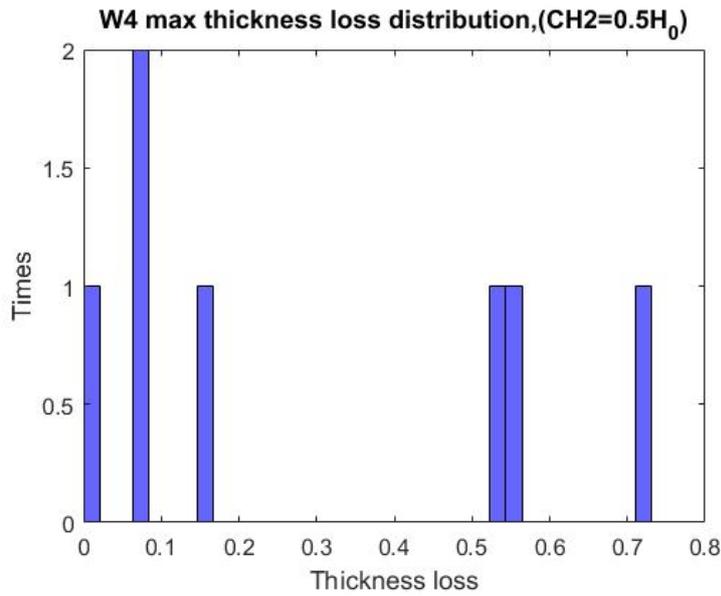
Figure 166: Max web thickness loss distribution of W4 web corrosion pattern, with corrosion height up to 50% of H_0 for beams without a diaphragm - MassDOT

$$\frac{t_{loss}}{t_{web}} \text{ takes values of } \{0.05, 0.15, 0.55, 0.75\}$$

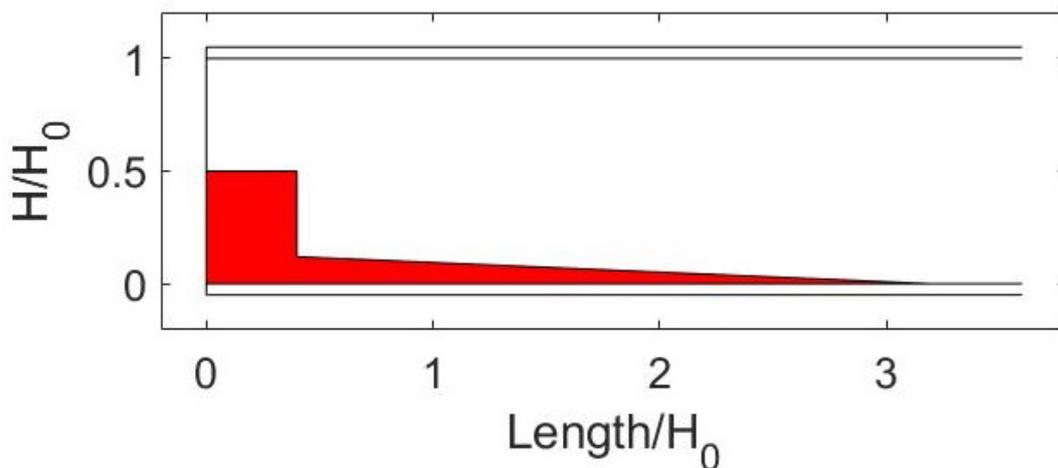
Figure 167: First extreme W4 web corrosion scenario for beams without a diaphragm - MassDOT

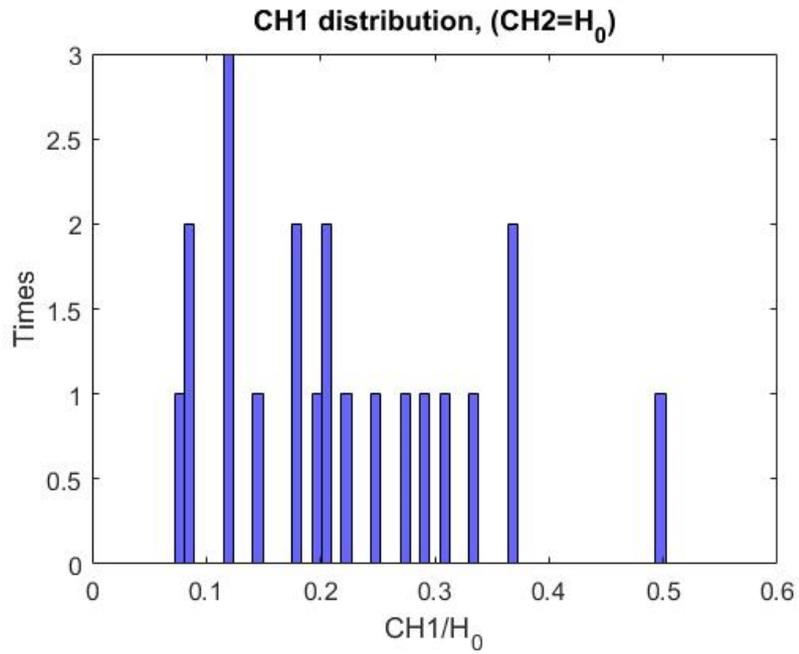
Figure 168: CH1 distribution of W4 web corrosion pattern, with full height corrosion for beams without a diaphragm - MassDOT

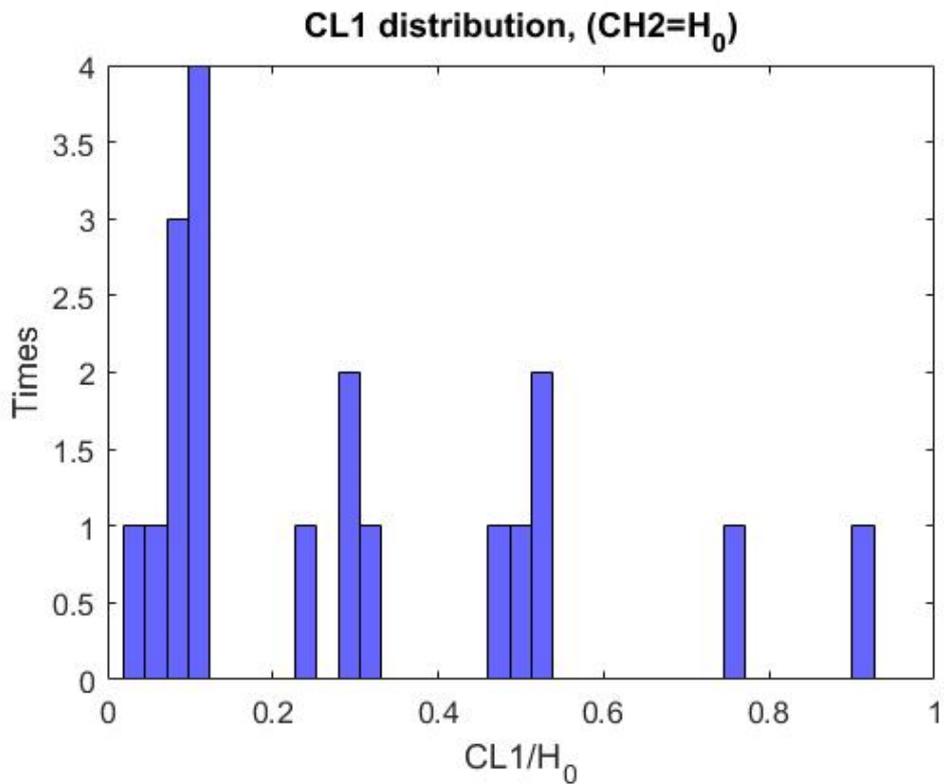
Figure 169: CL1 distribution of W4 web corrosion pattern, with full height corrosion for beams without a diaphragm - MassDOT

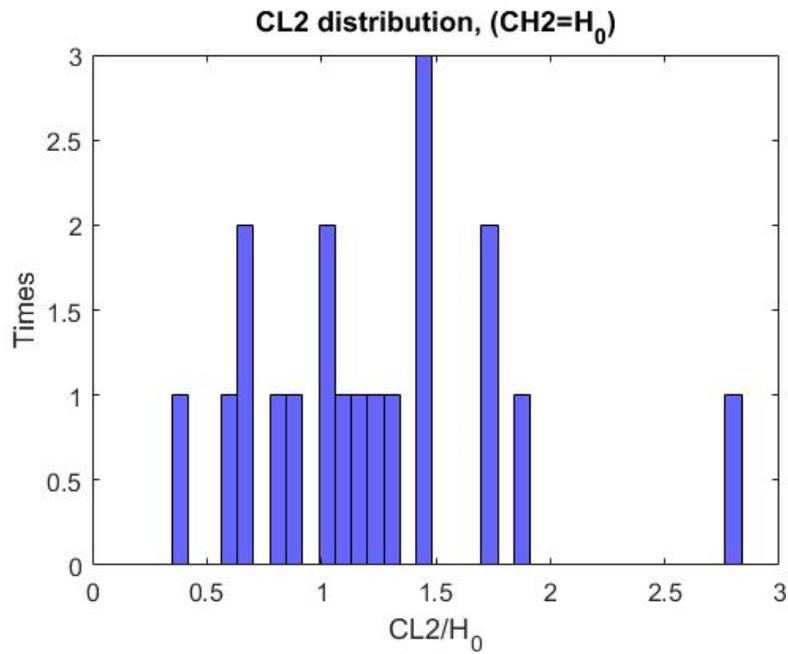
Figure 170: CL2 distribution of W4 web corrosion pattern, with full height corrosion for beams without a diaphragm - MassDOT

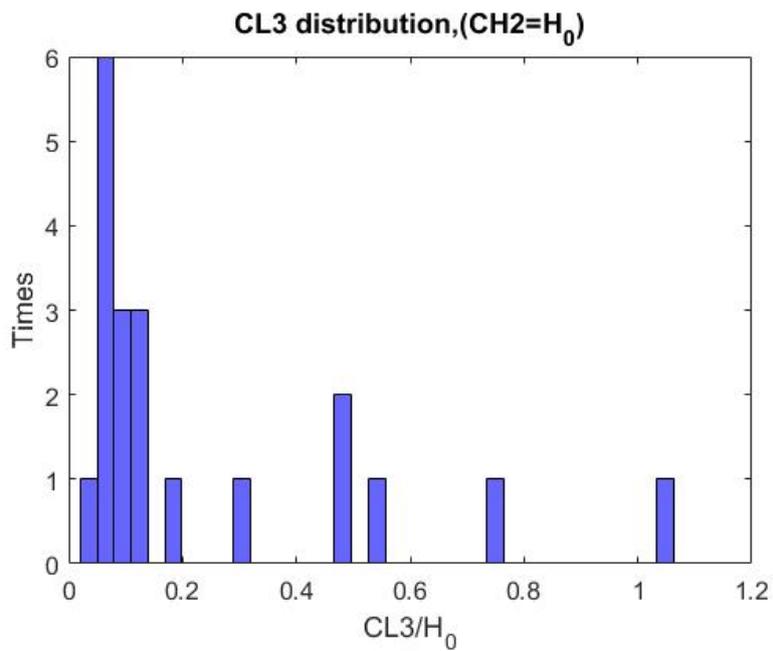
Figure 171: CL3 distribution of W4 web corrosion pattern, with full height corrosion for beams without a diaphragm - MassDOT

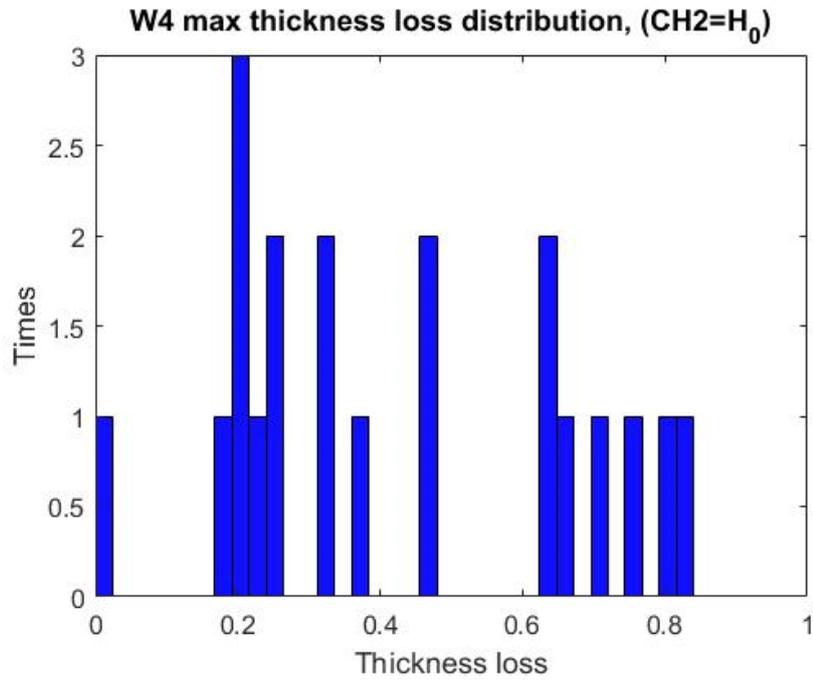
Figure 172: Max web thickness loss distribution of W4 web corrosion pattern, with full height corrosion for beams without a diaphragm - MassDOT

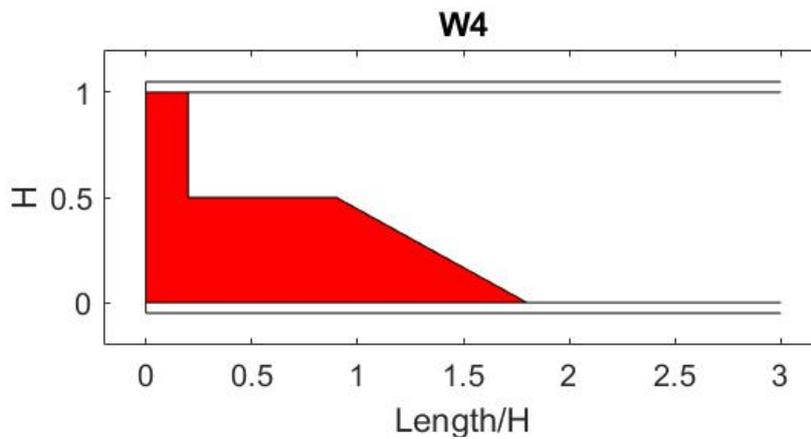
$$\frac{t_{loss}}{t_{web}} \text{ takes values of } \{0.2, 0.4, 0.6, 0.8\}$$

Figure 173: Second extreme W4 web corrosion scenario for beams without a diaphragm - MassDOT

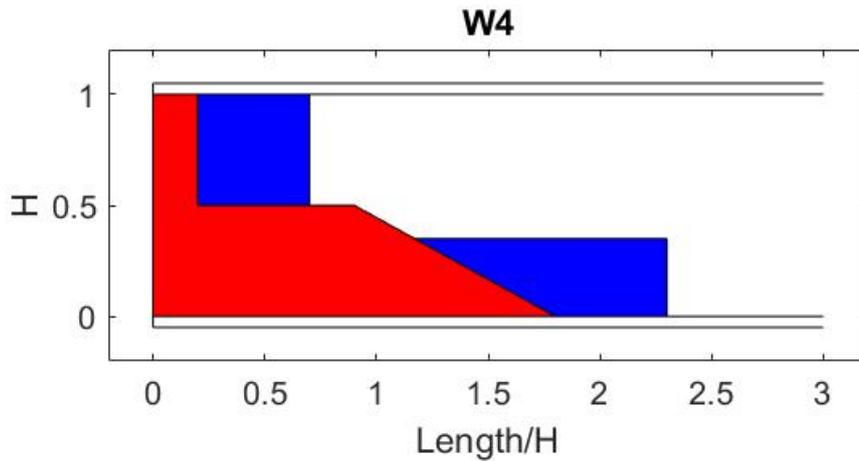
Figure 174: First extreme W4 scenario (red) projected over extreme W3 web corrosion scenario (blue) - MassDOT

Considering the way W3 and W4 have been defined, W3 can be expressed by W4 if we set $W4CL1=W4CL3$ and $W4CH3 \neq 0$. Figure 174 and Figure 175 demonstrate that W3 includes the extreme W4 scenarios, thus W3 and W4 could be merged to one pattern.

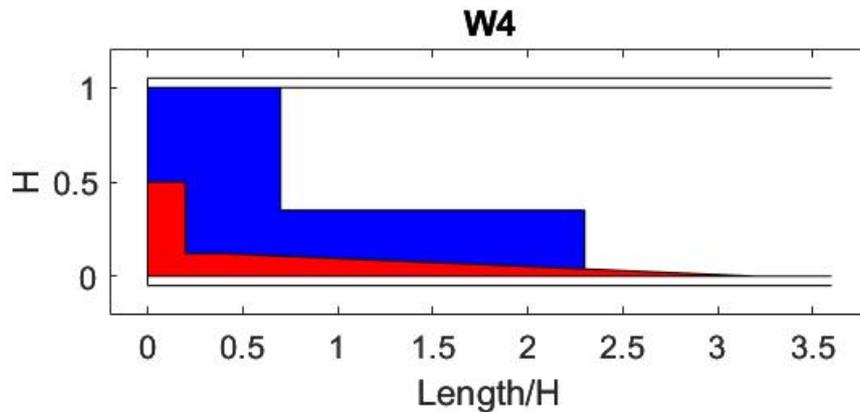
Figure 175: Second extreme W4 scenario (red) projected over extreme W3 web corrosion scenario (blue) - MassDOT

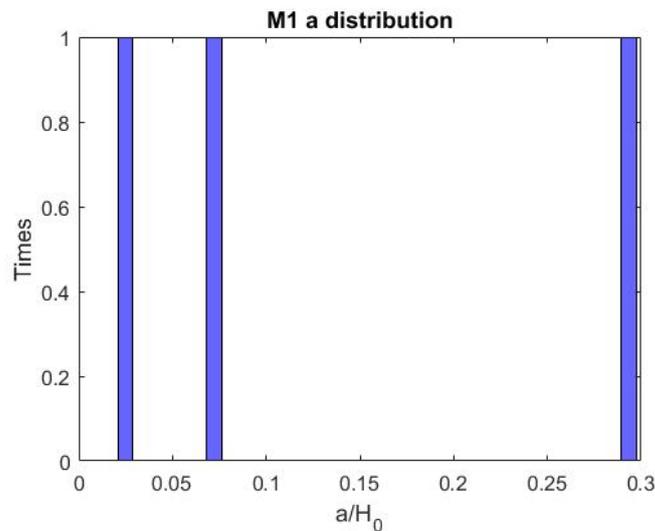
Figure 176: M1 web hole's pattern height distribution of W4 web corrosion pattern for beams without a diaphragm - MassDOT

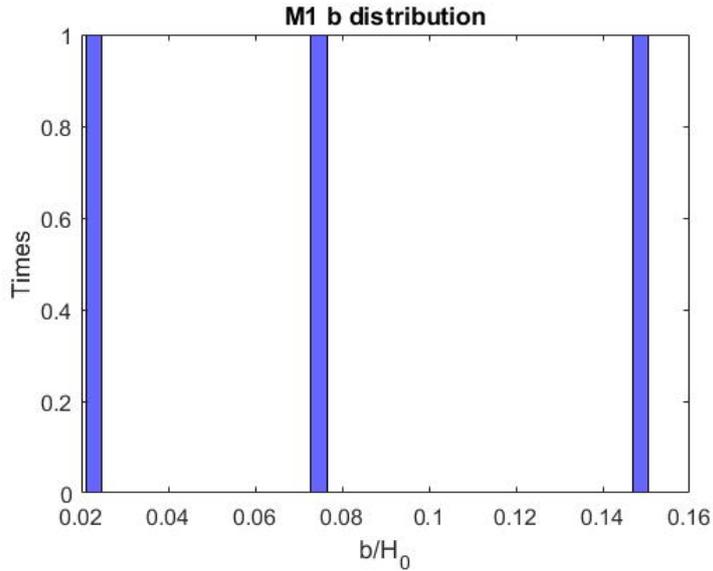
Figure 177: M1 web hole's pattern length distribution of W3 web corrosion pattern for beams without a diaphragm - MassDOT

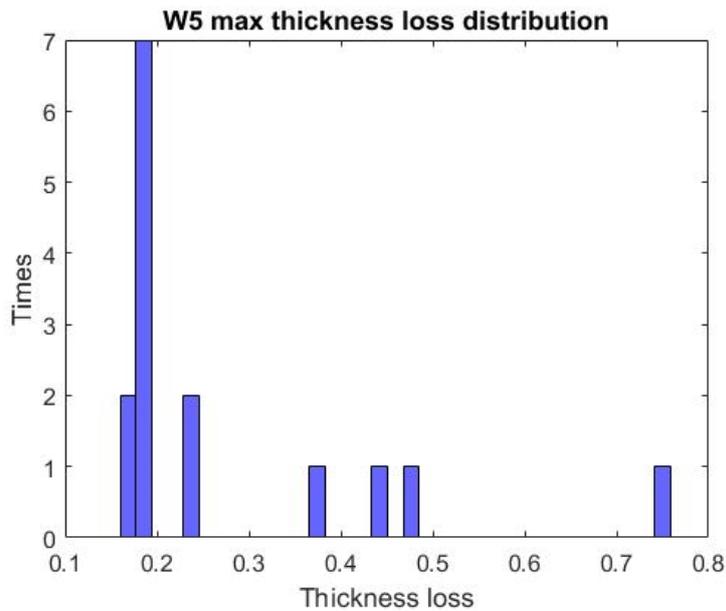
Figure 178. Max web thickness loss distribution of W5 web corrosion pattern for beams without a diaphragm - MassDOT

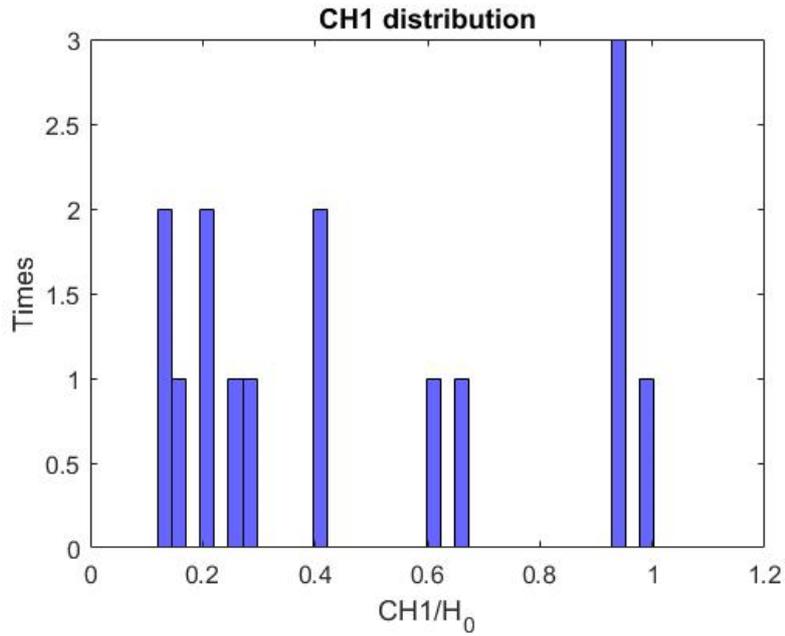
Figure 179: CH2 distribution of W5 web corrosion pattern for beams without a diaphragm - MassDOT

From Figure 179, our team described the following: $0.15H_0 \leq CH_1 \leq H_0$

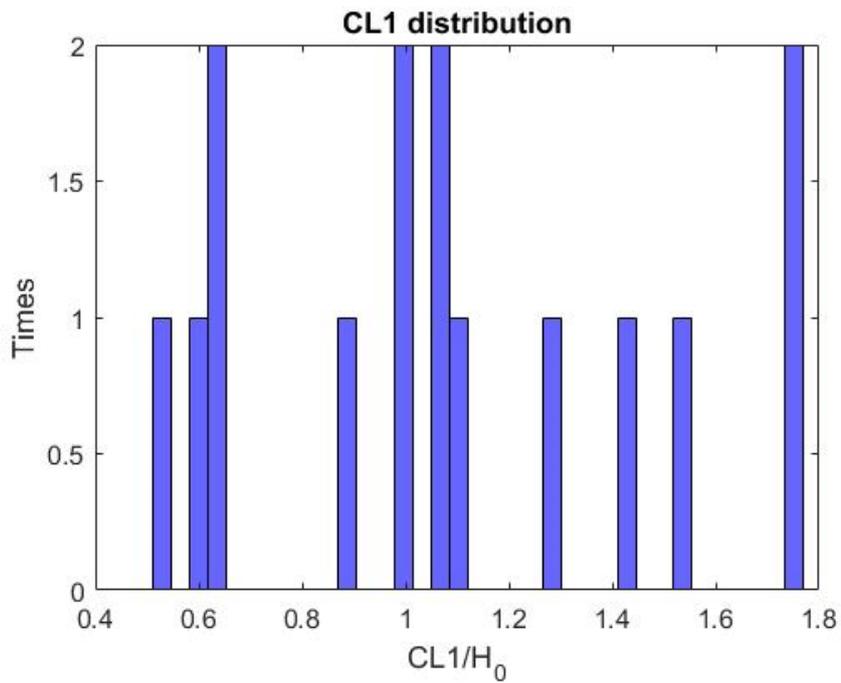
Figure 180: Max web thickness loss distribution of W5 web corrosion pattern for beams without a diaphragm - MassDOT

From Figure 180, our team described: $0.5H_0 \leq CH_1 \leq 1.8H_0$, with thickness loss: $\frac{t_{loss}}{t_{web}}$ that takes values of {0.2,0.5}

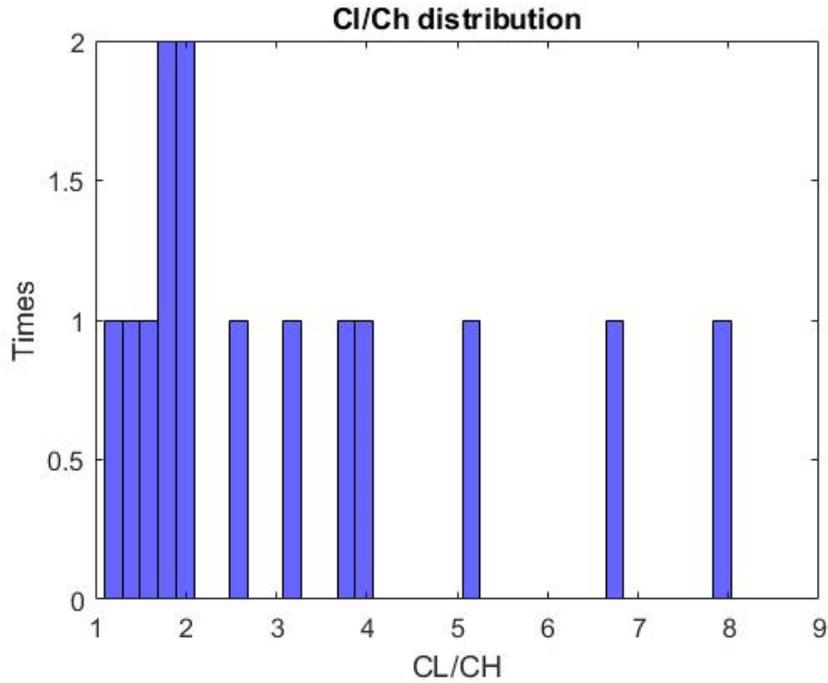
Figure 181:Ratio of corrosion length to height of W1 web corrosion pattern for beams without a diaphragm - MassDOT

According to Figure 181 the tested cases should have a ratio $1 \leq \frac{CL}{CH} \leq 4$.

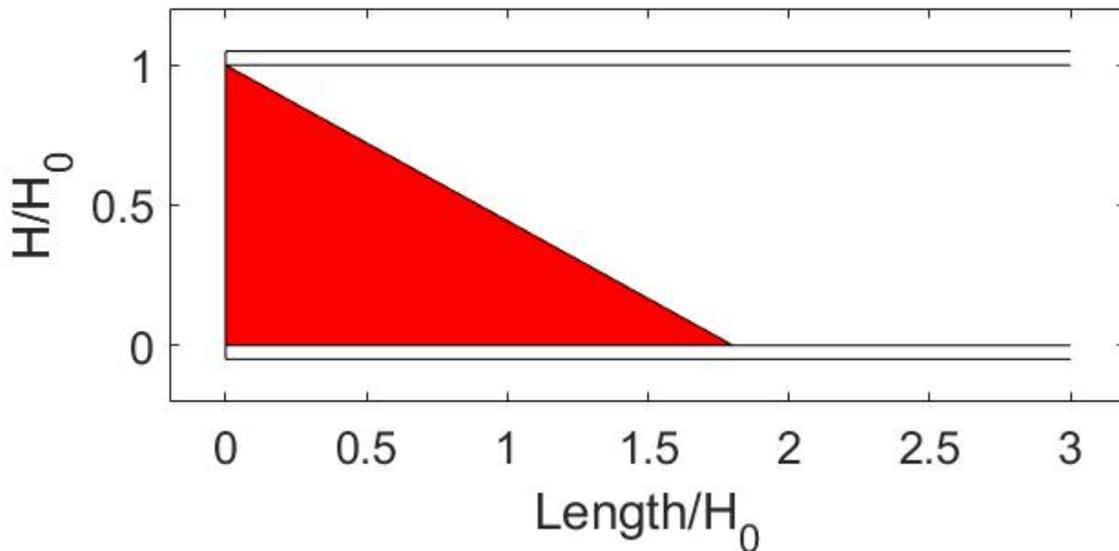
Figure 182: Extreme W4 web corrosion scenario for beams without a diaphragm - MassDOT

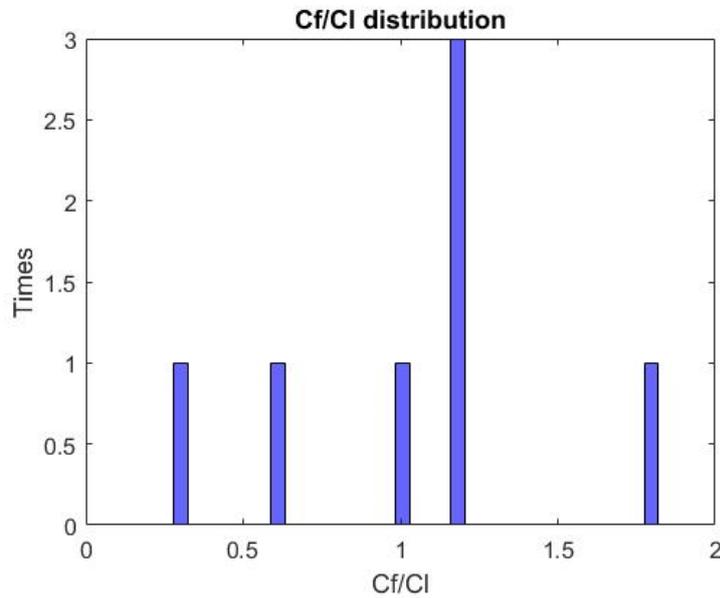
Figure 183: Ratio of flange to web corrosion length distribution of W5 web corrosion pattern for beams without a diaphragm - MassDOT

Thus, our team stated the following: $1 \leq \frac{C_f}{C_l} \leq 1.8$

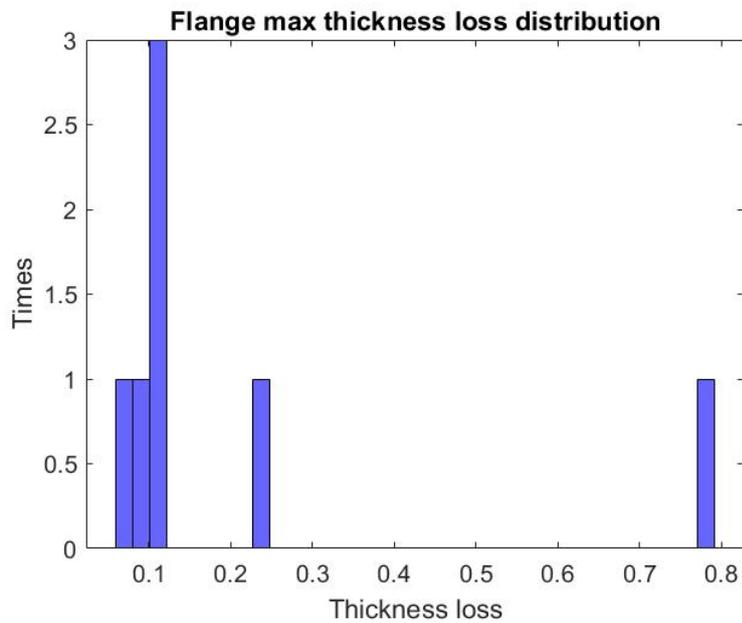
Figure 184: Max flange thickness loss distribution of W5 web corrosion pattern for beams without a diaphragm - MassDOT

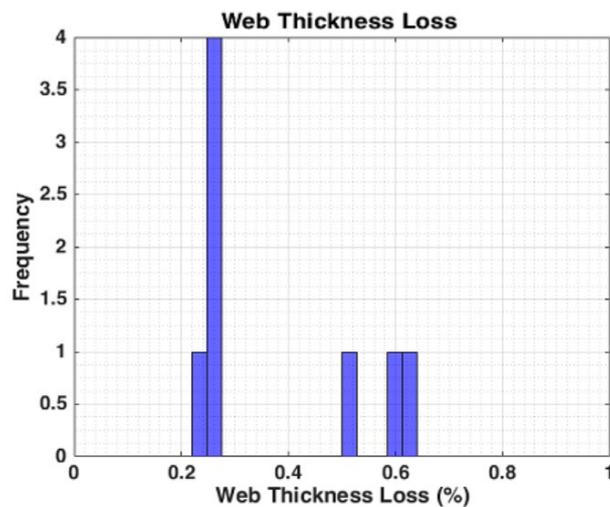
Figure 185: Web thickness loss histogram from the beam ends compiled - NHDOT

The inspection reports do not always provide information regarding web thickness loss. More precisely, only 20% of the reports provided such information. Figure 185 depicts the histogram of the web thickness loss reported in the bridge inspection reports from NHDOT.

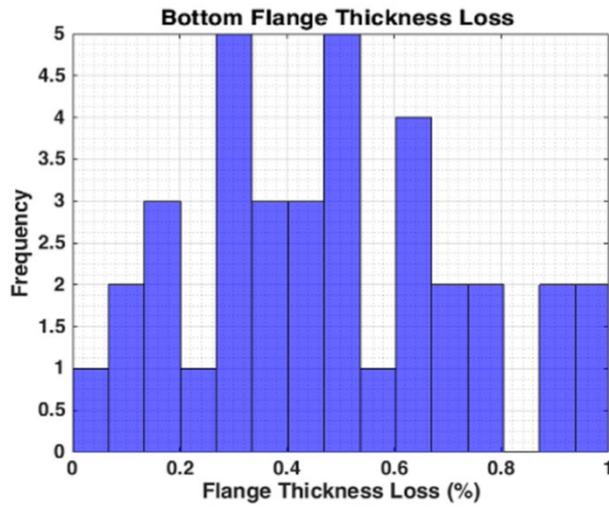
Figure 186: Bottom thickness loss histogram from the beam ends compiled - NHDOT

Many inspection reports provided by NHDOT had information regarding flange corrosion. Specifically, 36 out of the 40 compiled beam ends had information of flange corrosion either on the top flange or on the bottom flange. Figure 186 and Figure 187 depict the histogram of corrosion obtained for the bottom and top flanges, respectively.

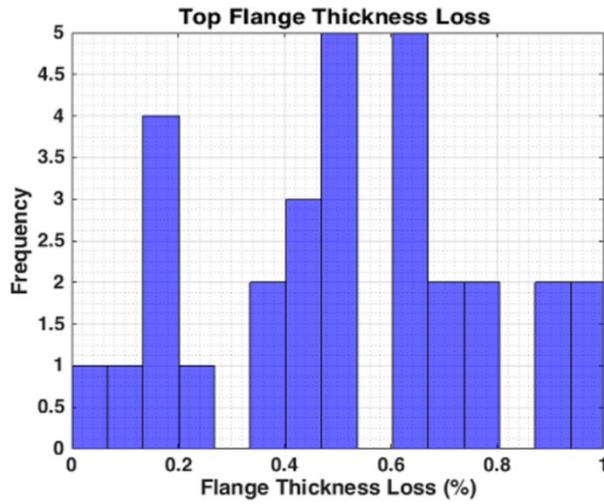
Figure 187 : Top thickness loss histogram from the beam ends compiled - NHDOT

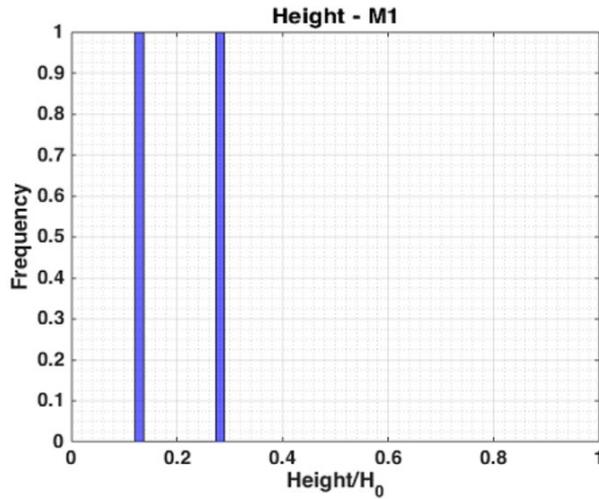
Figure 188: M1 web hole’s height distribution of W1 web corrosion pattern for beams without a diaphragm - NHDOT

Only two holes were observed in the inspection reports provided by NHDOT. Additionally, both holes were reported with photographs. The dimensions of the holes are described by the plots in Figure 188 and Figure 189.

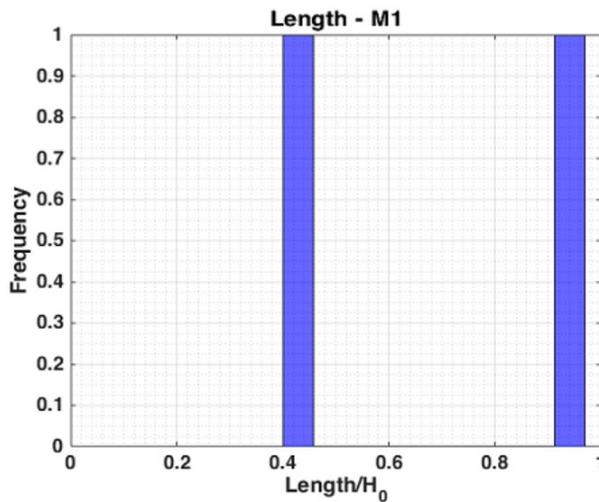
Figure 189: M1 web hole’s length distribution of W1 web corrosion pattern for beams without a diaphragm - NHDOT

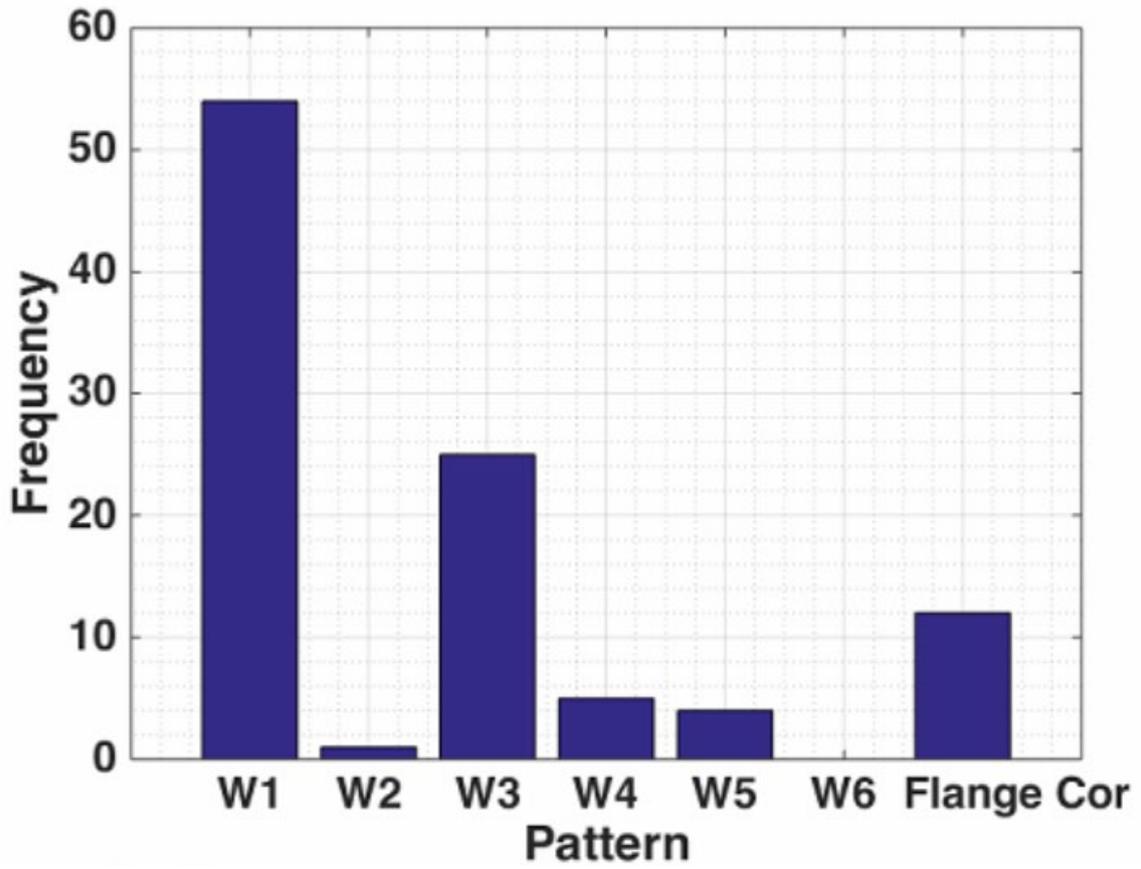
Figure 190 : Web corrosion patterns distribution for beams ends without diaphragm – RIDOT

From the reports provided by RIDOT, the research team was able to gather corrosion information of 89 beam ends without a diaphragm. Figure 190 depicts the frequency of corrosion patterns for beam ends without a diaphragm.

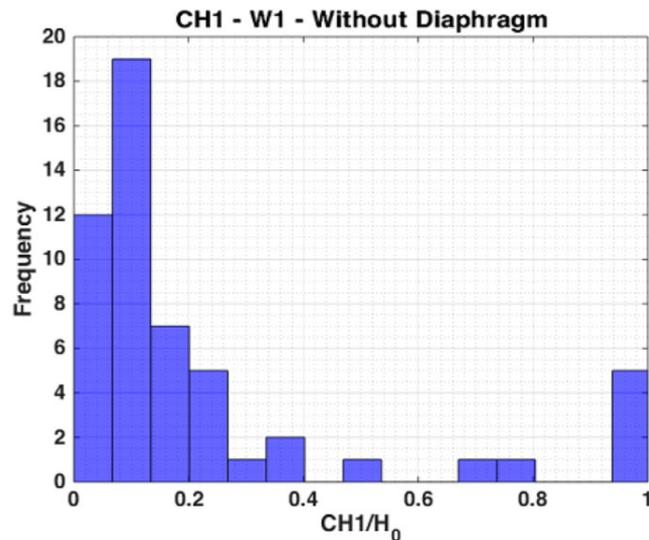
Figure 191: CH1 distribution of W1 pattern for beams without diaphragm - RIDOT

The parameters for the corrosion patterns can be found with corresponding diagrams in Section 1.5 *Corrosion Patterns* of this report. The study starts by analyzing the height of corrosion for pattern W1, depicted in Figure 191.

From Figure 191 is possible to observe that most of the beam ends have $CH_1 < 0.5$. Our team was able to isolate the beams which present $CH_1 < 0.5$. By doing this, we expected to understand the interaction between the parameters of the corrosion pattern W1. Additionally, our team expected to detect a pattern from which there is opportunity to determine an extreme scenario.

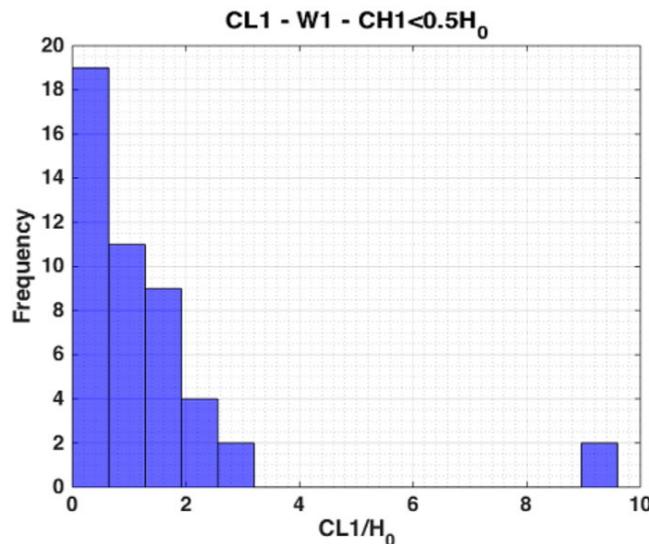
Figure 192: CL1 distribution of W1 pattern for beams without a diaphragm and $CH_1 < 0.5H_0$ - RIDOT

Figure 192 clearly depicts a trend, which is $CL_1 < 3$. Therefore, our team assumed that:

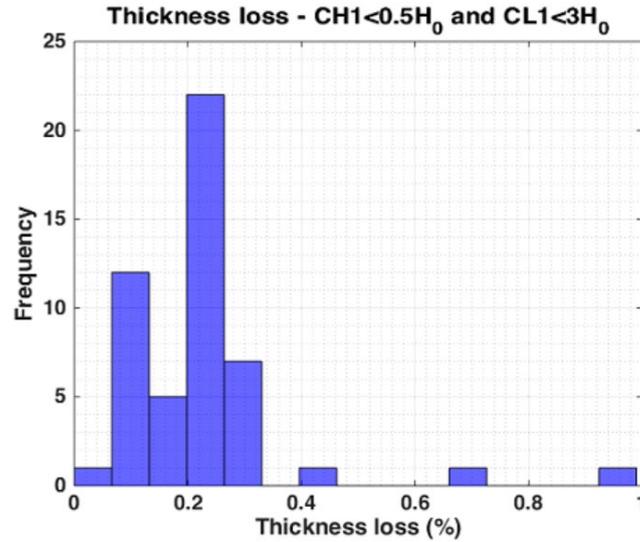
Figure 193: Web thickness loss of W1 pattern for beams without a diaphragm, $CH_1 < 0.5H_0$ and $CL_1 < 3H_0$ – RIDOT

Figure 193 depicts the web thickness loss for the case $CH_1 < 0.5H_0$ and $CL_1 < 3$.

Figure 193 depicts that the thickness loss clusters between 0% until 30%. That, is:

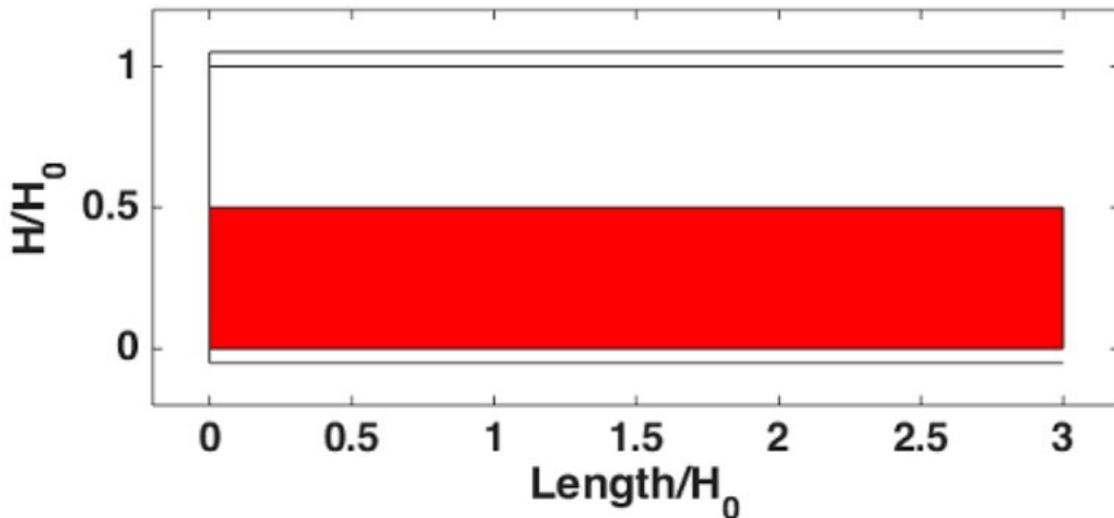
Figure 194: Extreme scenario for pattern W1 – RIDOT

By gathering the intervals determined from Figure 191, Figure 192 and Figure 193, our team was able to determine the extreme case of corrosion for pattern W1. A schematic illustration of this extreme case of corrosion is depicted in Figure 194.

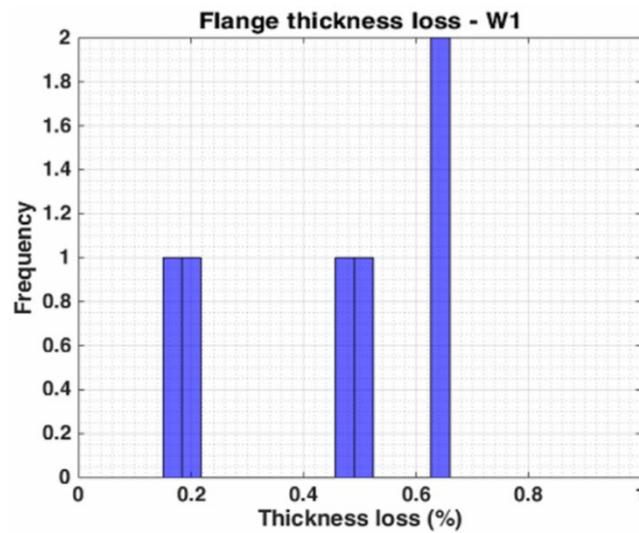
Figure 195: Flange thickness Loss for pattern W1 – RIDOT

Due to the limited quantities of beams with flange corrosion, the team was not able to detect any trend regarding flange corrosion from the recorded data. Figure 195, Figure 196 and Figure 197 depict the statistics the research team was able to extract from the available data.
