Improved Load Rating Procedures for Deteriorated Unstiffened Steel Beam Ends

Prepared For:
New England Transportation Consortium
January 2024

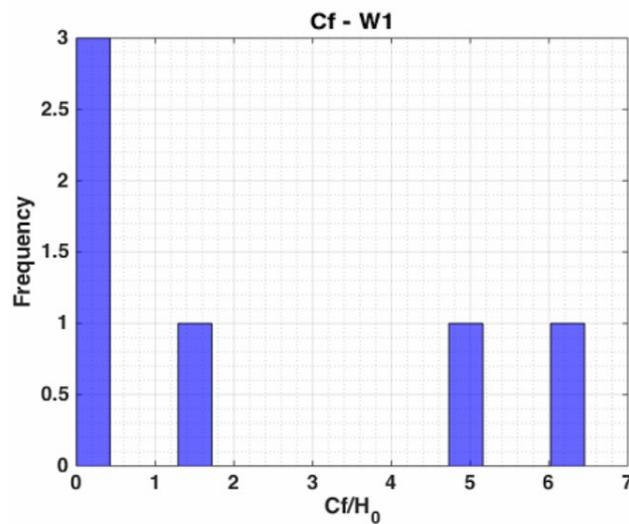
Figure 196: Flange corrosion length for pattern W1 – RIDOT

Due to the limited quantities of beams with flange corrosion, the team was not able to detect any trend regarding flange corrosion from the recorded data. Figure 195, Figure 196 and Figure 197 depict the statistics the research team was able to extract from the available data.

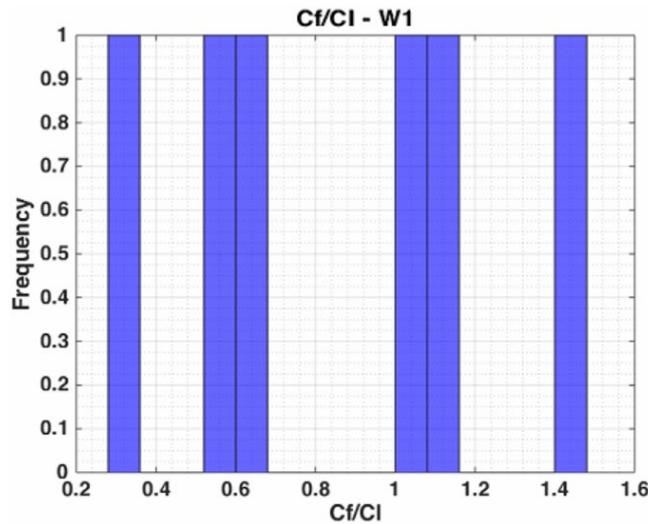
Figure 197: Ratio between flange corrosion length and web corrosion length for pattern W1 – RIDOT

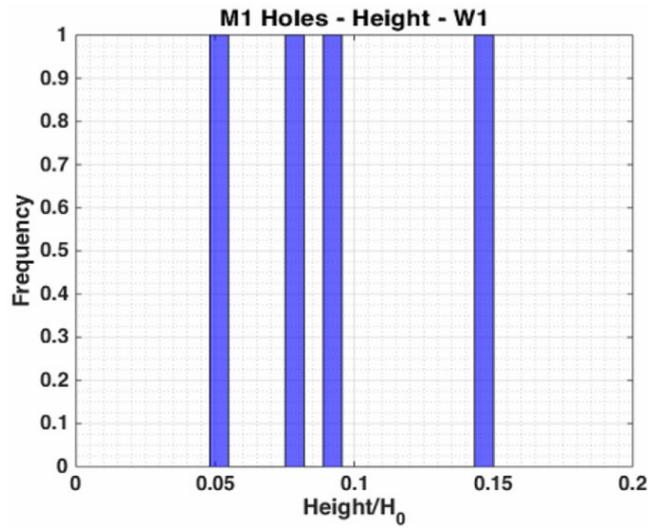
Figure 198: Height of M1 holes combined with W1 pattern – RIDOT

Therefore, only 5 holes were reported and were combined with the W1 corrosion pattern. Unfortunately, no trend was detected by the research team. Figure 198, Figure 199, Figure 200 and Figure 201 depicts the dimensions of the recorded corrosion holes.

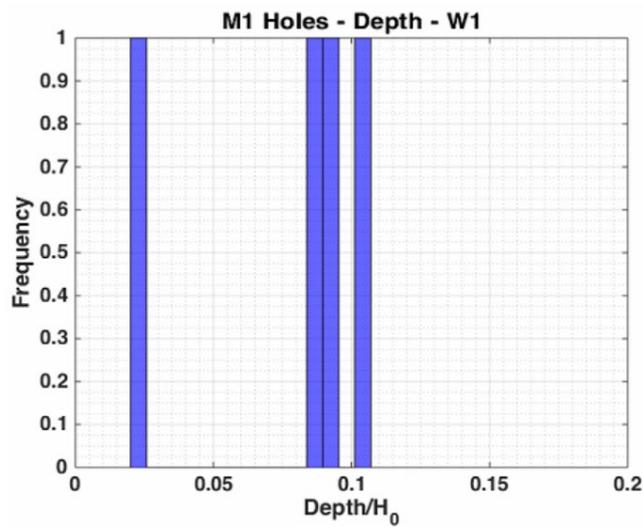
Figure 199: Depth of M1 holes combined with W1 pattern – RIDOT

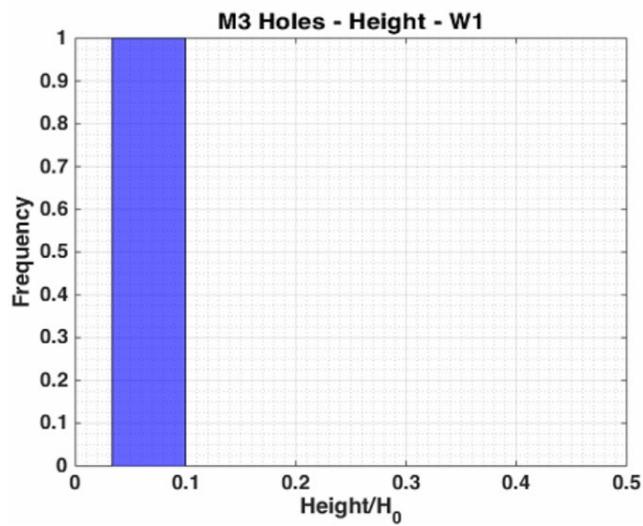
Figure 200: Height of M3 hole combined with W1 pattern – RIDOT

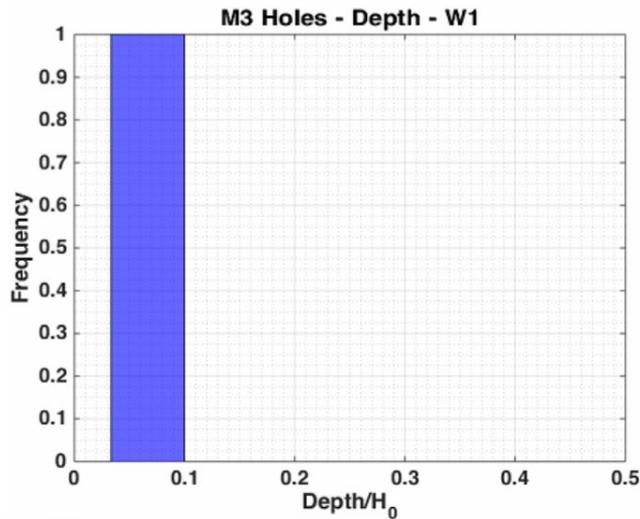
Figure 201: Depth of M3 holes combines with W1 pattern – RIDOT

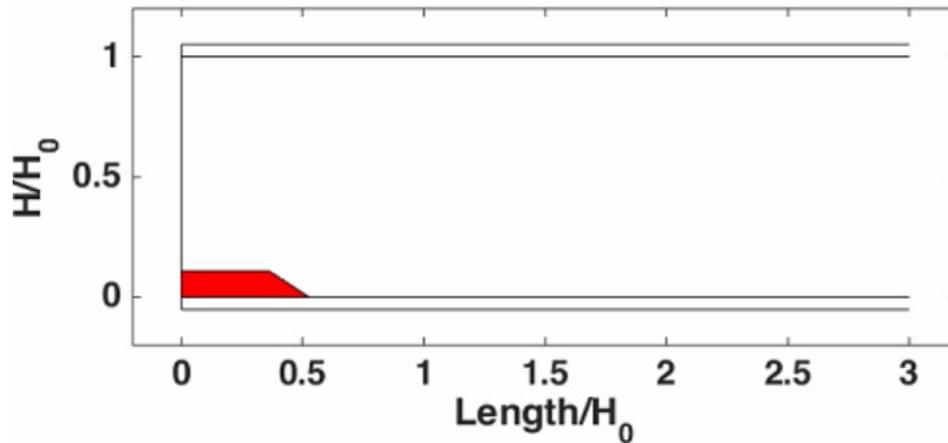
Figure 202: Schematic representation of W2 pattern – RIDOT

Figure 202 depicts a schematic sketch of the recorded W2 case.

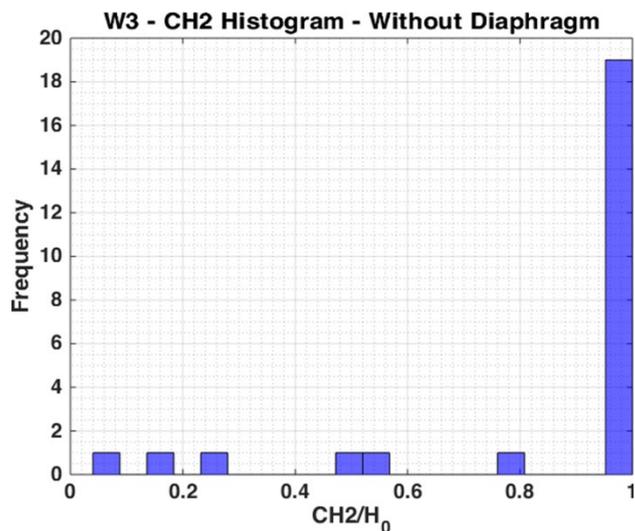
Figure 203: CH2 distribution for W3 pattern - RIDOT

Similar to the other cases, the study of W3 corrosion pattern begins by the analysis of the total corrosion height, characterized by parameters CH2 of pattern W3. The parameters for the corrosion patterns can be found with corresponding diagrams in Section 1.5 *Corrosion Patterns* of this report. Figure 203 depicts the resulting distribution of CH2 for beams ends without diaphragm.

Figure 203 depicts the clear trend that $CH_2 > 0.9H_0$. Therefore, one is able to obtain the distribution of the other parameters given that $Ch_2 > 0.9H_0$. Figures Figure 204, Figure 205,

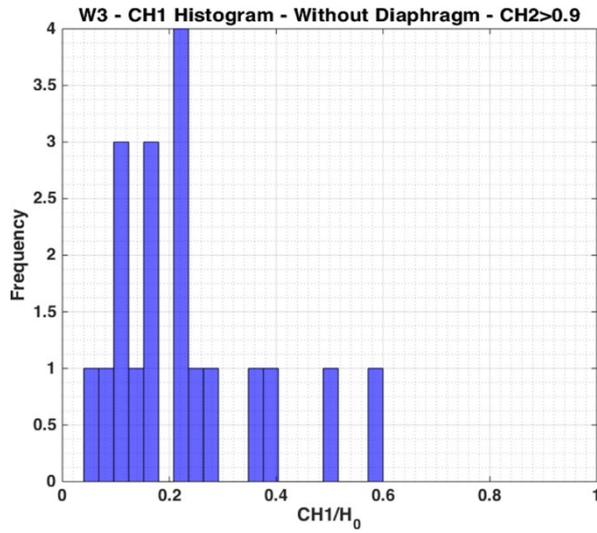
Figure 204: CH1 distribution for W3 pattern and $CH2 > 0.9H0$ - RIDOT

Figure 206, Figure 207 and Figure 208 depict the behavior of the other parameters given that $CH2 > 0.9H0$.

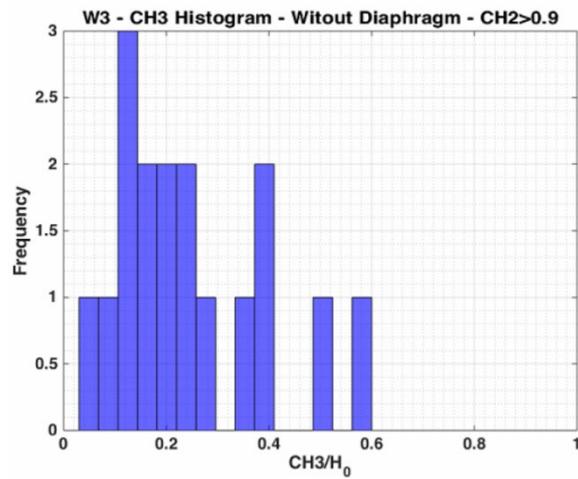
Figure 205: CH3 distribution for W3 pattern and $CH2 > 0.9H0$ - RIDOT

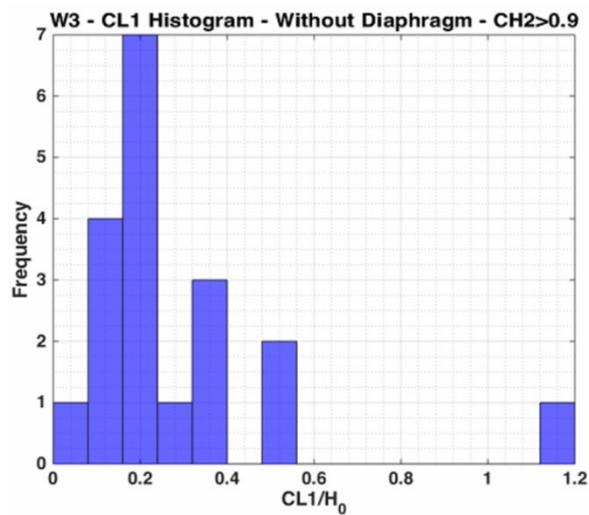
Figure 206: CL1 distribution for W3 pattern and $CH2 > 0.9H0$ - RIDOT

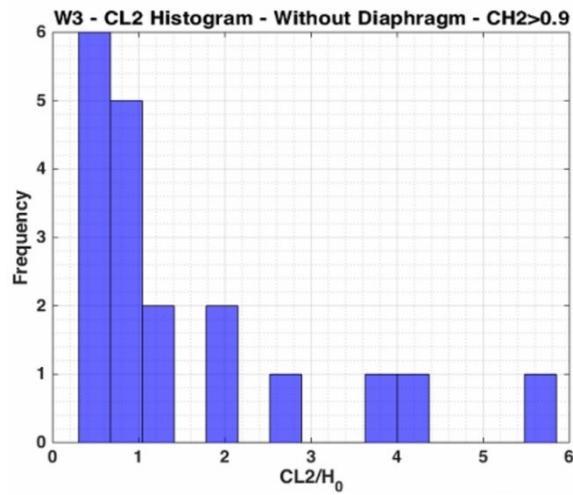
Figure 207: CL2 distribution for W3 pattern and CH2>0.9H0 - RIDOT

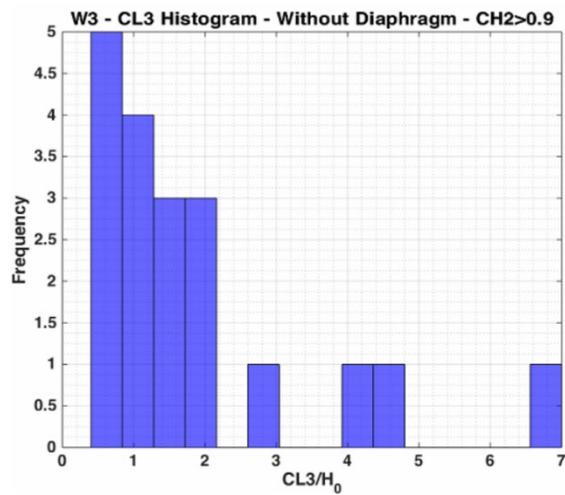
Figure 208: CL3 distribution for W3 pattern and CH2>0.9H0 - RIDOT

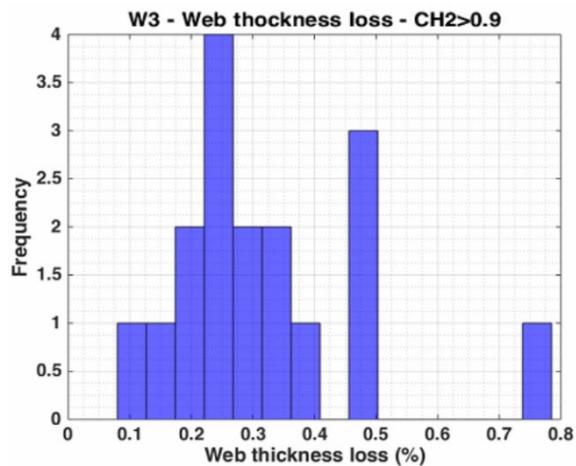
Figure 209 depicts the web thickness loss for the W3 corrosion pattern.

Figure 209: Web thickness loss distribution for W3 pattern and CH2>0.9H0 - RIDOT

From the previous figures, our team was able to determine the intervals for the W3 corrosion patterns, which can be written as:

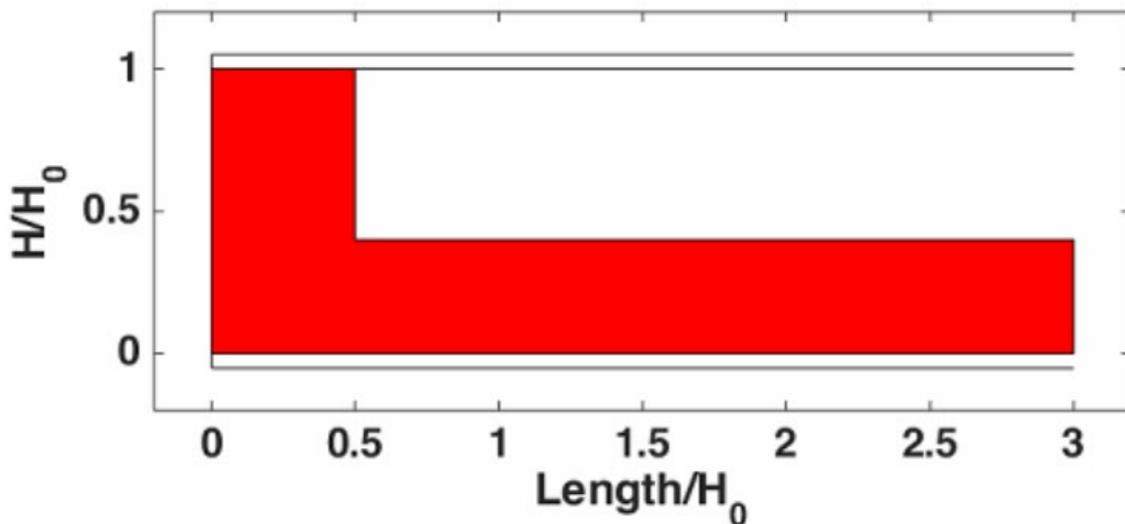
Figure 210 depicts a schematic representation of the extreme corrosion case for W3 corrosion pattern.

Figure 210: Extreme corrosion case for W3 pattern - RIDOT

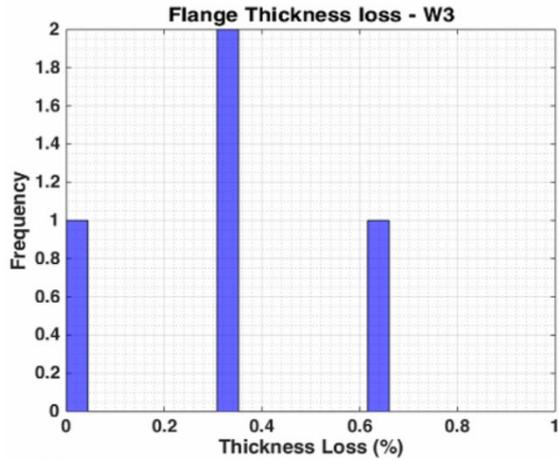
Figure 211: Flange thickness loss distribution for W3 pattern – RIDOT

From the bridge inspection reports, the research team was able to record 4 cases of flange corrosion combined with the pattern W3. No trend was detected by the research team regarding the flange thickness loss. Figures Figure 211, Figure 212 and Figure 213 depict the statistics that the research team was able to obtain from the bridge inspection reports.

It is worth noting that, although no trend was depicted, it is possible to observe that the behavior of the corrosion of the flanges is similar to the corrosion of the web. That is, the length of corroded flange is close to the total length of web corrosion.

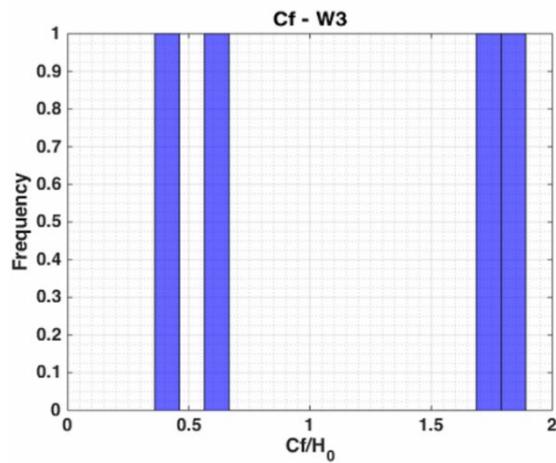
Figure 212: Flange corrosion length for W3 pattern – RIDOT

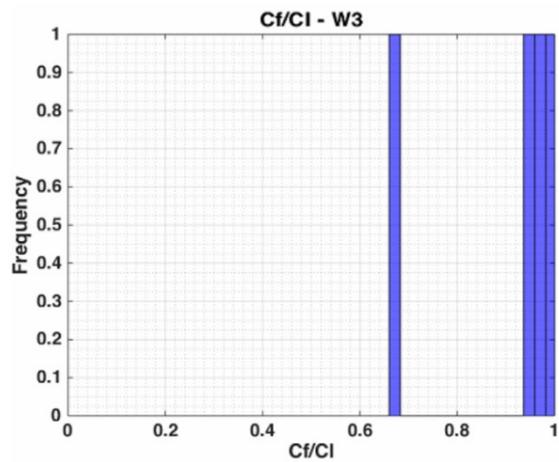
Figure 213: ratio between flange corrosion length and web corrosion length for W3 pattern – RIDOT

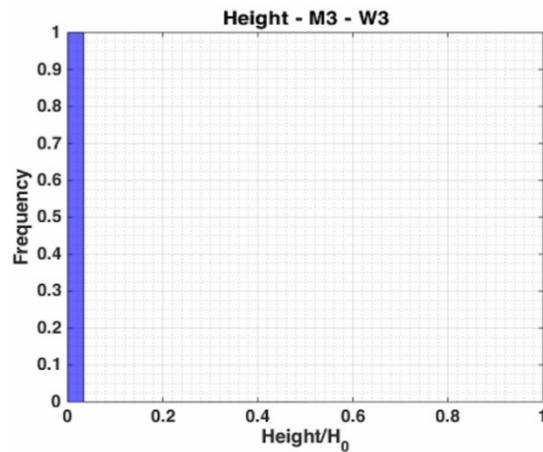
Figure 214: Height of M3 hole combined with W3 pattern – RIDOT

Figure 214, Figure 215, Figure 216 and Figure 217 depict the dimensions of the recorded holes.

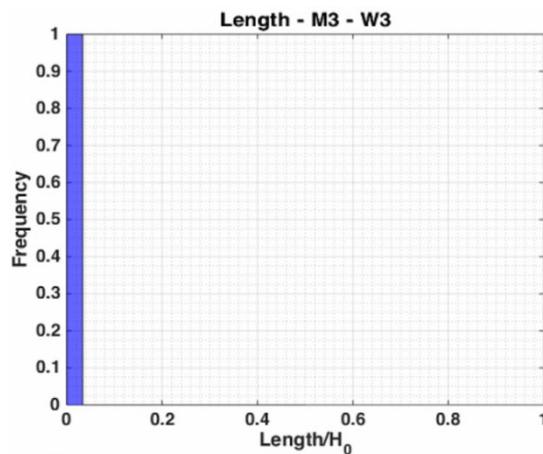
Figure 215: Length of M3 hole combined with W3 pattern – RIDOT

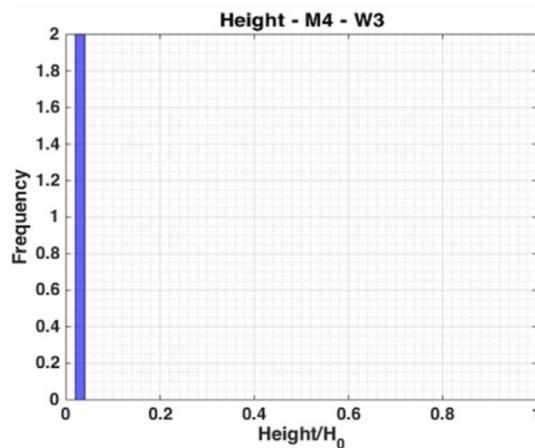
Figure 216: Height of M4 holes combined with W3 pattern – RIDOT

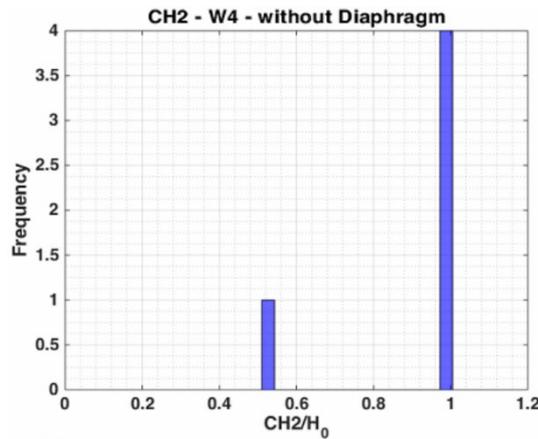
Figure 218: CH2 distribution for W4 pattern – RIDOT

Figure 218 depicts the distribution of CH2 of pattern W4. Figure 218 clearly depicts the trend of $CH2 > 0.9H_0$. The research team was not able to detect trends as the other parameters of W4 pattern are scattered, which limited our research team in detecting trends. The parameters for the corrosion patterns can be found with corresponding diagrams in Section 1.5 *Corrosion Patterns* of this report. Figure 219, Figure 220, Figure 221 and Figure 222 depict the distribution of the other parameters recorded from the bridge inspection reports.

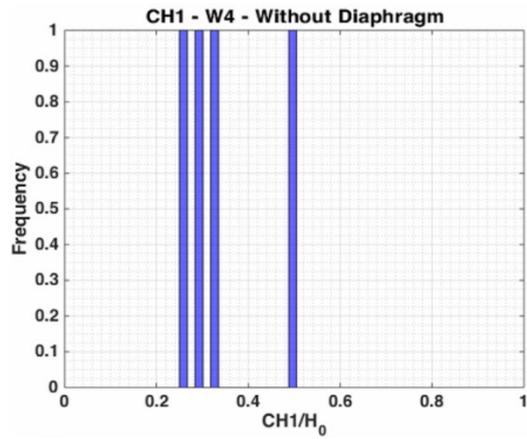
Figure 219: CH1 distribution for W4 pattern – RIDOT

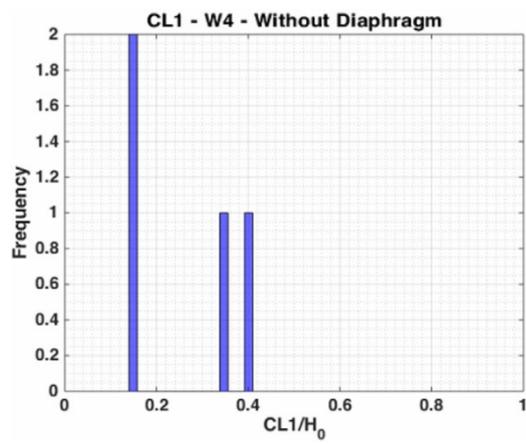
Figure 220: CL1 distribution for W4 pattern – RIDOT

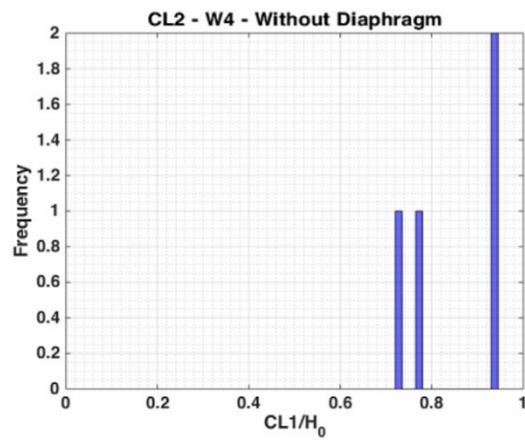
Figure 221: CL2 distribution for W4 pattern – RIDOT

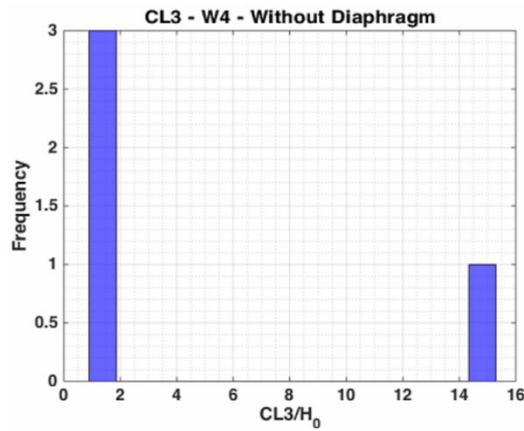
Figure 222: CL3 distribution for W4 pattern – RIDOT

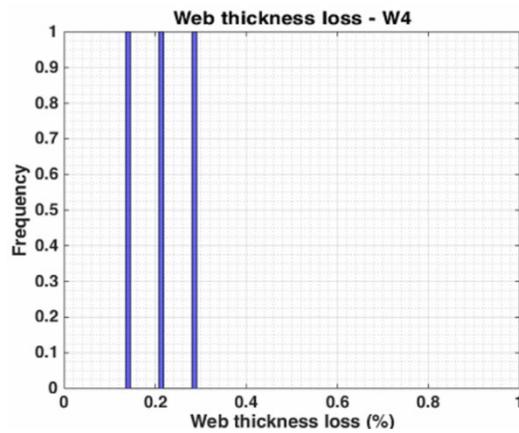
Figure 223 depicts the web thickness loss of the W4 corrosion pattern.

Figure 223: Web thickness loss distribution for W4 pattern – RIDOT

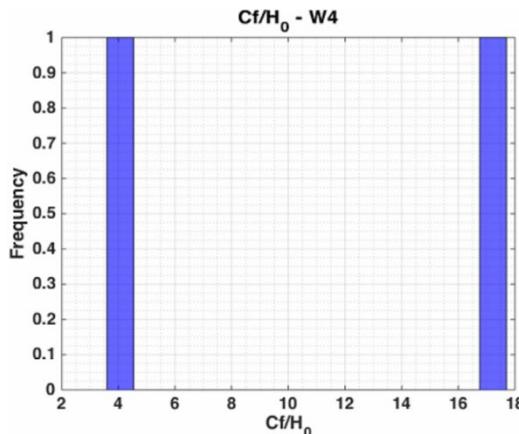
Figure 224: Flange corrosion length distribution for W4 pattern – RIDOT

From the bridge inspection reports, the research team was able to record just two measurements of flange corrosion combined with the W4 corrosion pattern. As two recorded pattern instances are not enough to define trends, Figure 224, Figure 225, and Figure 226 depict the measurements provided by the inspection reports.

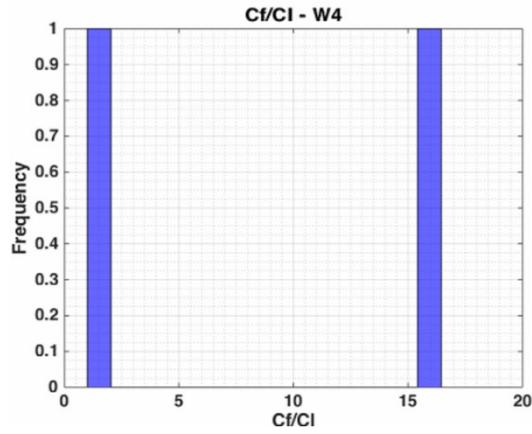
Figure 225: Ratio between flange corrosion length and corrosion length for W4 pattern – RIDOT

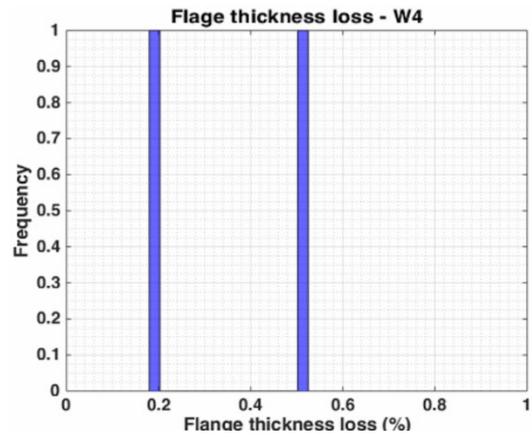
Figure 226: Flange thickness loss distribution for W4 pattern – RIDOT

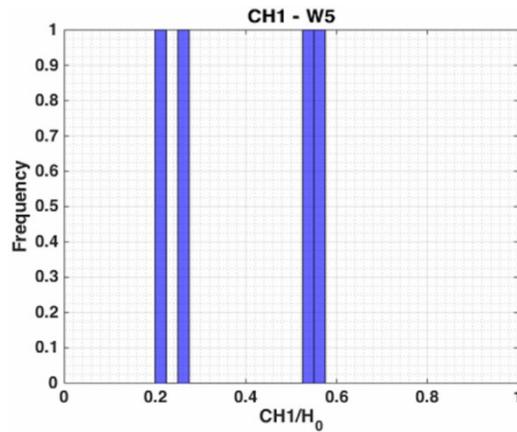
Figure 227: CH1 distribution for W5 pattern – RIDOT

The research team was able to record data from 4 cases of the W5 corrosion pattern. The parameters for the corrosion patterns can be found with corresponding diagrams in Section 1.5 *Corrosion Patterns* of this report. As the amount of data recorded was not enough to detect any trends, Figure 227 and Figure 228 depict only the histogram of the parameters.

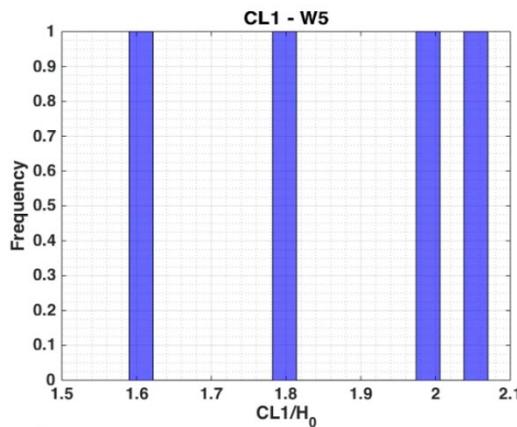
Figure 228: CL1 distribution for W5 pattern – RIDOT

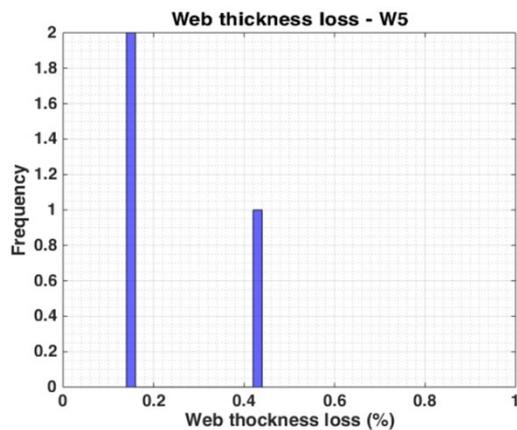
Figure 229 depicts the web thickness loss for the W5 corrosion pattern.

Figure 229: Web thickness loss for W5 pattern – RIDOT

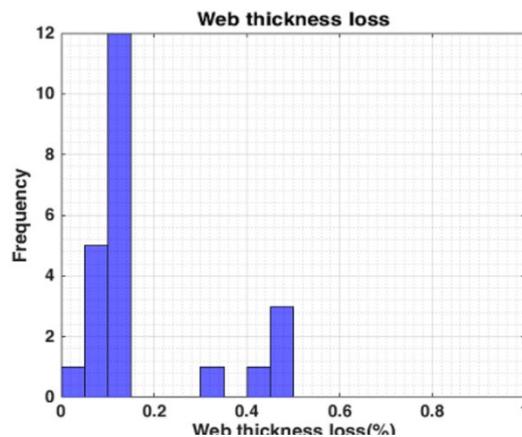
As stated above, the absence of sketches and labels on the pictures hampered the research team to classify the corrosion topology. For this reason, the only information regarding web corrosion that the research team was able to obtain from the VTrans bridge inspection reports was the web thickness loss. Figure 230 depicts the histogram of web thickness loss obtained from the data provided by VTrans reports.

Figure 230: Web thickness loss histogram from the beam ends compiled - VTrans

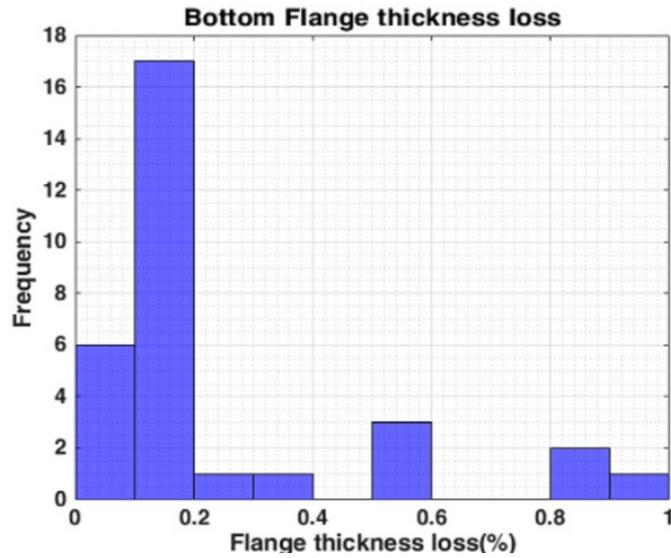
Figure 231: Bottom flange thickness loss histogram from the beam ends compiled - VTrans

Similar to the reports from MaineDOT and NHDOT, the reports from VTrans often present information regarding the thickness loss in the flanges. Figures Figure 231 and Figure 232 depict the thickness loss for bottom and top flanges, respectively.

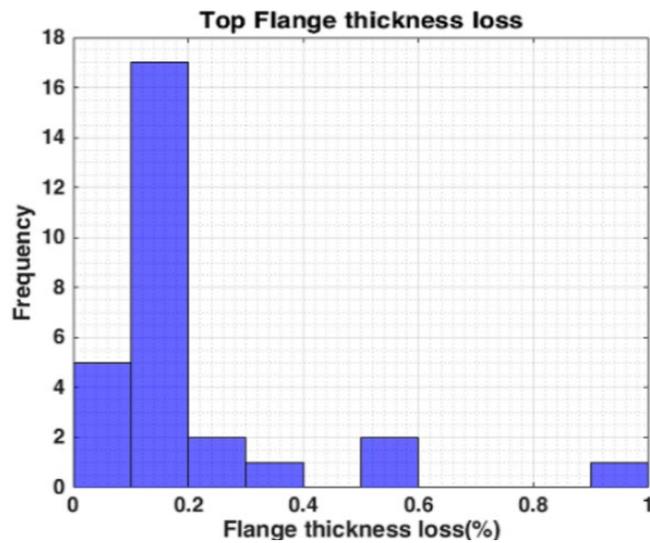
Figure 232: Top flange thickness loss histogram from the beam ends compiled - VTrans

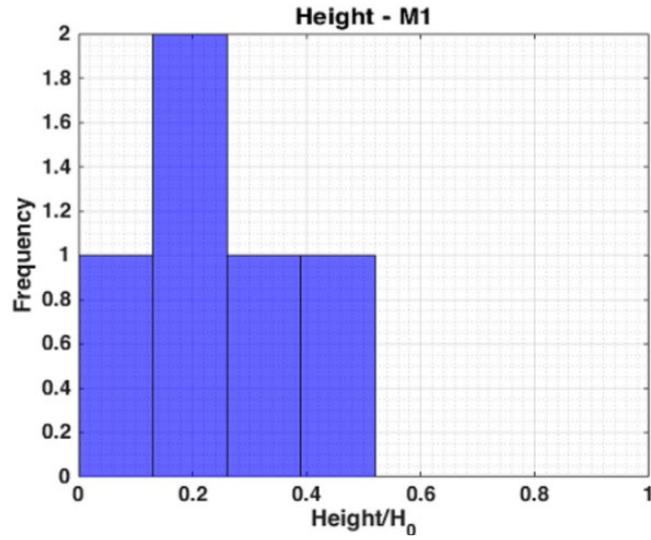
Figure 233: M1 web hole's height distribution beams without a diaphragm - VTrans

The dimensions of the holes are depicted in Figure 233, Figure 234, Figure 235, Figure 236, Figure 237, Figure 238, and Figure 239.

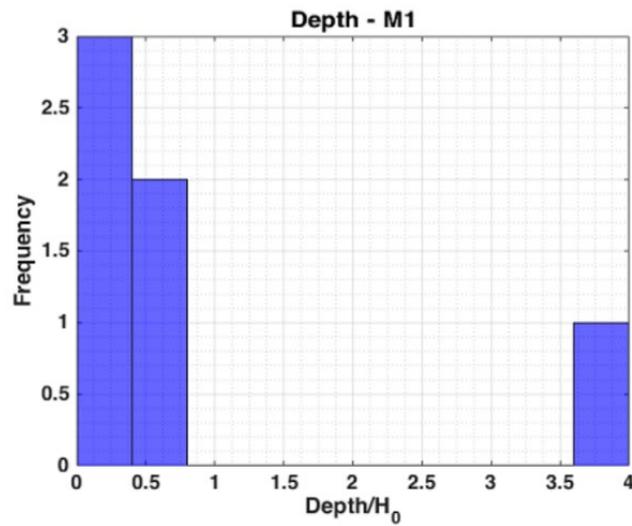
Figure 234: M1 web hole's depth distribution beams without a diaphragm - VTrans

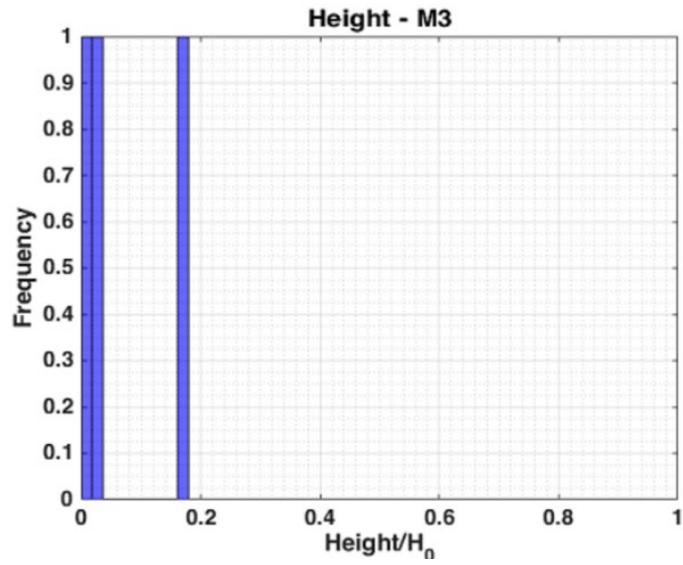
Figure 235: M3 web hole's height distribution beams without a diaphragm - VTrans

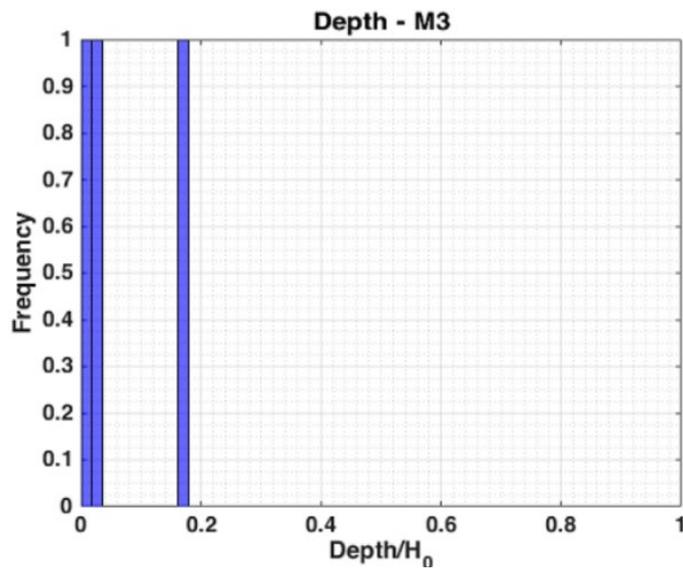
Figure 236 : M3 web hole's depth distribution beams without a diaphragm - VTrans

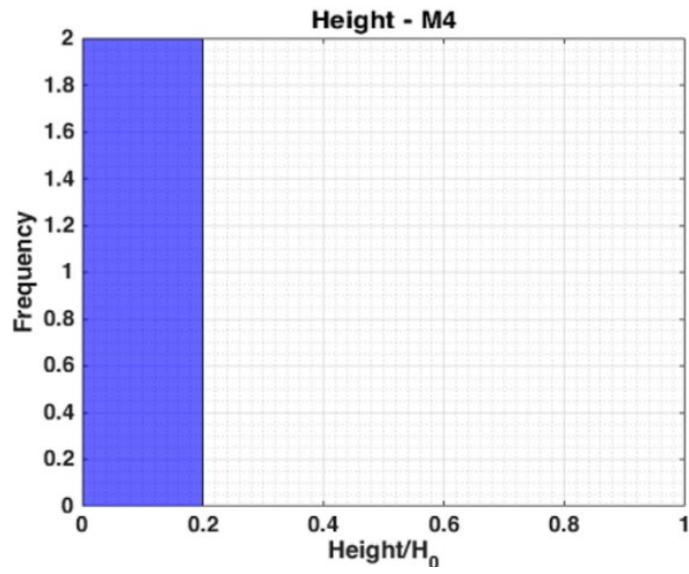
Figure 237: M4 web hole's height distribution beams without a diaphragm - VTrans

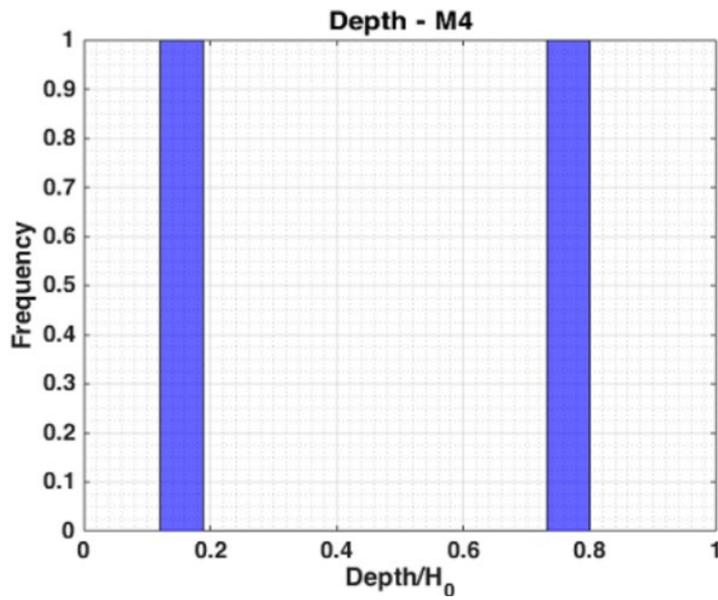
Figure 238: M4 web hole's depth distribution beams without a diaphragm - VTrans

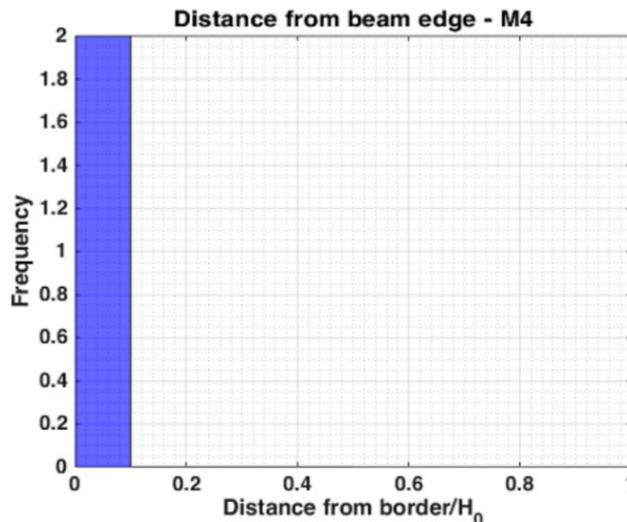
Figure 239 : M4 web hole's distance from beam edge distribution beams without a diaphragm - VTrans

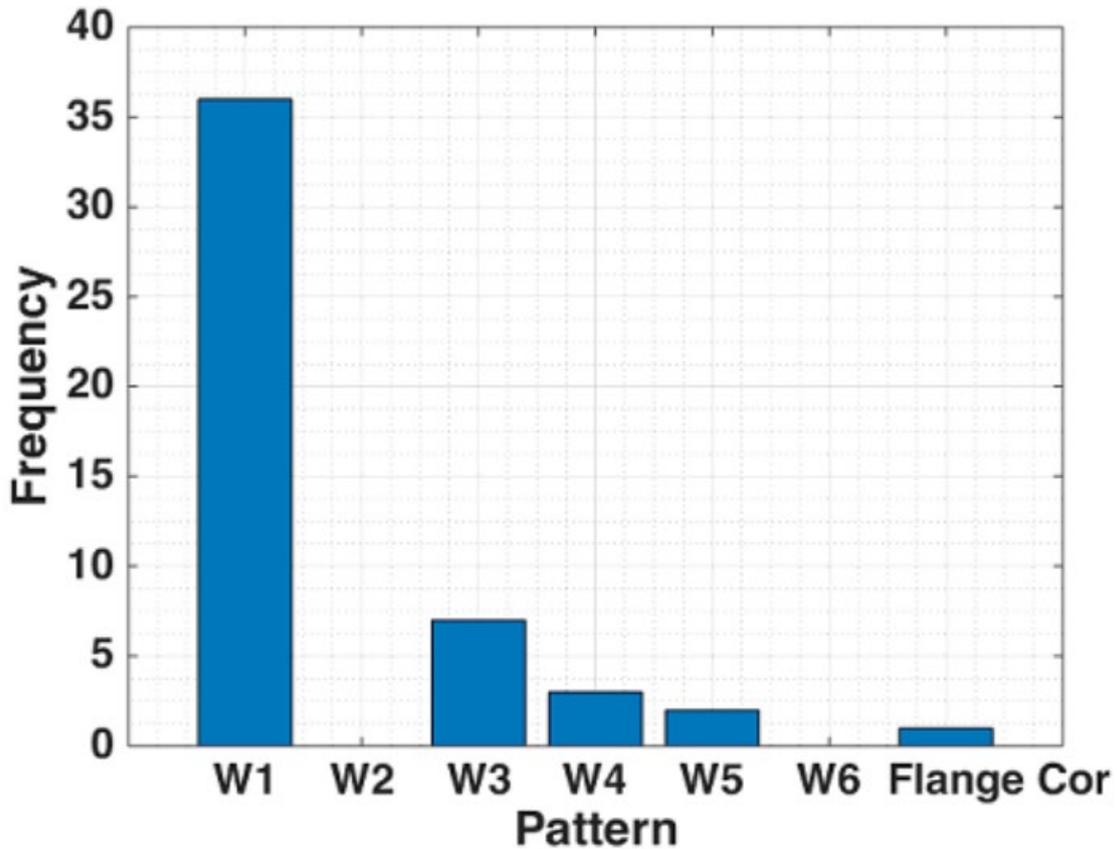
Figure 240 depicts the frequency of patterns obtained for beam ends with a diaphragm from the reports provided by CTDOT.

Figure 240: Web corrosion patterns distribution for beams ends with a diaphragm – CTDOT

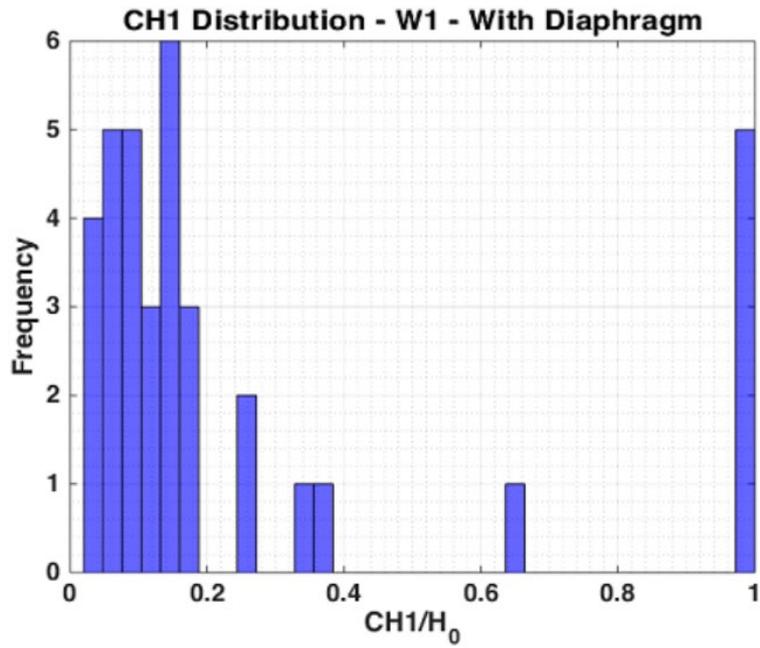
The study began with the analysis of the distribution of the corrosion height, depicted in Figure 241. The parameters for the corrosion patterns can be found with corresponding diagrams in Section 1.5 *Corrosion Patterns* of this report.

Figure 241: Distribution of corrosion height for W1 pattern – CTDOT

Our team discovered that, similar to the beams without a diaphragm, two trends are noticeable: (i) $CH1 < 0.2H_0$, (ii) $CH1 > 0.9H_0$.

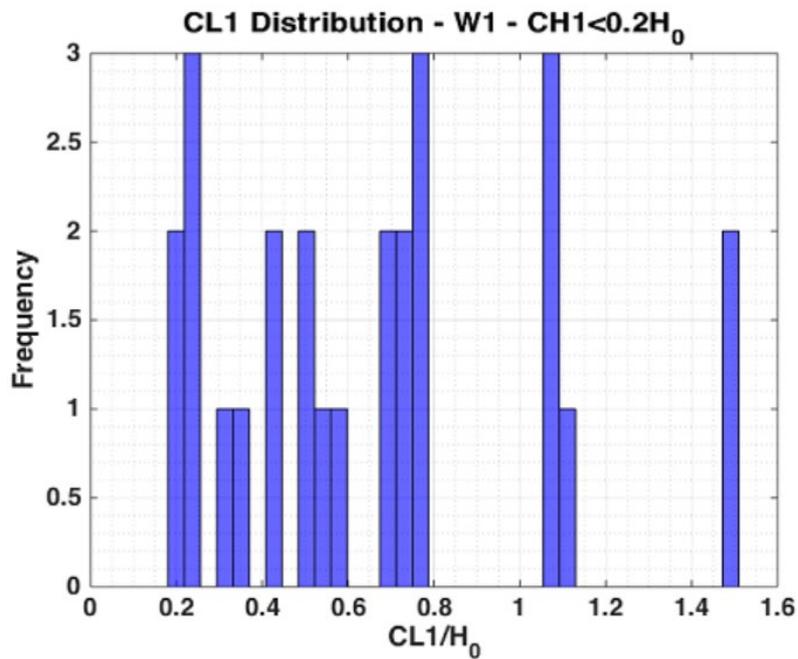
Figure 242: Corrosion length distribution for W1 pattern and $CH1 < 0.2H_0$ – CTDOT

Figure 242 depicts the length of corrosion for $CH1 < 0.2H_0$, whereas Figure 243 depicts the length corrosion distribution for $CH1 > 0.9H_0$.

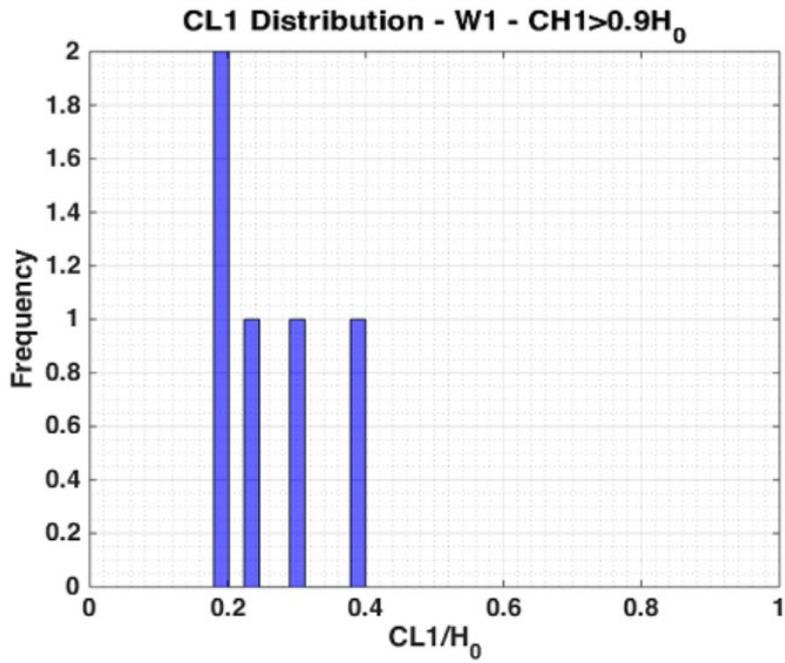
Figure 243 : Corrosion length distribution for W1 pattern and CH1 > 0.9H0 – CTDOT

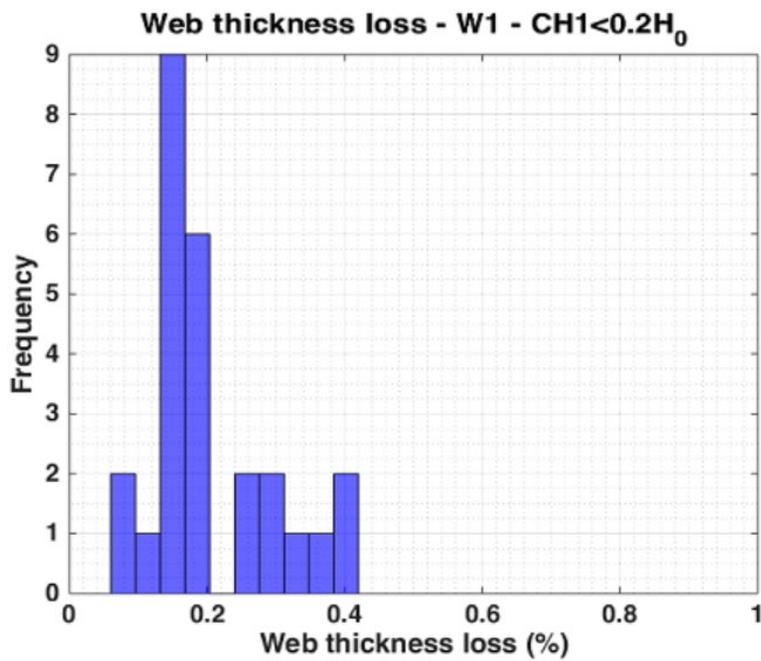
Figure 244 : Web thickness loss for W1 pattern and CH1 < 0.2H0 – CTDOT

Figure 244 and Figure 245 depict the web thickness loss for CH1 < 0.2H0 and CH1 > 0.9H0, respectively.

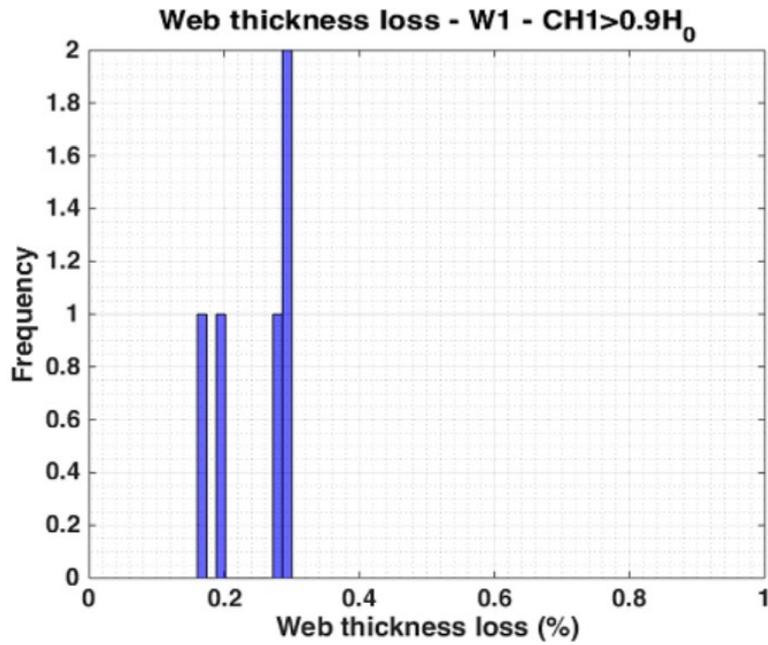
Figure 245 : Web thickness loss for W1 pattern and $CH1 > 0.9H_0$ – CTDOT

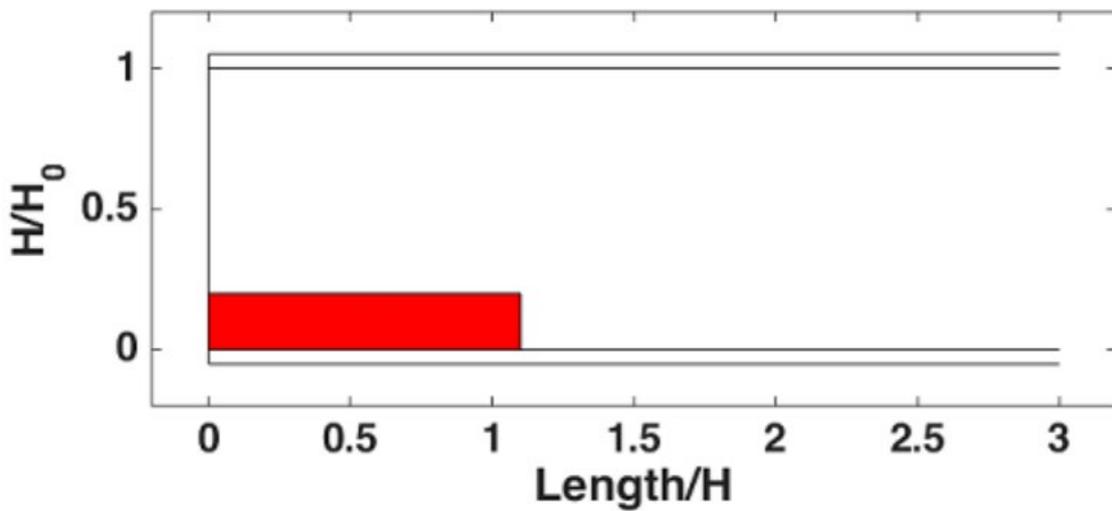
Figure 246: Extreme corrosion scenario (case A) for beams with a diaphragm, W1 pattern – CTDOT

Figure 246 and Figure 247 depict Case A and B.

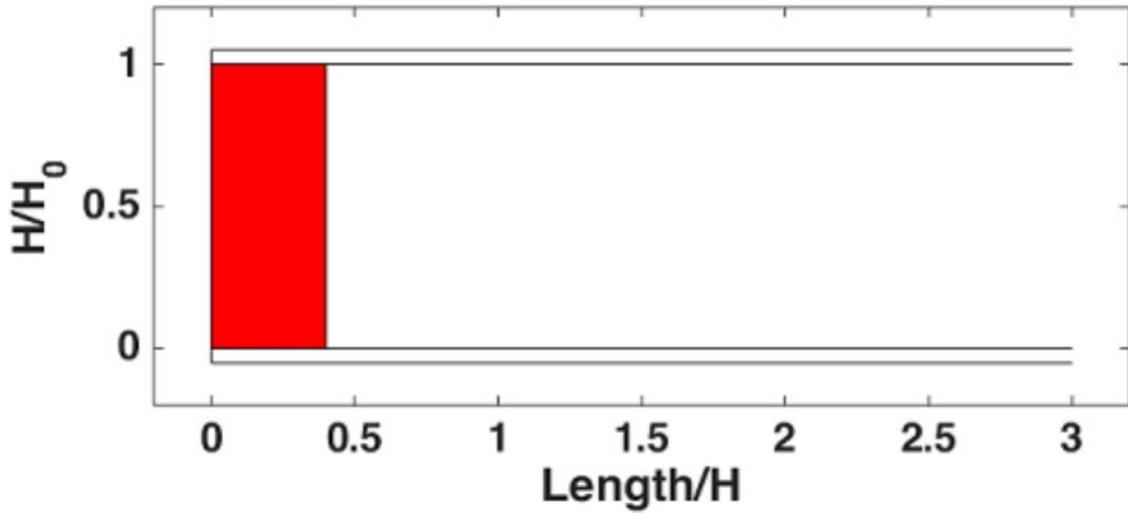
Figure 247: Extreme corrosion scenario (case B) for beams with a diaphragm, W1 pattern – CTDOT

Case B {■($0.9H_0 \leq CH1 \leq 1H_0 @ 0.2H_0 \leq CL1 \leq 0.4H_0 @ 0.1 \leq t_{loss}/t_{web} \leq 0.3$)}

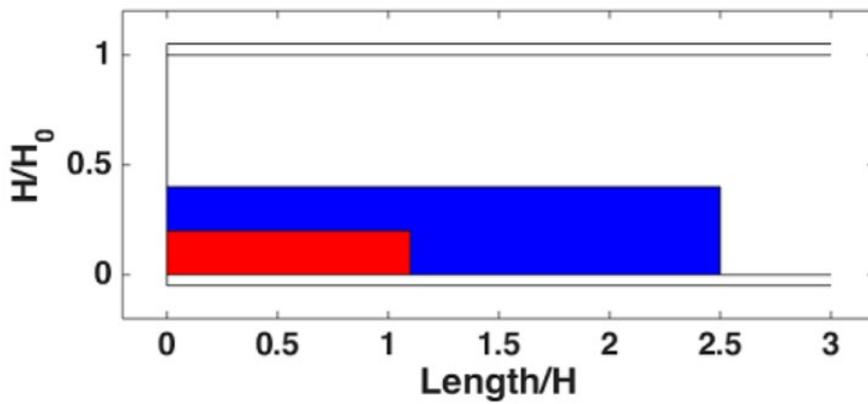
Figure 248: Comparison between extreme corrosion scenarios. Blue represents the extreme scenario for beams without diaphragm, whereas the region in red depicts extreme corrosion scenario for beams with a diaphragm – CTDOT

Figure 248 and Figure 249 depict the overlapping of extreme corrosion cases for beams with and without a diaphragm system.

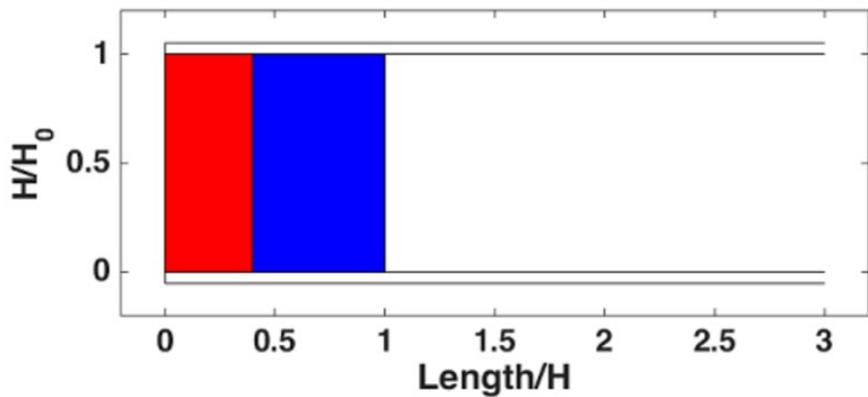
Figure 249: Comparison between extreme corrosion scenarios. Blue represents the extreme scenario for beams without diaphragm, whereas the region in red depicts extreme corrosion scenario for beams with a diaphragm – CTDOT

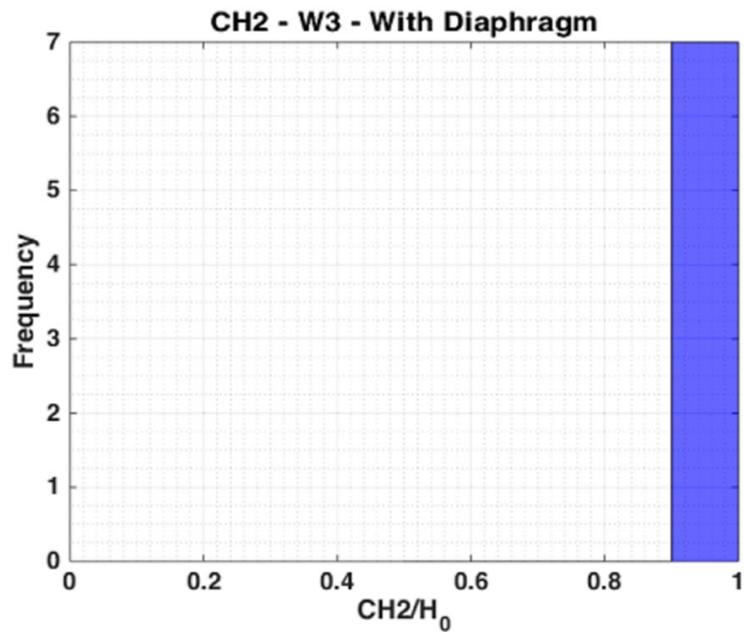
Figure 250: CH2 distribution for W3 pattern for beams with a diaphragm – CTDOT

Although just seven cases of the W3 corrosion pattern combined with diaphragms were recorded, all cases presented corrosion height equal to the height of the web, as depicted in Figure 250. The parameters for the corrosion patterns can be found with corresponding diagrams in Section 1.5 *Corrosion Patterns* of this report.

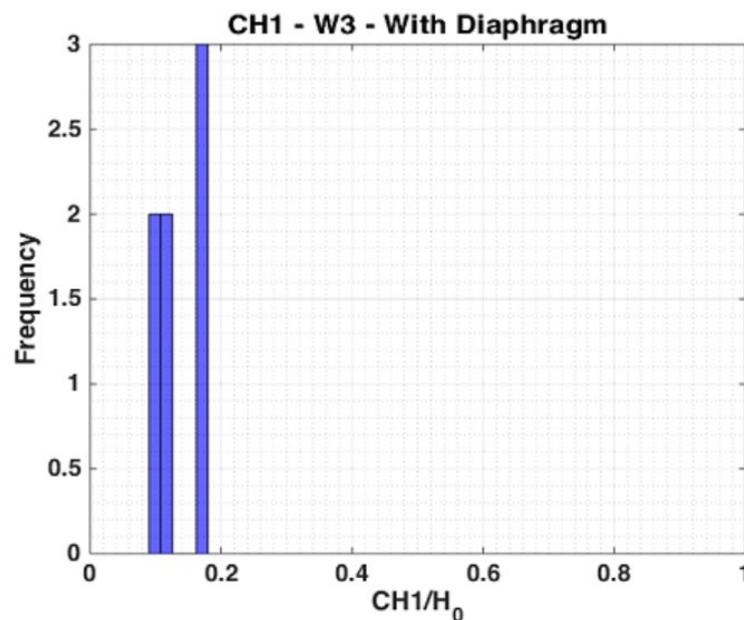
Figure 251: CH1 distribution for W3 pattern for beams with a diaphragm – CTDOT

The other parameters of the W3 corrosion pattern are plotted in Figure 251, Figure 252, Figure 253, Figure 254 and Figure 255.

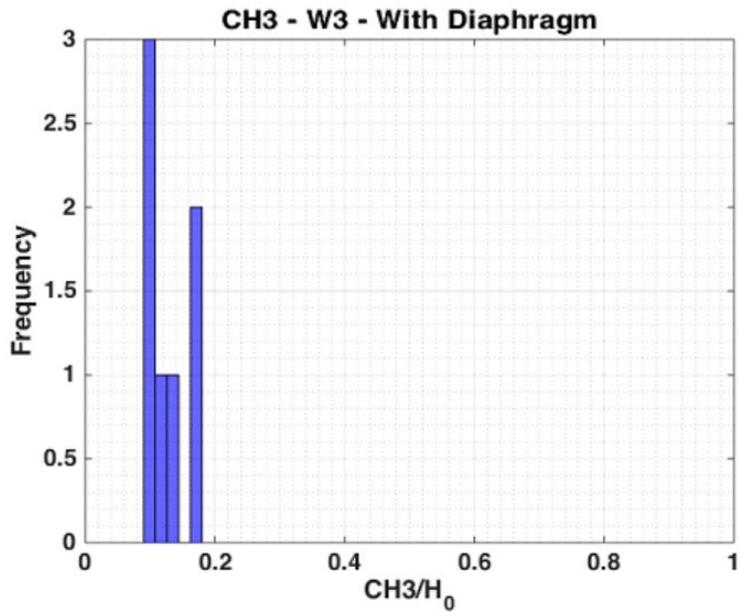
Figure 252: CH2 distribution for W3 pattern for beams with a diaphragm – CTDOT

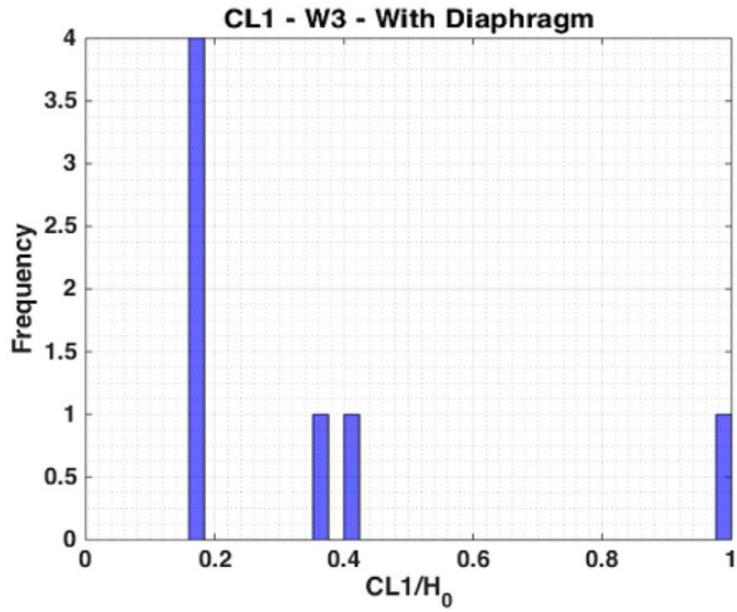
Figure 253: CL1 distribution for W3 pattern for beams with a diaphragm – CTDOT
