Improved Load Rating Procedures for Deteriorated Unstiffened Steel Beam Ends

Prepared For:
New England Transportation Consortium
January 2024

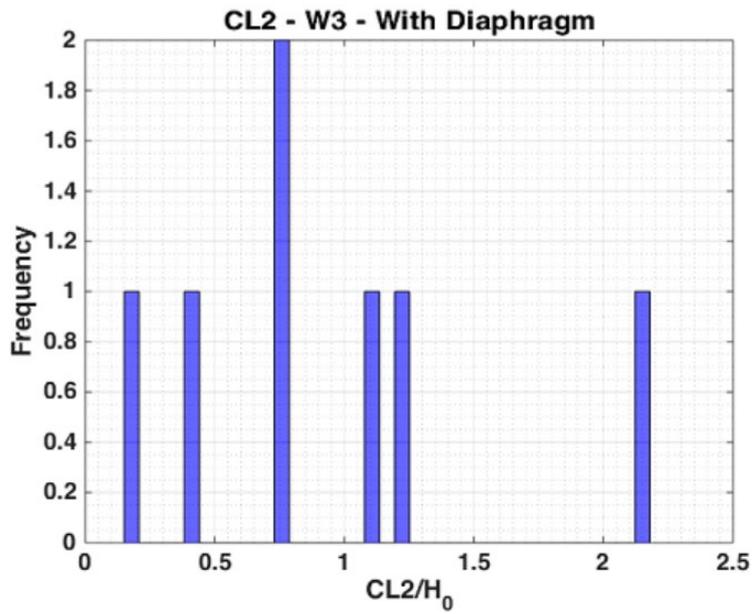
Figure 254: CL2 distribution for W3 pattern for beams with a diaphragm – CTDOT

The other parameters of the W3 corrosion pattern are plotted in Figure 251, Figure 252, Figure 253, Figure 254 and Figure 255.

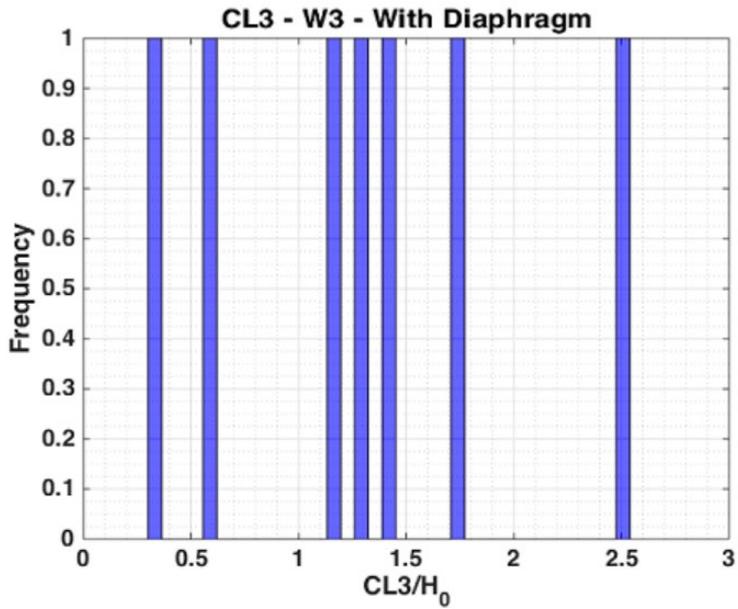
Figure 255: CL3 distribution for W3 pattern for beams with a diaphragm – CTDOT

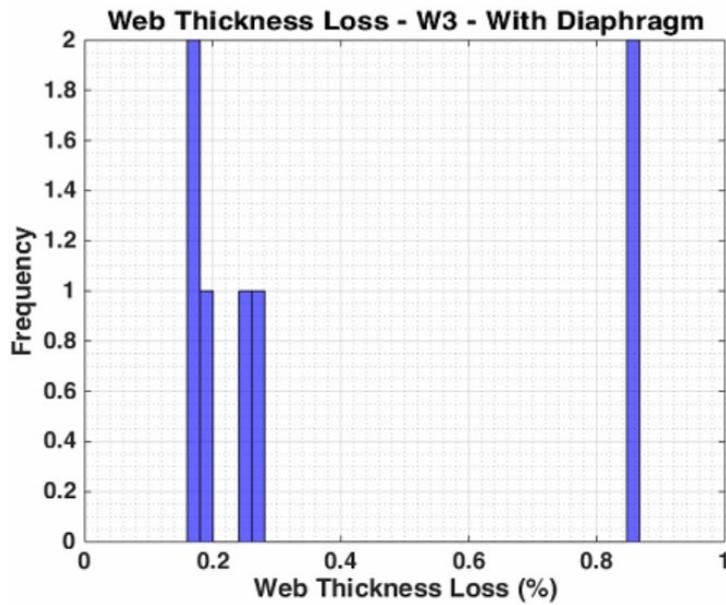
Figure 256: Web thickness loss distribution for W3 pattern for beams with a diaphragm – CTDOT

Figure 256 depicts the web thickness loss distribution for pattern W3.

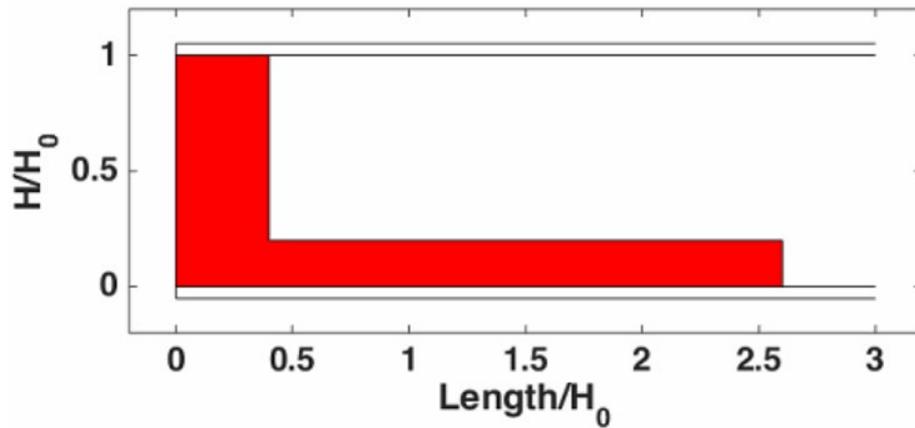
Figure 257: Extreme corrosion scenario of W3 pattern for beam ends with a diaphragm – CTDOT

Figure 257 depicts the extreme case of the W3 corrosion pattern for beam ends with a diaphragm system.

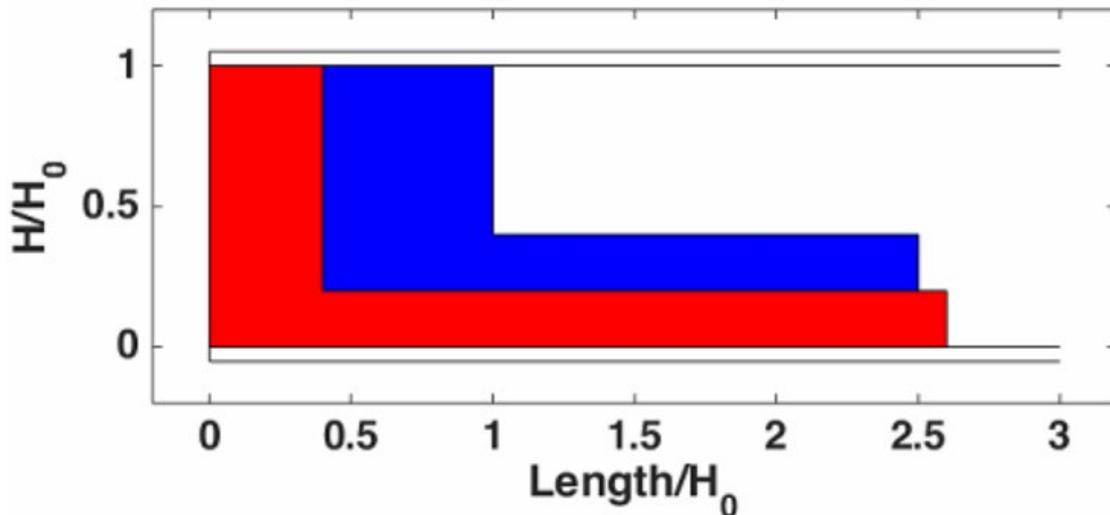
Figure 258: Comparison between extreme corrosion scenarios. Blue represents the extreme scenario for beams without diaphragm, whereas the region in red depicts extreme corrosion scenario for beams with a diaphragm – CTDOT

Figure 258 displays the comparison between the corrosion for beam ends with and without a diaphragm system.

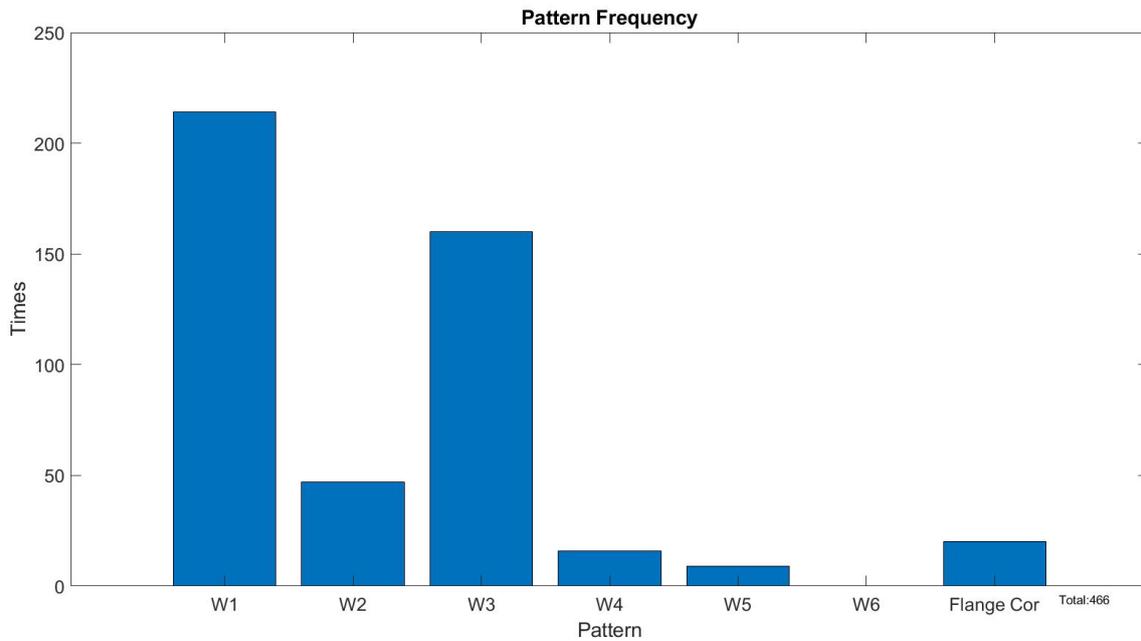
The data was divided into two main categories, beams ends with a diaphragm system and beam ends without a diaphragm system. All the graphs in this part of the document represent the first case. The histogram below contains the frequency of each of the defined corrosion patterns (the total amount of times each pattern appears in the reports).

Figure 259. Web corrosion patterns distribution for beams with a diaphragm - MassDOT

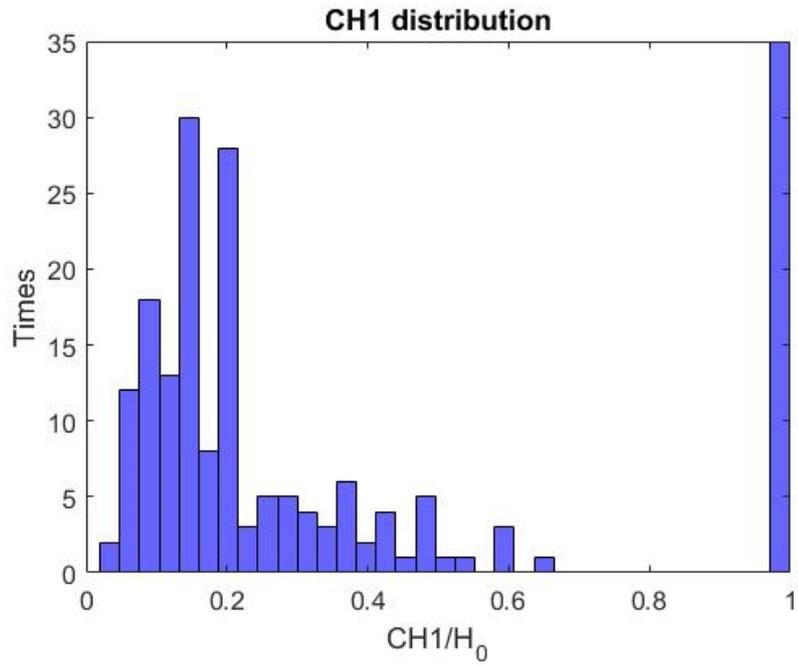
Figure 260. CH1 distribution of W1 web pattern for beams with a diaphragm (total 189). - MassDOT

From the CH1 histogram, two main trends are noticed, which cover almost the 85% of cases (158 out of 189): either a) full height corrosion, or b) corrosion up to 30% of H_0 .

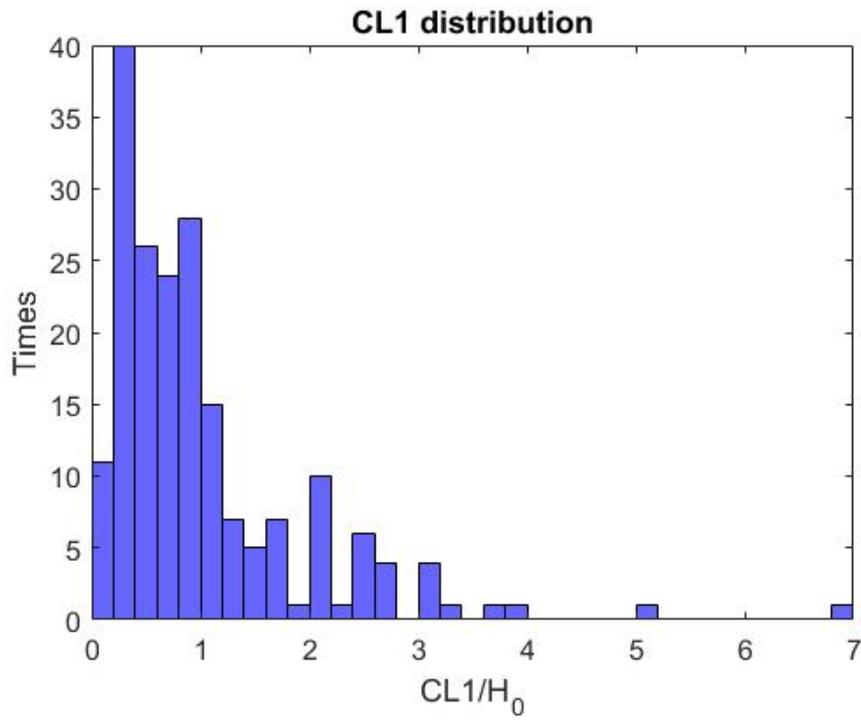
Figure 261: CL1 distribution of W1 web corrosion pattern for beams with a diaphragm - MassDOT

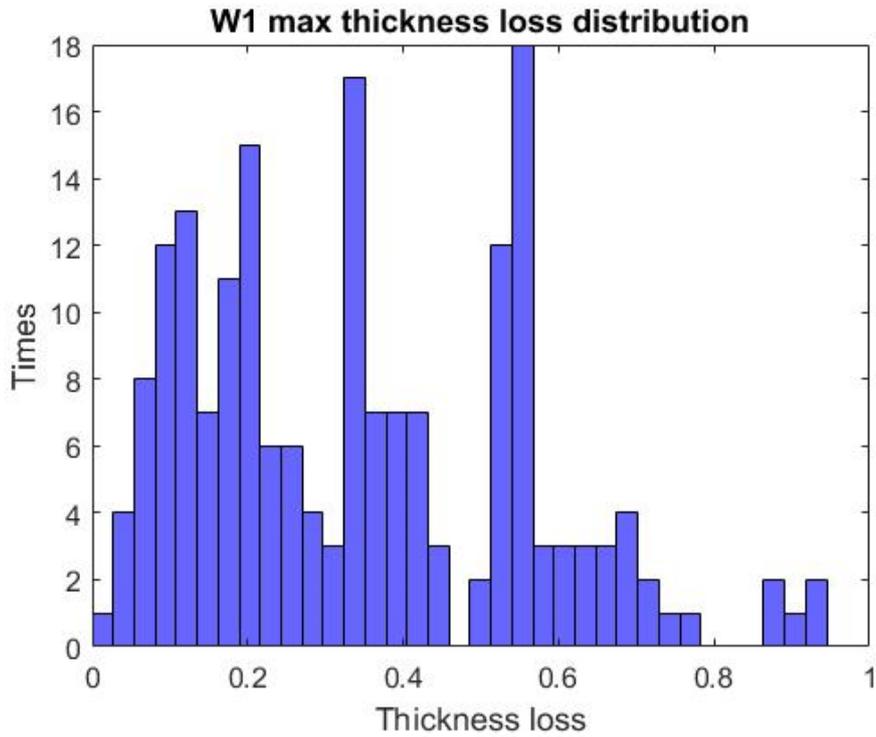
Figure 262: Max thickness loss distribution of W1 web corrosion pattern for beams with a diaphragm - MassDOT

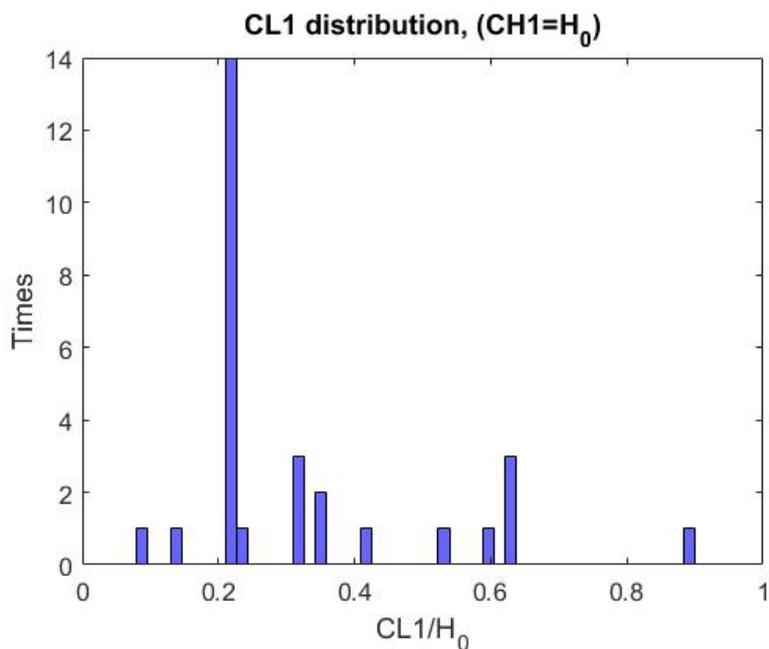
Figure 263: CL1 distribution of full height W1 web corrosion pattern for beams with a diaphragm - MassDOT

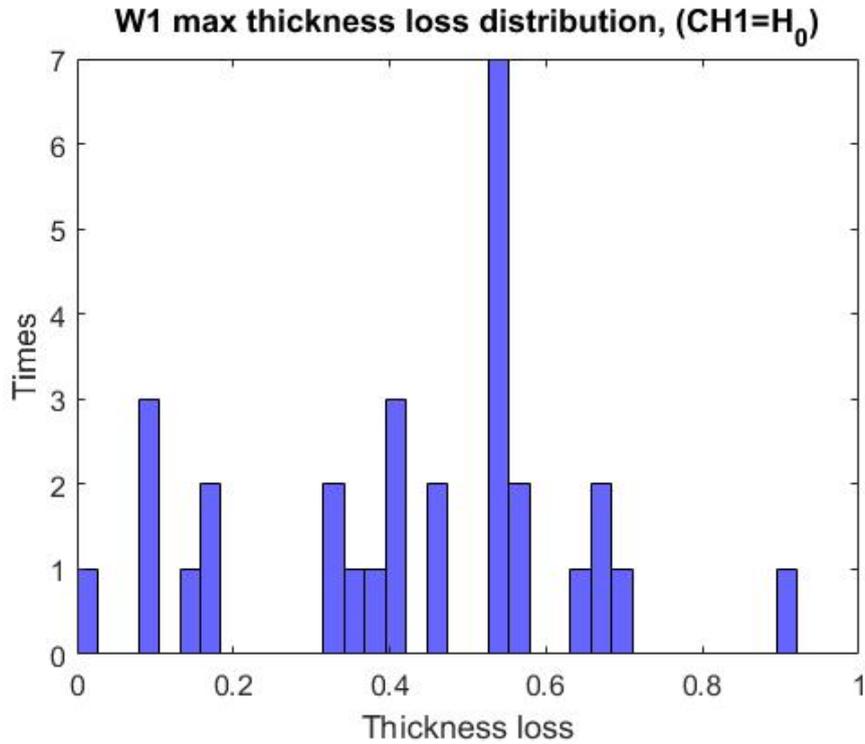
Figure 264: Max thickness loss distribution of full height W1 web corrosion pattern for beams with a diaphragm - MassDOT

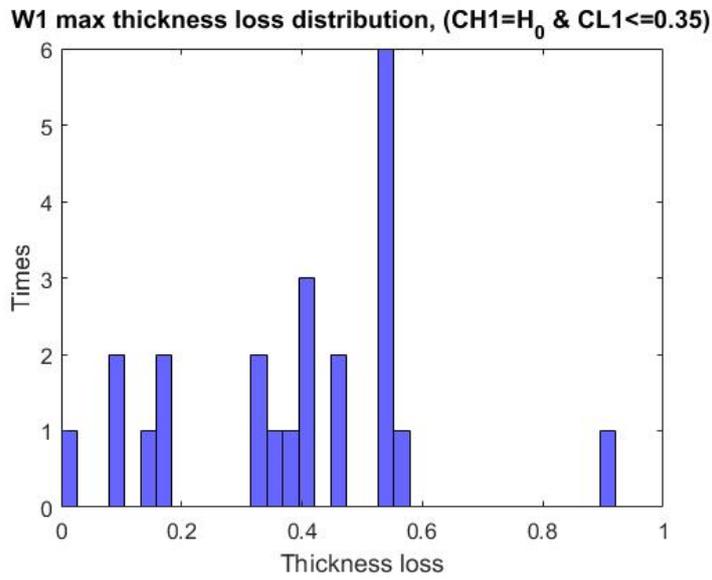
(8)

Figure 265: Max web thickness loss distribution of W1 web corrosion pattern, with corrosion height up to 35% of H₀, for beams with a diaphragm - MassDOT

By observing the figure for full height corrosion and $CL \leq 0.35H$, we saw:

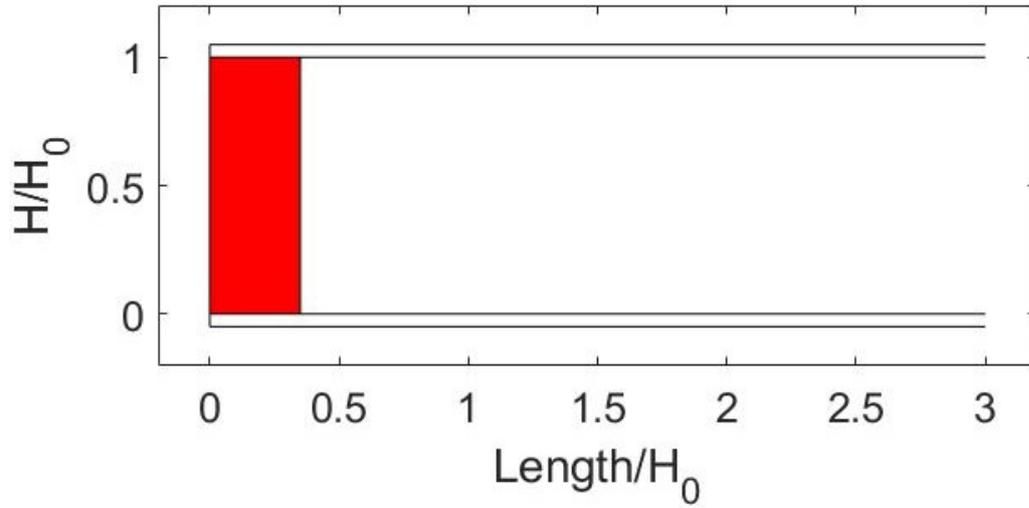
Figure 266: First extreme W1 web corrosion pattern, with full height corrosion for beams with a diaphragm - MassDOT

With web thickness loss $\frac{t_{\text{loss}}}{t_{\text{web}}}$ takes values of $\{0.2, 0.4, 0.6\}$ (Figure 86)

For the full height corrosion case, one case is identified: **CASE A**

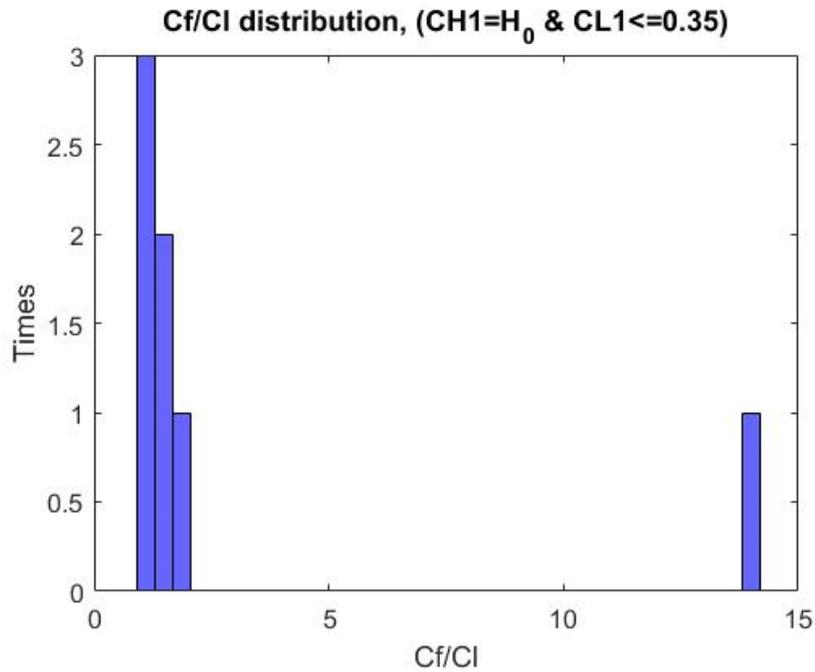
Figure 267: Ratio of flange to web corrosion length distribution of W1 web corrosion pattern, with full height corrosion and up to 35% of H_0 length, for beams with a diaphragm - MassDOT

For Case B: $\frac{t_{loss}}{t_{flange}}$ takes values of {0.2,0.4,0.6,0.8} (Figure 269). The ratio of the length of the corroded flange over the length of the corroded web $0 < \frac{c_f}{c_l} \leq 1$ (Figure 267).

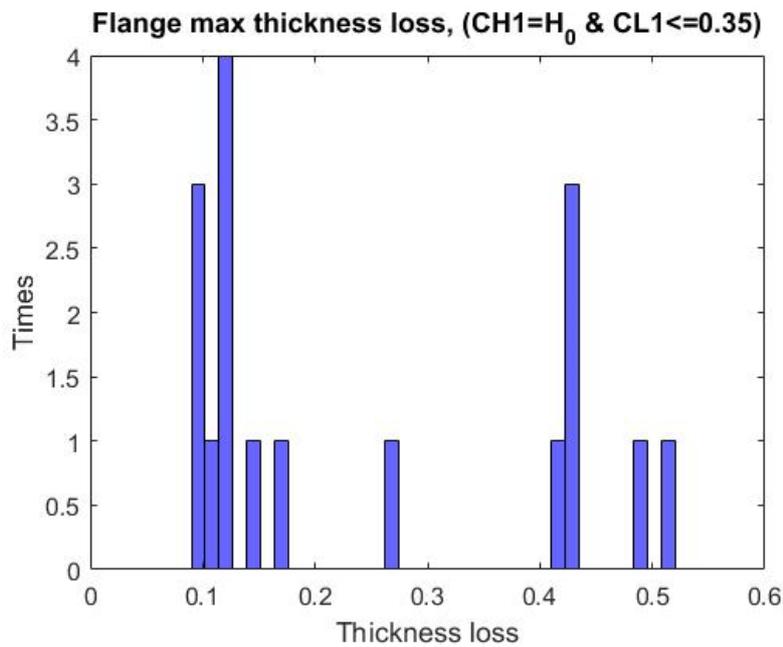
Figure 268: Max flange thickness loss distribution of W1 web corrosion pattern, with full height corrosion and up to 35% of H_0 length, for beams with a diaphragm - MassDOT

Thus, for case A: $\frac{t_{loss}}{t_{flange}}$ takes values of {0.15,0.45} (Figure 268). The ratio of the length of the corroded flange over the length of the corroded web $1 \leq \frac{C_f}{C_l} \leq 1.7$

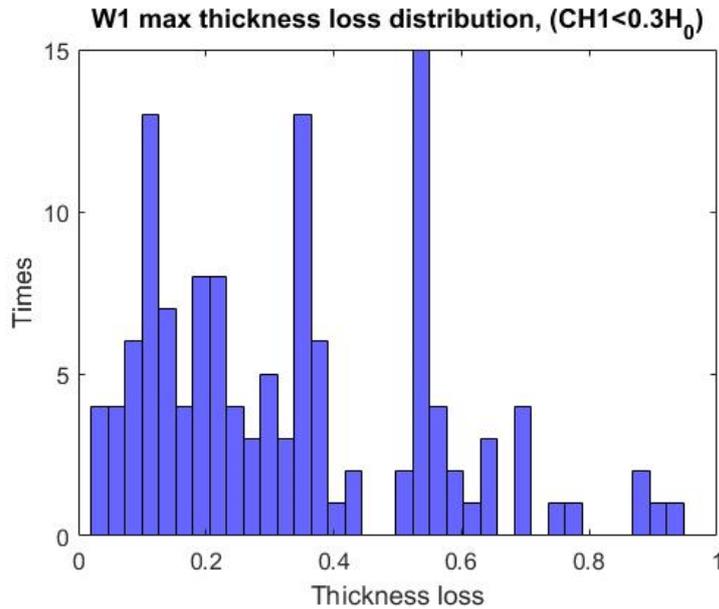
Figure 269: Max web thickness loss distribution of W1 web corrosion pattern with corrosion height up to 30% of H_0 for beams with a diaphragm - MassDOT

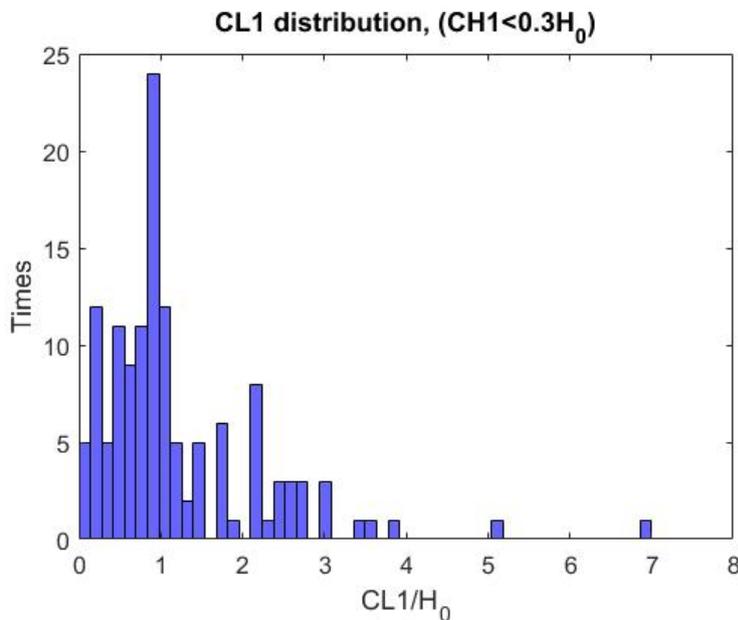
Figure 270: CL1 thickness loss distribution of W1 web corrosion pattern with corrosion height up to 30% of H_0 for beams with a diaphragm - MassDOT

From Figure 270, $0 < CL_1 \leq 2.5$ with web thickness loss $\frac{t_{loss}}{t_{web}}$ takes values of {0.2,0.4,0.6,0.8}.

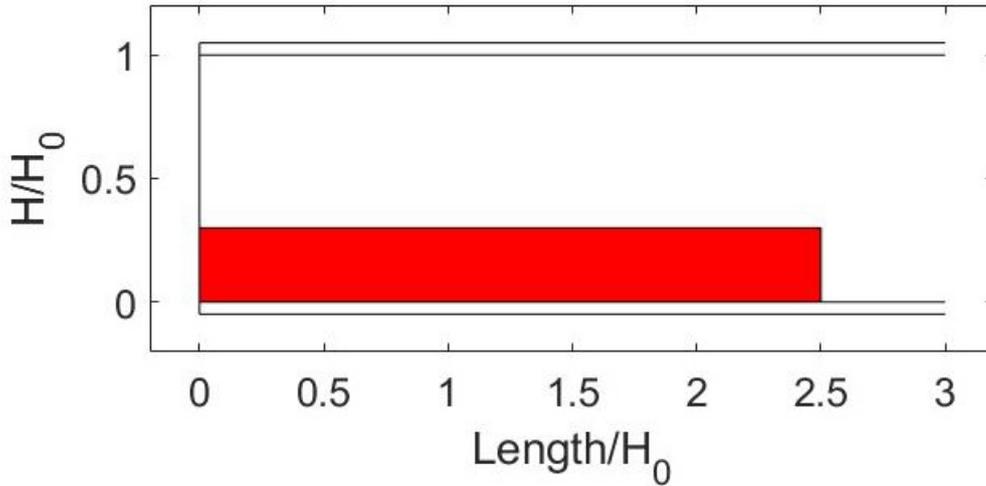
Figure 271: Second extreme W1 web corrosion pattern, with corrosion height up to 30% of H_0 for beams with a diaphragm - MassDOT

CASE B

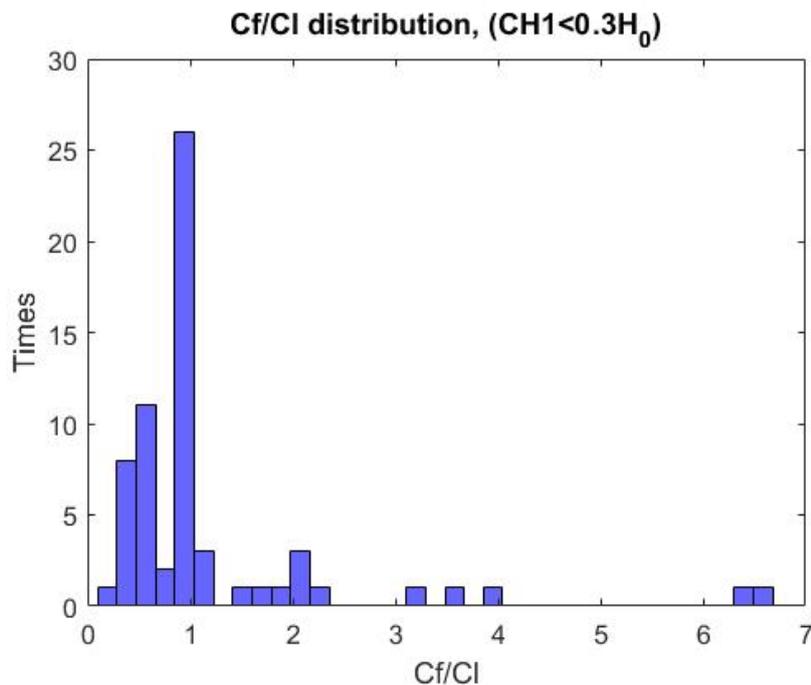
Figure 272: Ratio of flange to web corrosion length distribution of W1 web corrosion pattern with corrosion height up to 30% of H_0 for beams with a diaphragm - MassDOT

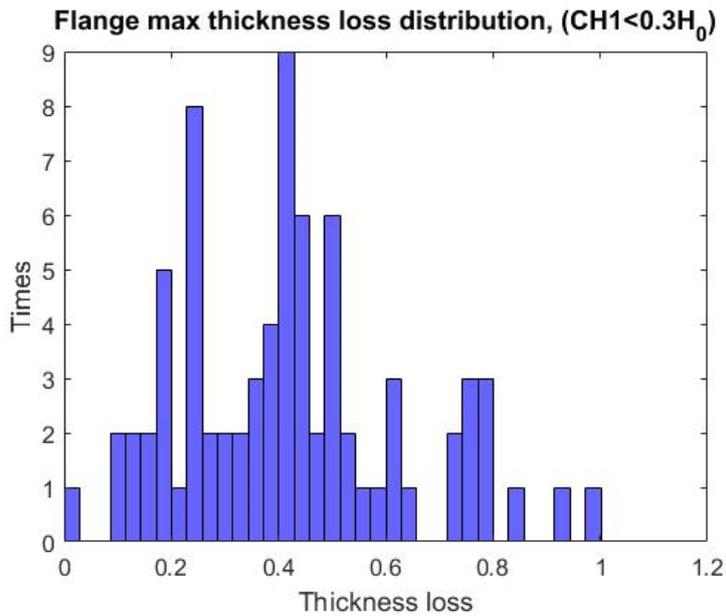
Figure 273: Max flange thickness loss distribution of W1 web corrosion pattern with corrosion height up to 30% of H_0 for beams with a diaphragm - MassDOT

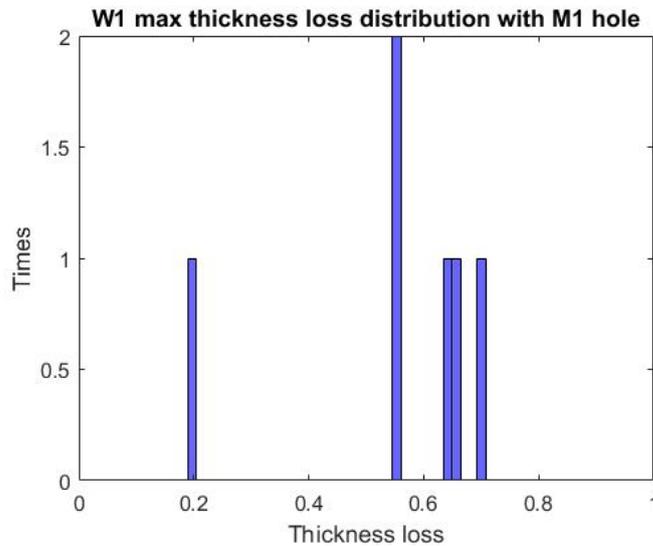
Figure 274. Max thickness loss distribution for W1 web corrosion patterns and M1 hole for beams with a diaphragm - MassDOT

The W1 corrosion pattern is combined 11 times with the M1 hole corrosion pattern. The web thickness loss, holes dimensions, and corrosion height at these cases are given as:

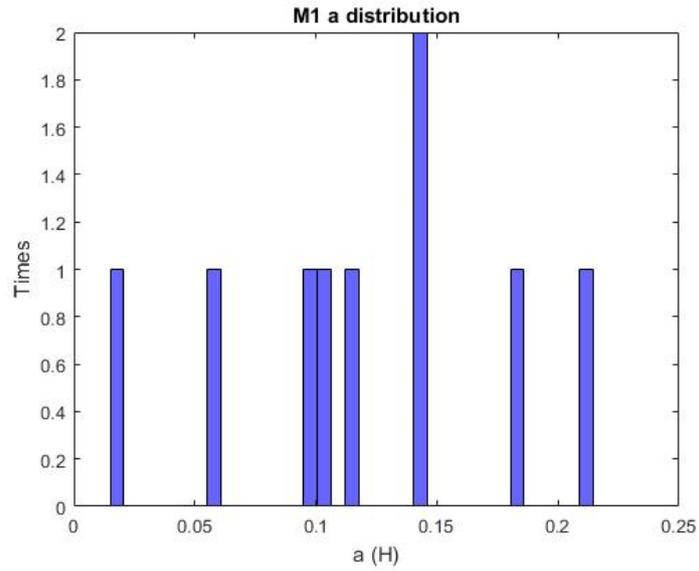
Figure 275: M1 web hole's pattern height distribution of W1 web corrosion pattern for beams with a diaphragm - MassDOT

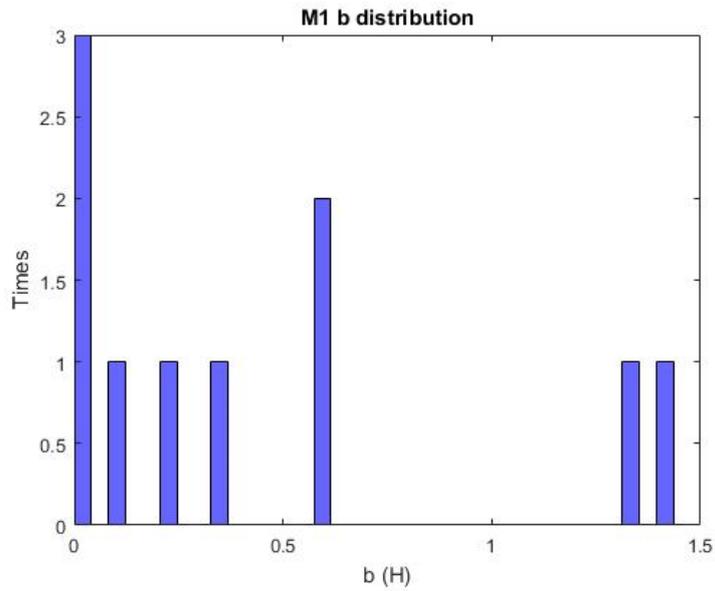
Figure 276: M1 web hole's pattern length distribution of W1 web corrosion pattern for beams with a diaphragm - MassDOT

From Figure 277, we can conclude that holes are equally distributed between web corrosion scenarios CASE A and CASE B. It is worth mentioning that there are two cases of long holes that are parallel to flange holes (Figure 276). The two longest holes ($1.3H_0$ and $1.4H_0$) are also the corrosion holes with the highest height (0.18 and 0.21) respectively. As a result, an extreme hole case is considered the following (projected on Case B web corrosion scenario):

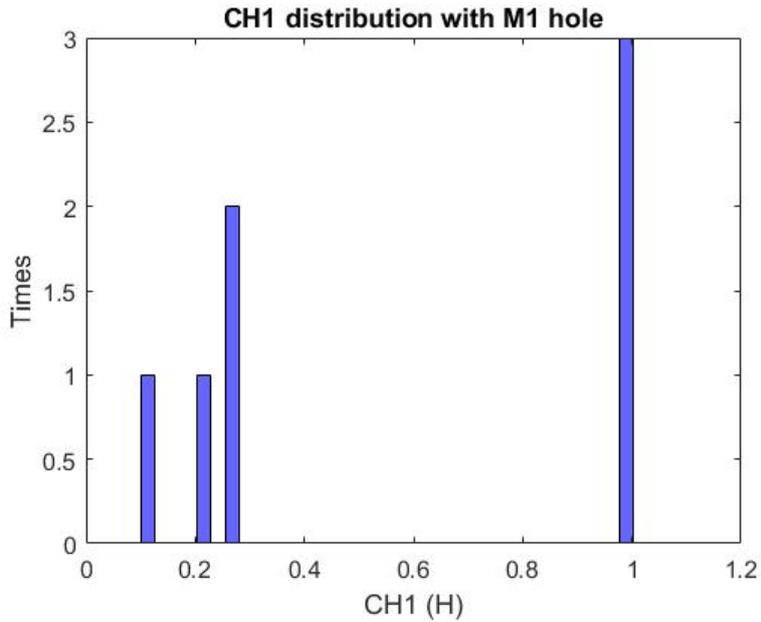
Figure 277: CH1 distribution for beams with M1 hole and W1 web corrosion pattern and a diaphragm - MassDOT

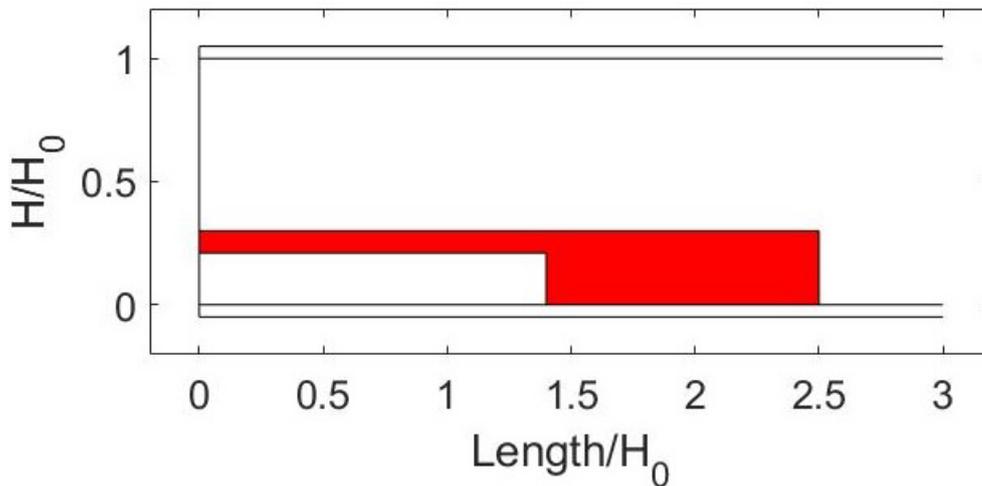
Figure 278: M1 extreme web hole pattern scenario of W1 web corrosion pattern, for beams with a diaphragm - MassDOT

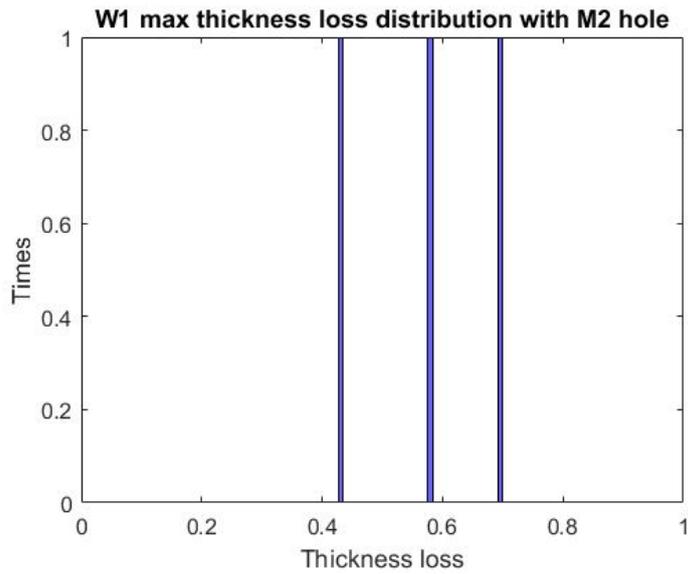
Figure 279. Max thickness loss distribution for W1 web corrosion patterns and M2 hole for beams with a diaphragm - MassDOT

There are also 4 cases of the M2 corrosion hole pattern. The web thickness loss, holes dimensions, and corrosion height at these cases are given as:

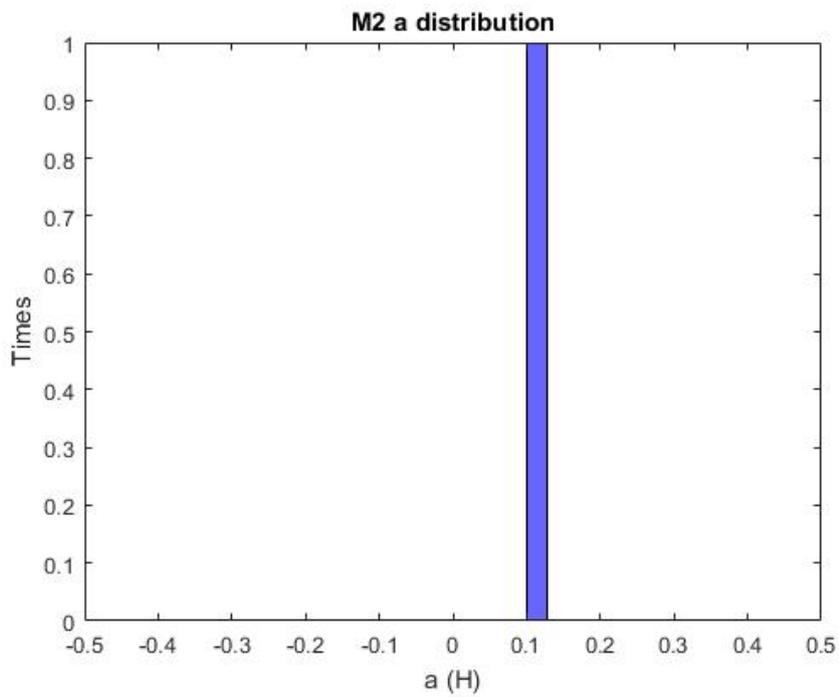
Figure 280: M2 web hole's pattern height distribution of W1 web corrosion pattern for beams with a diaphragm - MassDOT

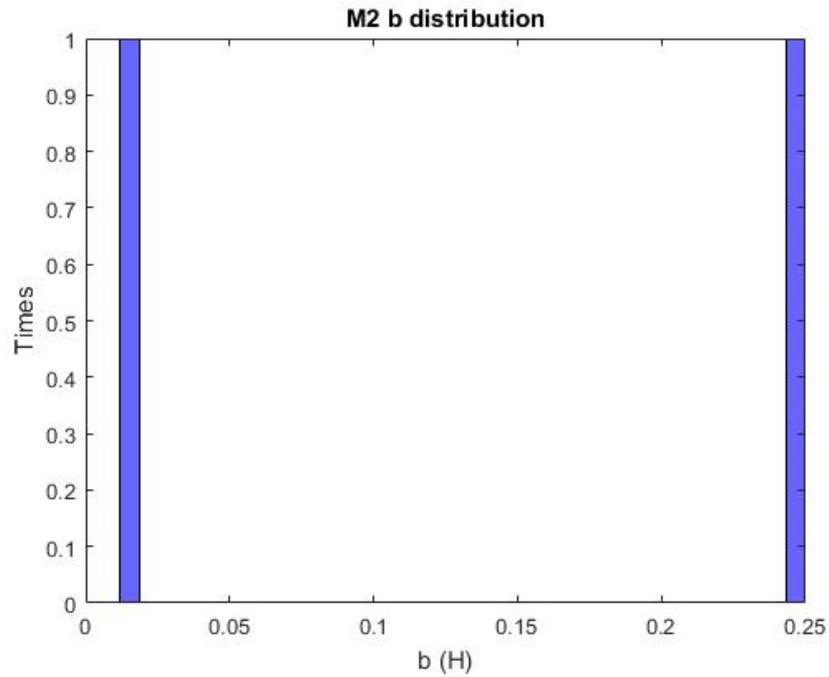
Figure 281: M2 web hole's pattern length distribution of W1 web corrosion pattern for beams with a diaphragm - MassDOT

The data gathered from the inspection reports is very small for the research team to extract valid conclusions.

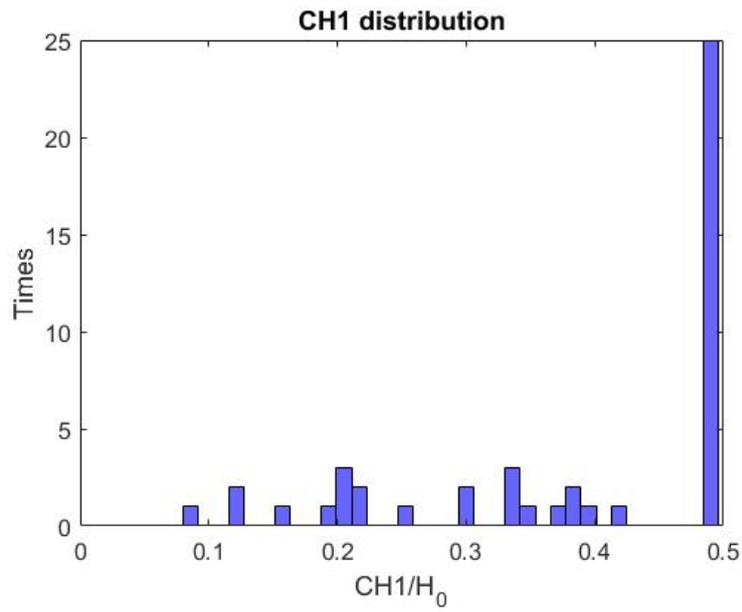
Figure 282. CH1 distribution of W2 pattern for beams with a diaphragm - MassDOT

The W2 corrosion pattern was observed in total only 47 times. The parameters for the corrosion patterns can be found with corresponding diagrams in Section 1.5 *Corrosion Patterns* of this report.

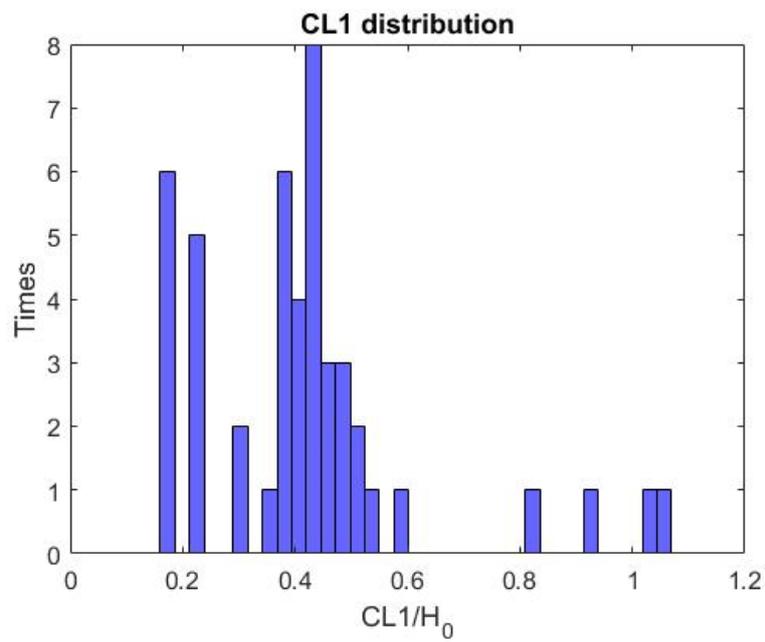
Figure 283: CL1 distribution of W2 pattern for beams with a diaphragm - MassDOT

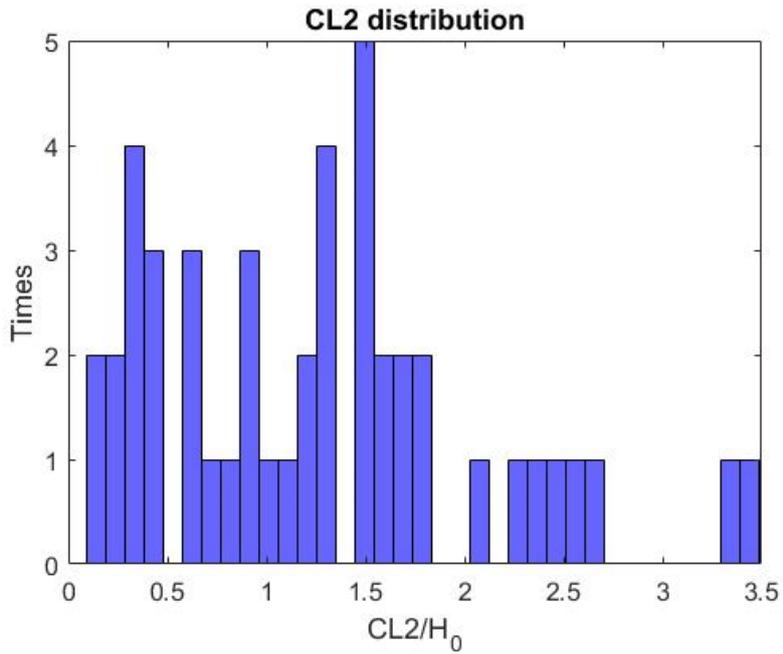
Figure 284: CL2 distribution of W2 pattern for beams with a diaphragm - MassDOT

$$0 < CL_2 \leq 1.8H_0$$

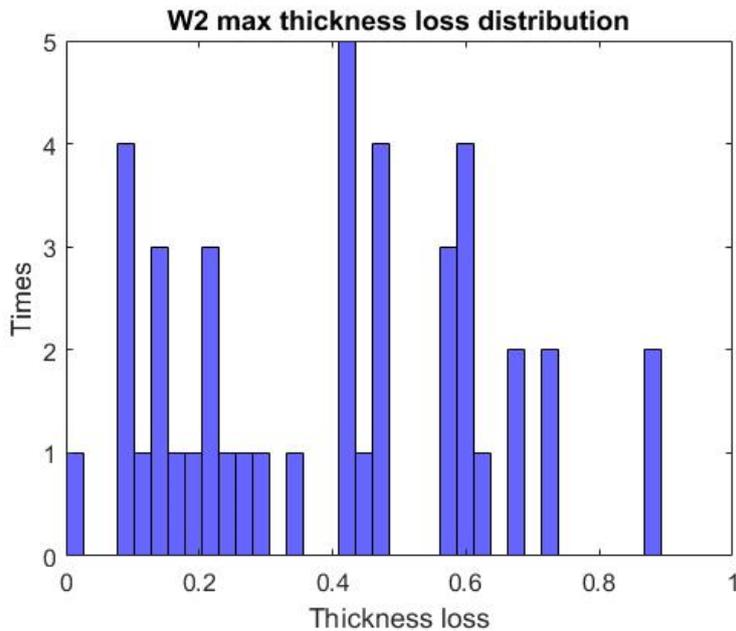
Figure 285: Web thickness loss distribution of W2 pattern for beams with a diaphragm - MassDOT

From the above figure, our team stated:

$\frac{t_{loss}}{t_{web}}$ takes values of {0.2,0.4,0.6,0.8}

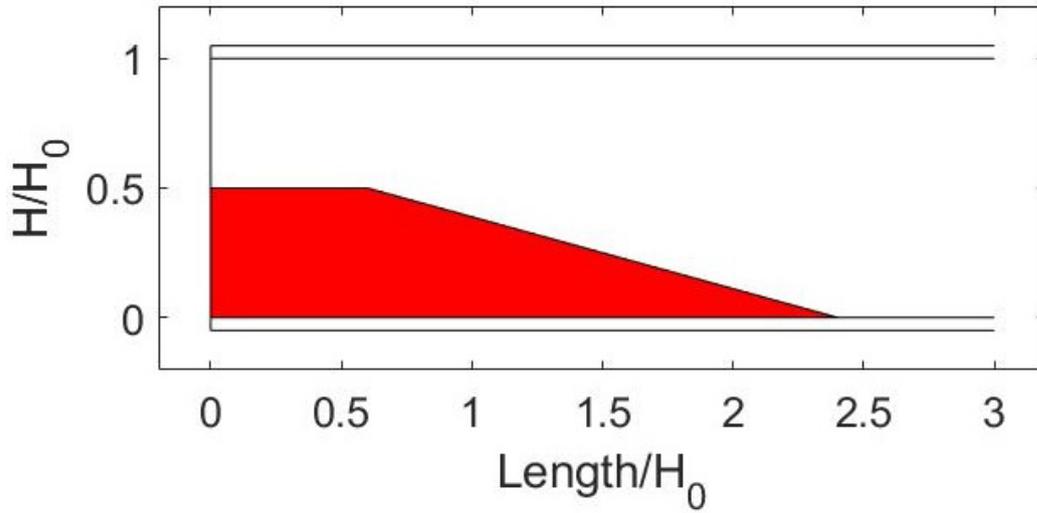
Figure 286: Extreme W2 web corrosion pattern for beams with a diaphragm - MassDOT

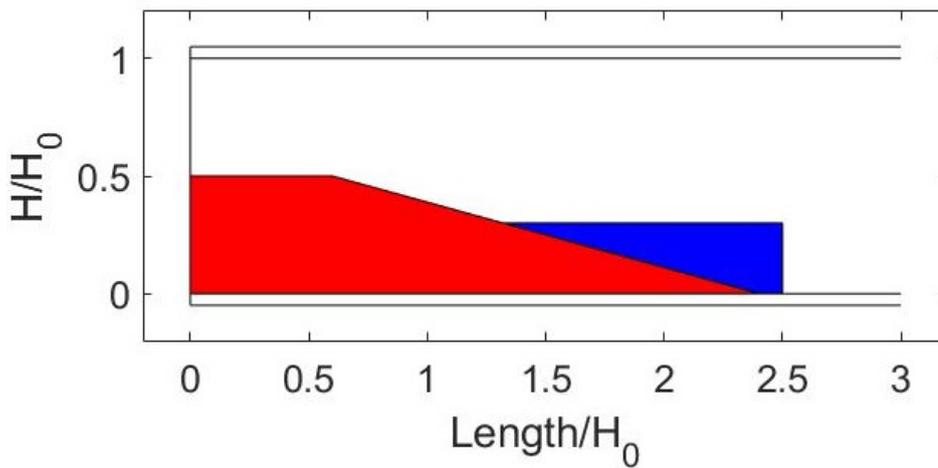
Figure 287: W2 extreme web corrosion scenario (with red color) projected over W1 CASE B extreme web corrosion scenario (with blue color) - MassDOT

The W1 corrosion pattern can be considered as a case of W2 with CL2 equal to zero here.

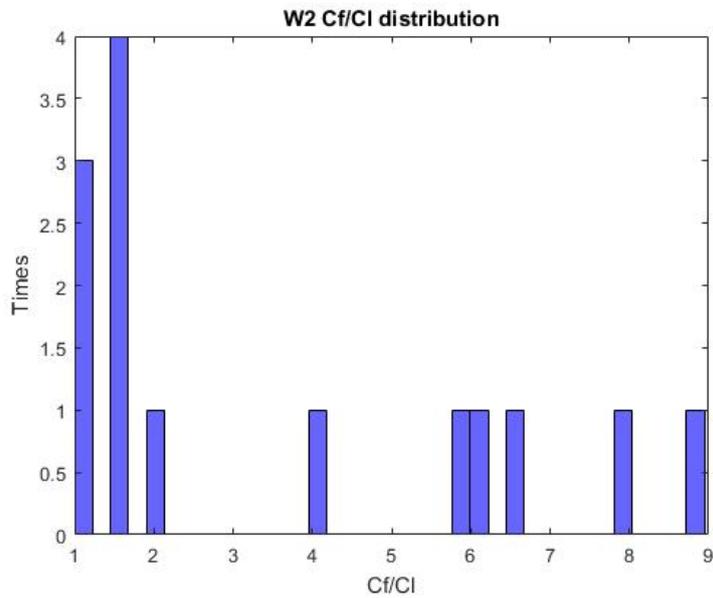
Figure 288: Ratio of flange to web corrosion length distribution of W2 web corrosion pattern corrosion for beams with a diaphragm - MassDOT

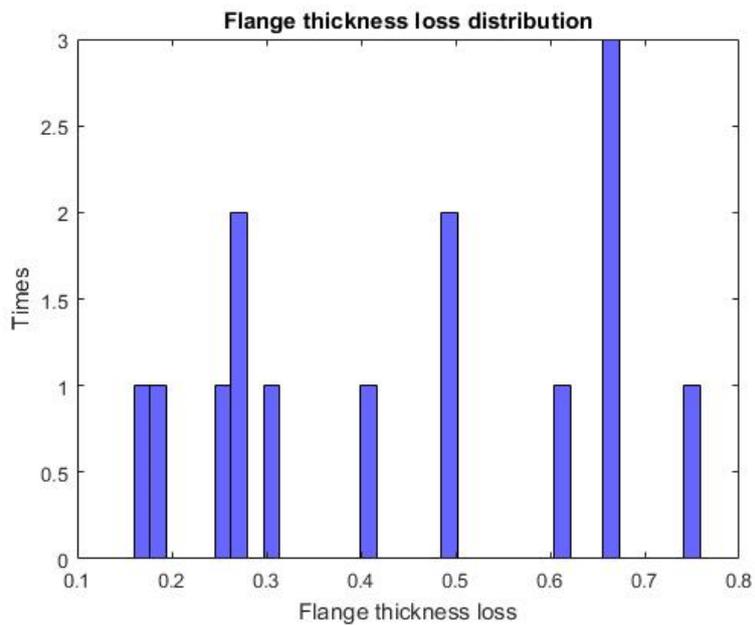
Figure 289: Max flange loss thickness distribution of W2 web corrosion pattern for beams without a diaphragm - MassDOT

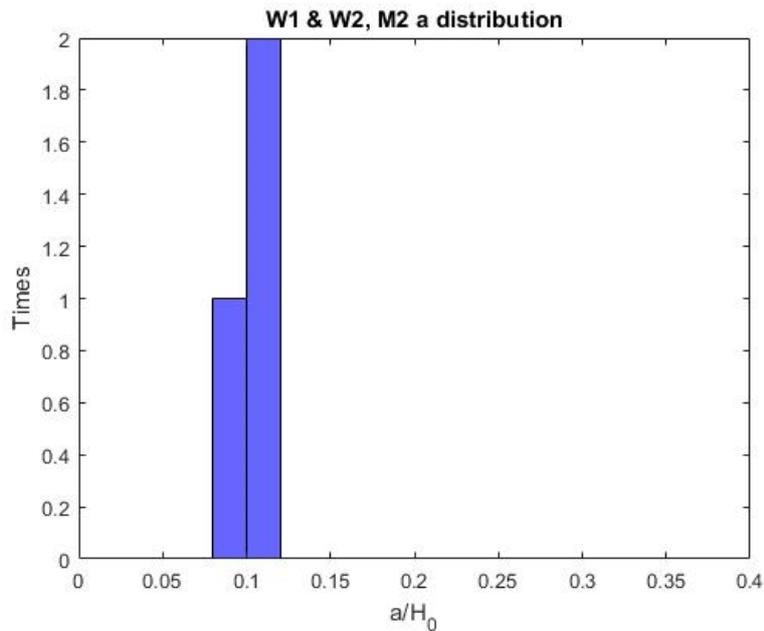
For M2 hole corrosion pattern, the sample for the W1 pattern was very small, so the team was not able to extract conclusions. This led our team to process the M2 hole corrosion pattern for both W1 and W2 together:

Figure 290: M2 web hole's pattern height distribution of W1 and W2 web corrosion patterns for beams with a diaphragm - MassDOT

Following this grouping, our team still found the sample to be very small (3 values for M2a, and 5 for M2b). We then assumed that M2 holes present thin and long 100% material loss areas underneath the diaphragm:

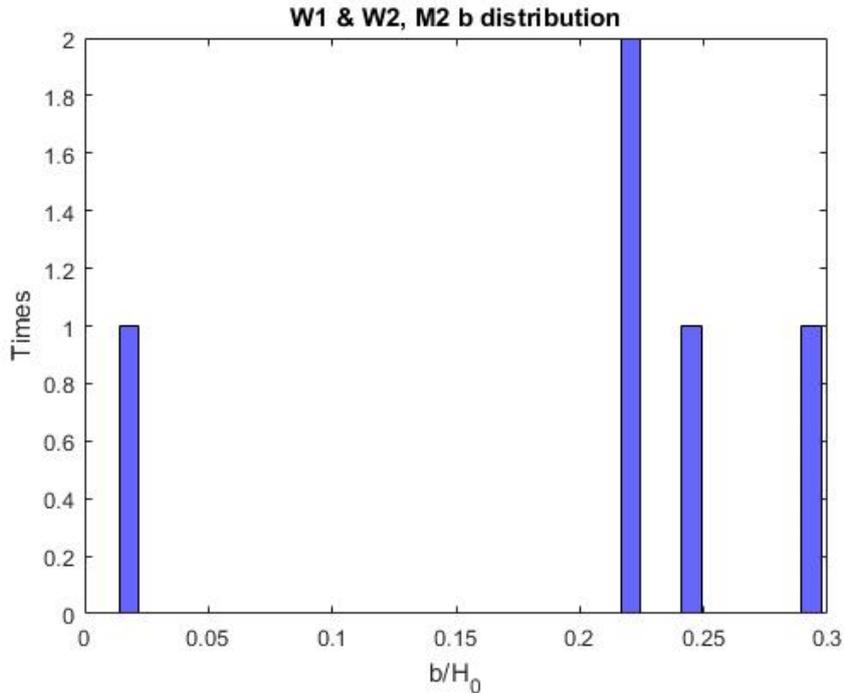
Figure 291: M2 web hole's pattern length distribution of W1 and W2 web corrosion patterns for beams with a diaphragm - MassDOT

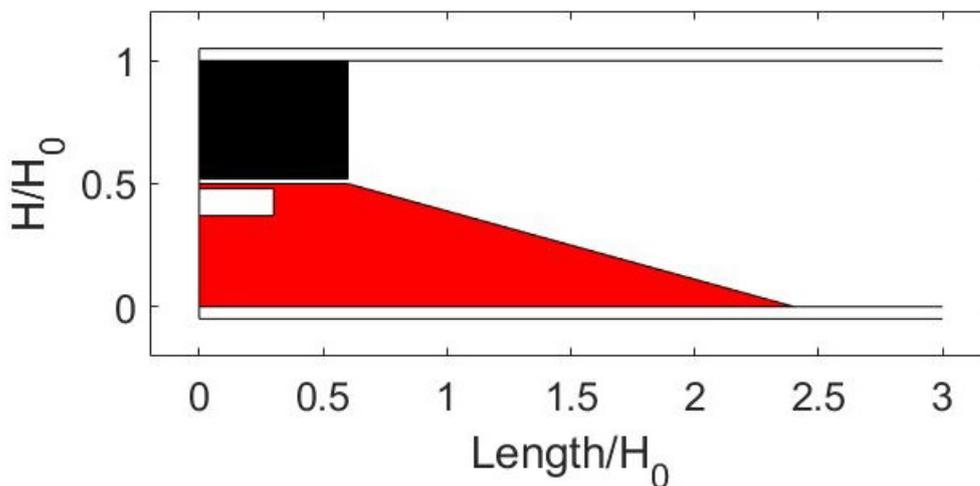
Figure 292: M2 hole pattern projected on the extreme W2 web corrosion pattern. With black color is illustrated the diaphragm that could be found with these patterns. The parameters are $a \leq 0.11$, and $b \leq 0.3$ - MassDOT

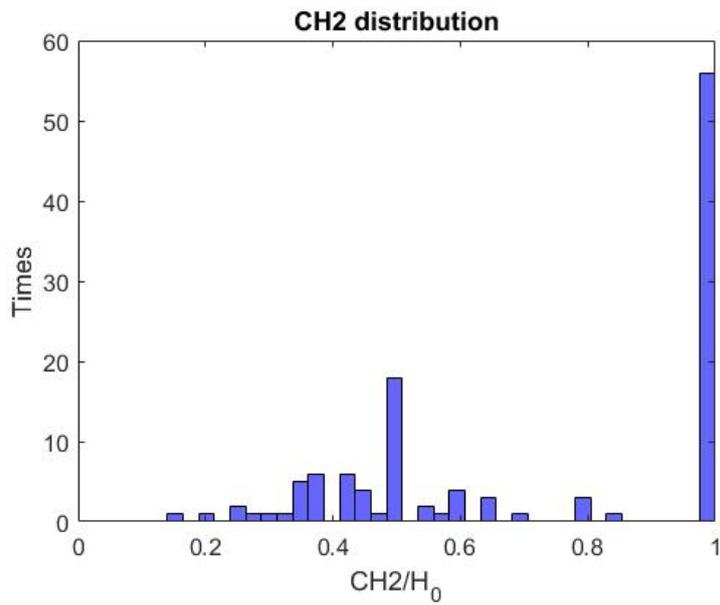
Figure 293. CH2 distribution of W3 web corrosion pattern for beams with a diaphragm - MassDOT

From the CH2 histogram, two main trends are noticed, either a) full height corrosion, or b) corrosion up to 50% of H_0 .

$$CH_2 = H_0 \text{ or } 0 < CH_2 \leq 0.5H_0$$

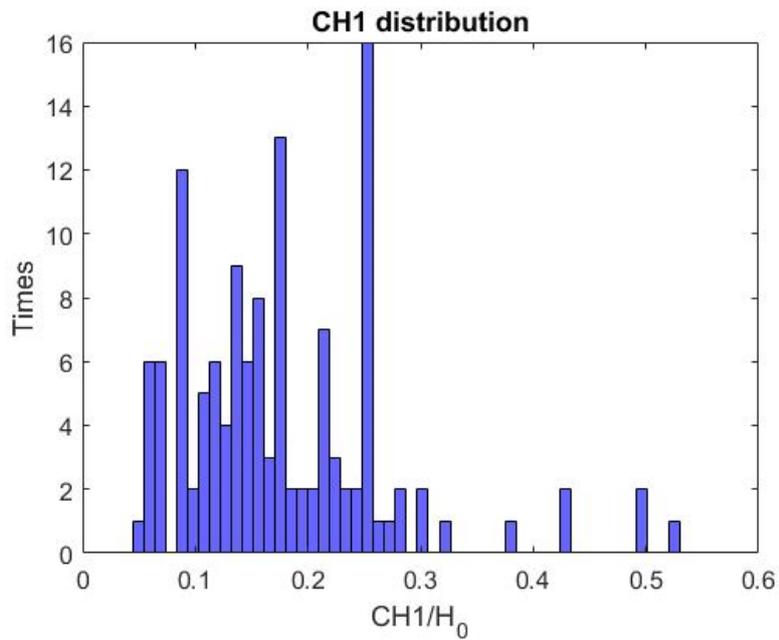
Figure 294: CH1 distribution of W3 web corrosion pattern for beams with a diaphragm - MassDOT
