Improved Load Rating Procedures for Deteriorated Unstiffened Steel Beam Ends

Prepared For:
New England Transportation Consortium
January 2024

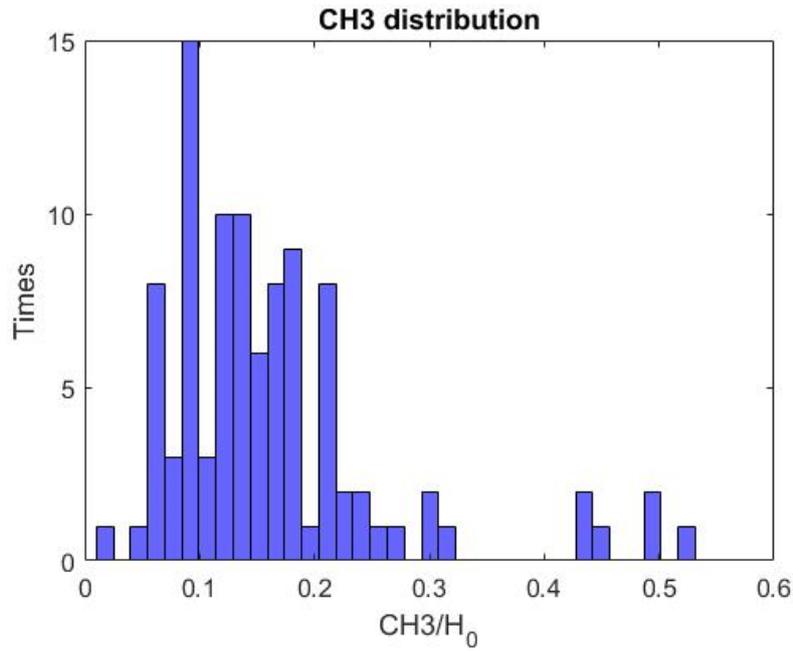
Figure 295: CH3 distribution of W3 web corrosion pattern for beams with a diaphragm - MassDOT

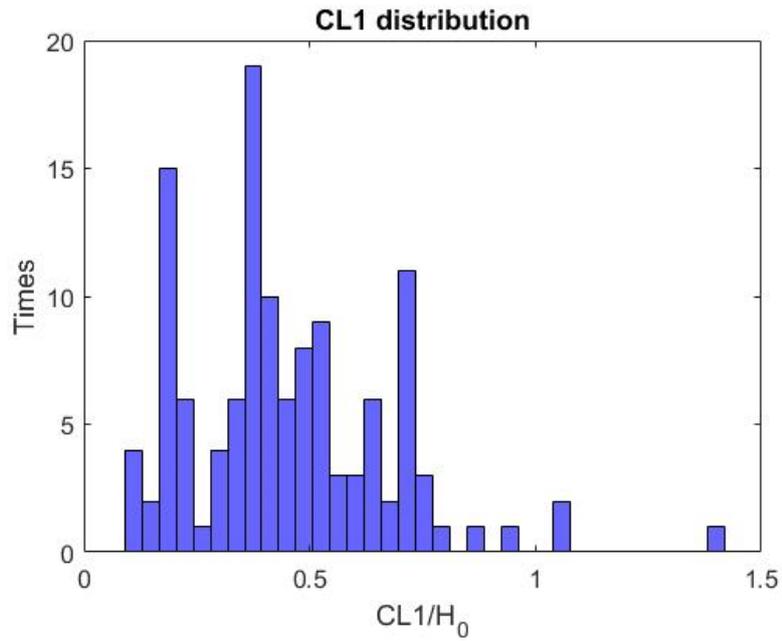
Figure 296: CL1 distribution of W3 web corrosion pattern for beams with a diaphragm - MassDOT

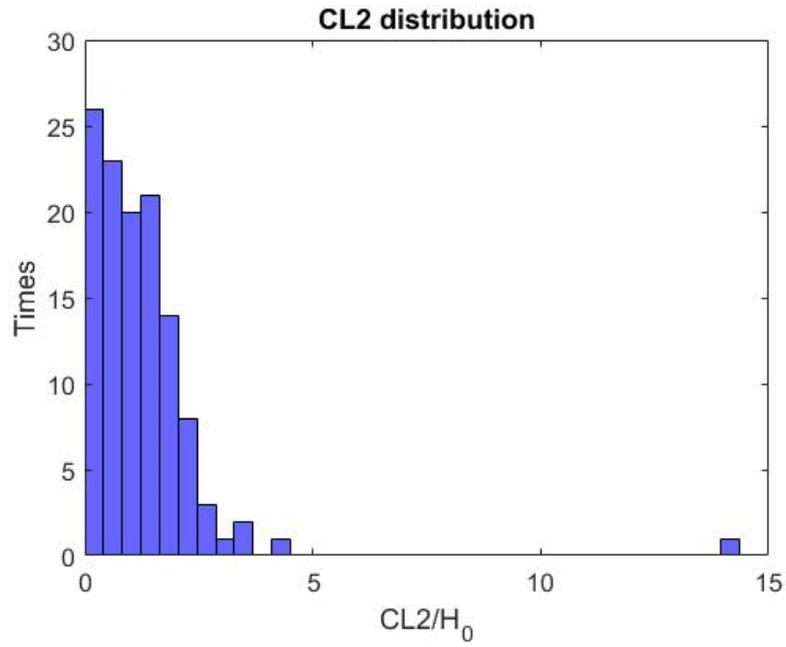
Figure 297: CL2 distribution of W3 web corrosion pattern for beams with a diaphragm - MassDOT

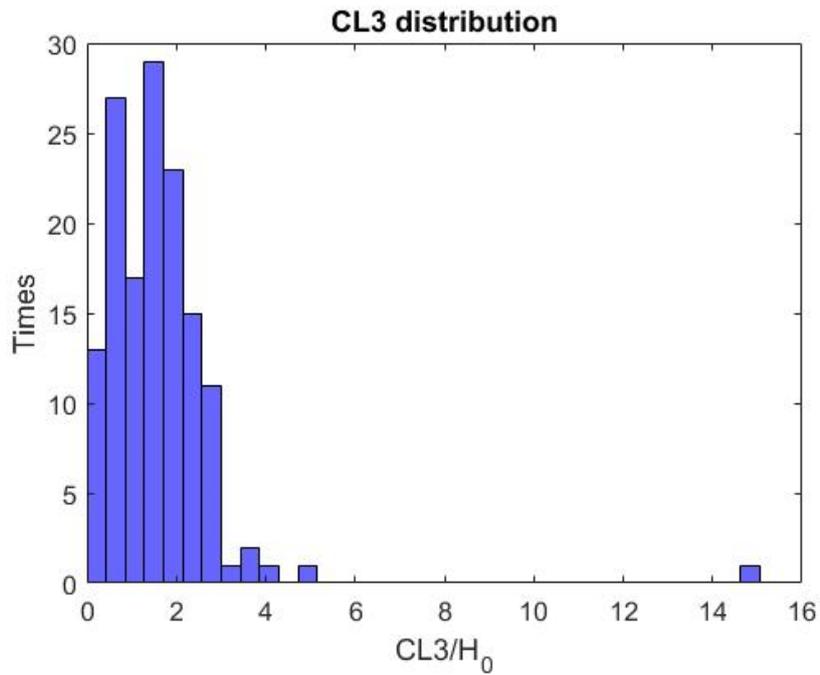
Figure 298: CL3 distribution of W3 web corrosion pattern for beams with a diaphragm - MassDOT

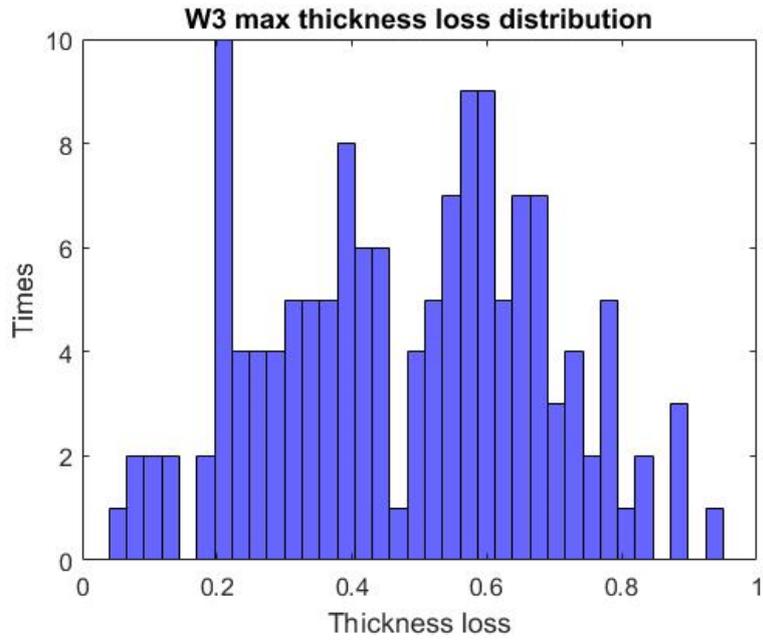
Figure 299: Ma web thickness loss distribution of W3 web corrosion pattern for beams with a diaphragm - MassDOT

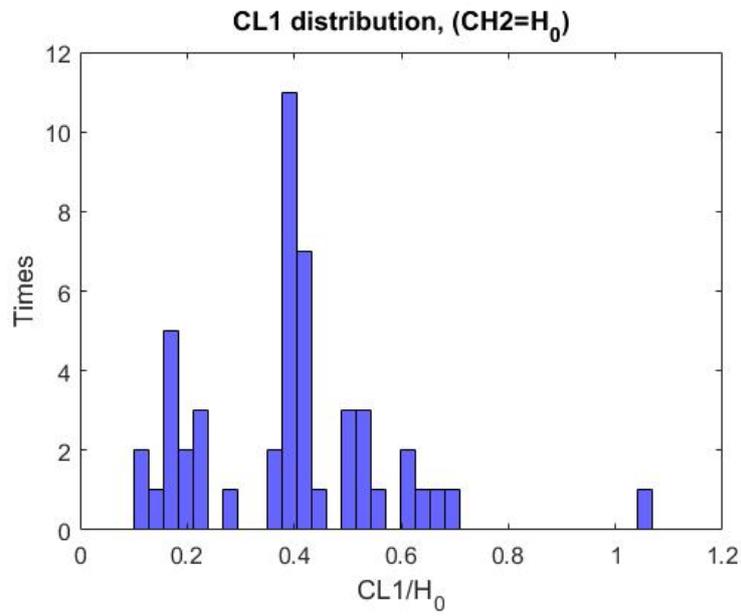
Figure 300: CL1 distribution of W3 web corrosion pattern with full height corrosion for beams with a diaphragm - MassDOT

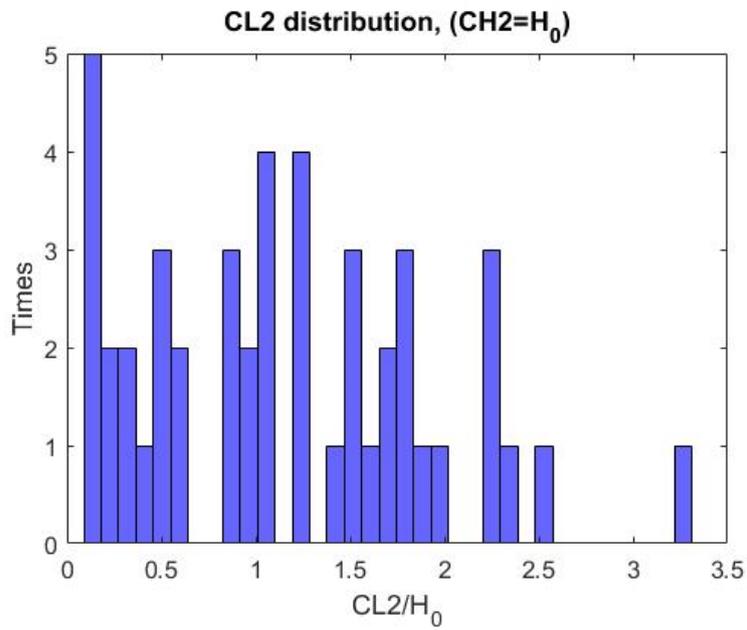
Figure 301: CL2 distribution of W3 web corrosion pattern with full height corrosion for beams with a diaphragm - MassDOT

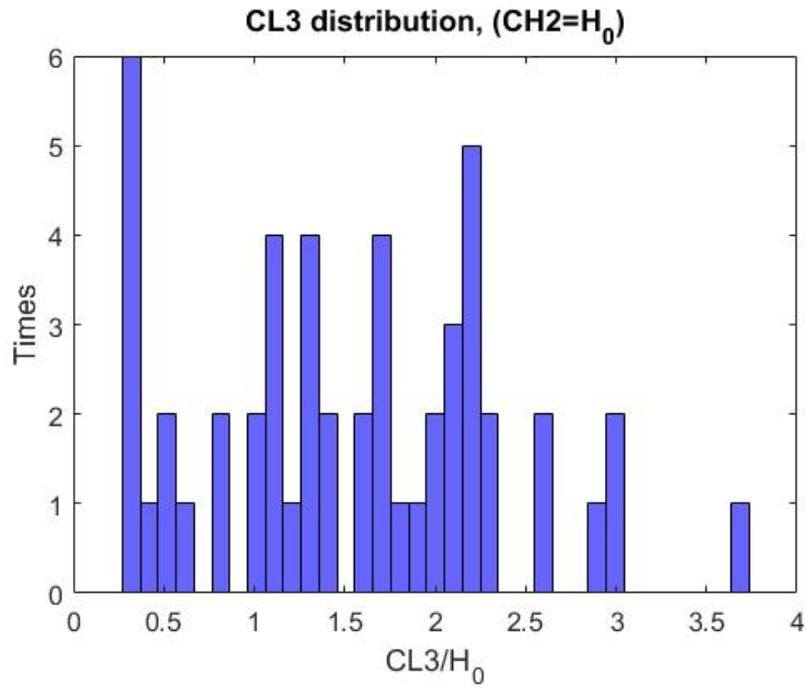
Figure 302: CL3 distribution of W3 web corrosion pattern with full height corrosion for beams with a diaphragm - MassDOT

From the CL3 histogram, two main trends were noticed:

$$0.25H_0 < CL_3 \leq 0.6H_0 \text{ and } 0.6H_0 < CL_3 \leq 2.25H_0$$

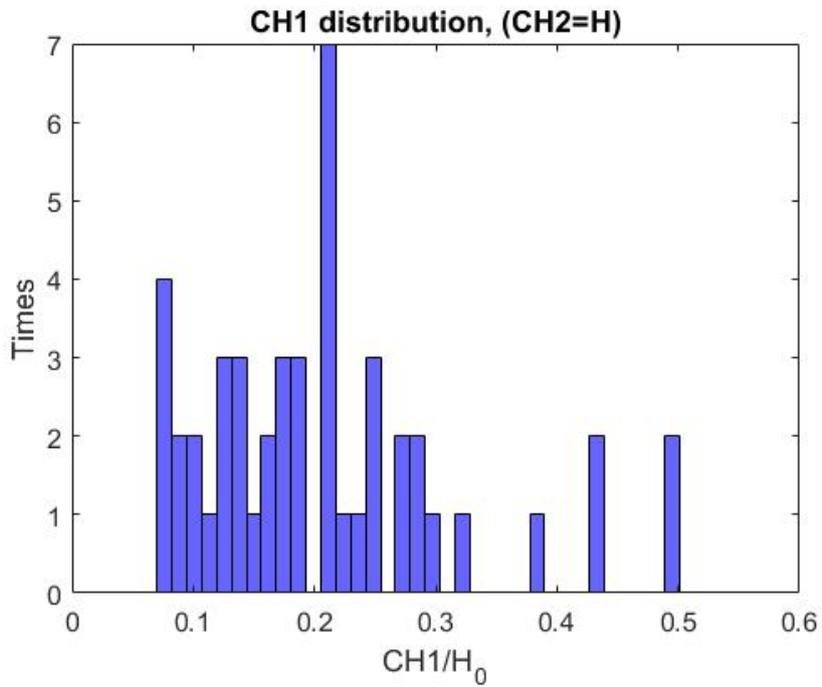
Figure 303: CH1 distribution of W3 web corrosion pattern with full height corrosion for beams with a diaphragm - MassDOT

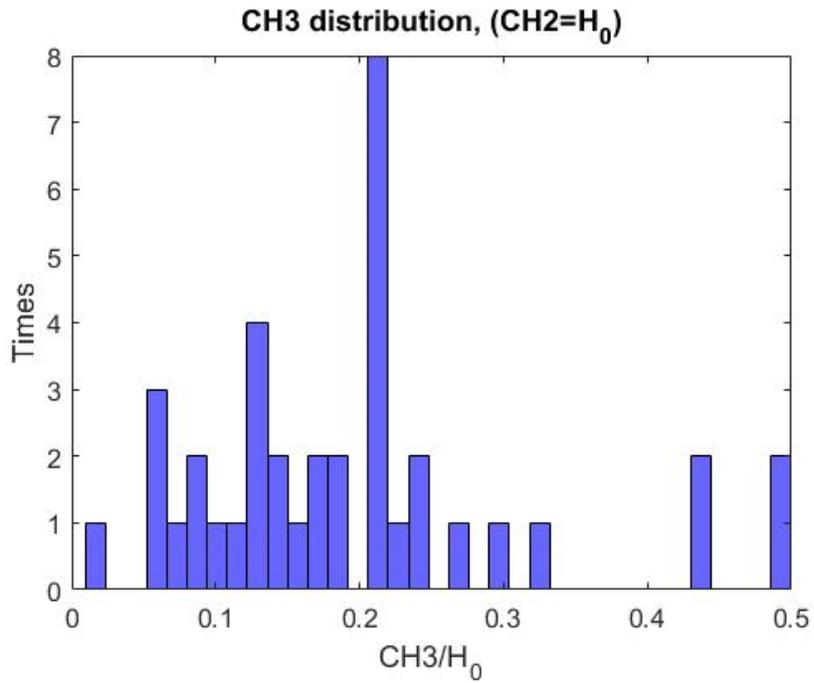
Figure 304: CH3 distribution of W3 web corrosion pattern with full height corrosion for beams with a diaphragm - MassDOT

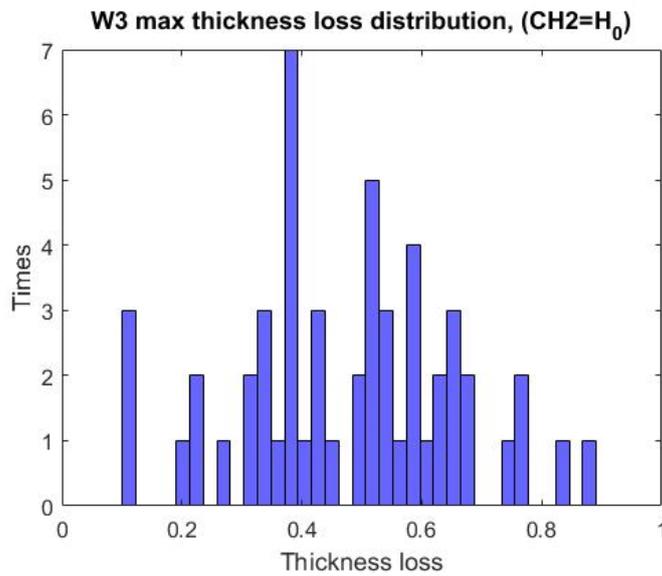
Figure 305: Max web thickness loss distribution of W3 web corrosion pattern with full height corrosion for beams with a diaphragm - MassDOT

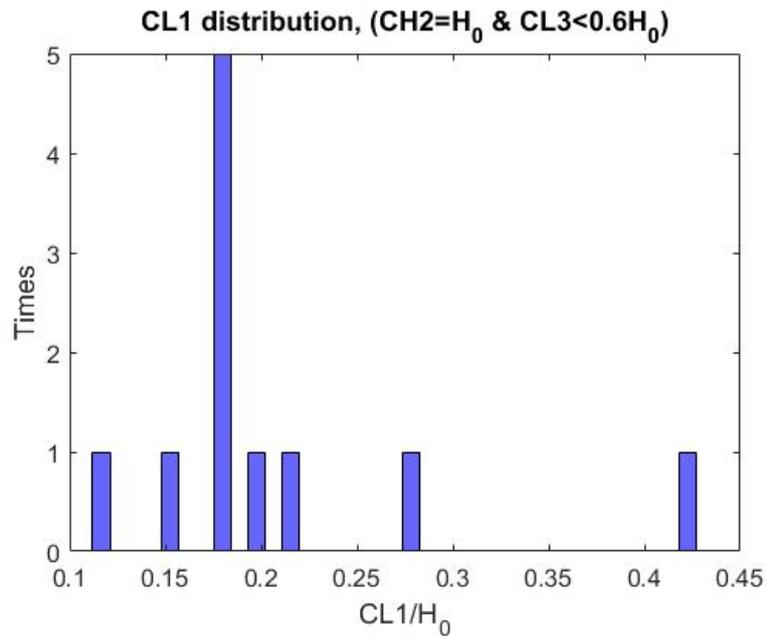
Figure 306: CL1 distribution of W3 web corrosion pattern with full height corrosion and deteriorated length up to 60% of H_0 for beams with a diaphragm - MassDOT

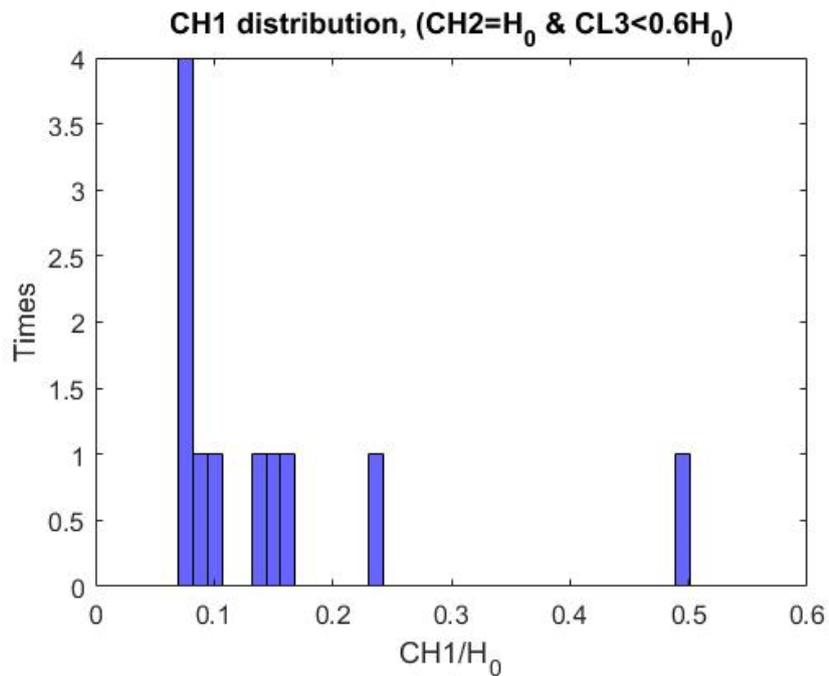
Figure 307: CH1 distribution of W3 web corrosion pattern with full height corrosion and deteriorated length up to 60% of H_0 for beams with a diaphragm - MassDOT

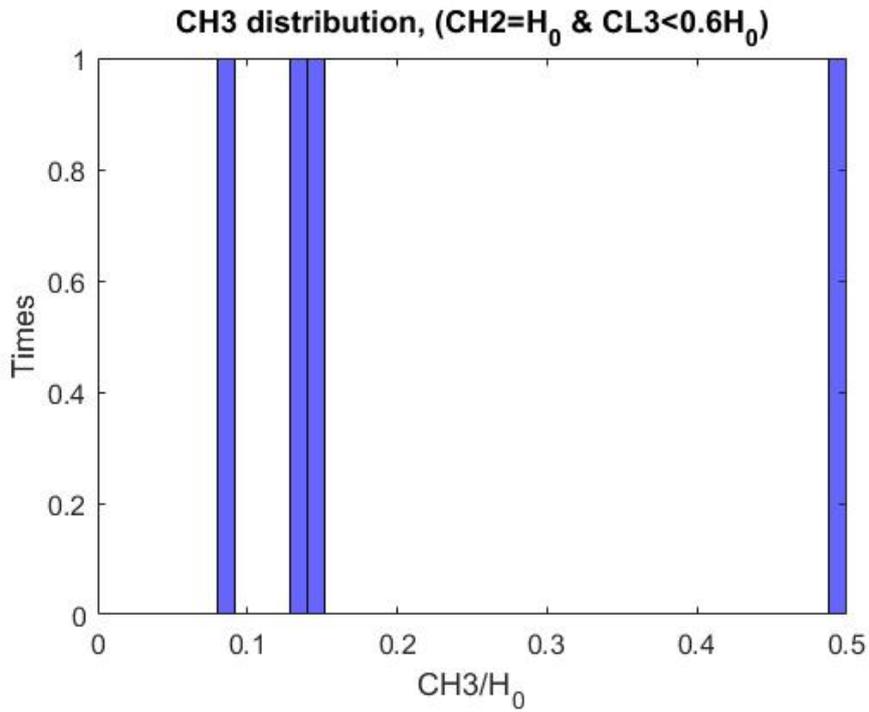
Figure 308: CH3 distribution of W3 web corrosion pattern with full height corrosion and deteriorated length up to 60% of H₀ for beams with diaphragm a - MassDOT

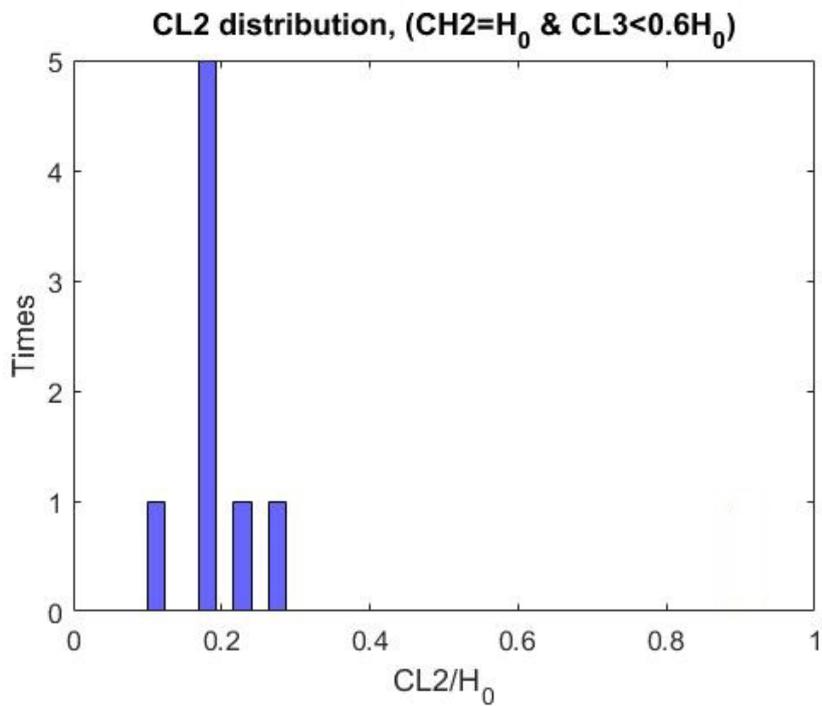
Figure 309: CL2 distribution of W3 web corrosion pattern with full height corrosion and deteriorated length up to 60% of H₀ for beams with a diaphragm - MassDOT

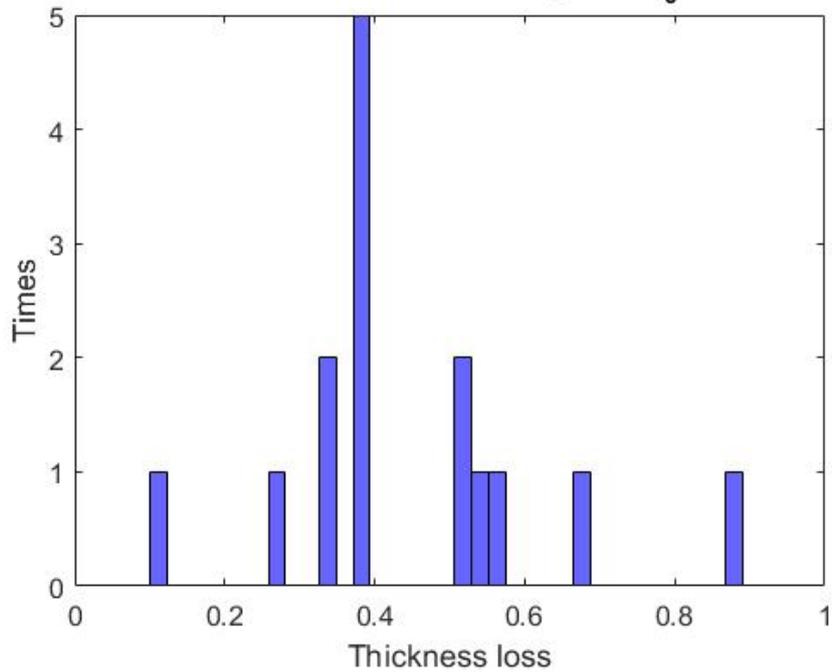
W3 max thickness loss distribution, ($CH2=H_0$ & $CL3<0.6H_0$)

Figure 310: Max web thickness loss distribution, of W3 web corrosion pattern, with full height corrosion and deteriorated length up to 60% of H_0 for beams with a diaphragm - MassDOT

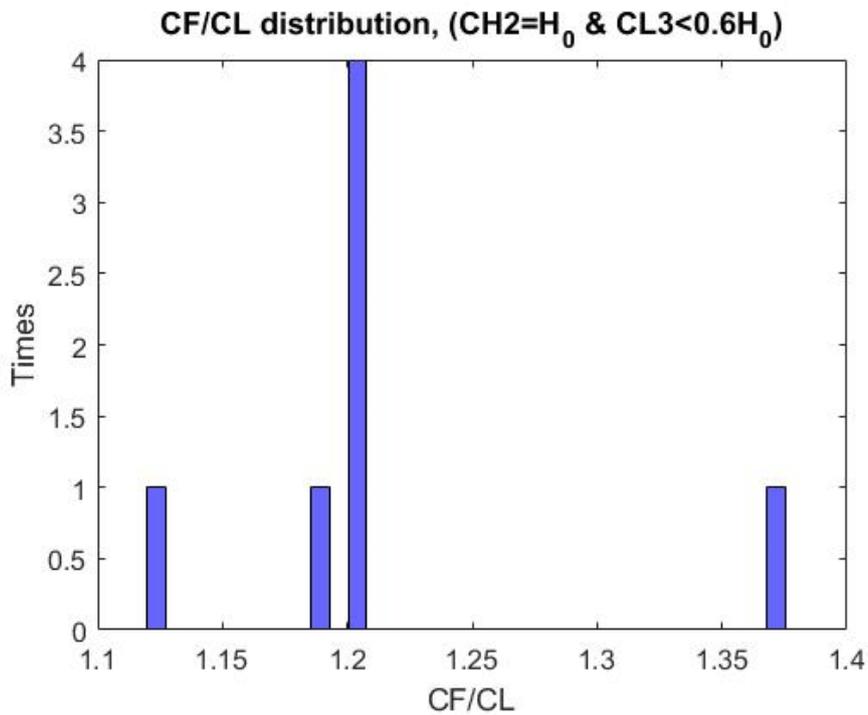
Figure 311: Ratio of flange to web corrosion length distribution, of W3 web corrosion pattern, with full height corrosion and deteriorated length up to 60% of H_0 for beams with a diaphragm - MassDOT

$$\frac{c_f}{c_l} = 1.2 \text{ and}$$

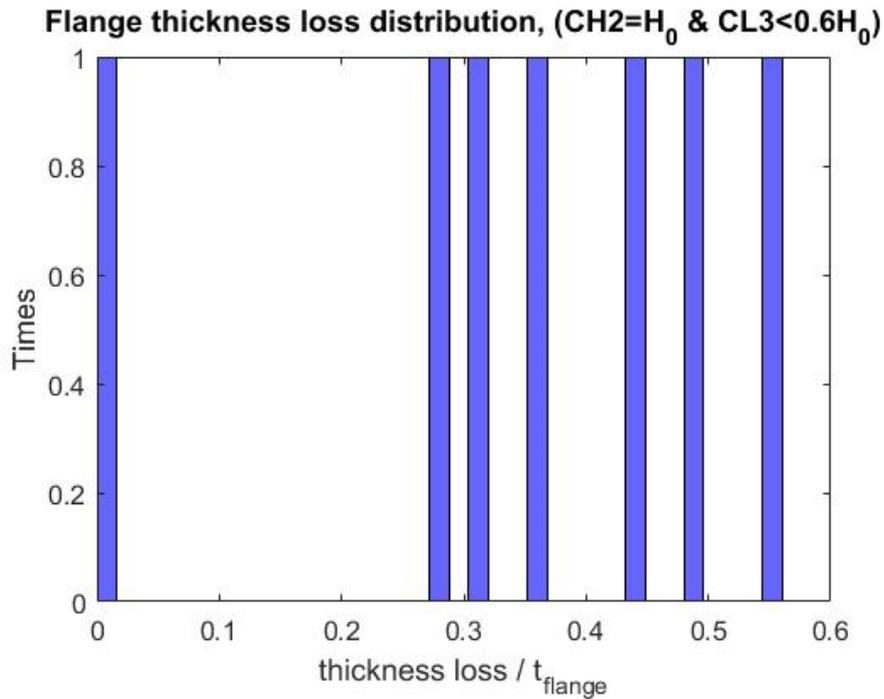
Figure 312: Max flange loss thickness distribution, for beams with W3 web corrosion pattern, with full height corrosion, deteriorated length up to 60% of H₀ and with a diaphragm - MassDOT

$$\frac{t_{loss}}{t_{flange}} \text{ takes values of } \{0.3, 0.6\}$$

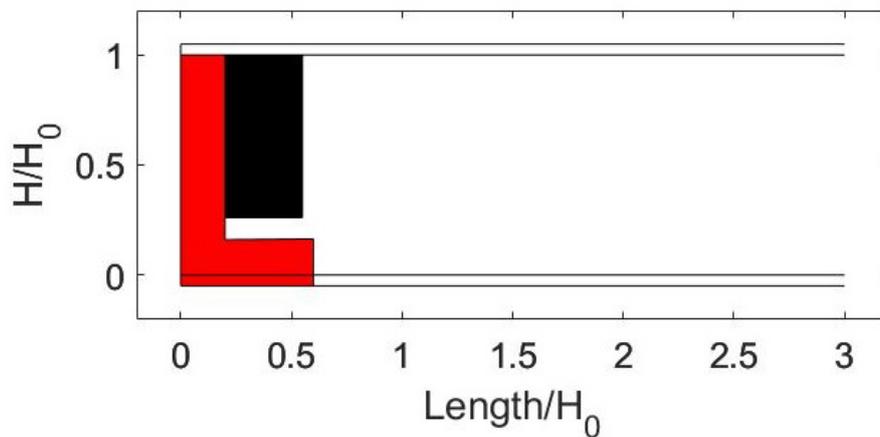
Figure 313: First extreme flange and W3 web corrosion scenario for beams with a diaphragm. - MassDOT

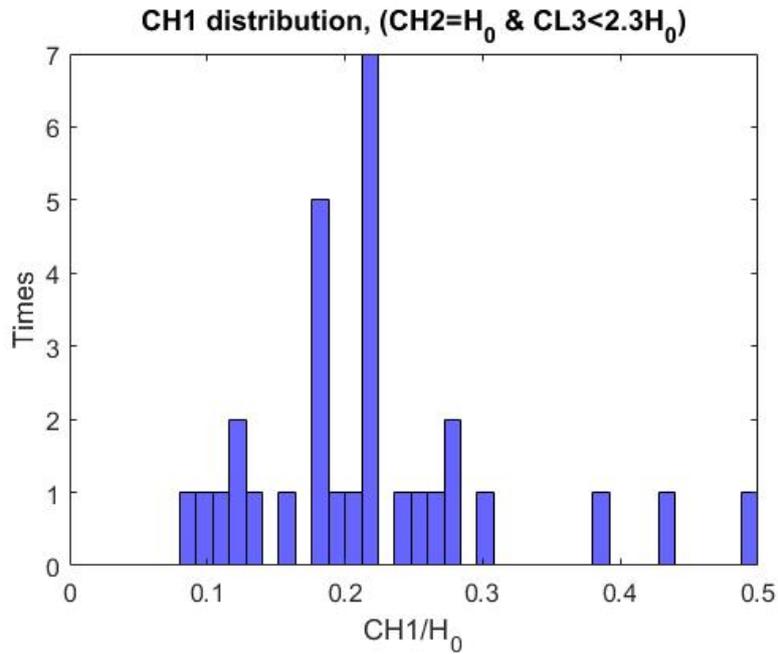
Figure 314: CH1 distribution of W3 web corrosion pattern, with full height corrosion and deteriorated length up to 230% of H_0 , for beams with a diaphragm - MassDOT

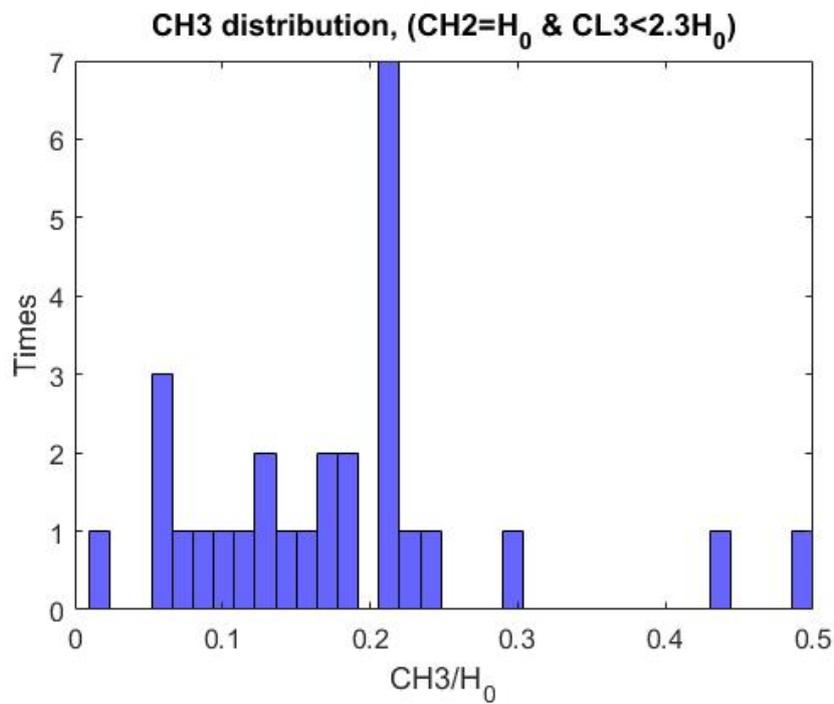
Figure 315: CH3 distribution of W3 web corrosion pattern, with full height corrosion and deteriorated length up to 230% of H_0 , for beams with a diaphragm - MassDOT

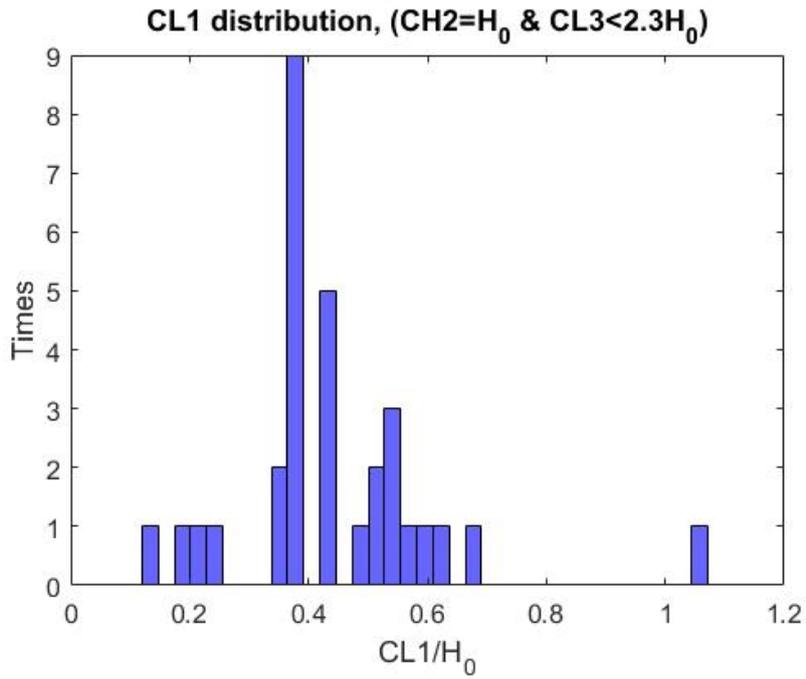
Figure 316: CL1 distribution of W3 web corrosion pattern, with full height corrosion and deteriorated length up to 230% of H_0 , for beams with a diaphragm - MassDOT

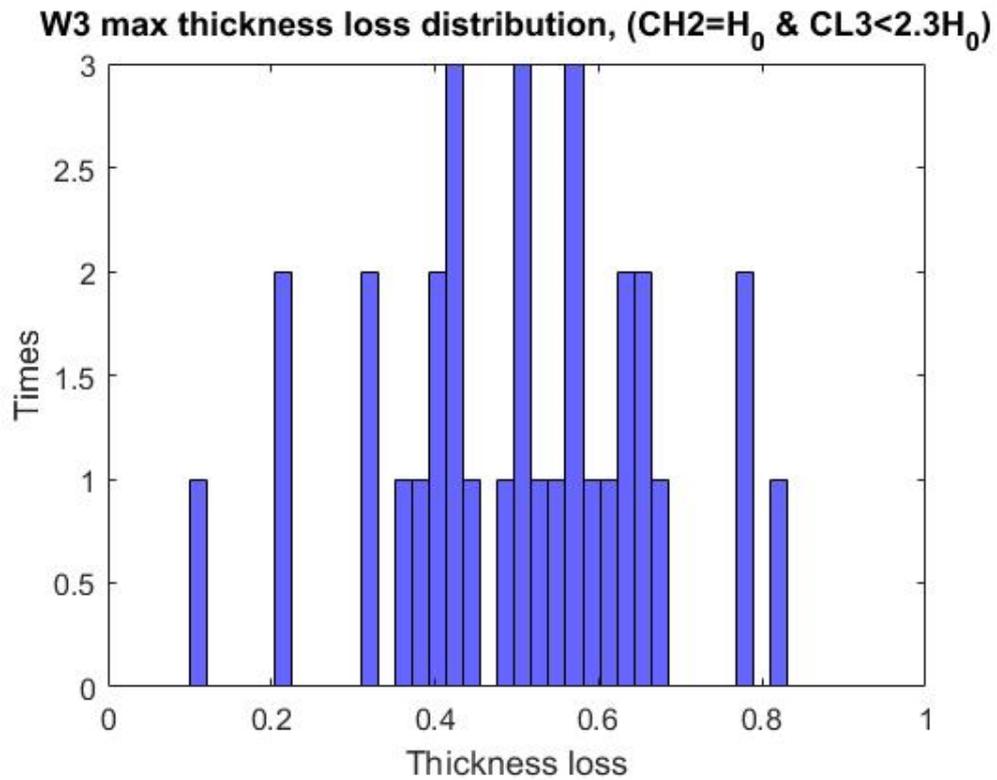
Figure 317: Max web thickness loss distribution, of W3 web corrosion pattern, with full height corrosion and deteriorated length up to 230% of H_0 , for beams with a diaphragm - MassDOT

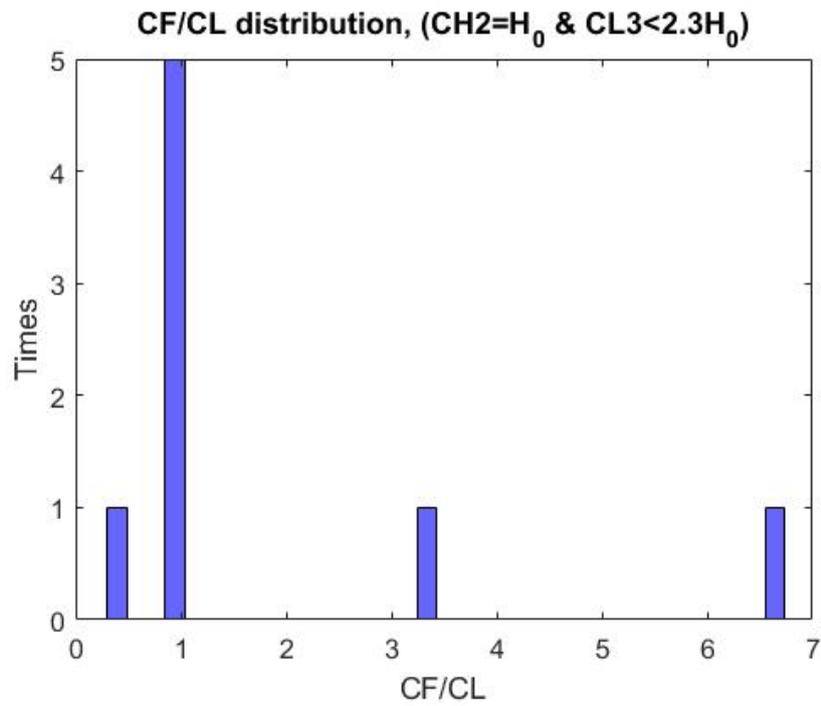
Figure 318: Ratio of flange to web corrosion length distribution, of W3 web corrosion pattern, with full height corrosion and deteriorated length up to 230% of H_0 for beams with a diaphragm - MassDOT

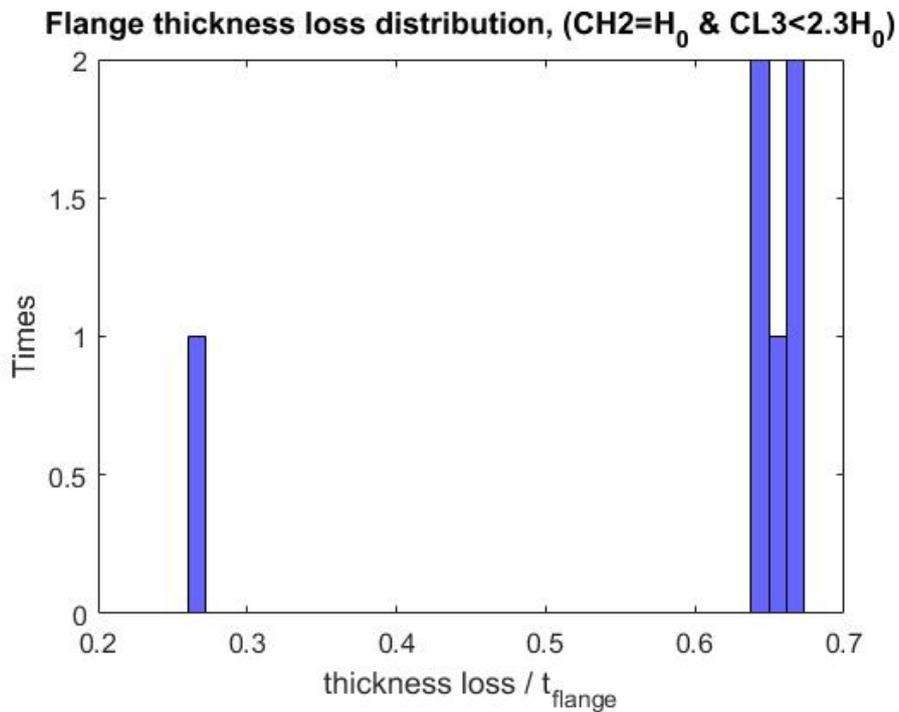
Figure 319: Max flange loss thickness distribution, for beams with W3 web corrosion pattern, with full height corrosion, deteriorated length up to 230% of H_0 and with a diaphragm - MassDOT

$\frac{t_{loss}}{t_{flange}}$ takes the value of {0.65}

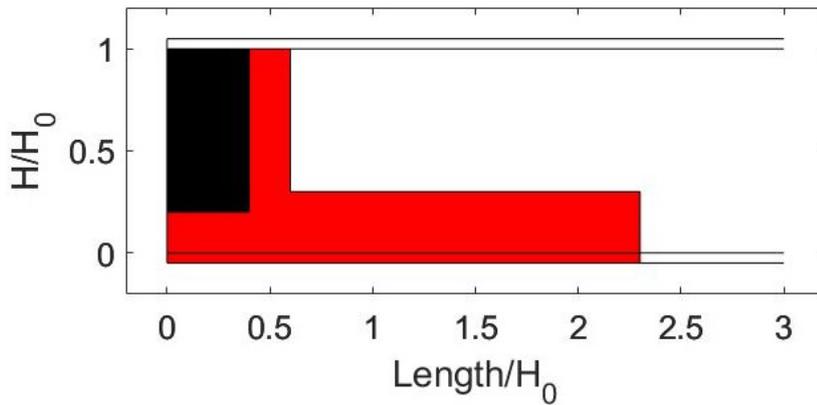
Below depicts the second extreme corrosion scenario for the flange and W3 corrosion pattern combination.

Figure 320: Second extreme flange and W3 web corrosion scenario for beams with a diaphragm - MassDOT

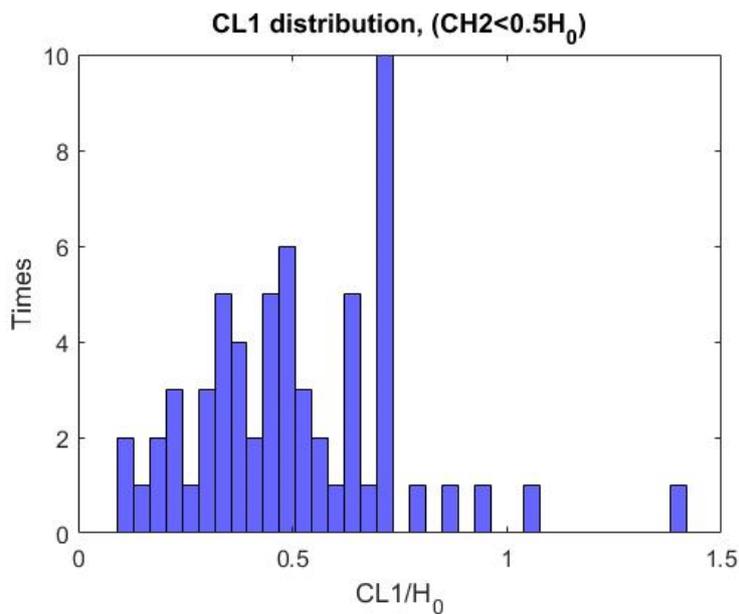
Figure 321: CL1 distribution of W3 web corrosion pattern, with corrosion height up to 50% of H_0 , for beams with a diaphragm - MassDOT

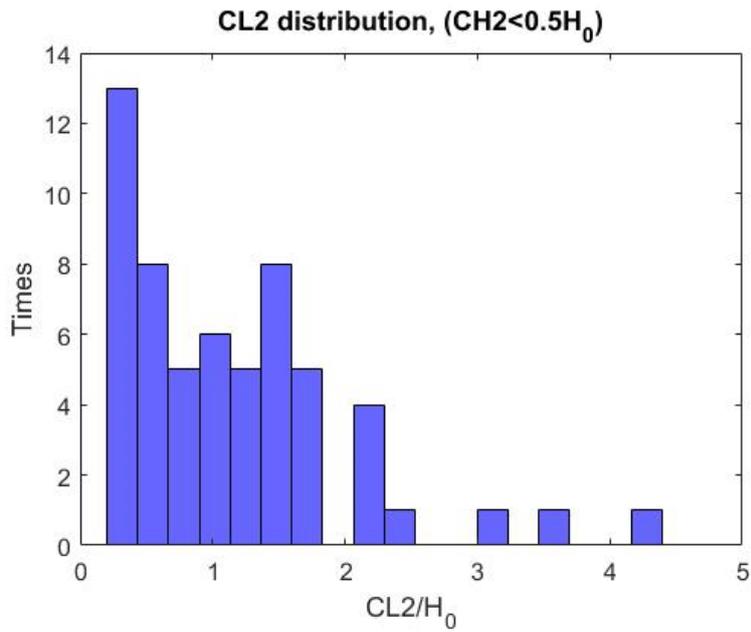
Figure 322: CL2 distribution of W3 web corrosion pattern, with corrosion height up to 50% of H_0 , for beams with a diaphragm - MassDOT

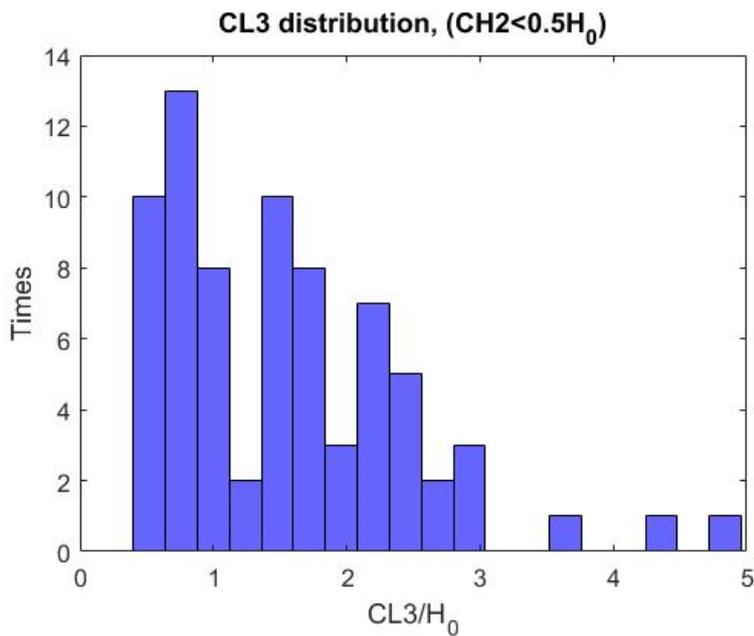
Figure 323: CL3 distribution of W3 web corrosion pattern, with corrosion height up to 50% of H_0 , for beams with a diaphragm - MassDOT

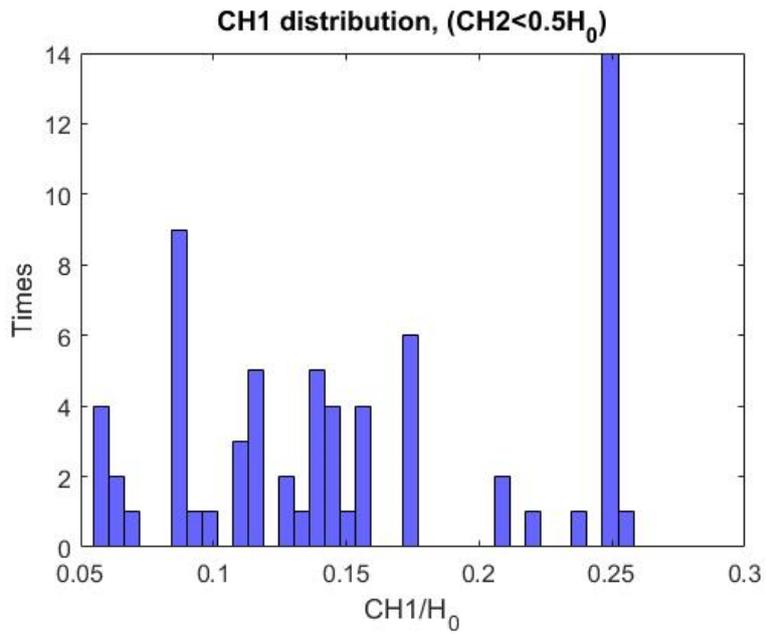
Figure 324: CH1 distribution of W3 web corrosion pattern, with corrosion height up to 50% of H₀, for beams with a diaphragm - MassDOT

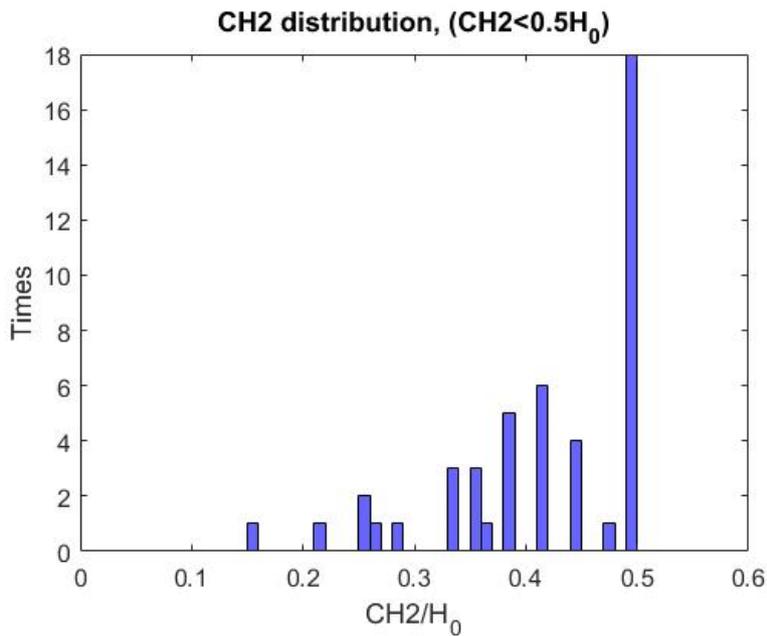
Figure 325: CH2 distribution of W3 web corrosion pattern, with corrosion height up to 50% of H₀, for beams with a diaphragm - MassDOT

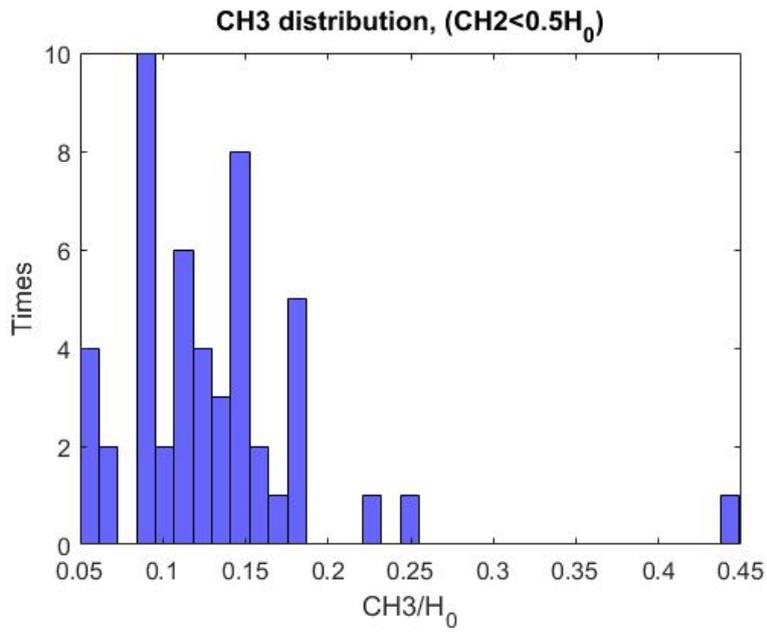
Figure 326: CH3 distribution of W3 web corrosion pattern, with corrosion height up to 50% of H_0 , for beams with a diaphragm - MassDOT

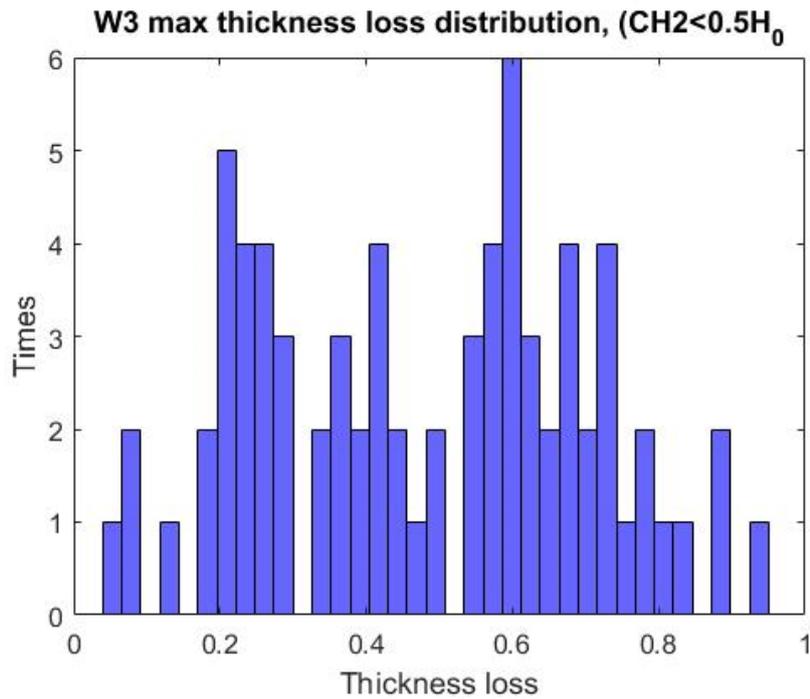
Figure 327: Max web thickness loss distribution of W3 web corrosion pattern, with corrosion height up to 50% of H_0 , for beams with a diaphragm - MassDOT

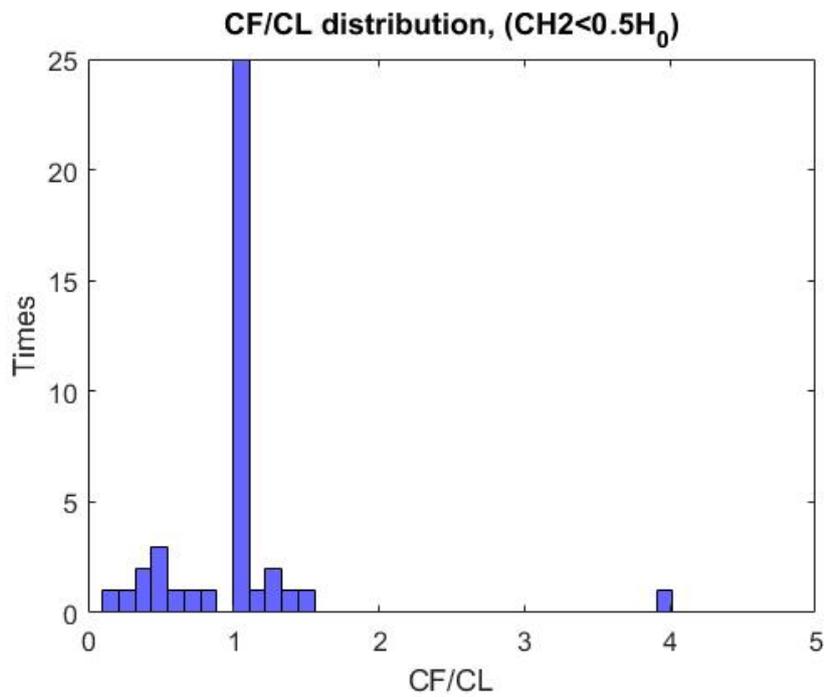
Figure 328: Ratio of flange to web corrosion length distribution, of W3 web corrosion pattern, with corrosion height up to 50% of H_0 , for beams with a diaphragm - MassDOT

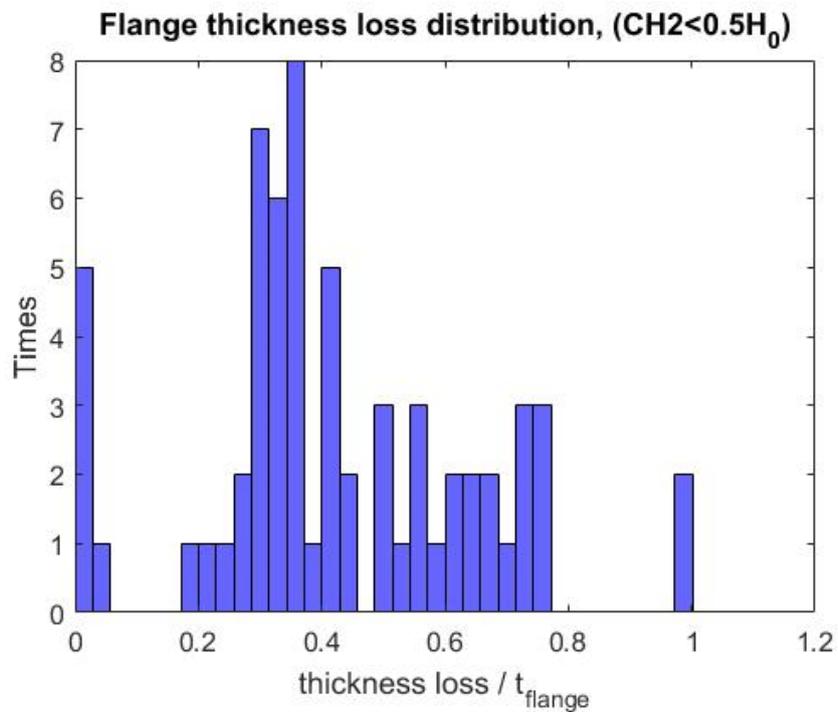
Figure 329: Max flange loss thickness distribution, for beams with W3 web corrosion pattern, with corrosion height up to 50% of H_0 , for beams with a diaphragm - MassDOT

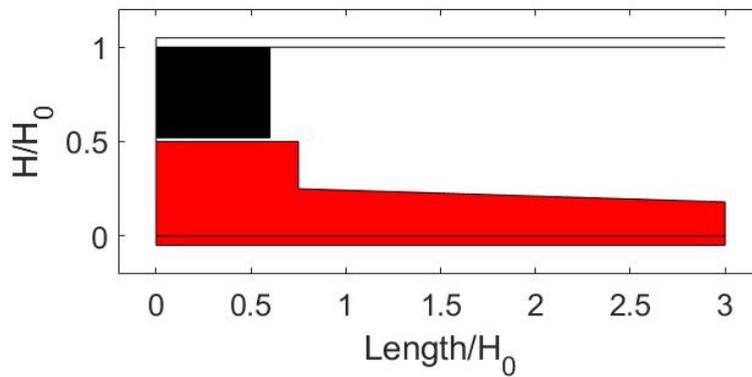
Below depicts the third extreme corrosion scenario for the flange and W3 corrosion pattern combination.

Figure 330: Third extreme flange and W3 web corrosion scenario for beams with a diaphragm - MassDOT

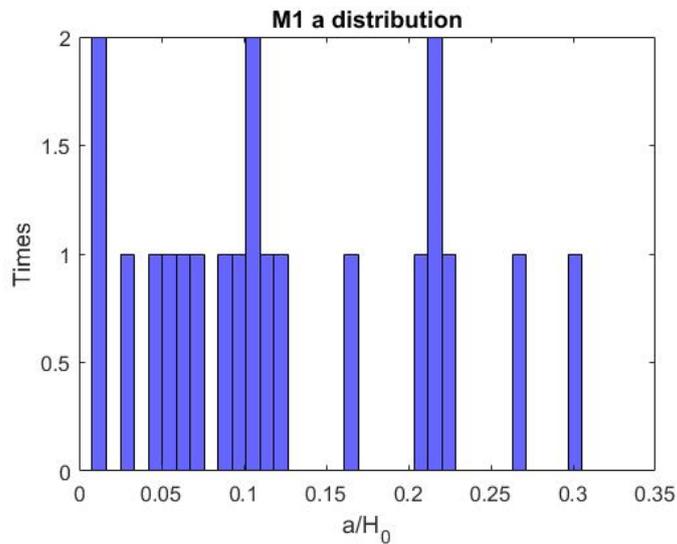
Below, the histogram describes the distribution of holes dimensions for the M1 hole corrosion pattern.

Figure 331: M1 web hole's pattern height distribution of W3 web corrosion pattern for beams with a diaphragm - MassDOT

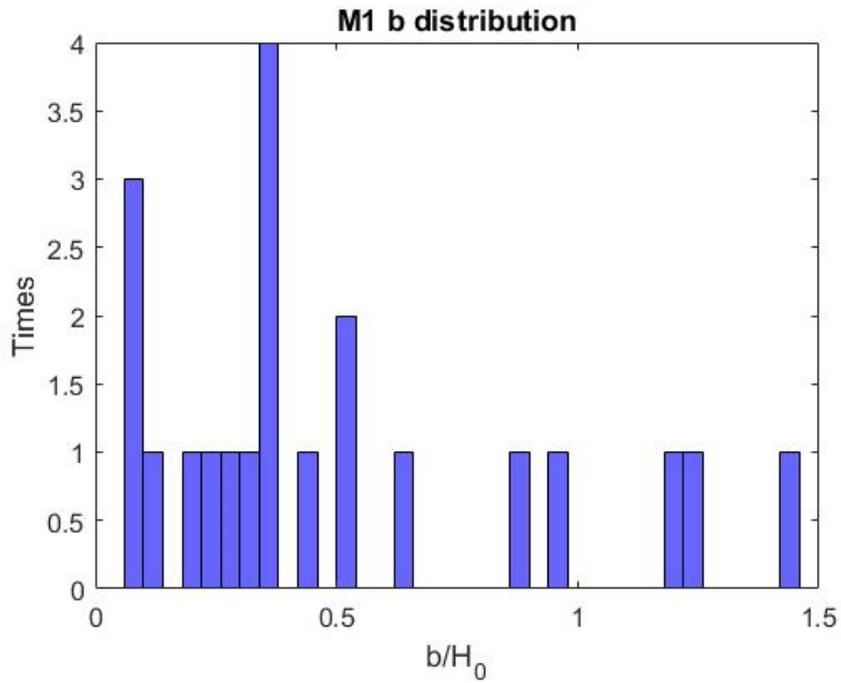
Figure 332: M1 web hole's pattern length distribution of W3 web corrosion pattern for beams with a diaphragm - MassDOT

From the figure above, it was noticed that holes appear mainly at the full height of the corroded web. The holes observed seem to be mainly thin and long across the web. From Figure 333, most of the cases have ratio of hole's length to height up to 6. From Figure 332, the hole length is up to 50% of H_0 . Thus, for the extreme corrosion hole scenario, the hole's height is considered as 0.083.

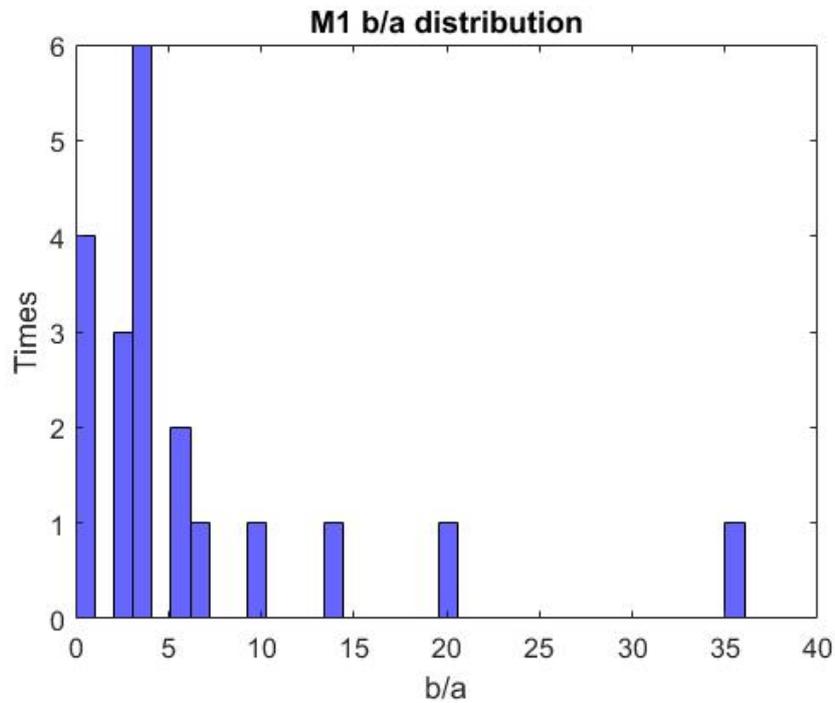
Figure 333: M1 web hole's ratio length to height distribution of W3 web corrosion pattern for beams with a diaphragm - MassDOT

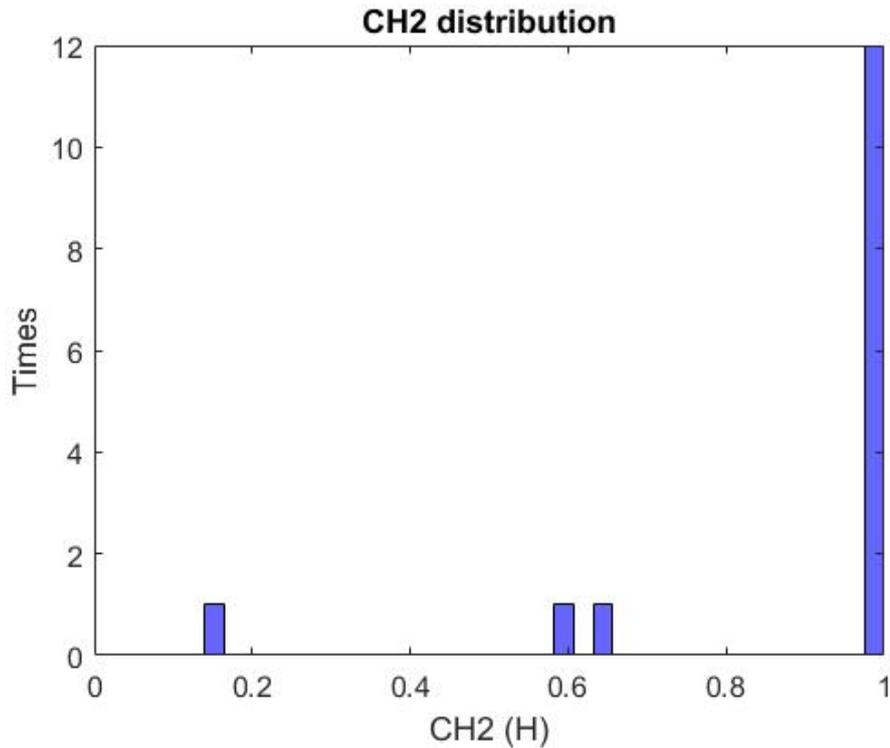
Figure 334: Max corrosion height distribution of W3 pattern with M1 hole, for beams with a diaphragm - MassDOT
