Improved Load Rating Procedures for Deteriorated Unstiffened Steel Beam Ends

Prepared For:
New England Transportation Consortium
January 2024

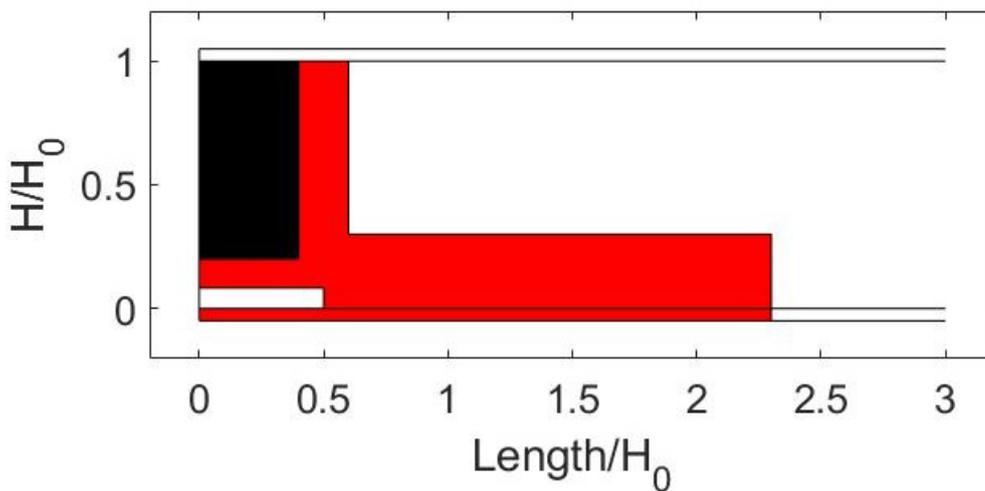
Figure 335: M1 hole pattern projected on the second extreme W3 web corrosion pattern scenario. With black color is illustrated the diaphragm that could be found with these patterns - MassDOT

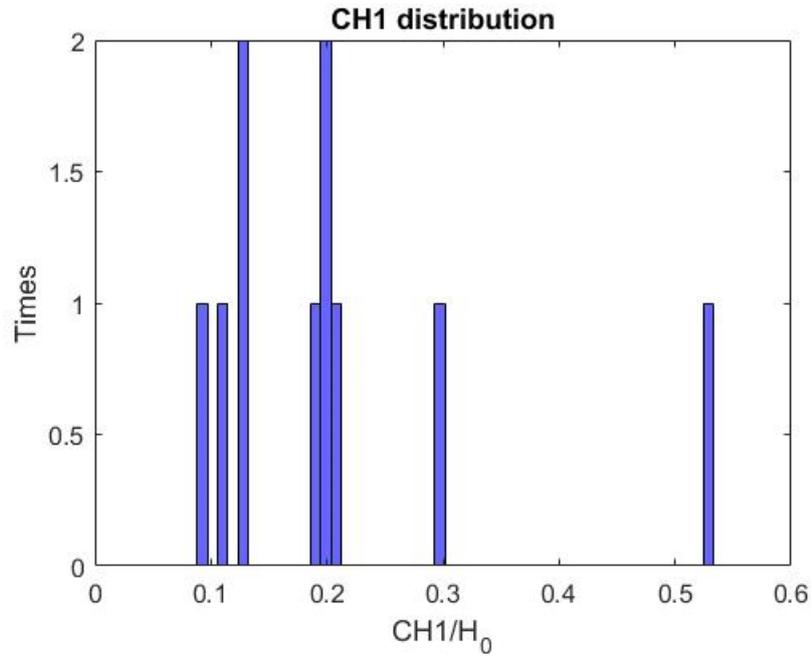
Figure 336: CH1 distribution of W4 web corrosion pattern for beams with a diaphragm - MassDOT

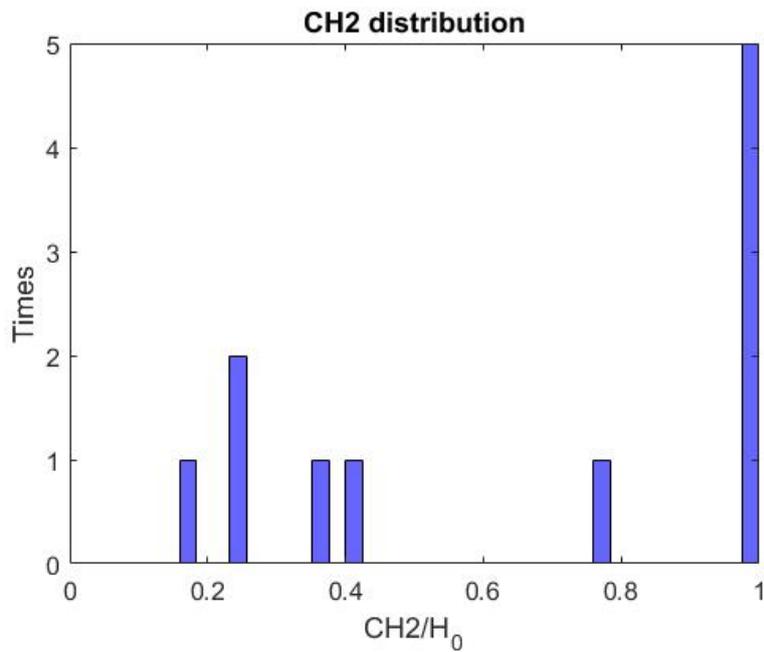
Figure 337: CH2 distribution of W4 web corrosion pattern for beams with a diaphragm - MassDOT

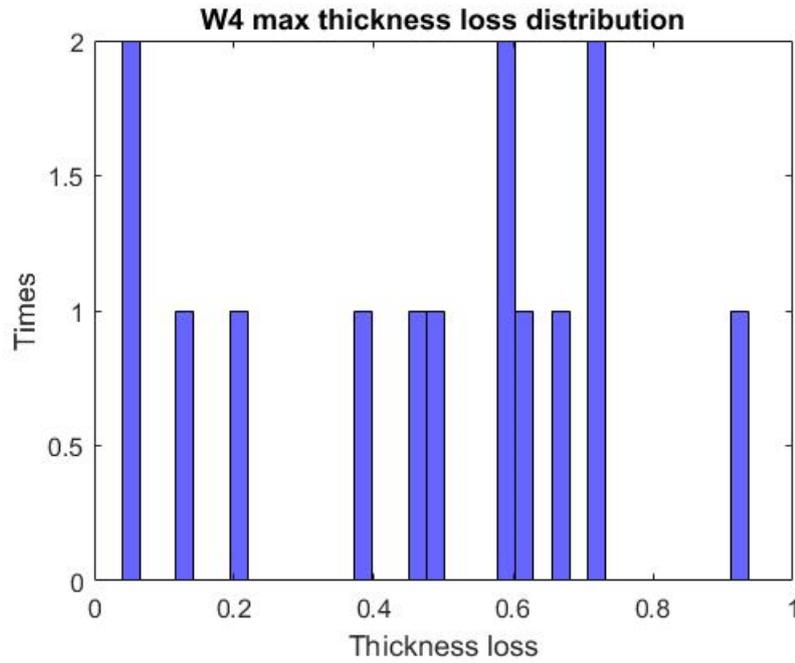
Figure 338: Max web thickness loss distribution of W4 web corrosion pattern for beams with a diaphragm - MassDOT

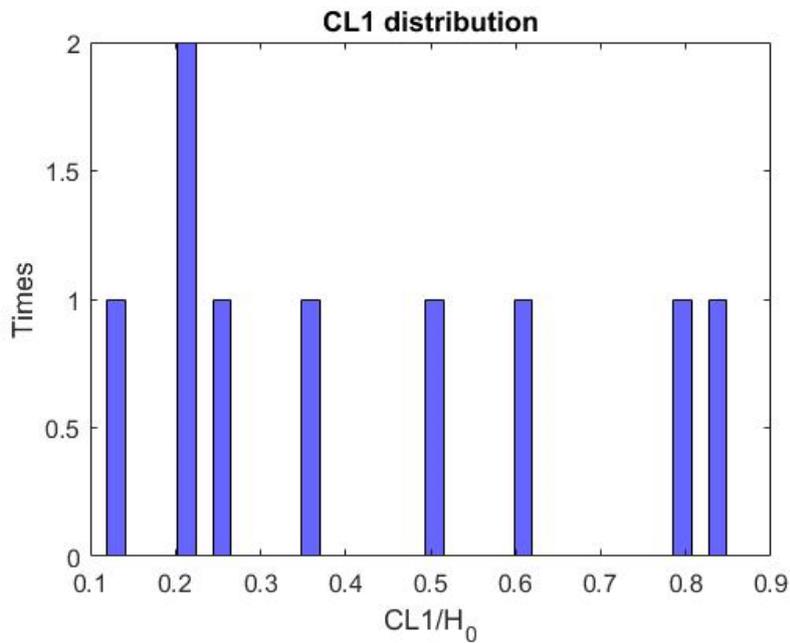
Figure 339: CL1 distribution of W4 web corrosion pattern for beams with a diaphragm - MassDOT

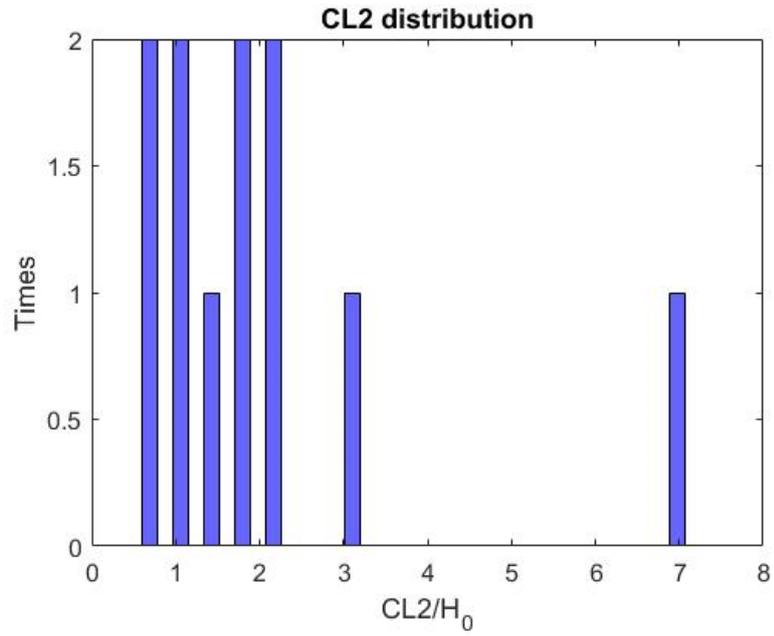
Figure 340: CL2 distribution of W4 web corrosion pattern for beams with a diaphragm - MassDOT

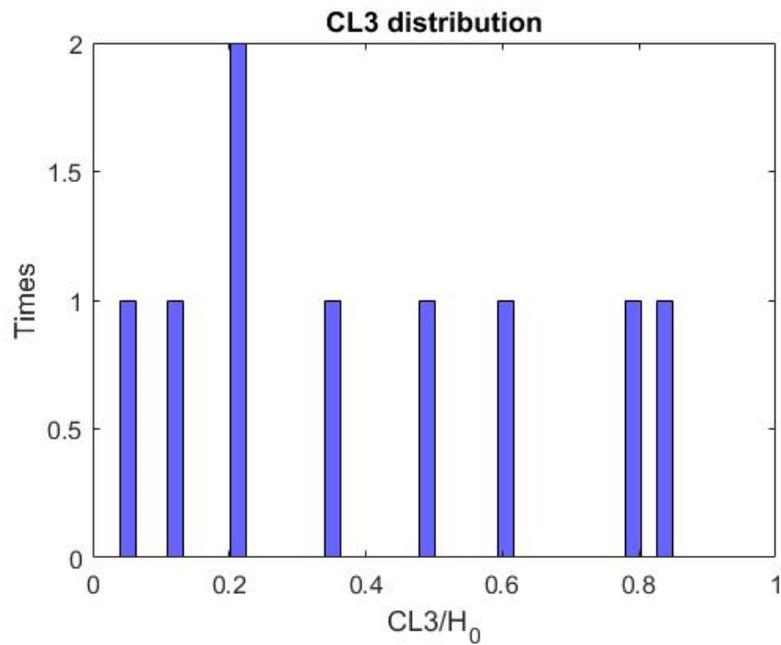
Figure 341: CL3 distribution of W4 web corrosion pattern for beams with a diaphragm - MassDOT

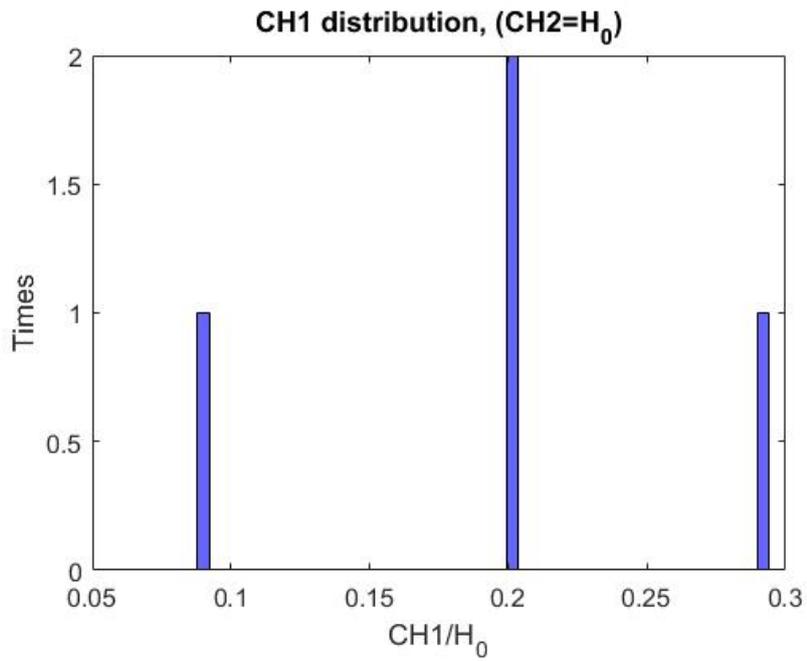
Figure 342: CH1 distribution of W4 web corrosion pattern with full height corrosion for beams with a diaphragm - MassDOT

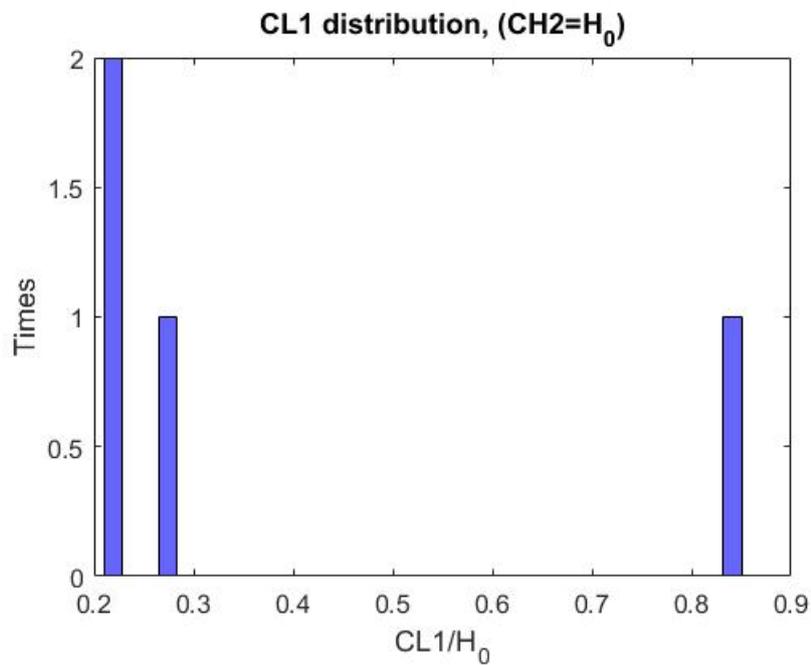
Figure 343: CL1 distribution of W4 web corrosion pattern with full height corrosion for beams with a diaphragm - MassDOT

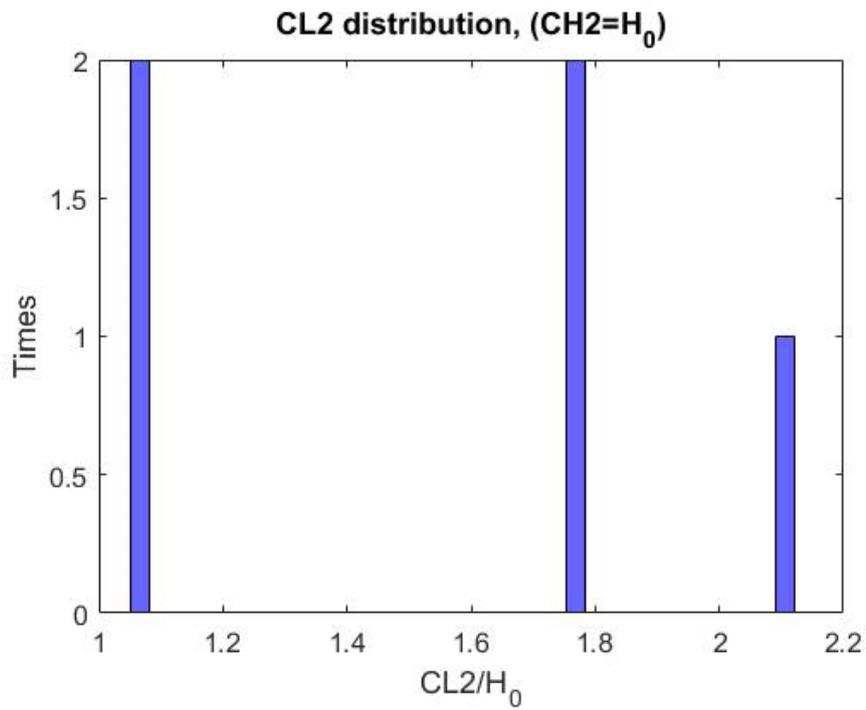
Figure 344: CL2 distribution of W4 web corrosion pattern with full height corrosion for beams with a diaphragm - MassDOT

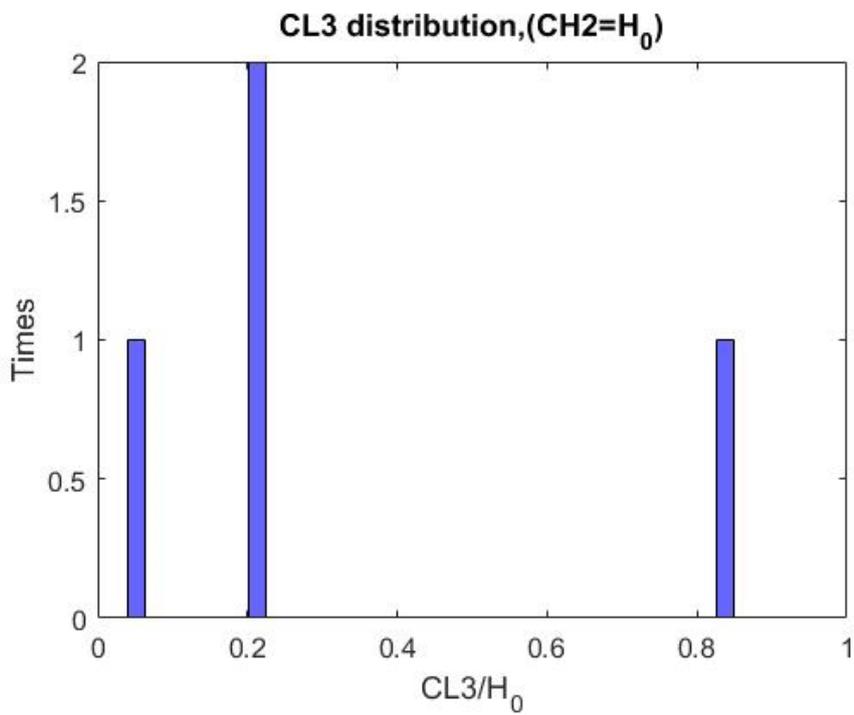
Figure 345: CL3 distribution of W4 web corrosion pattern with full height corrosion for beams with a diaphragm - MassDOT

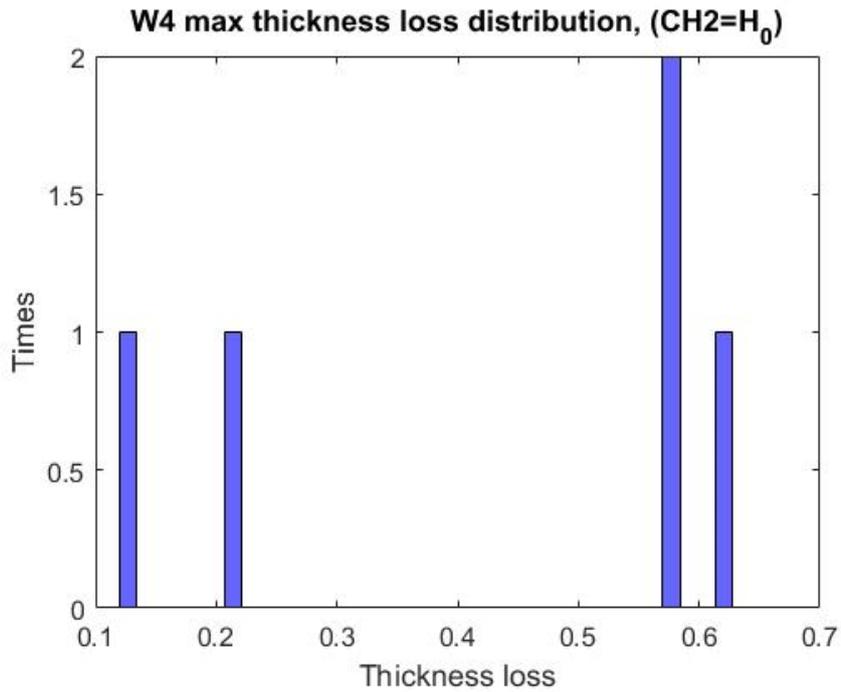
Figure 346: Max web thickness loss distribution of W4 web corrosion pattern with full height corrosion for beams with a diaphragm - MassDOT

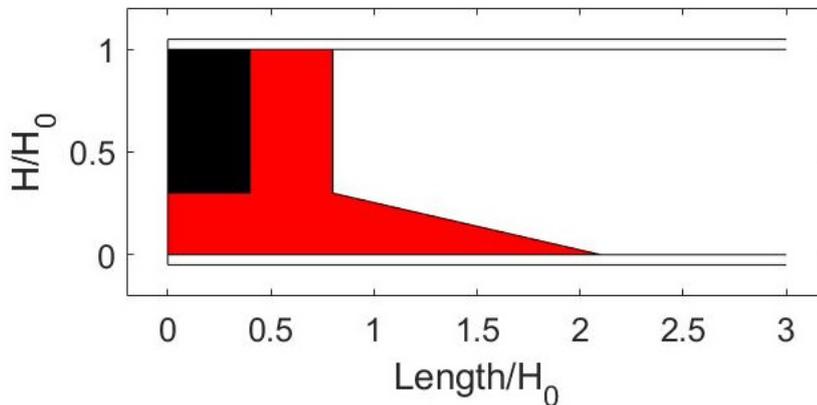
Figure 347: First extreme W4 web corrosion scenario for beams with a diaphragm - MassDOT

Even when considering the small sample, the W4 corrosion pattern with full height corrosion seems to follow the corresponding W3 corrosion pattern.

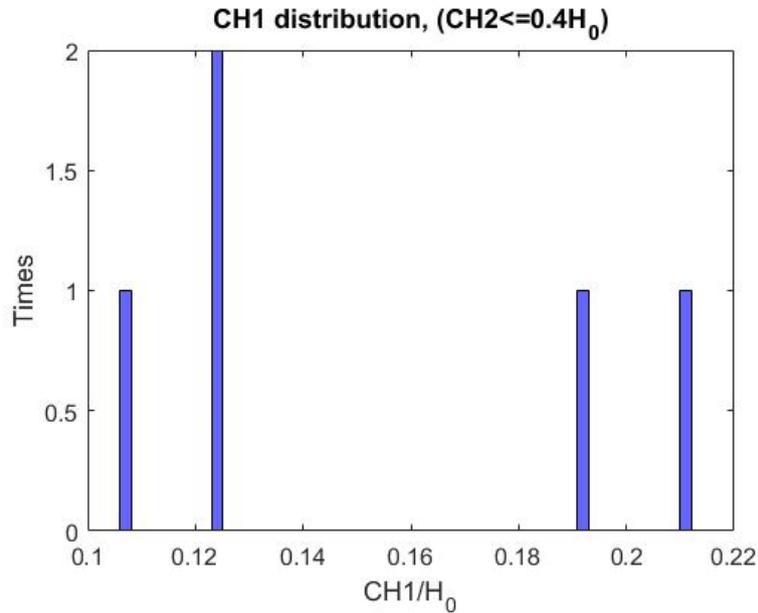
Figure 348: CH1 distribution of W4 web corrosion pattern, with corrosion height up to 40% of H_0 , for beams with a diaphragm - MassDOT

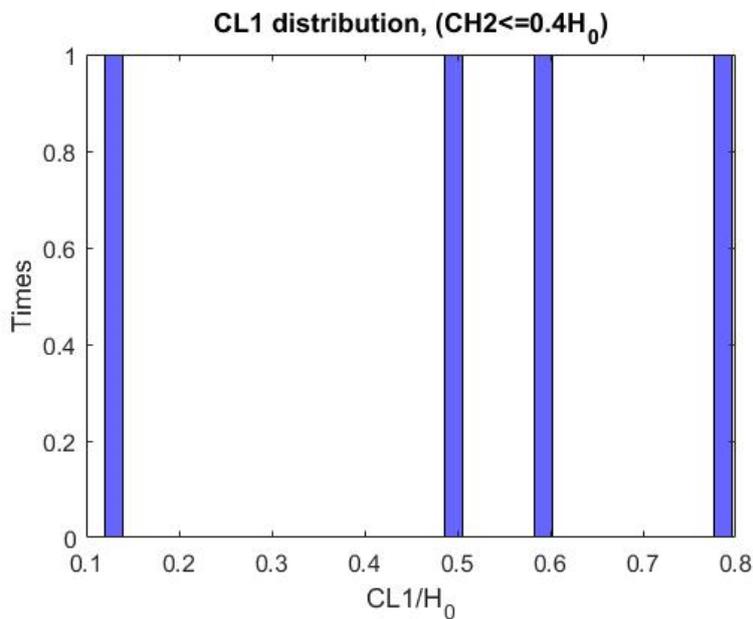
Figure 349: CL1 distribution of W4 web corrosion pattern, with corrosion height up to 40% of H_0 , for beams with a diaphragm - MassDOT

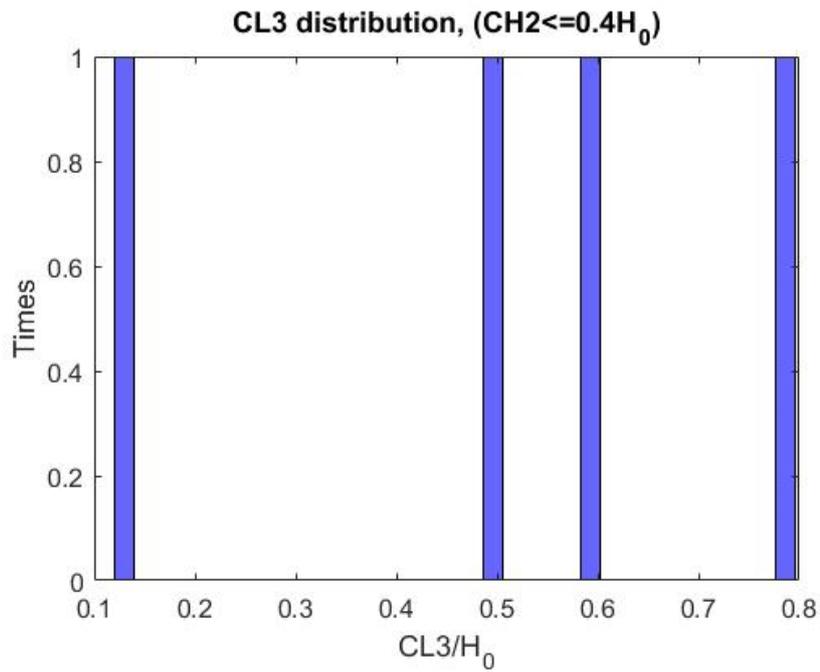
Figure 350: CL3 distribution of W4 web corrosion pattern, with corrosion height up to 40% of H₀, for beams with a diaphragm - MassDOT

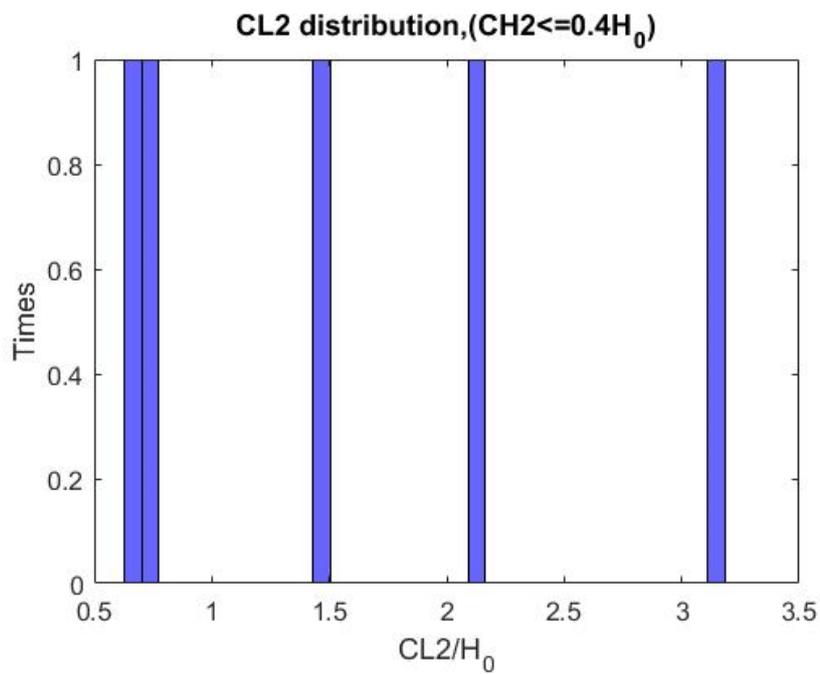
Figure 351: CL2 distribution of W4 web corrosion pattern, with corrosion height up to 40% of H₀, for beams with a diaphragm - MassDOT

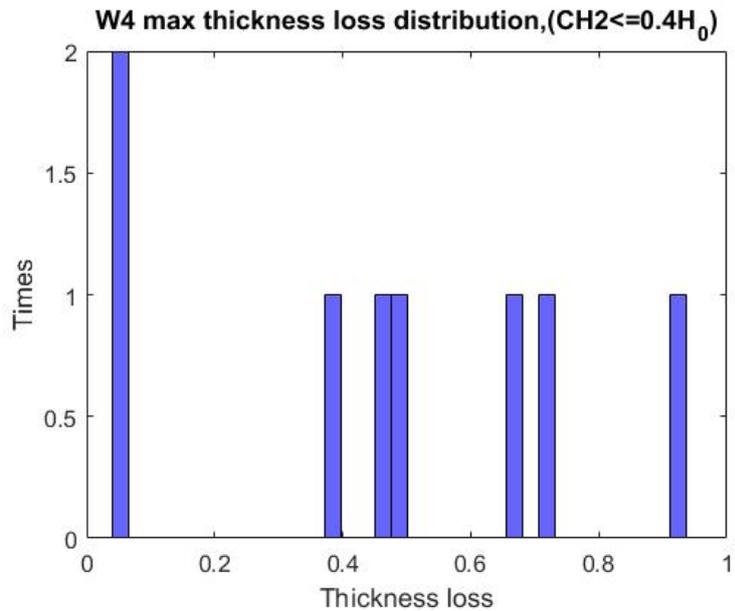
Figure 352: Max web thickness loss distribution of W4 web corrosion pattern, with corrosion height up to 40% of H_0 , for beams with a diaphragm - MassDOT

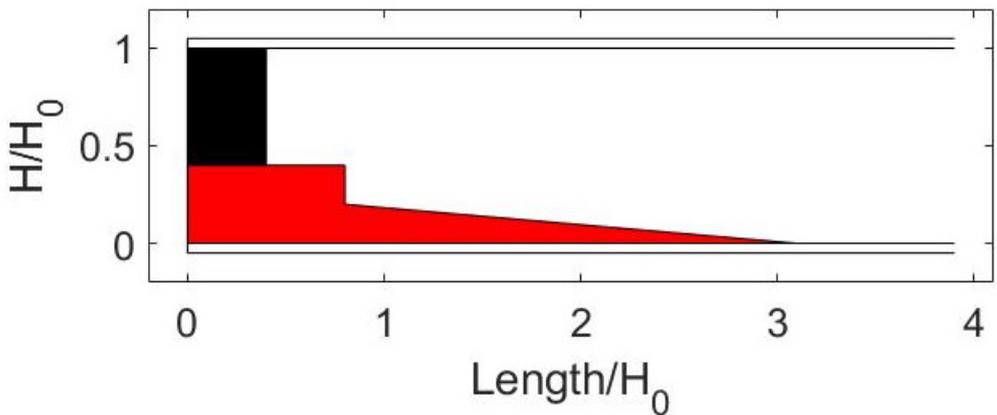
Figure 353: Second extreme W4 web corrosion scenario for beams with a diaphragm - MassDOT

Upon inspection, the W3 corrosion pattern seems to follow the corresponding W4 corrosion pattern.

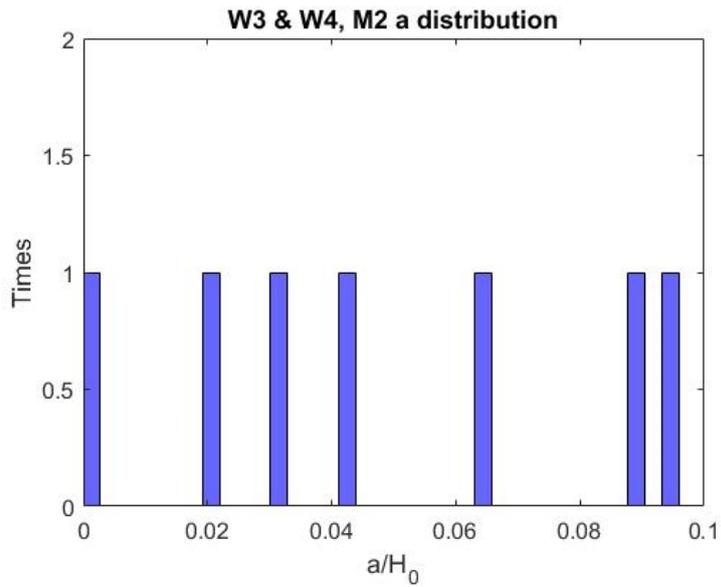
Figure 354: M2 web hole's pattern height distribution of W3 and W4 web corrosion pattern for beams with a diaphragm - MassDOT

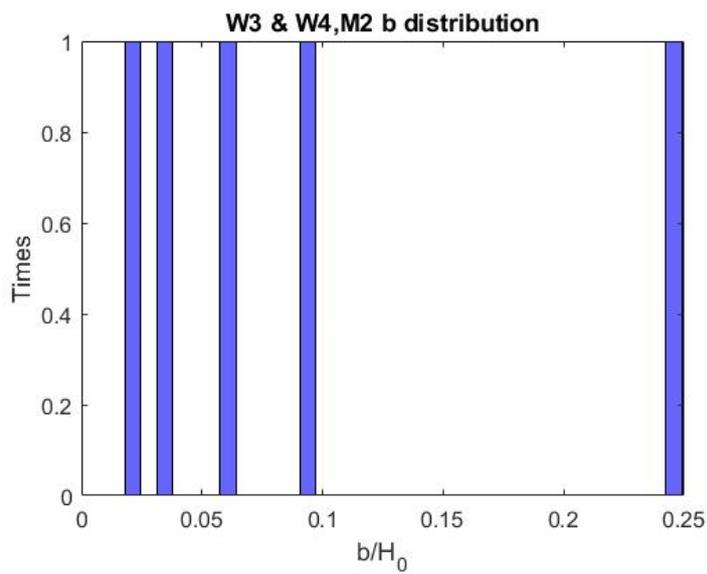
Figure 355: M2 web hole's pattern length distribution of W3 and W4 web corrosion pattern for beams with a diaphragm - MassDOT

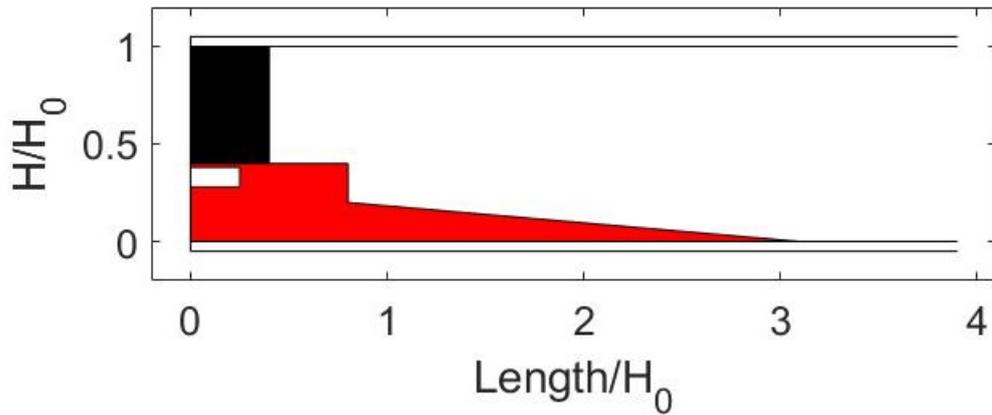
The worst-case scenario for the M2 hole corrosion pattern was projected on an extreme W4 corrosion pattern with the following parameters: $a=0.1$ $b=0.25$

Figure 356: Extreme M2 hole pattern scenario projected on second extreme W4 web corrosion scenario for beams with a diaphragm - MassDOT

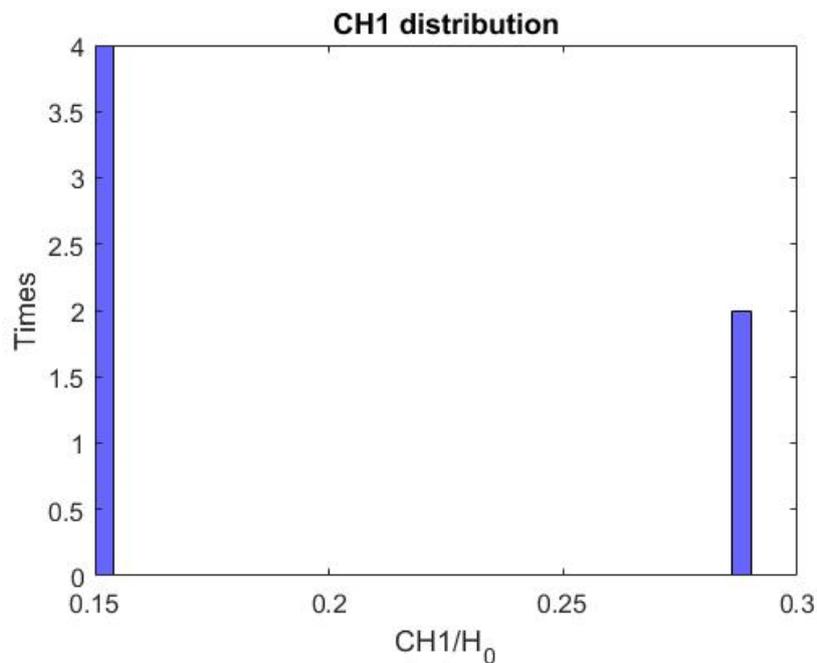
Figure 357. CH1 distribution of W5 web corrosion pattern for beams with a diaphragm - MassDOT

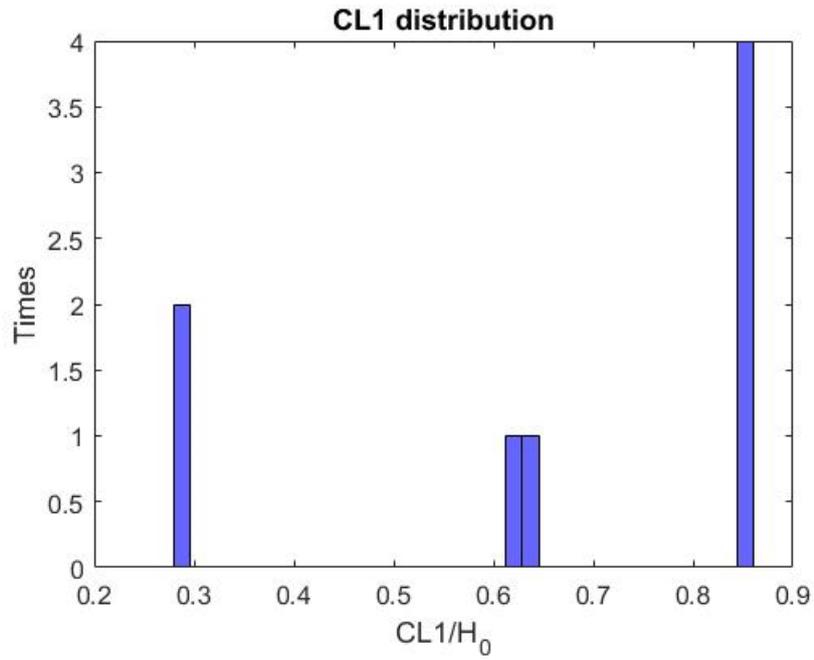
Figure 358: CL1 distribution of W4 web corrosion pattern for beams with a diaphragm - MassDOT

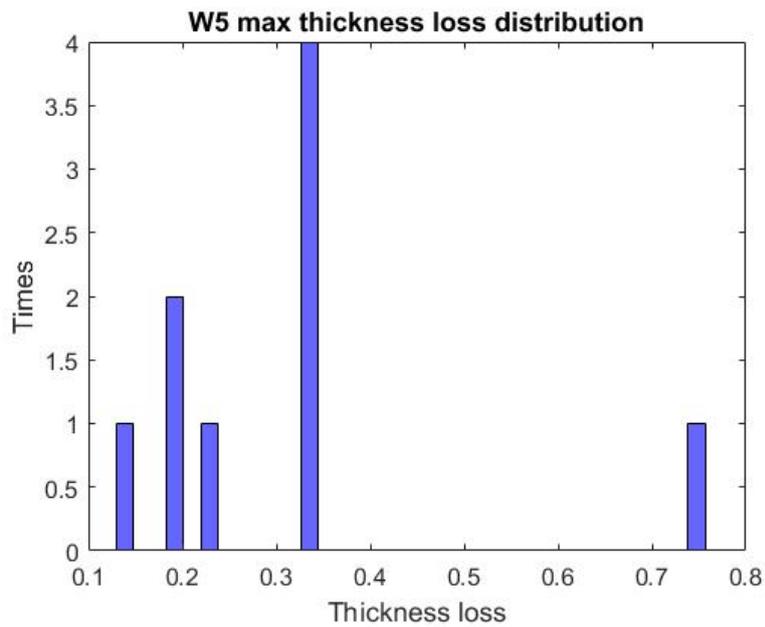
Figure 359: Max web thickness loss distribution of W5 web corrosion pattern for beams with a diaphragm - MassDOT

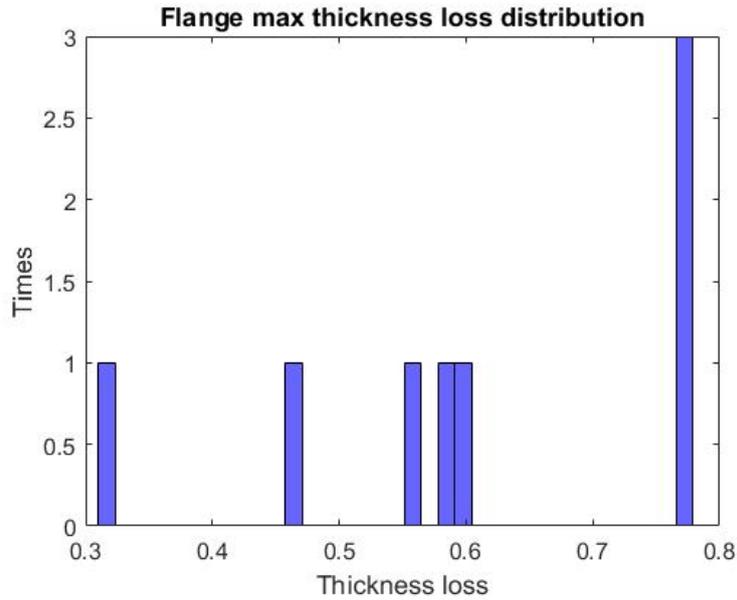
Figure 360: Max flange thickness loss of beams with W5 web corrosion pattern for beams with a diaphragm - MassDOT

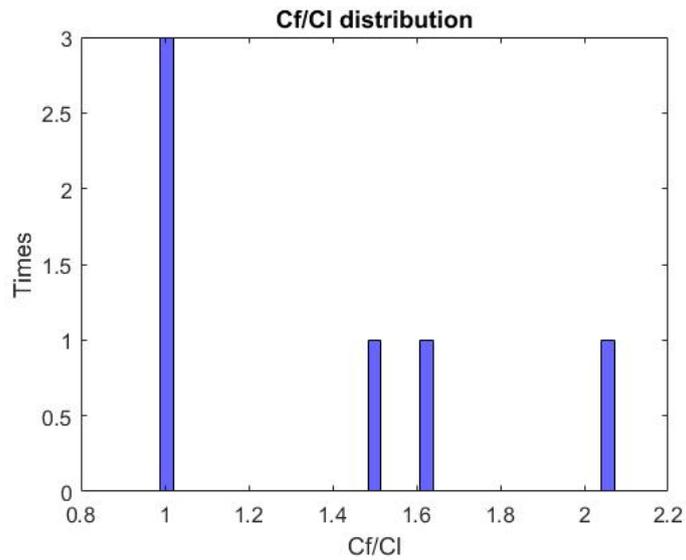
Figure 361: Ratio of flange to web corrosion length distribution, of W5 web corrosion pattern for beams with a diaphragm - MassDOT

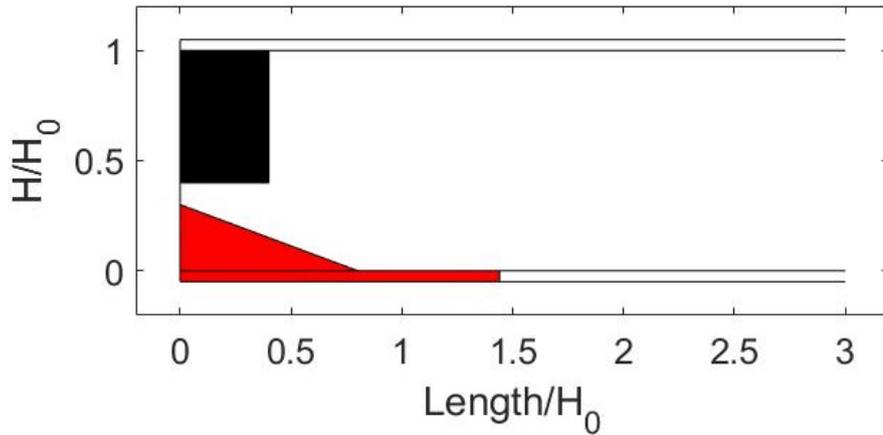
Figure 362: Extreme W5 web corrosion scenario for beams with a diaphragm - MassDOT

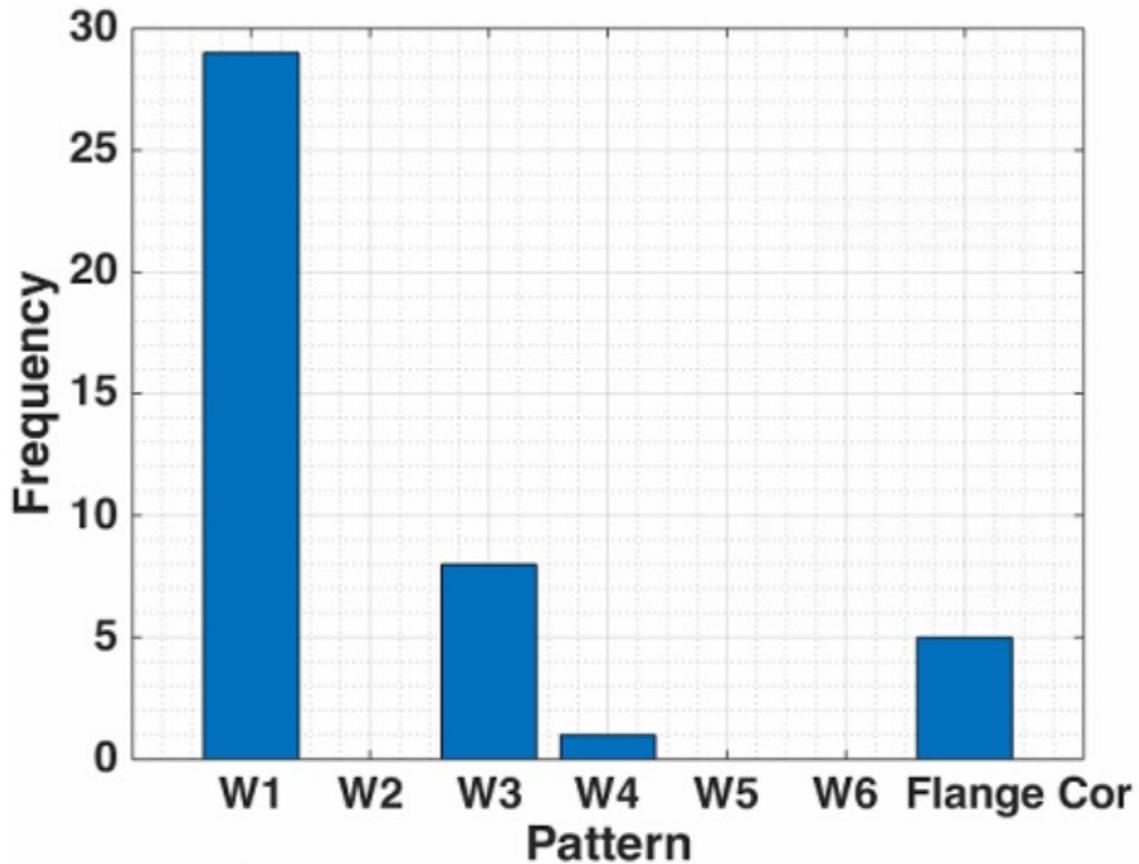
Figure 363: Web corrosion patterns distribution for beams ends with a diaphragm – RIDOT

Figure 363 depicts the frequency of corrosion patterns for beam ends with a diaphragm system from Rhode Island. This also means that the graph denotes the total amount of times each pattern appears in the reports.

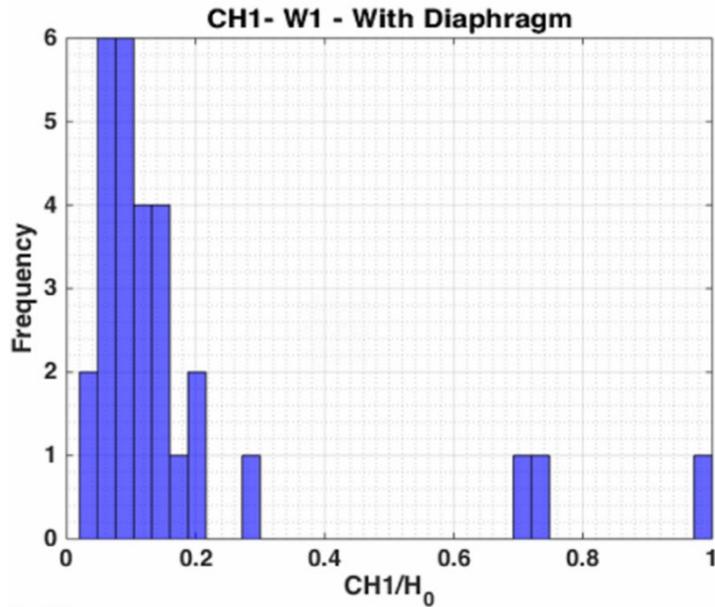
Figure 364: CH1 distribution for beams with diaphragm and W1 corrosion pattern – RIDOT

Figure 364 clearly depicts that $0 < CH_1 \leq 0.2H_0$. With the goal of understanding the relationship between the other parameters of corrosion and the corrosion height, our team had to analyze the behavior of the other parameters given that $CH_1 < 0.2H_0$. Figure 365 and Figure 366 depict the length of corrosion and the web thickness loss for this case.

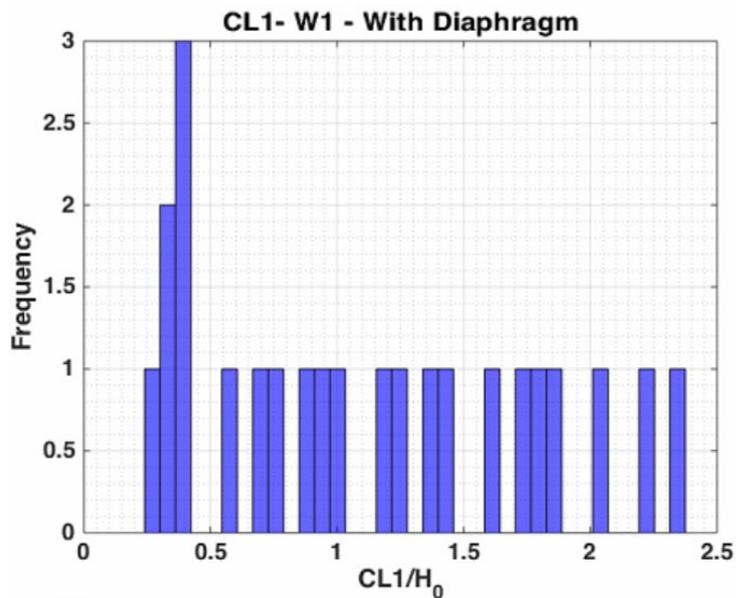
Figure 365: CL1 distribution for beams with diaphragm and W1 corrosion pattern – RIDOT

Although no clear trend is observed from Figure 365, the graph lead our team to state that the length can span $0.25H_0$ up to $2.5H_0$. That is, $0.25H_0 \leq CL_1 \leq 2.5H_0$.

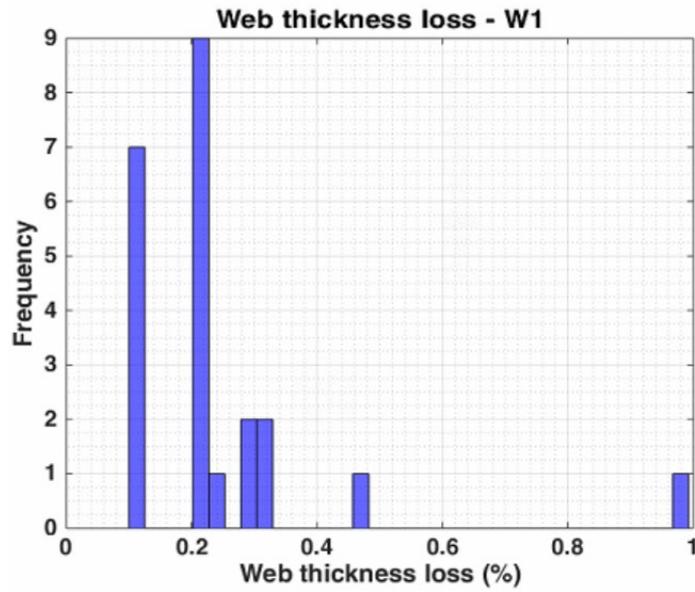
Figure 366: Web thickness loss distribution for beams with diaphragm and W1 corrosion pattern – RIDOT

Figure 366 depicts the distribution of web thickness loss given that $CH1 < 0.2H_0$.

From Figure 366, our team assumed that most of the beams have web thickness loss found in the following interval:

$$0.1 \leq \frac{t_{loss}}{t_{web}} \leq 0.3$$

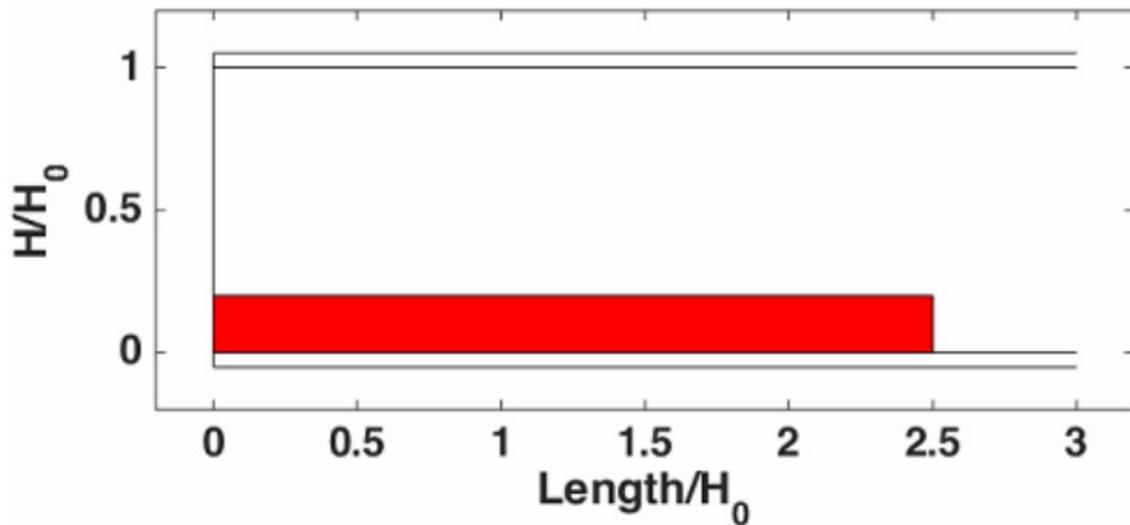
Figure 367: Extreme corrosion case of W1 pattern for beams with a diaphragm – RIDOT

Therefore, it is possible to define an extreme case of corrosion for beam ends with a diaphragm system, as depicted in Figure 367.

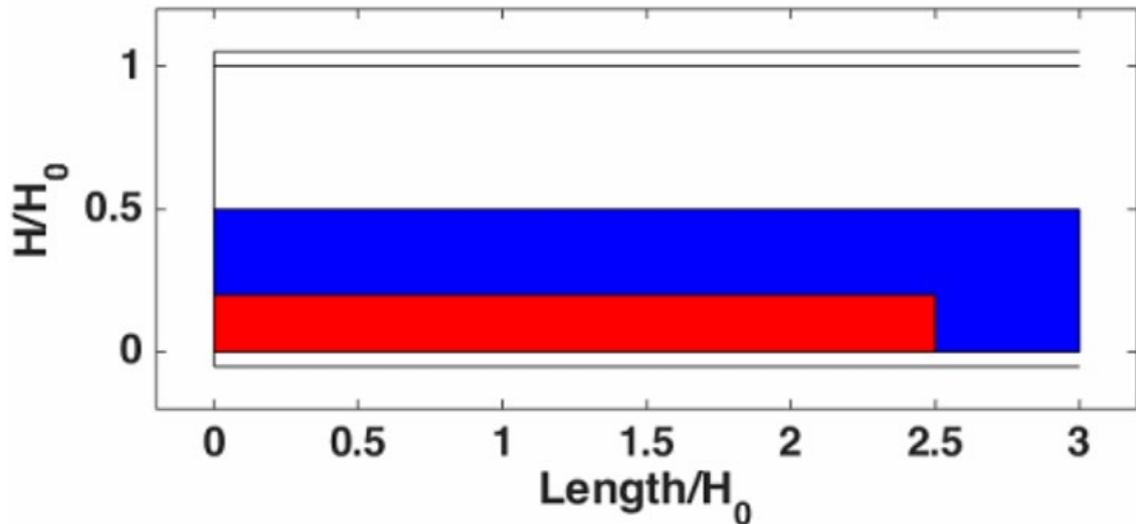
Figure 368: Comparison between extreme corrosion scenarios. Blue represents the extreme scenario for beams without diaphragm, whereas the region in red depicts extreme corrosion scenario for beams with a diaphragm – RIDOT

Figure 368 describes the comparison between the extreme corrosion case pattern for the W1 corrosion pattern of beam ends with and without a diaphragm system.

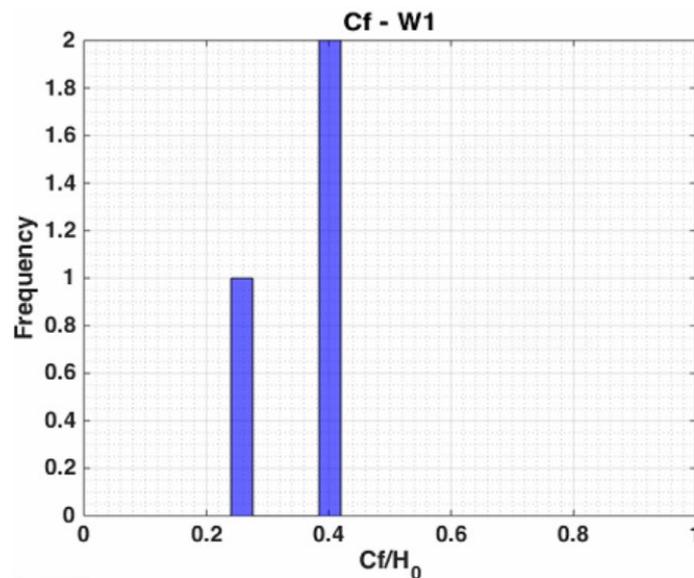
Figure 369: Flange corrosion length for beam ends with diaphragm for W1 pattern – RIDOT

Only three cases of flange corrosion were recorded combined with W1 corrosion pattern for beam ends with a diaphragm system. As the amount of data was not sufficient for the research team to draw conclusions, Figure 369, Figure 370, Figure 371 depict only the statistics the research team was able to record from the bridge inspection reports.

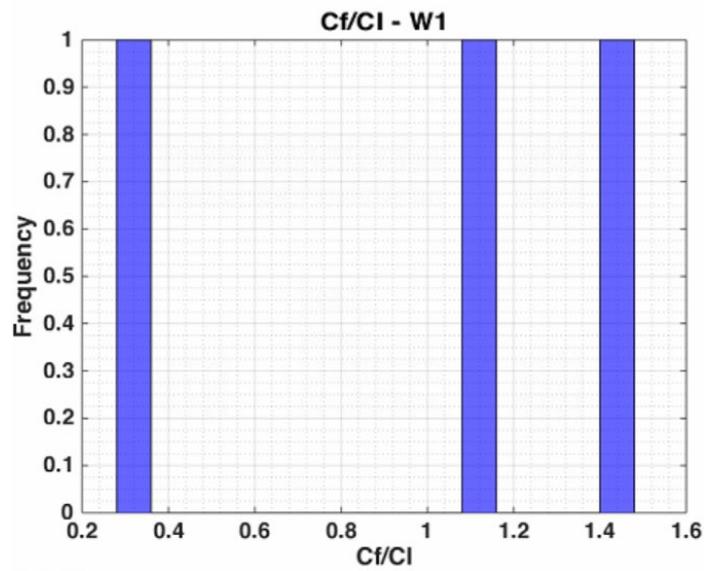
Figure 370: Ratio between flange corrosion length and web corrosion length for W1 pattern – RIDOT

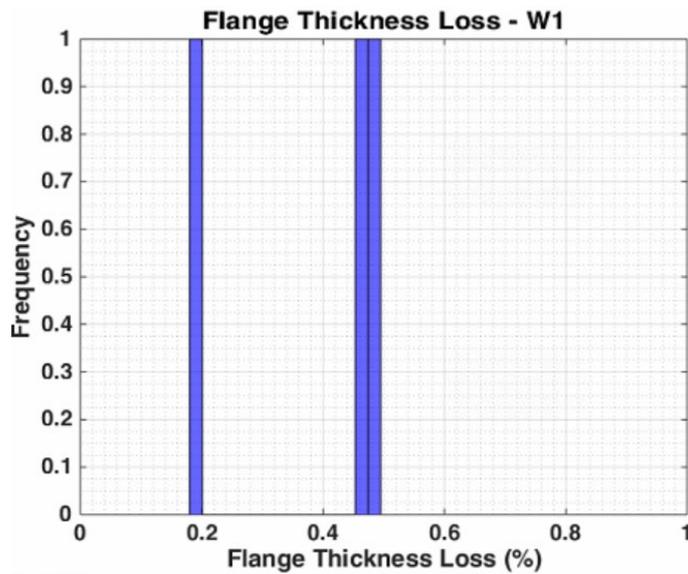
Figure 371: Flange thickness loss distribution for W1 pattern – RIDOT

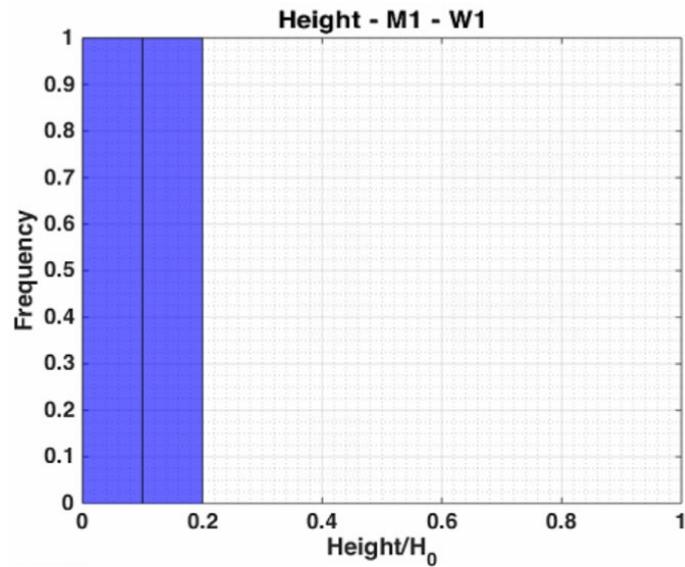
Figure 372: Height of M1 holes combined with W1 pattern – RIDOT

As shown in Table 81, just three holes were recorded combined with the W1 corrosion pattern. Due to the small amount of available data, it was not possible to detect any trends. For this reason, Figure 372 and Figure 373 depict the dimensions of the M1 corrosion holes. Figure 374 and Figure 375 depict the dimensions of the M3 corrosion hole.

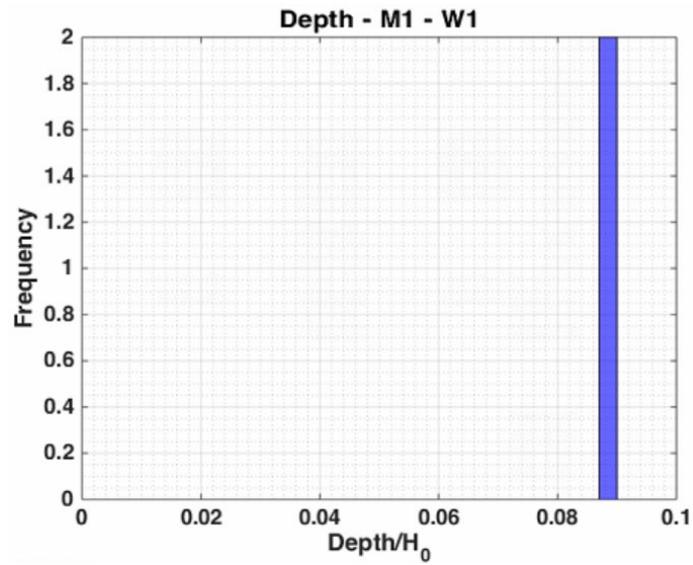
Figure 373: Depth of M1 holes combined with W1 pattern – RIDOT

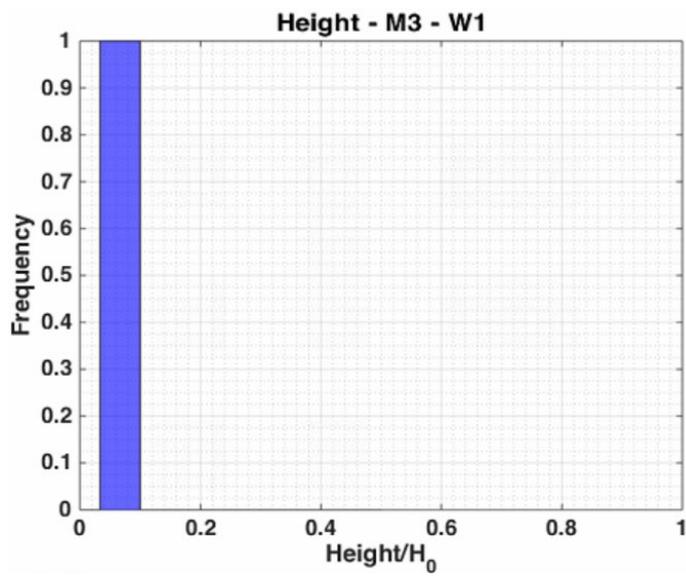
Figure 374: Height of M3 holes combined with W1 pattern – RIDOT

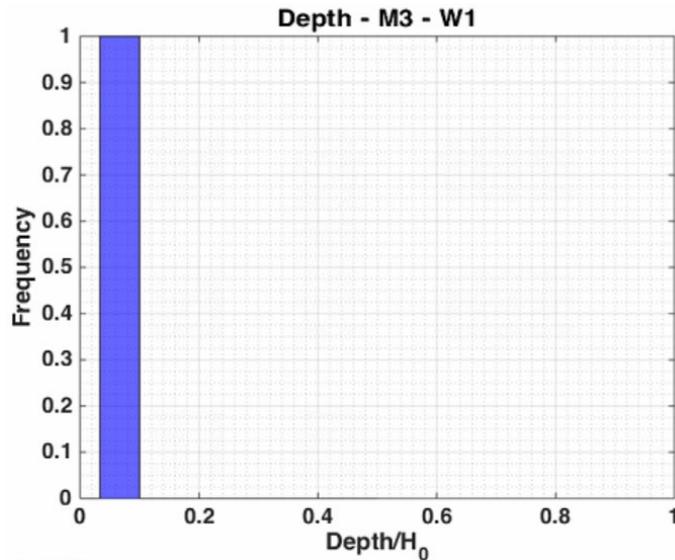
Figure 375: Depth of M3 holes combined with W1 pattern – RIDOT

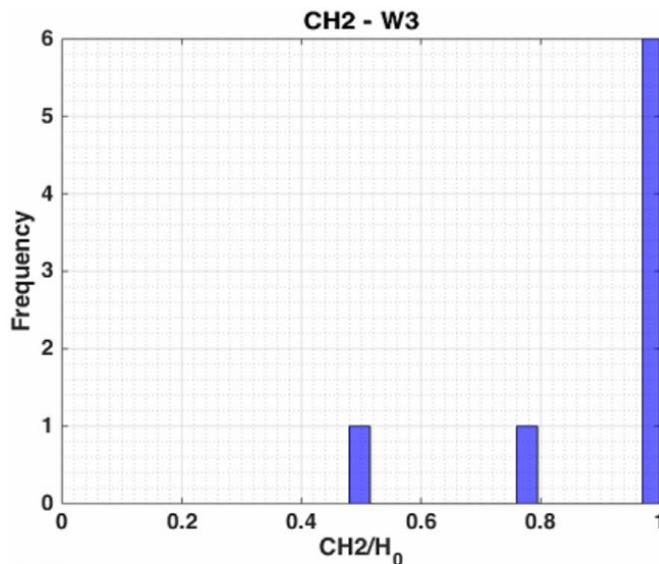
Figure 376: CH2 distribution for W3 pattern – RIDOT

Only eight cases of the W3 corrosion pattern were recorded by the research team. The parameters for the corrosion patterns can be found with corresponding diagrams in Section 1.5 *Corrosion Patterns* of this report. Similar to the other cases, the study began by analyzing the distribution of the total height of corrosion, depicted in Figure 376.

Although Figure 376 clearly depicts that most of the beam ends have the height fully corroded, it was not possible to detect other major trends. The reason for that can be found in Figure 377, Figure 378, Figure 379, Figure 380 and Figure 381. These figures depict scatter among the histograms of the corrosion shape parameters. This limited our team in being able to detect trends in the corrosion data.

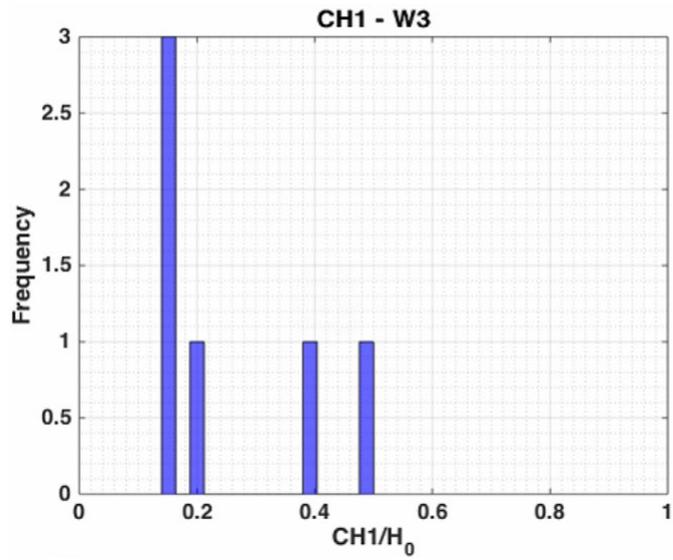
Figure 377: CH1 distribution for W3 pattern – RIDOT
