Improved Load Rating Procedures for Deteriorated Unstiffened Steel Beam Ends

Prepared For:
New England Transportation Consortium
January 2024

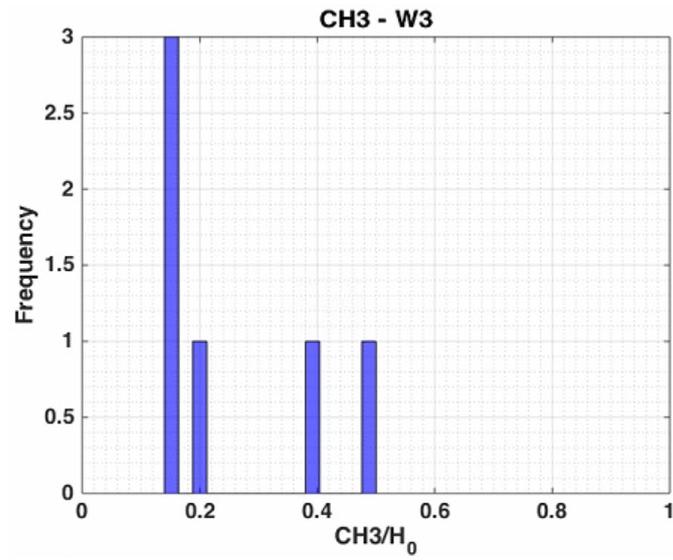
Figure 378: CH3 distribution for W3 pattern – RIDOT

Although Figure 376 clearly depicts that most of the beam ends have the height fully corroded, it was not possible to detect other major trends. The reason for that can be found in Figure 377, Figure 378, Figure 379, Figure 380 and Figure 381. These figures depict scatter among the histograms of the corrosion shape parameters. This limited our team in being able to detect trends in the corrosion data.

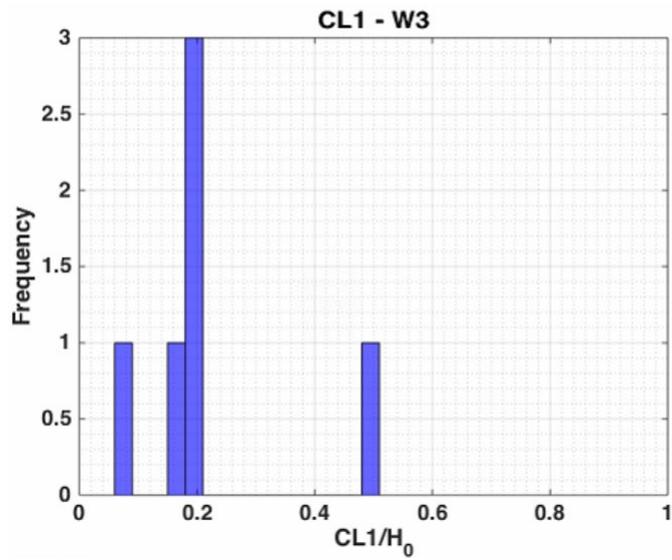
Figure 379: CL1 distribution for W3 pattern – RIDOT

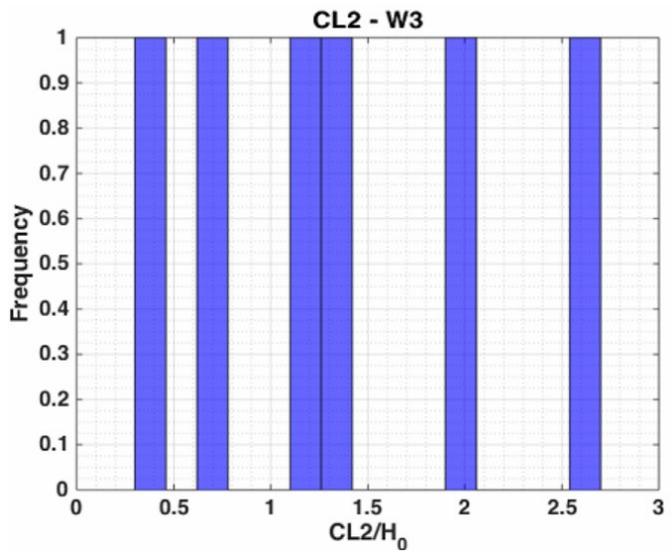
Figure 380: CL2 distribution for W3 pattern – RIDOT

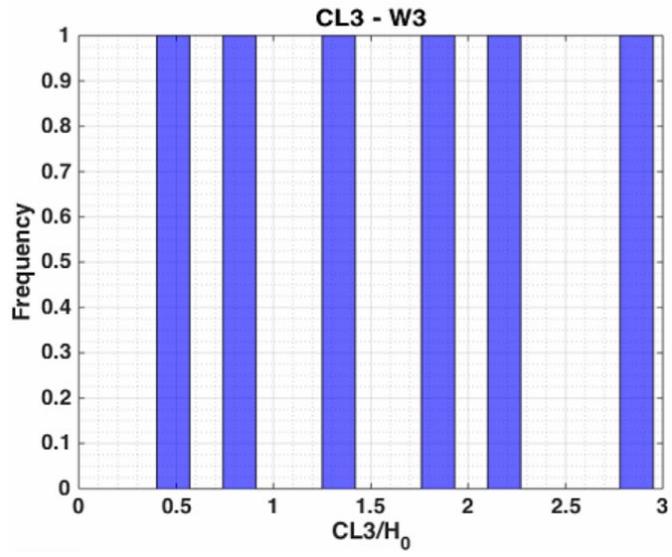
Figure 381: CL3 distribution for W3 pattern – RIDOT

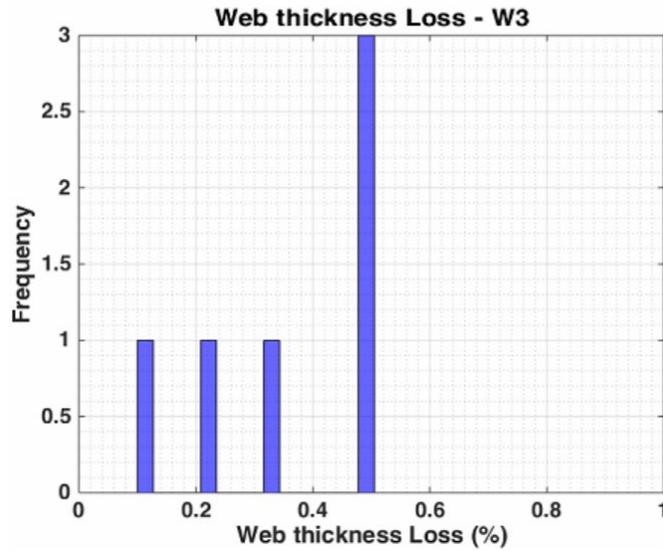
Figure 382: Web thickness loss distribution for W3 pattern – RIDOT

Figure 382 depicts the web thickness loss for beams whose $CH_2=1H_0$.

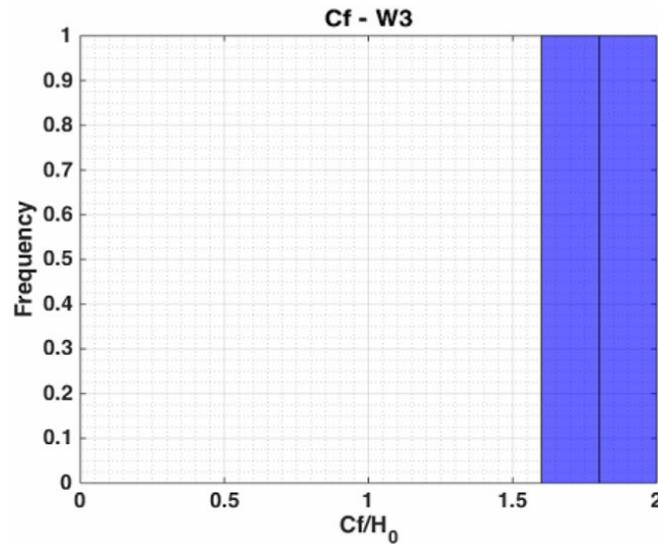
Figure 383: Flange corrosion length for W3 pattern – RIDOT

The research team was able to record information regarding the combination of flange corrosion and the W3 corrosion pattern for two cases. This meant that, due to the small amount of data available, the research team was not able to detect any trend in the data. Figure 383, Figure 384 and Figure 385 depict the statistics the research team was able to obtain from the compiled data.

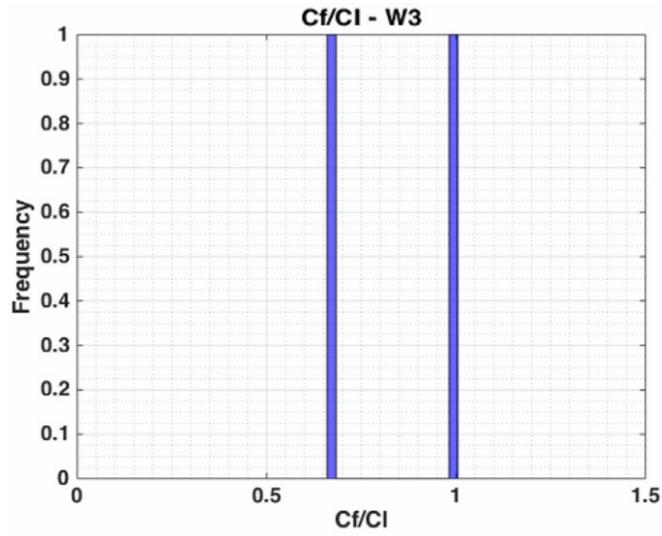
Figure 384: Ratio between flange corrosion length and web corrosion length for W3 pattern – RIDOT

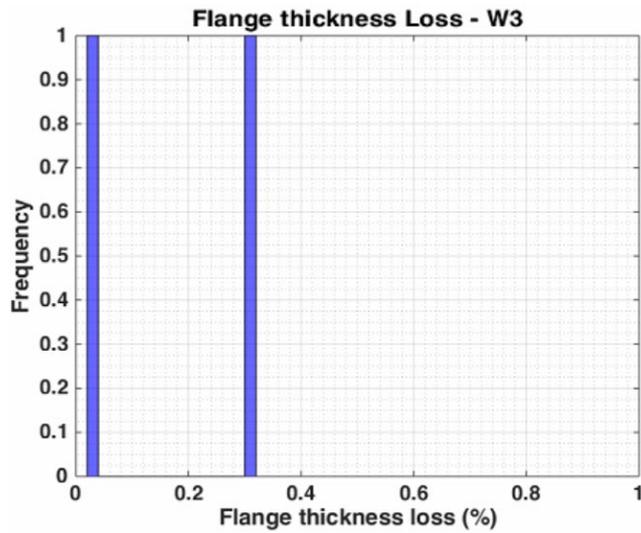
Figure 385: Flange thickness loss distribution for W3 pattern – RIDOT
