**Design, Fabrication and Preliminary Testing of a  
Composite Reinforced Timber Guardrail**

**Prepared for  
The New England Transportation Consortium**

**NETCR39                      March 31, 2004                      Project No. 00-3**

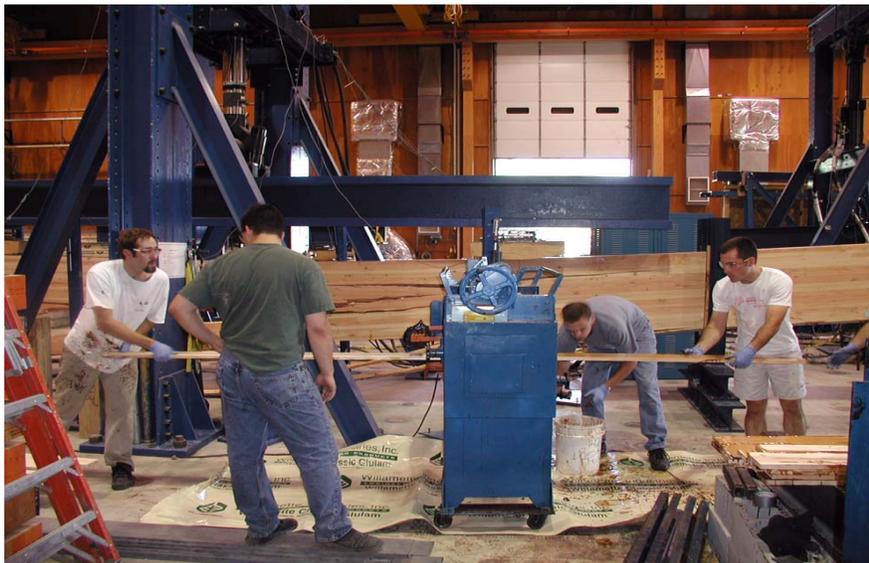
Figure 3.2: Resin Application and Lamination Stacking

Once the boards were finger jointed the next step in the fabrication process was to laminate the boards together. The boards were laminated in the cold clamps in the AEW center. Due to the inconsistency in the thickness of the planed boards, the boards required additional compression to eliminate the slight gaps. The clamping pressure used was approximately 2,760 kPa, which is significantly higher than the pressure required when laminating softwood glulam beams. The resin was applied using a resin applicator in a constant coating of 0.341 kg/m<sup>2</sup>. The laminations were then manually stacked. Figure 3.2 shows boards being fed through the resin applicator.

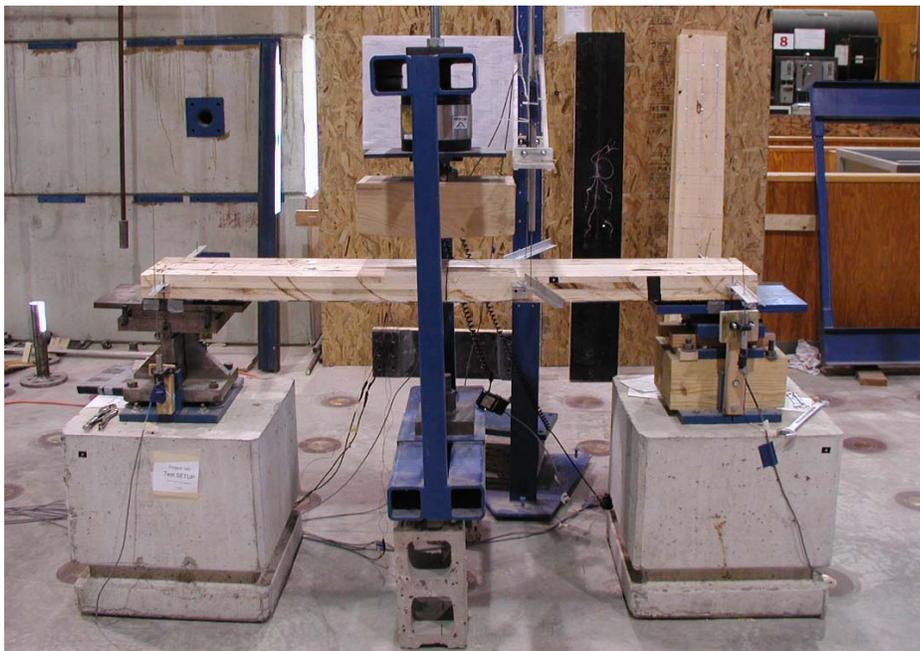
Figure 4.1: Flexural Test Setup

The load was applied at the center of the span by a 500 kN hydraulic actuator mounted below the floor. The actuator was attached to a loading frame above the floor with a section of 36-mm diameter Dywidag bar, and a 100 kN load cell was mounted on the load frame. A radiused hardwood load head with a pivot was attached to the 100 kN load cell. A rubber pad was placed between the load head and the specimen to raise the load head above the specimen and ensure that the point of load application remained at mid-span even under large deflections of the specimen. The test setup is shown in Figure 4.1.

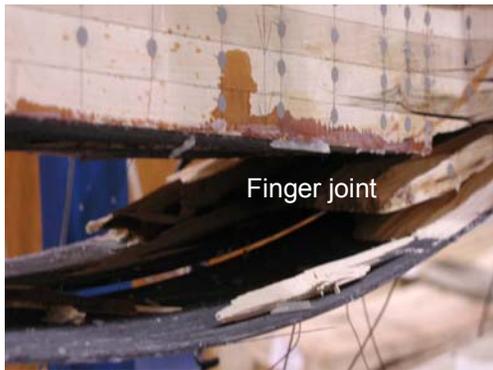
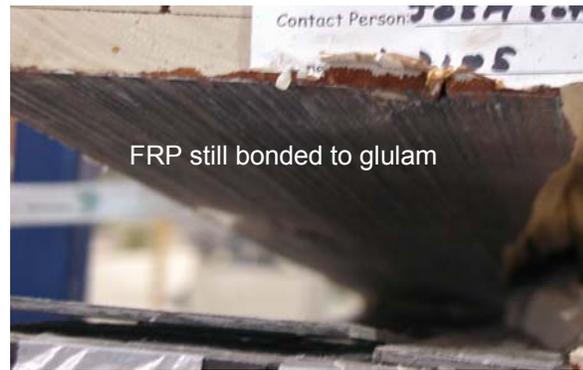
(a) Failure of B1

(b) FRP Delamination in B2

(c) Failure of B2

Figure 4.6: Flexural Failure Modes

In both specimens, the tensile laminations of the reinforced glulam failed, causing delamination of the FRP from the glulam. However, the delamination did not occur in the FPL-1 epoxy bondline, but was an inter-laminar shear failure in the FRP. The tensile lamination in specimen B1 failed at a finger joint approximately 75mm off center, while specimen B2 exhibited tensile failures over a larger portion of the glulam as shown in Figure 4.6(c).

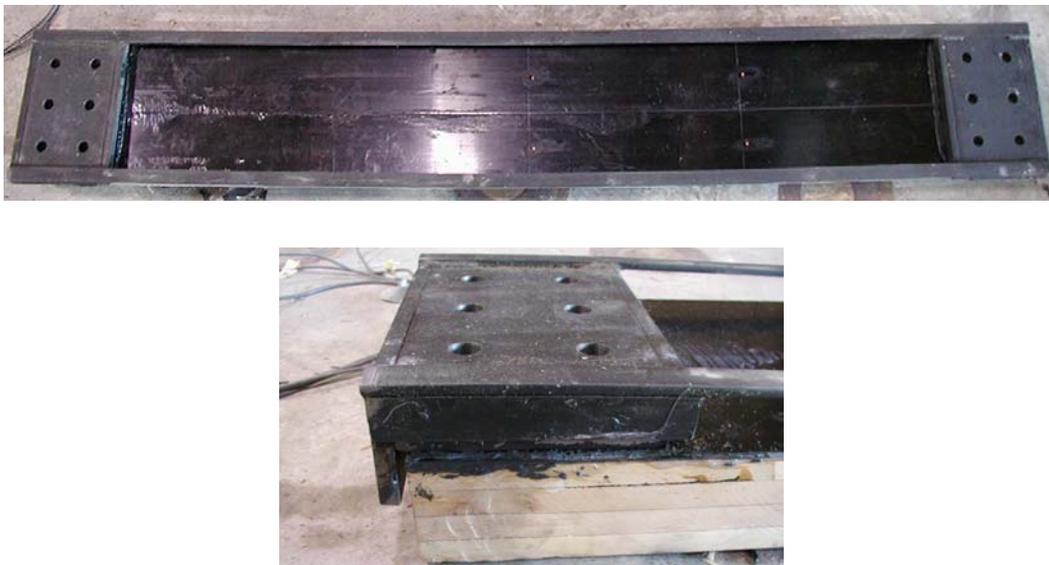
Figure 6.3 Alignment Fixture

The specimens were fabricated by first grit blasting the steel, then placing 162 g of epoxy on the bonded steel connection plates, as described previously in Section 5, and placing the bonded steel connection plates into the fixture. Next, the reinforced glulam was placed on top of the epoxy-covered bonded steel connection plates in the fixture. Then approximately 21 kPa of pressure was applied to the reinforced glulam as it was moved to remove air from the bond line and squeeze out excess epoxy. Finally, the reinforced glulam was aligned on the fixture and left to cure for three days. There was excess epoxy squeezed out on all of the specimens fabricated, and as described later in this section, none of the specimens failed due to poor bond quality. The alignment fixture with a glulam and bonded steel splice plates in place is shown in Figure 6.3.

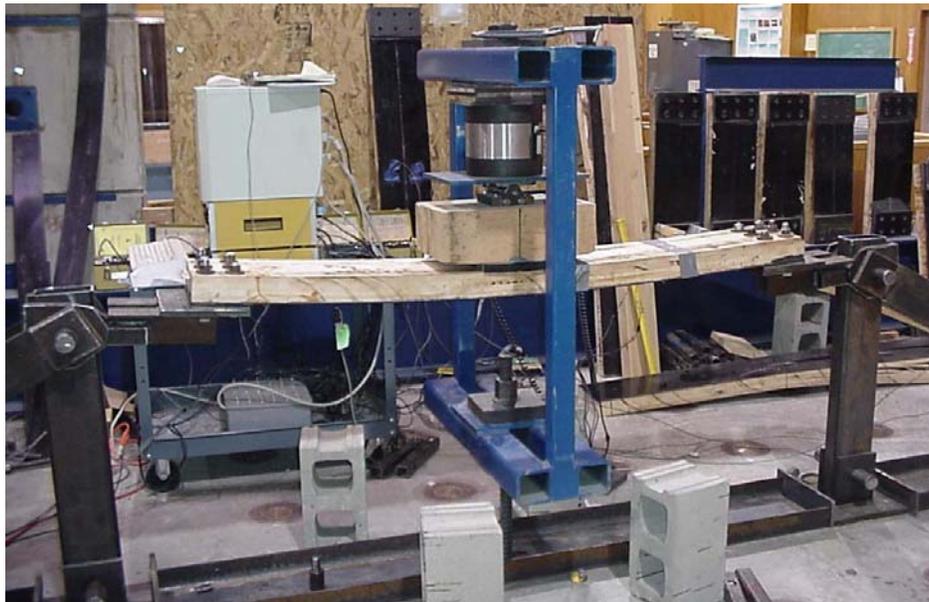
Figure 6.4 Bending-Tension Test Rig

The specimens were loaded with a 500 kN actuator mounted beneath the floor. The actuator was connected to a reaction frame on which a 250 kN load cell was mounted with a radiused wooded load head attached to the load cell. The load head rested on a 25mm thick rubber pad placed on the beam to distribute the load. The complete setup is shown in Figure 6.4:

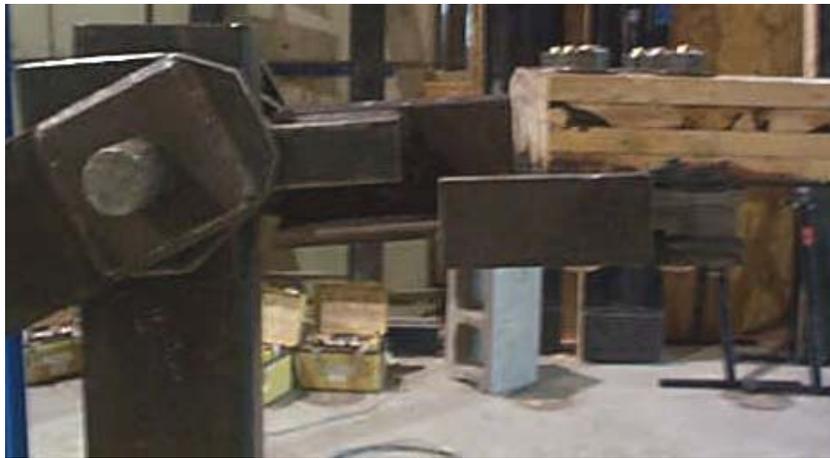
Figure 6.11 Yielded Connection

The third combined bending-tension test was performed on specimen BT3. Due to the yielding in the bolted connection that occurred during the testing of specimen BT2, additional shimming was needed in the system to remove gaps prior to loading specimen BT3. The effects of the yielding on the connection can be seen in Figure 6.11.
