**In-Place Response Mechanisms of Recycled Layers Due to
Temperature and Moisture Variations**

Prepared for
The New England Transportation Consortium
November, 2016

NETCR96

Project No. 07-1

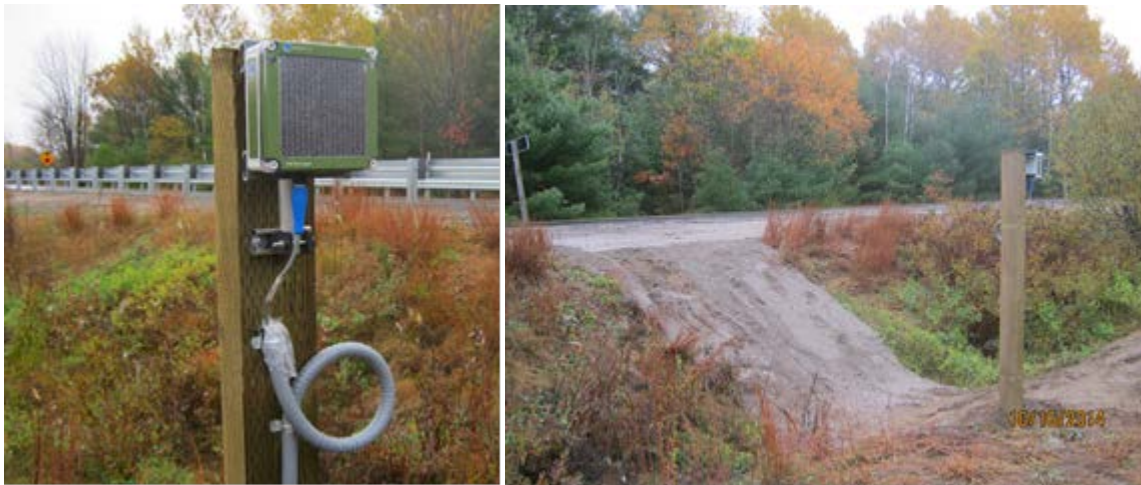
Figure 2. Auburn ME Data Logger Location

The Auburn, ME site is located on Rt 122 just east of the I-95 bridge, as shown in Figure 1. The instrumentation borehole is located in the eastbound lane and the data logger is located on a wooden post at the edge of the DOT maintenance shed area (Figure 2). Construction of this section was done in August of 2014 and consists of 3" of HMA over 6" of treated FDR and thermistors were installed to a depth of 80" (Figure 3); example data is shown in Figure 4.

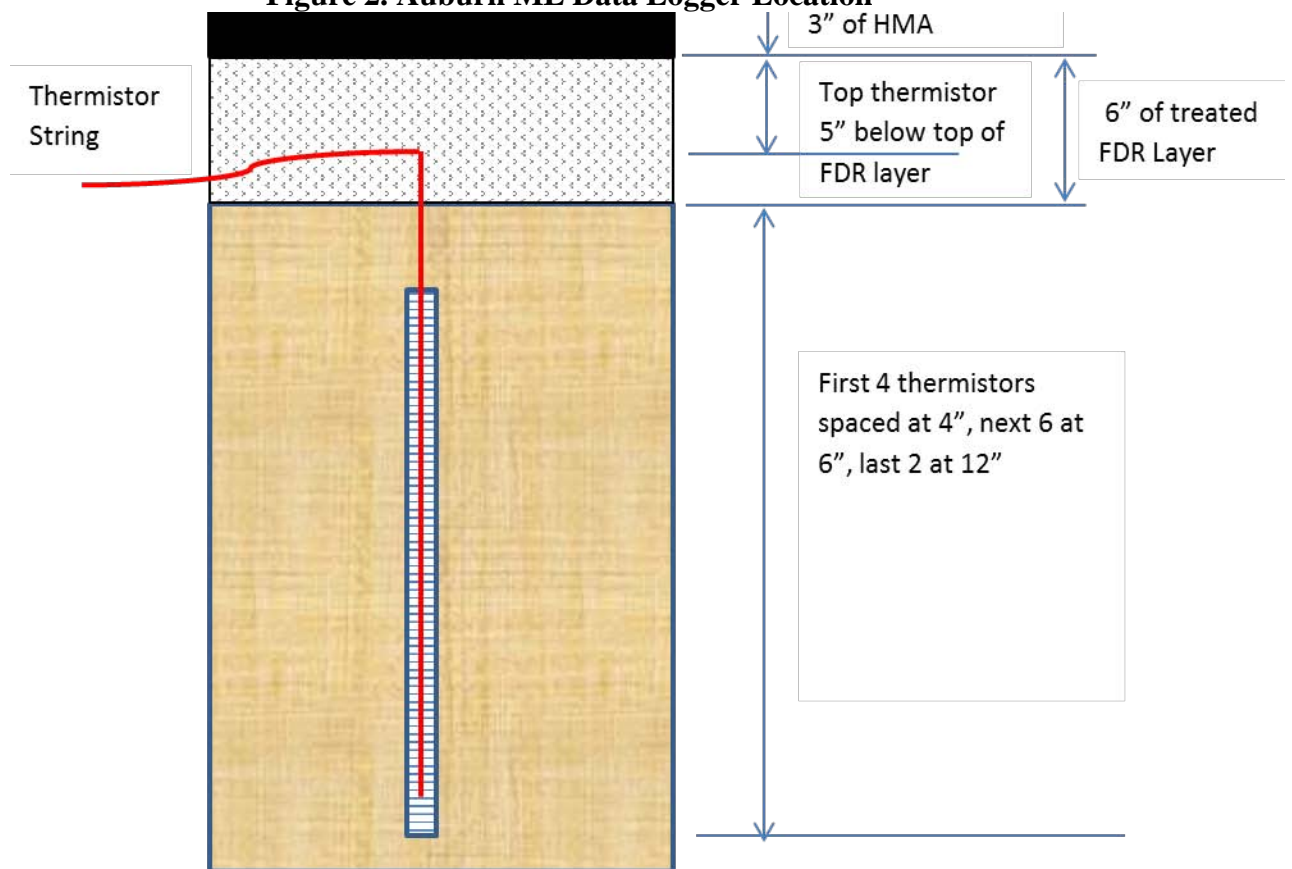
Figure 3. Auburn ME Instrumentation Cross-Section (not to scale)

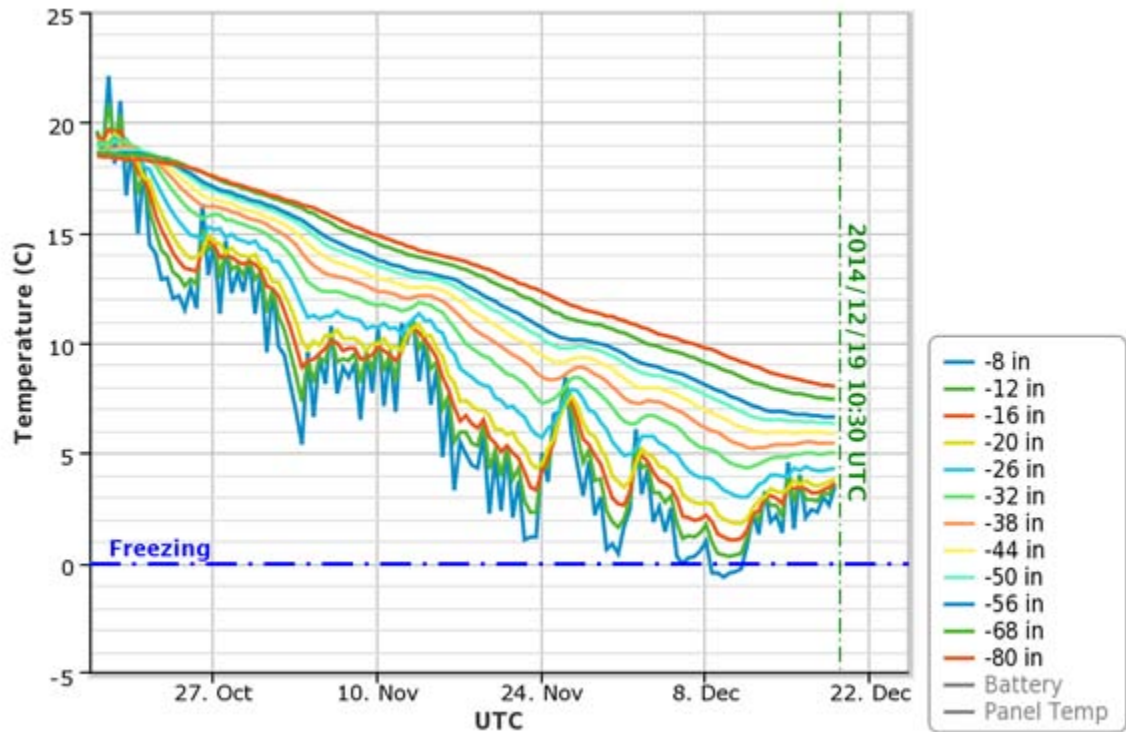
Figure 4. Temperature data collected from Auburn ME site in Fall 2014

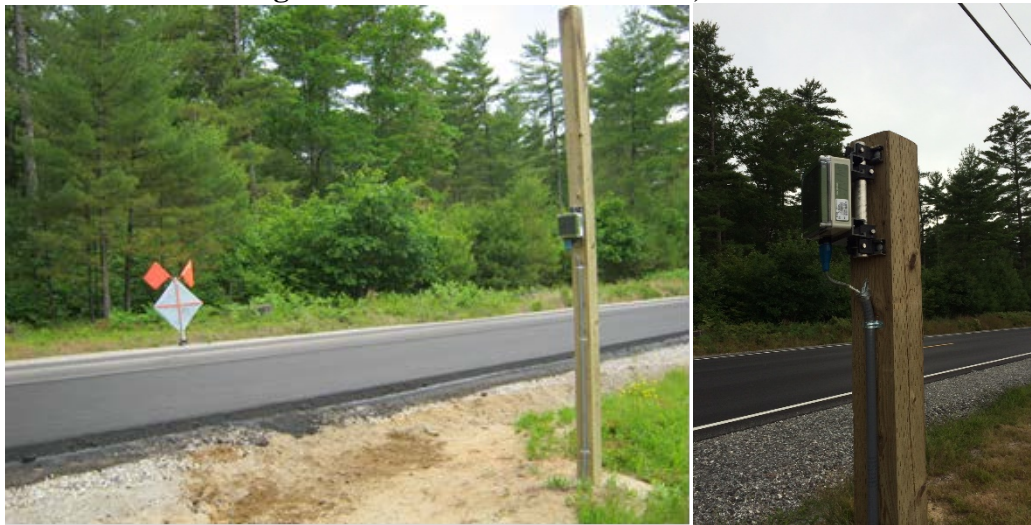
Figure 6. Waterford Instrumentation Site during PM RAP installation (left) and final (right)

The PMRAP was processed to minus ¾" size and then added to a portable pugmill with cement and emulsion in a cold mixing process. The material was placed in one lift to grade and cross slope using a paver and compacted. As a minimum, a 10 ton dual drum vibratory or oscillatory roller, 16 ton pneumatic roller, and 10 ton final roller were required and the density met 96% of control strip TMD for acceptance.

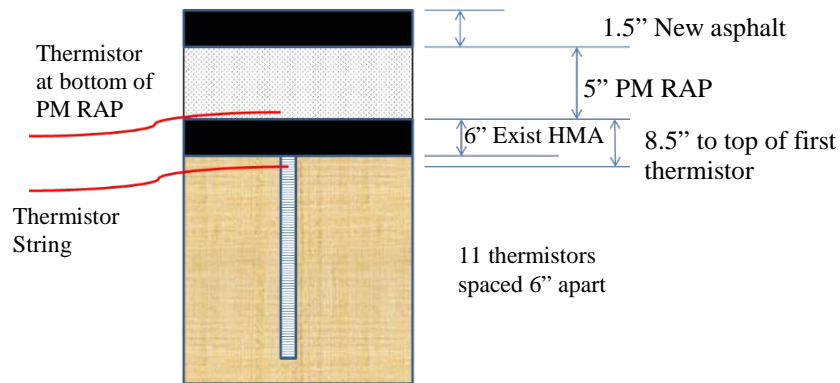
Figure 7. Waterford ME Instrumentation Cross-Section (not to scale)

The Waterford, ME site is located on Rt 118 (Figure 5). The instrumentation borehole is located in the westbound lane and the data logger is located on a wooden post near the edge of the baseball field. Figure 6 below shows the data logger during the installation of the PM RAP layer and after final paving. The instrumentation of the lower layers in this section was done in May of 2014 and the thermistor for the PM RAP layer was installed in June 2014. A schematic (not to scale) of the cross section for this site is shown in Figure 7. The site consists of 5" of plant-mixed RAP over the existing 6" of HMA and then topped with 1.5" of new HMA. There are 12 thermistors installed in the pavement section; the first thermistor is located at the bottom of the PM RAP layer, approximately 6.5" below the final pavement surface. The lower thermistor string consists of 11 thermistors located 6" apart, with the top thermistor located approximately 15" below the pavement surface. A sample of data collected from the Waterford site is shown in Figure 8.

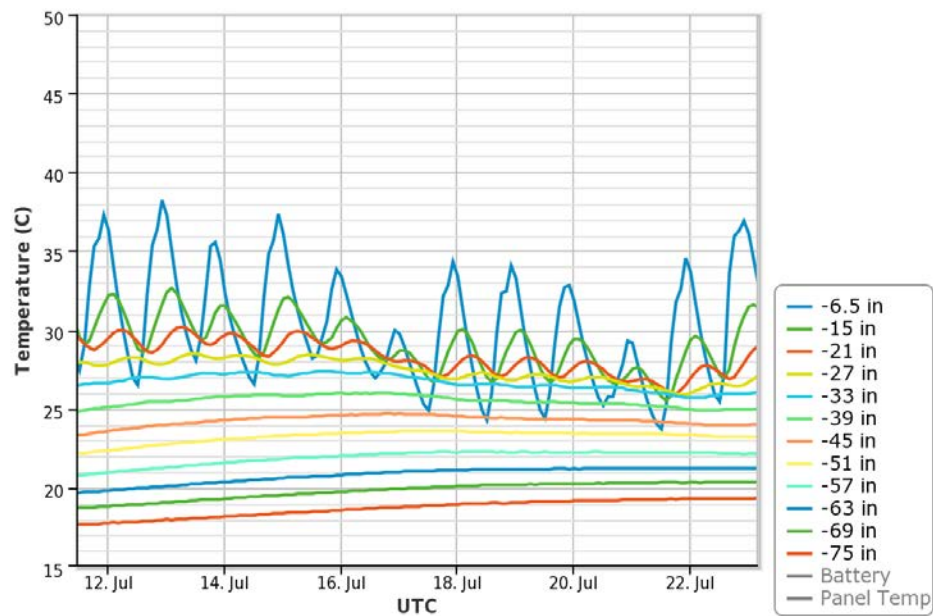
Figure 8. Temperature data collected from Waterford instrumentation site in July 2014

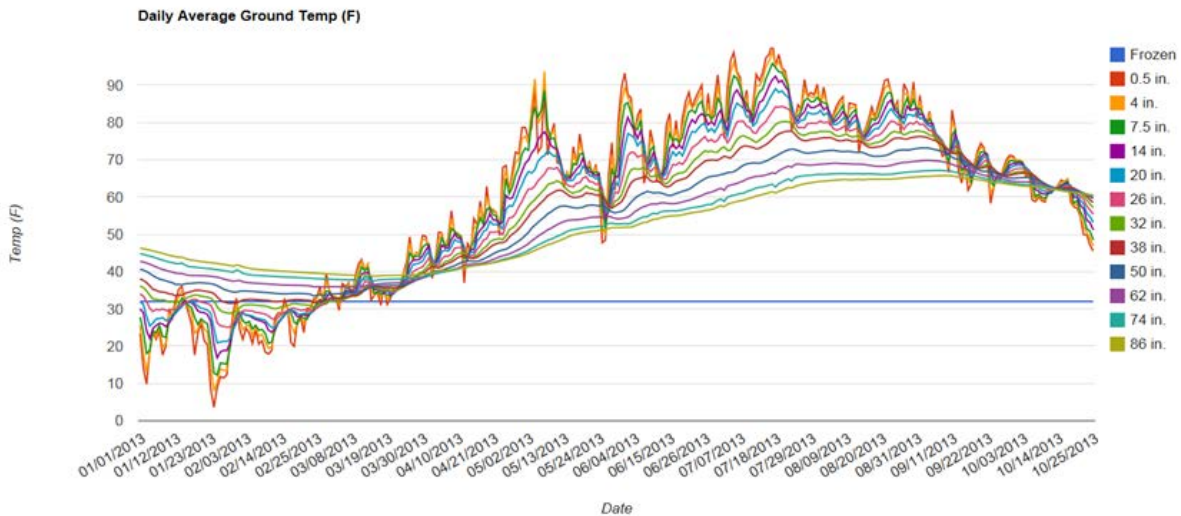
Figure 11. Temperature data collected from Warren Flats instrumentation site in 2013

A series of 12 thermistors (Yellow Springs Instrument, Inc. model 44007) are imbedded in the pavement; the deepest 4 sensors were placed at a spacing of 12 inches, and the remaining 5 were placed at a spacing of 6 inches. Additionally, thermistors are placed at the pavement surface, bottom of pavement, and within the granular base course. Example temperature data collected at this site is shown in Figure 11.

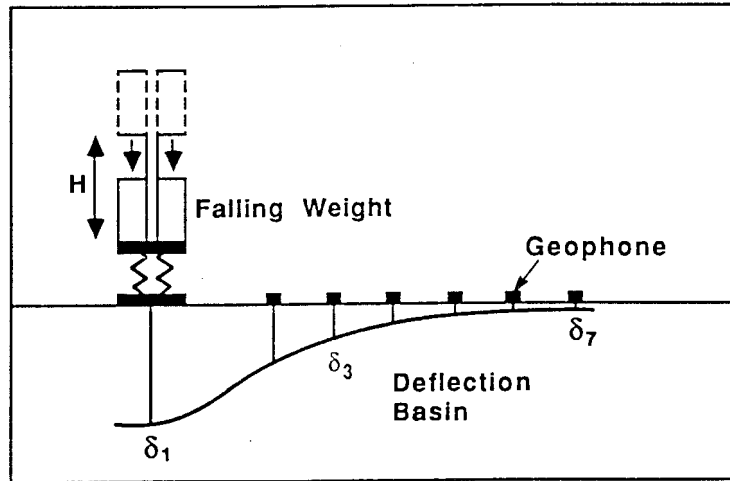
Figure 14. Schematic of Falling Weight Deflectometer

In FWD testing, an impulse load is generated by dropping weight from different heights. Loads from 6.7 kN to 120 kN can be generated. The load is generated by a mass falling onto a base plate through a set of rubber buffers, as shown in Figure 14. The base plate is fitted with a load cell for measurement of applied force. The pavement deflection, in response to the applied load, is measured by processing the signals from geophones, placed at different places including at the center of the plate and pavement surface.

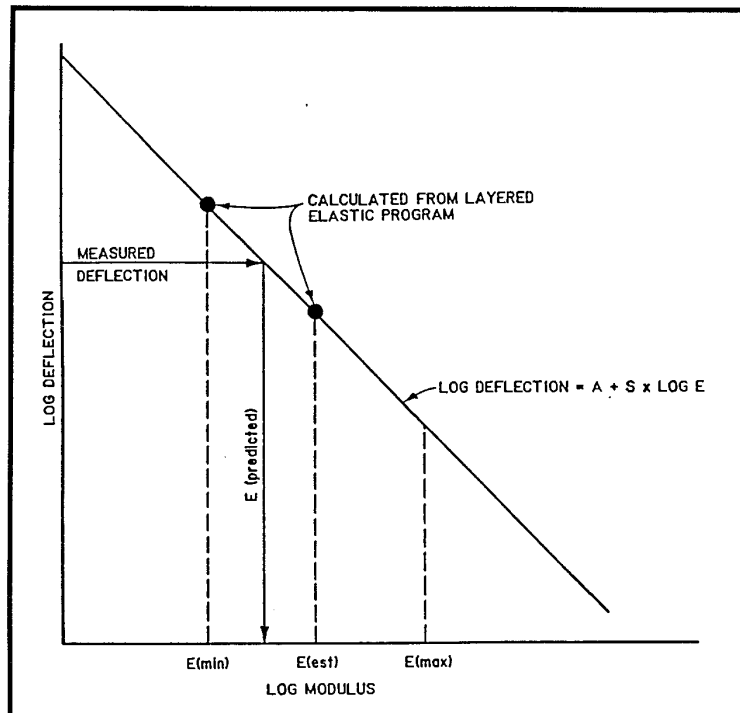
Figure 15. Backcalculation Process

Using pavement layer thickness and Poisson's ratio (which should be known), and a set of "seed" moduli for the different layers, "back calculation" analysis is done to arrive at a set of estimated moduli. The backcalculation process involves adjustment of the moduli values until a set of moduli is found such that the predicted deflection basin is approximately identical to the measured deflection basin (within tolerances). An example of the backcalculation process is illustrated in Figure 15.

An initial set of layer moduli with minimum and maximum values are assumed. The process starts by varying the modulus of each layer and computing the deflection (as shown in Figure 15 for one deflection point and one layer). For multiple deflections and layers, the process consist of solving a set of equations with slope and intercept for each deflection and each layer modulus:

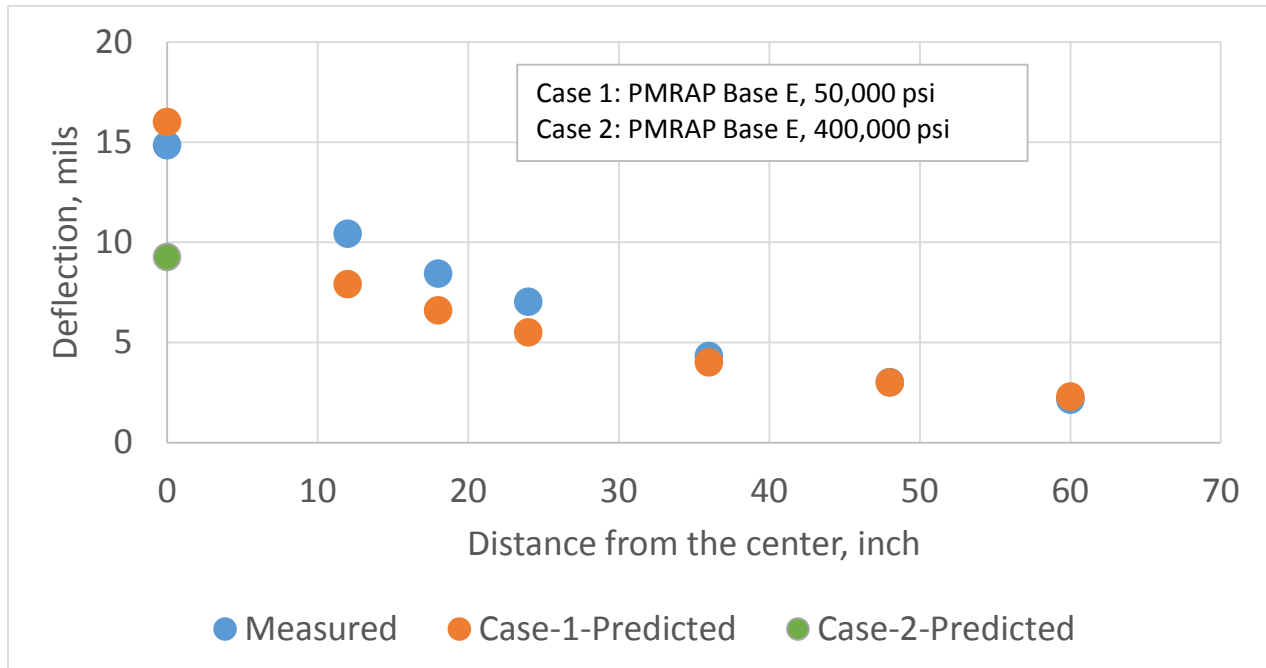
Figure 16. Comparison of predicted and actual deflections at different sensor locations for backcalcul values of the base layer (Auburn, ME)

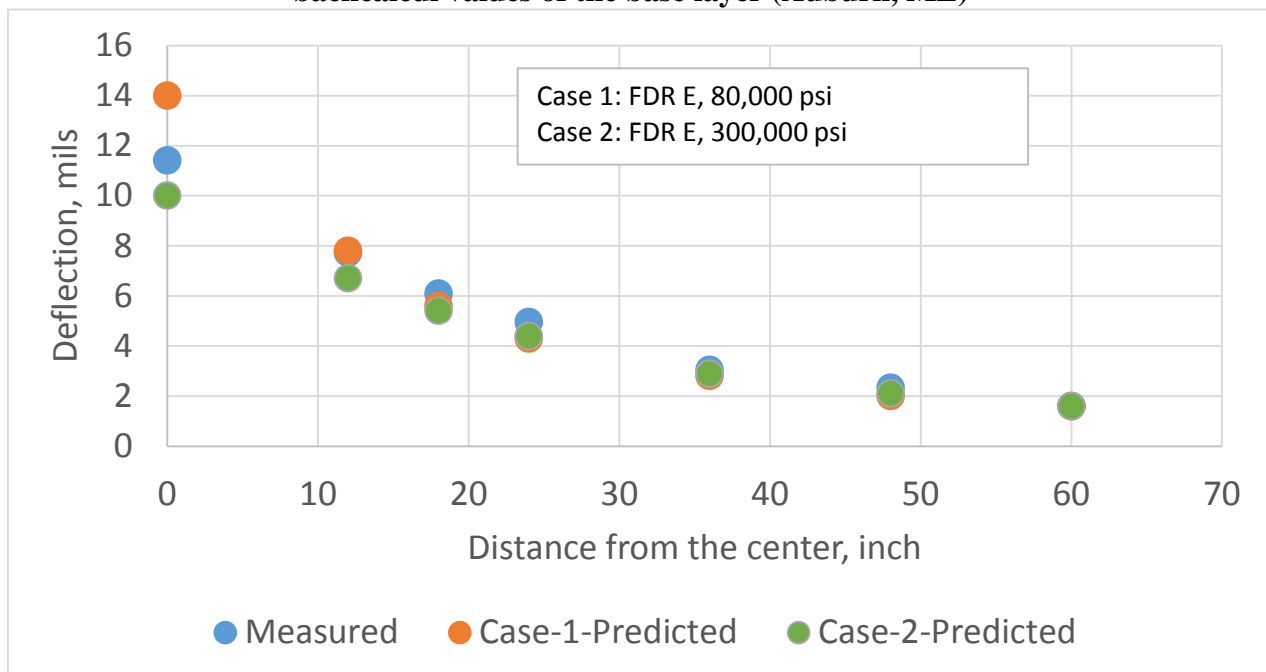
Figure 17. Comparison of predicted and actual deflections at different sensor locations for backcalculated values of the base layer (Waterford, ME)

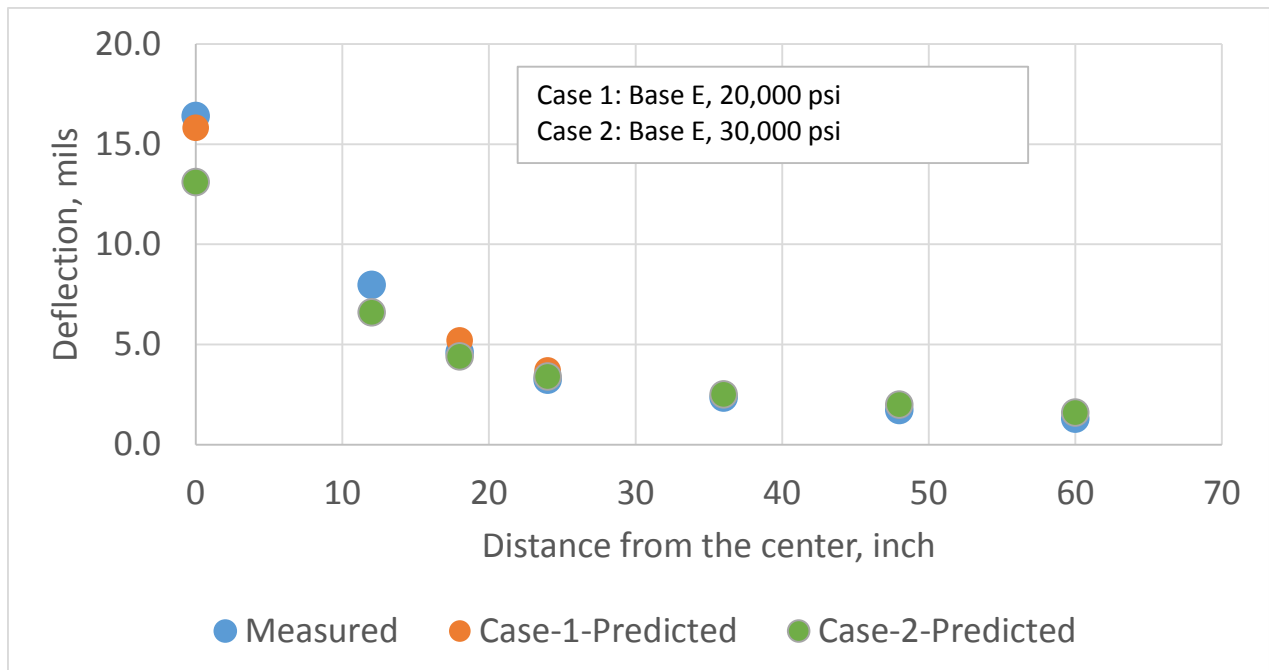
Figure 18. Comparison of predicted and actual deflections at different sensor locations for backcalculated values of the base layer (Warren Flats, NH)

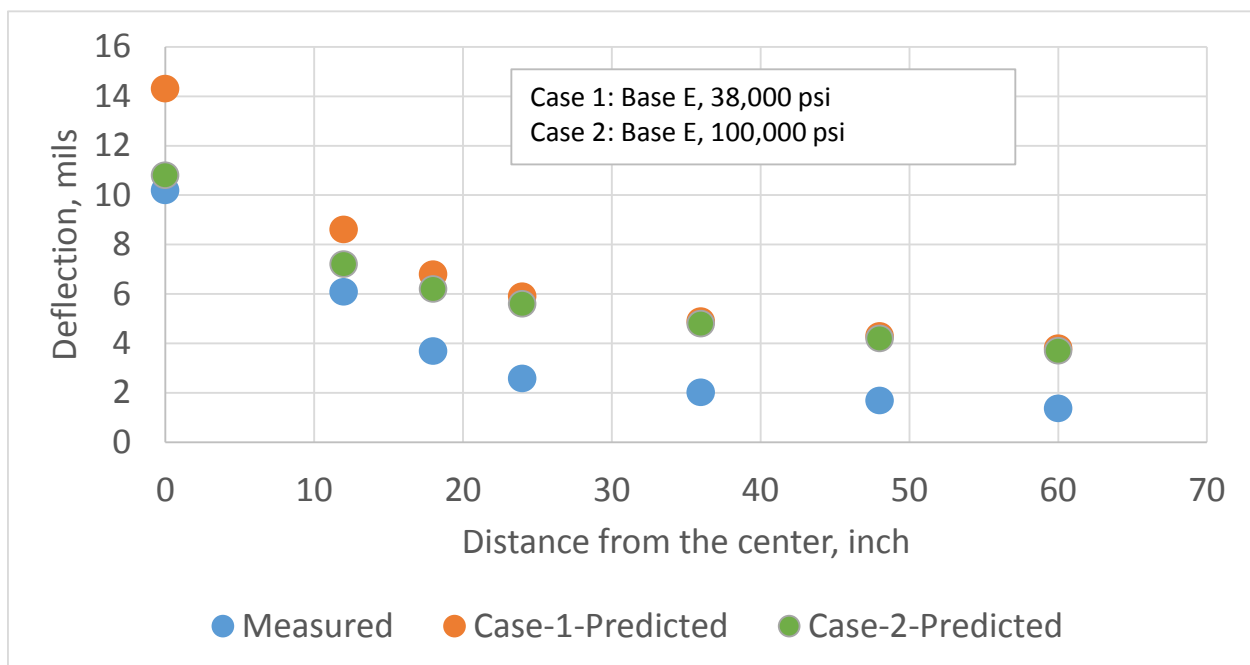
Figure 19. Comparison of predicted and actual deflections at different sensor locations for backcalculated values of the base layer (Kancamagus 1)

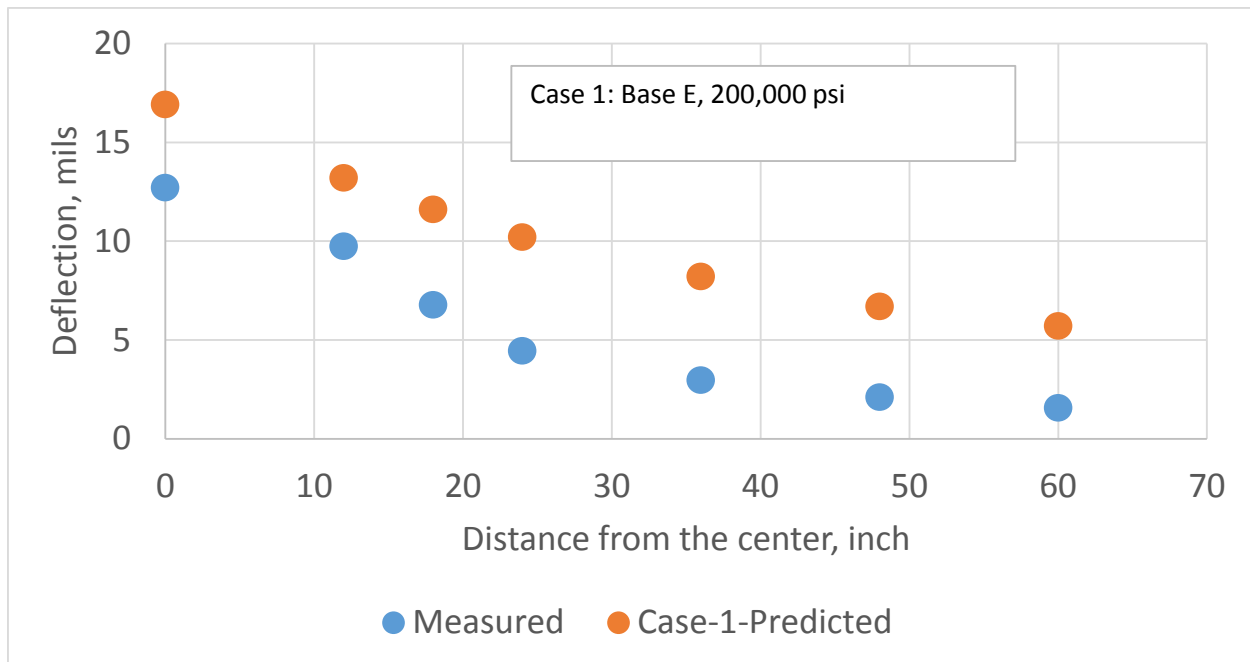
Figure 20. Comparison of predicted and actual deflections at different sensor locations for backcalculated values of the base layer (Kancamagus 2)

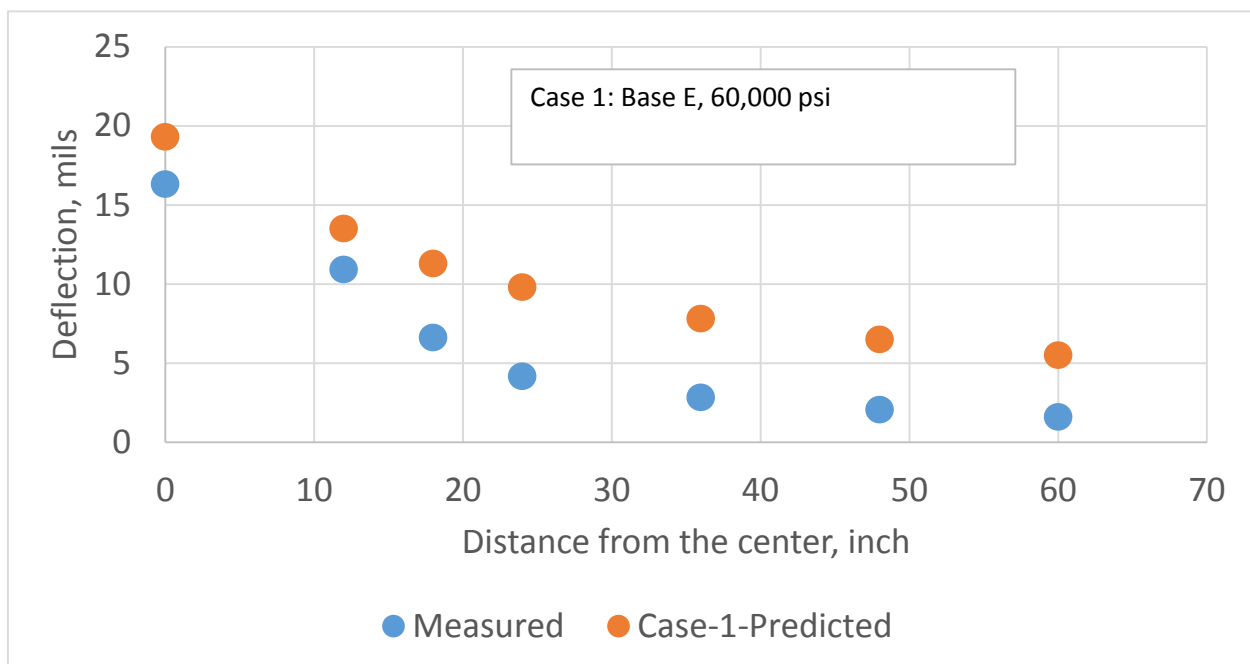
Figure 21. Comparison of predicted and actual deflections at different sensor locations for backcalculated values of the base layer (Kancamagus 3)

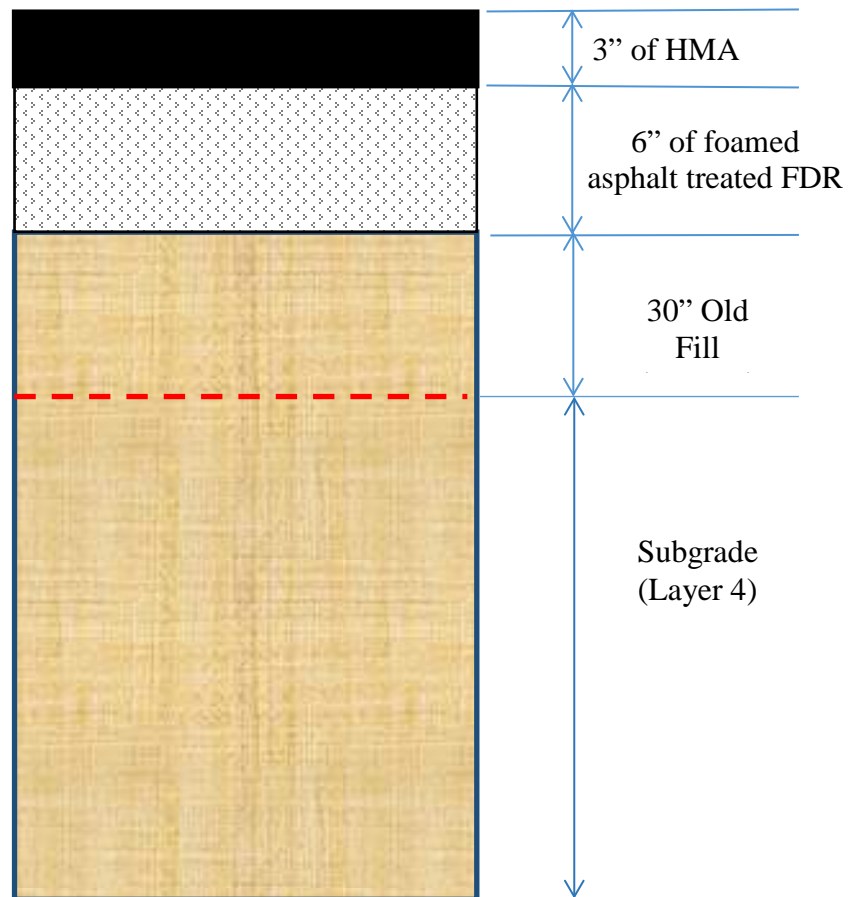
Figure 22. Assumed Cross-Section for Site at Auburn, ME

Stiff Layer Not Assumed in This Analysis

As shown in Figure 22 through Figure 26, a “stiff layer” was assumed at all sites except for Auburn, Maine. As discussed in the “*EVERSERIES User's Guide*” (4), backcalculation procedures can often result in erroneously high modulus values for base and subgrade layers when a stiff layer is not assumed as the lower (infinite thickness) layer. In that guide, they recommend using a stiff layer modulus value of about 100,000 psi when the stiff layer is due to a dense glacial till or bedrock, and a value of about 50,000 psi when the stiff layer is due to a groundwater table. At the NH sites, periodic measurements of groundwater levels had been

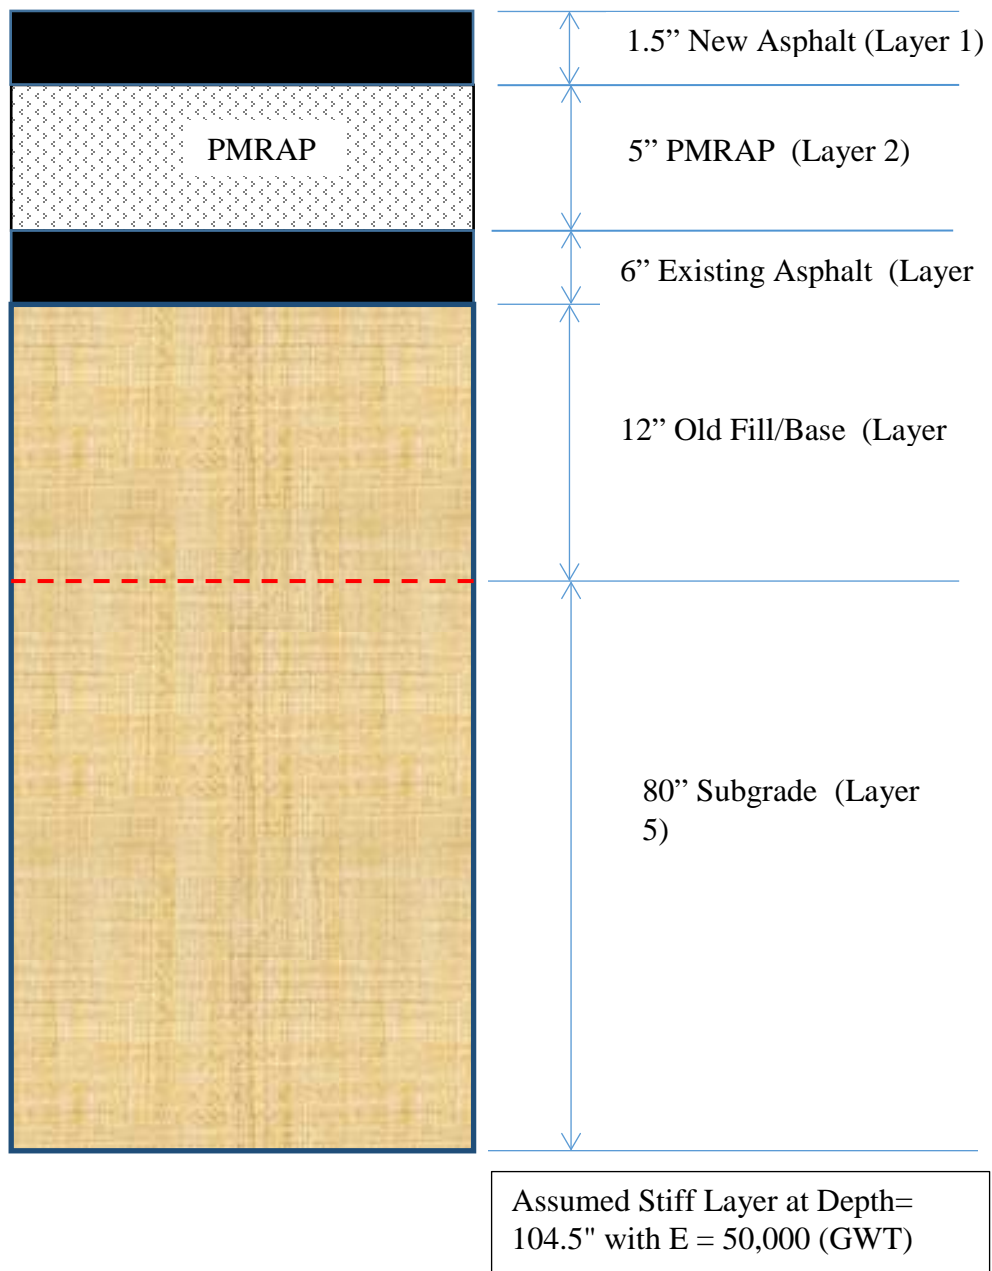
Figure 23. Assumed Cross-Section for Site at Waterford, Maine

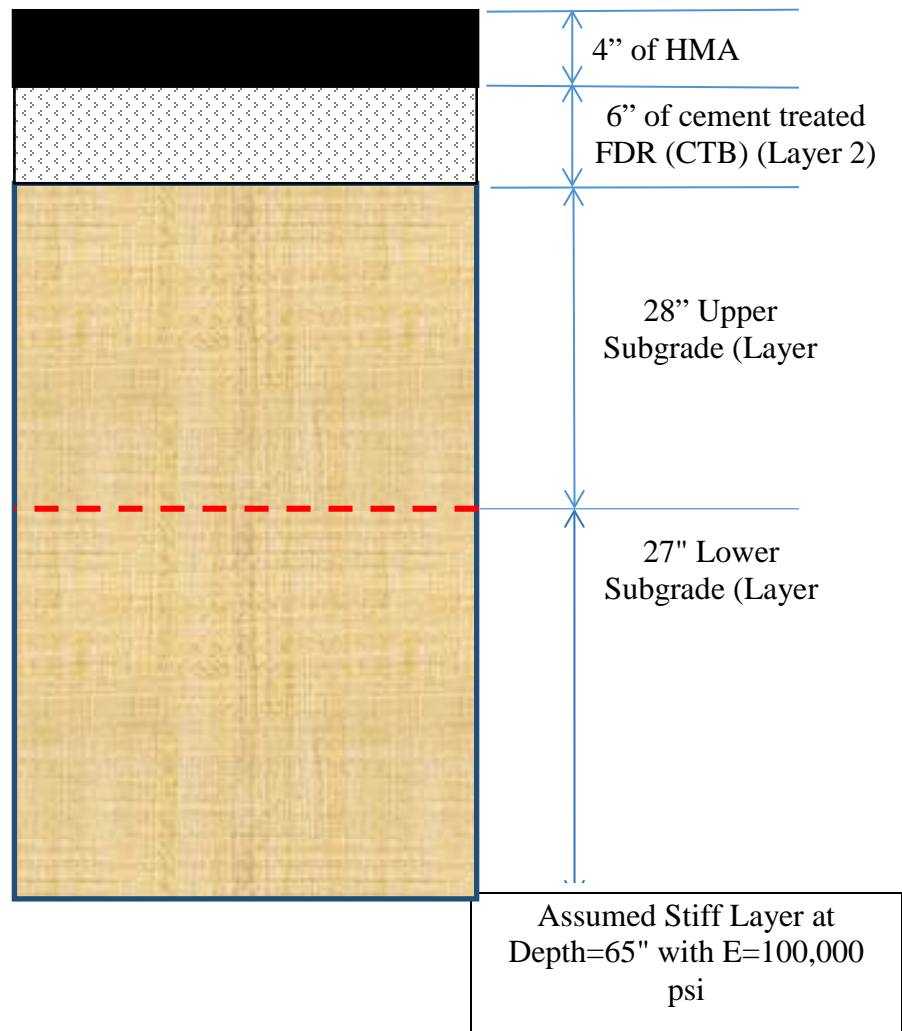
Figure 24. Assumed Cross-Section for Site at Kanc 2, NH

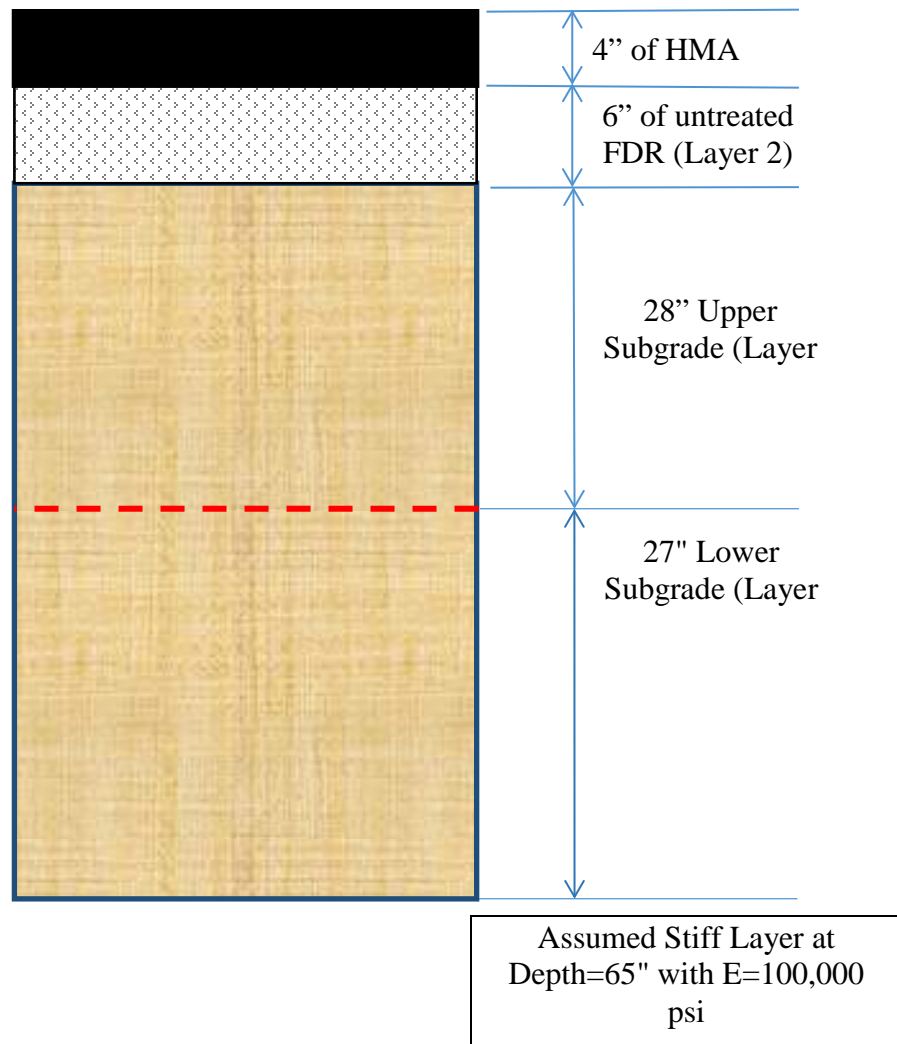
Figure 25. Assumed Cross-Section for Site at Kanc 3, NH

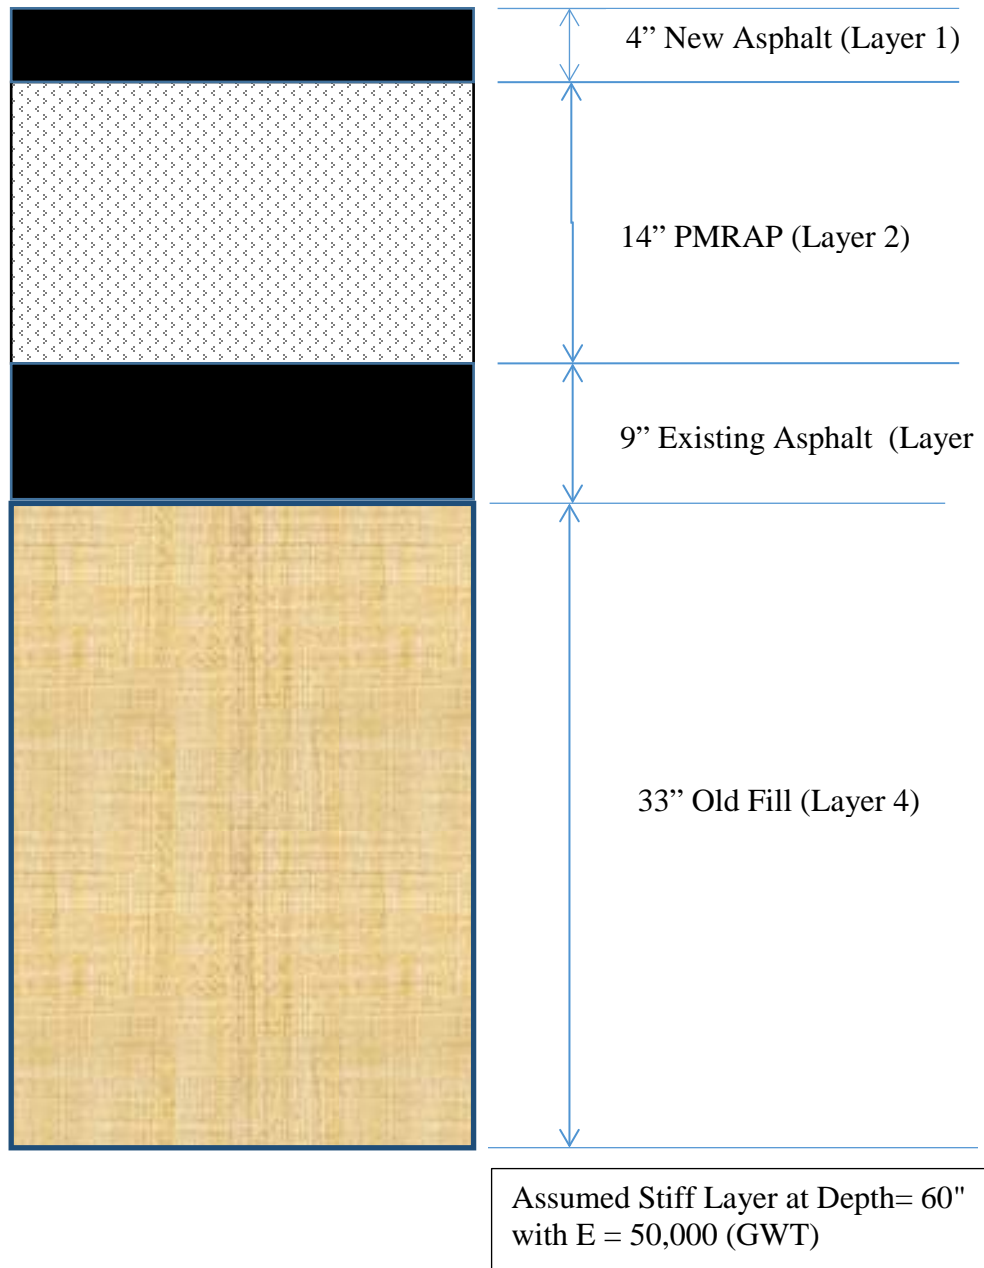
Figure 26. Assumed Cross-Section for Site at Warren Flats, NH

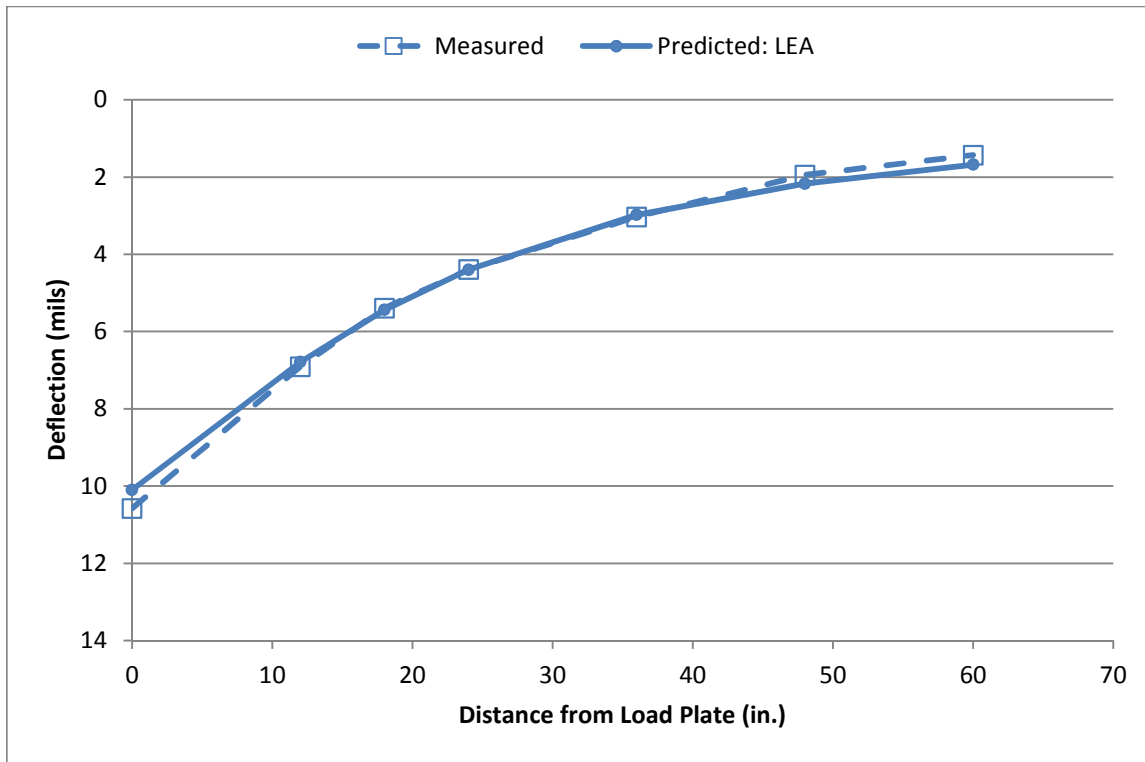
Auburn, ME

10/15/14 Baseline (after Re-construction)

Subgrade $E = 25,000$ psi

The figures in this appendix show the measured FWD deflections at each sensor location along with the deflections predicted using the WinJULEA software with the given layer properties. These figures support the forward calculation summary presented in section 3.2.

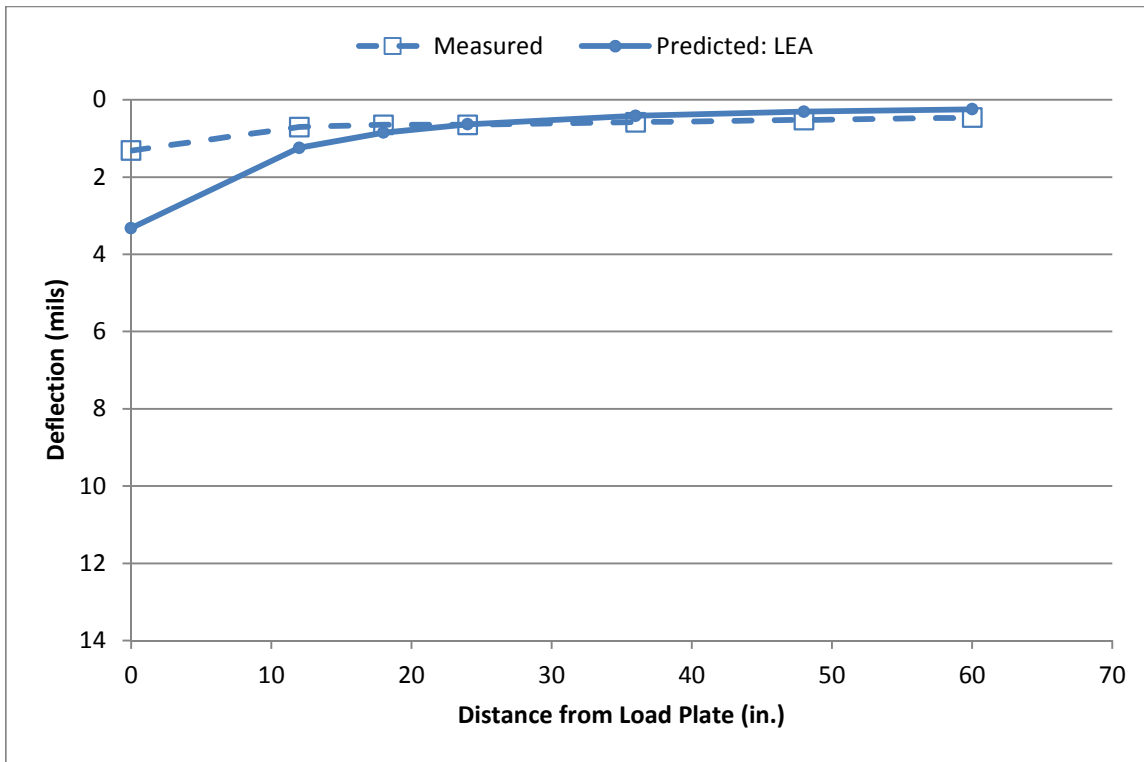
Auburn, ME

03/03/15 Frozen

Subgrade E = 169,500 psi

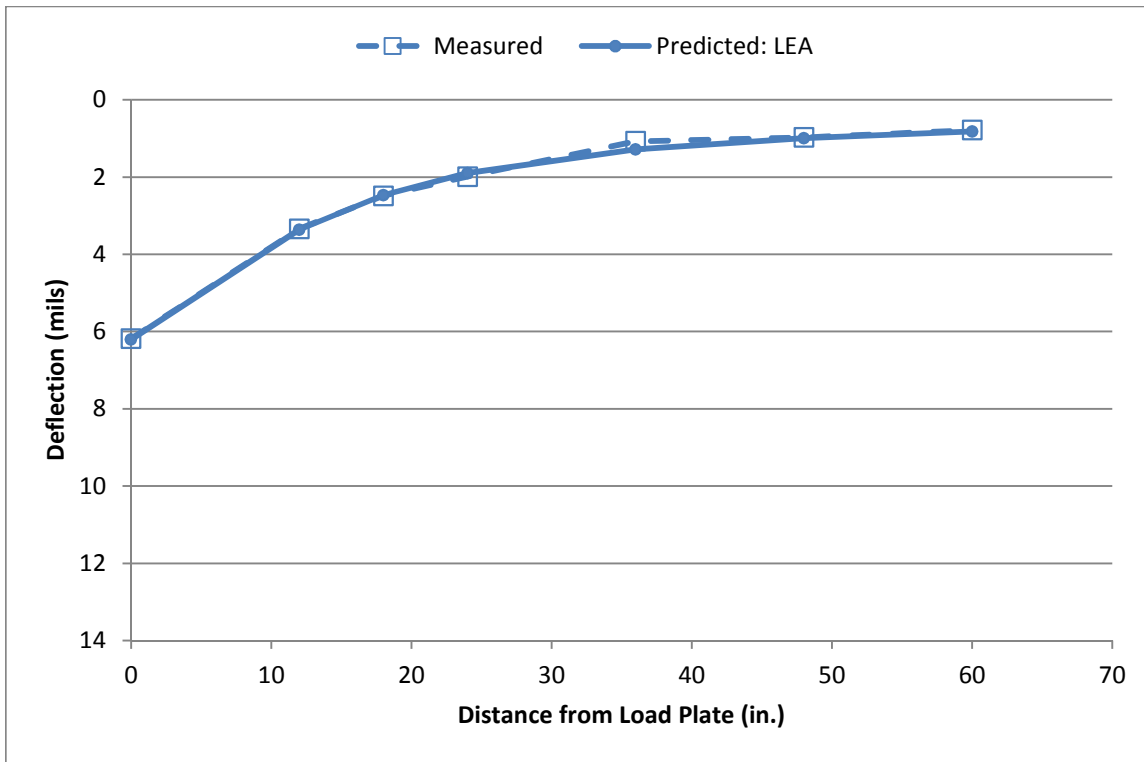
Auburn, ME

03/11/15 Thawed to about 13"

E = 50,000 psi

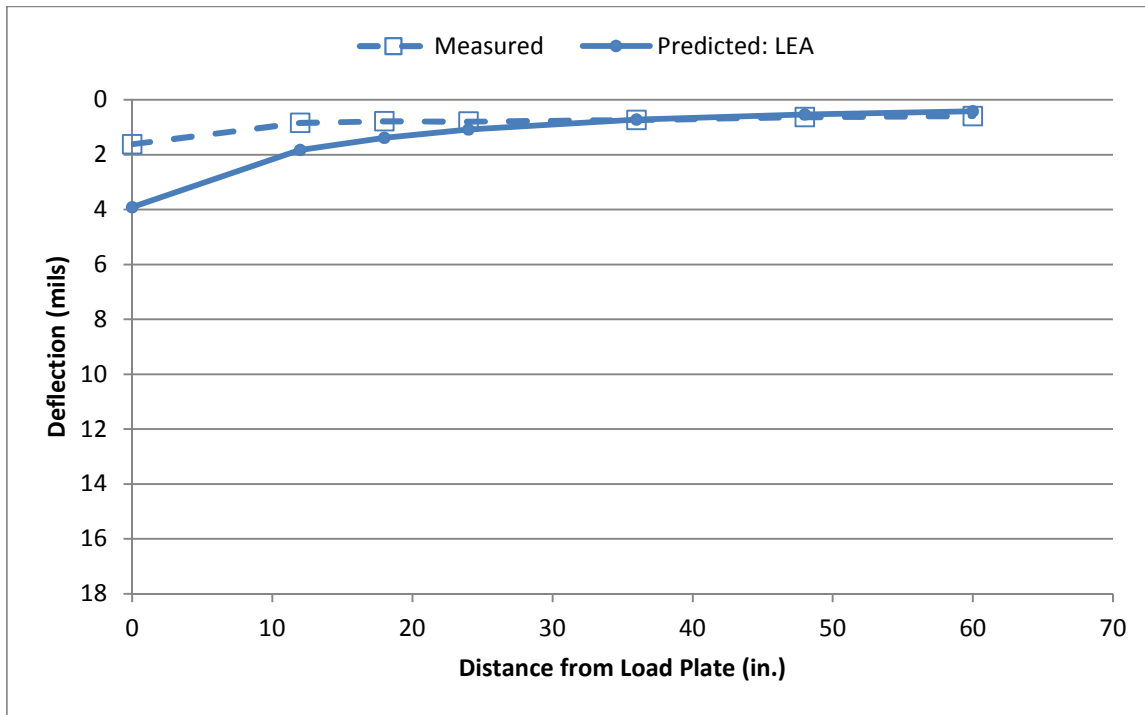
Waterford, ME 03/03/15 All layers Frozen

1.5" HMA E = 500,000 psi

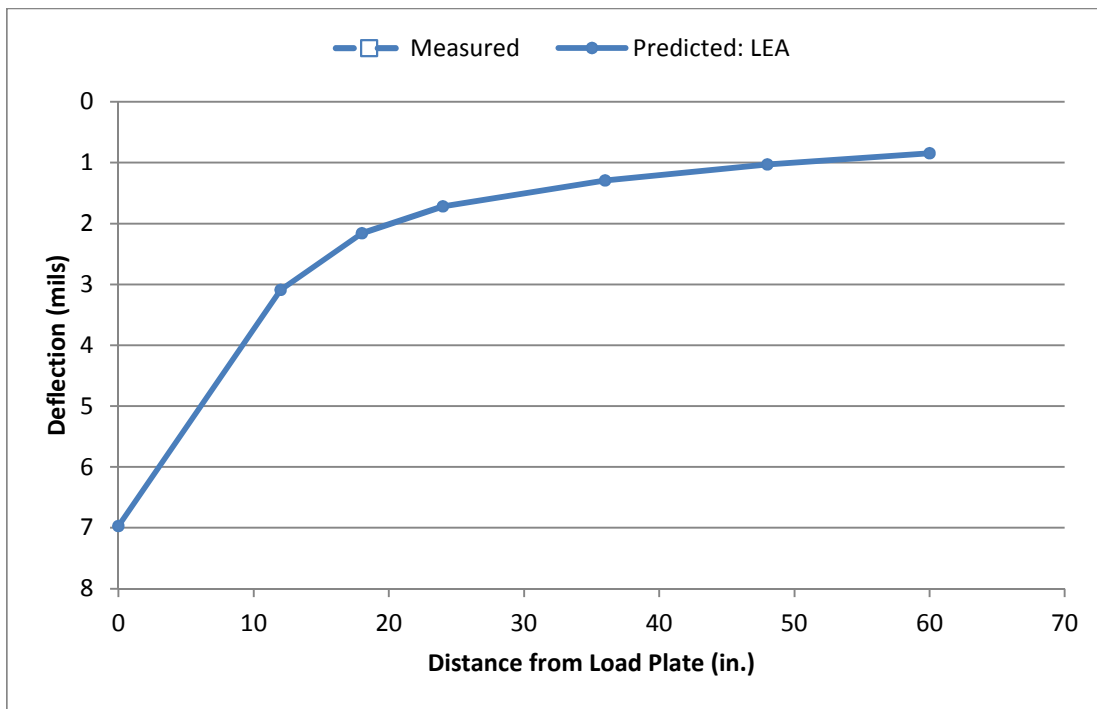
Warren Flats, NH 03/16/15 Frozen (all layers) **after** thaw & then re-freeze in PMRAP layer

4" HMA E = 500,000 psi

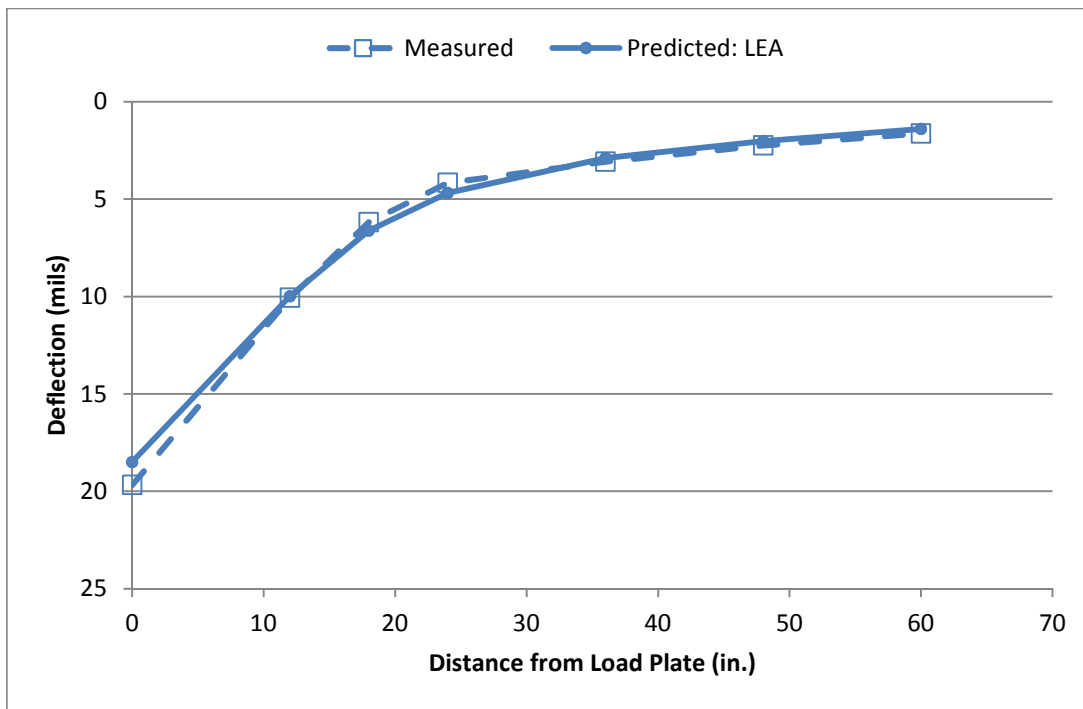
Warren Flats, NH 04/23/15 All layers thawed (weakest condition)

4" HMA E = 500,000 psi
